**An Archaeological Evaluation at Kensington Palace, Royal Borough of
Kensington and Chelsea**

Site Code: KP09 (temp)

Written by Stuart Watson

Pre-Construct Archaeology Limited, April 2009

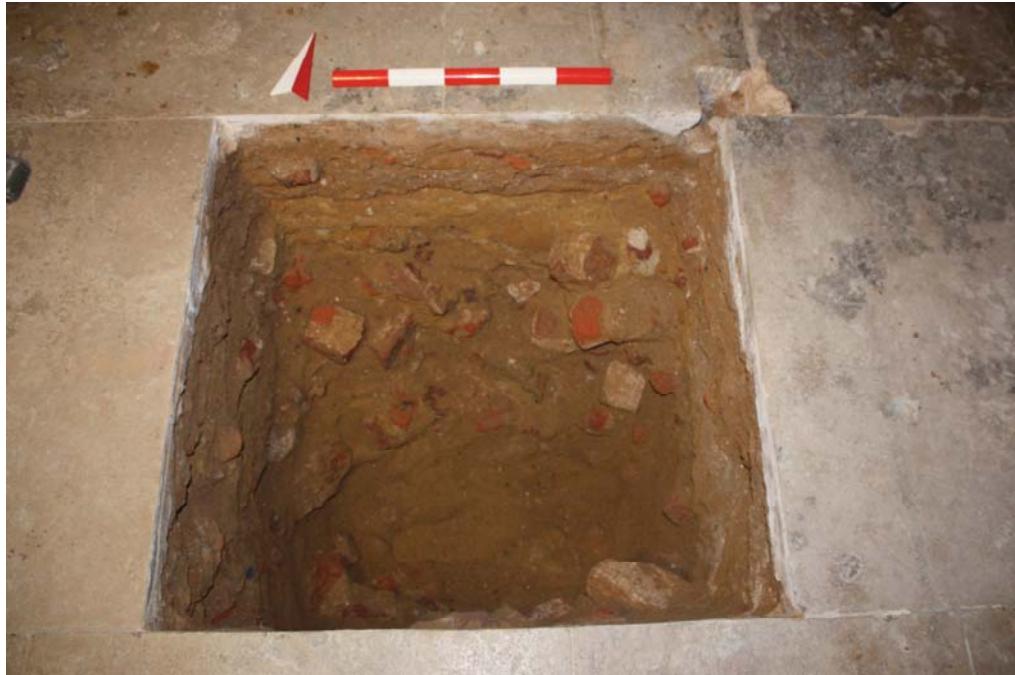
North Facing Shot of Test Pit 2

- 7.2.1. Test Pit 2 was located internally within Kensington Palace in the centre of Stone Hall, room GF083A, and was excavated to a maximum depth of approximately 0.92m below ground level at 22.58mOD.

- 7.2.2. The earliest feature encountered was a layer of dumped brick material [8] that formed the majority of the Test Pit's fill. Initially it was thought that an earlier remnant of wall existed *in-situ* below this mass (given context [7], but since voided) as it survived as a short intact section. However, further investigation indicated that it was not *in-situ* and thus constituted part of [8]. The fabric analysis and date range of the brick samples taken from this layer include Post-Great Fire 3034 machine made frogged brick dated to 1850-1900, transitional 3039 red stock brick and red 3033 brick both dated to 1450-1700. The later dates suggest this is a 19th century deposit and is interpreted as a layer of dumped material for ground make up and consolidation. The highest level for this deposit was at 23.15m OD and continued down beyond the trench base limit of excavation to 22.57mOD.

- 7.2.3. Within the centre of [8] and partly overlying it, was layer [11]. This was a mid yellow brown sandy silt deposit with moderate fragments of Ceramic Building Material (CBM). A fragment of clay tobacco pipe stem recovered from this layer was spot dated to the 19th century. This layer was 0.48m thick with a level at the top of 23.00mOD, and is interpreted as 19th century dump layer associated with layer [8].

- 7.2.4. Above layer [11] was layer [10], a thin (0.10m thick) layer of mixed green grey and mid yellow sand which was interpreted as re-deposited natural, and is similar to layers [24] in Trench 9 and [34] in TP 5 (Figure 6). The top of this layer was recorded at 23.10mOD.

- 7.2.5. This in turn was sealed by layer [9], a 0.35m thick deposit of loosely compacted mid brown sandy silt with frequent inclusions of fragments of CBM. The top level was recorded at 23.45mOD and formed the sub-strata to the limestone slabs above which was the current ground level at 23.50mOD.

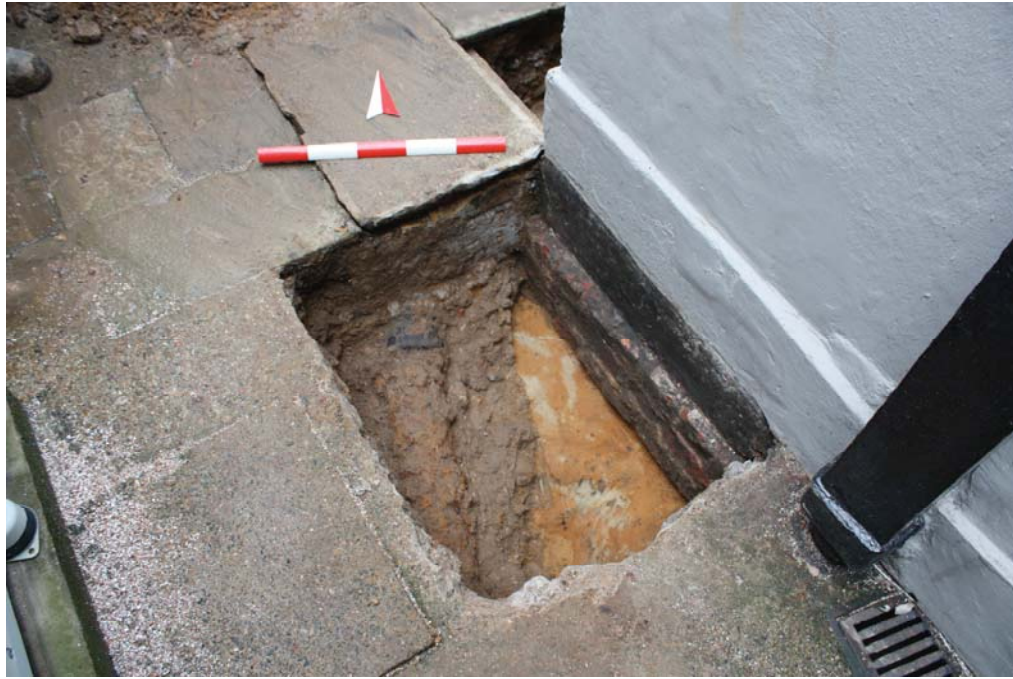
North Facing Shot of Test Pit 3a (0.50m Scale)

- 7.3.2. TP 3a occupied the western part of the corner and was excavated to a depth of 0.45m. The lowest feature observed was a layer of green grey and mid yellow natural sand [1] at 23.04mOD. The western side of this natural deposit had been truncated by cut [2], the construction cut for a modern cast iron service pipe that ran northeast by southwest in the centre of the trench. The construction cut was filled with [3], a modern bedding layer of concrete to support the pipe. This in turn was sealed by a 0.29m thick layer of demolition rubble used as ground raising [4] and was topped by modern concrete slabs, the top of which formed the current ground surface at 23.43mOD.

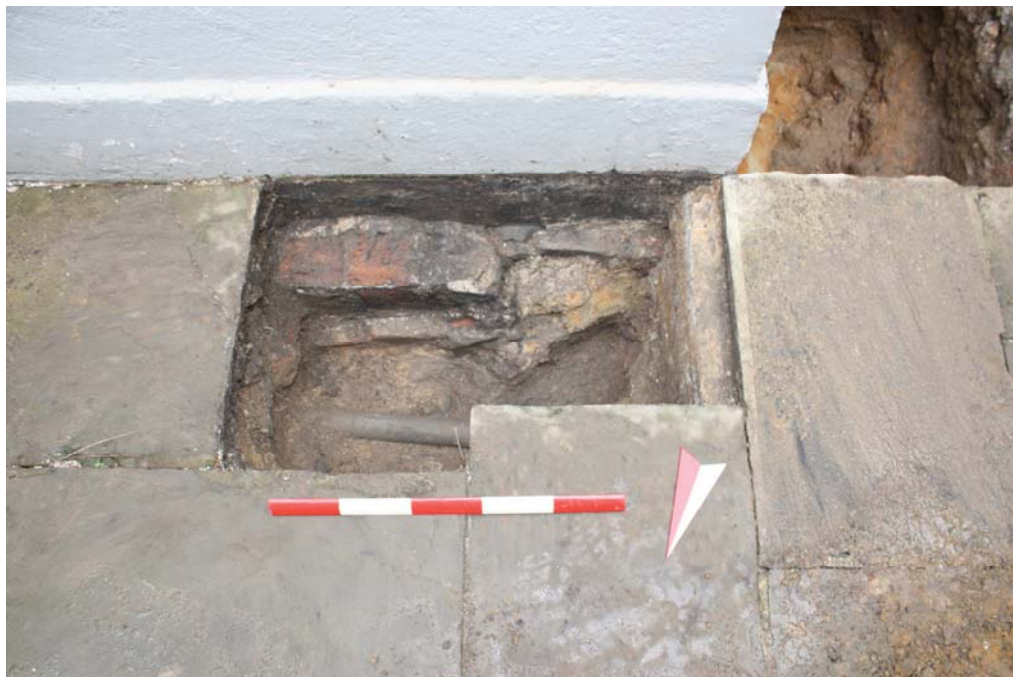
South Facing Shot of Test Pit 3b (0.50m Scale)

- 7.3.3. The service pipe continued into TP 3b, which was located on the northern corner of the cleaners' room. Excavated to a depth of 0.37m, the southern side of the test pit exposed the brick footings of the standing wall above. In the base of the trench, at 23.04mOD, was a lead pipe encased in a bedding layer of concrete [5] covered by a further layer of concrete [6]. This in turn was sealed by a 0.34m thick layer of modern demolition rubble [12] used as ground raising and consolidation which was topped by flagstones, the top of which formed the current ground level at 23.43mOD.

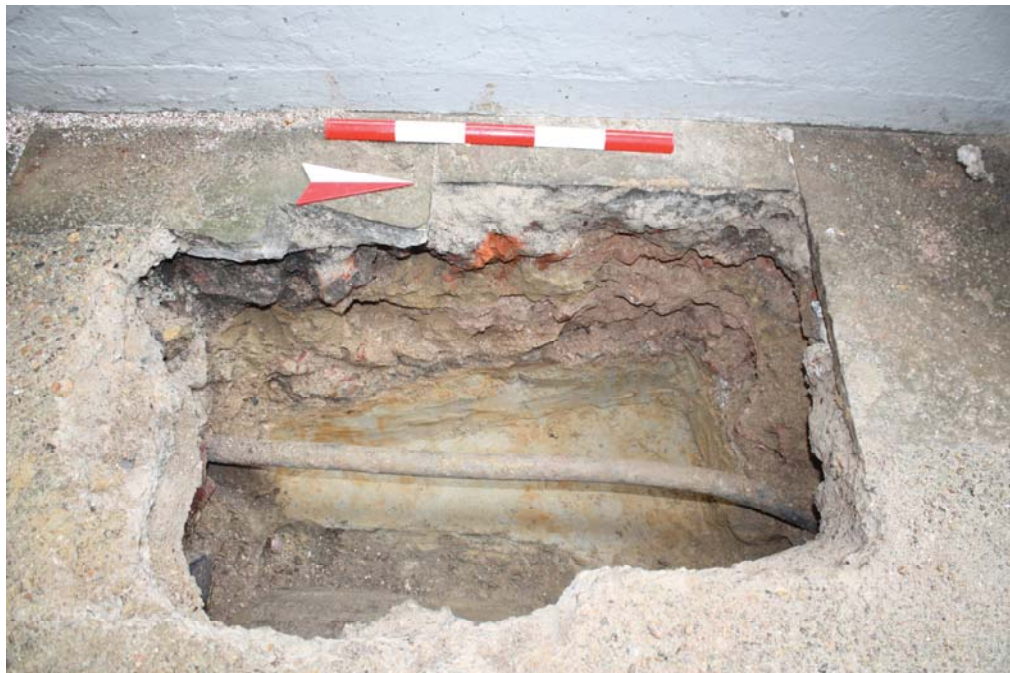
West Facing Shot of Test Pit 4 (0.50m Scale)

7.4.1. Test Pit 4 was located near the south east corner of the plant room GF077 and was excavated to a depth of 0.68m below current ground level to 22.74mOD.

7.4.2. The earliest deposit observed was a greenish grey mixed with mid yellow brown natural sand layer [17], the top of which was encountered at 22.90mOD. This was truncated on its eastern side by a modern construction cut [18] for a metal pipe, which

is probably the same service run observed in TPs 3a and 3b described above. The cut [18] was backfilled with dark grey brown silty sand [19]. This in turn was sealed by a thin (0.04m) crudely made concrete layer [16], which covered the pipe, the top of which was at 22.94mOD.

- 7.4.3. Layer [16] was sealed by a sequence of deposits of demolition rubble acting as ground raising, levelling and consolidation layers. Layer [15] was a pinkish grey sandy mortar layer with frequent fragments of CBM, 0.20m thick. This was overlain by layer [14], a re-deposited natural sand combined with modern demolition rubble 0.08m thick, which in turn was sealed by [13] a 0.15m thick layer of demolition rubble composed of whole and fragmentary unfrogged red bricks in a dark brown sandy matrix. This in turn was sealed by a modern flagstone and concrete surface, the top of which formed the current ground level at 23.42mOD.

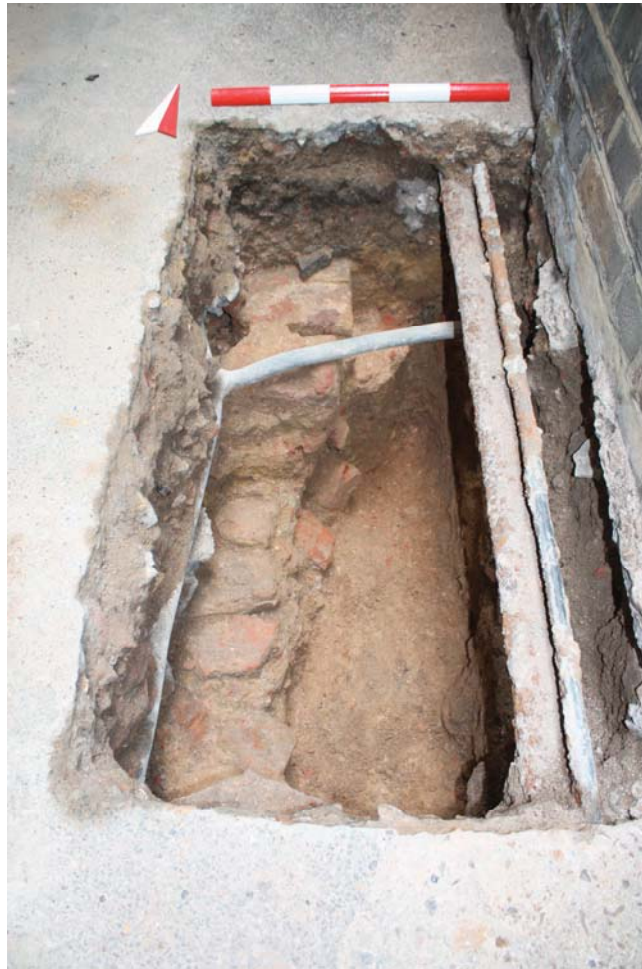
North Facing Shot of Wall [21] in Test Pit 5 (0.50m Scale)

- 7.5.2. The lowest feature observed was wall [21], recorded running north to south along the western side of the test pit. This was constructed from unfrogged red 3033 and purple 3032 stock brick in an irregular bond. Brick samples recovered from the wall were spot dated to the mid 17th century, however these appear to have been re-used as the bonding material is much later, composed of coarse Roman cement indicative of a 19th century date (see discussion below). The wall as found measured 1.02m north-south by 0.40m east-west and had a highest level of 23.20mOD.

- 7.5.3. Partly overlying wall [21] was a single course of re-used 2276 peg tiles [20] laid on a thin bed of sand. Its function is unknown and the fabric has been spot dated to 1700-

1900. As it overlies wall [21], dated to the 19th century, the later part of the date range is more probable. The top of the tiles was at 23.01mOD.

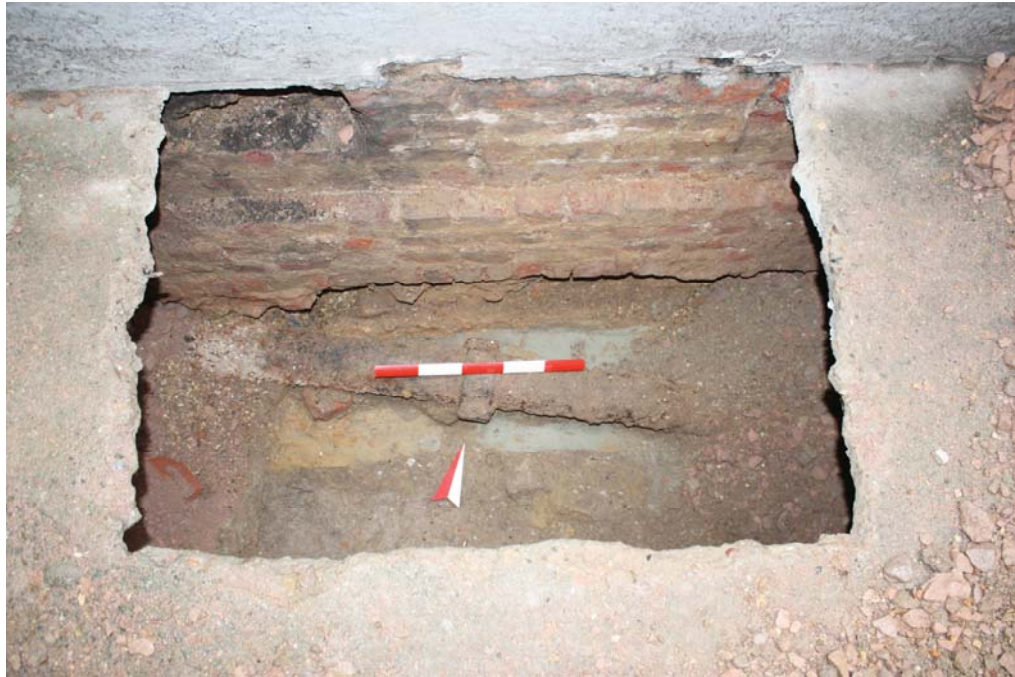
North Facing Shot of Test Pit 8 (0.50m Scale)

- 7.6.1. Test Pit 8 was located south of Plant Room GR077 and was excavated to a depth of 1.00m with the base of the test pit at 22.49mOD.
- 7.6.2. The earliest feature encountered was a natural deposit of greenish grey mixed with mid yellow brown sand [35] which measured 0.30m thick to the base limit of excavation and was recorded at a highest level of 22.79mOD. The natural layer had been truncated by a modern construction cut and its associated drain-pipe (not contexted). The natural layer appeared to underlie the base of brick footings of the standing southern wall of the plant room, which ran east-west along the northern limit of excavation. The base of the footings was recorded at 22.81mOD, 0.70m below

current ground level. All of the above features were overlain by a 1.00m thick layer of loose modern type 1 hardcore, presumably the backfilling to a modern waste pipe that could be seen beyond the eastern limit of excavation. This was sealed by the modern concrete floor surface, the top of which formed the current ground level at 23.49mOD.

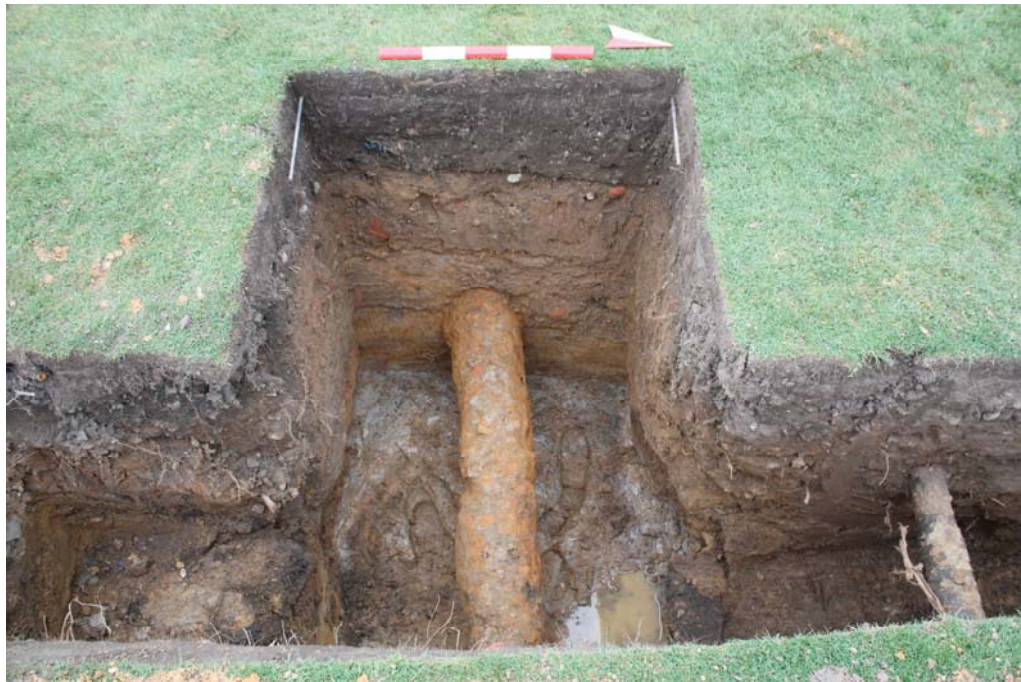
West Facing Shot of Cast Iron Pipe (0.50m Scale)

inclusions of occasional fragments of CBM. As with [24], this layer is presumed to be the backfill of the cast iron pipe [26].

9.7.3. In Trench 9 a short section of a cast iron pipe [26] was exposed running east-west. Its function is uncertain, but its relatively large diameter, 0.25m, would suggest drainage rather than water supply. Being cast iron, it is presumed to be 19th century in date. The pipe is off the line of the culvert, being approximately 1.00m north of it and therefore seems likely to be a separate feature, rather than connected to the culvert as, for instance, a later repair.

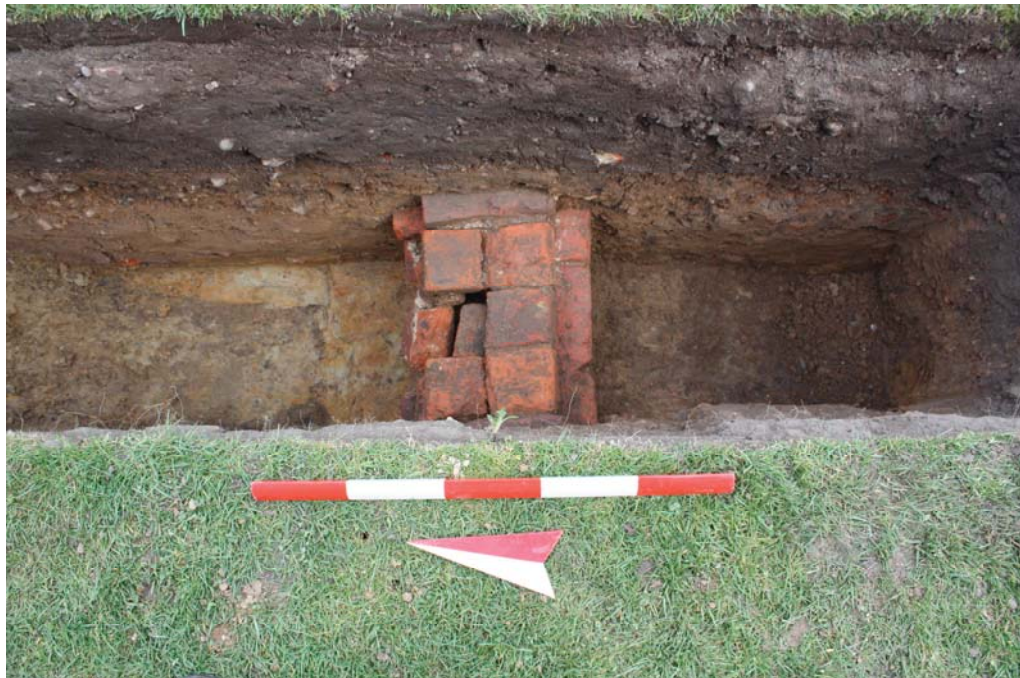
East Facing Shot of Brick Culvert with Capping (0.50m Scale)

8.2.1. A brick built drain culvert was observed in the base of Trench 10. Constructed from poorly made unfrosted red and purple brick, masonry samples recovered from the feature were spot dated to between 1664 and the early 18th century. A fragment of clay tobacco pipe recovered from the internal fill of the culvert gave a spot date of 17th-18th century. The construction cut of the culvert [31] had been cut through layers [29], [28] and [33], all layers of made ground that must pre-date the culvert, possibly dating to the early 17th century.

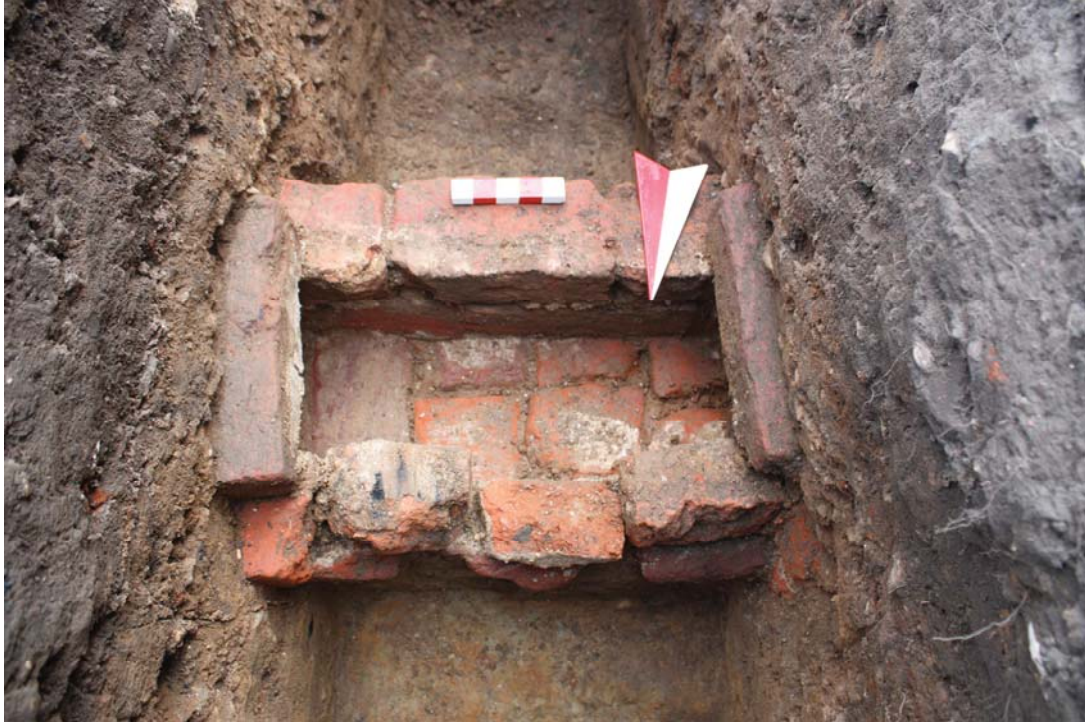
South Facing Shot of Culvert with Capping Removed (0.10m Scale)
