ROYAL CLARENCE YARD

ARCHAEOLOGICAL EXCAVATION

**Assessment of an Archaeological Excavation at Phase C at Royal
Clarence Yard, Gosport, Hampshire**

Site Code: B1790D

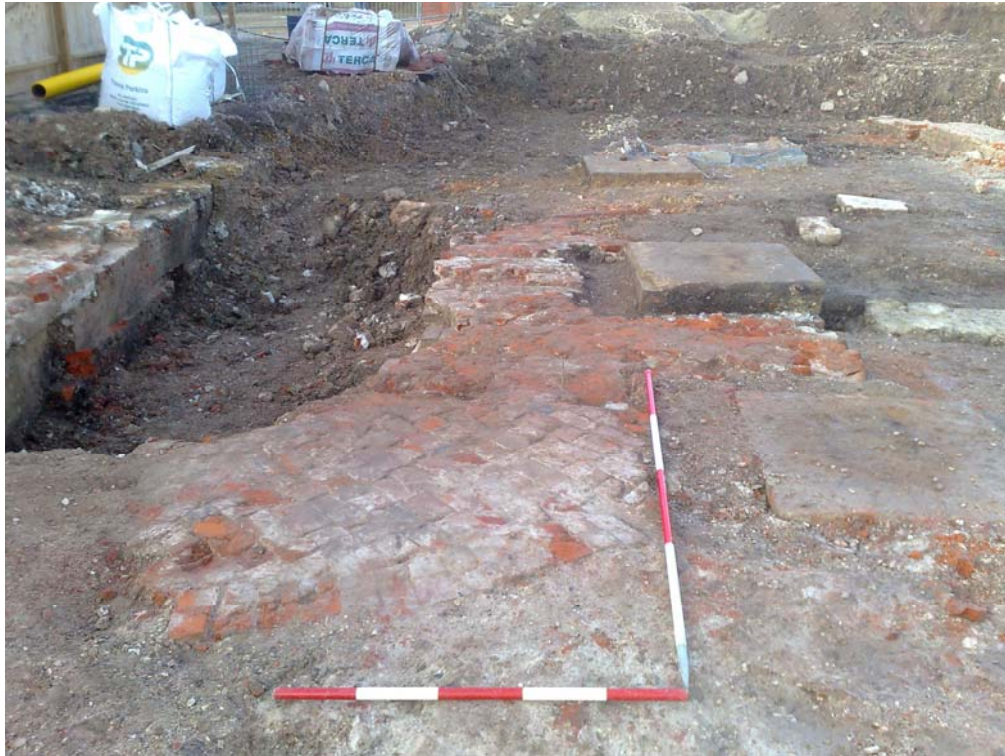
PLATE 1: Floor [1660] looking west with 1m and 2m scales

floor [1660] and its notable difference from bricks of the later Salt Meat Store. Where seen, it measured 0.67m north-south, was greater than 0.84m deep and measured 5.60m east-west.

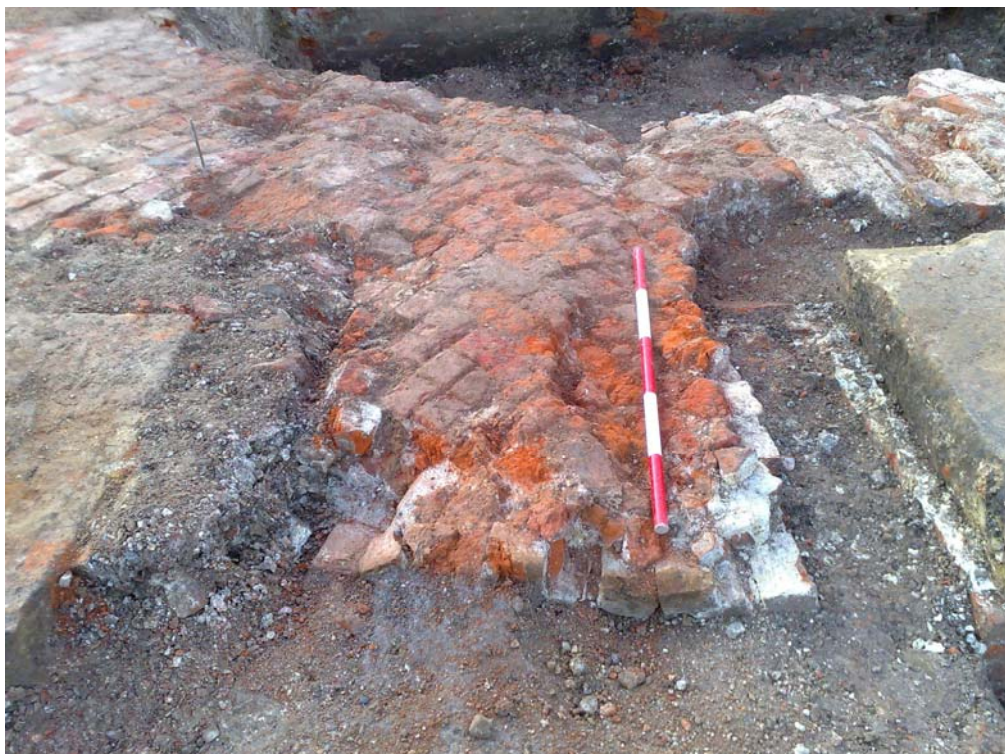
PLATE 2: Floor [1660] looking south with 1m scale

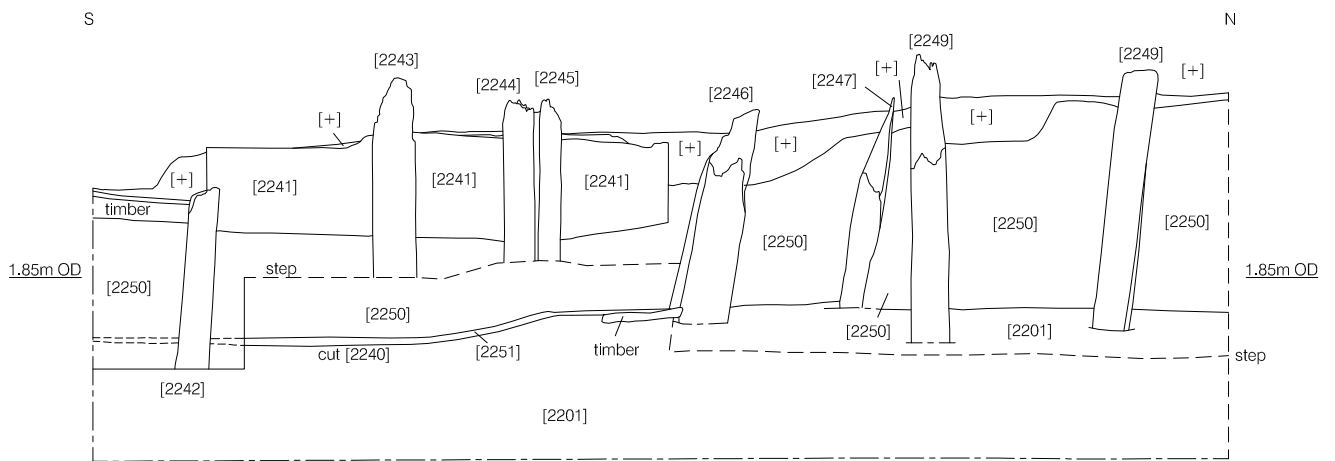
Figure 7
 Section 234
 1:25 at A4

Section 234
 Wall [2239]
 Phase 3
 Trench F3
 East Facing

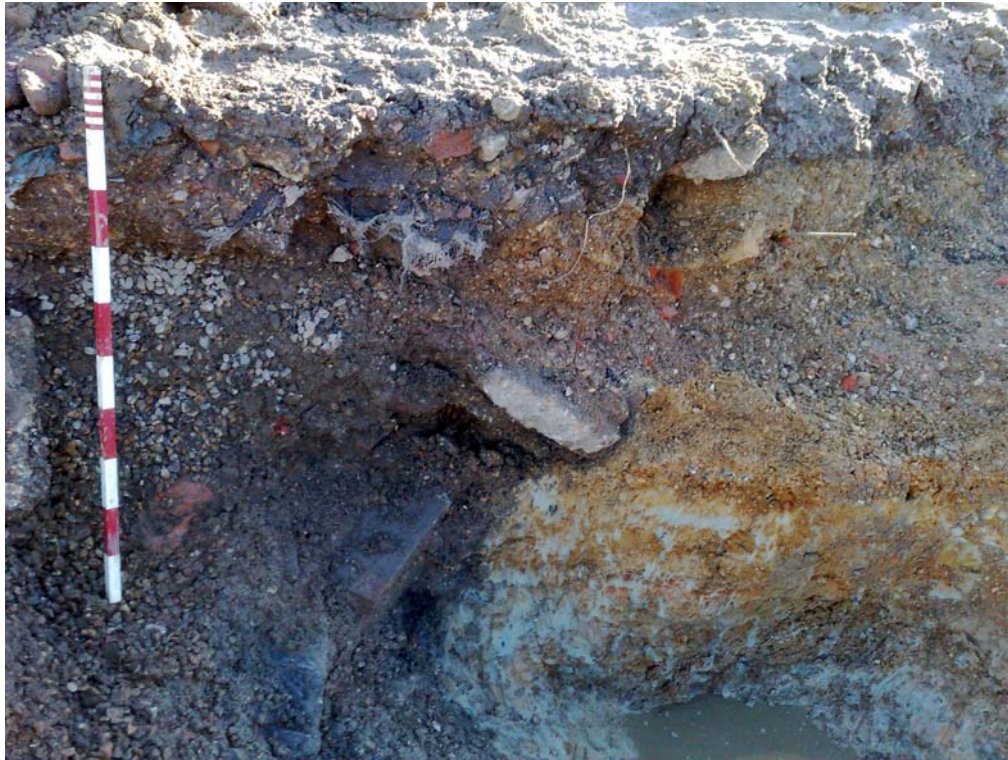
PLATE 3: Cut [2240] for reservoir [2239] looking southeast with 1m scale

- 7.4.12 An attempt was made to reveal a more complete sequence of the shuttering on the southern boundary of the feature and also to define its southern extent. A slot was excavated through the fill of the feature at the height of the natural material as detailed above. The southern boundary of [2239] was recorded as cut [2237] and was seen made through natural stratigraphy at a height of between 2.53m OD and 2.50m OD. No timber shuttering was observed here. Large concrete lumps of the fill were seen to directly abut natural stratigraphy that had the appearance of having been graded by a mechanised machine bucket. This may have been responsible for the absence of any timber shuttering. The base of the reservoir was observed approximately 0.5m below the top of the cut, at a height of 2.08m OD, although this

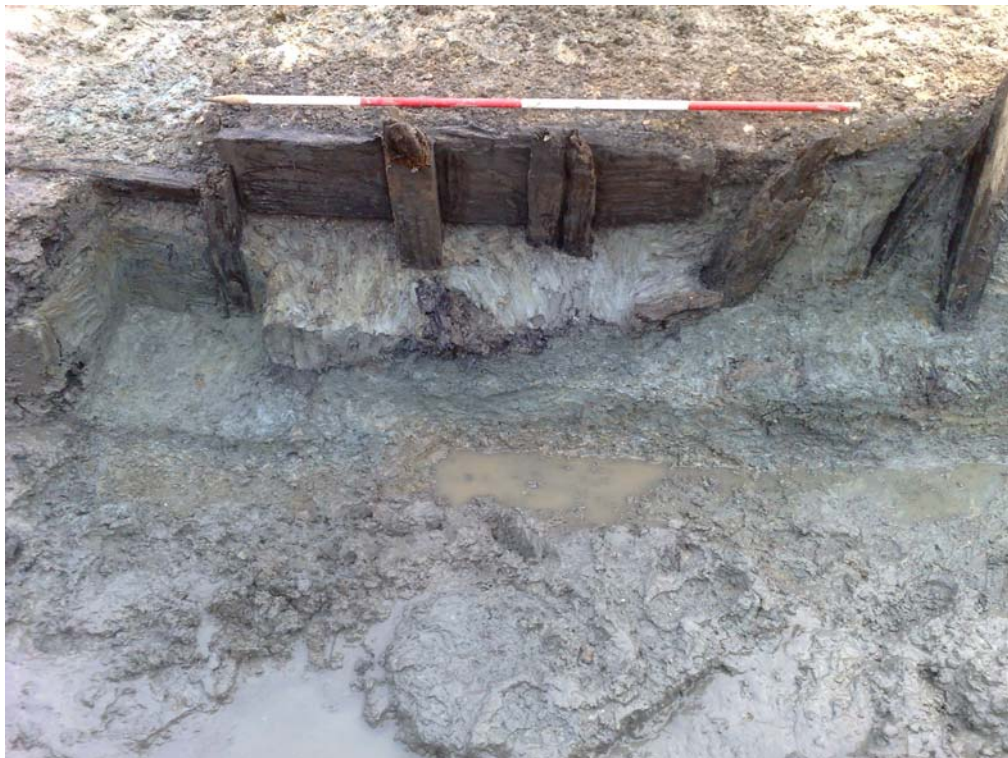
PLATE 4: Timber-lining of reservoir [2239] looking east with 2m scale

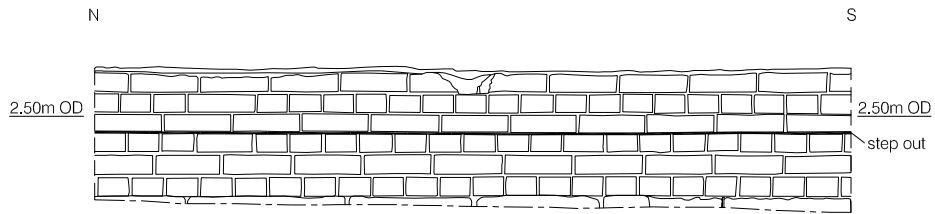
Section 227
 Wall [2200]
 Phase 4
 Trench F3
 West Facing

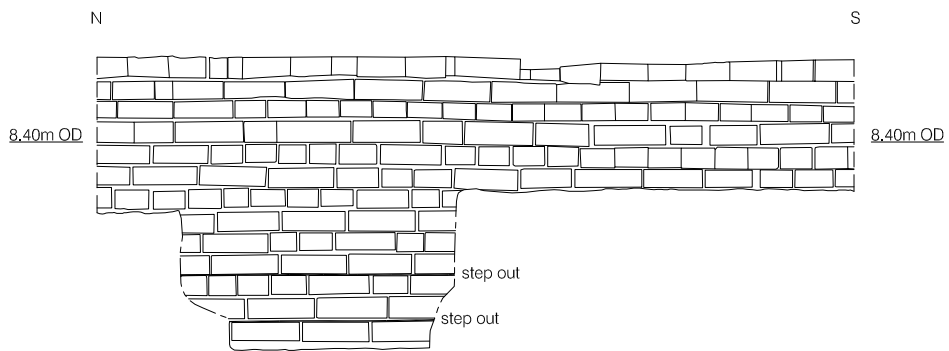
Section 228
 Wall [2206]
 Phase 5
 Trench F3
 West Facing

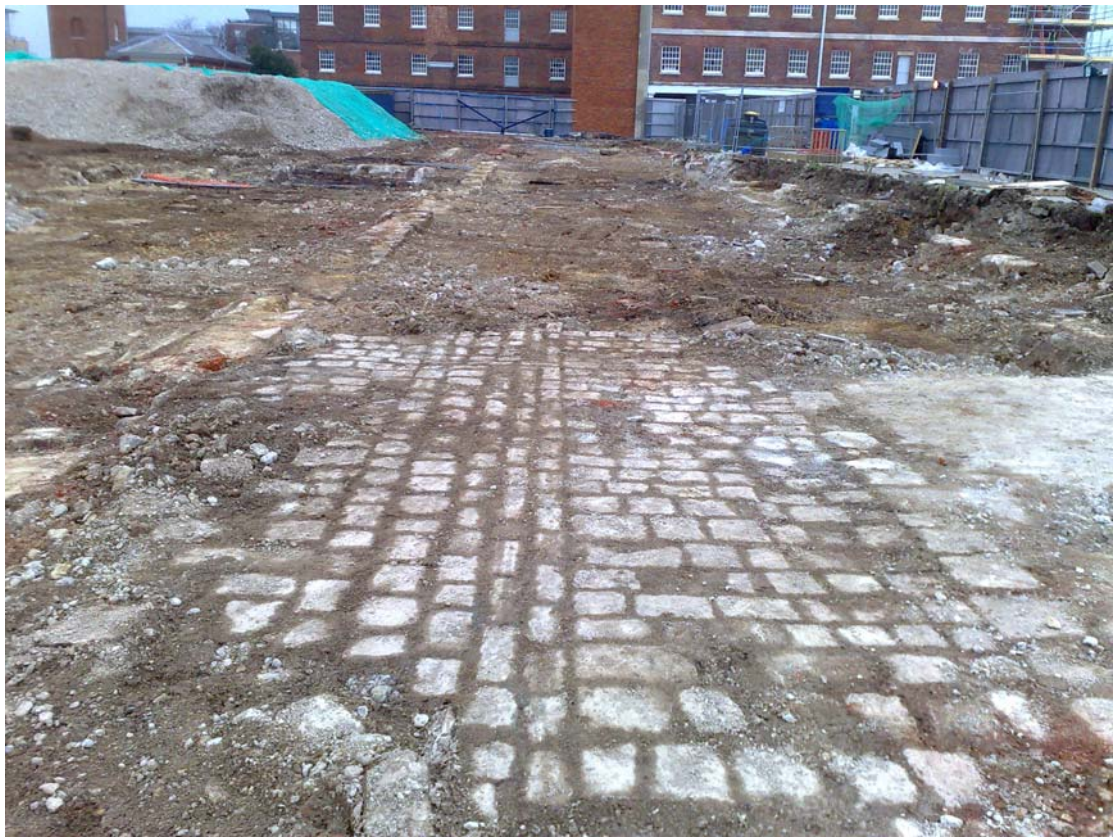
PLATE 5: Floor [1634] looking north

7.6.3 Floor [1634] was created from cobble setts and observed in the southeast corner of the Miscellaneous Stores, between the external wall [1603] and the eastern internal support wall [1602]. It measured some 13.16m north-south and was 7.40m wide. Heights were recorded as being between 2.03m OD and 2.19m OD. It was generally

in good condition with some evidence of repairs having been made to it in the form of poured concrete, presumably from the 20th century.

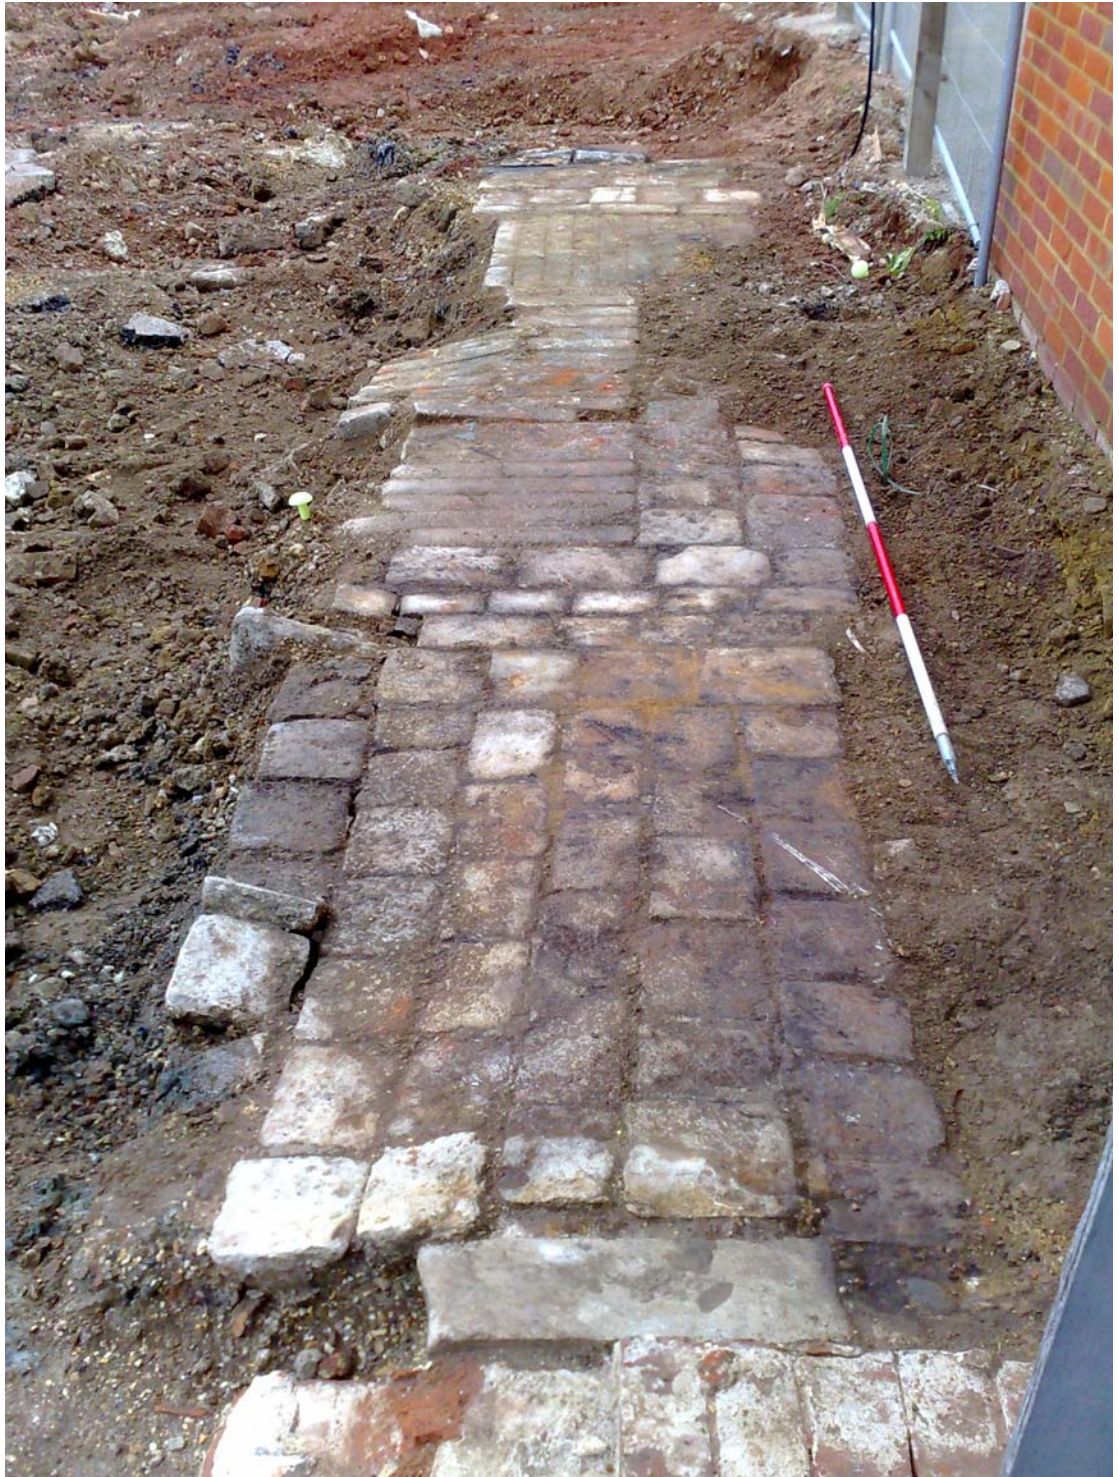
PLATE 6: Floor [1650] looking east with 2m scale

- 7.6.5 In the very north of the F1 building footprint, floor [1650] was recorded between the eastern external foundation [1603] and the eastern internal foundation [1602]. This measured 7.60m east-west by 1.60m north-south. The height of this floor was similar to those detailed above, being between 2.36m OD and 2.41m OD. Substantial concrete repairs had been made to this floor, presumably from between the late 19th to mid 20th century when the building was destroyed.

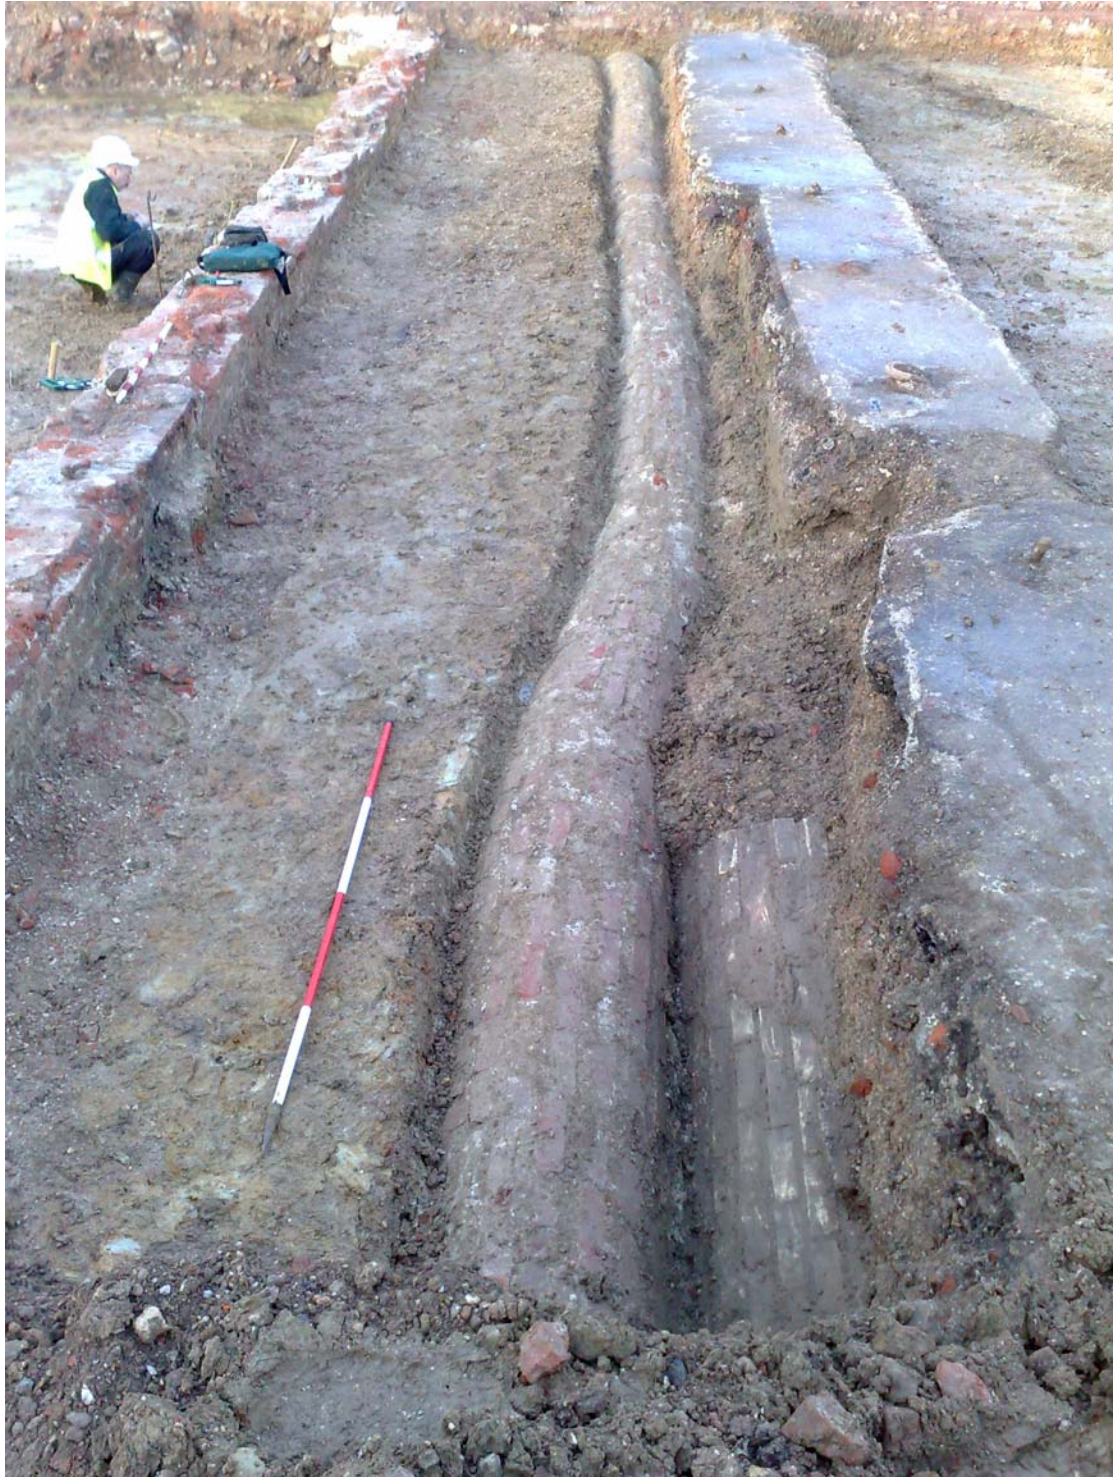
PLATE 7: Culvert [2203] looking north with 2m scale
