**An Archaeological Watching Brief at the Salvation Army Hostel, 39 City Road,
Newcastle-upon-Tyne, Tyne and Wear**

Central National Grid Reference: NZ 2359 6419

Site Code: SAN 09

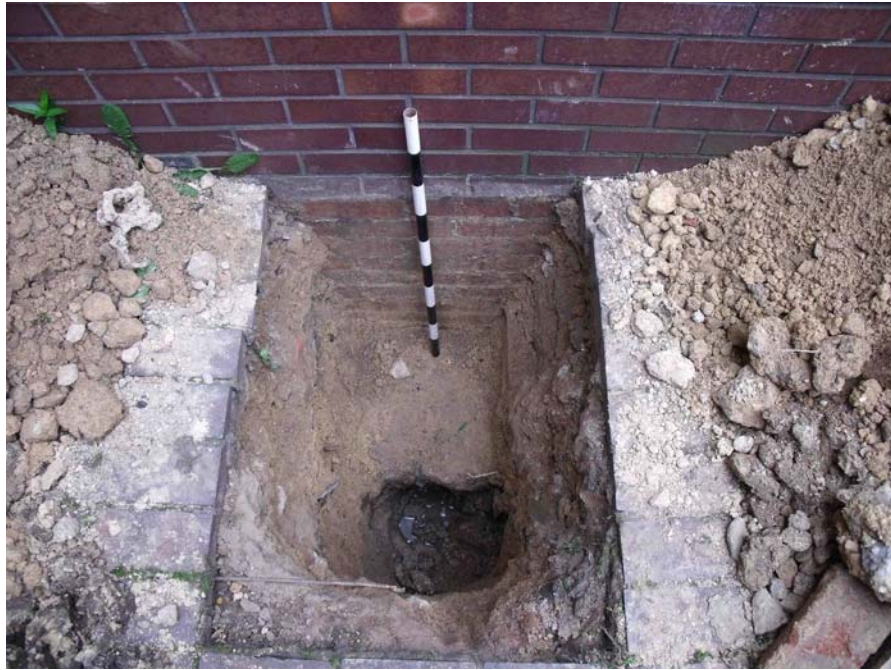
Figure 3. Trial Pit 1.

- 4.1.1 The earliest deposit, [102], encountered in TP1 comprised firm dark grey clay with occasional small sub-rounded stones. This deposit was exposed within a small area at the base of the pit and was at least 0.30m thick, its upper interface lying c. 0.80m below existing ground level. It is likely to represent ground levelling and consolidation material associated with the construction of the existing building.

- 4.1.2 Cut into deposit [102] was a NW-SE aligned construction cut, [107], for a brick wall [100], and a short length of a NW-SE aligned service trench, [106]. Both features were encountered at c. 0.80m below existing ground level.

- 4.1.3 Wall [100] formed the south-western limit of excavation of the trial pit and the north-east elevation of the existing building. The method of construction involved laying a concrete footing, [101], directly within construction cut [107]. The brickwork was laid in stretcher bond upon this footing. The bricks had standard dimensions of 220mm long x 70mm high and were bonded with hard grey mortar.

- 4.1.4 A substantial dump deposit, [104], comprising light yellow brown sandy gravel was encountered at c. 70mm below existing ground level, extending across TP1. It was up to 0.70m thick and had been dumped against the lower portion of wall [100] and upon its footing. The deposit represents infilling and ground raising prior to re-surfacing. It was directly overlain by a block paving surface, [103], which extended across this part of the yard area and forms the existing hard surface.

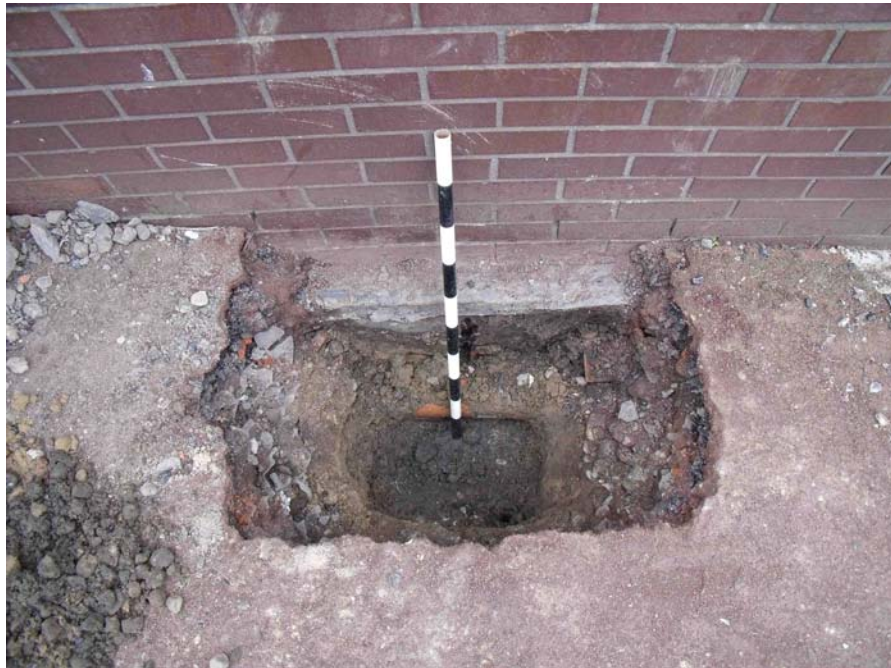
Figure 4. Trial Pit 2.

- 4.1.5 A NE-SW aligned brick wall [200] formed the south-eastern limit of excavation of TP2 and the north-western elevation of the building against which the pit was excavated. The method of construction involved laying a concrete footing, [101], encountered at a maximum depth of c. 0.64m below existing ground level, then – probably against shuttering - a concrete foundation, [201]. Overlying this foundation was the brickwork, again in stretcher bond. Again the bricks had standard dimensions of 220mm long x 70mm high and were bonded with hard grey mortar. Due to the limited dimension of this trial pit, the construction cut for this wall was not observed.

- 4.1.6 Adjacent to the base of foundation [201] part of a NE-SW aligned ceramic drain was recorded. No cut was observed indicating that it was probably installed at the same time as a dump deposit [204], which, along with a rubble layer, [203], formed the uppermost deposits within TP2. Their combined average thickness was 0.73m. Directly overlying rubble layer [203] was a tarmac surface, this being the current hard surface across this area.

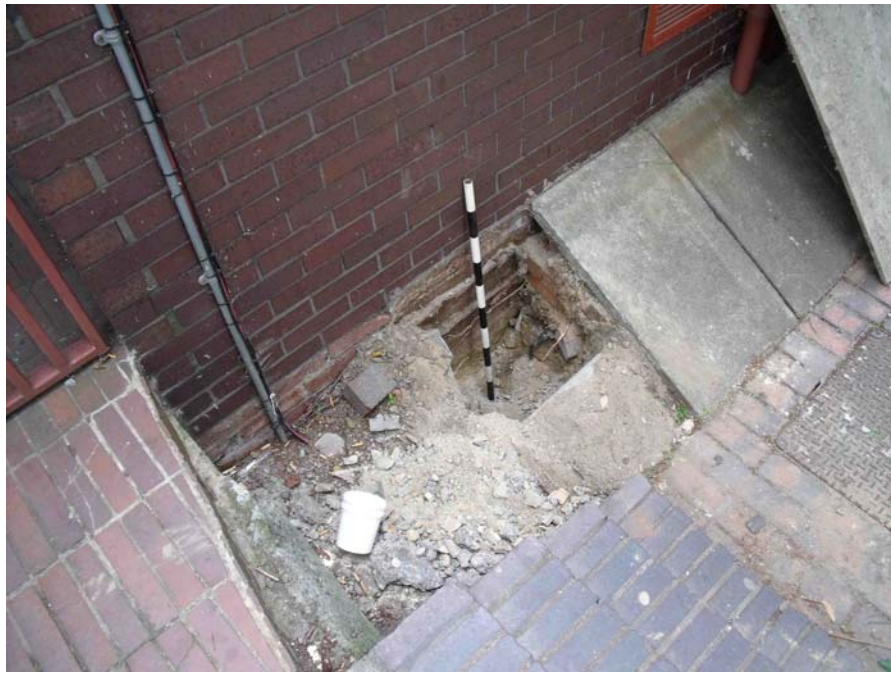
Figure 5. Trial Pit 3.

- 4.1.7 A NE-SW aligned wall, [300], was recorded in TP3. This formed the north-western limit of excavation and the south-eastern elevation of the building against which the pit was excavated. The method of construction was similar to that of wall [100] in TP1 and involved laying a concrete footing, [301], to a depth of c. 0.46m below existing ground level. The brickwork, again in stretcher bond, directly overlay this. Again the bricks had standard dimensions of 220mm long x 70mm high and were bonded with hard grey mortar.

- 4.1.8 Towards the base of TP3 a NW-SE aligned service, [307], was recorded, set within the footing [301]. It was backfilled with a gravel deposit, [306].

- 4.1.9 A silty dump layer, [304], for ground levelling and a sub-base layer. [305], of crushed stone hardcore, were recorded lying against wall [300], and overlying service [307]. These deposits had a combined thickness of 0.45m. Two brick courses of the south-western side of what was probably a drain chamber, [303], were recorded in the north-eastern side of the trial pit. This may have been constructed against wall [300] prior to infilling with layers [304] and [305], although this is uncertain.

- 4.1.10 Overlying drain chamber [302] and rubble layer [303] were concrete paving slabs, [302], this being the current hard surface across this area.

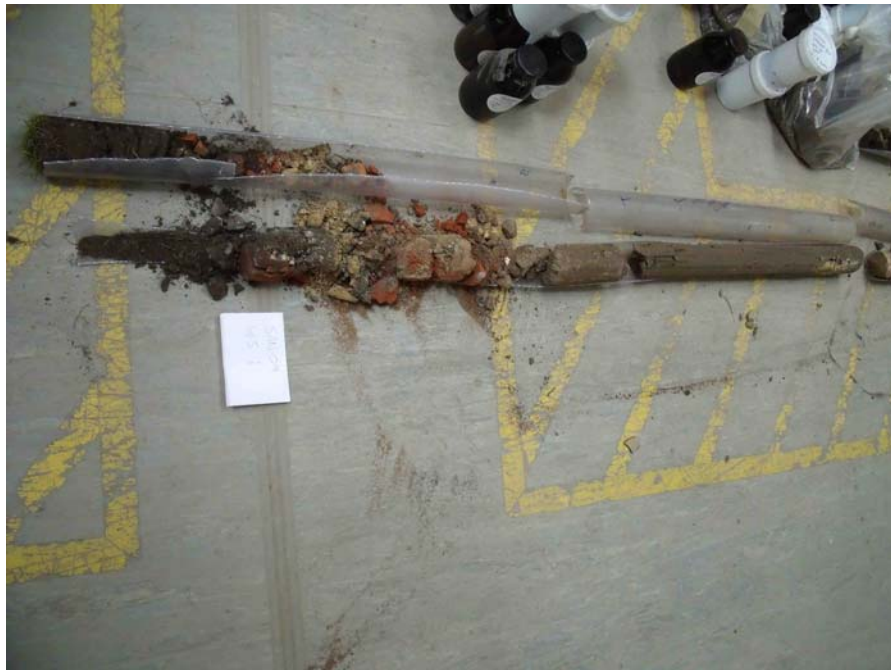
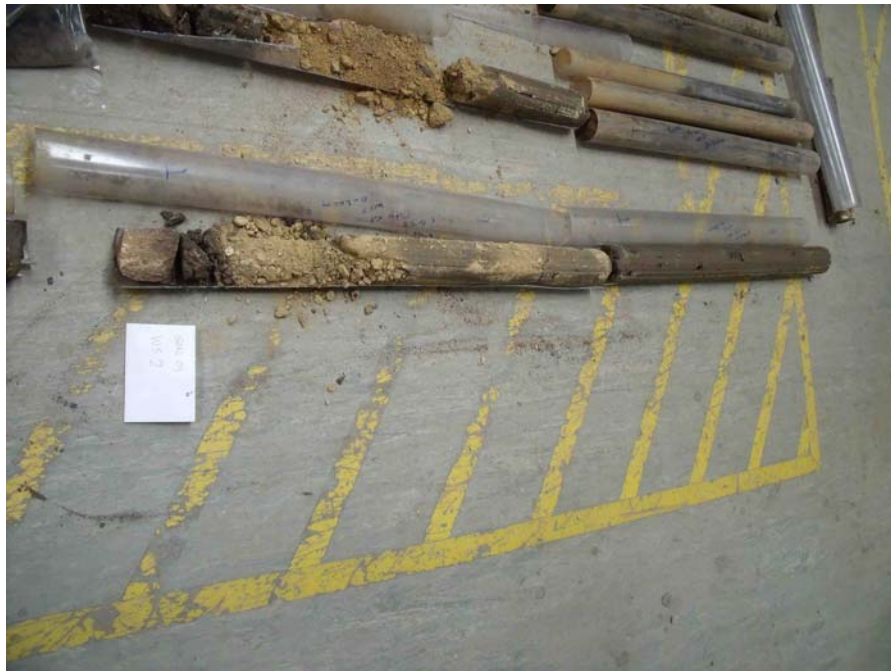
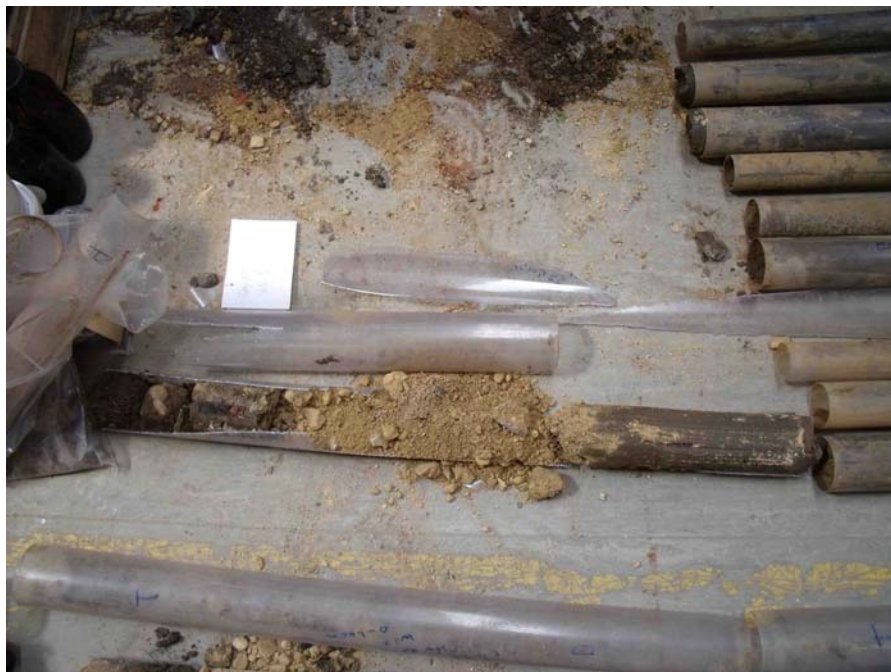
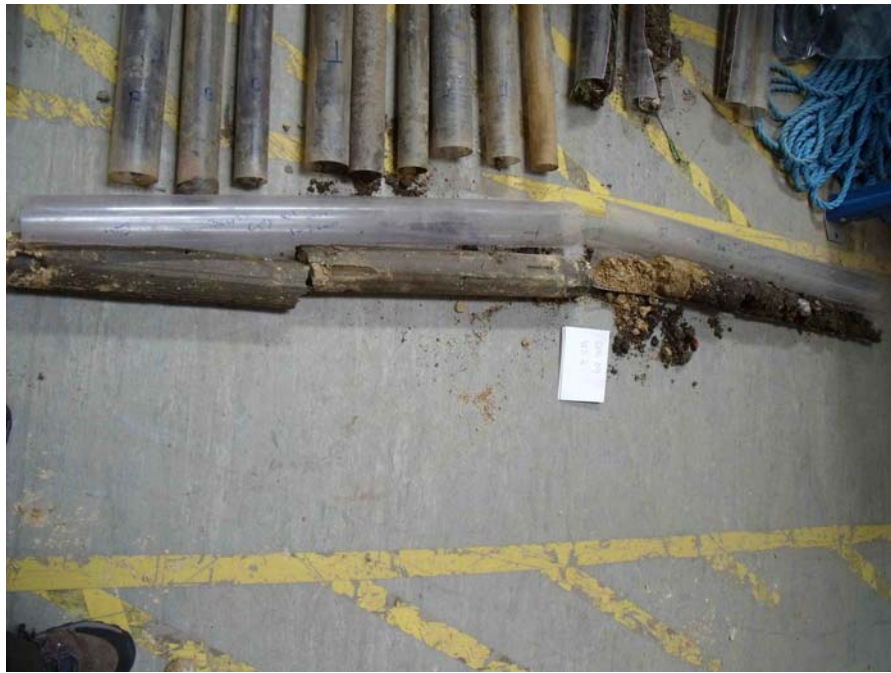
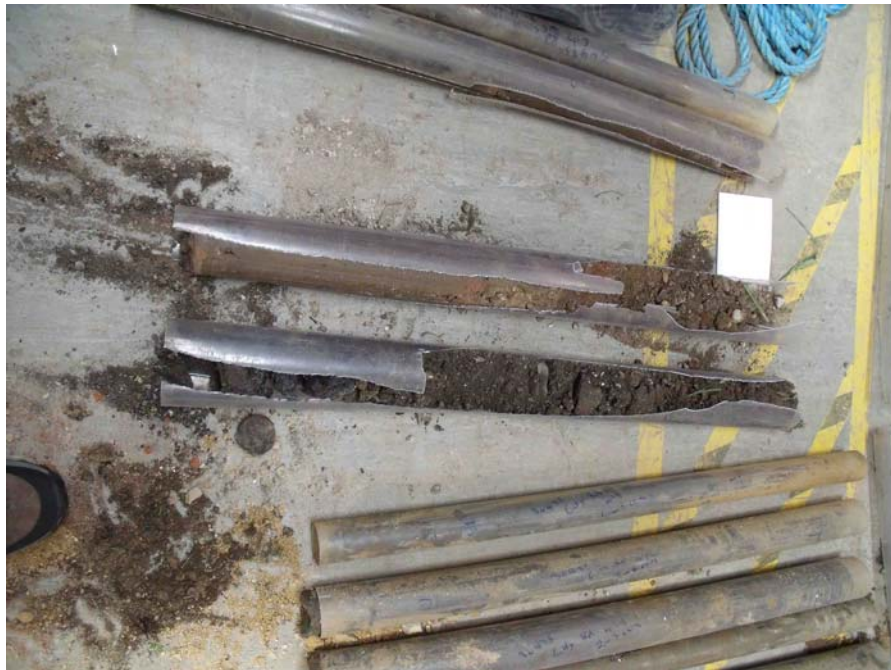
- 4.3.1 The earliest recorded deposits within the five window samples were glacial drift deposits, which comprised various compositions of silt, sand, clay and gravel. The highest level recorded on any such deposit – a stiff brown, mottled with blue grey, slightly sandy, slightly gravelly clay in WS2 - was 23.46m OD, this at 0.37m below existing ground level. The lowest level – on a similar clayey deposit in WS3 – was 22.72m OD, this at 0.60m below existing ground level.

- 4.3.2 In all five window samples glacial drift material was directly overlain by deposits interpreted as modern dumps of rubble for levelling and ground consolidation. These comprised various combinations of silt, sand and clay with varying quantities of fragmented brick, coal, clinker, and dolomite. These deposits varied in thickness from a maximum of 1.30m in WS1 to a minimum of 0.30m thick in WS2. In WS4 this 'made ground' was the uppermost deposit recorded, this the gravel surface at the south-western end of the existing building, where existing ground level was 24.36m OD,

- 4.3.3 The latest deposit recorded in WS1-3 and WS5 was existing topsoil, which generally comprised dark brown silty sand. The maximum height at which the upper interface of this deposit was recorded was 24.69m OD in WS5, this in the garden at the south-western end of the existing building, while the lowest was 23.23m OD in WS3, this sited on the grass bank to the south of the development area.
