ARCHAEOLOGICAL BUILDING RECORDING OF 15
DOCK STREET, LONDON BOROUGH OF TOWER
HAMLETS

SITE CODE: DOK05

COMMISSIONING CLIENT: STERLING PARTNERS

**WRITTEN AND RESEARCHED BY: JAMES DIXON
NOVEMBER 2005**

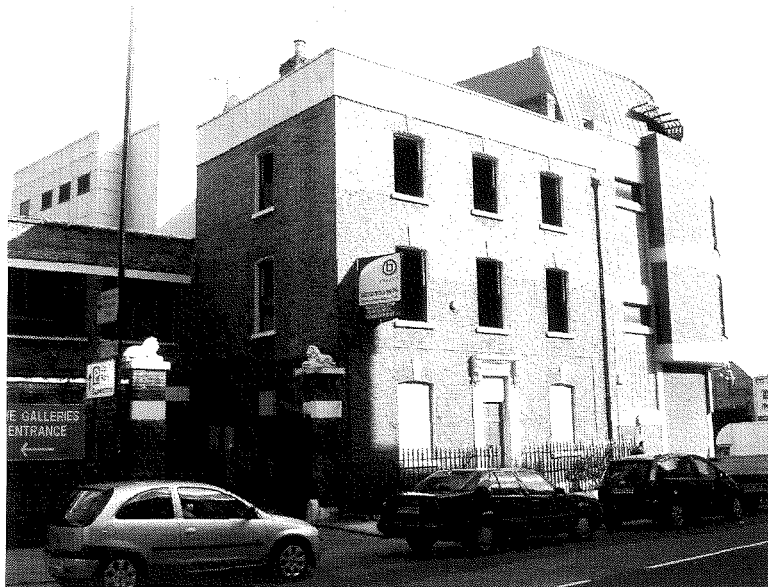
Plate 1: 15 Dock Street from the south

4.1 15 Dock Street has three storeys in addition to the basement. The building is rectangular on plan with a slightly angled south wall. It is flat fronted and three bays wide, fronting the street, with a central front door to the slightly raised ground floor. There were originally two rooms to each floor, with a smaller rear room in the northeast corner of the house. The northwest corner houses the staircase.

The external elevations are of yellow stock brick (fabric 3032 using the Greater London archaeological system of building material classification) laid in Flemish bond. The fenestration on the front and north flank wall has segmental heads and arches. The rear windows (of which there are two per floor) have segmental arches. The windows have rendered reveals. The front elevation's window arches have prominent brick keystones. There are sash windows throughout which, on the front elevation, have two panes to the upper sash, separated by a single mullion, and a single pane beneath. The sash windows on the side elevation have single pane sashes. On the front elevation the ground and first floors are emphasised by having larger windows. There is a rendered string-course between the ground floor and the basement and a

rendered parapet forming the entablature to the orders implied above the string course. The door case is simple with scrolled consoles supporting the cornice. The six-panel front door is topped by a plain rectangular fanlight. The exterior joinery is painted red. There are railings fronting the street. The basement windows on the front elevation are probably replacements of the original windows. The rear yard is at basement level and is surrounded on all sides by walls, the north and east yard walls being retaining walls.

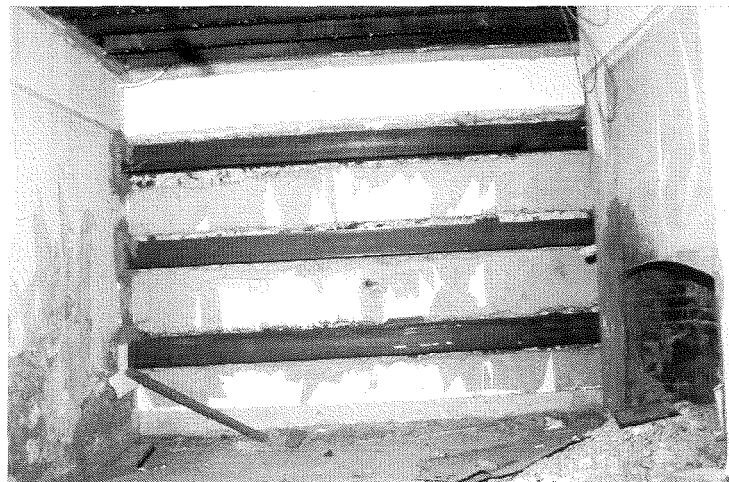
Plate 2: 'I' section beams in the north of the basement

4.2.6 The basement floor of the building had been only slightly altered since the initial assessment. It was possible to observe that the north wall of the northwest room of this floor had been horizontally strengthened with three steel 'I' sections each of approximately 20x25 cm with a 2.5° taper flanges. These add a strengthening element between the outer wall of the building and the central interior wall of the building.

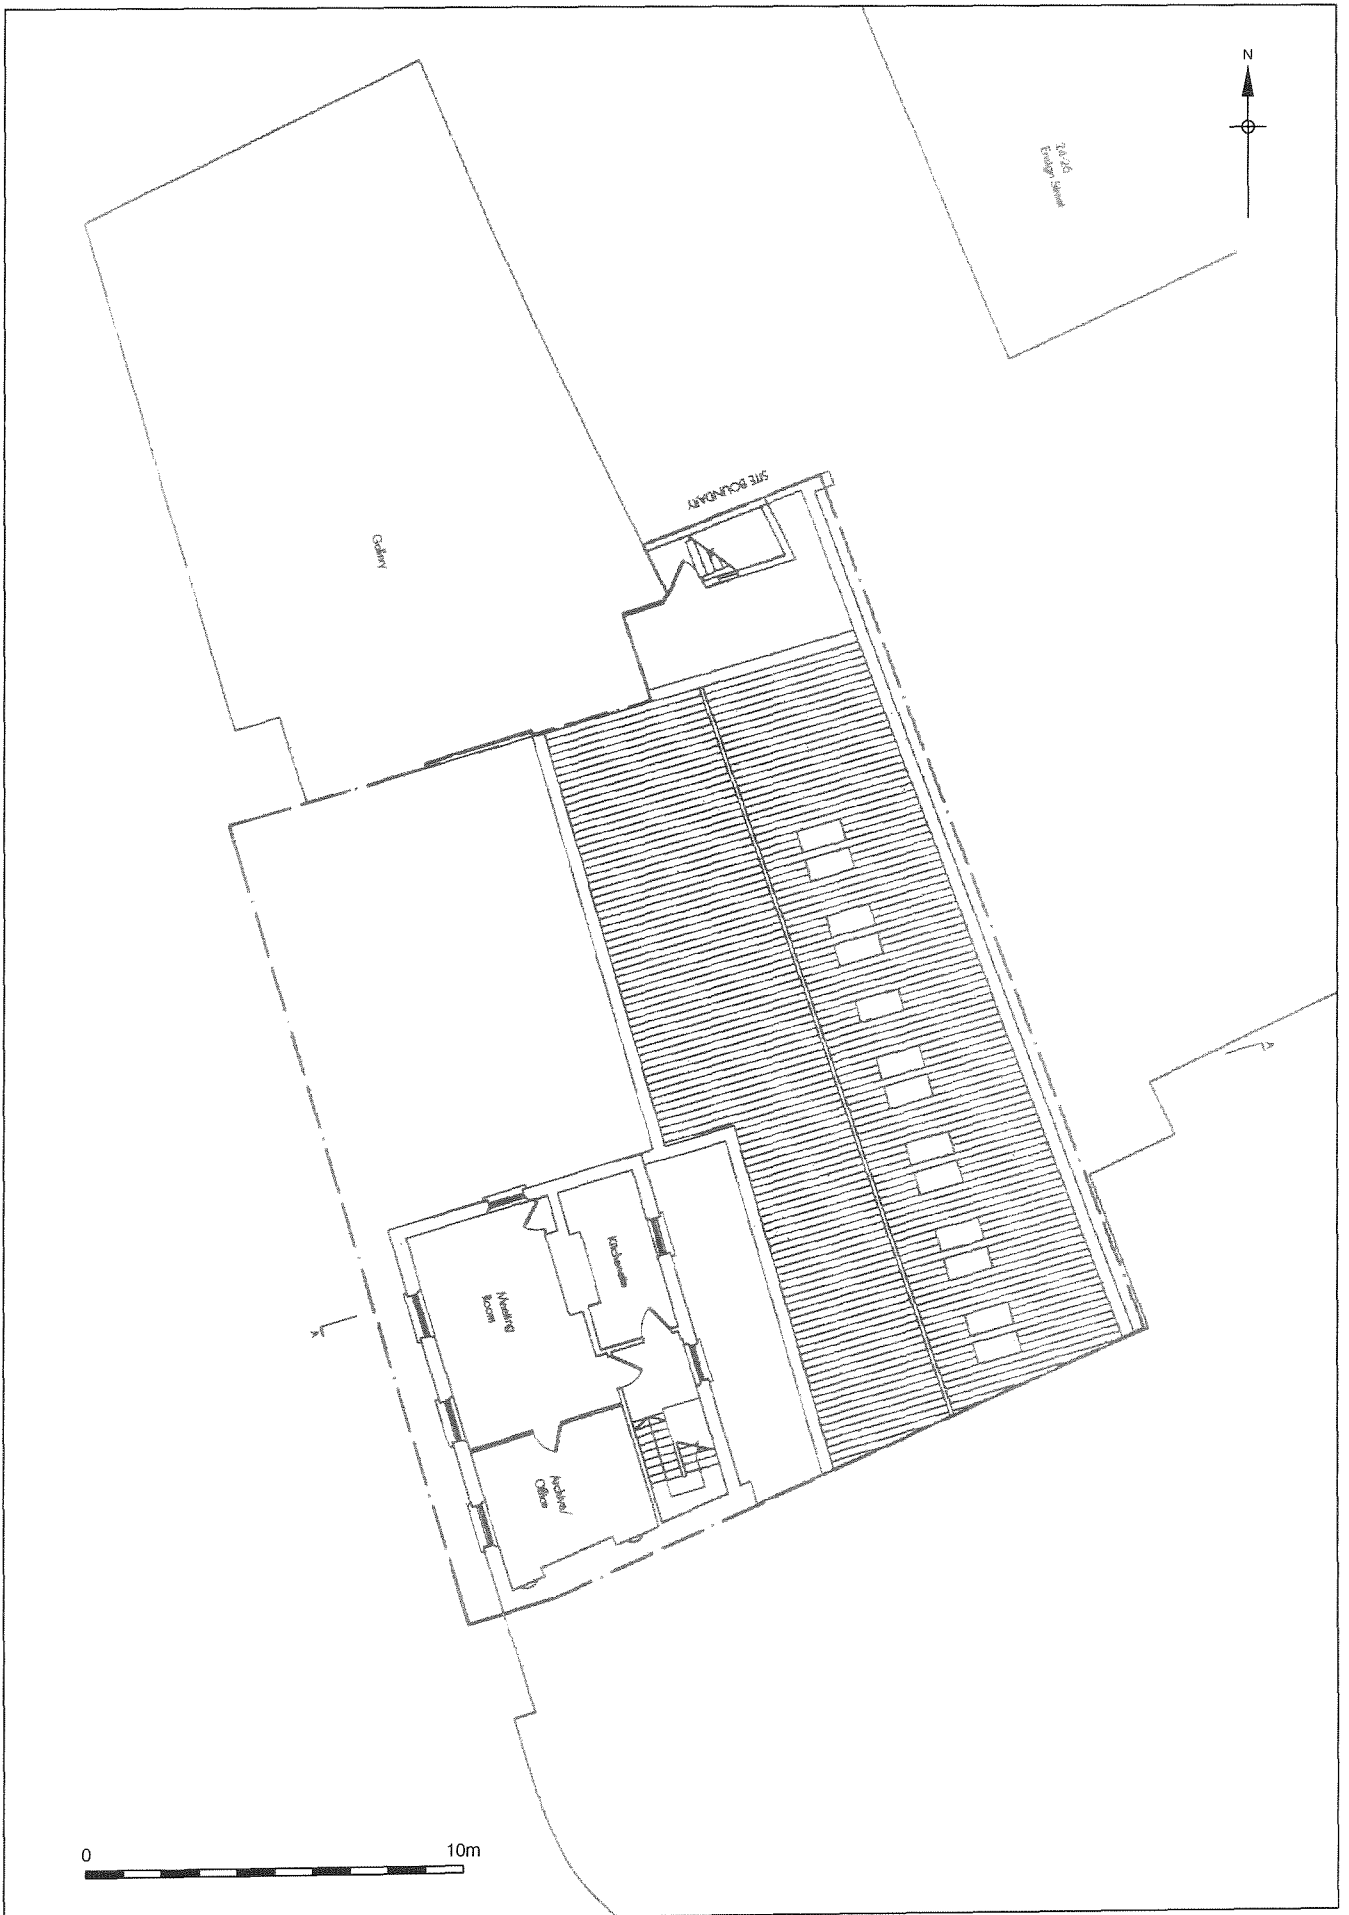
Figure 9b
Existing Floor Plan
Approximately 1:200

Based on a drawing by Tasou Associates, Architects and Structural Engineers

Following the removal of wall coverings, the fabric and construction of the second floor were observed to be identical to the floor below with the same brick set bracing timbers at floor beam level and a timber stud wall, this time with two diagonal bracing timbers, dividing the staircase from the front rooms. The rear room most recently functioned as a kitchen.
