**HISTORIC BUILDING SURVEY OF 98-100 & 103, 105 & 107 CARPENTERS  
ROAD, STRATFORD, LONDON, E15**

**Written and Researched by: James Dixon  
MoLAS/PCA  
December 2004**

**Contractor: MoLAS/PCA Ltd**

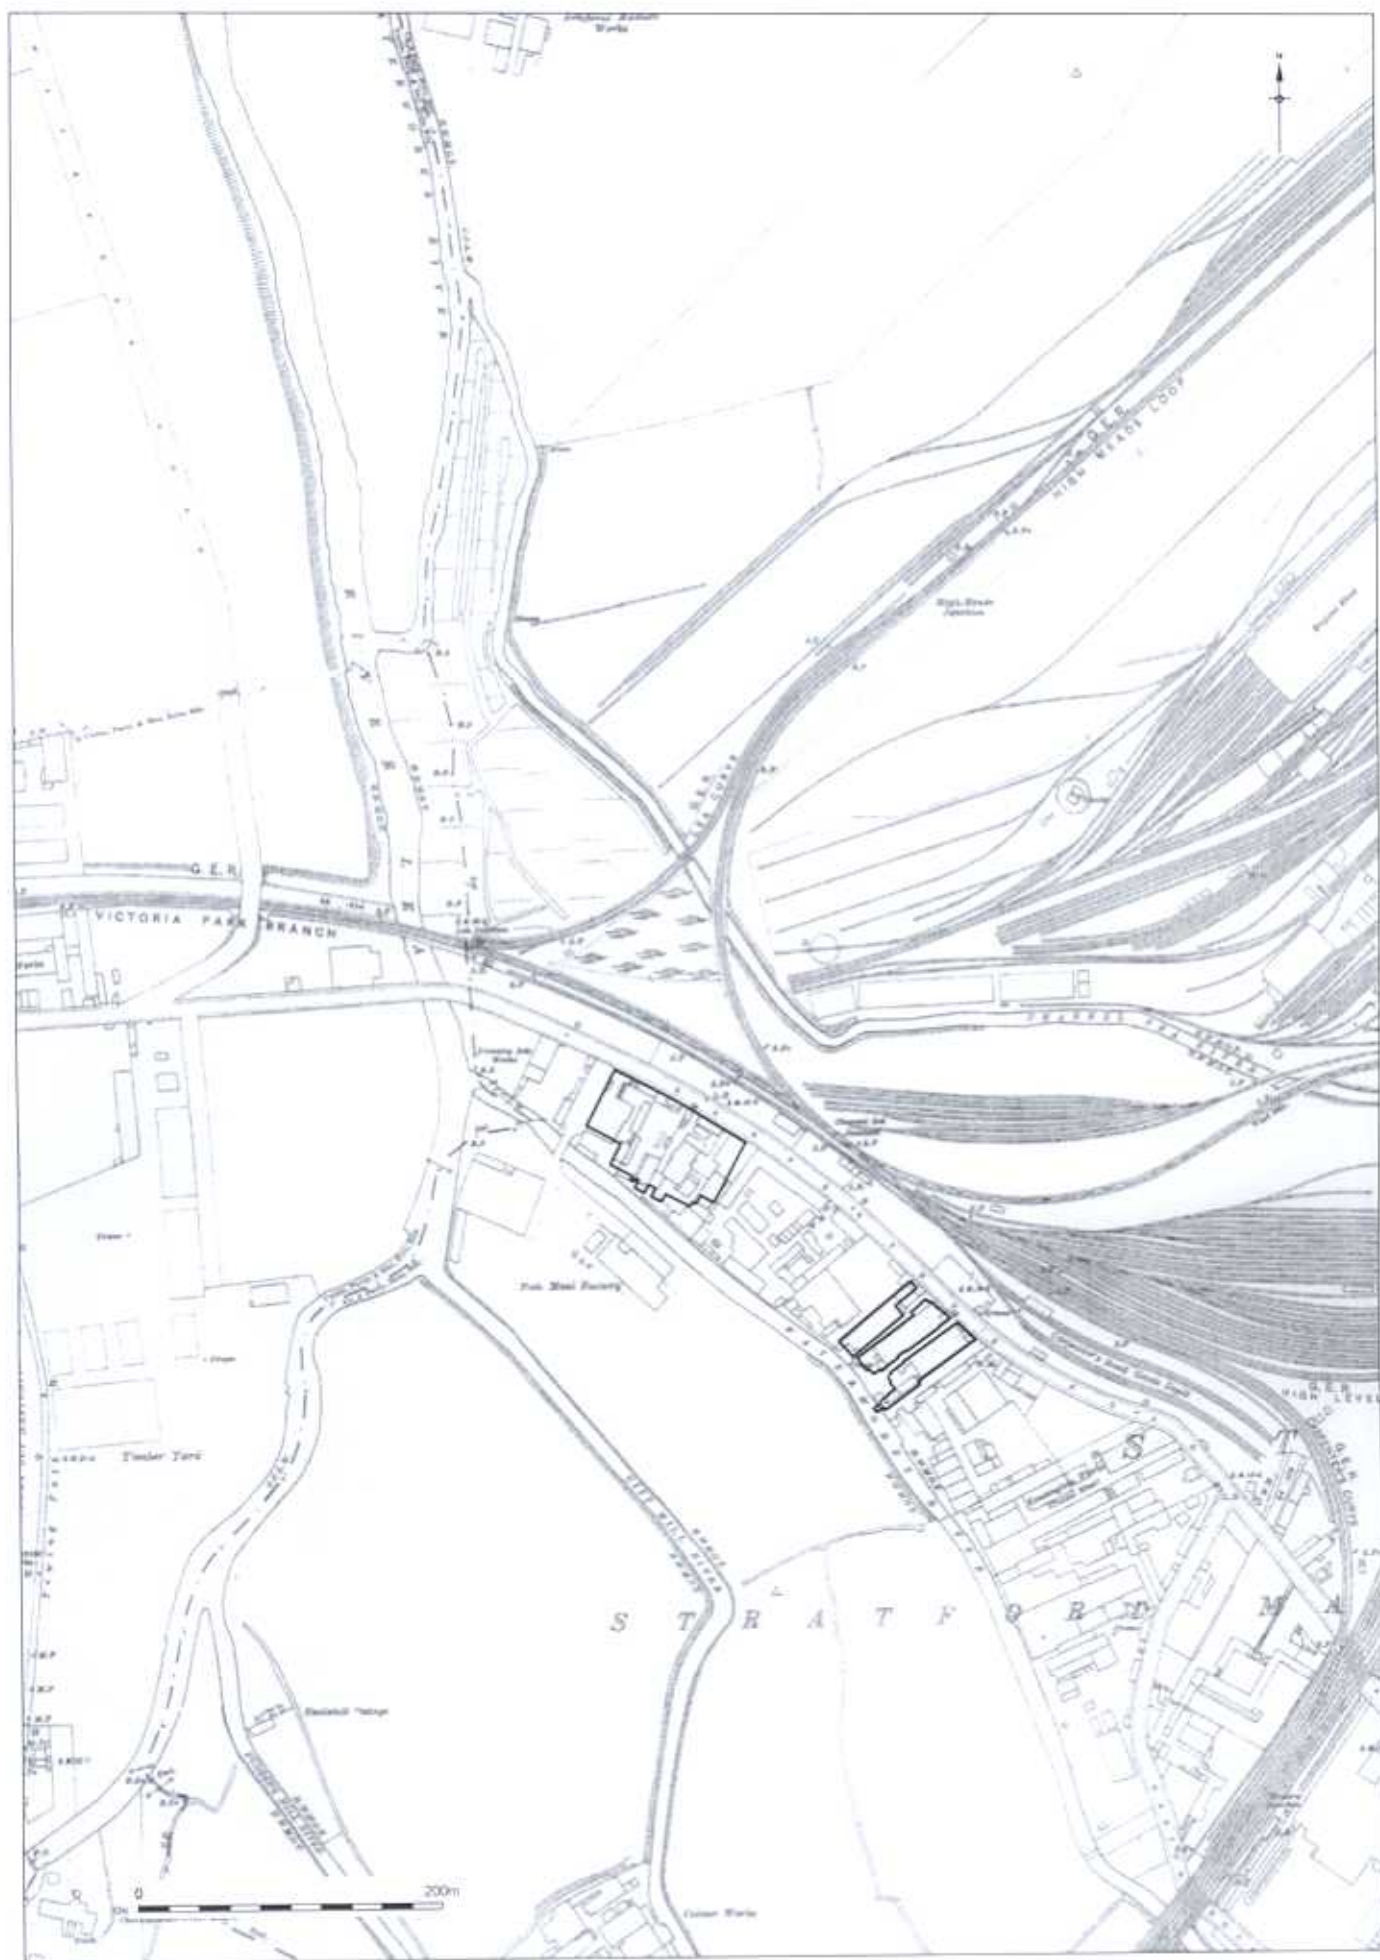
Figure 4  
3rd edition OS, 1916  
1:5,000

4.1.3 On the 1916 Ordnance Survey map (Fig 4), more development on the W side of Carpenters Road can be seen, including on the area of the Yardley factory, where there are a number of small ranges of buildings, and at the S end of the site, where there are a number of large warehouse structures.

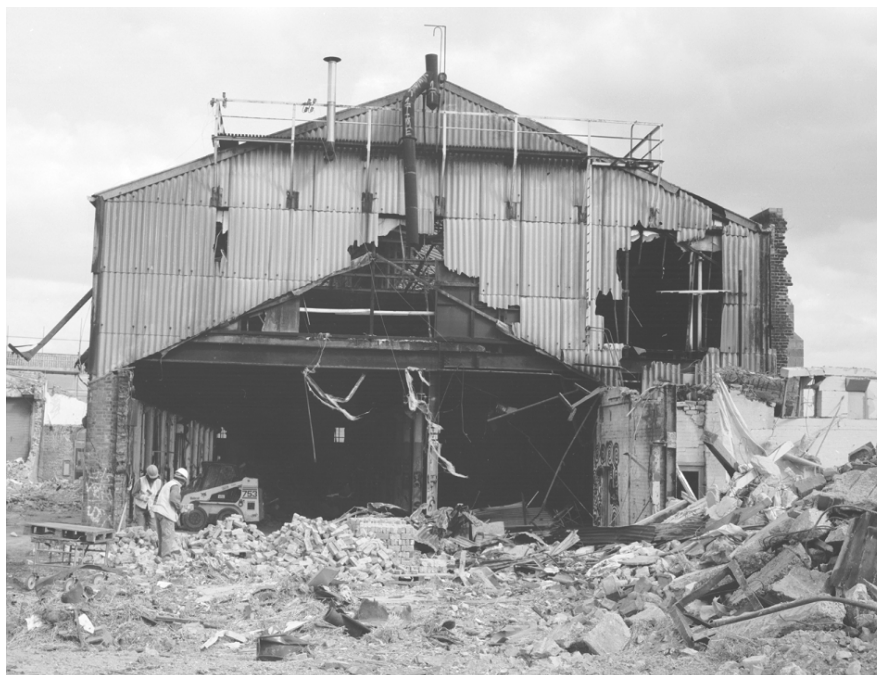
Plate 1: West Elevation of Building J1

- 5.1.5 The W elevation of the warehouse is open at ground floor level and clad in corrugated sheet asbestos at first floor level (Plate 1). There are scars of single storey projecting warehouse buildings along the W elevation and the remains of a small adjoining brick structure to the SW although these were demolished before further analysis.

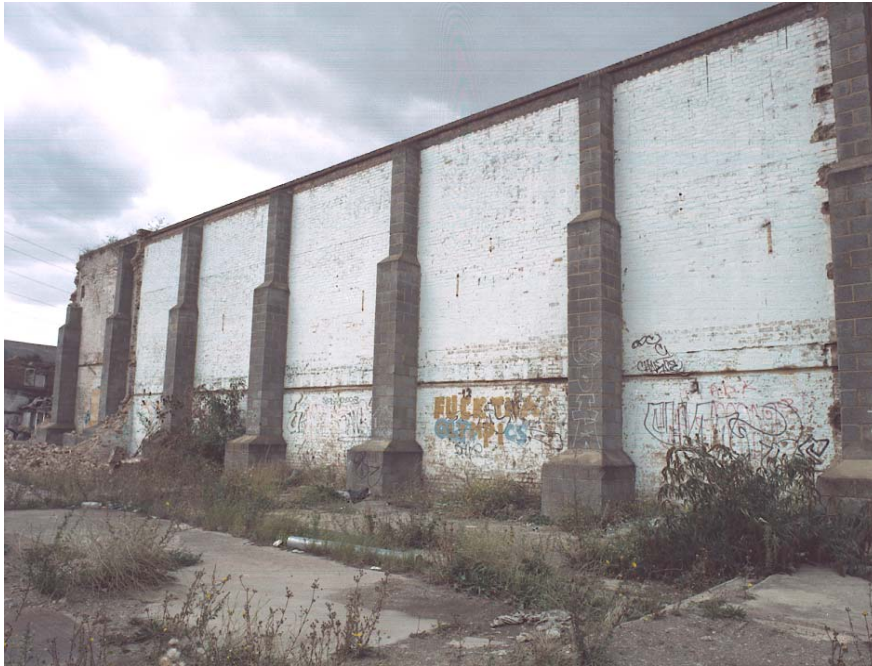
Plate 2: South Elevation of Building J1

- 5.1.6 The free-standing S elevation is of brick to just above eaves level, the wall predating the steel framed structure of J1. To the W, a bay incorporating three blocked windows at first floor level could be observed. This was, however, demolished before full analysis could be undertaken and it was recorded by photograph only (Plate 2). The remainder of the elevation, as far as access was possible, is of brick type 3032<sup>9</sup> laid in English bond. It is buttressed on its N side by regularly spaced brick pilasters that are continued on the exterior in breeze block. These are on an different alignment, offset from the steel columns of the main frame of the building (see 5.1.7).

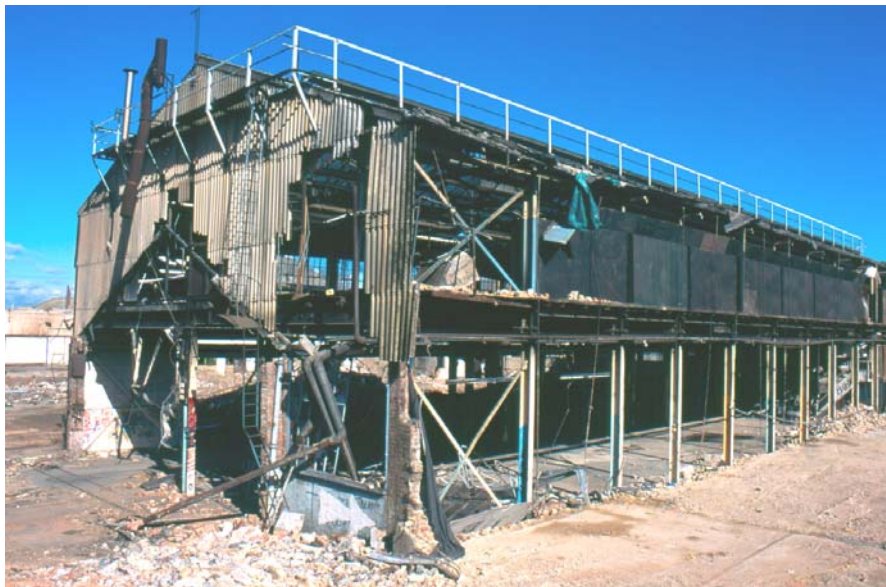
Plate 3: South Elevation of Building J1 showing exposed steel framing

5.1.7 The steel frame of the building is of 14 bays E-W (Fig 5, Plate 3) with three lines of columns forming two bays N-S. The stanchions are of rolled 'I' sections. The N row of steel stanchions are made by, and bear the stamps of, a number of different manufacturers; *Skinningrove England*, *Dorman Long & C<sup>o</sup> L<sup>td</sup> Middlesborough England*, and *Appleby - Frodingham*. All are made to imperial measurements of 10" x 6" and are rolled with 8° flanges dating them to after c.1880-1910. The longitudinal girders supported by the N row are all made by *Skinningrove England* as far as can be discerned. The central row of stanchions are made by the same three manufacturers with their corresponding supported longitudinal girders being of *Skinningrove England*, *Appleby - Frodingham*, and *Shelton England*. All are made to imperial measurements of 10" x 8" and are rolled with 8° flanges. The S row of stanchions are of the same dimensions as the N, however, all the stanchions in the row and the longitudinal girders they support are manufactured by *Skinningrove England*. All of the girders are connected to the stanchions on supporting riveted steel brackets.

'I' section columns by means of riveted brackets, which are then bolted to a connecting steel plate.

- 5.1.9 In the N bay, the crane mechanism and rails, supported by brackets bolted to the columns, are constructed by *Dorman Long & C<sup>o</sup> L<sup>td</sup> Middlesborough England*. The cranes themselves bear the marking 50 CWT.
- 5.1.10 Although there was no direct access to the first floor of the warehouse, it was possible to observe that the roof is a light steel frame construction of trusses of the Polonceaux or Fink family adapted for three purlin bays and supported by steel stanchions directly above those on the ground floor. It was not possible to observe how the stanchions and trusses were connected.

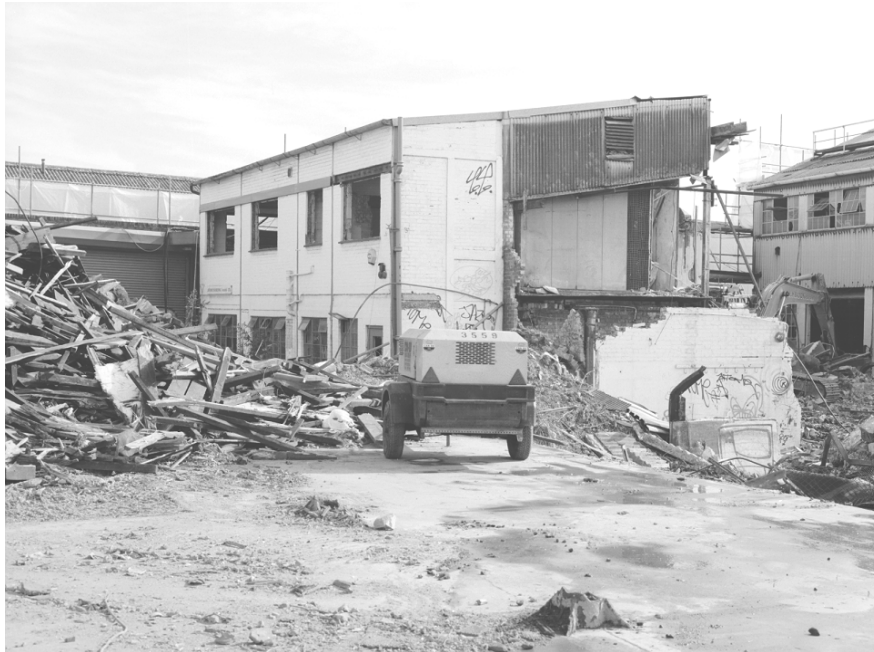
Plate 4: West elevation of Building J3

5.3.2 The W elevation of the building is of white painted brick of fabric 3035<sup>10</sup> laid in stretcher bond to the N, implying a light cladding, and a mixture of Fletton brick laid in stretcher bond at ground floor level with corrugated sheet asbestos over to the S (Plate 4). The ground floor brick is built around a cast iron column supporting an 'I' section steel beam that in turn supports the first floor. The fact that the first floor is open with evidence of a sloping roof above indicates that the building continued to the W prior to the commencement of demolition.

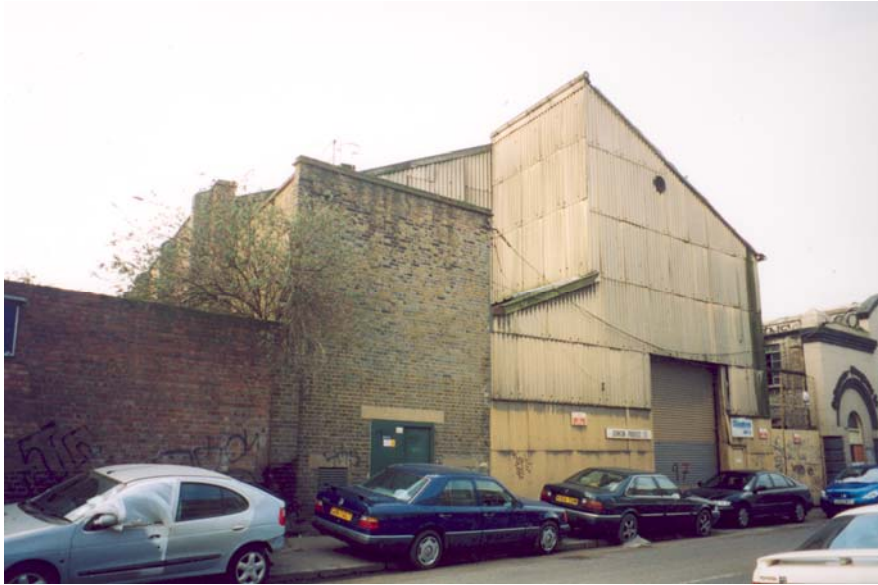
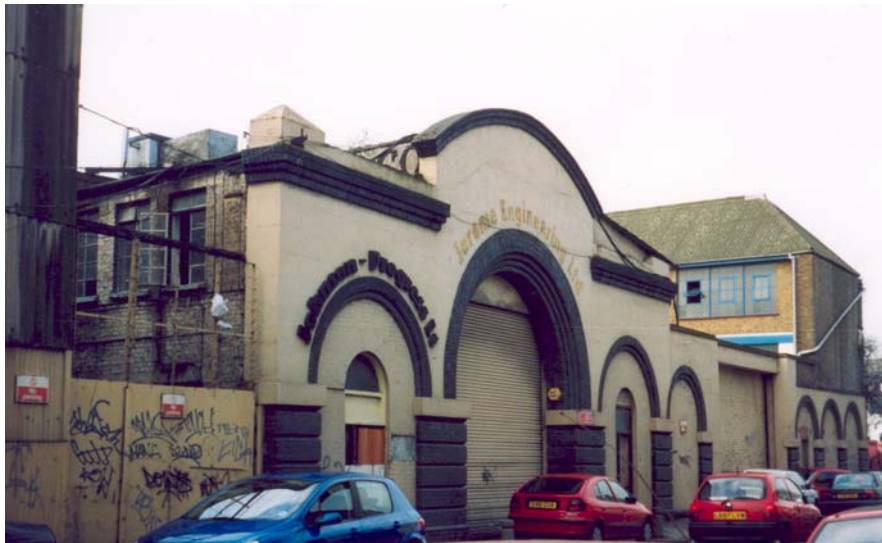
5.6 East façade (south) (Fig 6) (Plate 6a/b).

5.6.1 The east façade of this complex can be divided into two, that of building J1 and that of buildings J3 – J5, these being separated by a steel gateway leading to area J2.

- 5.6.4 The E façade of buildings J3 – J5 can be seen to demonstrate three possible phases of development.
- 5.6.5 Running the length of all three buildings is a brick and concrete rendered arcuated façade. On building J3 it has four arches of descending sizes from the second from the S. The arches are in blue bull-nose engineering brick and are supported by rusticated piers of blue brick each topped by a plain white painted concrete capital. Running from the south, the first arch is filled with painted Fletton brick and an arched doorway with a space for a removed fanlight in the tympanum, the second, largest arch with a roller shuttered door, the third infilled in the same manner as the first, and the fourth is blind, filled with white painted concrete blockwork.

- 5.6.7 At ground floor level on the façade of building J5, the three arches are all of the same size, with the same blue brick arches and rusticated piers as elsewhere. The northernmost two are blind, filled with painted concrete blockwork and the southernmost has a door surrounded same concrete blockwork.

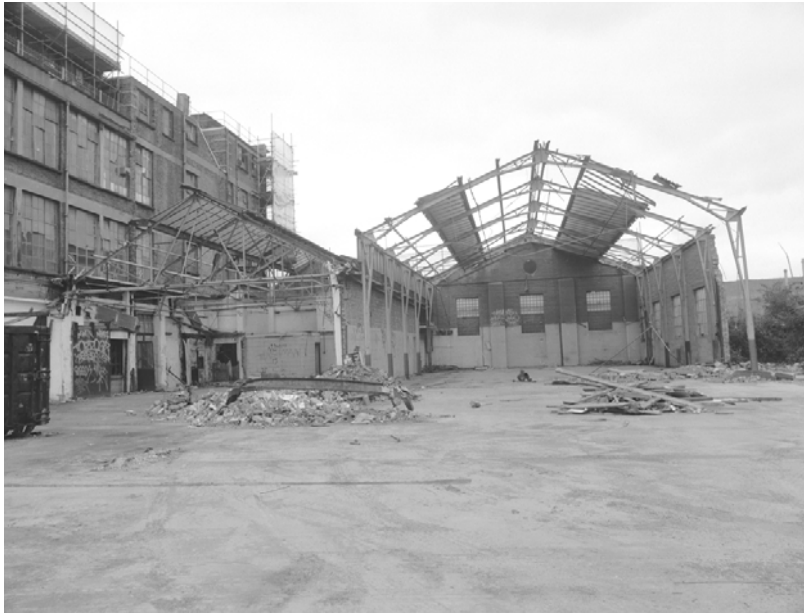
Plate 7: Buildings Y1 and Y2 from the west

- 5.7.3 The material used for the roof covering was unclear as it had been removed before the beginning of recording, but due to the nature of the rest of the site, it was likely to have been of corrugated asbestos. The roof also had skylights on both pitches.

- 5.7.4 The instability of elements of the surviving structure rendered building Y1 inaccessible for further detailed analysis.

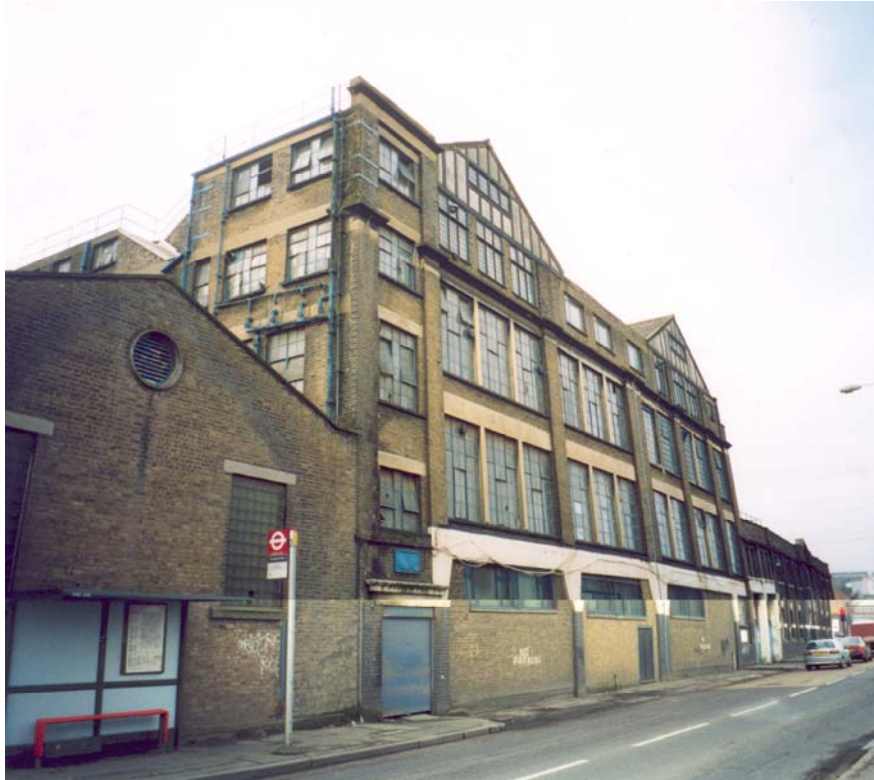
Plate 8: East elevation of Building Y3

- 5.9.5 The central of the three ground floor bays is infilled with a lighter, machine made yellow brick and does not continue the blue brick plinth. Each of the bays has a horizontally proportioned high-level casement window within it.

- 5.9.6 At the S end of building Y3, the entrance and staircase bay has a moulded concrete cornice above a roller shuttered doorway leading to the wood-panelled principal entrance lobby discussed above. This staircase rises to the top storey of the building and houses three mezzanine levels below a third floor level room, each lit by a cast iron framed casement window.

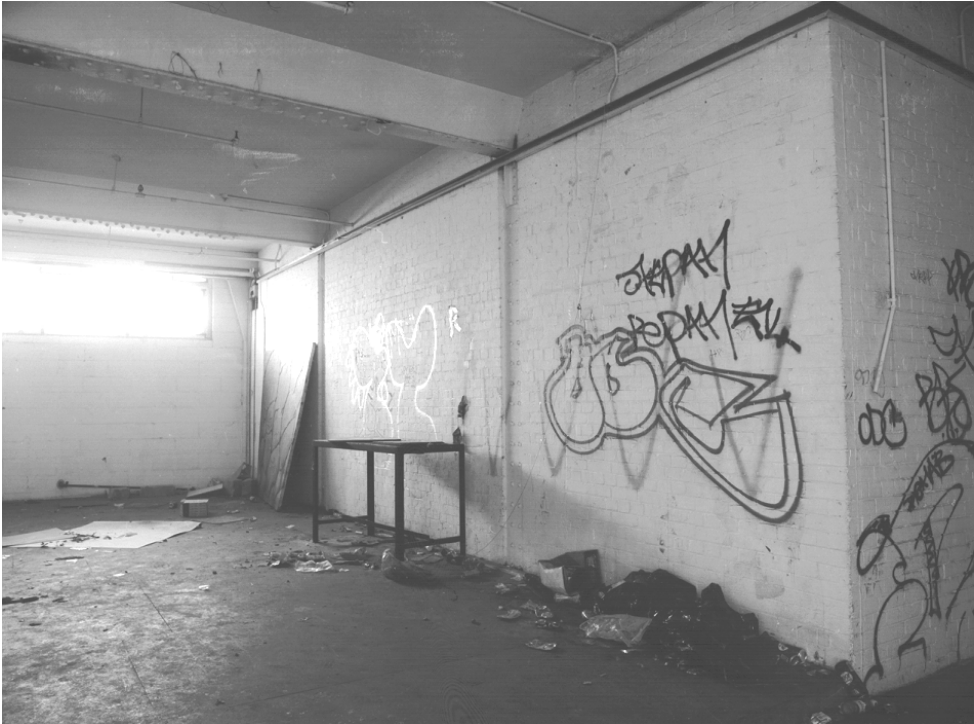
Plate 9: East ground floor of Building Y3

5.9.11 At ground floor level, the building is centred around a roofed courtyard. Steel 'I' section columns support the inner walls of both the N and S ranges that face onto the courtyard. Between these and the columns built into the exterior walls are concrete encased steel girders which are further supported centrally by another row of steel columns. The exterior columns are set into brickwork piers, and in the ground floor of the south range, the spaces between these are filled in with modern Fletton brick indicating that they were previously open to the yard area S of the building. All of the accessible columns have flange angles measuring 5° dating them to after the 1910s/1920s. The glazed roof over the courtyard is supported on a series of steel king-post trusses that are built into the brick wall rather than resting on the steel columns. In the NE corner of the ground floor, there is a white-painted brick dividing wall laid in Flemish bond extending from the N wall at the W end of the second bay from the E as far S as the fourth bay from the N as defined by the internal column grid (see Fig 9) and returning to meet the Carpenters Road elevation. In the SE of the building is a similar dividing wall to the SE laid in English bond (Plate 9) extending from the W of the SE stairwell and running N before returning to meet the Carpenters Road elevation between the third and fourth bays. The whole floor is divided further with breeze block and timber stud partitions (Plate 10).

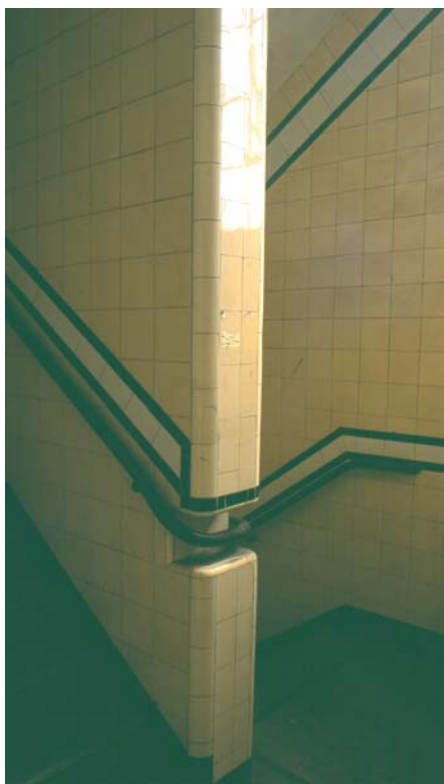
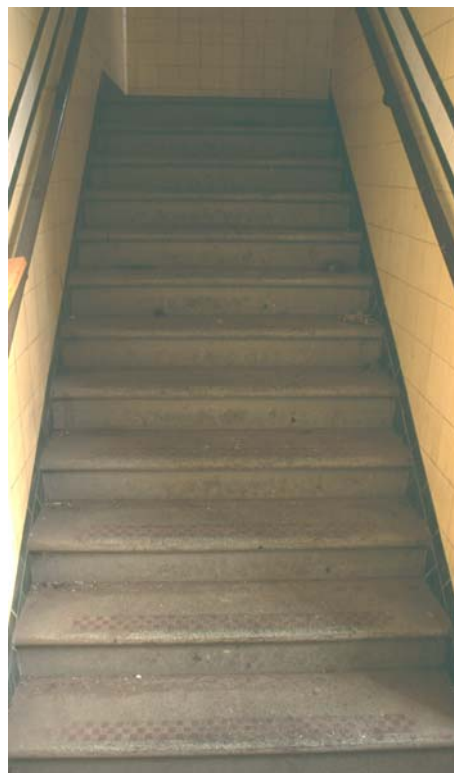
Plates 12a and b: Decoration in southeast stairwell of Building Y3

5.9.18 The SE stairwell represents the principal entrance to the building from Carpenters Road. The ground floor contains dark-wood fittings and a small glass and wood panel lobby. Rising from this, the staircase itself is of concrete with black and white tiles forming a checked pattern on the edges. The walls and central column are of brick and faced with yellow and green tiles. All of these decorative features show an Art Deco influence (Plate 12a/b). The stairwell has doorways to all levels and toilet rooms at mezzanine level between all floors.

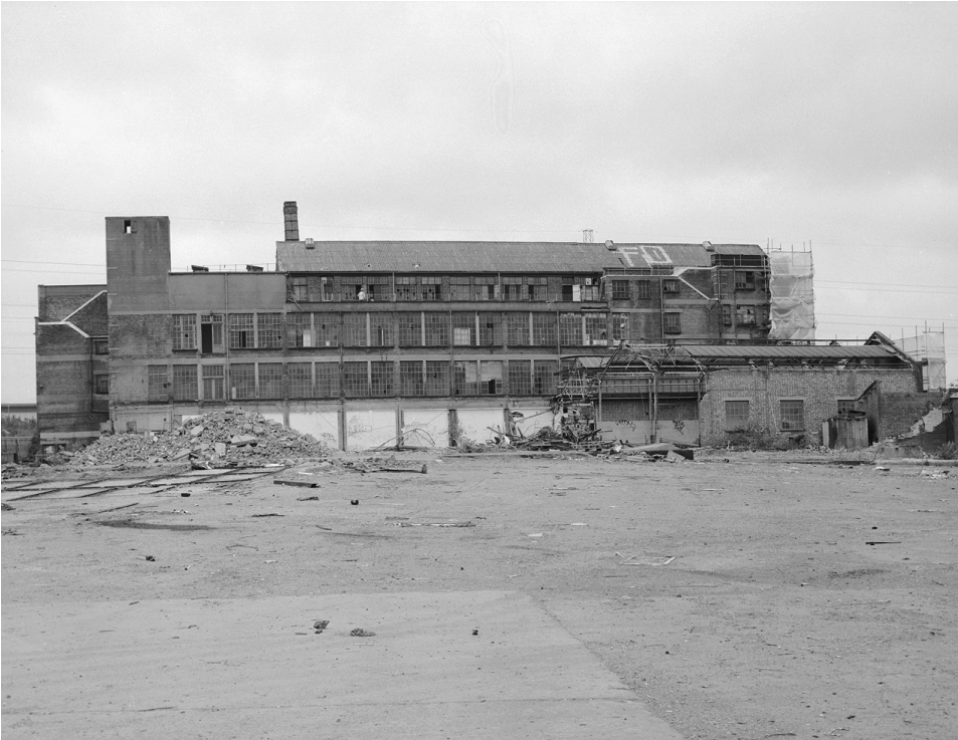
Plate 13: South elevation of Building Y3

- 5.9.3 The exterior of the building (with the exception of the E façade) is of yellow stock brick of fabric 3035<sup>14</sup> on the N, W and S faces, with blue brick dressings including the window surrounds and quoins (Plate 13). The workspace is lit by cast iron casement windows running the length of every floor. 'I' section steel hoist beams extend out from a double loading door on each of the N and S elevations above the second floor.

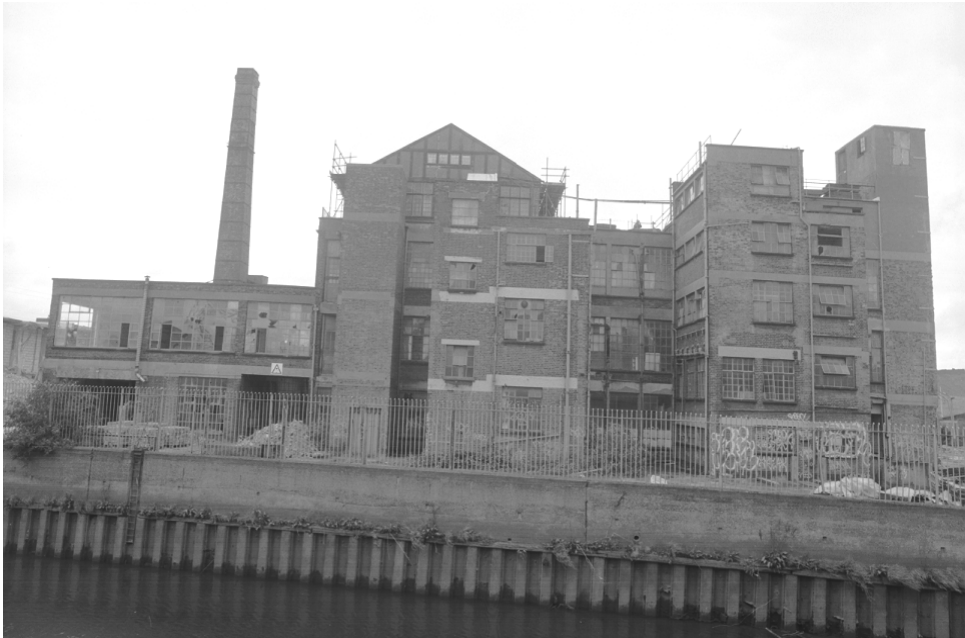
Plate 14: West elevation of Buildings Y3 and Y4

5.10 Y4 – Manufacturing workshop with chimney (Plate 14).

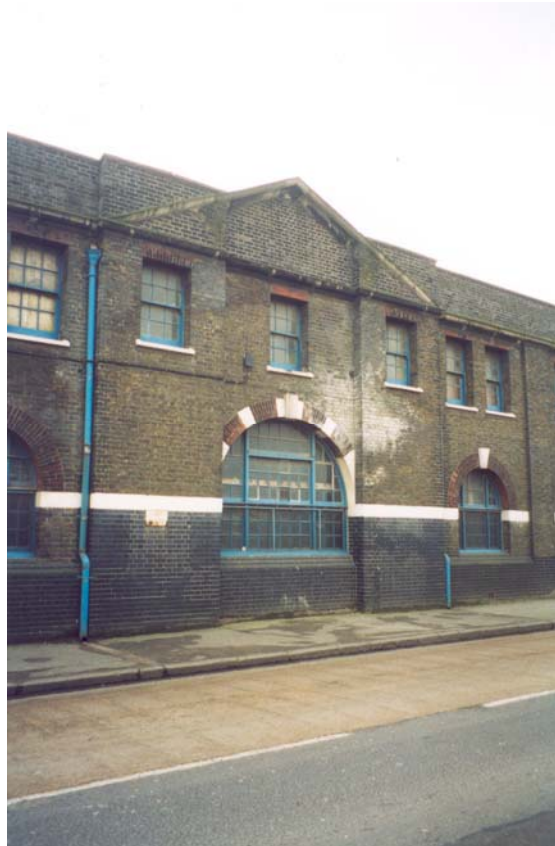
Plate 15: Centre of east elevation of Building Y5

5.11.2 The principal elevation is that facing E onto Carpenters Road with the elevations that face W into the yard and N onto Marshgate Lane being more utilitarian. The E (Fig 7) and W faces of the range are built in red brick of fabric 3032<sup>18</sup> with occasional burning and laid in English bond. The E elevation (Plate 15) is Classical with the orders expressed by plain pilasters between the chamfered plinth and a plain brick cornice. The elevation is divided by the pilasters into eleven bays. Each bay has a ground floor arched window with a red gauged brick semi-circular arch with a white painted stone keystone. Above each arched window, there is a pair of red sash windows on the first floor. There is a stone string course halfway up the ground floor. The principal three bays of this elevation are emphasised by a triangular pediment set over a three bay projection with a large arched window occupying its central recessed bay and three single rectangular sash windows on each of the first floor bays. At the S end of

5.11.4 Other features were removed before the beginning of the recording process, but can be seen on Plates 15 and 16. Plate 17 shows that at least parts of the upper storey were open to the roof, that this floor was used as workshops and that the workspace was both top-lit and lit by continuous fenestration on the W side of the building.

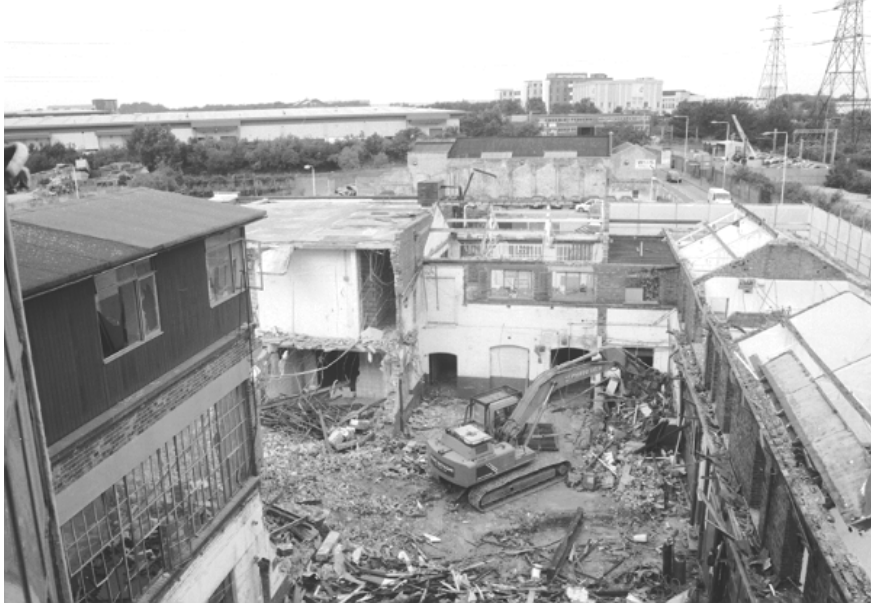
Plate 16: Buildings Y5 and Y6 during demolition

5.11.1 The demolition and recording programmes were undertaken concurrently. The former precluded recording of this nine bay range and it was only possible to fully record the roadside elevation. All other descriptions were written from a distance due to the presence of active heavy plant (Plate 16).

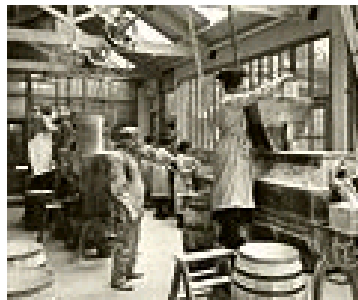
Plate 17: Historic interior of Building Y5

5.11.3 It was not possible to get close enough access to the range to make a detailed recording of the internal structure. It was, however, observed that the roof was supported by steel king post trusses in the southernmost four bays as defined by the pilasters of the E elevation, and by timber king post trusses above the northernmost five. The king posts have splayed heads and sloping joggles supporting raking braces towards their bases. The timber trusses were strengthened with wrought iron bolts and straps. Unusually, the principal rafters are set into notches cut into the tie beams. It was possible to record one of the wooden trusses by hand after its removal from the building (Fig 12). The wooden truss is particularly interesting as its style indicates an earlier phase of building than on the rest of the site. Plate 17 shows this truss during early use of the range.
