**AN ARCHAEOLOGICAL
EVALUATION AND BUILDING
RECORDING INVESTIGATION
AT THE BRITISH MUSEUM
NORTH WEST
DEVELOPMENT,
BLOOMSBURY, LONDON WC1**

British Museum, North West Development,
Great Russell Street, London Borough of Camden

Evaluation & Building Recording Investigation

Site Code: MPB09

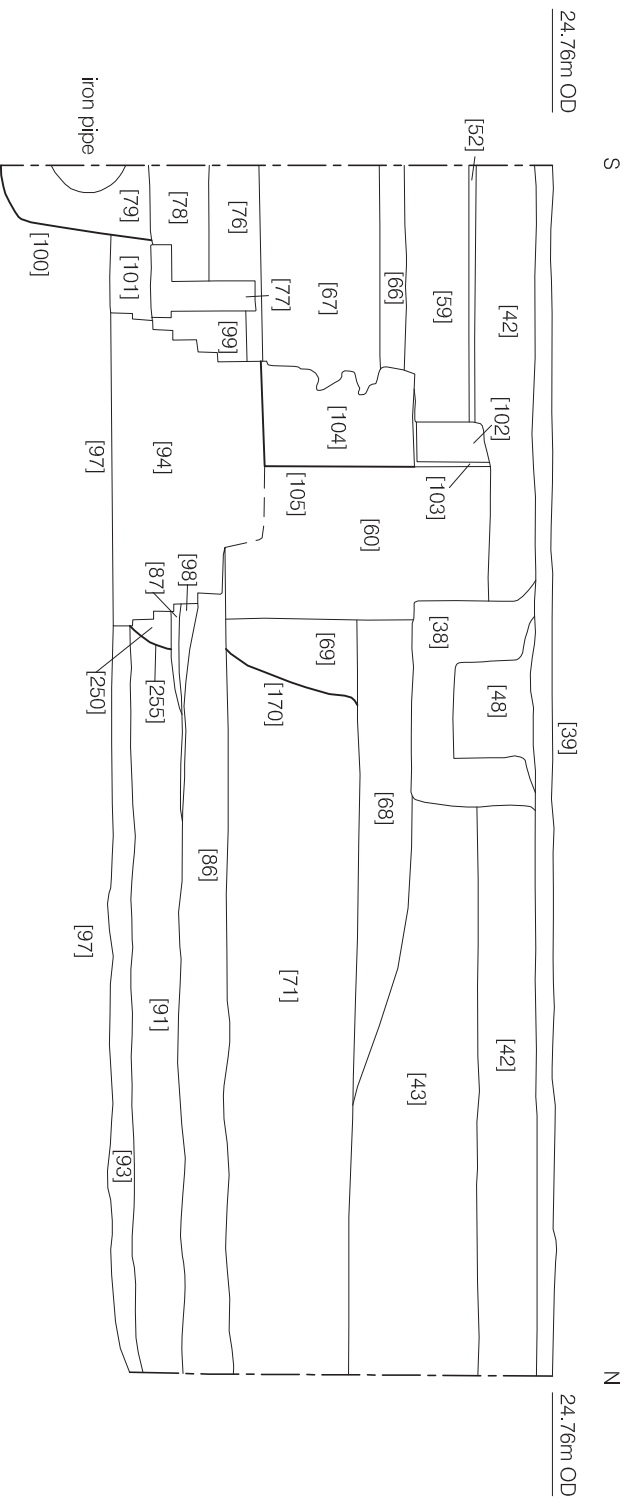
Figure 7
Trench 3, east facing section
1:25 at A4

Section 8
Trench 3
East Facing

7.3.3.2 Above this stepped foundation the main body of the wall [60] on the north facing elevation was wider than the foundation (Plate. 1, Figs. 6 & 7). This wider upper section of wall was constructed from exactly the same bricks as the lower foundation from a height of 23.68m O.D. There was no obvious reason for this change of design, other than a desire for a wall of greater thickness and may suggest a hiatus between the foundation and wall construction. No attempt was made to dismantle the wall to address this question and should be answered by further and more thorough excavation at a later date. The fifth course was also unusual in that the bricks were headers laid on their sides with very deliberate gaps left between each brick. The eighth course was set back from those beneath to create a small 5cm step and the wall was then vertical until its truncation at 24.56m O.D.

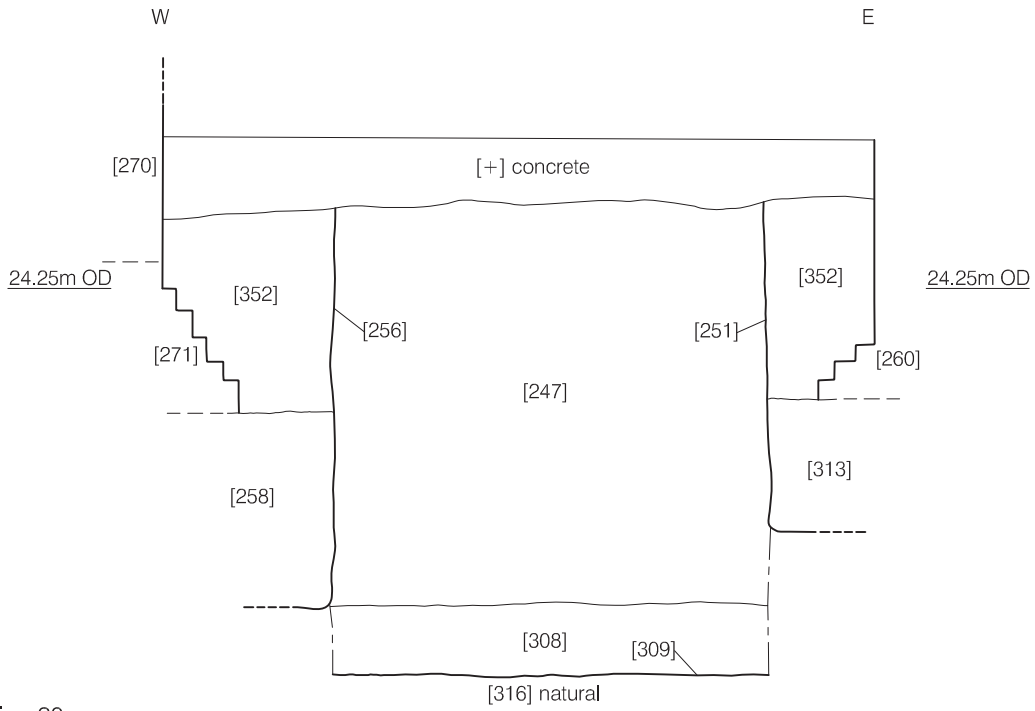
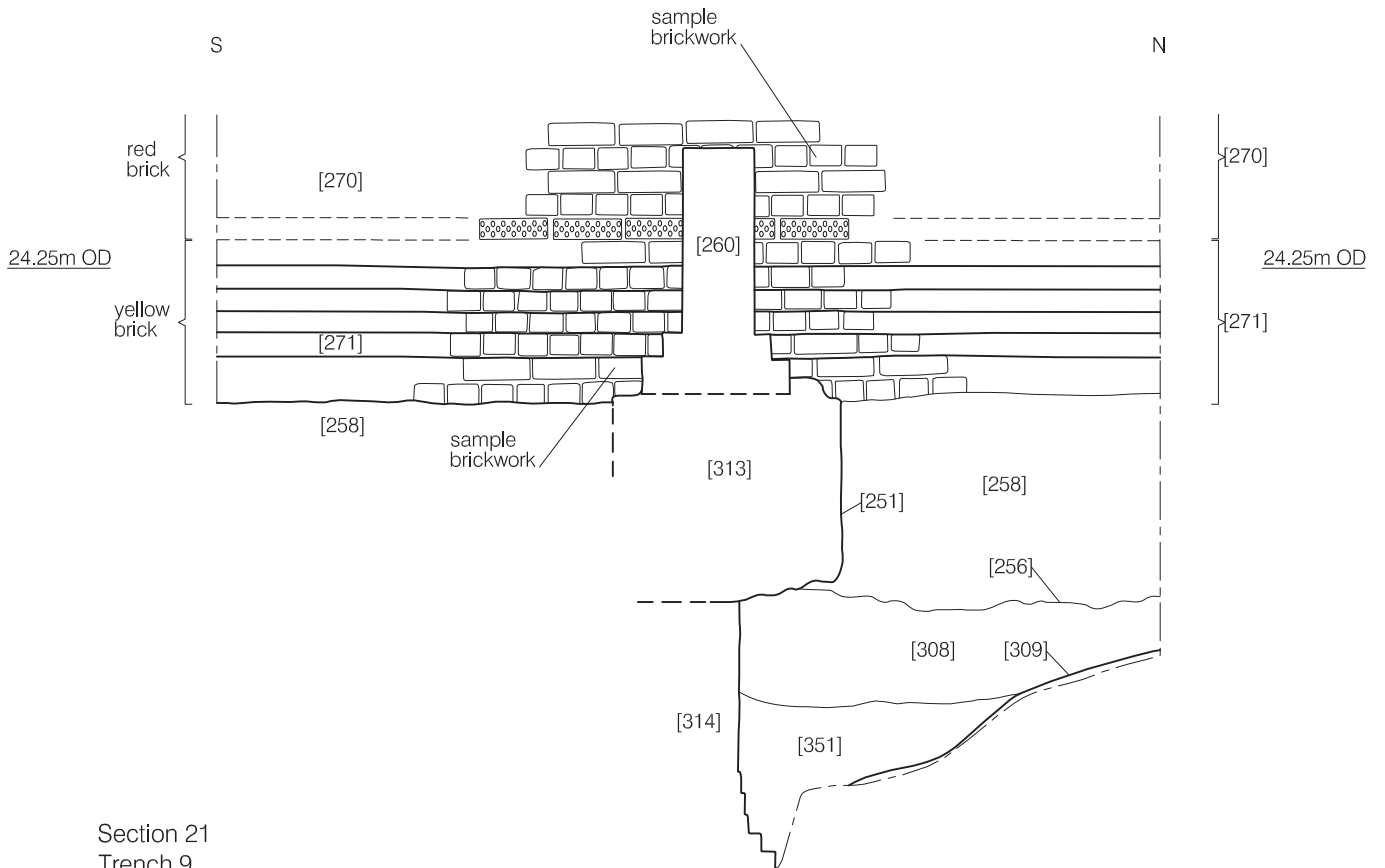
Figure 20
Trench 9, south and east facing sections
1:25 at A4

Section 20
Trench 9
South Facing

Section 21
Trench 9
East Facing

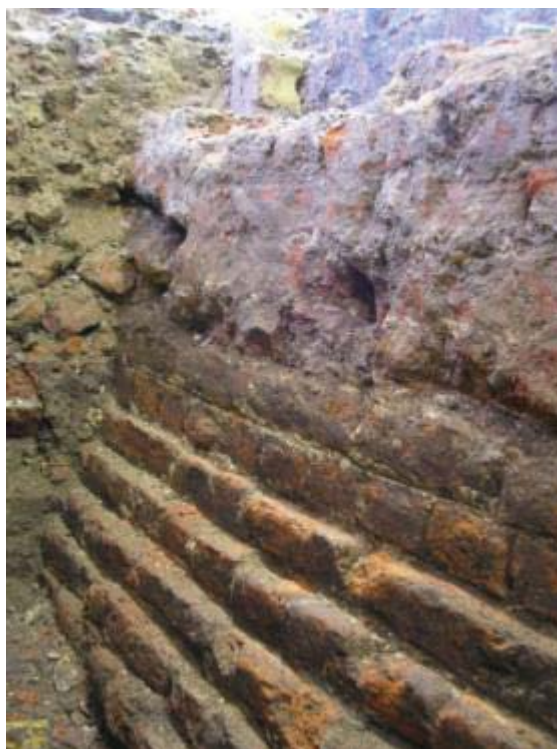
Plate 2. Trench 3, south facing elevation of Montagu House boundary wall, showing rebuild of upper section.

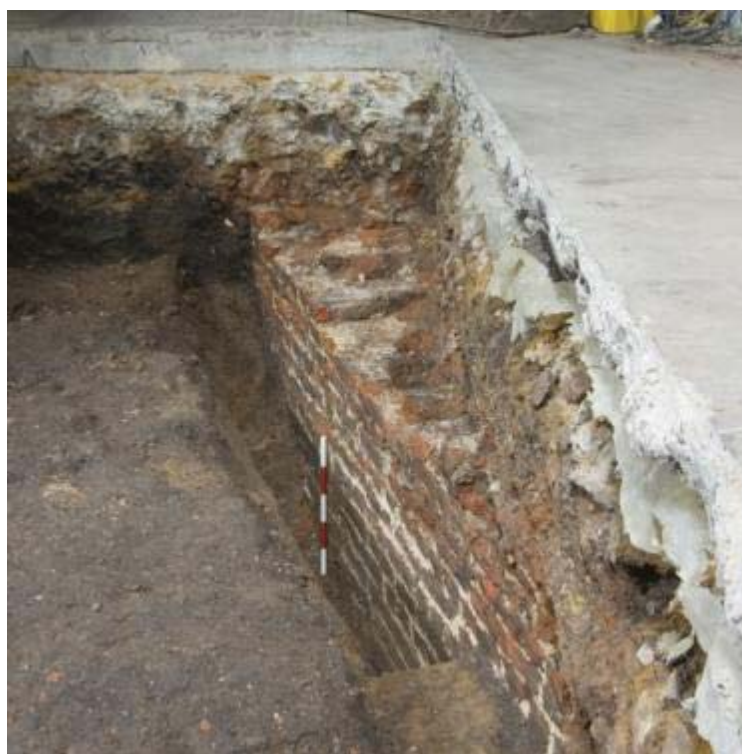
Plate 4. Trench 5, detail of exposed Montagu House boundary wall, looking east.

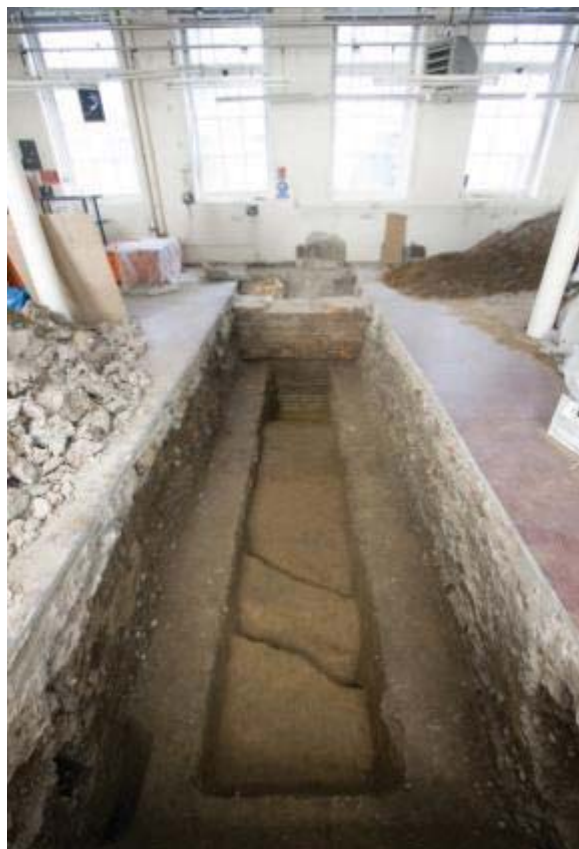
Plate 5. Trench 7, linear cuts and Montagu House boundary wall looking south.

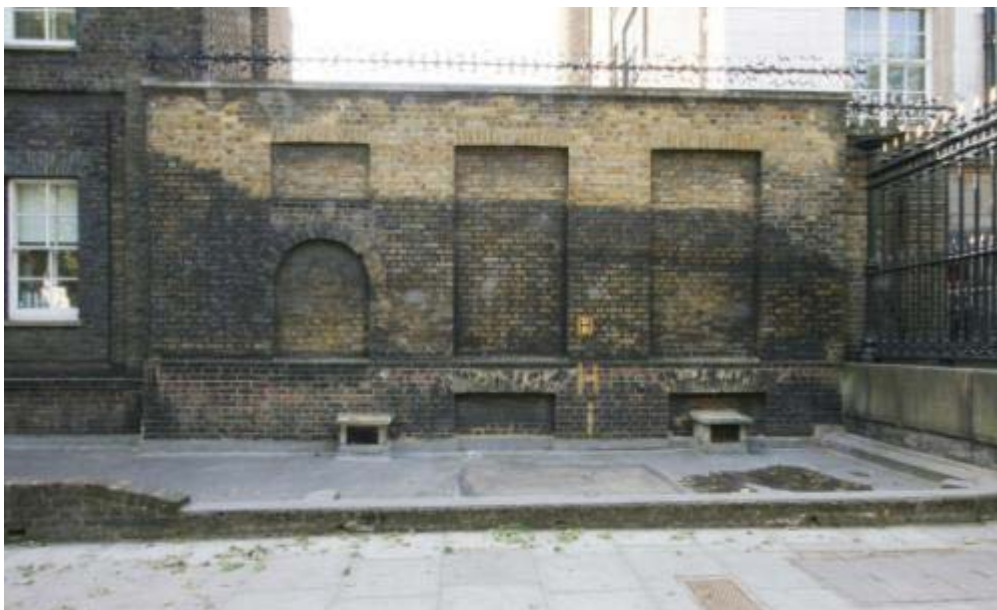
Plate 9. Trench 6, north facing elevation of carpenters' workshop north wall. The lowest section of red brick forms the basement of the original building, the infilled arched doorway relates to the porters lodge behind and the upper yellow brick section is associated with the construction of the workshop.

8.5.1 After this adjacent building had been built a small square structure was erected in the north east corner of the area once occupied by the house fronting onto Montague Place. It was built against the extension to 38 Russell Square and reused the low wall [8] that survived from the original terraced house. Approximately 2m square, this building had yellow brick stepped foundations [25] and a flagstone floor [26] at 25.81m O.D. (Plate 13). To give access to Montague Place a doorway was created in the original house wall [8] in the same place as the original house entrance. However, to provide this access at street level, rather than slightly above, as was the case with the original front door of the terraced house, a section of original wall [8] was removed. To create the north wall of this new structure, wall [8] was raised in height along its length. This brickwork was executed in a yellow stock brick and coursed in Flemish bond. The north facing elevation of the wall had an arched doorway and two blind windows, which were approximately aligned with the two blocked basement windows beneath (Plate 9).

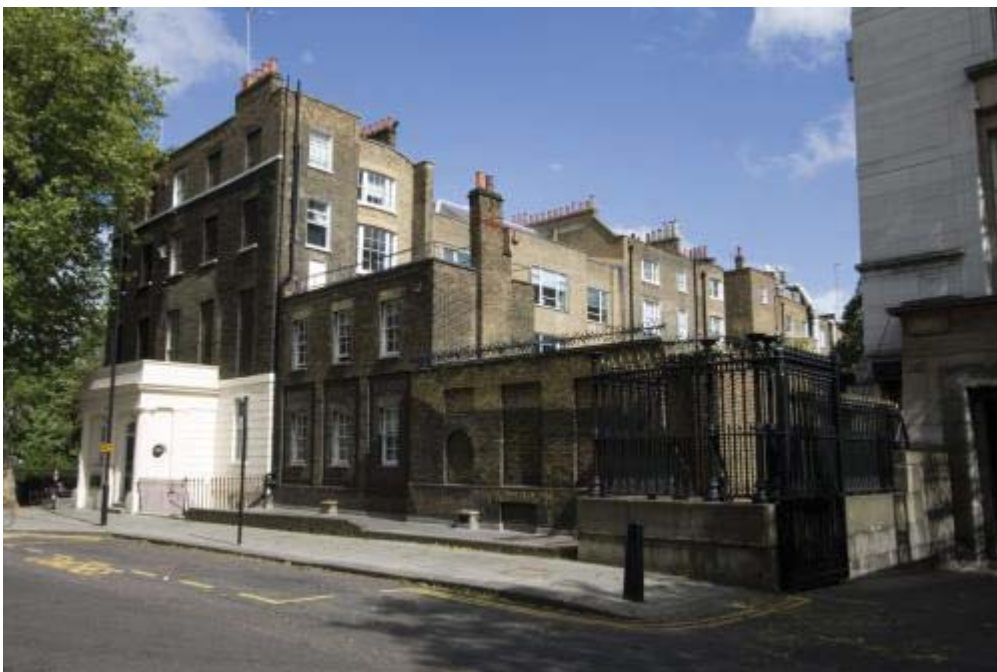
Plate 10. Trench 6, location of workshop looking south east from Montague Place. On the left are the Georgian terraces facing onto Russell Square and on the right is the north eastern corner of the King Edward VII Gallery, with vehicle access to the rear of the British Museum.

8.4.3 After demolition of the building and backfilling of the basement the next phase of activity was the construction of an extension to 38 Russell Square (plate 10). This basemented building had a ground and first floors and reused the eastern wall of the basement of the demolished building.

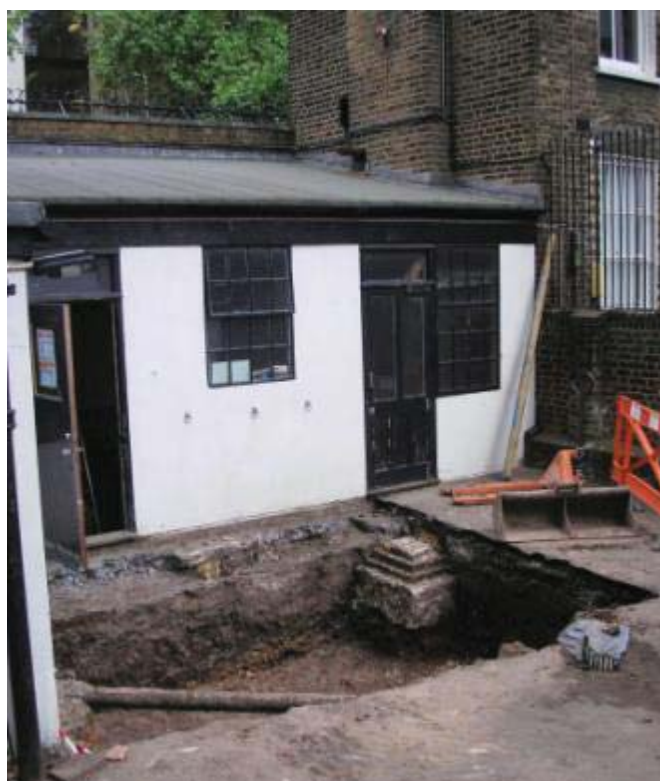
Plate 12. Trench 6, external view of workshop and excavations looking northeast.

8.7.4 As there were no windows in the pre existing walls, all light into the workshop came from windows in the new walls. These differed in style and age between the main structure and the kitchen wing. The main structure had three windows of two sizes, but all of the same design and material (Plate 12). The metalled framed windows were made up of a number of rectangular glass panes set into two halves. The upper
