BUILDING RECORDING OF
THE COAL AND FISH
OFFICES
KING'S CROSS CENTRAL
LONDON BOROUGH OF
CAMDEN

SITE CODE: KXE08

DECEMBER 2009

Building Recording

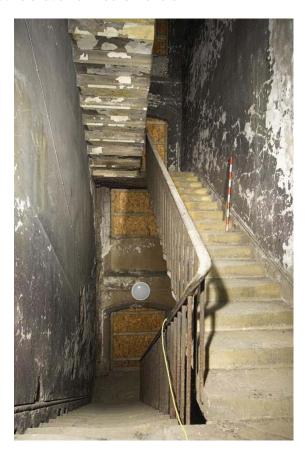
Plate 10: Internal stairwell in Block 2

- 5.3.19 A dog-leg, self-supporting staircase constructed of interlocking stone steps with heavily worn treads, runs in an anti-clockwise direction centrally up the building (**Plate 10**). The balustrade has slender squared wrought iron balusters and a wooden handrail (**Figure 29**). The southern half-landings, between ground and first floors and first and second floors, cut across the middle of the window openings (**Plate 10**).

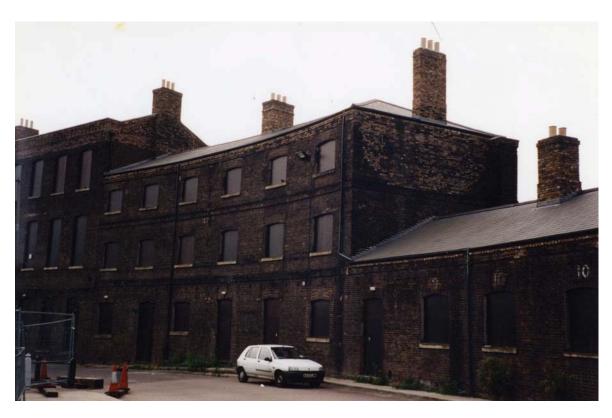
Plate 14b: Front (north) elevation of Block 3 (photograph by Michael Bussell)

brick at the sides and centre. The windows in Block 3 are not as tall as those in Block 2. At first and second floor levels, the six equally spaced window openings in Block 3 are in the same style. Those at ground and first floor level are the same size, while those at second floor level are slightly shorter (**Figure 11**; **Plate 14b**). All the original doors and windows have been replaced with modern wooden boarding. The former sash windows in this block had larger panes than the former windows in Blocks 1 and 2 and were grouped two by two.

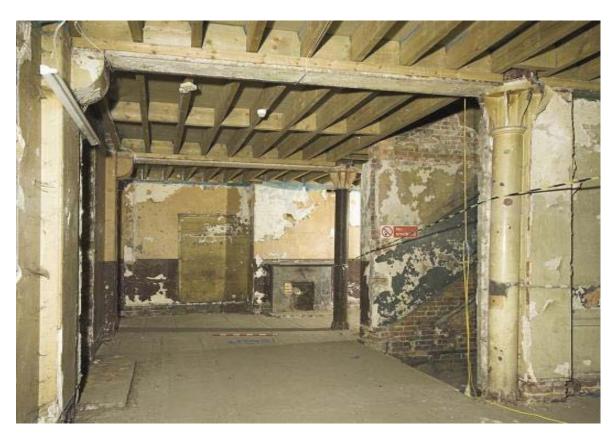
Plate 15: Concrete slab floor and columns in Room CFO3G1

- 5.4.16 The late 1990s replaced ground floor is of precast concrete joists and hollow concrete blocks as in Block 2 (**Plate 15**). The replaced first and second floors are of chipboard on modern timber joists. The second floor is spanned by a series of battens and timber gangnailed trusses, which support the rebuilt roof. All the windows and doors had been removed, in some cases damaging the surrounding brickwork.

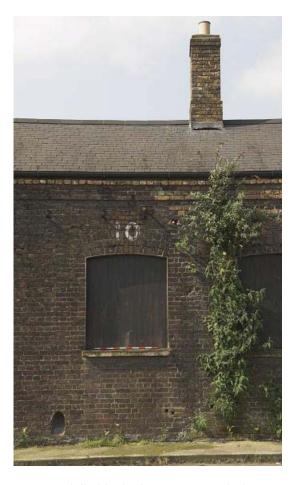
Plate 18: Former doorway partially blocked to create a window opening in the north wall of Block 4

- 5.5.4 The window opening within the fourth bay from the east is narrower than the other window openings. From the replacement brickwork located beneath the window sill, it is clear that an earlier doorway had been partially infilled to create the window (**Plate 18**). The window sill is thinner and therefore not original.

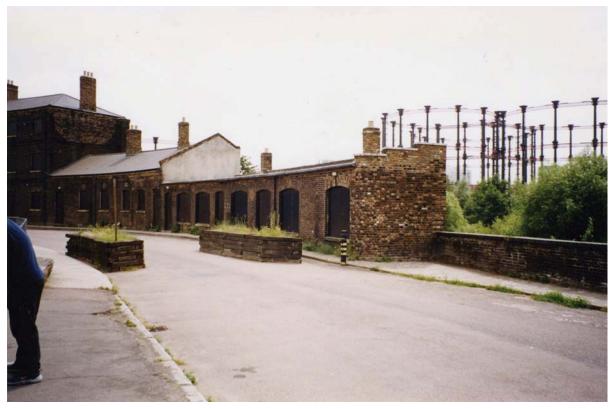
Plate 21: Front (north) elevation of Block 5 (photograph by Michael Bussell)

Front (North) Elevation (Plate 21, Figure 11)

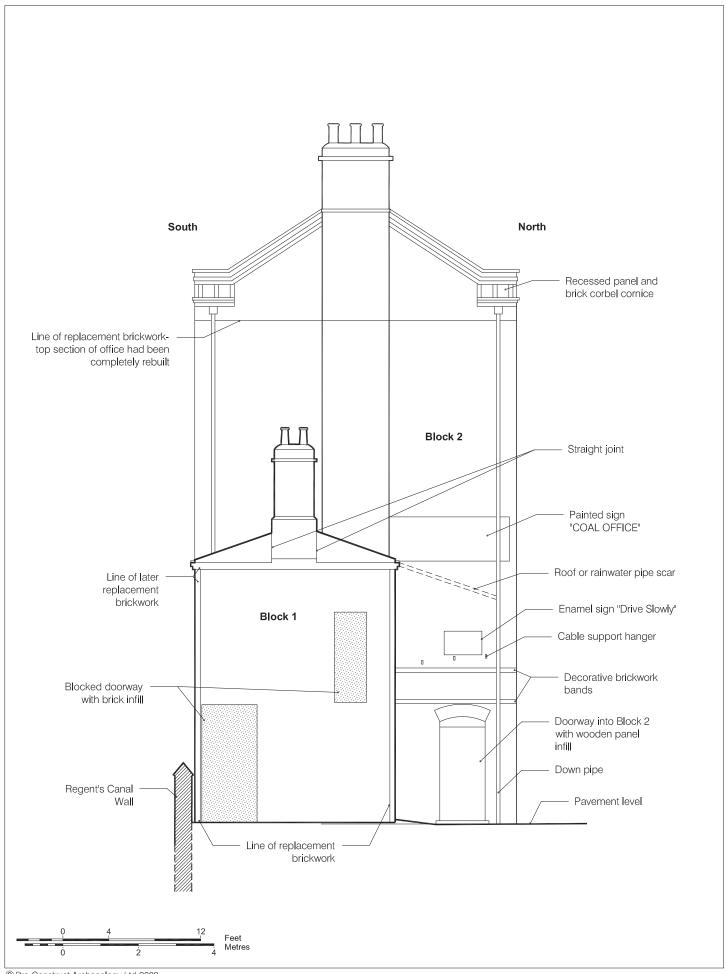
Figure 13
East Elevation
Coal and Fish Offices
1:100 at A4

- 5.3.11 The side (east) gabled elevation is partially obscured by Block 1 (**Plate 1a**, **Figure 13**). At ground floor level, there is a doorway with a segmental brick arch with three courses of brickwork at the northern end of the elevation. The original door has been replaced with a modern one. Above the door is an enamel 'Drive Slowly' sign and above is a faded painted sign that reads 'Coal Office'.
