**BUILDING RECORDING OF  
THE BOUNDARY WALL  
BETWEEN NO.S 1 AND 1A  
MONTAGUE PLACE, BRITISH  
MUSEUM, LONDON  
BOROUGH OF CAMDEN**

**SITE CODE: MPB 09**

**OCTOBER 2009**

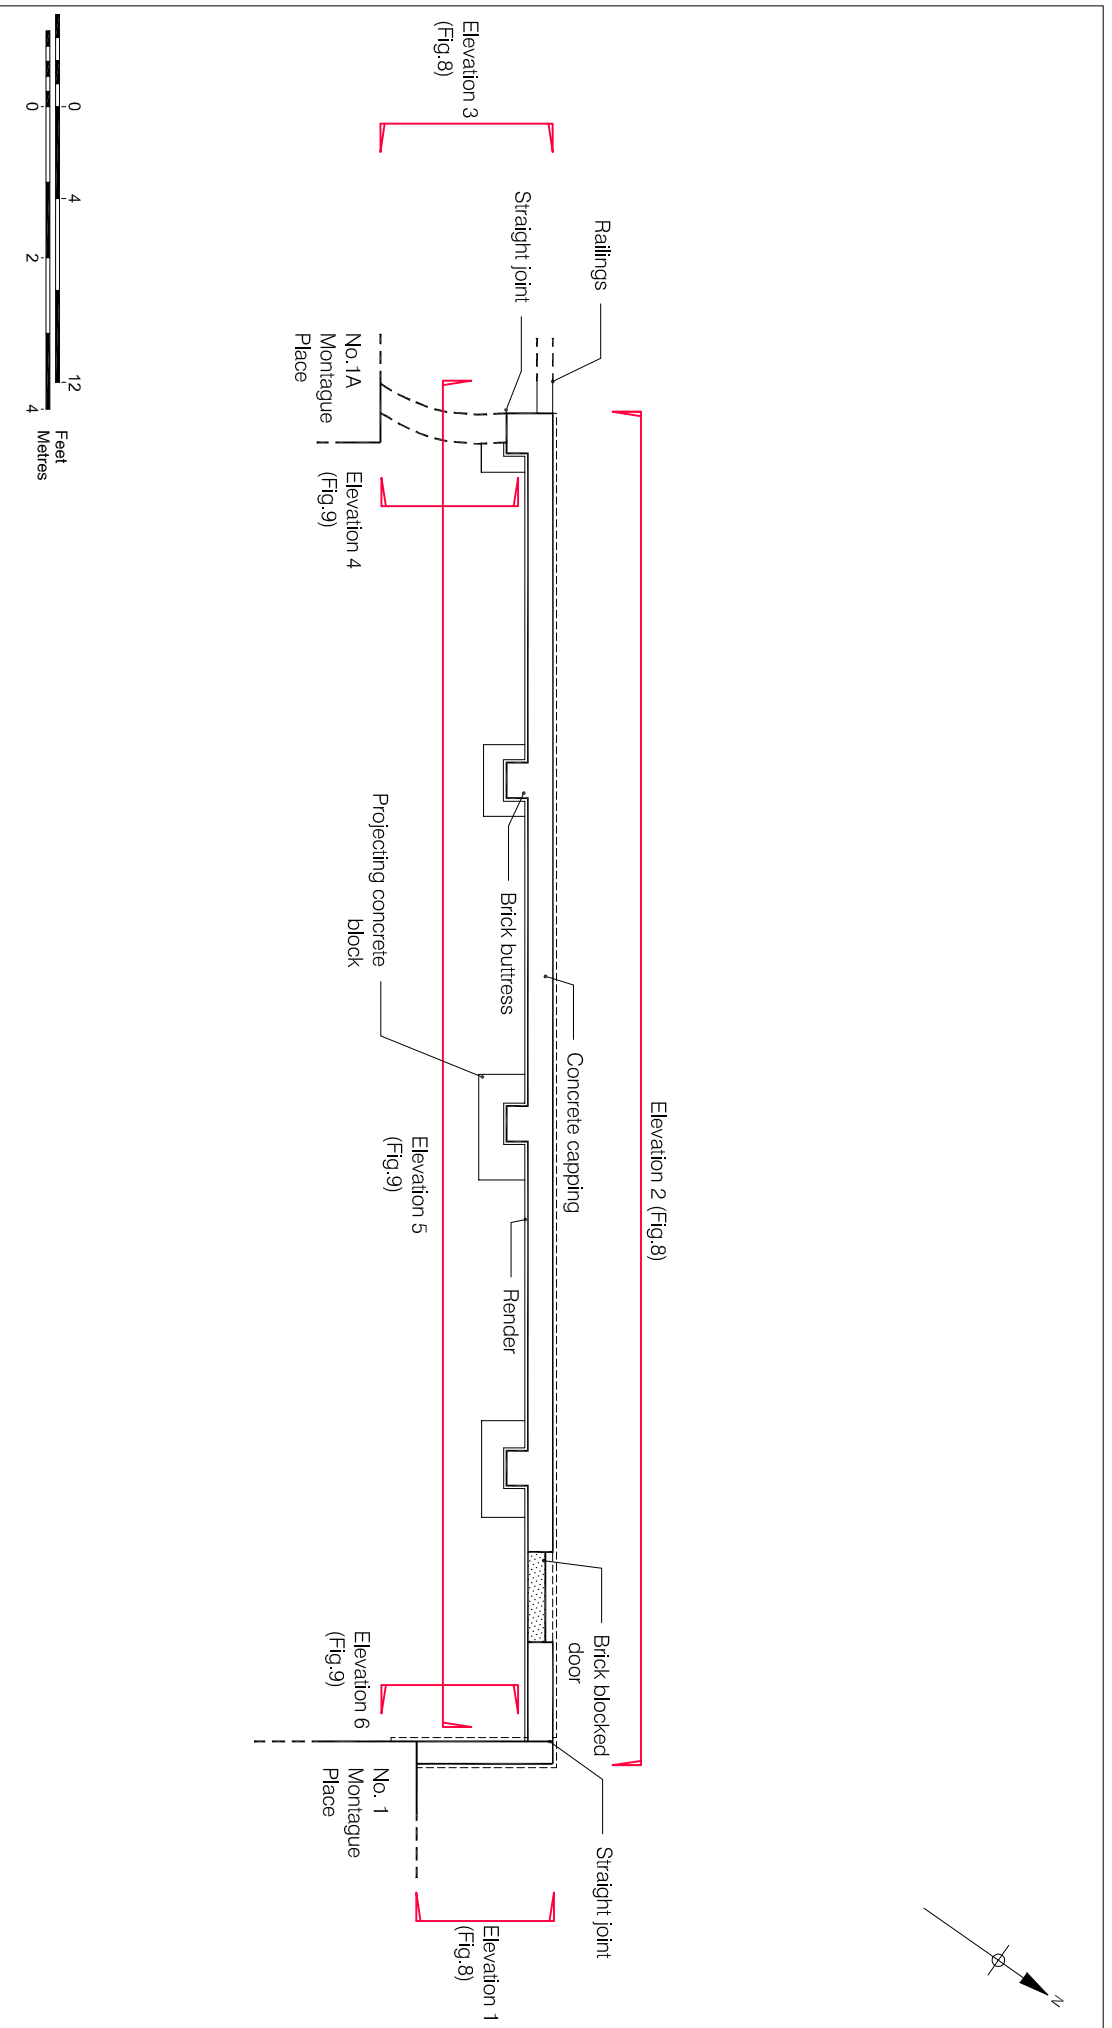
Figure 7  
 Plan of Boundary Wall  
 Montague Place, British Museum  
 1 : 100 at A4

4.2.1 The boundary wall (**Figure 7**) is straight and is abutted at each end by shorter walls, which were built later to join the wall to No.s 1 and 1A Montague Place at the time these buildings were built. Straight joints indicate where these shorter walls connect.

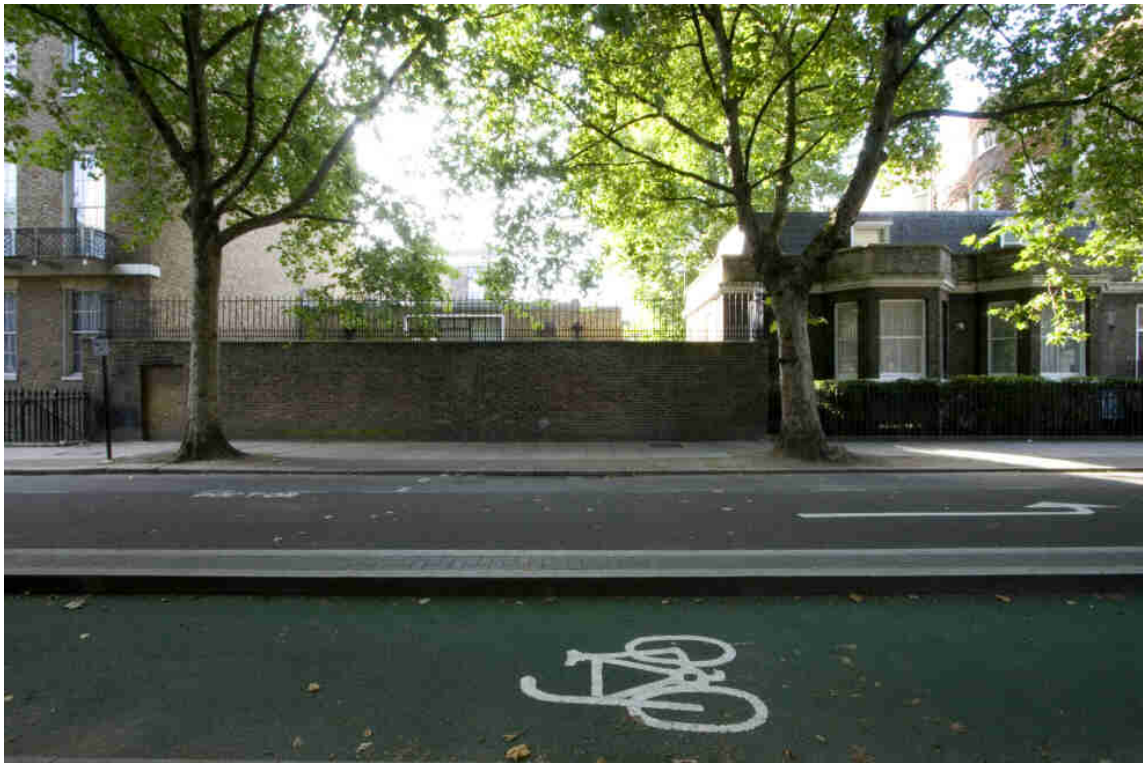
4.2.2 The wall is constructed in a mixture of yellow stock and red brick laid in a Flemish bond (**Plate 1**). The mortar is predominantly original and is mid yellowish brown in colour with small gravel inclusions. Several areas of the wall have been re-pointed in the late 20<sup>th</sup> century with strap (prominent) pointing in a mid to light brown mortar with no inclusions.

**Plate 1 North elevation of boundary wall**

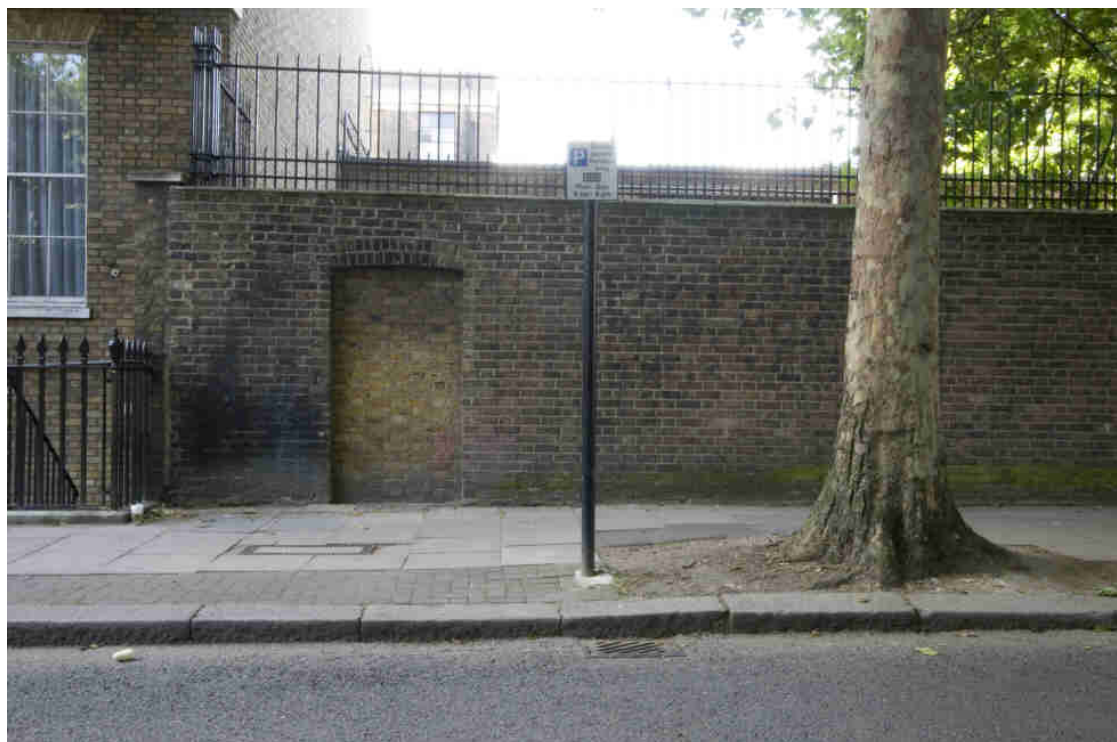
4.2.3 At the east end of the wall, a doorway (**Figure 8; Plate 2**) into the former garden has been infilled with late 20<sup>th</sup> century yellow stock brick in Flemish bond with a light greyish brown mortar with no inclusions. The doorway was presumably infilled when the electrical substation immediately to the south was built in the late 1980s. The doorway has a segmented arch constructed from two courses of brickwork in a 'rowlock' or 'brick on edge' position i.e. bricks laid on their sides, with the shortest end of the brick exposed and vertical. A vertical straight joint filled with a thick seam of mortar to the east of the doorway marks the position where the original wall has been replaced by a late 20<sup>th</sup> century wall connecting the garden wall with No. 1 Montague Place (**Plate 3**). The top part of the garden wall has been rebuilt in English bond where it joins the connecting wall to No. 1 Montague Place.

**Plate 2 Infilled doorway in north elevation of boundary wall**

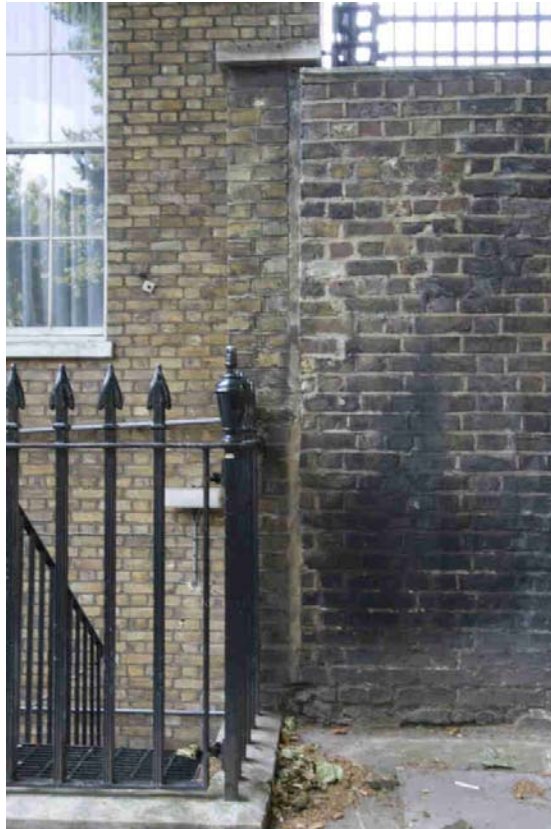
**Plate 3 Straight joint at the east end of the boundary wall (view from the north)**

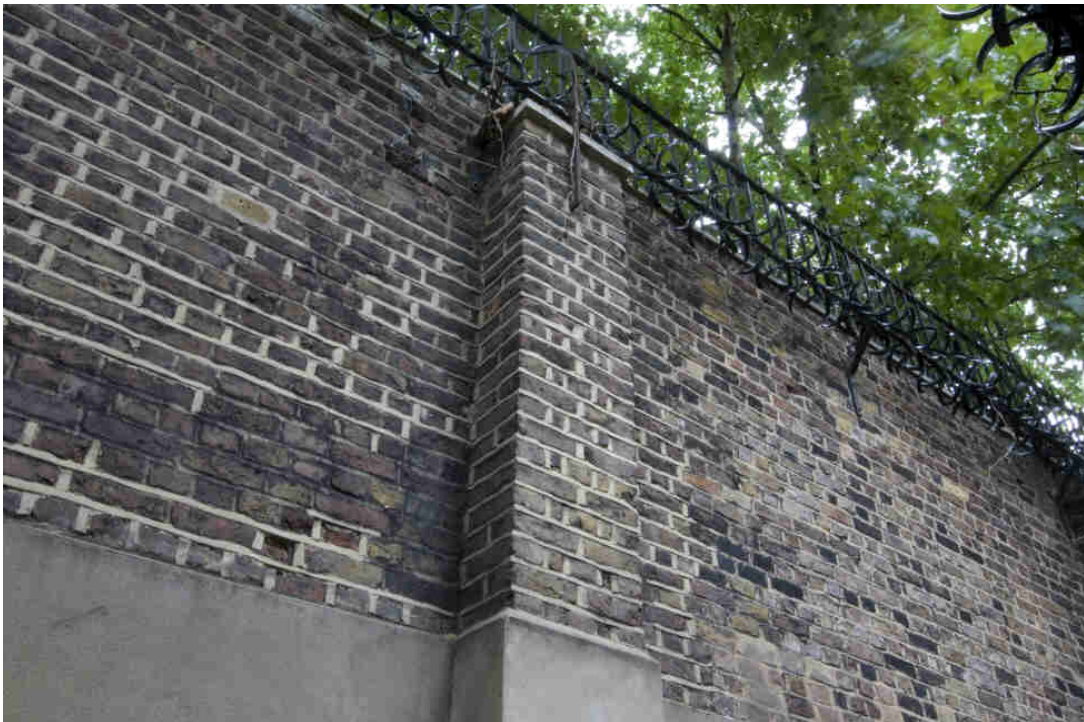
4.3.1 The south elevation of the boundary wall is constructed in a mixture of yellow stock and red brick laid in English bond with light yellowish brown mortar which does not contain any inclusions. Some areas of the wall have been re-pointed. The wall is supported by four buttresses (**Figure 9**), which stop three courses from the top of the boundary wall (**Plate 4**). They are capped by concrete slabs and the base of each buttress is encased in a large late 20<sup>th</sup> century concrete block. The west buttress is only partially visible because it is abutted by the wall, which connects the boundary wall to No. 1A Montague Place.

4.3.2 The lower half of the wall and the buttresses have been rendered in cement with a chamfered top. Apart from at the east end, the wall has a projecting concrete plinth at its base.

**Plate 4 South elevation of the boundary wall**

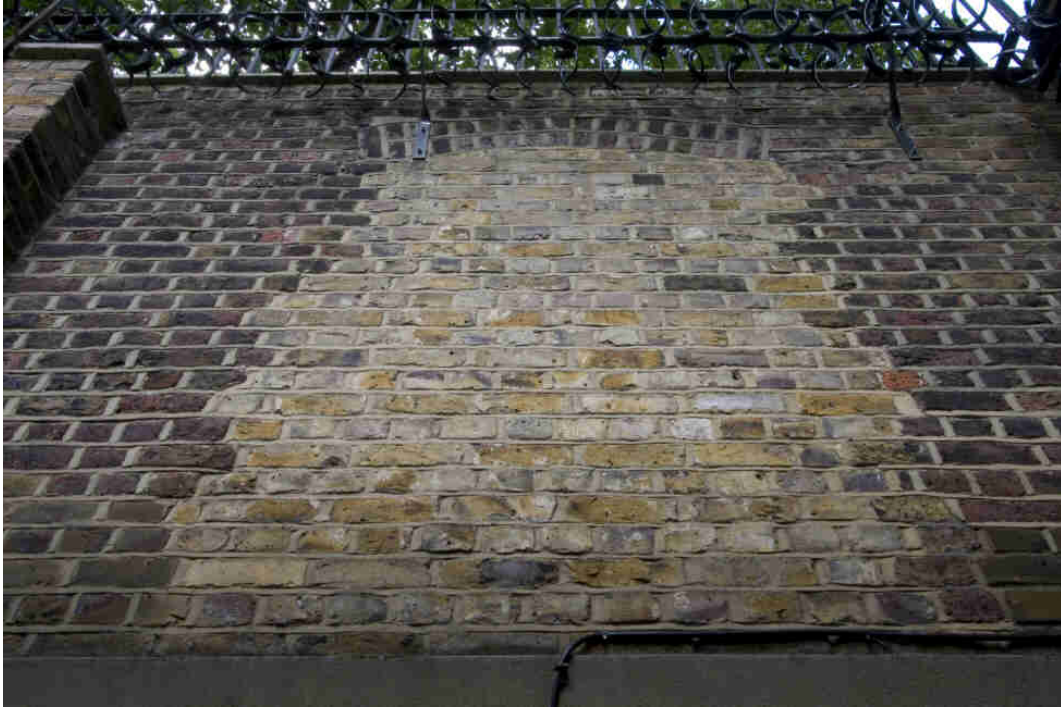
4.3.3 The infilled doorway at the east end of the wall sits above the cement rendered lower part of the wall (**Plate 5**). The infill is flush with the boundary wall and constructed of yellow stock brick in English bond. The doorway has a segmental arch head of two courses of rowlock set bricks with a soldier brick at each end. It presumably originally had a flight of steps leading down to the garden from the street; these are not shown on any 19<sup>th</sup> or 20<sup>th</sup> century maps.

**Plate 5** Infilled doorway at east end of the boundary wall (view from the south)

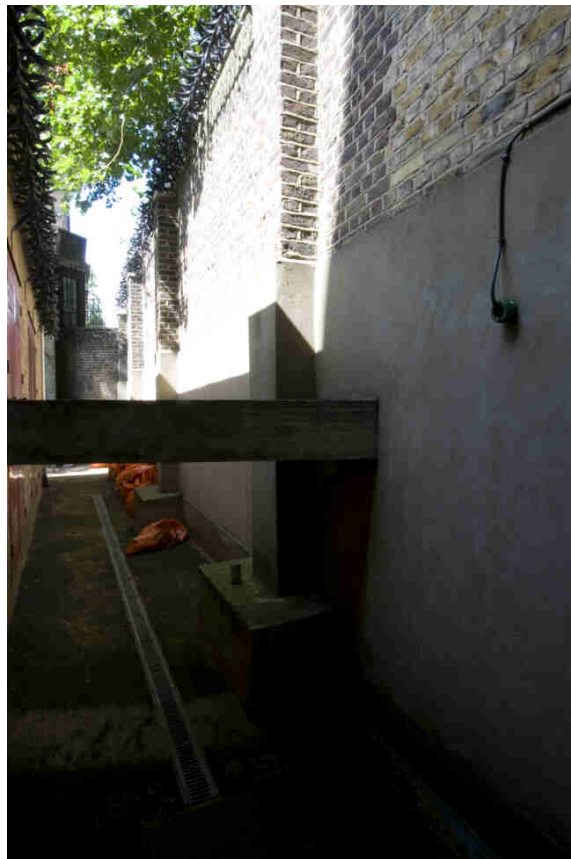
4.3.4 At the east end of the wall, a large late 20<sup>th</sup> century horizontal concrete beam runs between the boundary wall and the substation (**Plate 6**). A line of 19 former rafter or joist holes, four brick courses high, have been infilled with red brick (**Plate 7**). These lie just above the top of the cement render on the south side of the wall. They appear to represent the remains of a temporary structure, possibly a garden shed or green house. On top of the wall there is a series of concrete capping slabs with iron railings inserted into them. The railings are supported by iron curved brackets that attach into the brickwork. Some vertical scars at the top of wall appear to relate to earlier railing supports.

**Plate 6** Concrete beam between the boundary wall and the substation (view from the east)

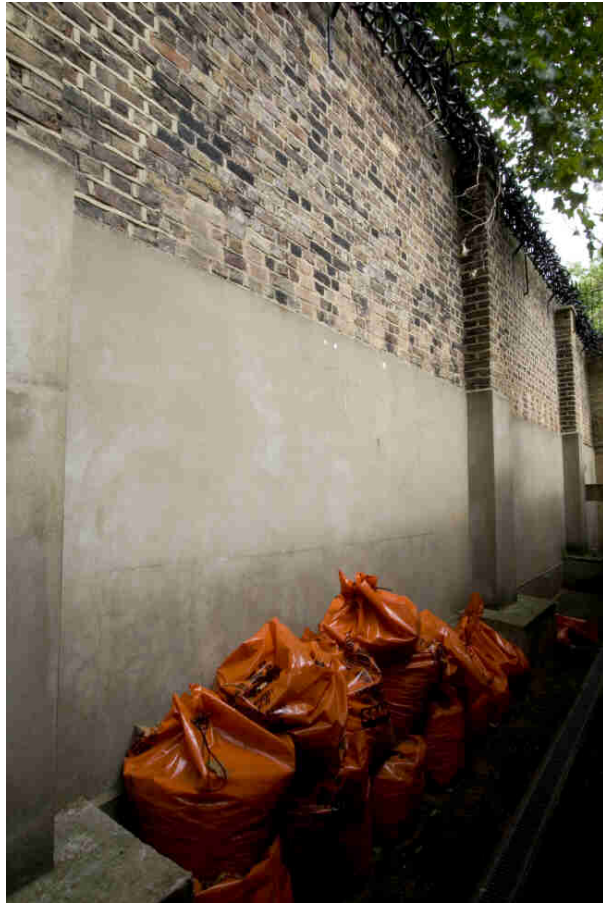
**Plate 7 Line of infilled holes in south elevation of the boundary wall**

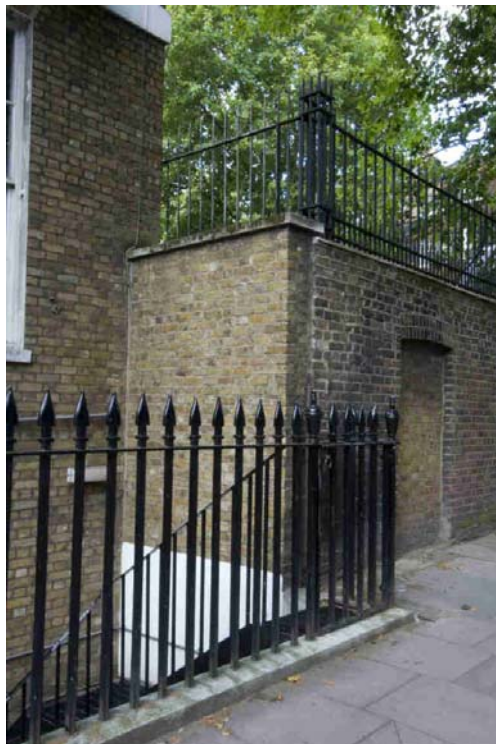
- 4.4.1 The east elevation of the wall connecting the boundary wall to No. 1 Montague Place (**Plate 8**) is constructed of late 20<sup>th</sup> century yellow stock brick in Flemish bond with a mid yellowish brown mortar with tiny gravel inclusions. The bricks are the same as those used in the construction of No. 1 Montague Place, which suggests that the connecting wall was built in 1971 when No. 1 was built. The wall is capped with concrete slabs which are thicker than those of the boundary wall. Iron railings are set into the capping slabs.

- 4.4.2 The lower part of the wall is covered in cement render and extends below the pavement level of Montague Place. It forms the west wall of the light well of 1 Montague Place; a metal stairway rests against this wall and leads from the pavement to the light well below. The south wall of the basement forms the north wall of the basement of No. 1 Montague Place, while the north wall of the light well contains coal cellars beneath the pavement and the pavement along Montague Place.

**Plate 8 East elevation of the wall connecting the boundary wall to No. 1 Montague Place**

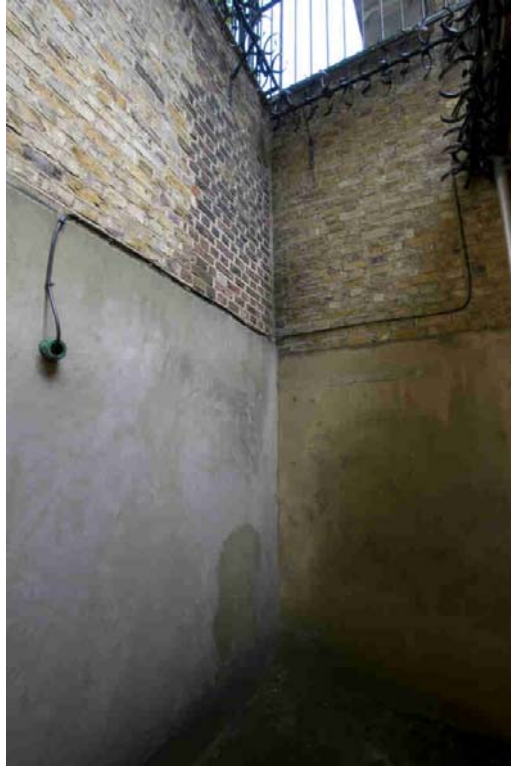
- 4.4.3 The west elevation of the wall connecting the boundary wall to No. 1 Montague Place (**Plate 9**) is constructed from yellow stock brick in Flemish bond with a mid yellowish brown mortar with tiny gravel inclusions. The south end of the wall abuts No. 1 Montague Place, while the north end abuts the boundary wall. The lower part of the wall is covered in cement render.

**Plate 9 West elevation of the wall connecting the boundary wall to No. 1 Montague Place**

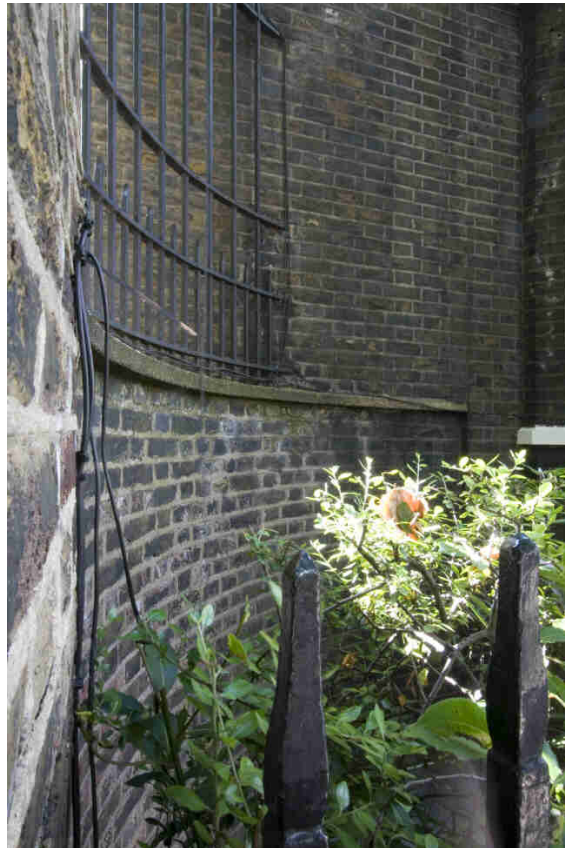
- 4.1.16 The west elevation of the wall connecting the boundary wall to No. 1A Montague Place (**Plate 10**) is a convex curved wall. It abuts the boundary wall to the north and is keyed into No. 1A Montague Place at its south end.

- 4.1.17 The wall is constructed of red brick similar to those used in the construction of No. 1A Montague Place. The brickwork is constructed in Flemish bond. The wall has been re-pointed in most areas in a mid yellowish brown cement mortar with no inclusions. Areas of earlier mortar have small inclusions. The wall is capped by concrete slabs with many large irregular inclusions. It is lower than the boundary wall and the buttress to the north.

**Plate 10 West elevation of the wall connecting the boundary wall to No. 1A Montague Place**

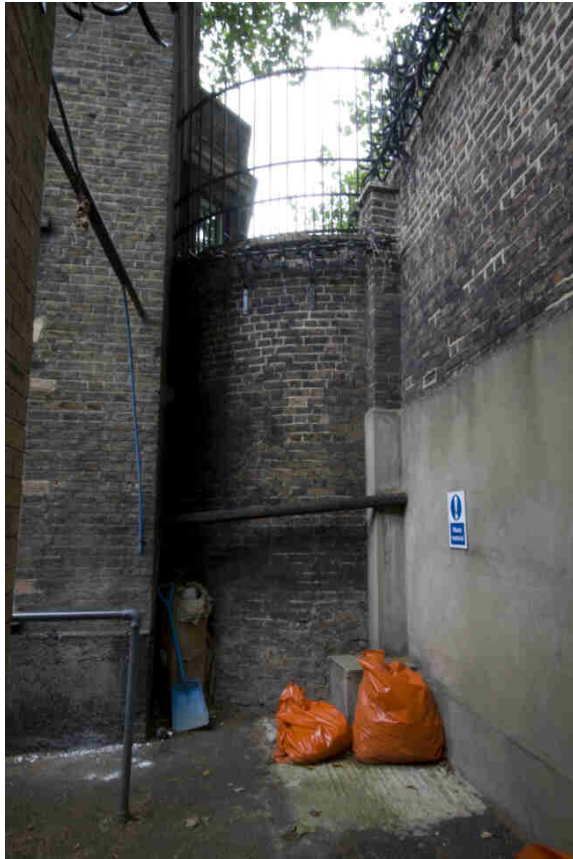
- 4.1.18 The east elevation of the wall connecting the boundary wall to No. 1A Montague Place (**Plate 11**) is a concave curved wall. The wall is constructed of red stock brick in a random bond. The wall has been re-pointed in several areas in a mid yellowish brown cement mortar with no inclusions. Areas of earlier mortar have inclusions. The lower part of this elevation is not rendered.

**Plate 11 East elevation of the wall connecting the boundary wall to No. 1A Montague Place**
