**AN ARCHAEOLOGICAL EVALUATION ON LAND OFF  
CHURCH BANK, BOLTON, GREATER MANCHESTER**

**Central National Grid Reference: SD 7211 0929**

**Site Code: CHB 09**

**© Pre-Construct Archaeology Limited**  
**February 2010**

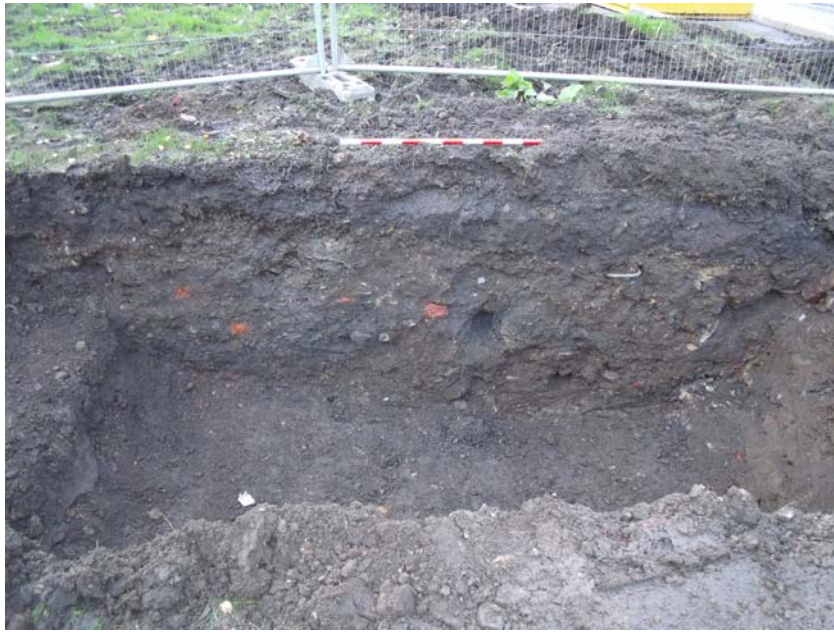
Figure 7. South-east facing section (Section 1) in Trench 1 (*1m scale*).

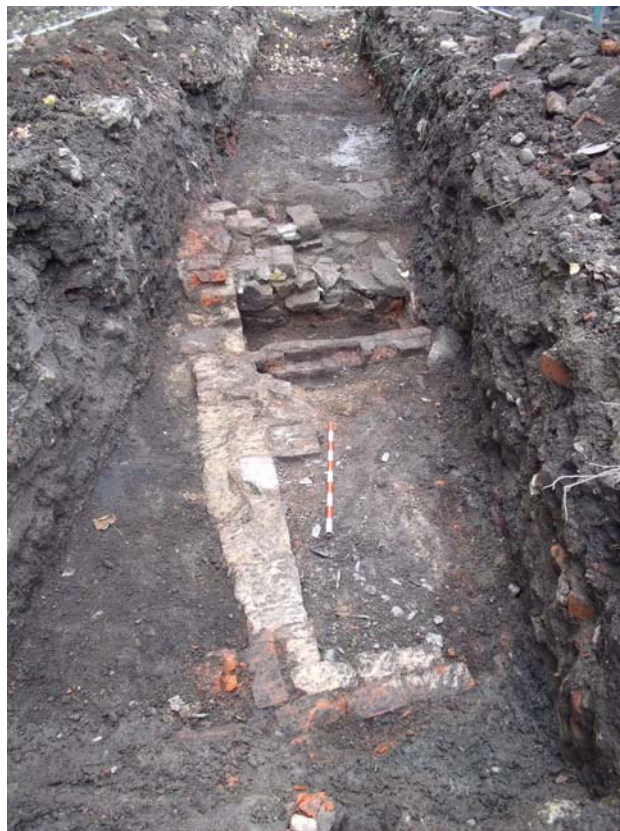
Figure 8. Overview of structure [225] in Trench 2, looking south-east (*1m scale*).

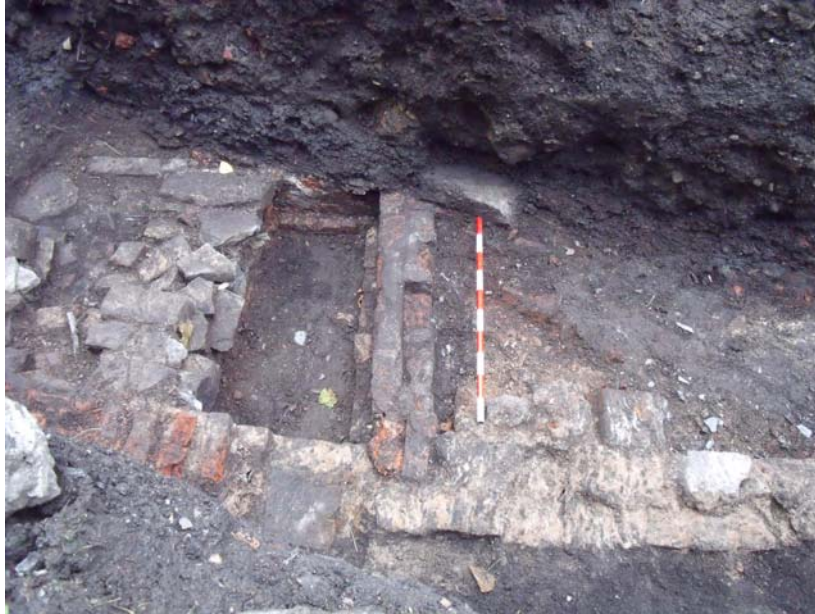
Figure 9. Detail of structure [225] in Trench 2, looking north (*1m scale*).

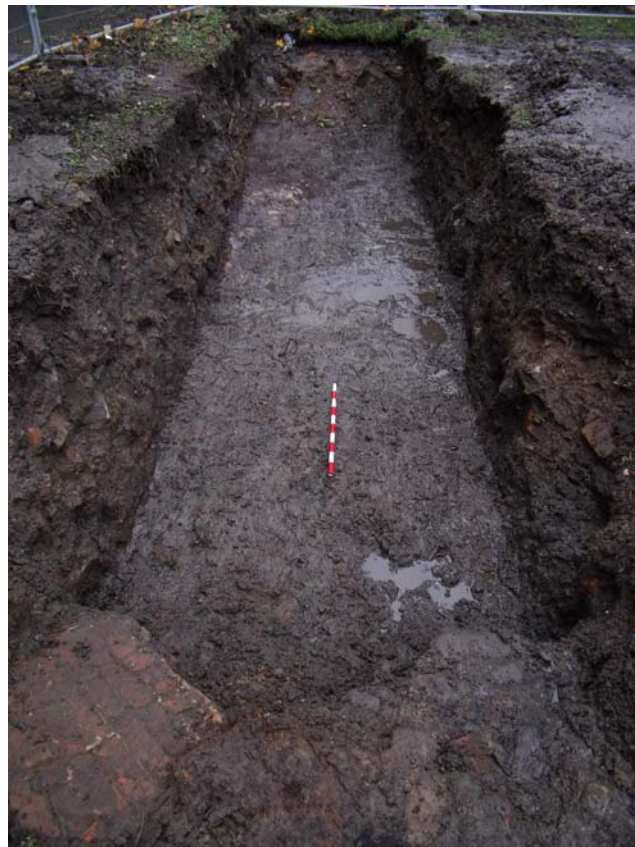
Figure 10. Overview of north-westernmost portion of Trench 3, looking north-west (*1m scale*).

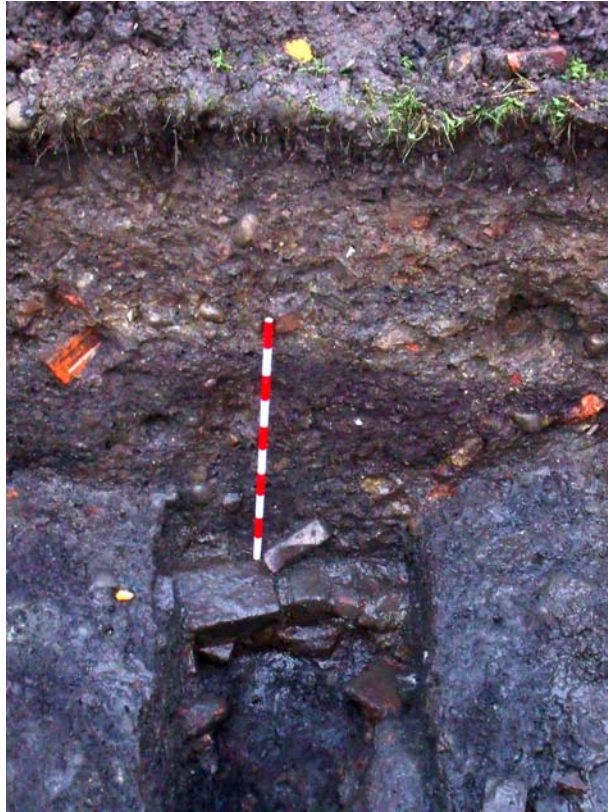
Figure 11. Part of south-east facing section (Section 3), Trench 3 (1m scale).

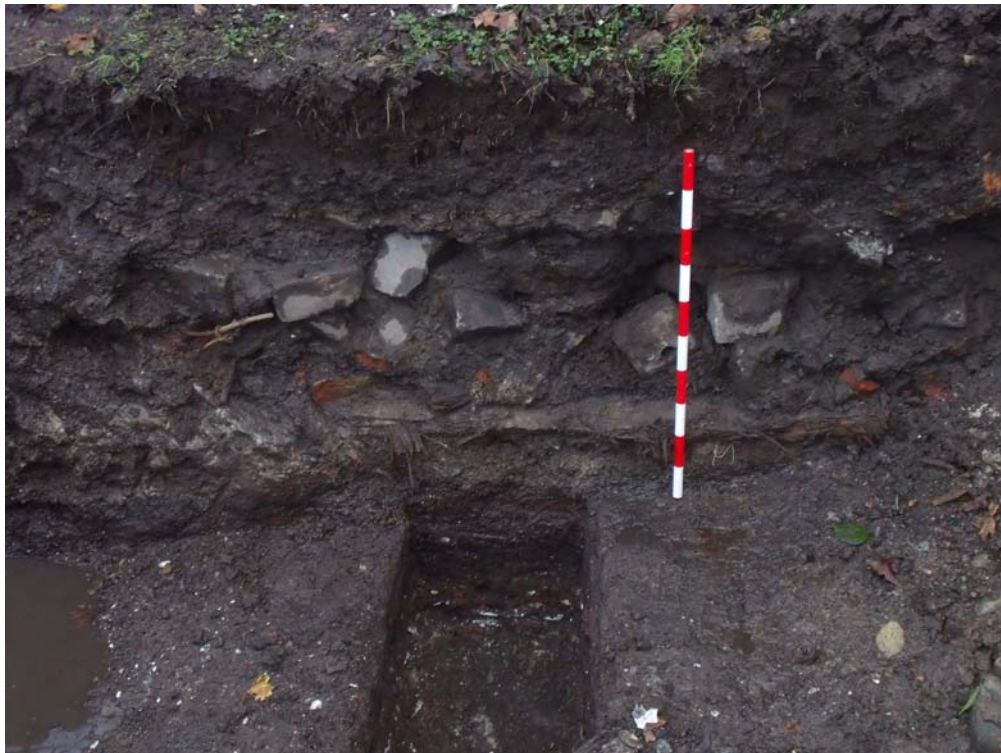
Figure 12. Part of north-east facing section (Section 5), Trench 3 (1m scale).
