GREENWICH REACH &

43-81 GREENWICH HIGH ROAD

ASSESSMENT OF TWO

GQR 06 & GHI 08

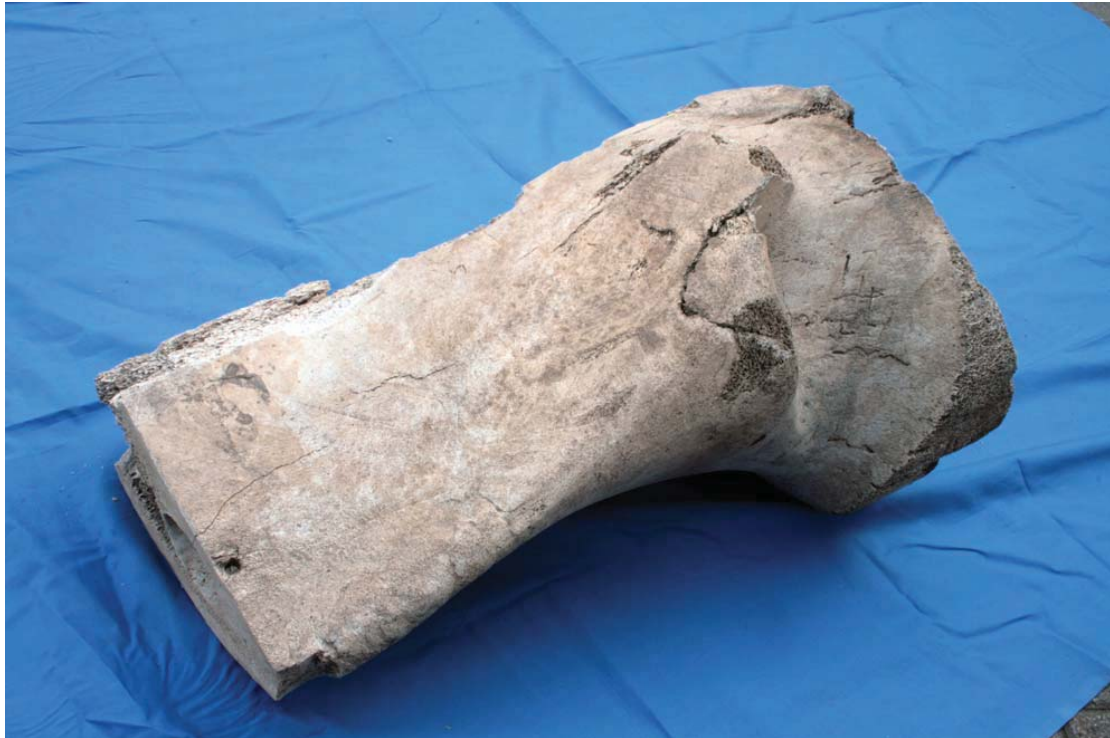
Figure 1. A mandible from a large baleen whale (possibly Greenland Right Whale), which has been sawn through the shaft (on the left) and the proximal end (on the right). It is 672mm in length.

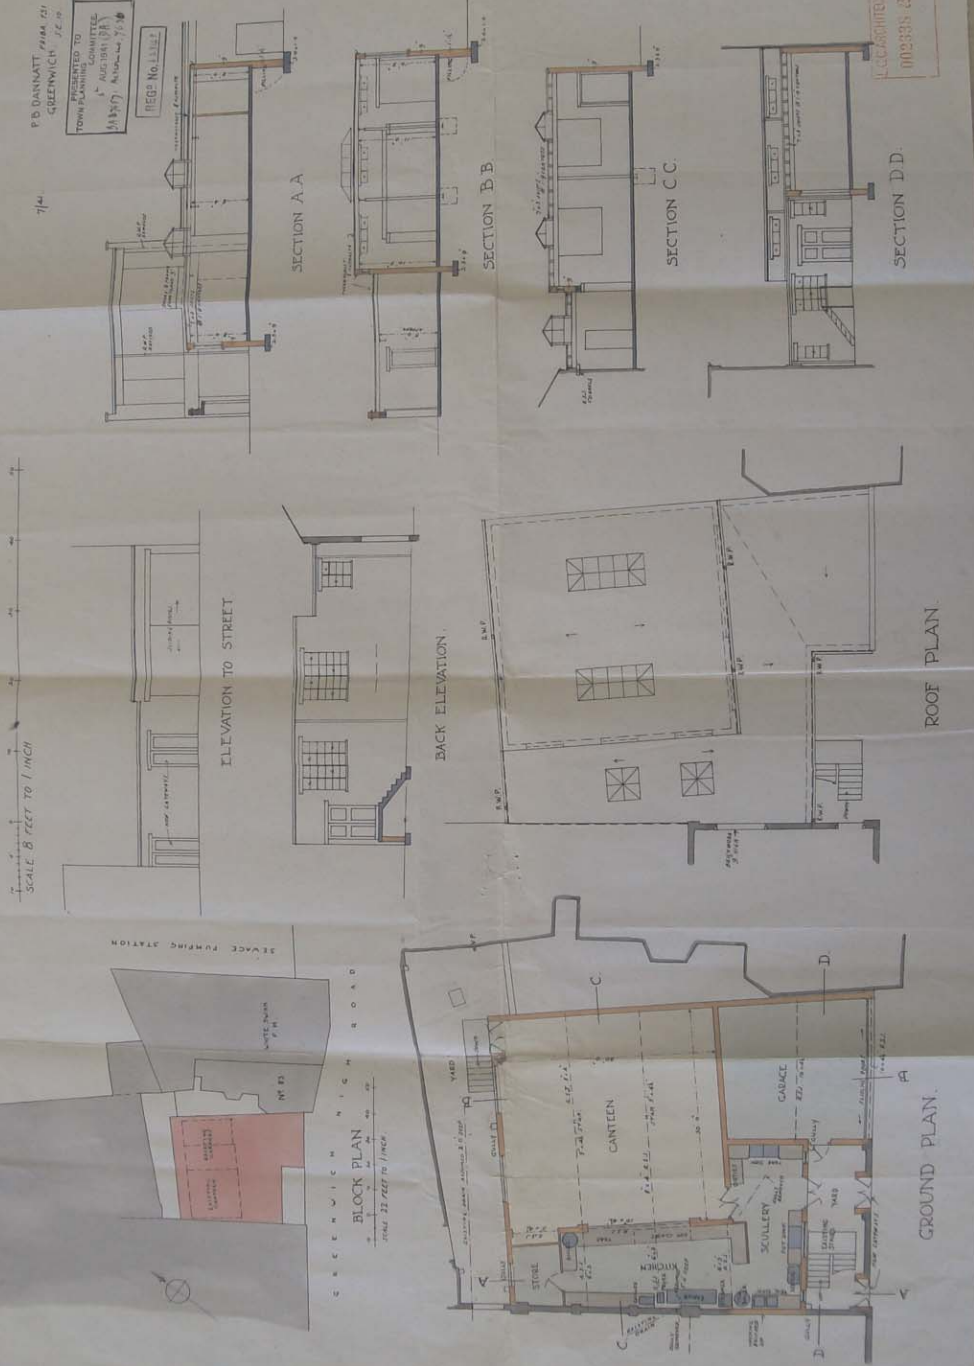
Doorway converted from a window

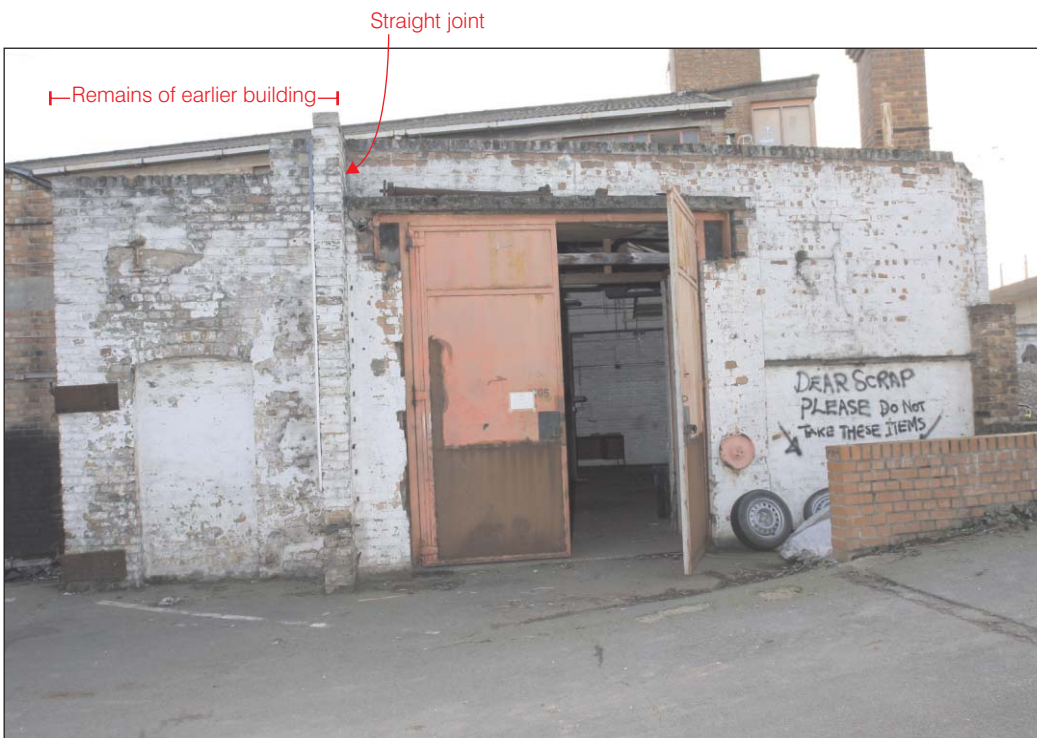
Plate 4: Remains of 19th century building incorporated within the Engine House

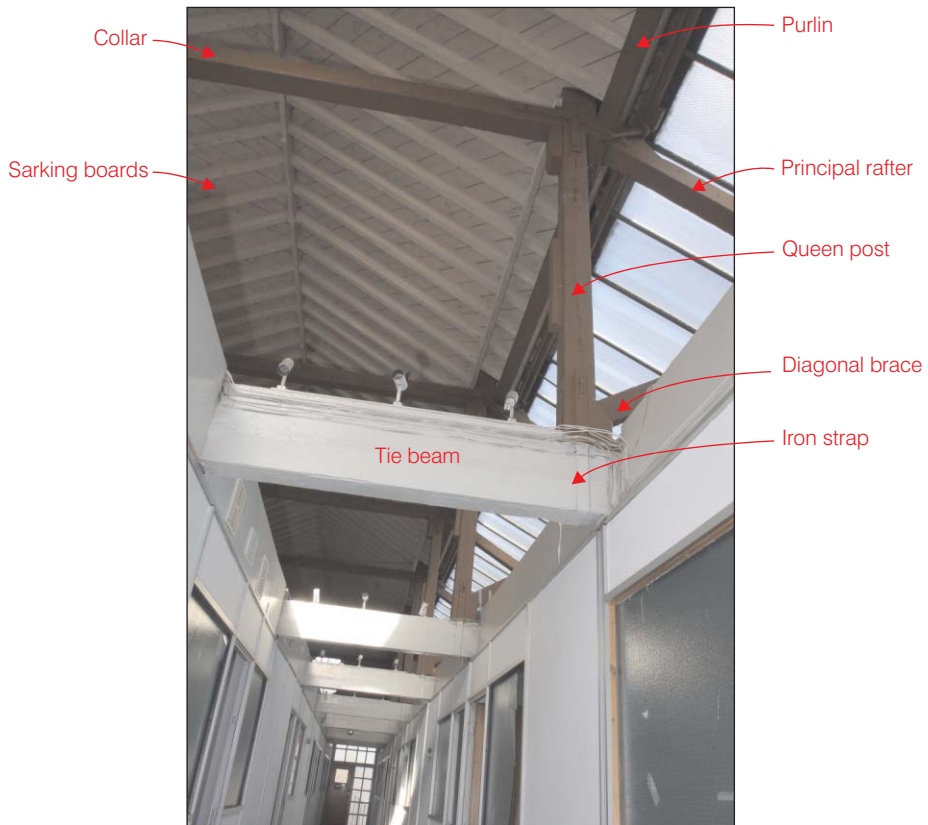
Plate 8: Queen post truss roof in the Station House

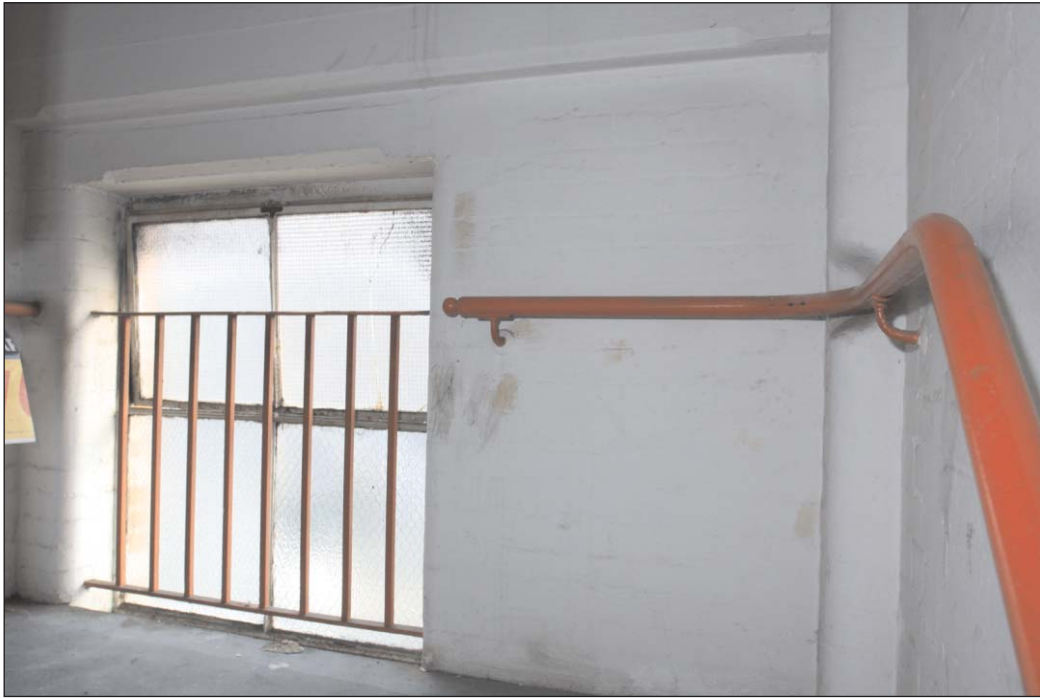
Plate 11: Metal staircase rail in the Pump House

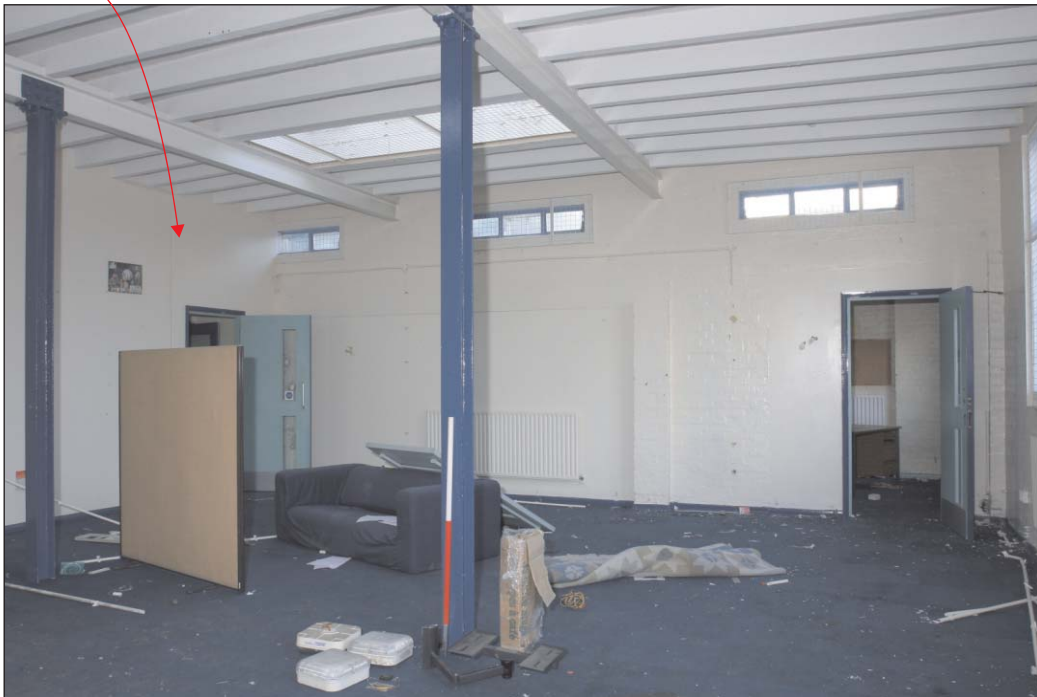
Later partition wall

Plate 15: Interior of the canteen in the Brigade House
