**ARCHAEOLOGICAL INVESTIGATIONS AT
1-7 WESTGATE ROAD & ARCHES 23/24 QUEENS LANE,
NEWCASTLE-UPON-TYNE, TYNE AND WEAR**

Assessment Report

Site Code: WEG 09

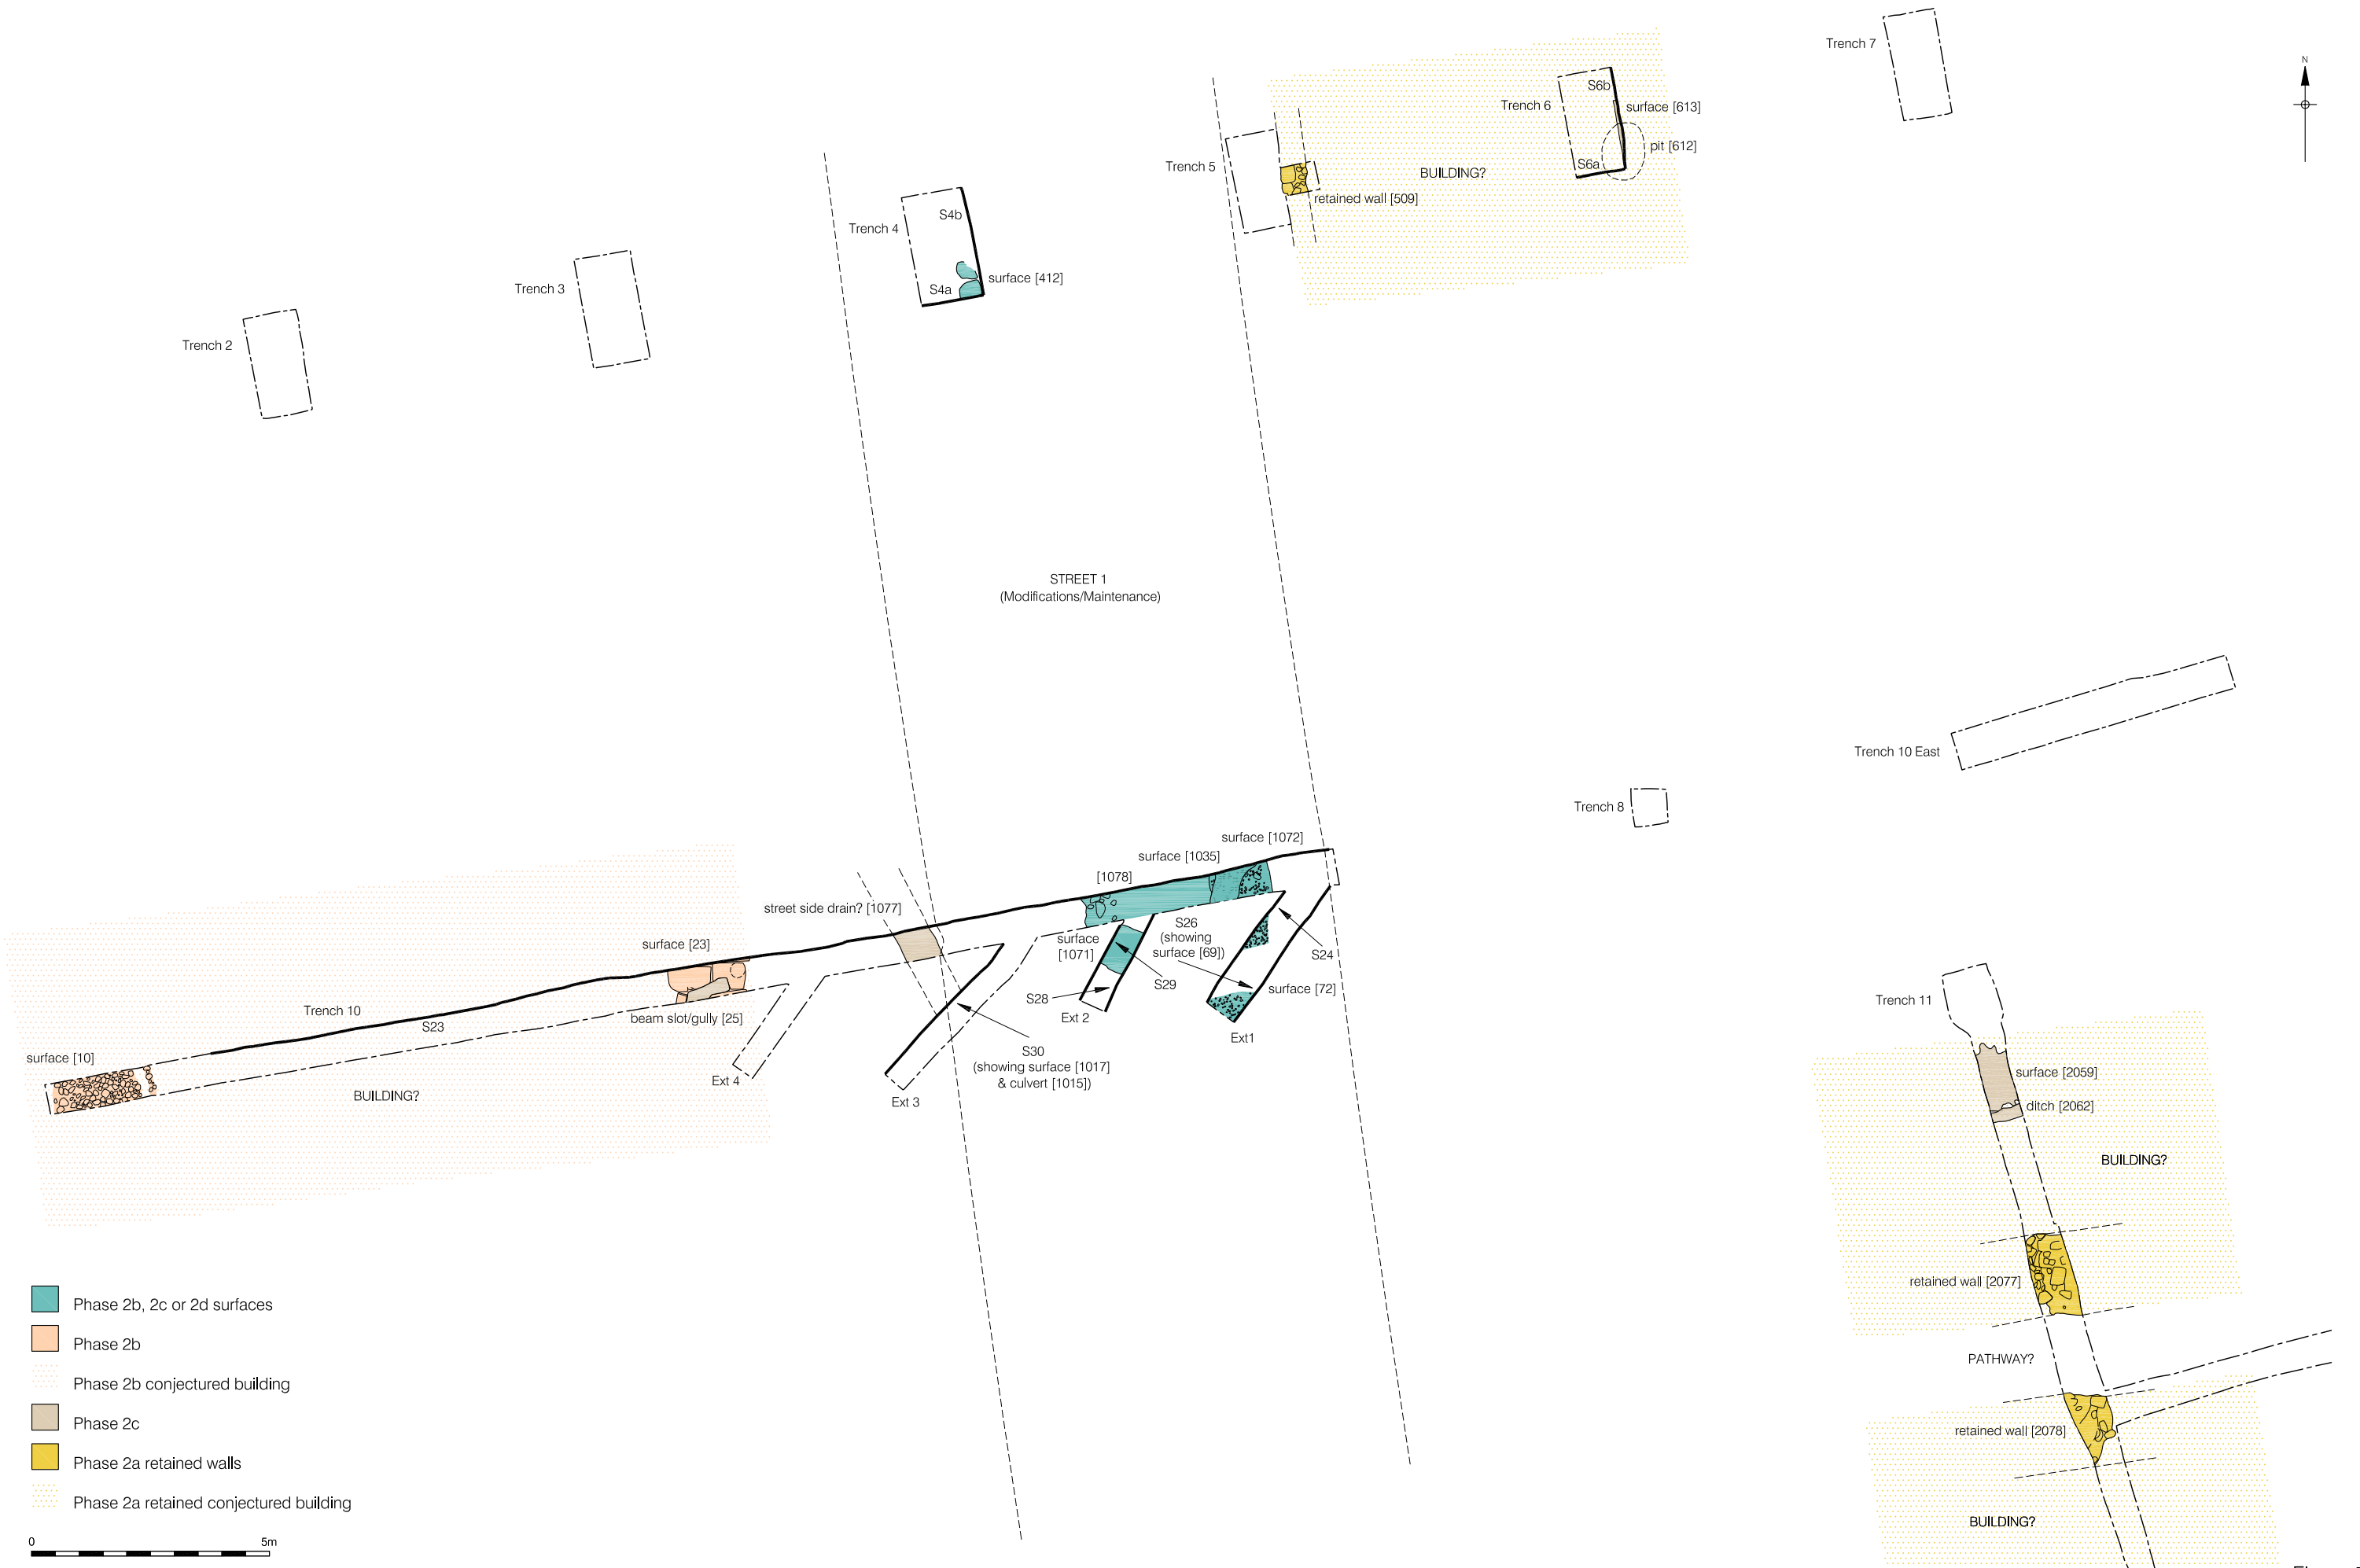
Figure 5
Phases 2b & 2c
Street 1 and associated frontage modifications
1:125 at A3

- Phase 2b, 2c or 2d surfaces
- Phase 2b
- Phase 2b conjectured building
- Phase 2c
- Phase 2a retained walls
- Phase 2a retained conjectured building

5.6.1.1 Following the structural development evident to the east and west of Street 1 during Phase 2a, it is probable that the street frontage buildings remained in use for varying lengths of time, into Phase 2b. However, whilst modification of the existing buildings may have been undertaken, e.g. laying down of new floor surfaces, no evidence of new structural development was found and, in some parts of the site, e.g. the western frontage of Street 1, a period of construction inactivity seems to have typified the early part of Phase 2b.

5.6.3.1 To the east of Street 1 within Trench 11 it is possible that buildings constructed during Phase 2a remained in use during Phase 2b. A friable silty sand levelling layer, [2081], abutted the Phase 2a masonry, in turn overlain by a soft clayey silt levelling layer, [2076], encountered at 27.41m OD. The combined thickness of the two levelling layers was 0.21m. Moderate quantities of 3rd century pottery and occasional fragments of ceramic building material, glass, fired clay lining and a corroded iron bar (SF111) were retrieved from these deposits.

- 5.7.3.1 A firm, silty clay beaten-earth surface, [2059], 0.12m thick, was recorded in Trench 11 at a height of 27.94m OD. It has been assigned to Phase 2c.
- 5.7.3.2 To the south, the surface was truncated by an east-west aligned linear feature, [2062], recorded at 27.91m OD and 0.25m wide and 0.66m deep. Its loose coal and silt fill, [2061], produced no artefactual material. Investigation of the feature was limited within the confines of the trench, however it may represent a beamslot or possibly a drainage feature.

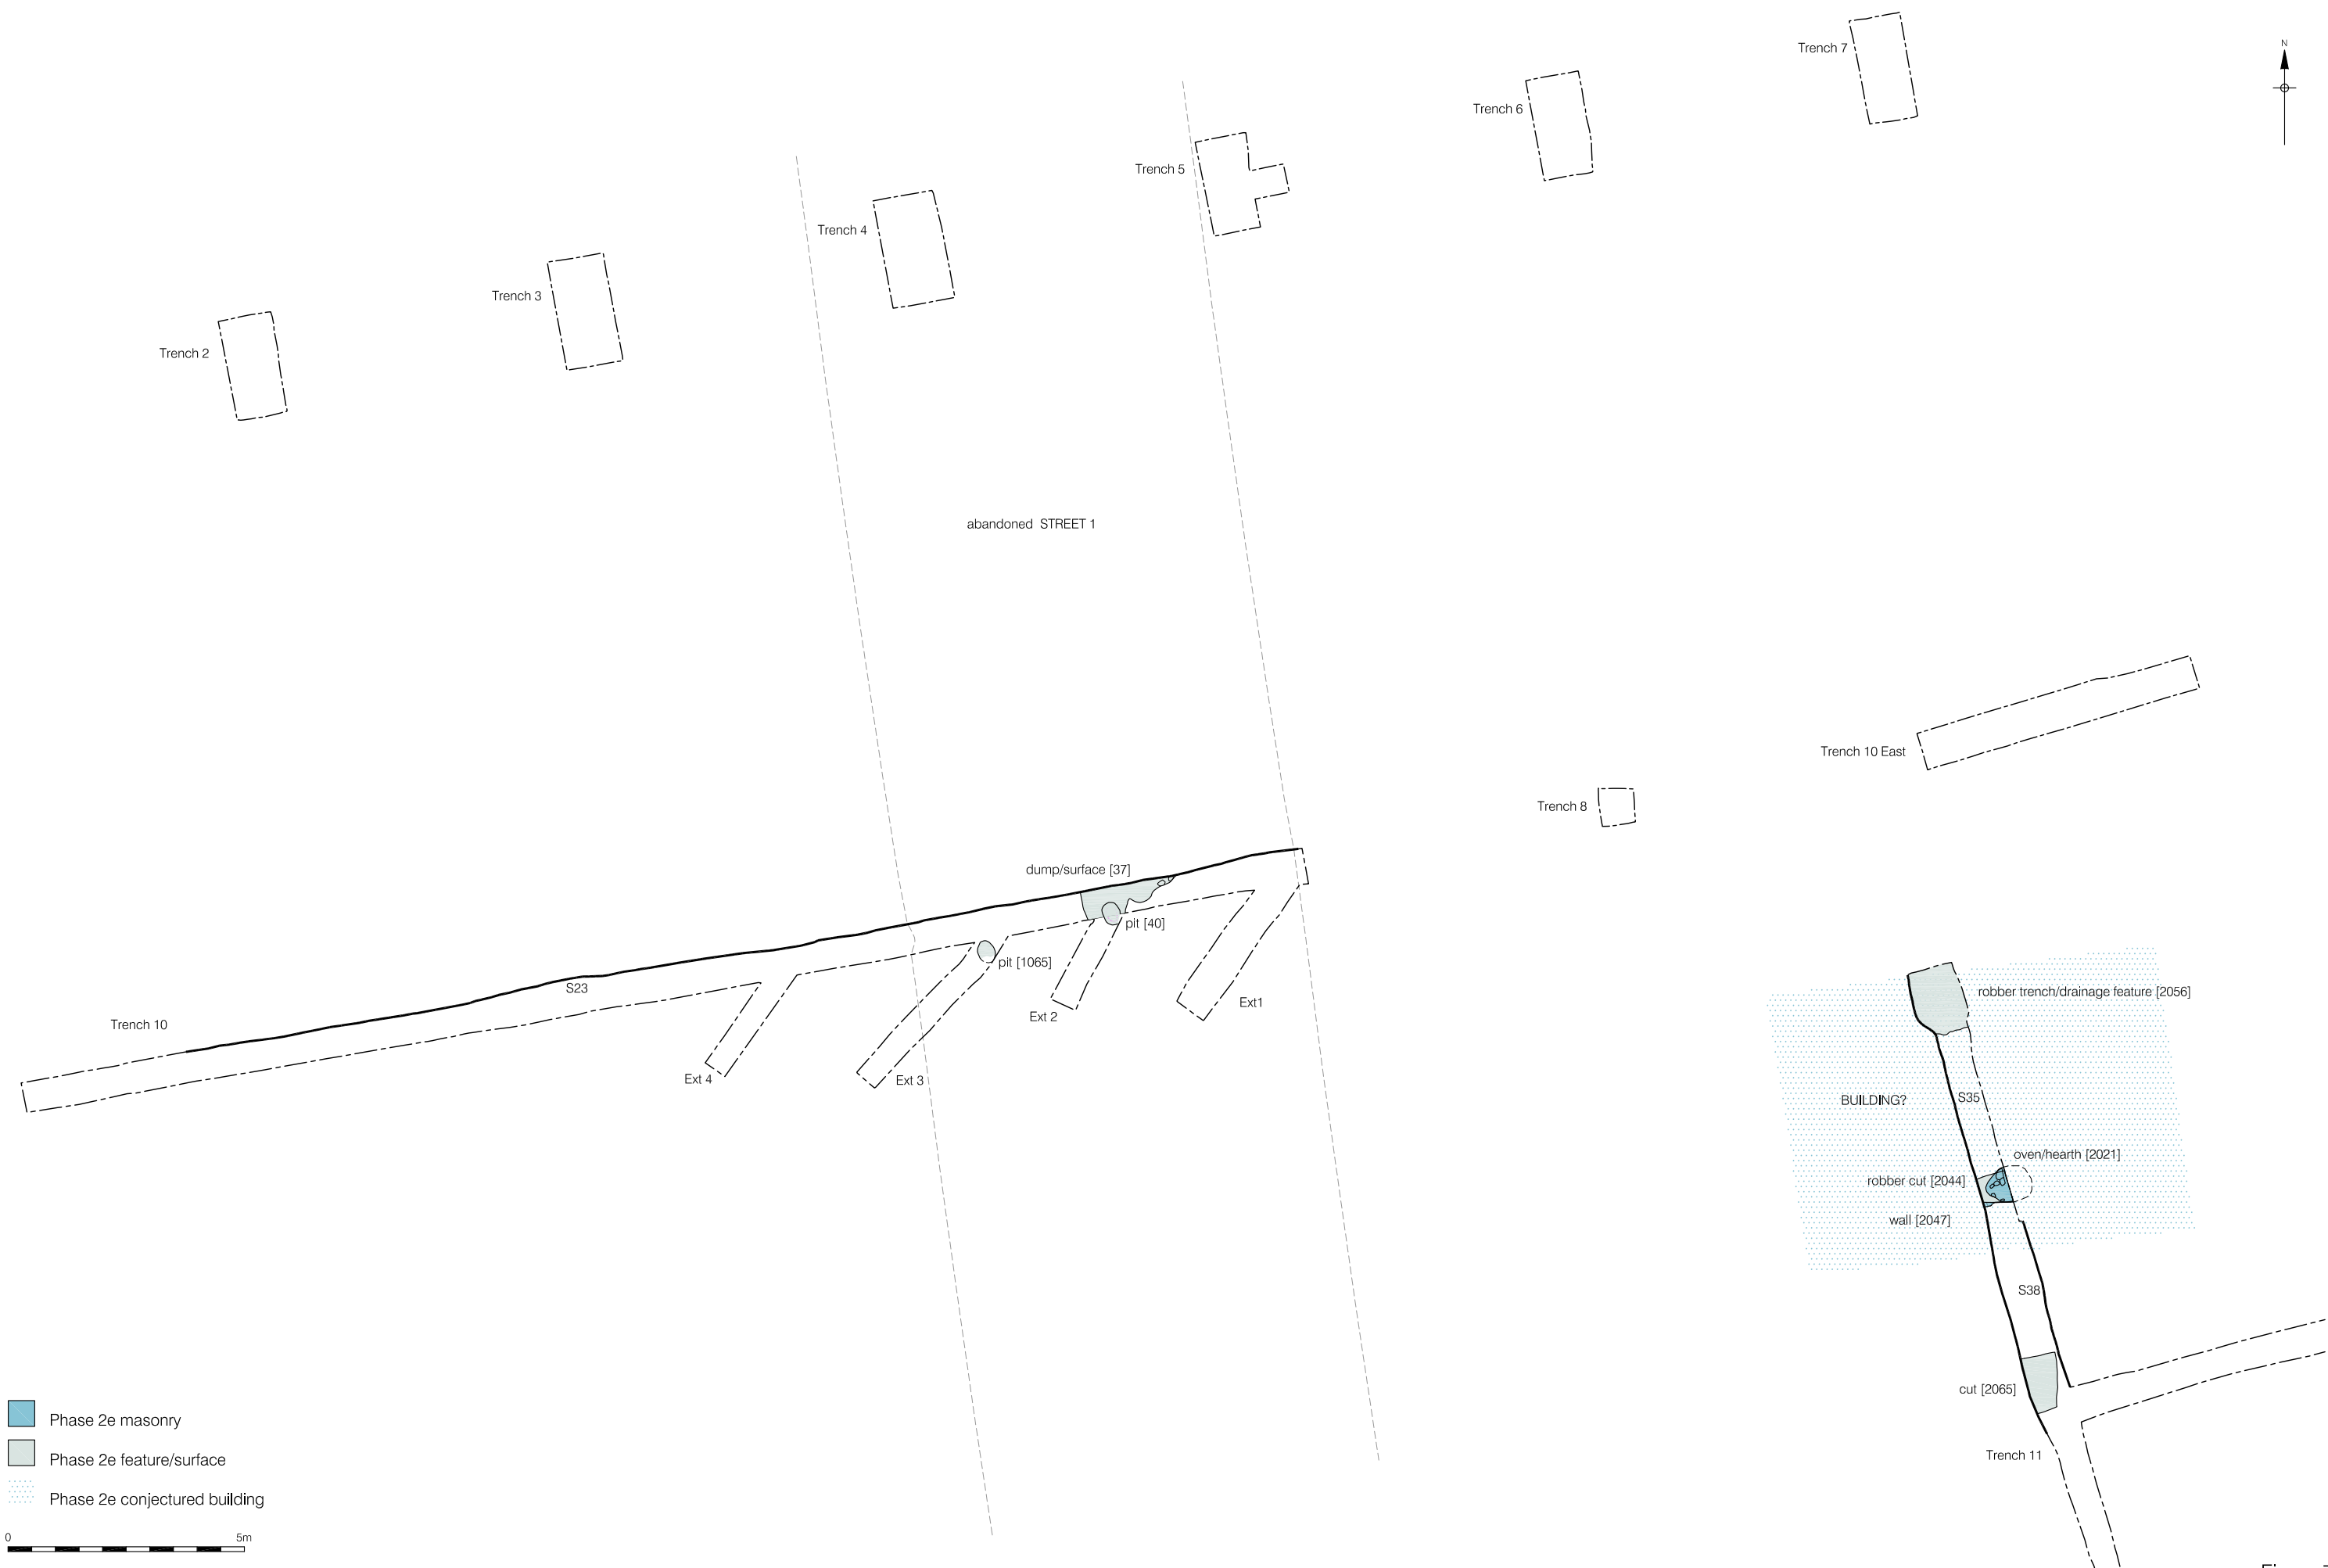
Figure 7
 Phase 2e
 activity post-dating usage of Street 1
 1:125 at A3

■ Phase 2e masonry
 ■ Phase 2e feature/surface
 ■ Phase 2e conjectured building

- 5.9.3.1 A dump/levelling layer, [2045], up to 0.10m thick and recorded at a maximum height of 28.00m OD, represents the earliest Phase 2e activity in Trench 11. This was subsequently truncated by an east-west aligned construction cut, [2048], at least 0.22m wide and 0.33m deep, which contained a sandstone and clay wall foundation, [2047]. The existence of masonry within Trench 11 during Phase 2e suggests that, unlike the western part of the site, as described above, usage of land to the east was probably less affected by disuse of Street 1.

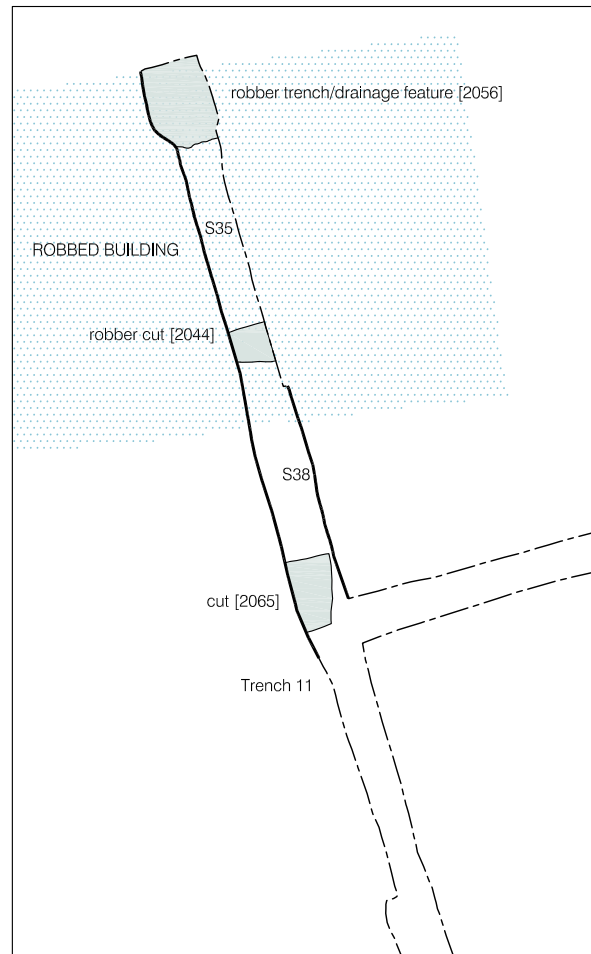
Figure 8
Phase 2e
sub-phasing in Trench 11
1:125 at A4

Phase 2e (i)

Phase 2e (ii)

Phase 2e (iii)

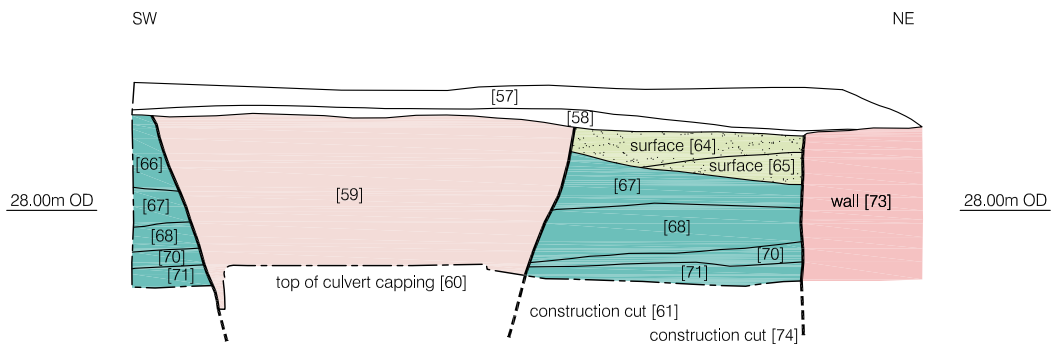
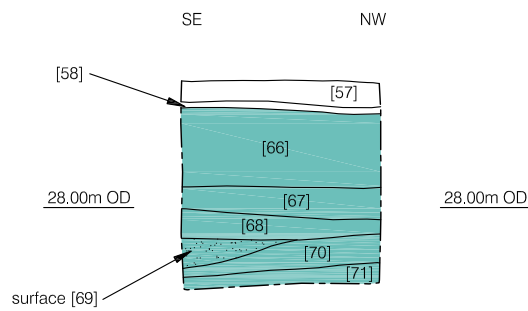
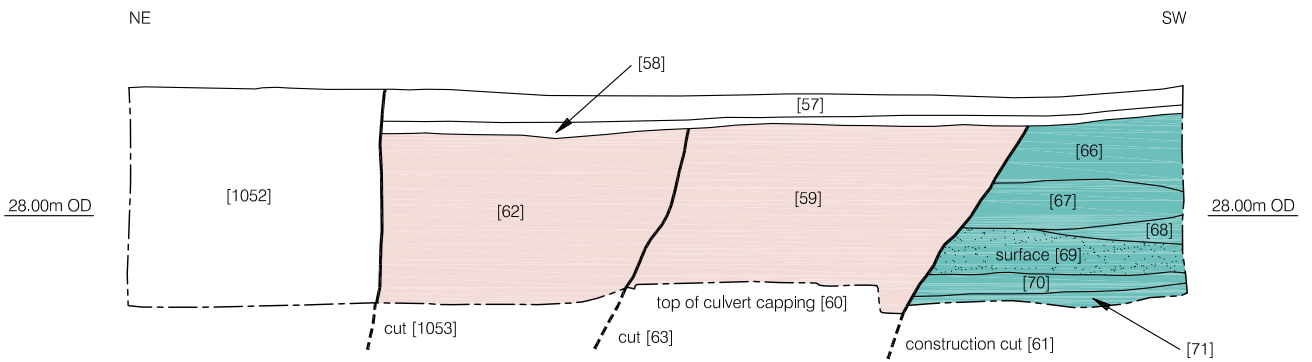
Figure 17
Trench 10 Extension 1 Sections
1:25 at A4

Section 24
South East facing
Trench 10
Extension 1

Section 25
North East facing
Trench 10
Extension 1

Section 26
North West facing
Trench 10
Extension 1

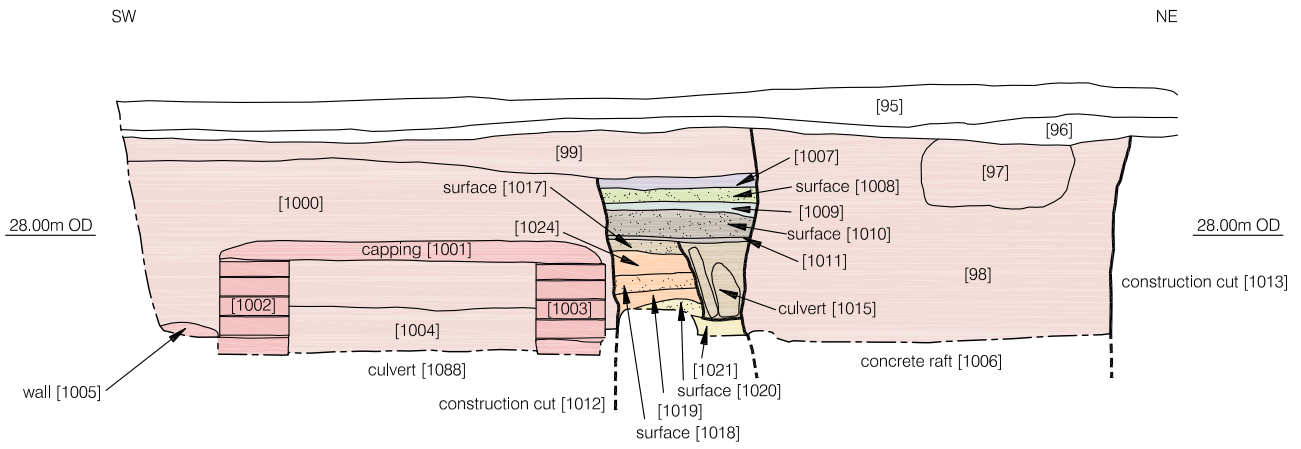
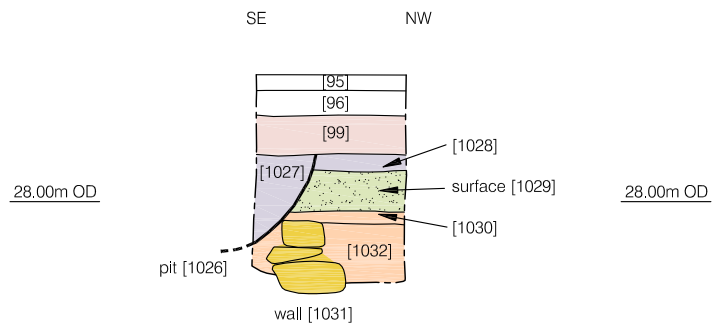
Figure 19
 Trench 10 Extension 3 Sections
 1:25 at A4

Section 30
 South East facing
 Trench 10
 Ext. 3

Section 31
 North East facing
 Trench 10
 Ext. 3

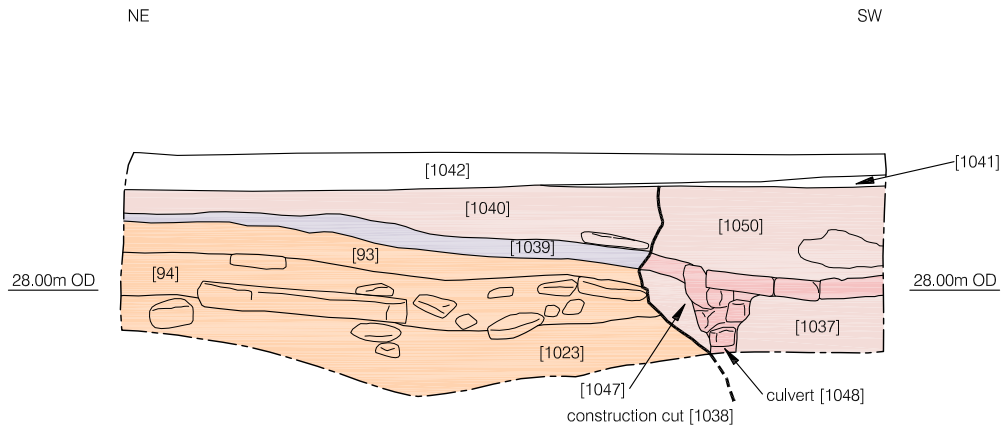
Figure 20
Trench 10 Extension 4 Section
1:25 at A4

North West facing section
Trench 10
Ext. 4

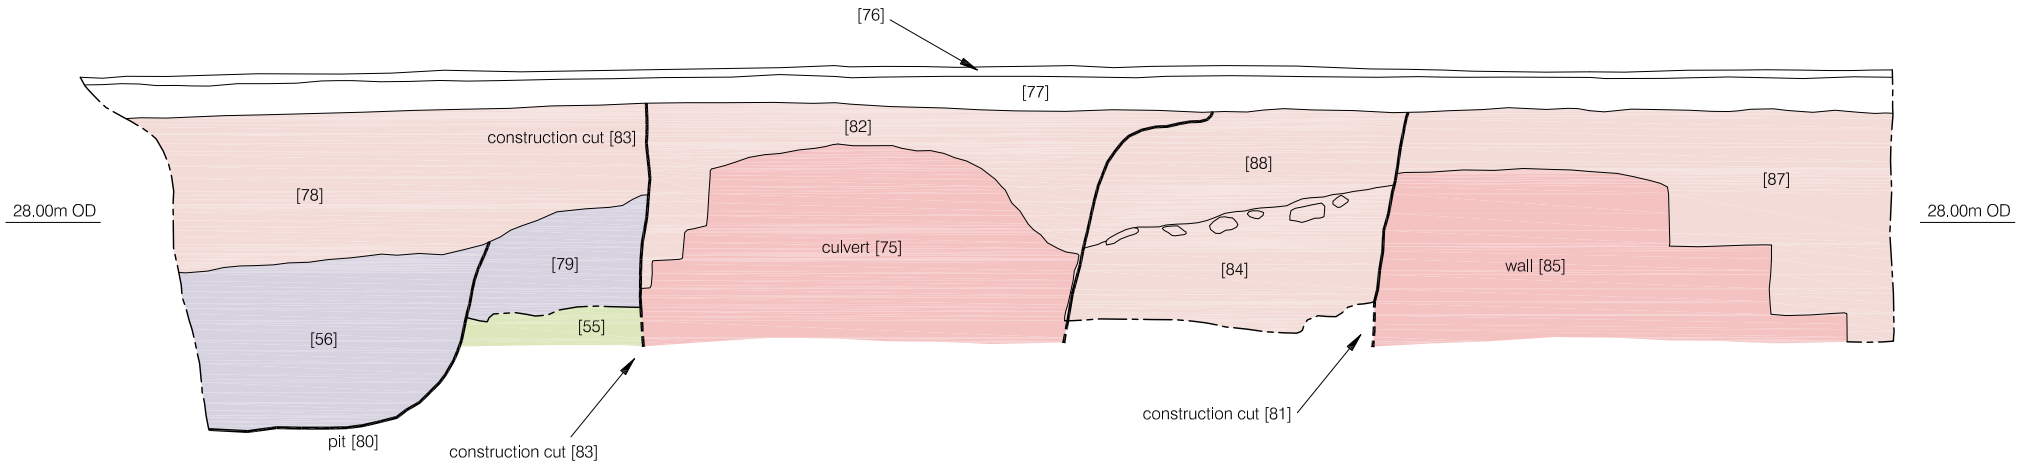
Section 22
North facing
Trench 10 East

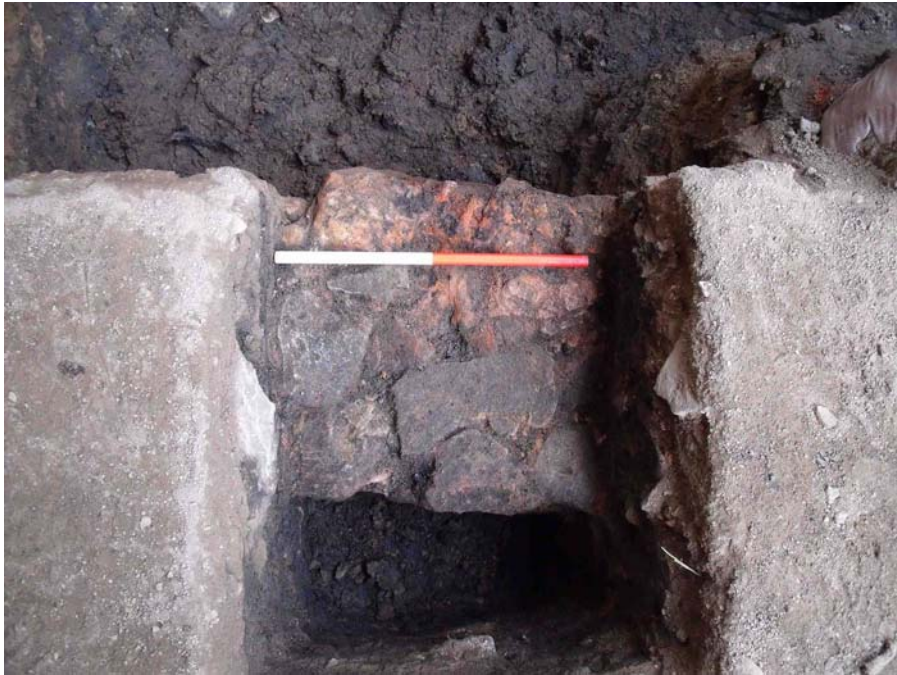
Plate 1. Wall [509], Trench 5, looking west (scale 0.5m)

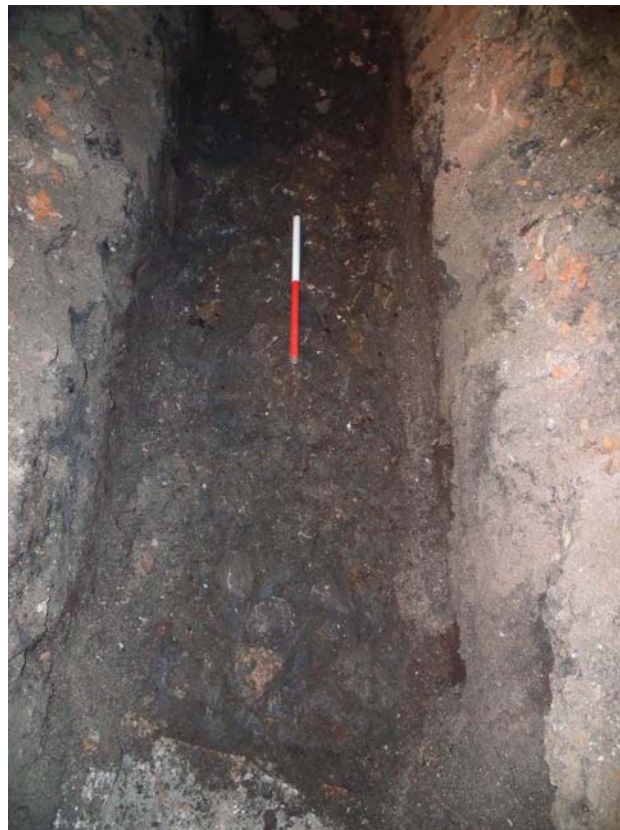
Plate 2. Surface [10], Trench 10, looking east (scale 0.5m)

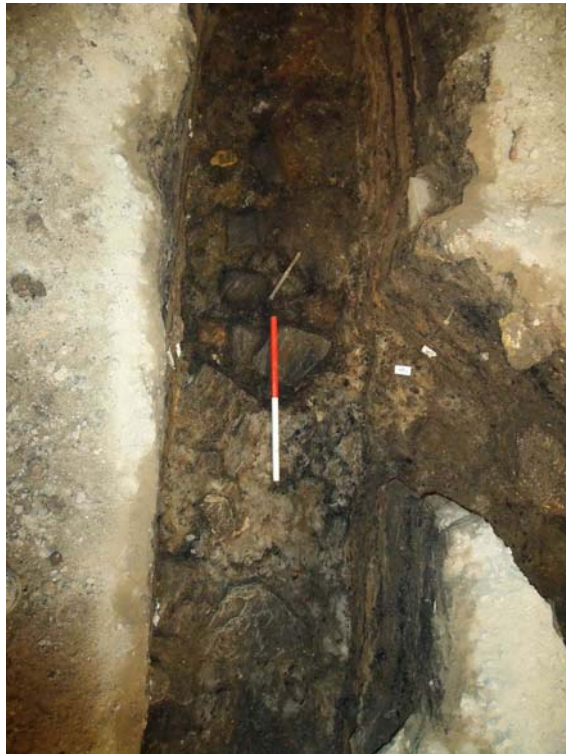
Plate 3. Surface [1079], Trench 10, looking east
(scale 0.5m)

5.4.1.2 Overlying these foundation layers was a stone surface, [1079], mostly comprising rounded and sub-rounded cobbles up to 30mm in diameter, within a sandy silt matrix (Plates 3 and 4). The surface was encountered at a maximum height of 27.78m OD and likely represents the Phase 2a surface of Street 1 or possibly the sub-base of a surface which had subsequently been removed. The arched form of the eastern extent of the metalling was likely representative of a road camber, indicating that this was probably close to eastern street edge, implying that Street 1 was orientated roughly north-south.

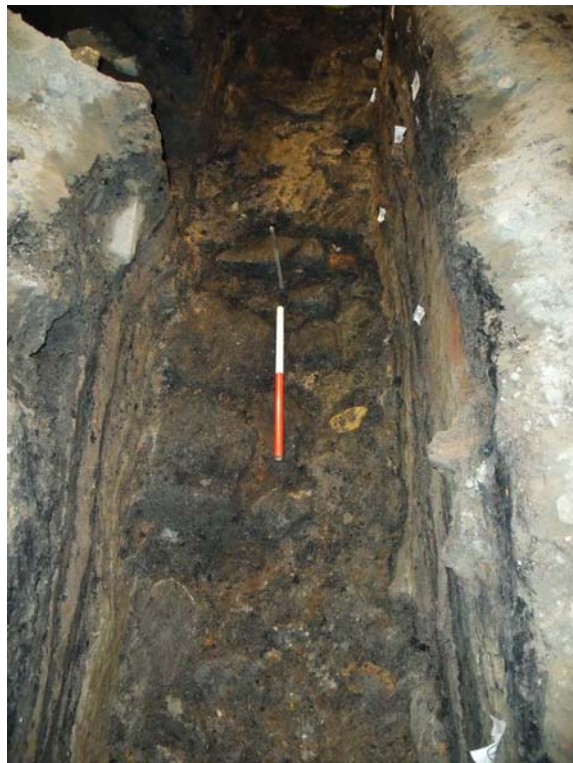
Plate 4. Surface [1079], Trench 10, looking west
(scale 0.5m)

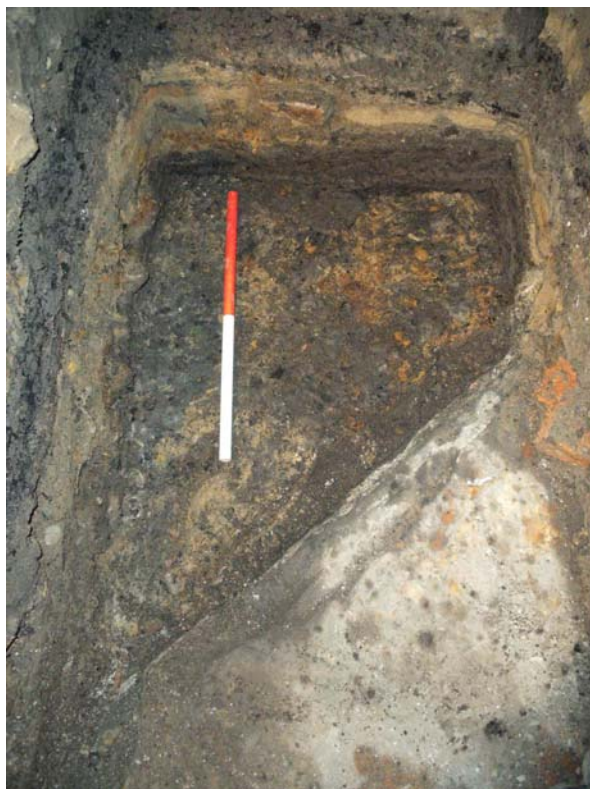
Plate 5. Surface [72], Trench 10, looking southwest (scale 0.5m)

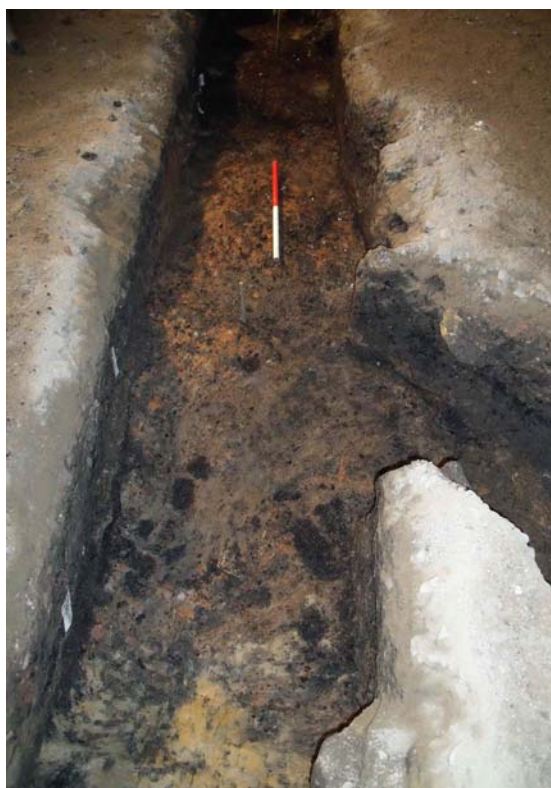
Plate 6. Make-up layer [1033], Trench 10, looking west (scale 0.5m)

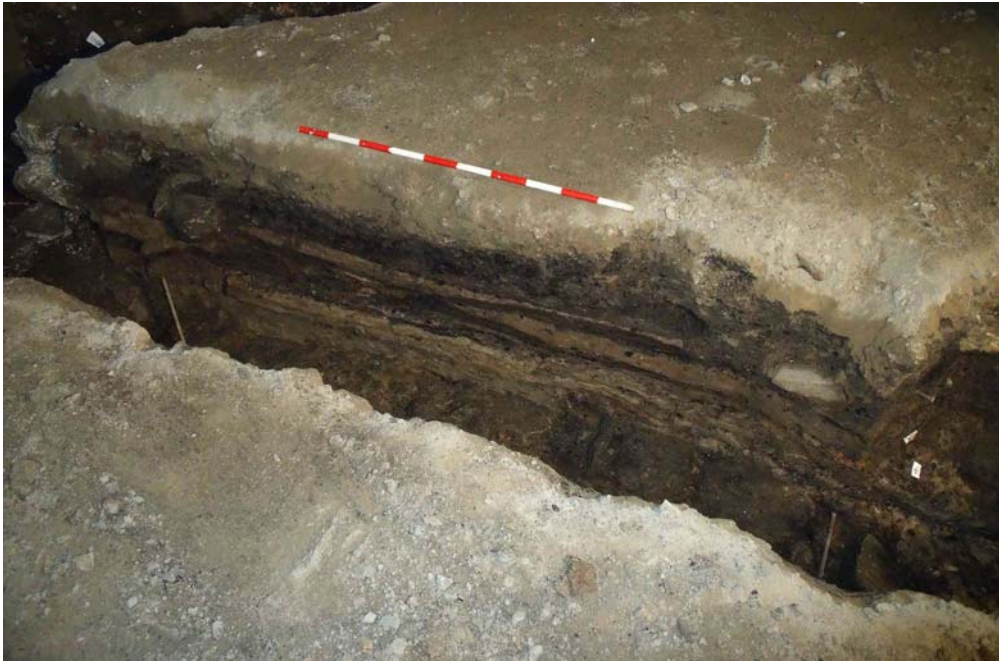
Plate 7. Section 21 (easternmost portion), Trench 10, south facing (scale 1.0m)

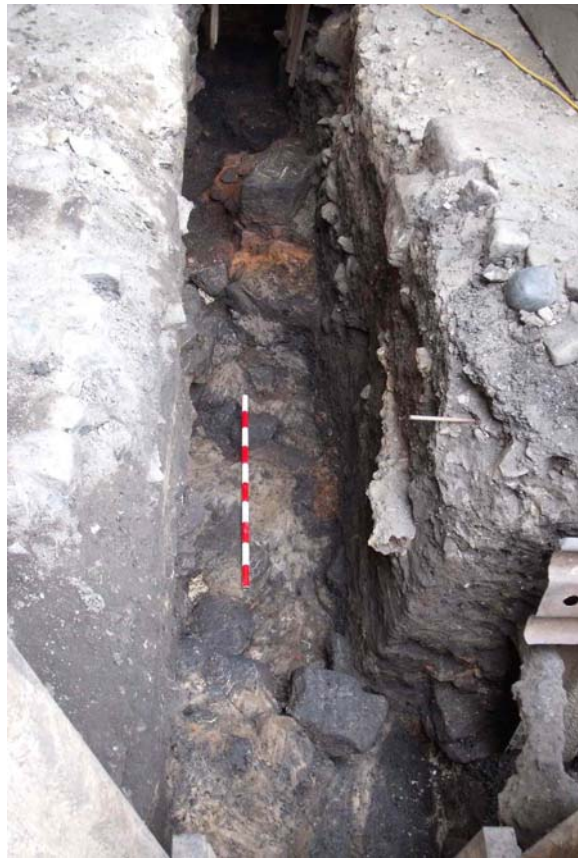
Plate 8. Clay surface [2082] and walls [2077] & [2078], Trench 11, looking north (scale 1.0m)

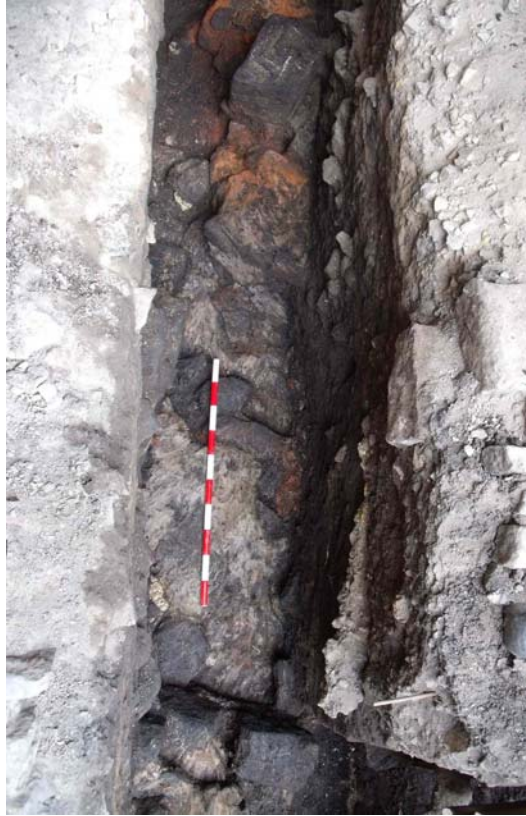
Plate 9. Detail of clay surface [2082], Trench 11, looking north (scale 1.0m)

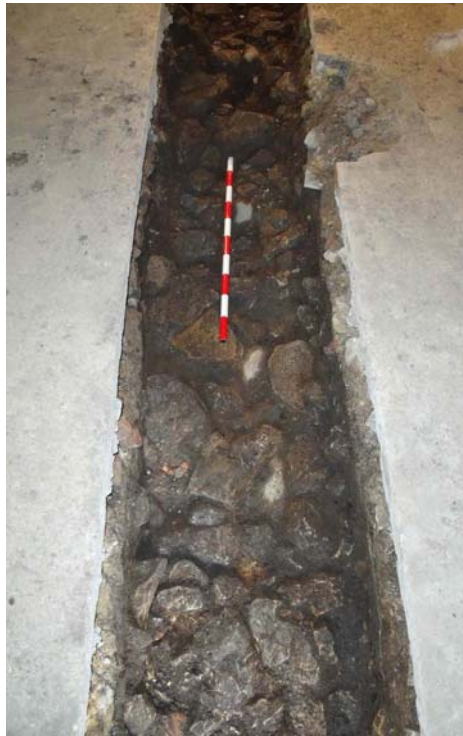
Plate 10. Surface [2016], Trench 11, looking north (scale 1.0m)

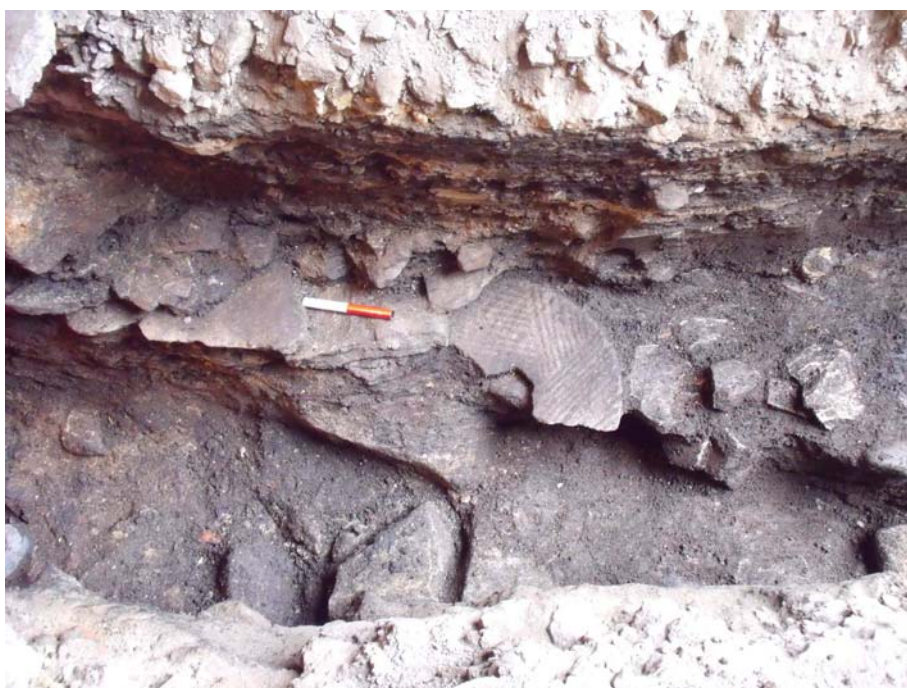
Plate 11. Surface [2038], with quern SF104, Trench 11, looking west (scale 1.0m)

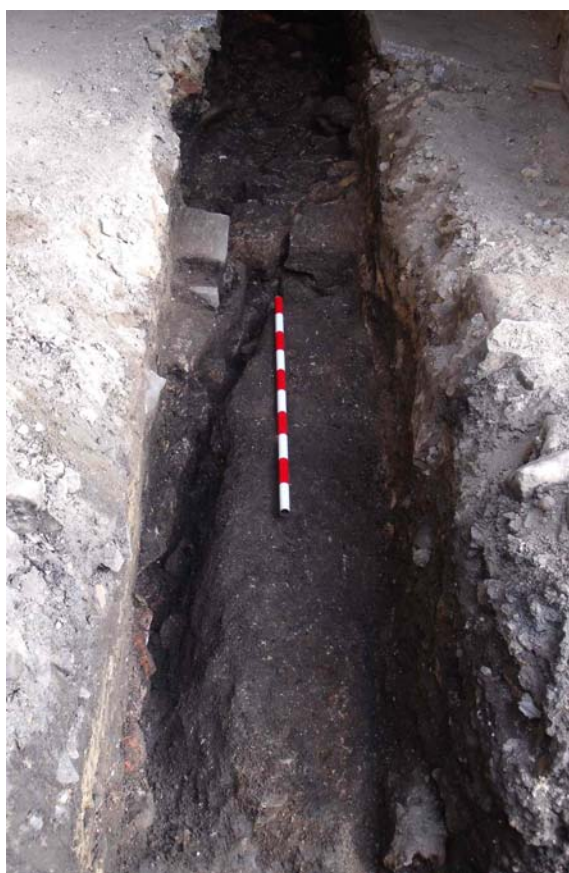
Plate 12. 'Robber' cut [2017], Trench 11, looking north (scale 1.0m)

- 5.13.2.1 Trench 11 contained what may have been the earliest post-medieval activity at the site, in the form of a substantial, irregularly shaped feature, [2017], probably a 'robber' cut (Plate 12). It extended at least 4.10m north-south and was at least c. 1.20m deep. Recorded at a maximum height of 28.35m OD, it contained a loose sandstone rubble fill, [2009], from which post-medieval pottery, residual Roman pottery, clay tobacco pipe and a clay marble were recovered. It is possible that this feature represents efforts to remove Roman or medieval structural material for reuse. Fill [2009] was overlain by a loose sandy silt dump/levelling layer, [2006], up to 0.75m thick.

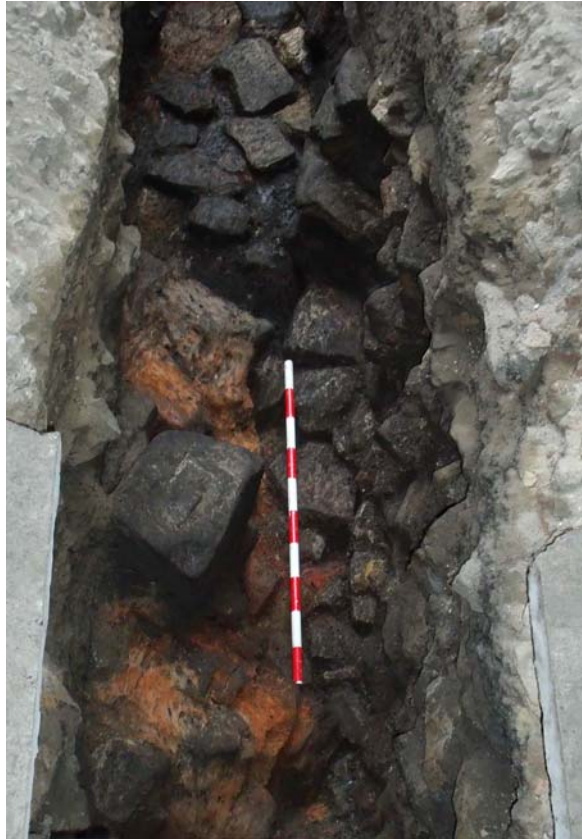
Plate 13. Detail of wall [2077], Trench 11, looking south (scale 1.0m)

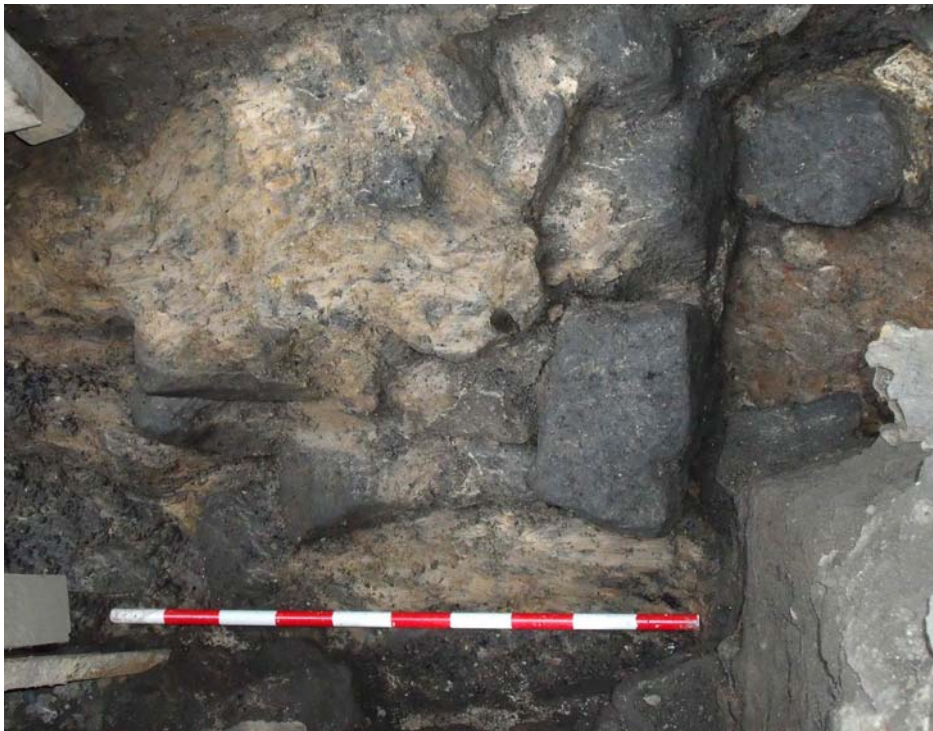
Plate 14. Detail of wall [2078], Trench 11, looking west (scale 1.0m)

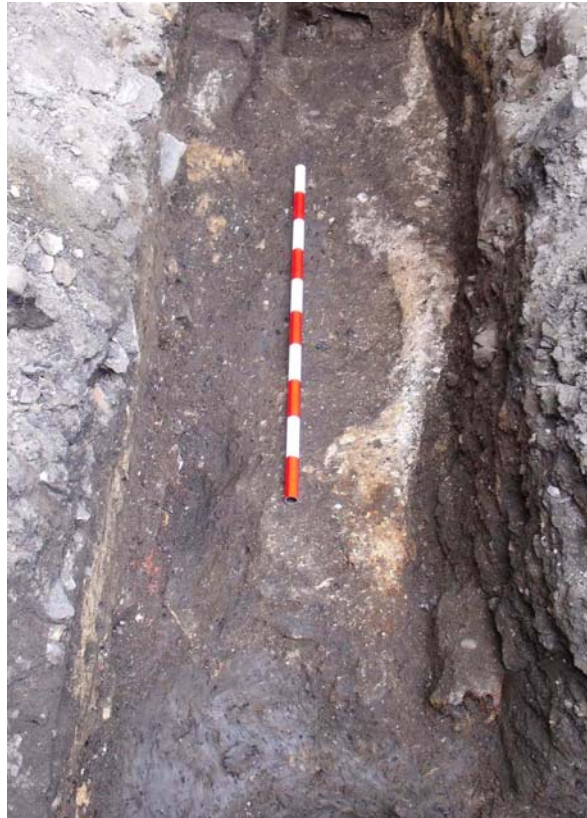
Plate 15. Mortar patching [2007], Trench 11, looking north (scale 1.0m)

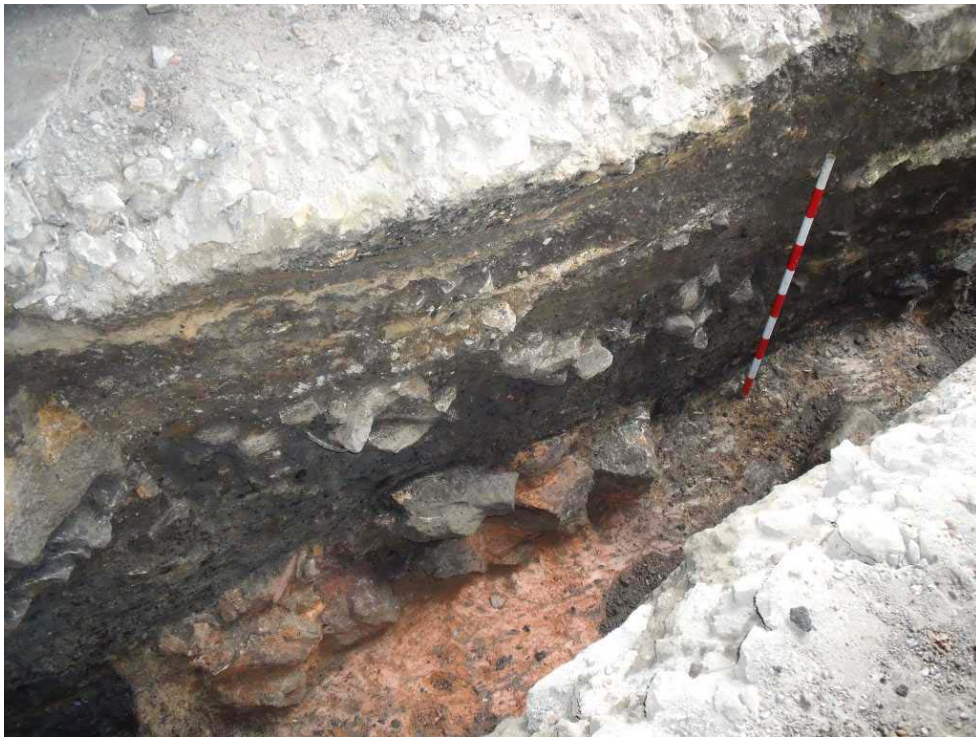
Plate 16. Section 38, Trench 11, west facing, looking south-east (scale 1.0m)

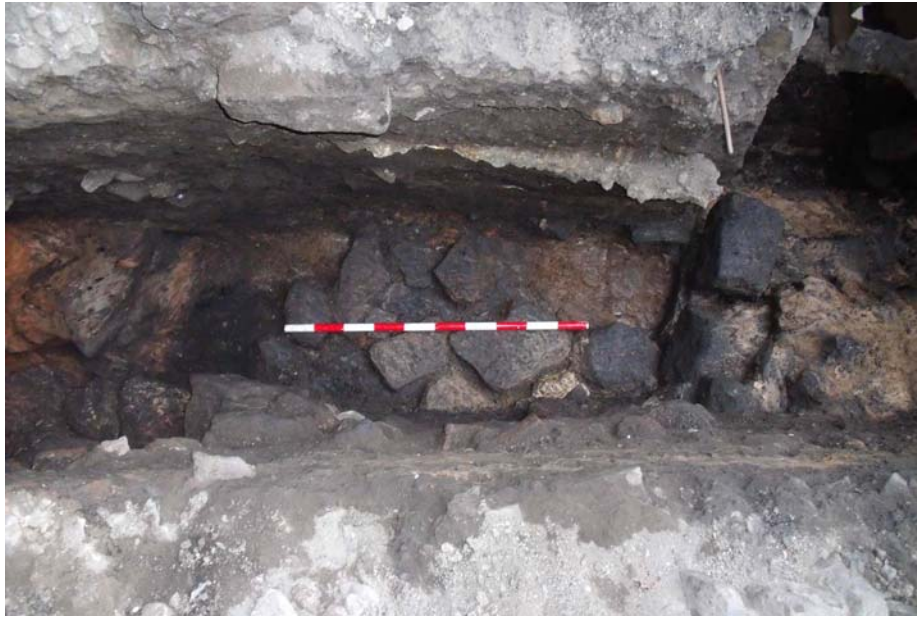
Plate 17. Surface [2083] and walls [2077] & [2078], Trench 11, looking east (scale 1.0m)
