**AN ARCHAEOLOGICAL WATCHING BRIEF  
ON B6318 SIGNING IMPROVEMENTS,  
HARLOW HILL, NORTHUMBERLAND**

**JANUARY 2011**

***Site Code: HWL 10***

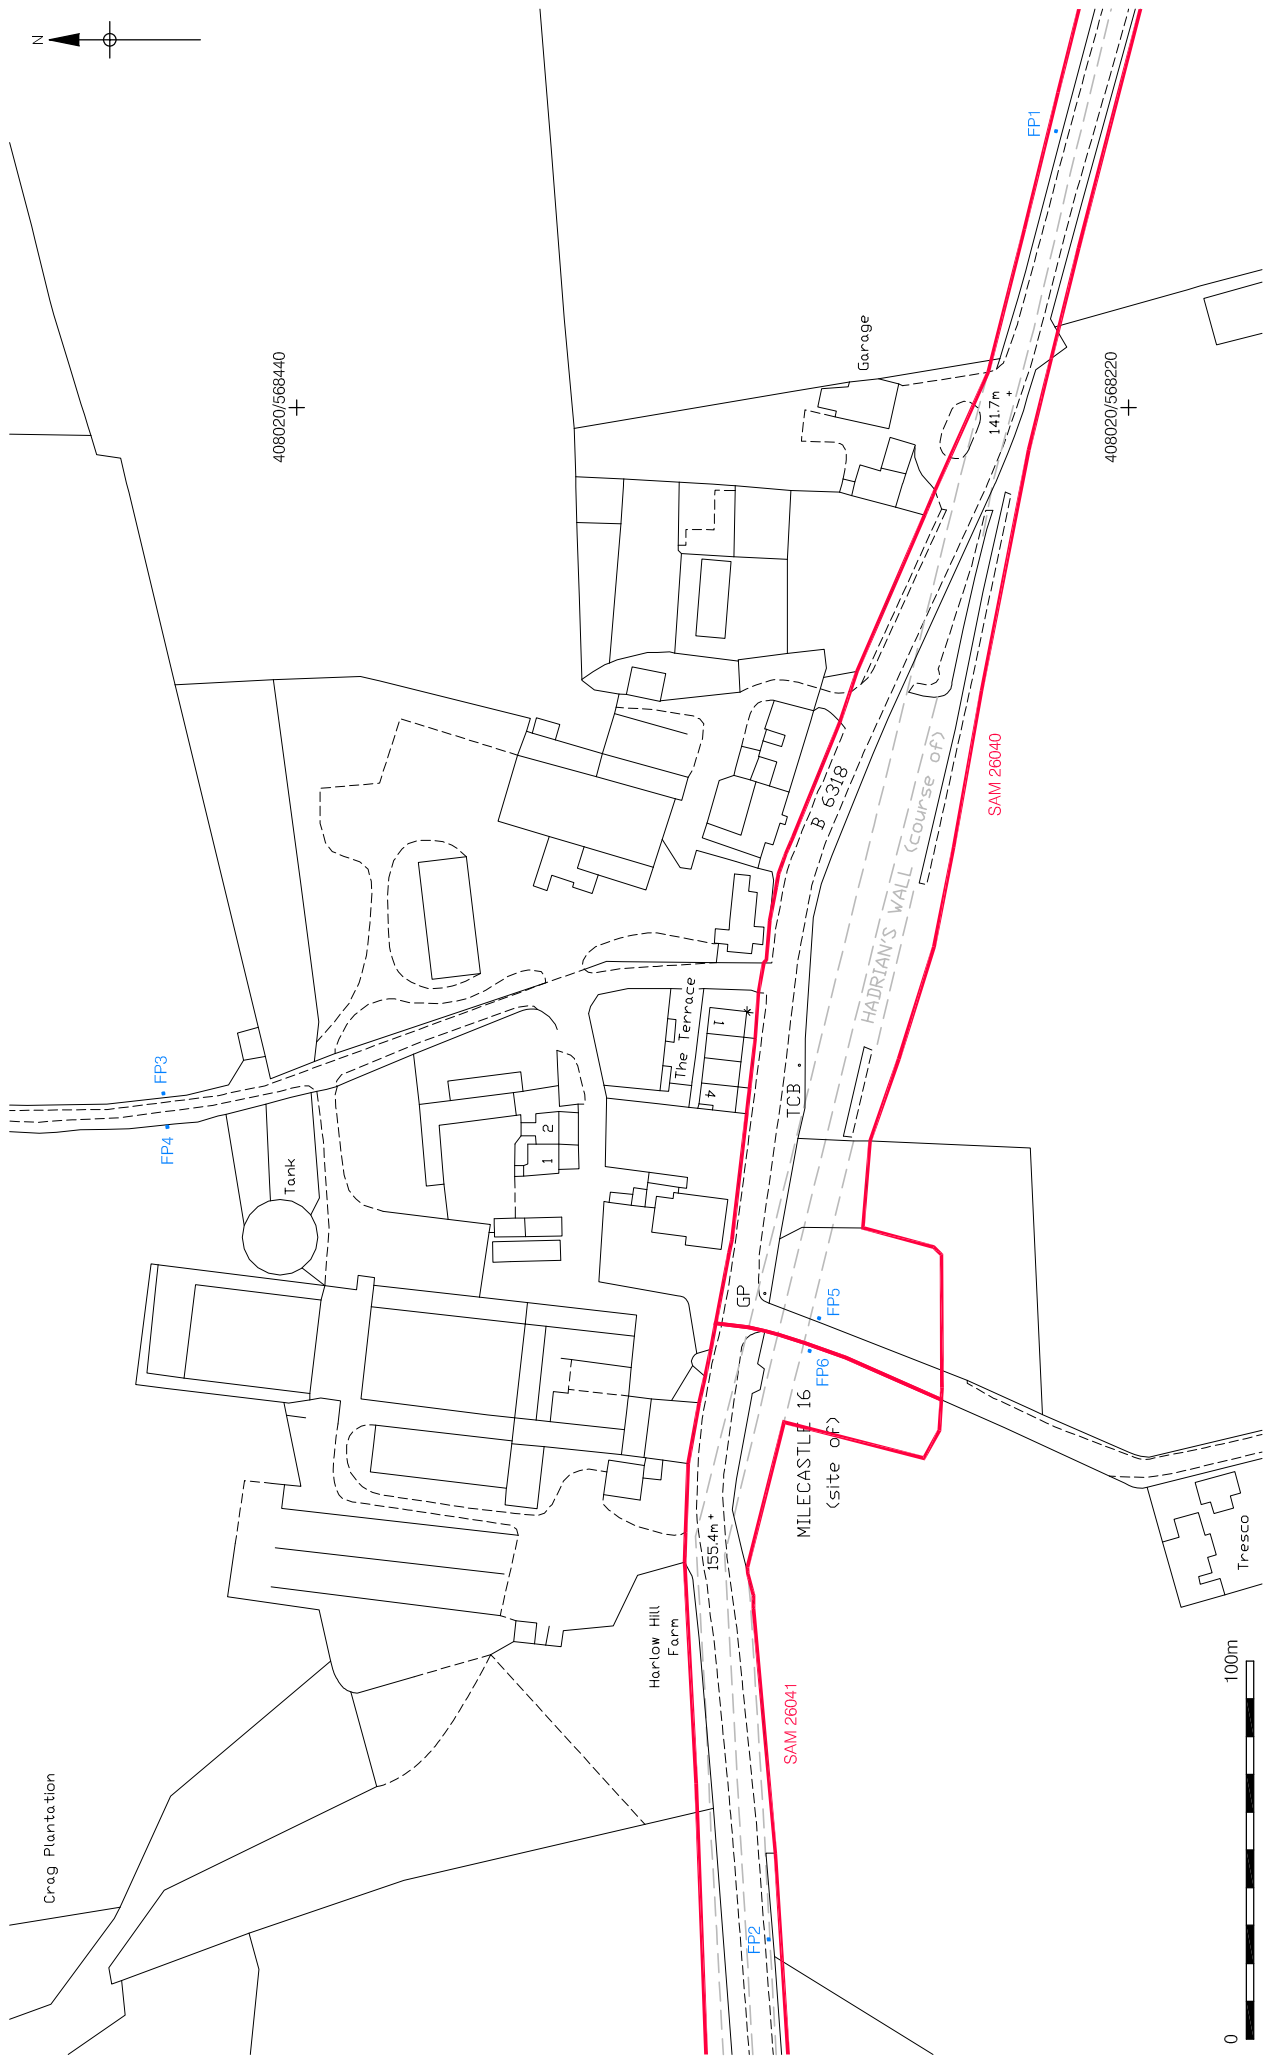
Figure 2  
Foundation Pit Locations  
1:2,000 at A4

- 4.1.2 The groundworks comprised hand excavation of six foundation pits (FPs 1-6) in advance of the installation of new traffic signs (Figure 2). Each sign was to be mounted on a 76mm diameter tubular steel post housed within an approximately 600mm square concrete foundation. Other new signs were to be mounted on existing posts or on existing post extensions thereby obviating the need for intrusive foundation excavations. All intrusive groundwork was subject to continuous monitoring by the attendant archaeologist.

- 4.1.3 FP 1 was located on the northern highway verge of the B6318 at the eastern limit of Harlow Hill village, within SAM 26040. The pit measured 0.50m north-south by 0.50m east-west and was 0.50m deep.

- 4.1.4 FP 2 was located on the southern highway verge of the B6318 at the western limit of Harlow Hill village within SAM 26041. The pit measured 0.50m north-south by 0.55m east-west and was 0.60m deep.

- 4.1.5 FPs 3 and 4 were located on the eastern and western highway verges, respectively, of the road running northwards between the B6318 and Ouston Airfield, to the north of SAM 26040. FP 3 measured 0.50m north-south by 0.50m east-west and was 0.60m deep, while FP 4 measured 0.50m north-south by 0.65m east-west and was 0.55m deep.

- 4.1.6 FPs 5 and 6 were located on the eastern and western highway verges, respectively, of the road running from the B6318 southwards to the A69. FP 5 lay within SAM 26040 and FP 6 lay at the junction of SAMs 26040 and 26041. FP 5 measured 0.50m north-south by 0.50m east-west and was 0.60m deep, while FP 6 measured 0.50m north-south by 0.45m east-west and was 0.60m deep.

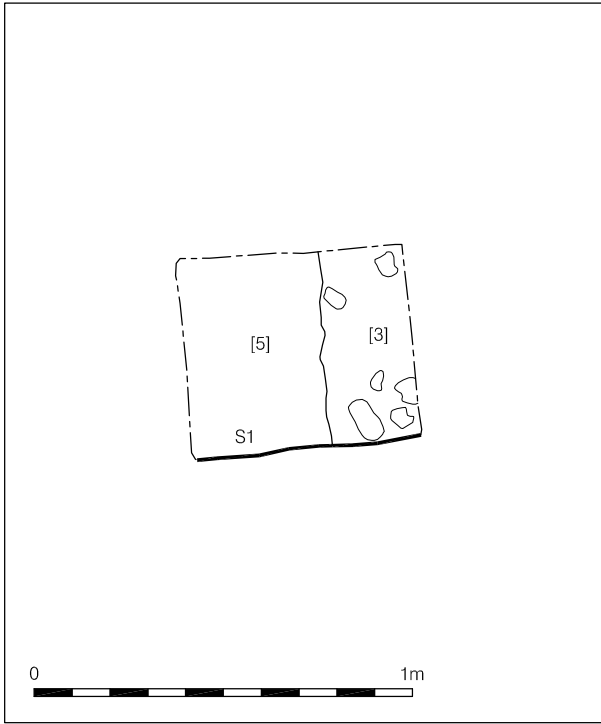
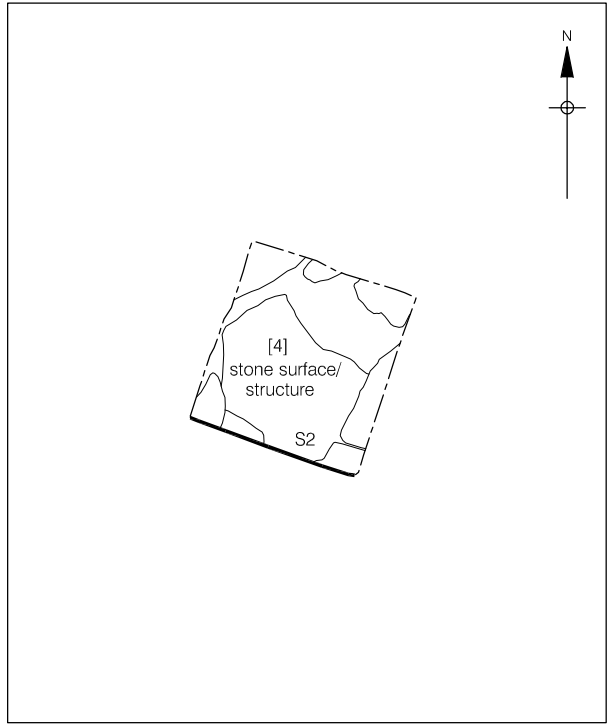
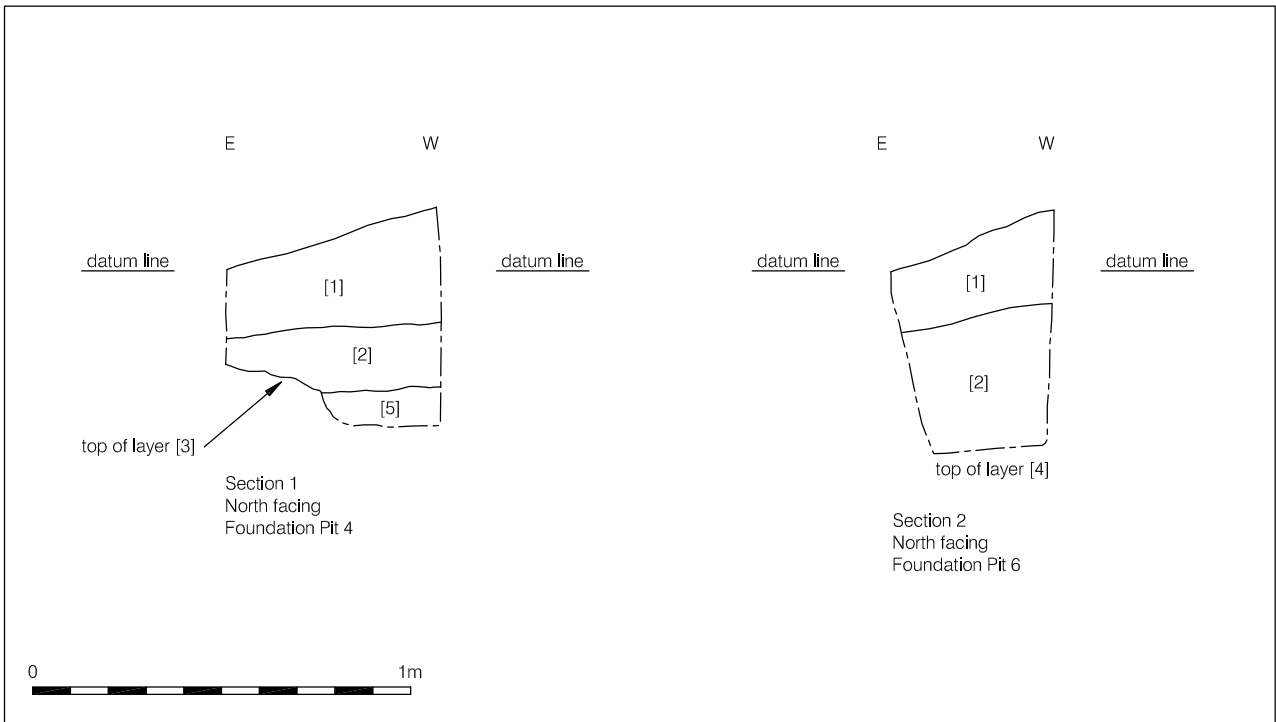
Figure 3  
Sections and Plans from Foundation Pits 4 & 6  
1:20 at A4

- 5.1.2 Overlying the sub-soil in FP 4 was a layer, [3], c. 0.10m thick, comprising compact, light orange brown silt, with frequent small and medium angular fragments of sandstone throughout (Figures 3 and 5). Interpreted as dump/levelling deposit, its period of origin is uncertain.

- 5.1.3 In FP 6, a compact layer, [4], comprising roughly worked fragments of sandstone, up to c. 100mm x 100mm in size, in a mid greyish brown sandy silt matrix, was encountered at a depth of c. 0.55m below existing ground level, this forming the basal deposit at this location (Figures 3 and 4). It appeared to be a deliberately compacted stone surface, or possibly another form of structural element, such as a wall, although the former is the preferred interpretation. Its period of origin is uncertain but it could potentially be related to Hadrian's Wall. It was preserved *in situ*, at the base of the foundation pit.

Plan of Foundation Pit 4  
1:20 at A4

Plan of Foundation Pit 6  
1:20 at A4

Sections 1 & 2  
1:20 at A4

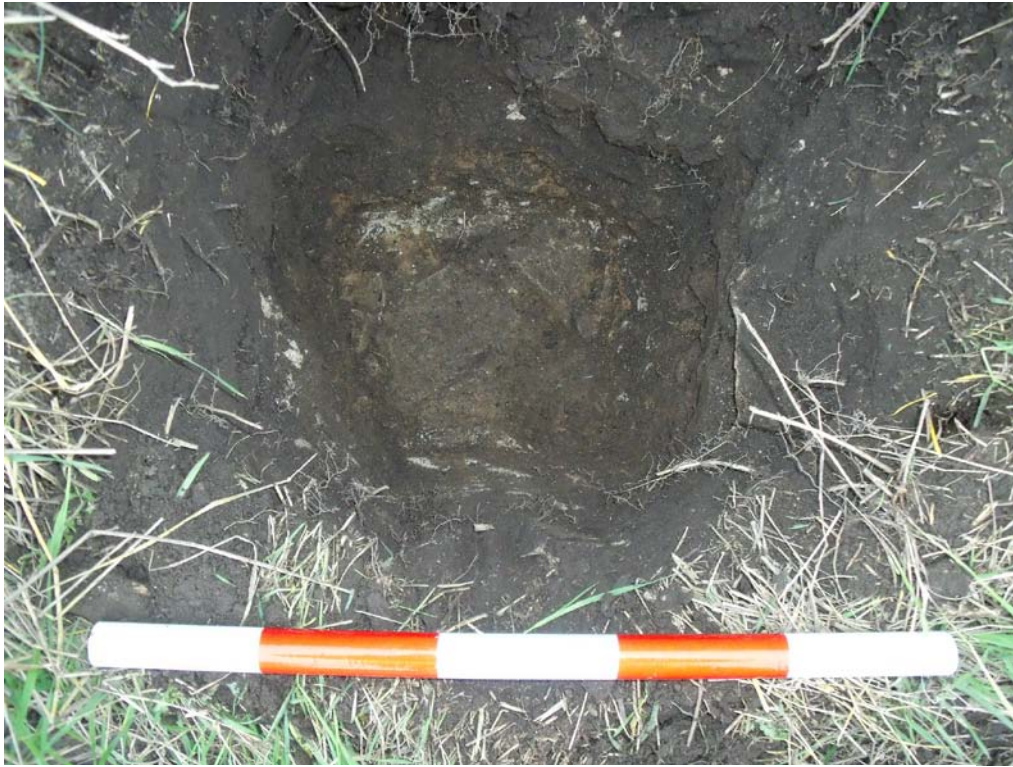
Figure 4: Layer [4] in Foundation Pit 6 (scale 0.5m)

- 6.1.3 Part of what appeared to be a sandstone surface was recorded as the basal deposit in FP 6. This could represent part of a surface or structural element associated with Hadrian's Wall. However, no dating evidence was found in association with it and a precise interpretation is impossible based on the limited degree of exposure.

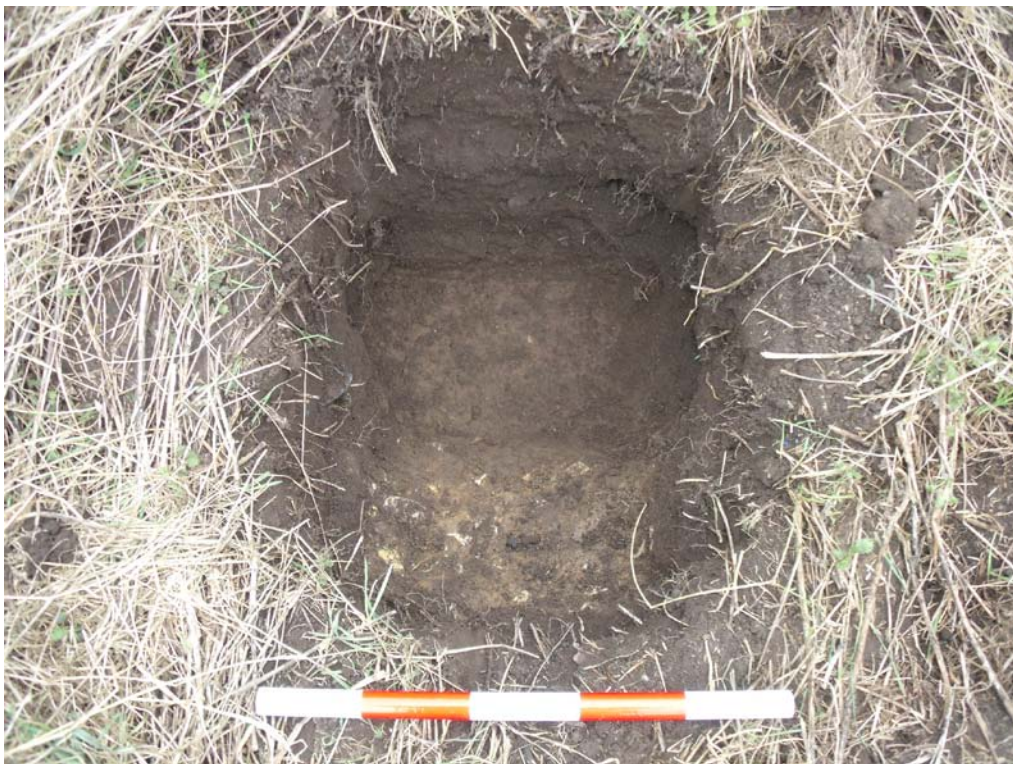
Figure 5: Layer [3] in Foundation Pit 4 (scale 0.5m)
