**AN ARCHAEOLOGICAL WATCHING BRIEF
ON CORBRIDGE BRIDGE, CORBRIDGE,
NORTHUMBERLAND**

Central National Grid Reference: NY 9889 6412

Site Code: CBN 10

**© Pre-Construct Archaeology Limited
June 2010**

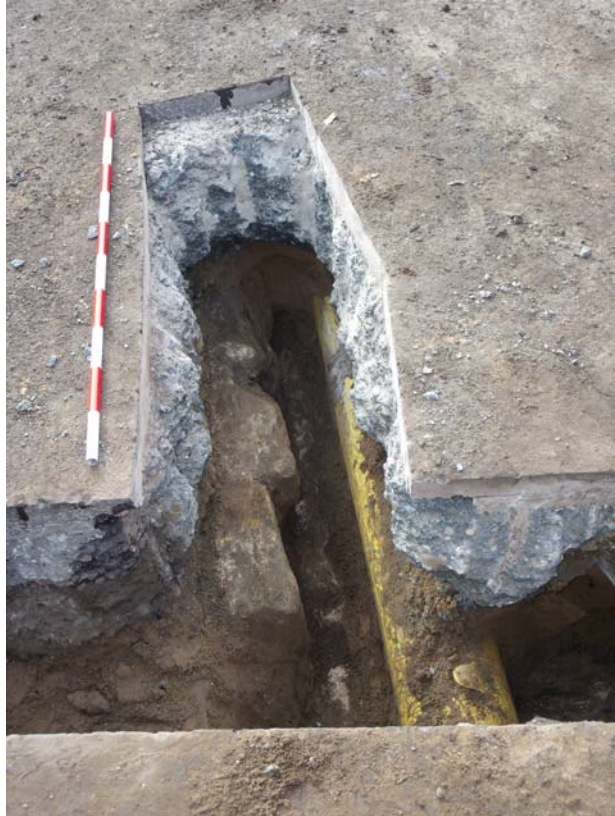
4.1.3.1 In the southern part of TH1, an area of masonry, [5], was exposed (Figures 3 and 4). This comprised sandstone blocks, measuring up to 350mm x 320mm x 200mm and bonded with silty clay. It was exposed across an area measuring 0.90m north-south by 0.20m east-west and was recorded at a height of 31.08m OD. This masonry is interpreted as part of cantilever extensions associated with the widening of the bridge during the 19th century.

Figure 4 Trial Hole 1 (N-S arm), Masonry [5], looking SSW (*scale 1m*)

- 5.1.3 Evidence of alteration to the bridge in the 19th century (Phase 3) was recorded in TH1 and TH7, where the presence of sandstone masonry is thought to reflect cantilever extensions of Span 7, associated with the widening of the bridge during this period.

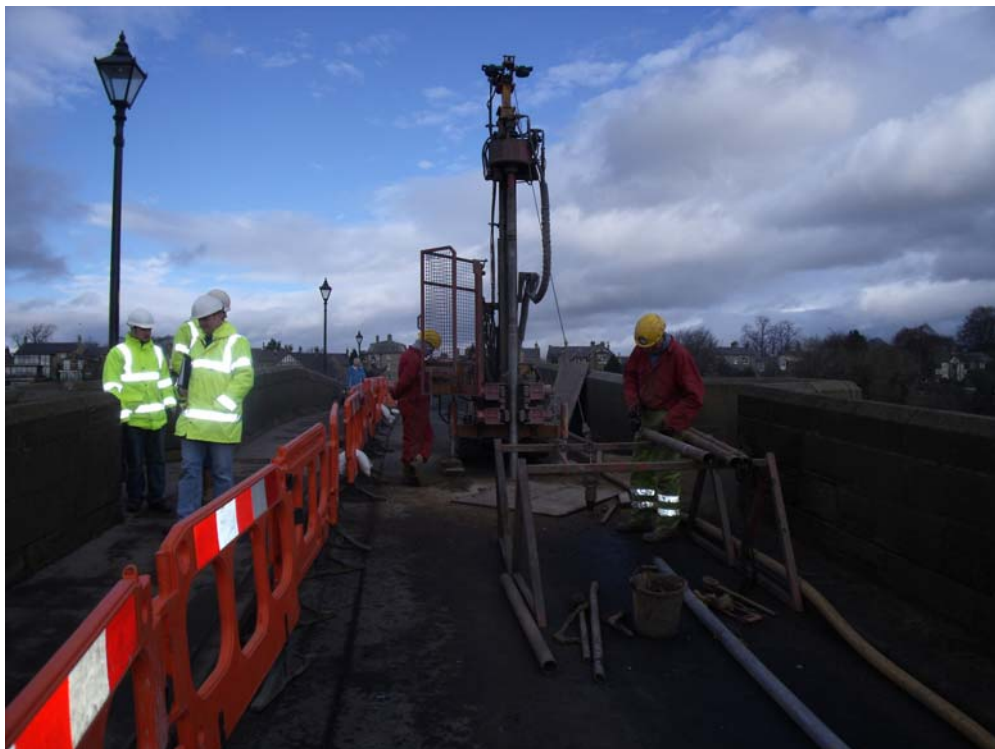
Figure 5 View of Boreholing in Progress, looking N

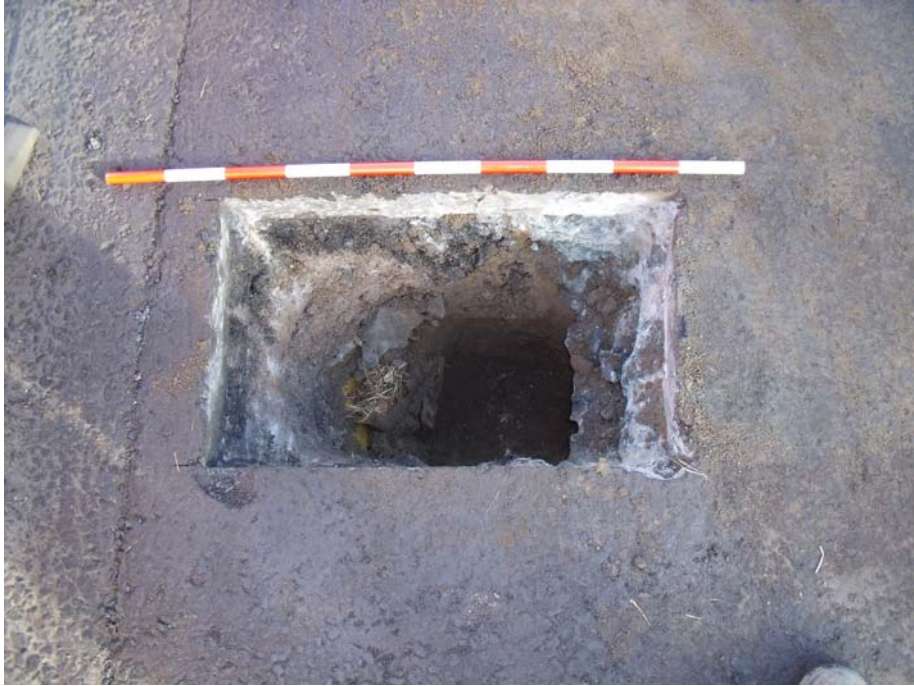
- 4.1.4.1 North-south aligned service trenches, [4], [10] and [22], all backfilled with loose sand fills, [3], [9] and [21], respectively, were recorded in TH1, TH2 and TH6 (Figure 6). Apparently contemporary with these services was a sandy 'made-ground' layer, [13], [18] and [26], recorded in TH3, TH5 and TH7, respectively. This deposit varied in thickness between 0.18m and 0.90m.
- 4.1.4.2 The remainder of the deposits recorded in all seven trial holes comprised an up to c. 0.50m thick concrete aggregate layer, [2], [8], [12], [15], [17], [20] and [25] (THs 1-7, respectively), which formed the sub-base for a c. 50mm thick tarmac surface, [1], [7], [14], [16], [19], [24] and [29] (THs 1-7, respectively). Together these remains represent the modern carriageway surface of the bridge.

Figure 6 Trial Hole 6, looking N (*scale 1m*)

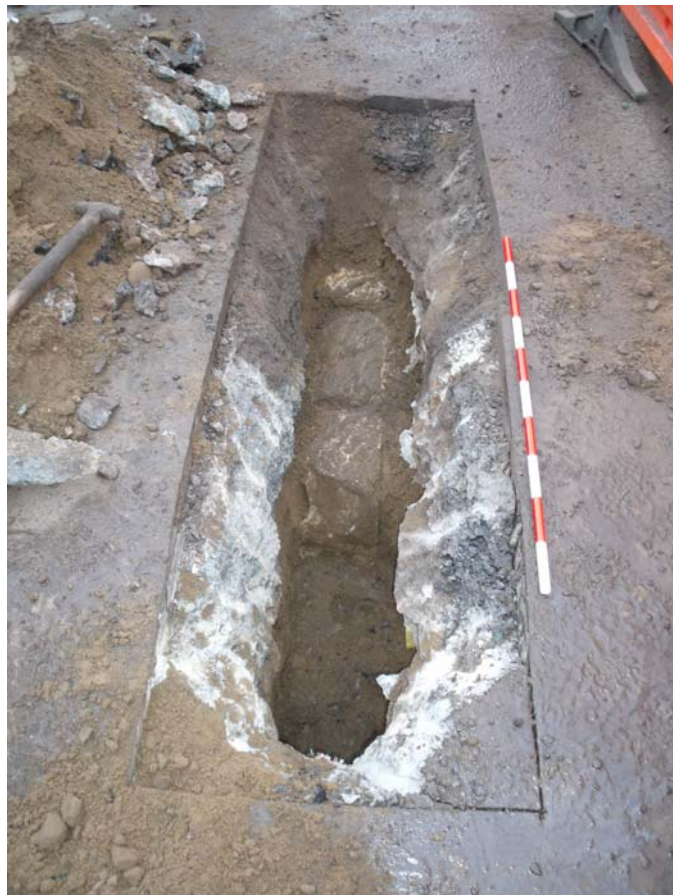
4.1.2.1 A small area of metallised surface, [28], was exposed within the northern half of TH7 (Figures 3 and 7). Measuring at least 0.72m north-south by 0.40m east-west it was encountered at 30.61m OD. The surface had been constructed from generally well-sorted, fine and medium rounded and sub-rounded stones set within a sandy silt matrix. Whilst no artefactual material was recovered from the surface, evidently it pre-dated 19th century alterations to the bridge and could, therefore, potentially represent a metallised road surface on the bridge of 17th or 18th century date.

4.1.3.2 In the northern part of TH7, an area of masonry, [27], was exposed (Figures 3 and 7). This comprised sandstone blocks, measuring up to 420mm x 300mm x 200mm, encountered at 30.96m OD. The masonry was exposed across an area measuring at least 1.10m north-south by at least 0.40m east-west and again is interpreted as part of cantilever extensions associated with 19th century widening of the bridge.

Figure 7 Trial Hole 7, Masonry [27], and Surface [28], looking S (*scale 1m*)

- 5.1.2 Potentially contemporary with the 17th century masonry, and certainly pre-dating an episode of bridge alteration in the 19th century, was an area of metalled surface in TH7 (Phase 2). The surface may represent an earlier road surface on the bridge, possibly during the 17th, 18th or early part of the 19th century.
