**BUILDING RECORDING OF
THE MIDLAND GOODS SHED
KING'S CROSS CENTRAL
LONDON BOROUGH OF
CAMDEN**

SITE CODE: KXM08

JUNE 2010

Building Recording

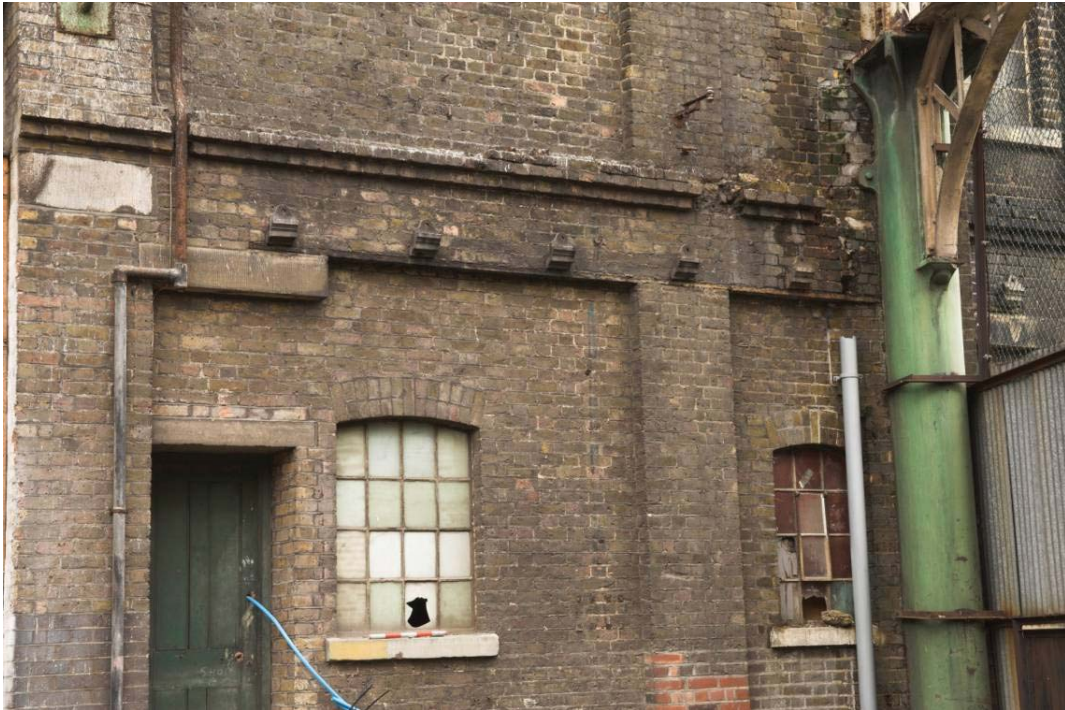
Plate 4: Bays 23 and 24 in the west elevation of the MGS showing lower flange of cast iron beam spanning 1858 opening (now infilled)

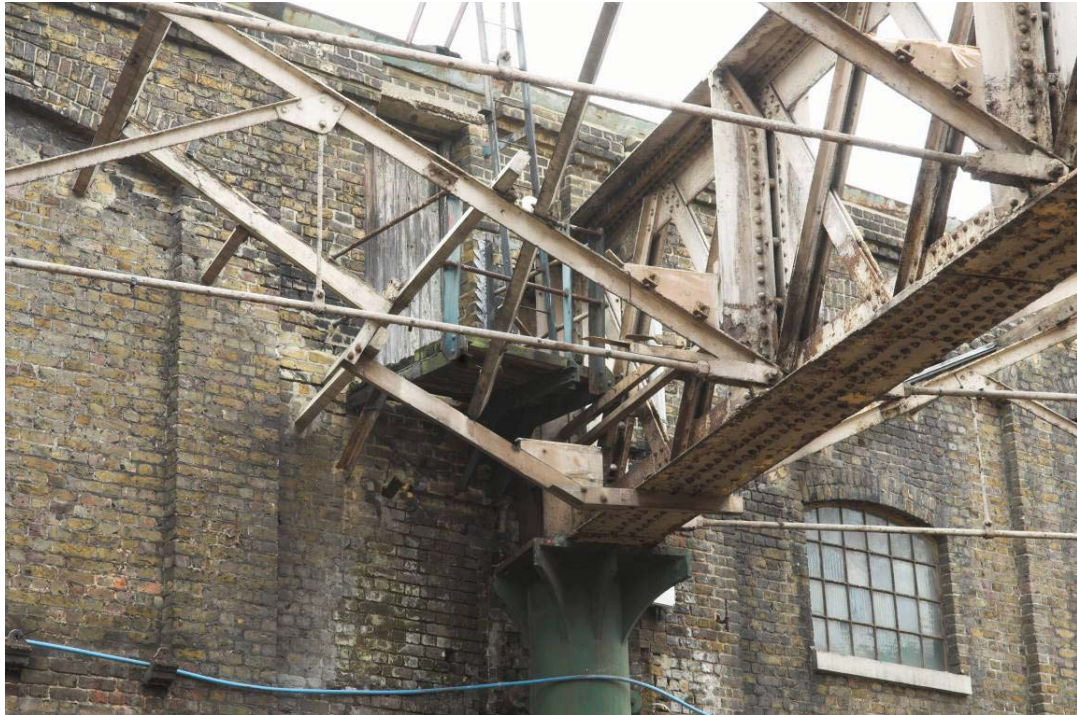
Plate 5: Loading door and roof access in Bay 11 of the west elevation of the MGS

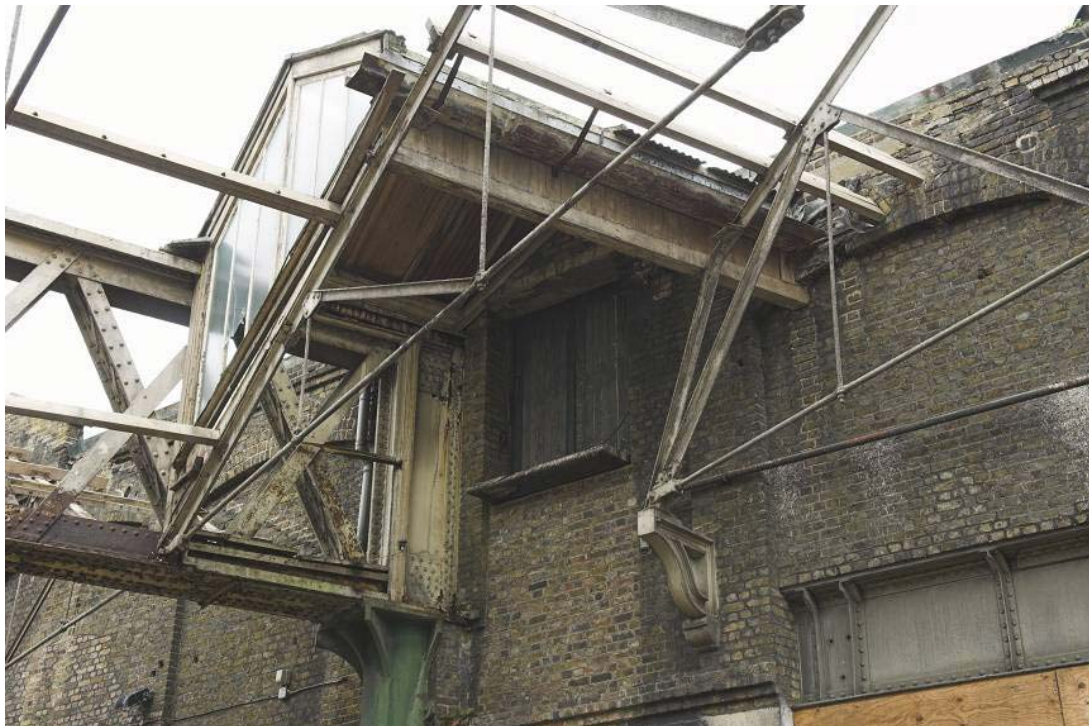
Plate 6: Loading doors and West Handyside Canopy truss with ornate iron bracket on stone corbel in Bay 20 of the west elevation of the MGS

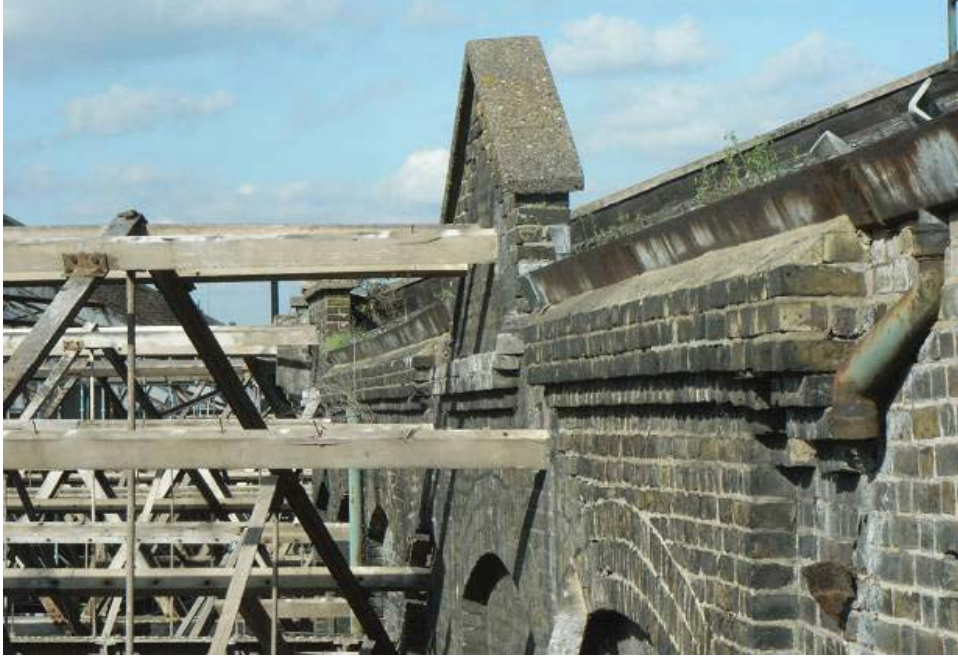
Plate 9: Junction between an apex of the West Handyside Canopy (left) and the west elevation of the MGS in Bay 5 (right)

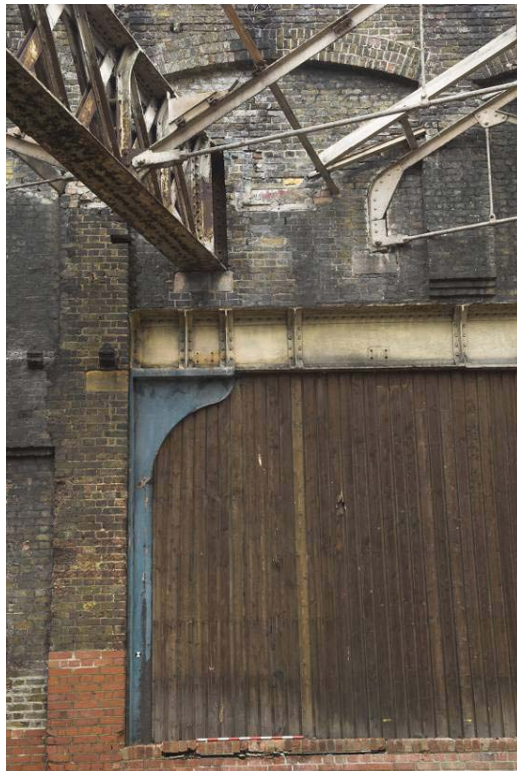
Plate 10: West Handyside Canopy girder and roof truss inserted above Loading Bay W1 in Bay 3 of the west elevation of the MGS

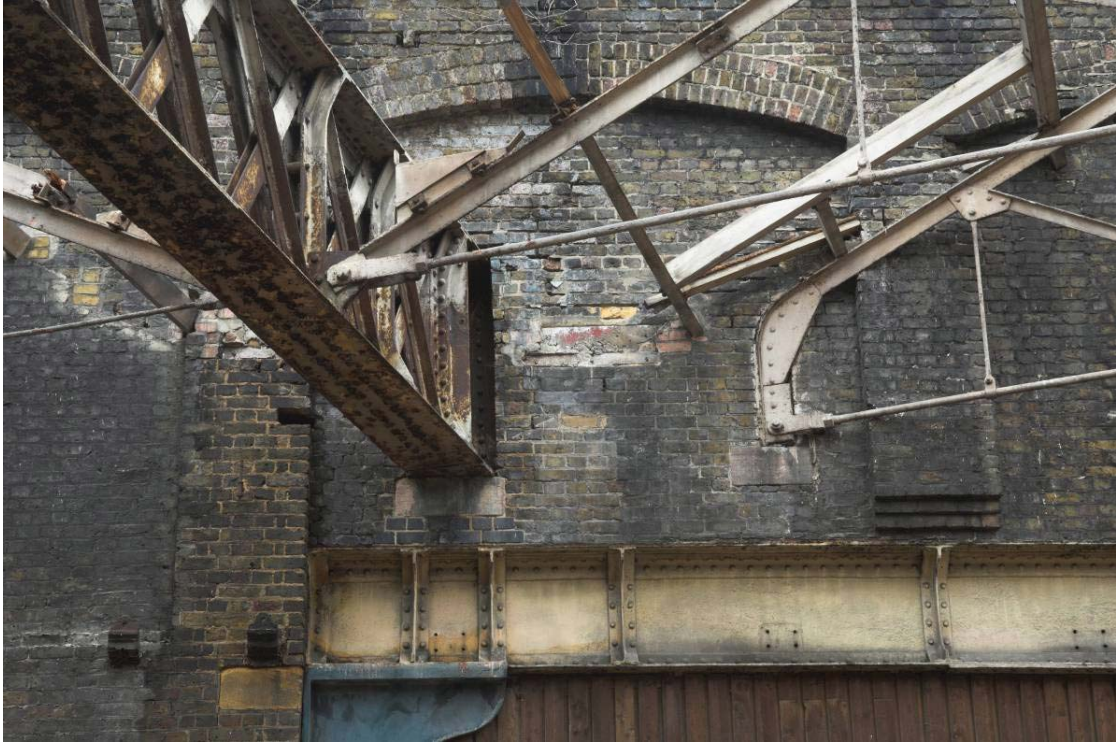
Plate 11: West Handyside Canopy girder and roof truss inserted above Loading Bay W1 in Bay 3 of the west elevation of the MGS

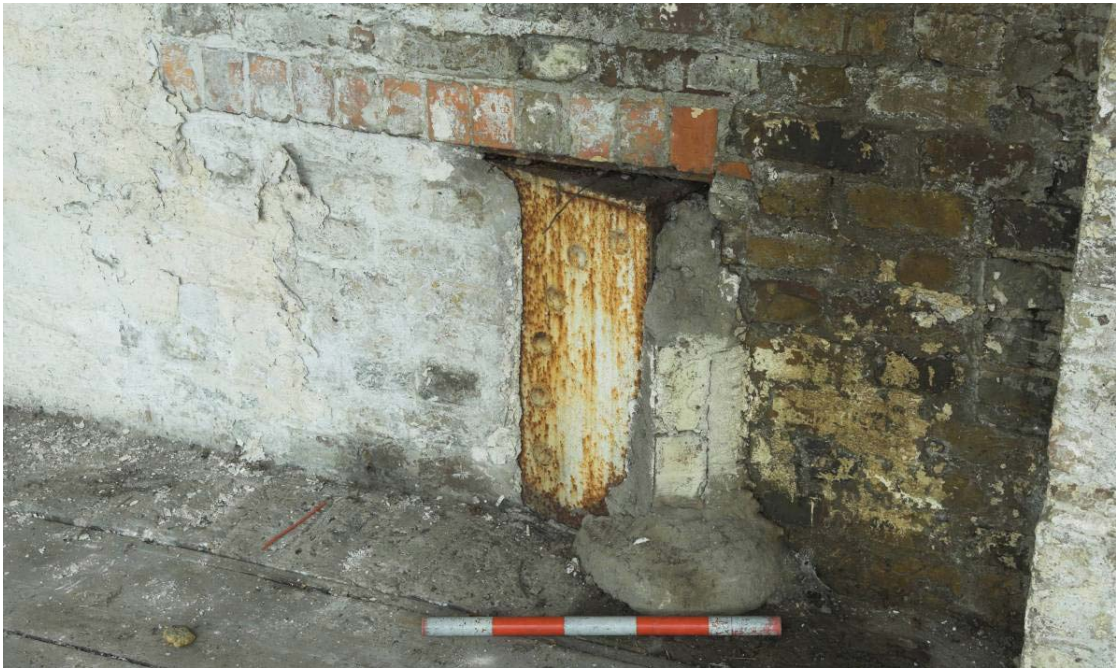
Plate 12: West Handyside Canopy girder visible in the interior of the of the MGS at first floor level in Bay 7 of the west wall

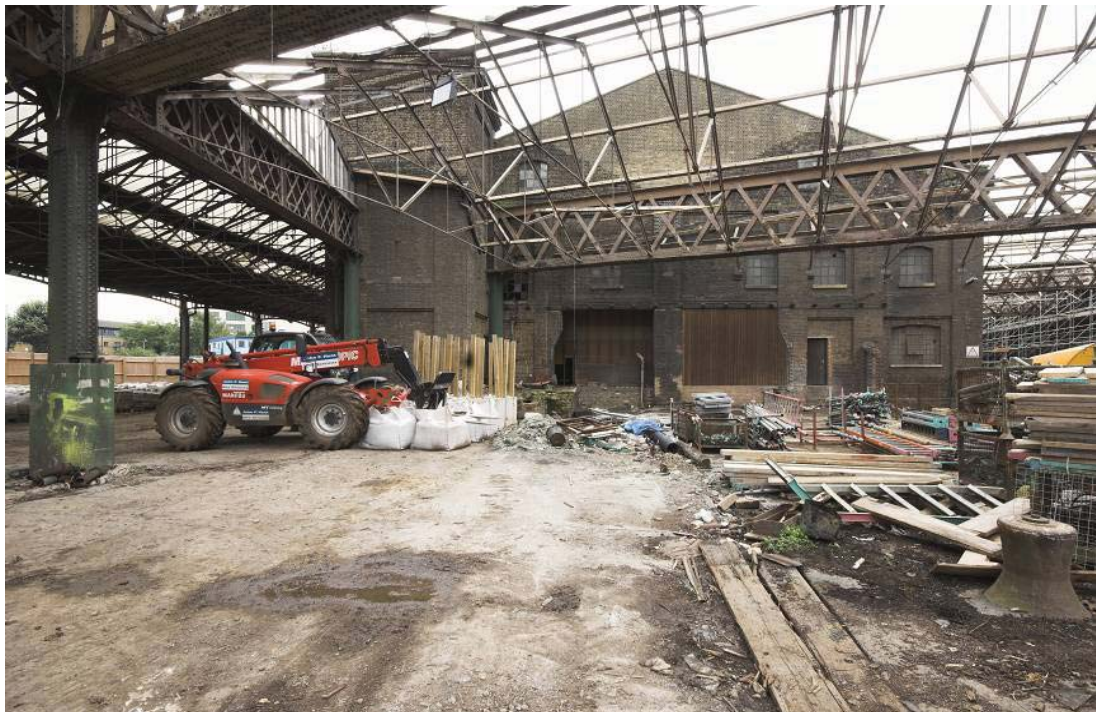
Plate 14: North elevation of the accumulator tower (left) and MGS (right) with capstan in the right (west) foreground

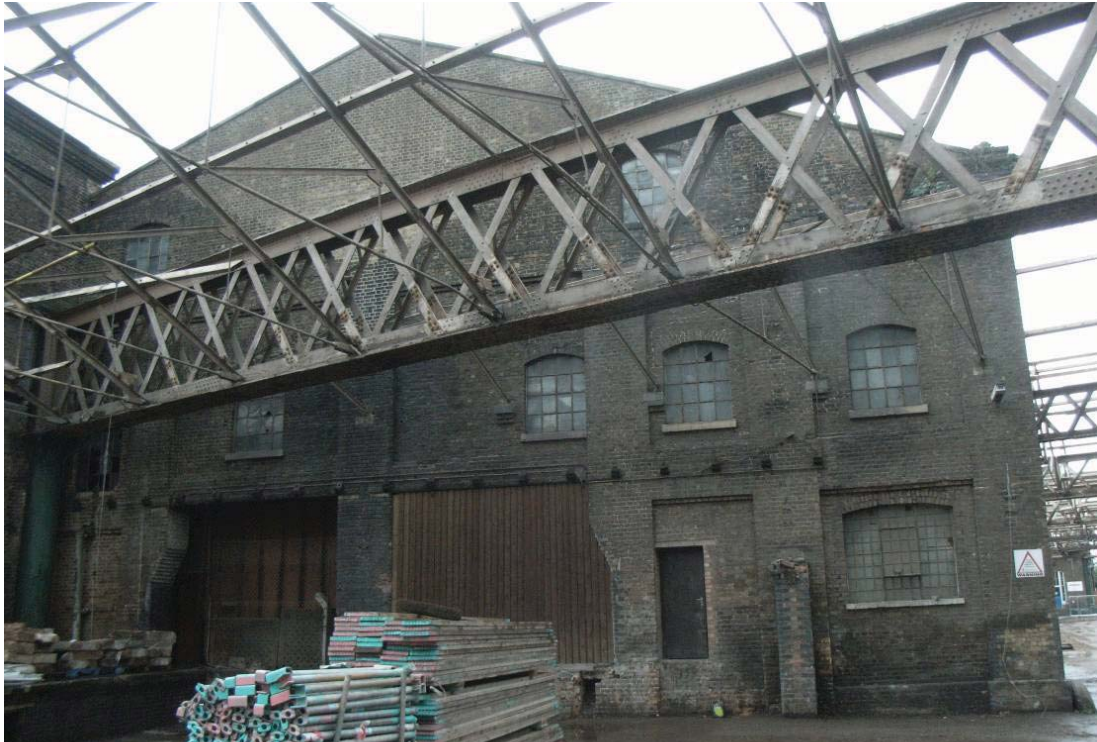
Plate 15: North elevation of the MGS

- 5.2.33 The double gabled roof, which is now visible as a scar on the north elevation of the Midland Goods Shed, was replaced by a clear-span symmetrically-pitched roof in 1957 (**Figure 16; Plates 14 to 16**). The elevation is topped by a low parapet wall with concrete copings.

- 5.2.36 A large crack is visible on the west side of the north wall at upper panel height (**Figure 16**; **Plates 15 and 16**).

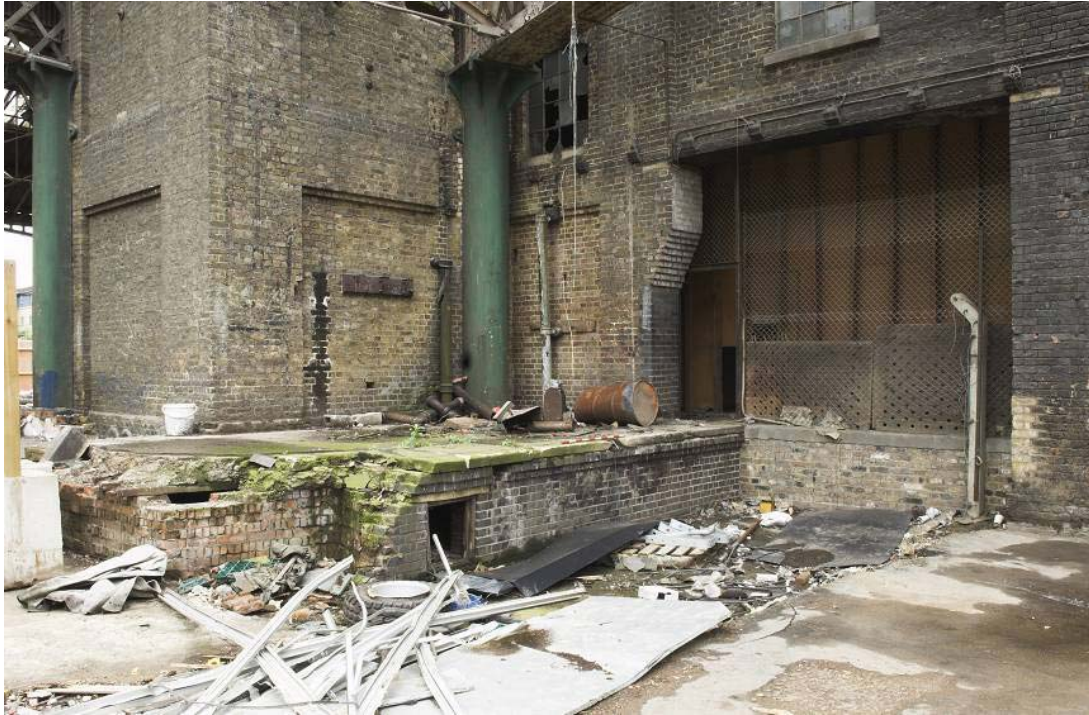
Plate 16: West end of the north elevation of the MGS

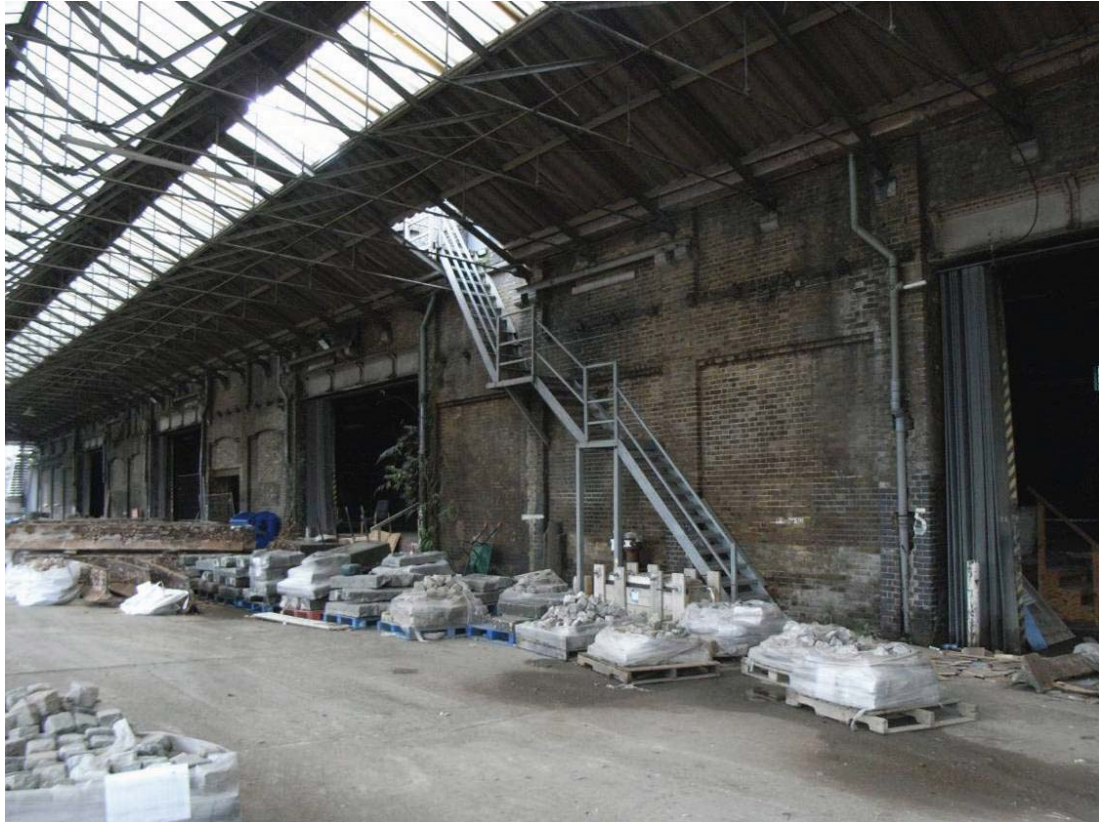
Plate 19: East elevation (Bays 4 to 20) of the MGS and the East Handyside Canopy (left)

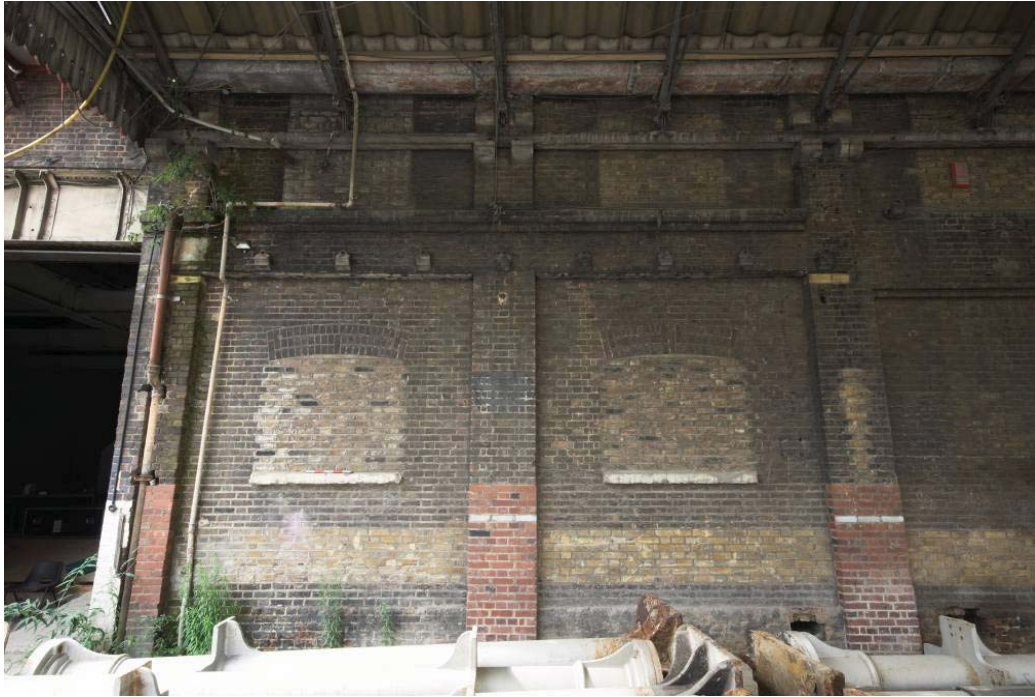
Plate 21: Bays 19 and 20 in the east elevation of the MGS showing lower flange of cast iron beam spanning 1858 opening (now infilled)

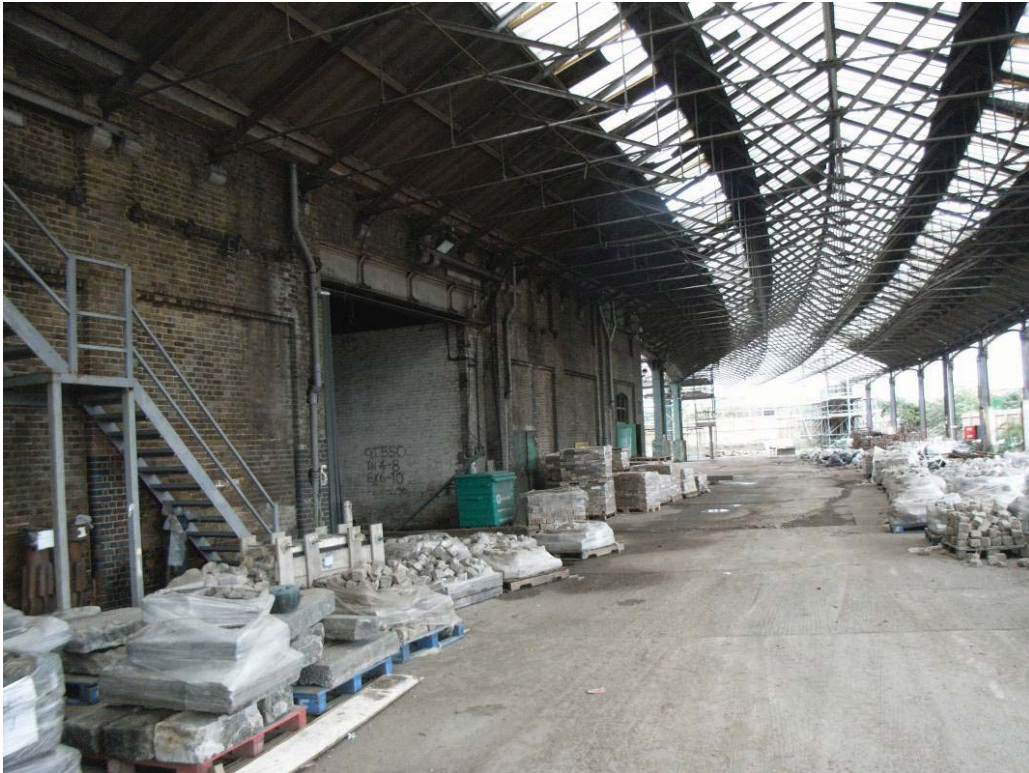
Plate 23: East elevation (Bays 1 to 6) of the MGS (left) and the East Handyside Canopy (right), view from the south

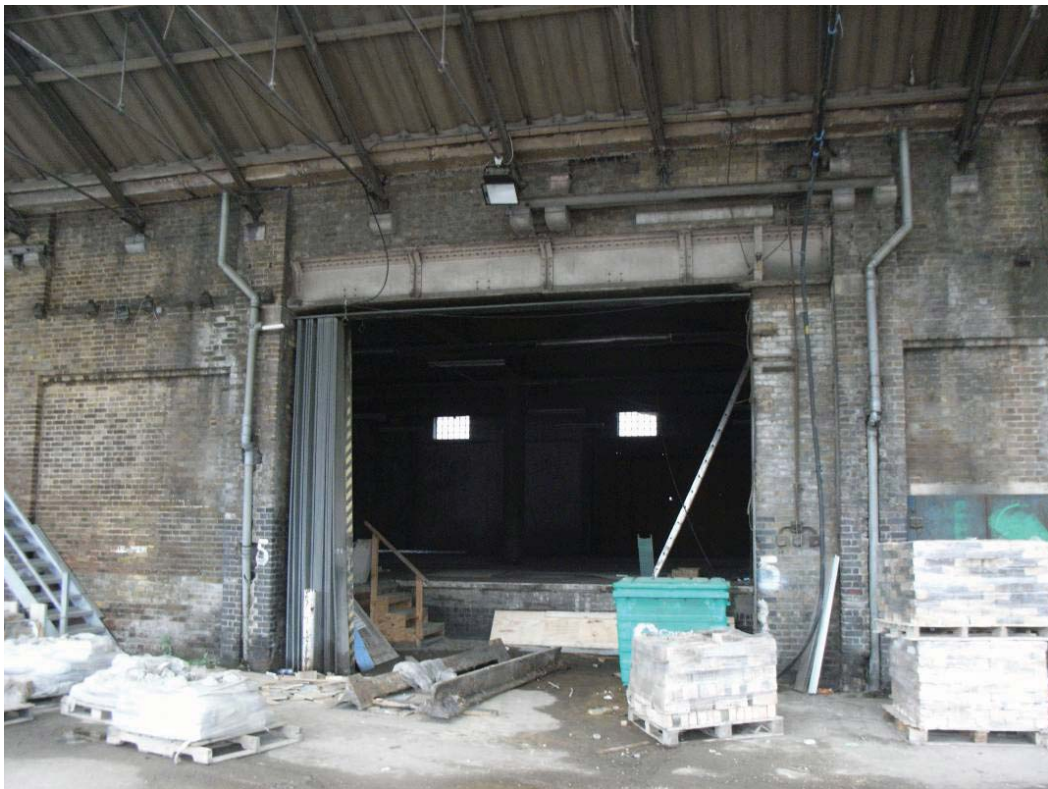
Plate 26: Loading Bay Opening E1 in the east elevation (Bays 2 to 5) of the MGS

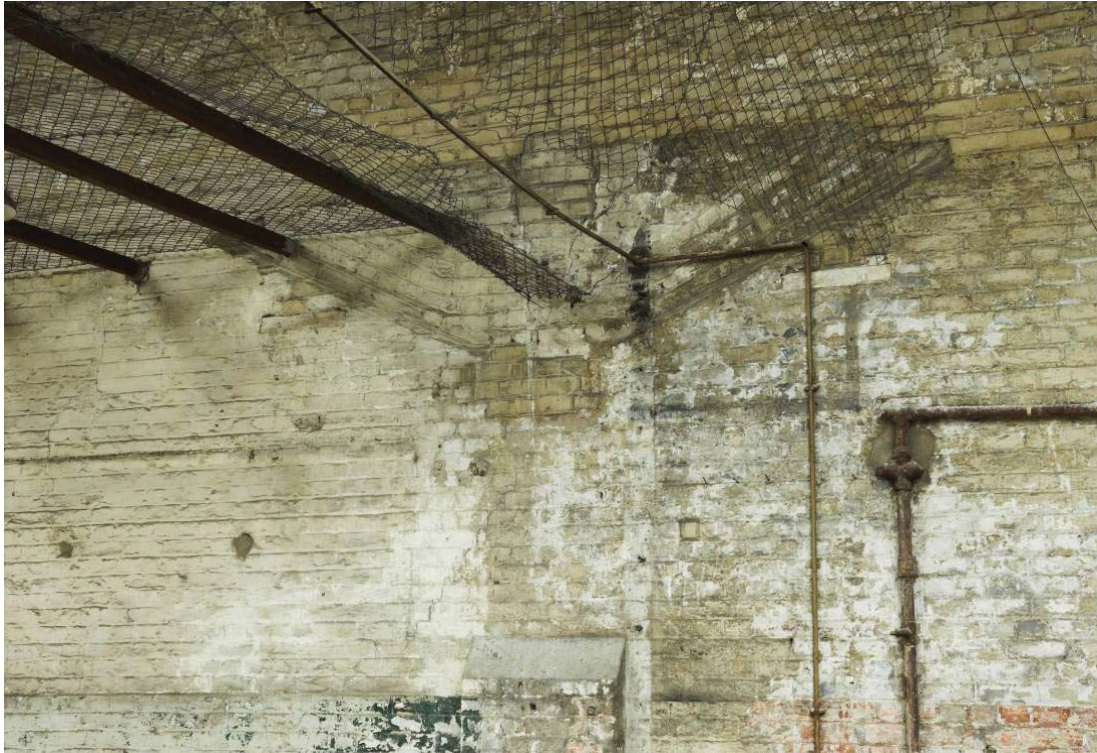
Plate 28: South wall of the interior of the MGS at first floor level

- 5.2.58 At the south end of the first floor there are two blocked fireplaces equally spaced along the wall (**Figure 26; Plate 28**). The chimney breasts and projecting flues for these rise vertically and are approximately in line with where each roof apex would once have been. These flues had been truncated at the height where the double gable wall had been rebuilt into a single gable to support the existing single span roof. The central valley of the previous arrangement is visible in the brickwork of the wall (**Figure 26; Plate 29**). A large crack now runs through this valley scar and another is visible to the east of the east chimney flue (**Figure 26**). Other cracks are also visible in the north wall at first floor level (**Figure 25; Plate 34**).

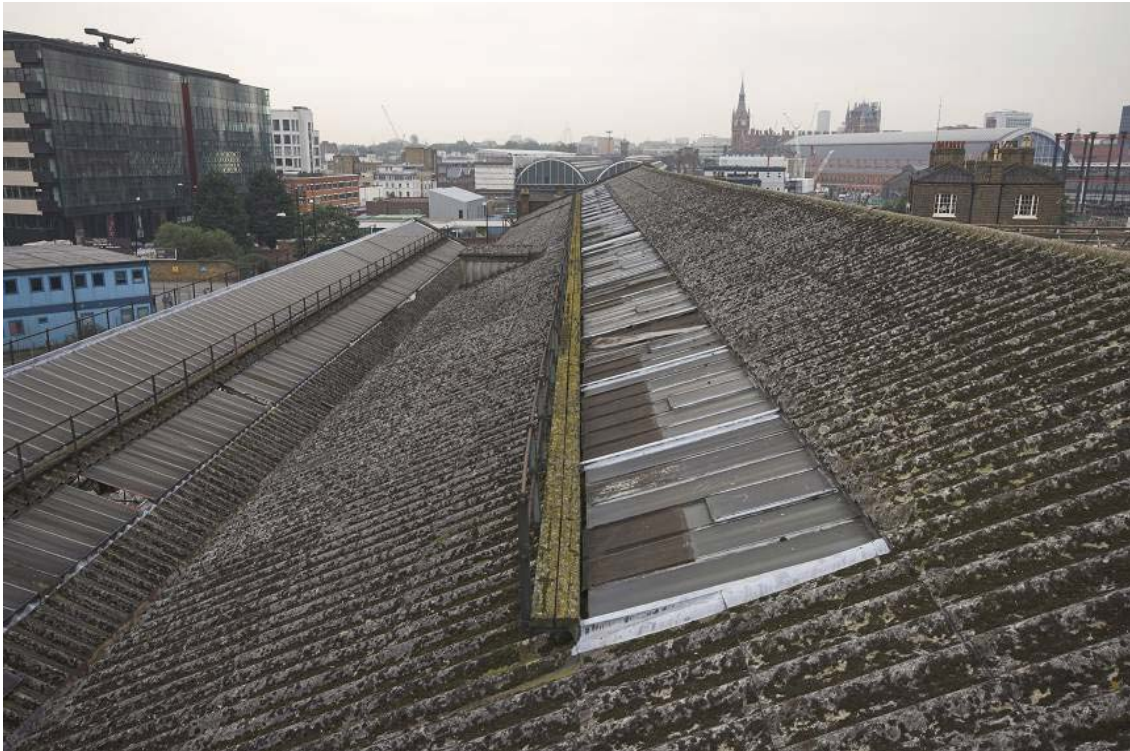
Plate 31: Roof of the East Handyside Canopy (left) and east side of the MGS (right), view from the north

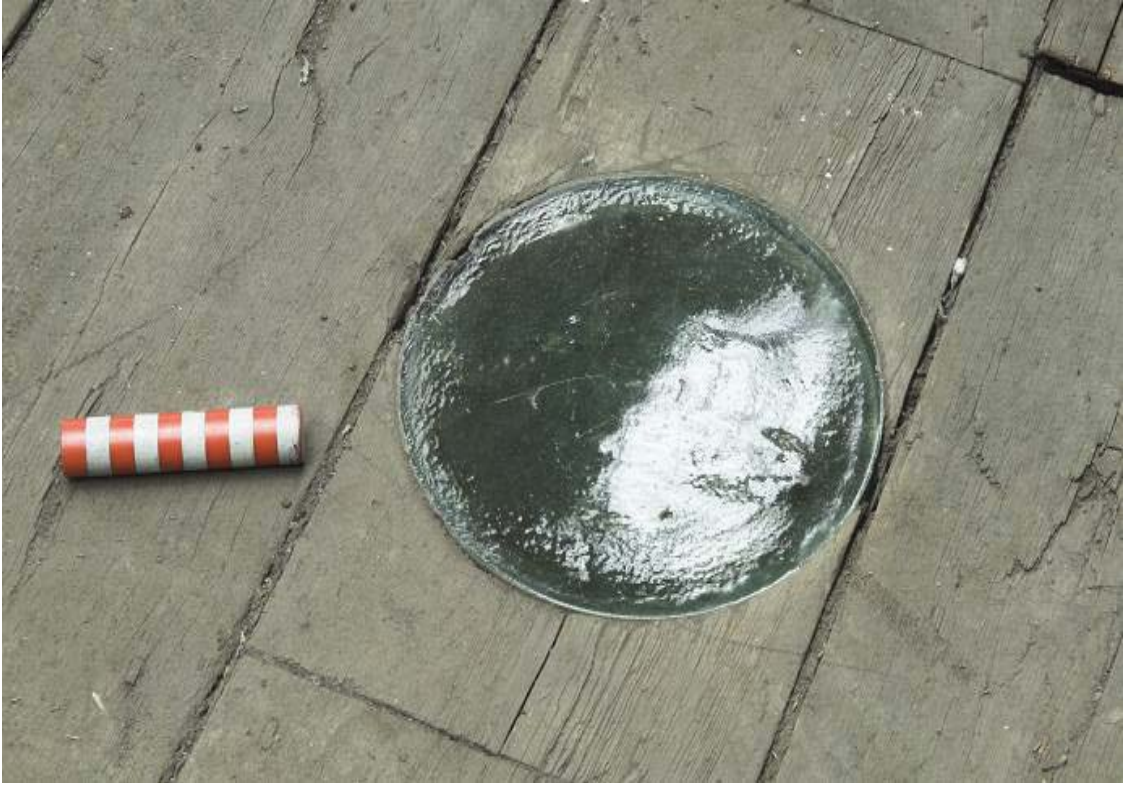
Plate 35: Glass disc in the first floor of the MGS

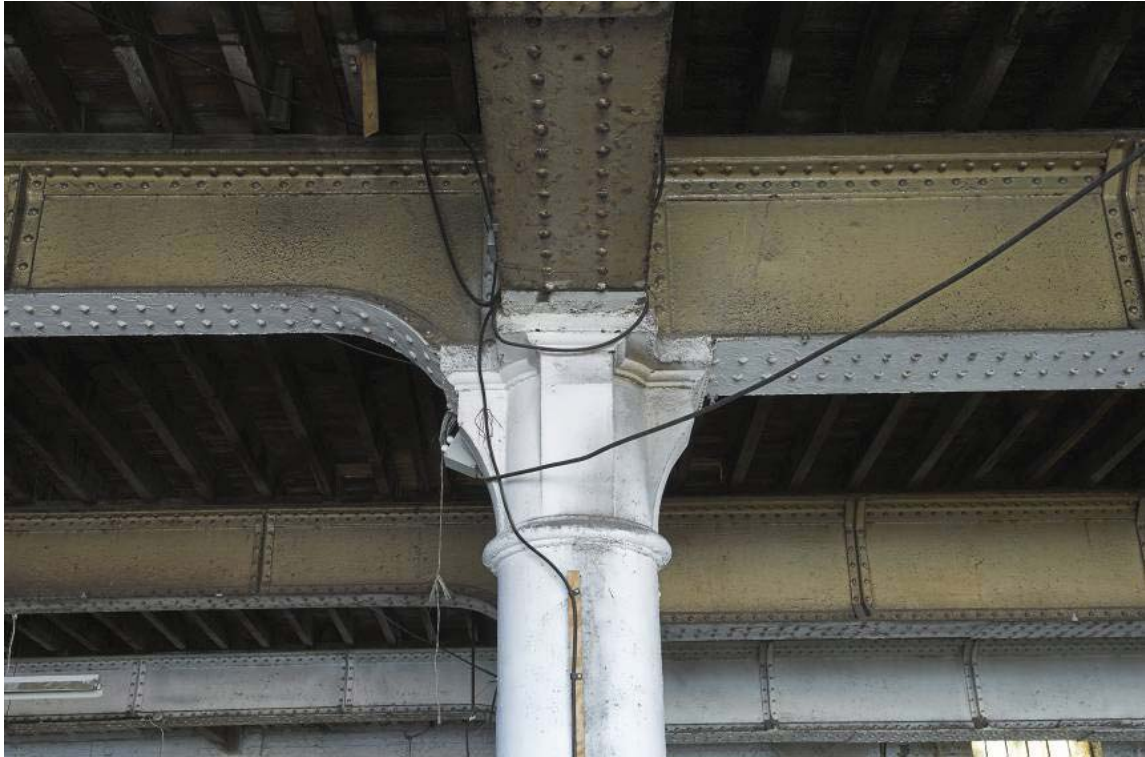
Plate 37: Column capital and ceiling girders supporting the first floor of the MGS

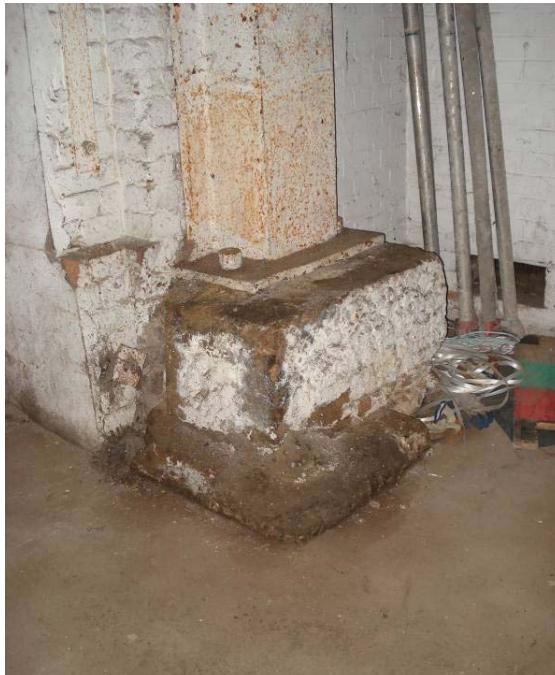
Plate 40: The base of a hollow cast iron side column in Pump House MGSG2 of the MGS, view from the north-west

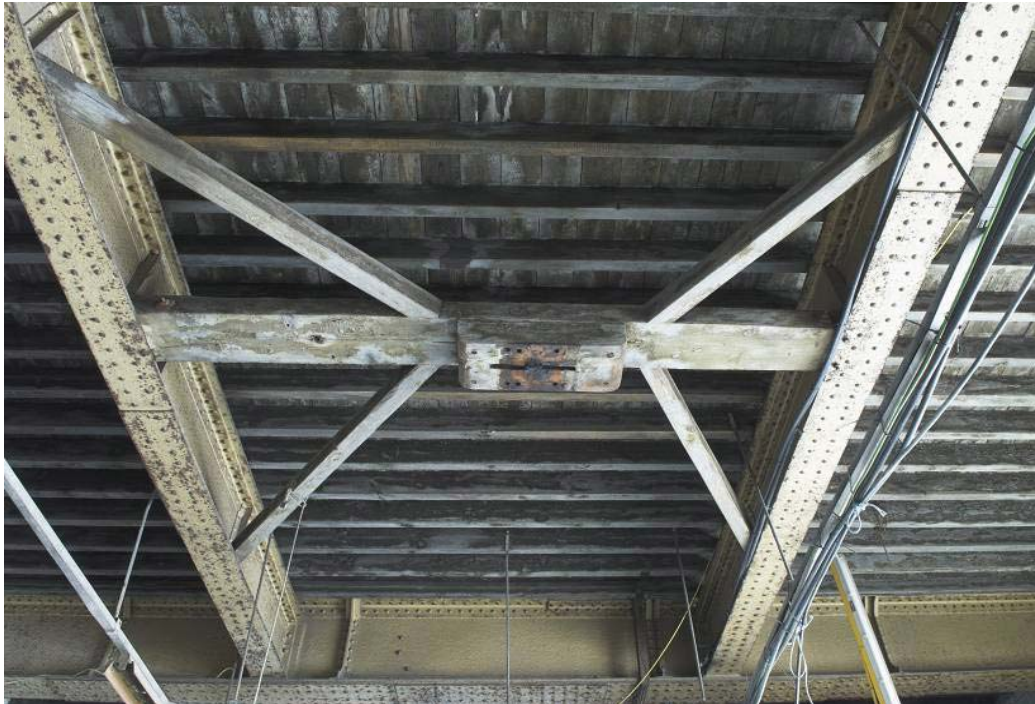
Plate 41: Ceiling-mounted fixing under the first floor of the MGS for a swivelling platform crane, view from the south

Crane Bracket (See Plate 41)
 Ceiling of Ground Floor Room MGS3
 (See Figure 19 for Location)
 Midland Goods Shed
 King's Cross
 1:20 at A3

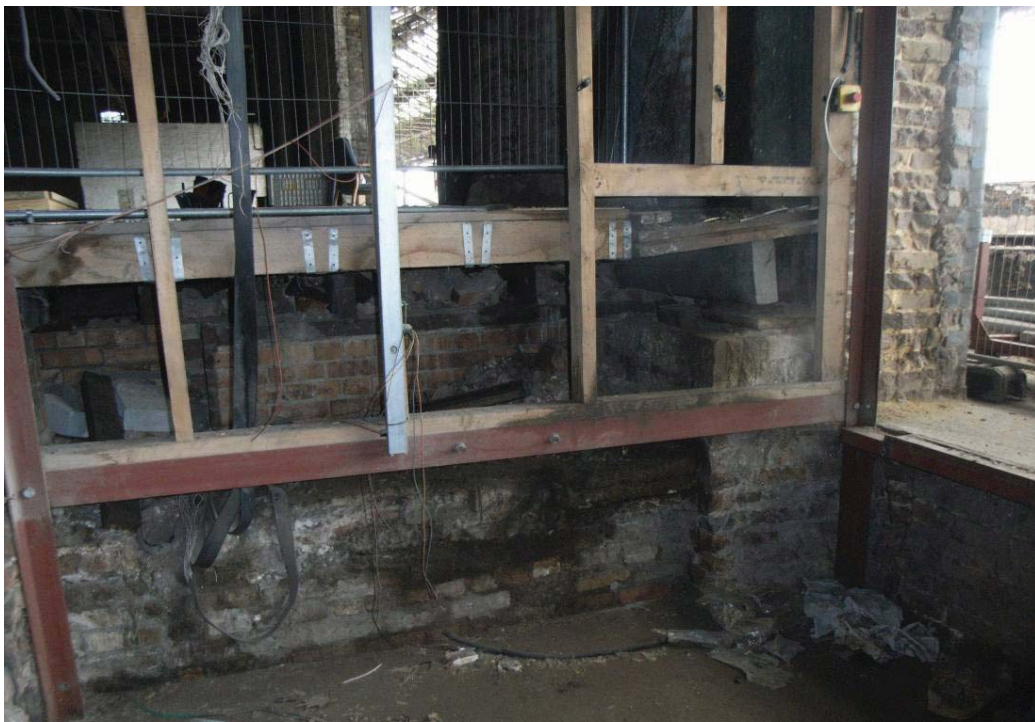
Plate 42: North side of the lift shaft in Bay 11 (east side) of the MGS showing construction of the platform

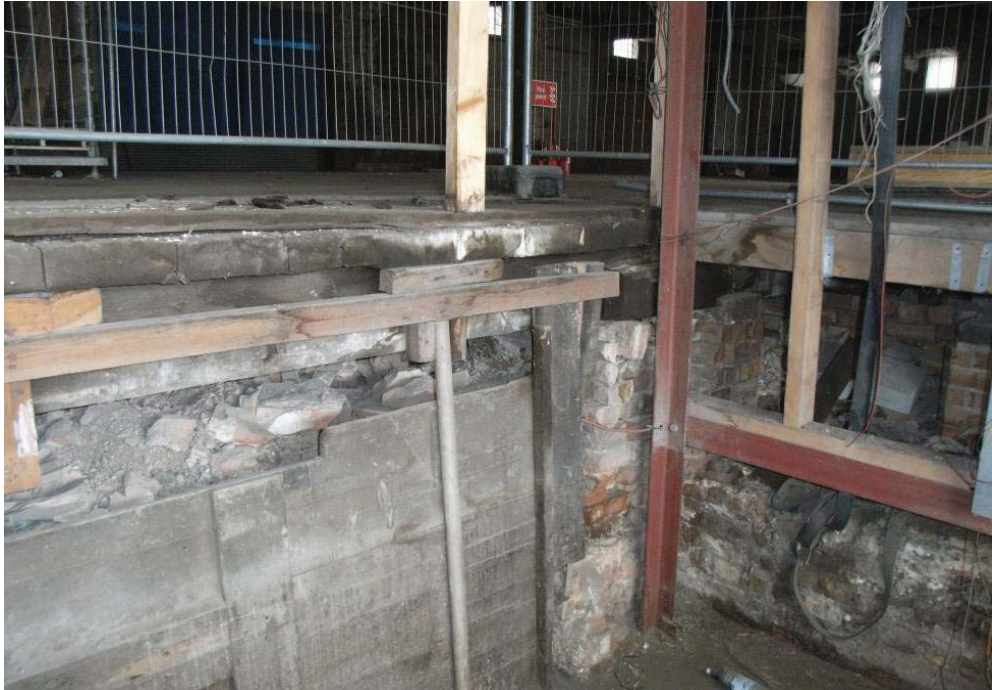
Plate 43a: North-west corner of lift shaft in Bay 11 (east side) of the MGS showing construction of the platform

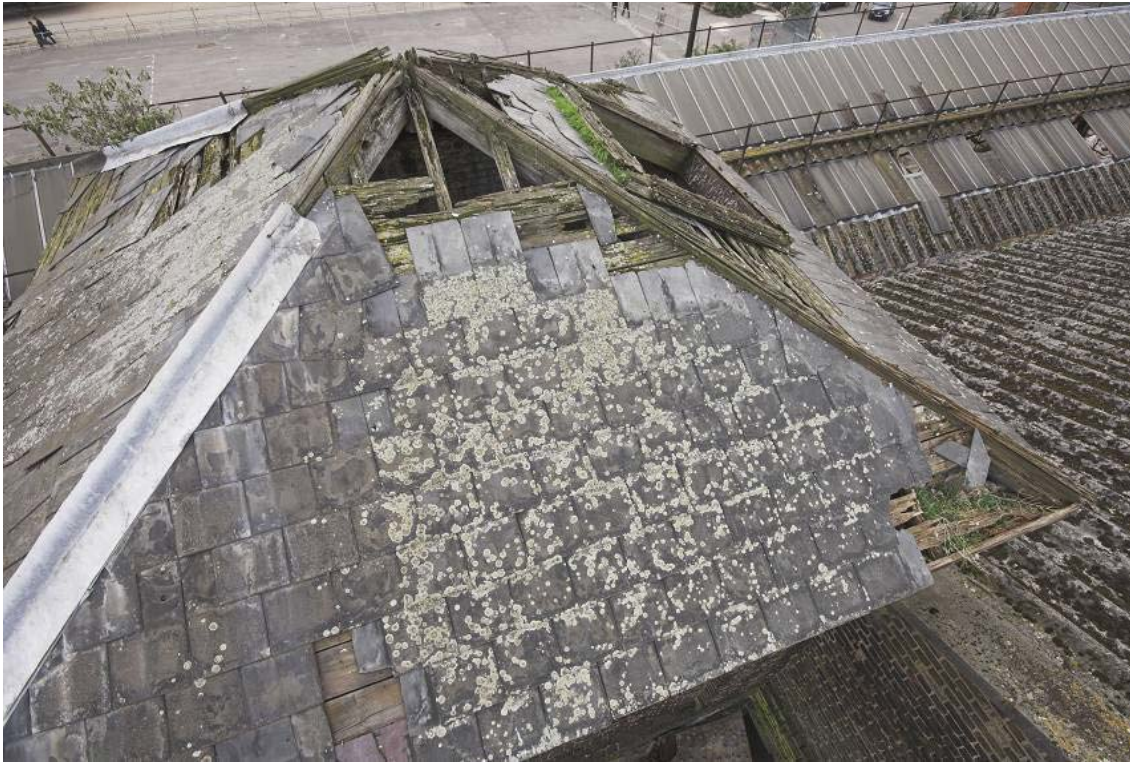
construction, this roof structure is in a very poor state of repair with many missing slates and sections of lead, and decaying timbers (**Plate 45**).

Plate 45: Roof of accumulator tower viewed from the east with the MGS to the south (right)

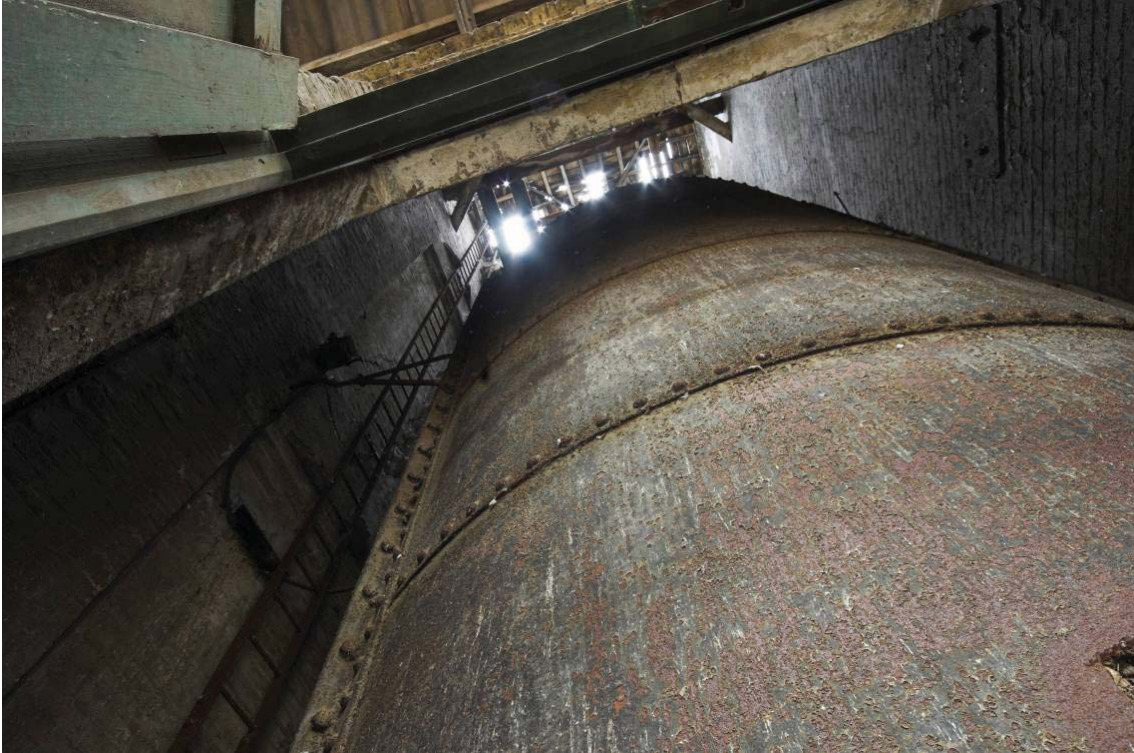
Plate 46: Blocked first floor window in the east elevation of the accumulator tower with girder across to support trusses for the East Handyside Canopy

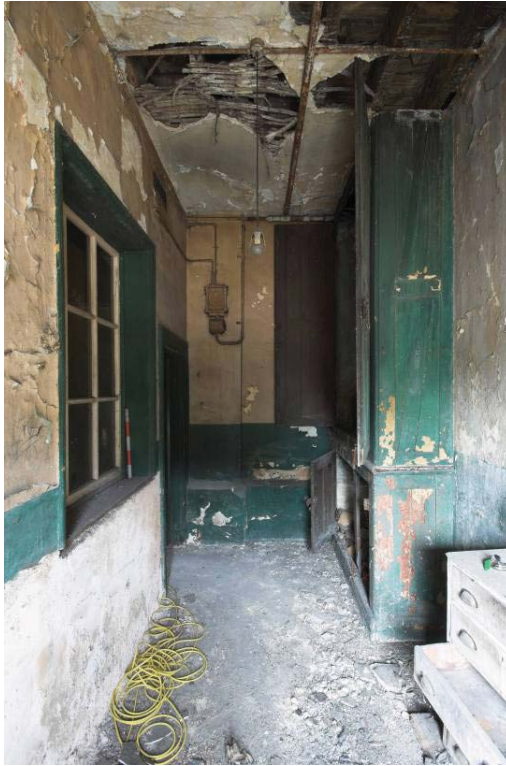
Plate 49: West, north and east wall of ground floor MGS Office Room MGSOG5, view from the south

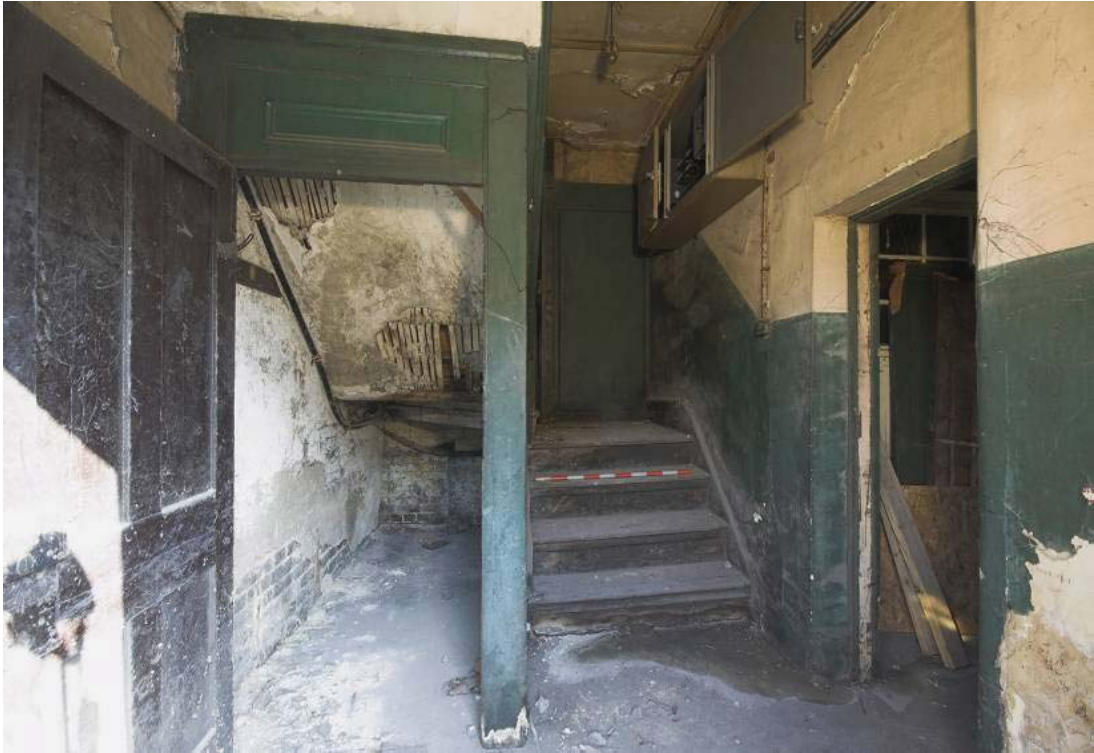
Plate 53: West, north and east wall of ground floor MGS Office entrance hall MGSOG6 with former doorway to the MGS in the north wall, view from the south

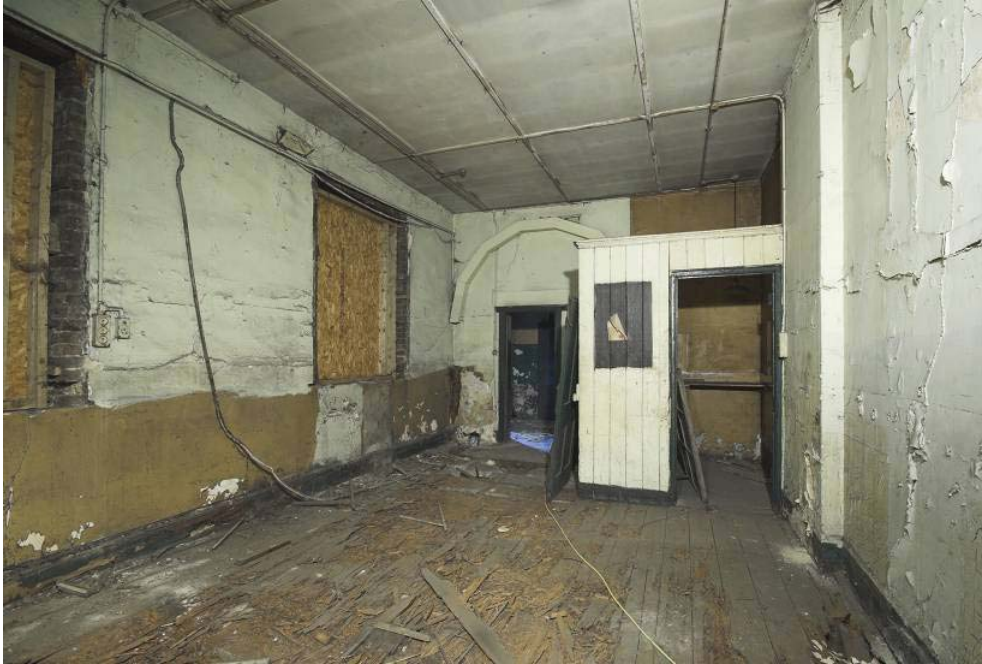
Plate 55: South, west and north wall of ground floor MGS Office MGSOG7 with 'telephone' cubicle (MGSOG9), view from the east

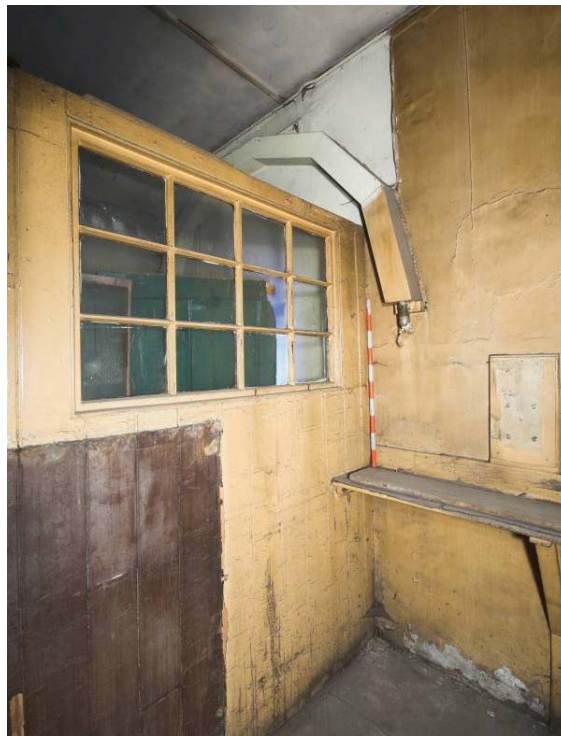
Plate 56: South and west wall of ground floor MGS Offices 'telephone' cubicle MGSOG9, view from the north-east

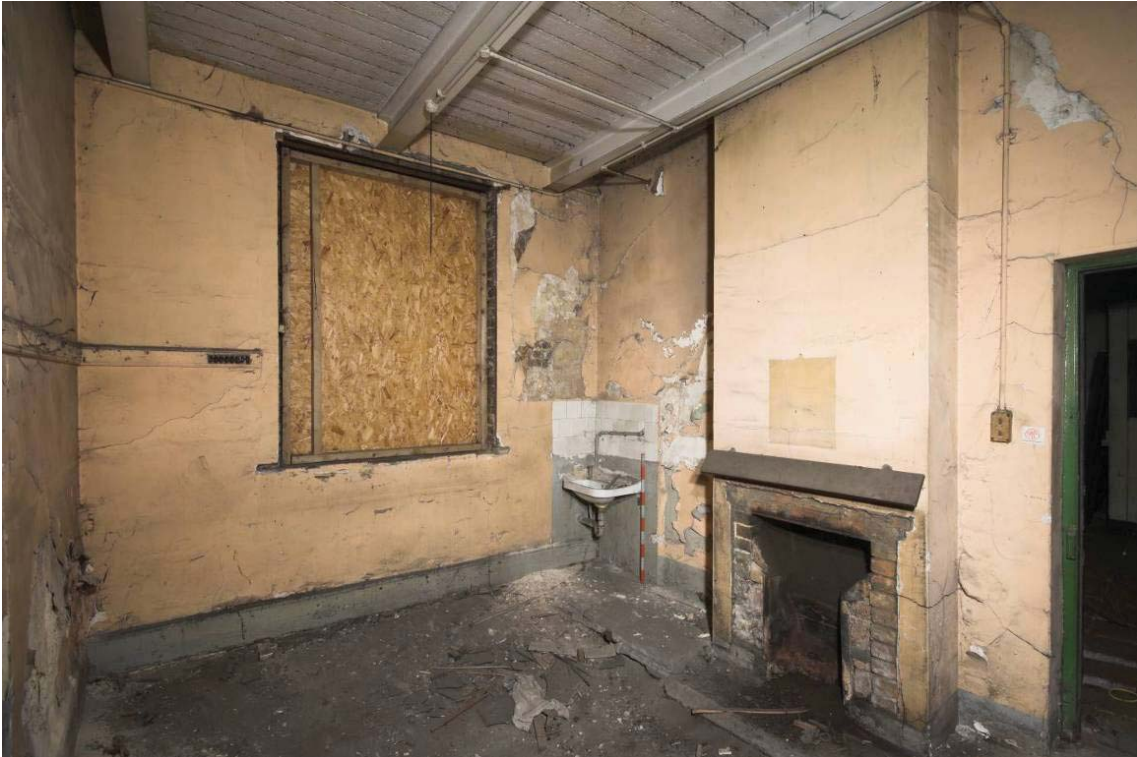
Plate 57: East, south and west wall of ground floor MGS Office MGSOG8, view from the north-east

- 5.4.18 East of the main office (MGSOG7) is a further room (MGSOG8; **Plate 57**). An original fireplace has had its grate and surround removed and a sink on the west wall mirrors that of the main room (MGSOG7). A similar poor condition is also evident. The concrete floor has suffered considerable subsidence, both east and west walls are heavily cracked and the ceiling has been renewed by a new system of east-west concrete beams over steel girders. The north end of the east wall has a later inserted door to the outside. This has a concrete step and late 20th century fittings.
