**BUILDING RECORDING OF
THE MIDLAND GOODS SHED
KING'S CROSS CENTRAL
LONDON BOROUGH OF
CAMDEN**

SITE CODE: KXM08

JUNE 2010

Building Recording

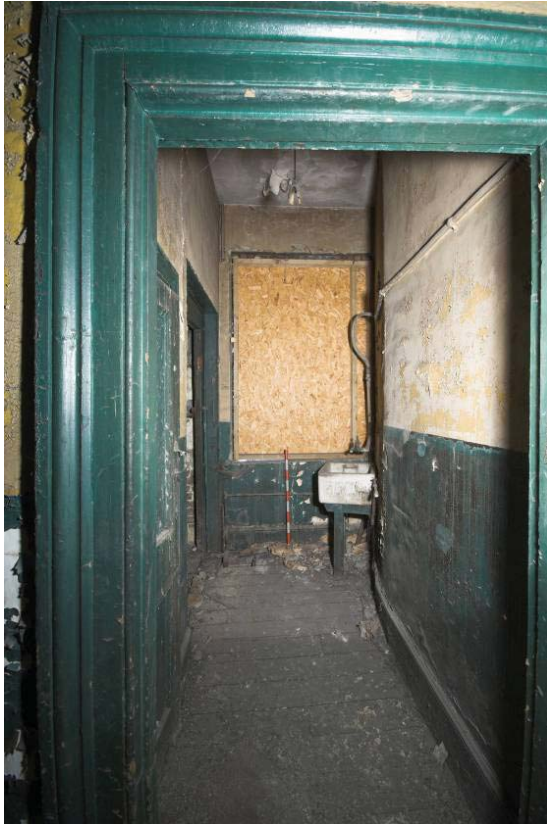
Plate 59: East, south, and west wall of first floor MGS Office MGSOF3, view from the north

- 5.4.20 The smaller room closer to the stairs has three distinct areas. The main space (MGSOF3) widens slightly at its south end to take in the full width of the window and a Belfast sink has been fitted here (**Plate 59**). Along one (east) side of this space are two walk-in cupboards. One of the cupboards has walls lined with an extra thick, unpainted lime plaster at a lower level and the floor reinforced with extra floorboards for the storage of some commodity, possibly coal.

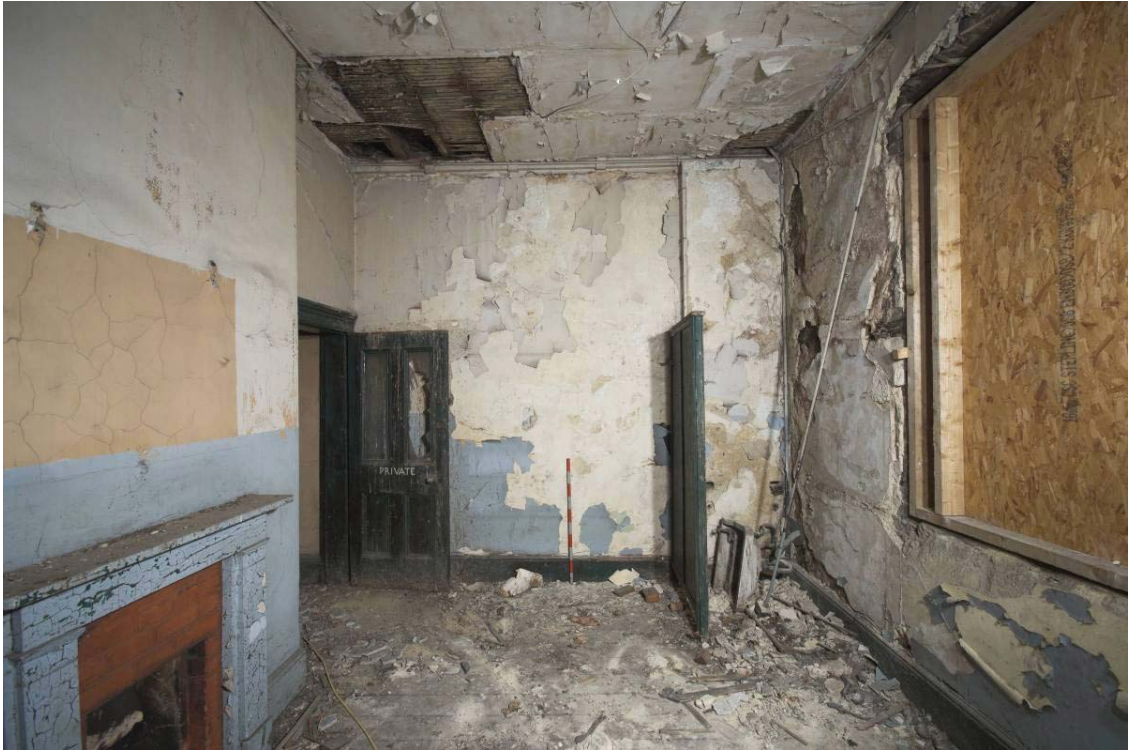
Plate 61: West, north and east wall of first floor MGS Office MGSOF6, view from the south

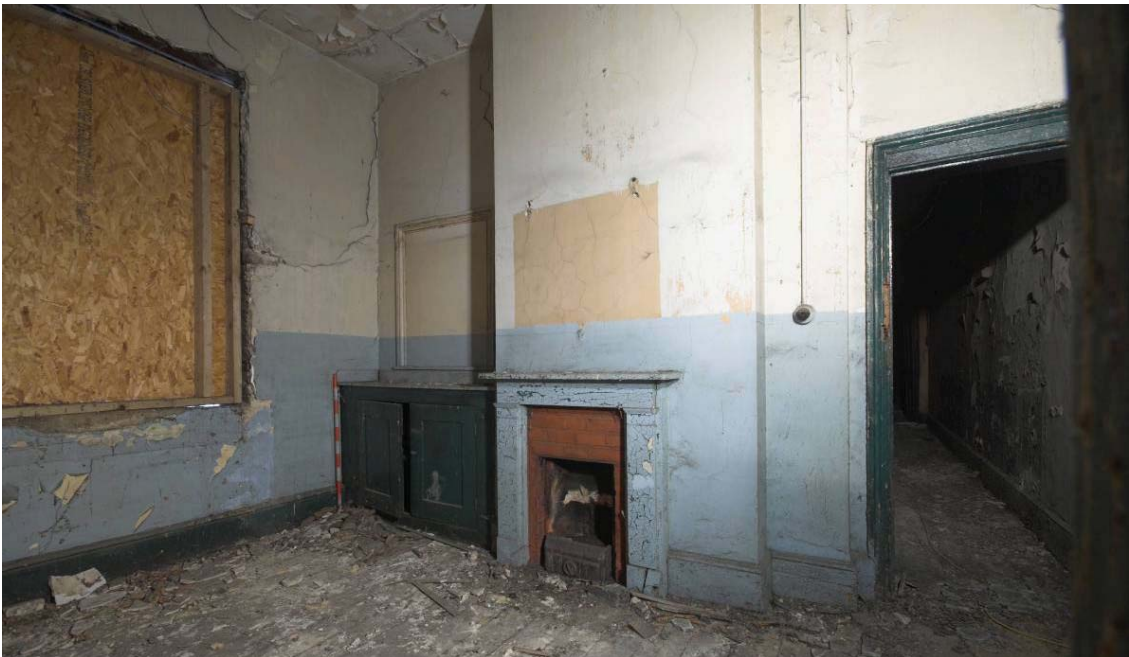
Plate 62: South and west wall of first floor MGS Office MGSOF6, view from the north-west

- 5.4.22 This room (MSGOF6) has 'PRIVATE' painted on the door and has been fitted with two locks, a cylinder rim latch lock and a horizontal mortice lock. This nineteenth century door has four moulded recessed panels; the upper two contain glass (**Figure 38**). The interior of the room (MSGOF6) has been painted light blue, like the first-aid room on the ground floor (MGSOG1), and the room contains a screened-off sink on the north wall (**Plate 61**), a fireplace with original surround (**Figure 39**), and a built-in cupboard beneath the hatch on the west wall (**Plate 62**).

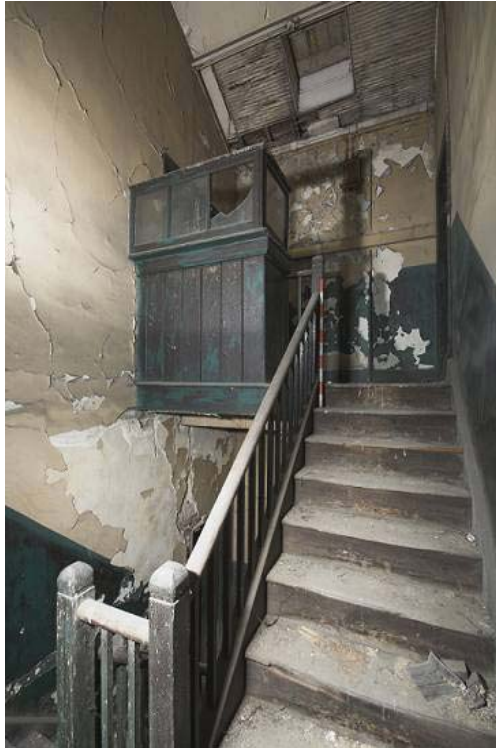
Plate 63: West, north and east wall of MGS Office Stairwell MGSOS2 showing second floor landing and desk, view from the south

- 5.4.24 The second floor landing (MGSOS2) at the top of the stairs has a built-in desk overlooking the stairwell (**Figure 21**; **Plates 63 and 64**). Tongue and groove boards enclose the lower section of the desk, while a short, clear glass screen forms the

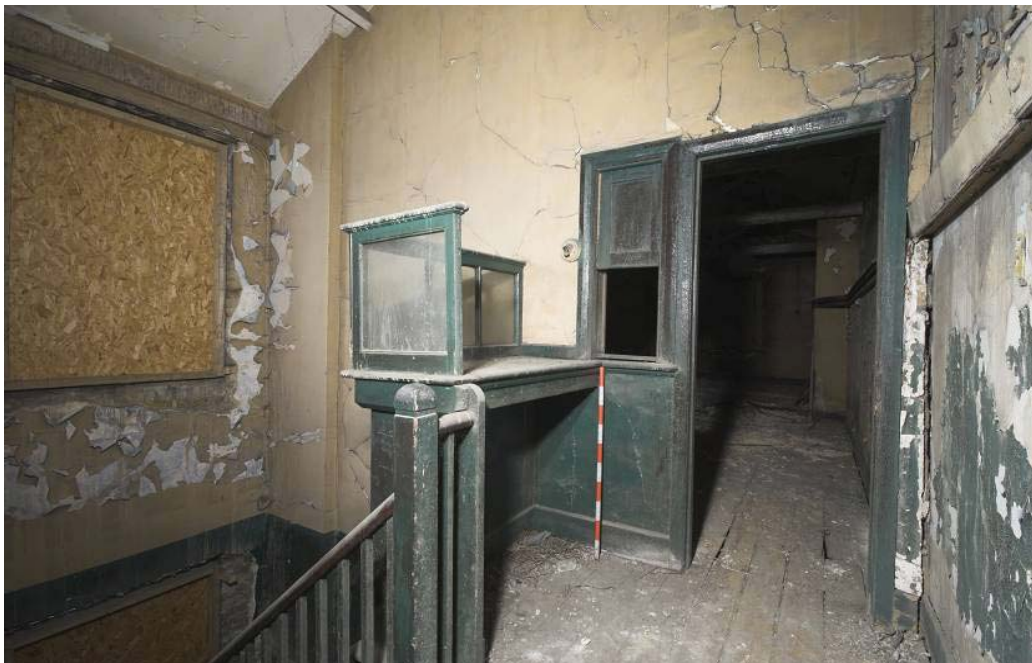
Plate 64: South, west and north wall of MGS Office MGSOS2 showing desk on second floor landing, view from the east

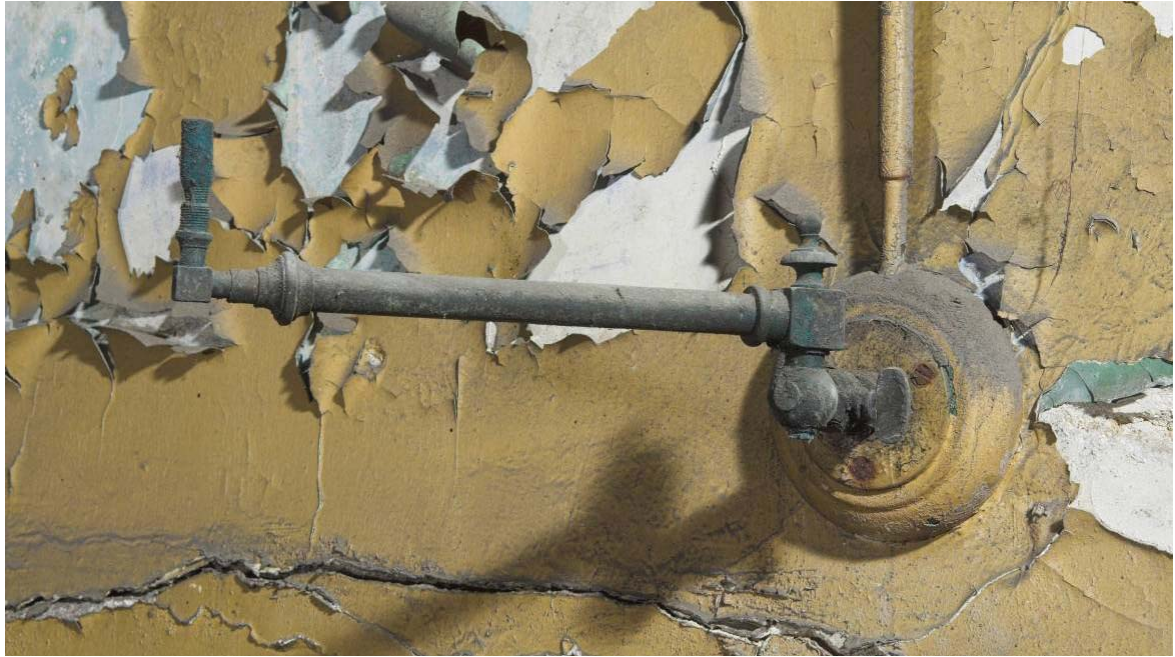
Plate 65: Gas light fitting on the south wall of MGS Office MGSOS1, view from the north-east

- 5.4.25 The large room to the west of the stairs (MGSOS1) contains more complete examples of gas light fittings (**Figure 41**; **Plate 65**). Like all spaces on this floor, this room is open to the roofline, exposing three timber roof trusses reinforced with wrought iron straps (**Figure 42**; **Plate 66**) with the lath and plastered ceiling between. The north wall has a plain fireplace, without a grate, and an original undecorated timber surround (**Figures 27** and **43**; **Plate 66**). On each side of the projecting chimney breast is a recessed section of wall that reveals the former goods shed roofline (**Figure 27**; **Plates 67** and **68**), before it was reroofed by a single-span structure.

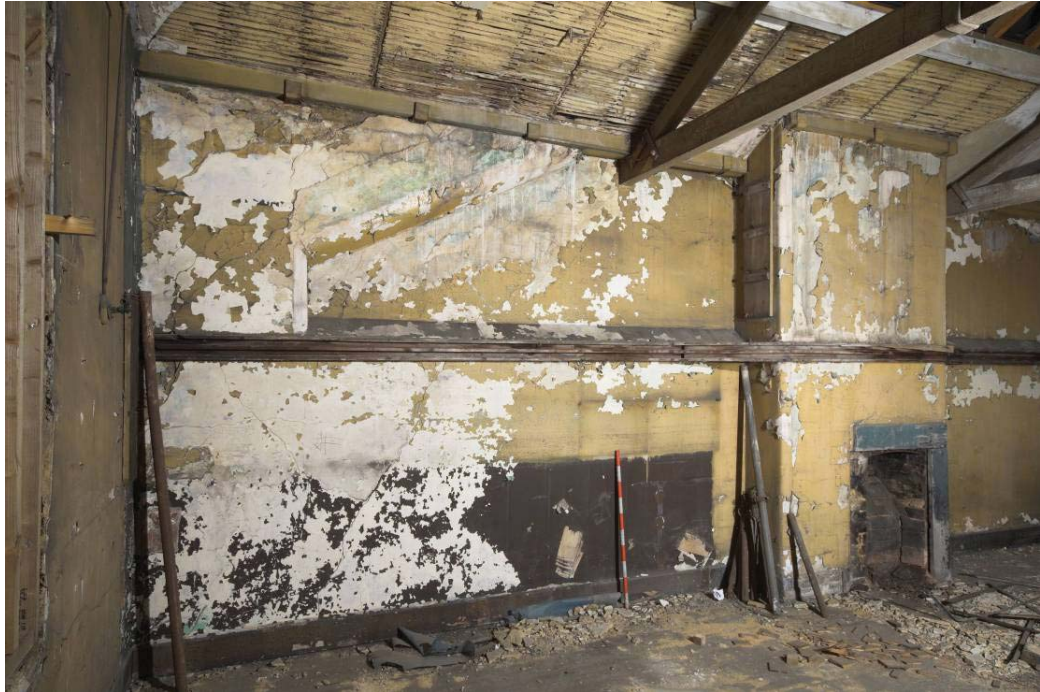
Plate 67: East end of north wall of MGS Office MGSOS1, view from the south

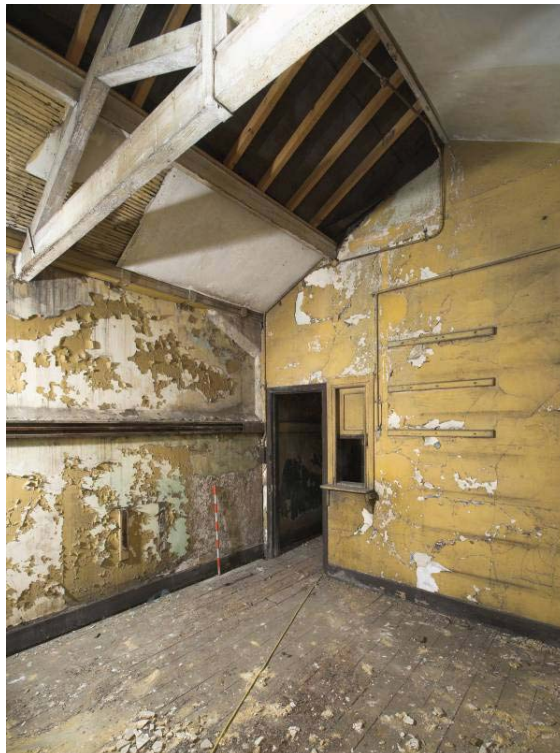
Plate 68: North and east wall of MGS Office MGSOS1, view from the south-west

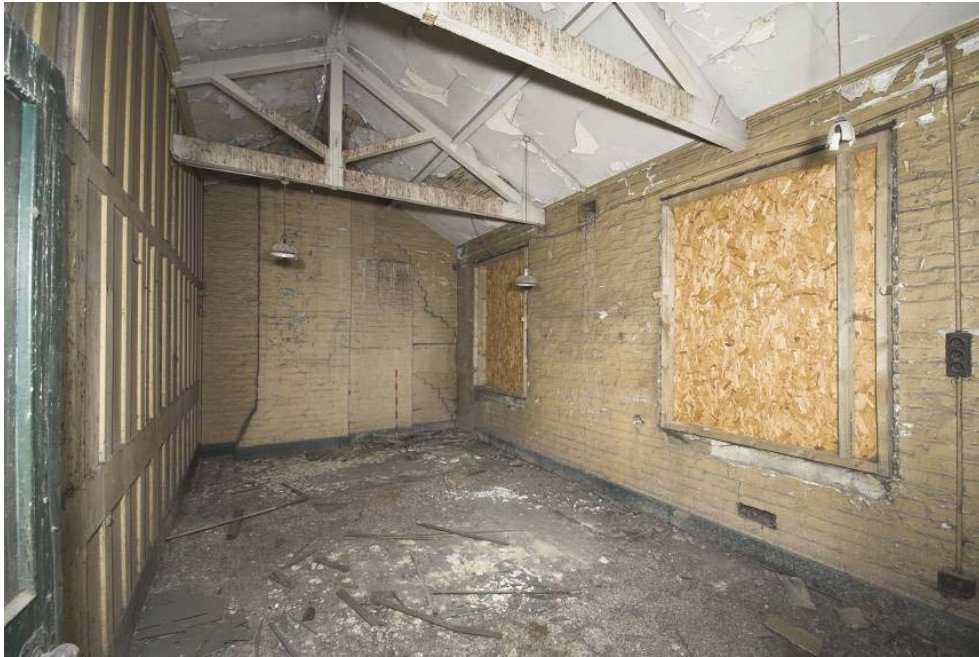
Plate 69: North, east and south wall of MGS Office MSGOS4, view from the west

- 5.4.26 East of the stairs, the layout differs from the two floors below, in that the first space is divided by a timber panelled partition into a room (MGSOS4; **Plate 69**) and long corridor against the north wall (MGSOS3; **Figure 21**; **Plate 70**). The room (MGSOS4) is unusual in that the south and east brick walls are unplastered and painted beige (**Plate 69**). The projecting chimney breast in the east wall does not have a fireplace and the wall has several large cracks. The roof trusses are visible and pass through the partition and are also exposed in the corridor (**Plate 70**).

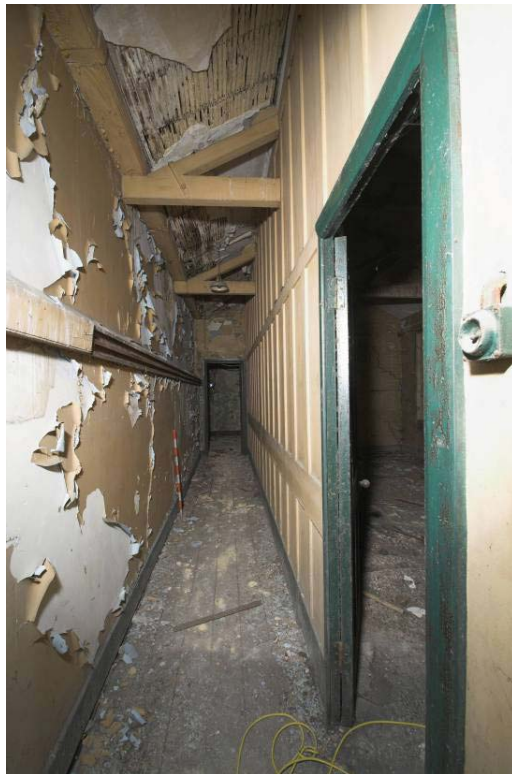
Plate 70: North, east and south wall of MGS Office Corridor MGSOS3, view from the west

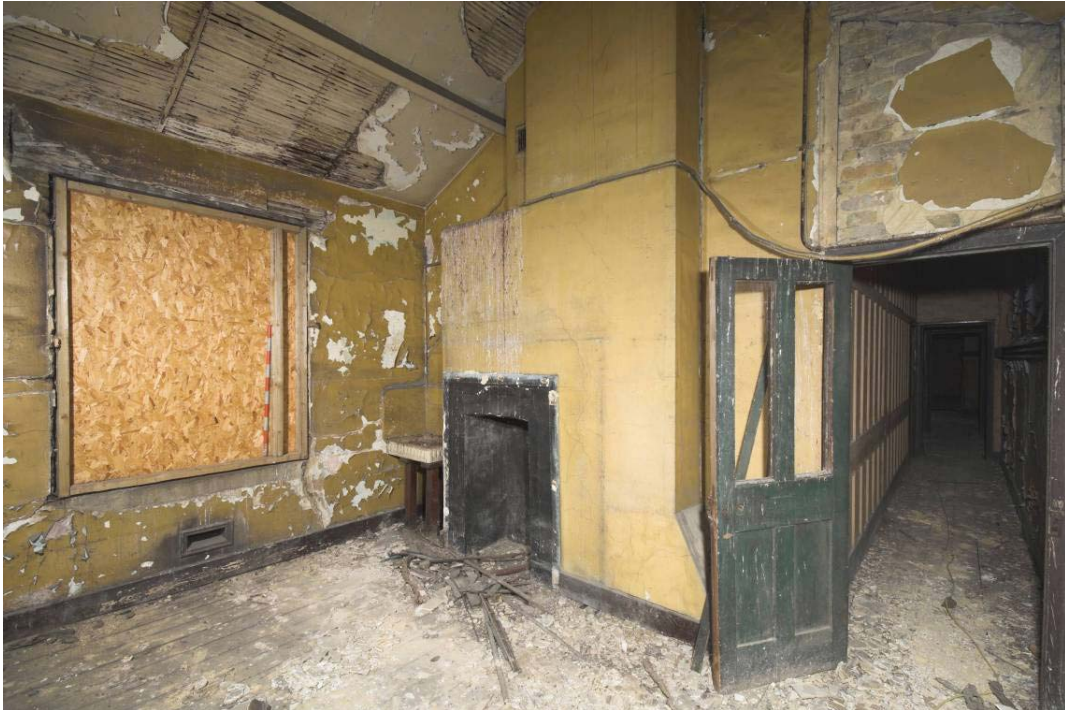
Plate 71: South and west wall of MGS Office MGSOS5, view from the north-east

- 5.4.27 The corridor is poorly lit by natural light from both ends and one glass panel in the partition with the room to the south (MGSOS4). The room at the far end of the corridor (MGSOS5), like the two rooms beneath it, has a fireplace and sink on its west wall (**Plate 71**). A shallow recessed section of the north wall displays the former roofline of the goods shed (**Figure 27**; **Plate 30**). The north wall plate of the Midland Goods Shed Offices is secured to the south wall of the Midland Goods Shed with iron brackets (**Figure 27**; **Plate 30**). The room is again open to the roof structure, but the purlins and ridge beam span the room from the chimney breast to the eastern gable wall without the need for another truss.
