Watching Brief

**An Archaeological Watching Brief at Kew Palace, Royal Botanic
Gardens, Kew, London Borough of Richmond upon Thames**

Site Code: Kew 4

Commissioning Client: Historic Royal Palaces

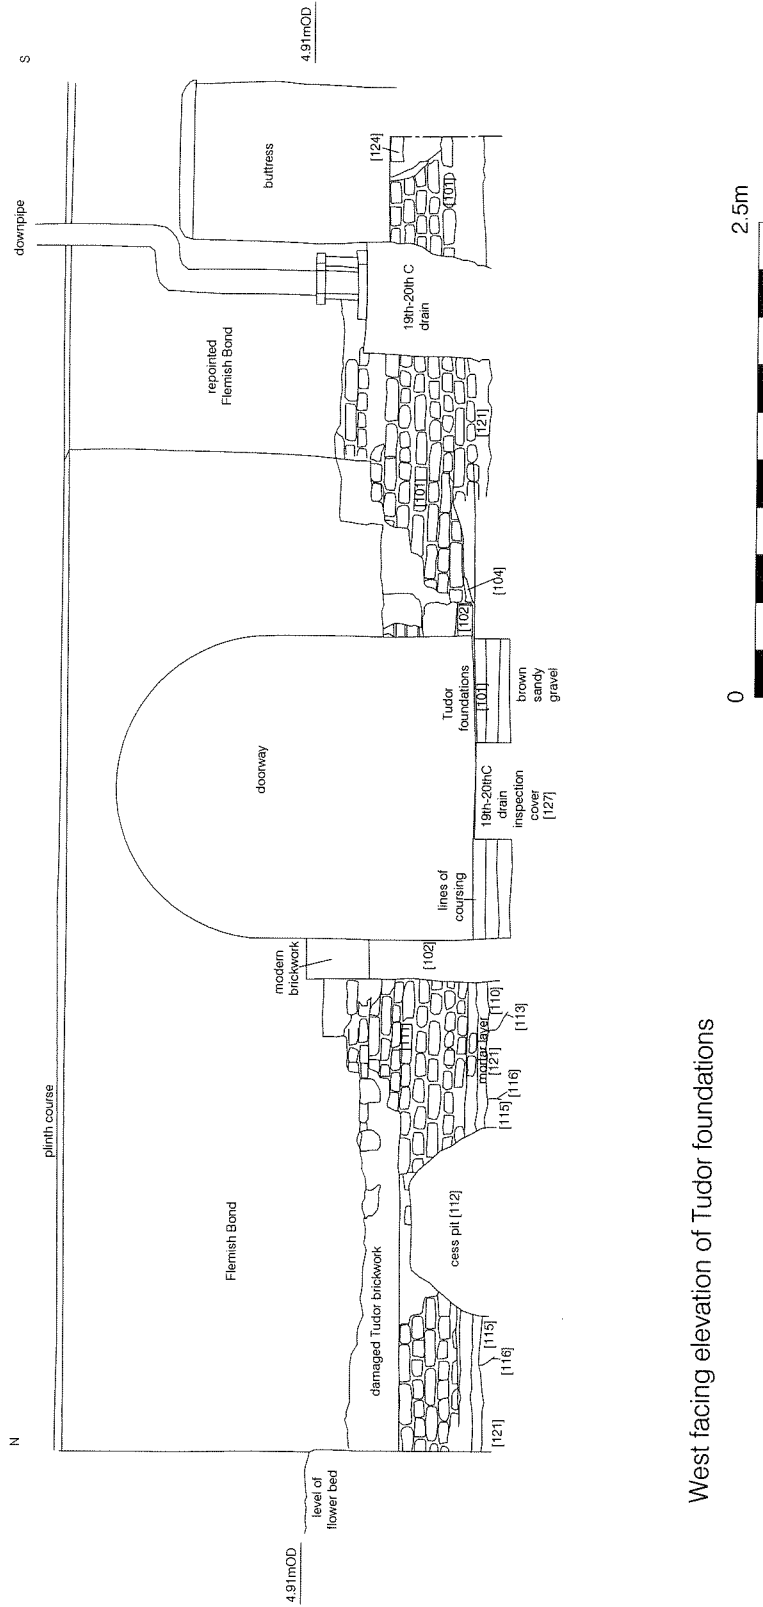
Figure 5
Section 11
1:40

7.2.2 The foundation [101]/[111] was revealed along the west façade in the north (trench PL) and stair well area (Trench SW), but was partially obscured to the south by the later addition of a drain run [20] identified in the evaluation. The total visible dimensions of [106]/[111] were 5.82m N/S along the eastern limit of excavation, 0.51m E/W and a maximum depth of c.0.87m with a highest level of 4.58m OD. The bricks were laid in irregular header/English bond, and bonded with off-white, lime and sand mortar. The bricks were of unfrogged, local orange-firing sandy fabric 3033, with dimensions of 205-210 x 98-100 x 50-54mm. The construction of the 'Dutch House' in 1631 entailed cutting into the Tudor foundations to provide access into the Tudor period cellar. This suggests an exit was not here previously, and may indicate a change of alignment for the main façade of the house from an E/W axis in the Tudor period to the current N/S axis, as suggested in the Desk-based Assessment⁶.

West facing elevation of Tudor foundations

Tudor Wall Foundation [101]/[111]

The extant building was found to be constructed upon earlier foundations of brick fabric 3033, unfrogged, narrow bricks with uneven bases and rounded arrises.

Fragments of render were observed below the current ground level on the Tudor foundations and a sample taken for closer examination. One small fragment of lime-based mortar was taken from [111], but most of the render was determined (by eye) to be of a type similar to Portland cement or 'Roman' cement, and most likely relates to the re-facing of the Western façade in the late 19th century following the demolition of the service wing.

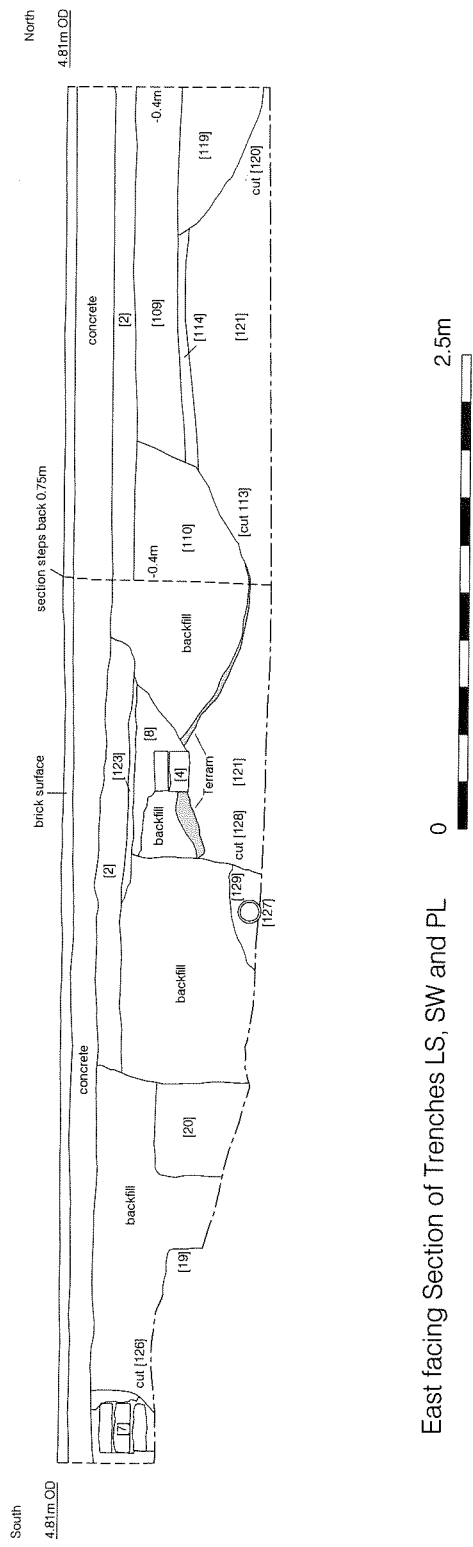
Figure 6
Section 12
1:40

7.4.1 In trench SW a mid to dark brown sandy silt containing frequent ceramic building material and mortar fragments was recorded in section (Fig. 6) dumped around wall [4]. It was identified as evaluation phase fill [8], and had a maximum thickness of 0.22m and a highest level of 4.32m OD, and is likely to be associated with the demolition of the service wing in the later 19th century. Overlaying this dump was a layer of mortar and Flemish-type unglazed floor tiles [123], laying on bed but probably not in situ. This layer spread for approximately 1.30m N/S and 0.78m E/W with a thickness of c.0.11m and a

maximum height of 4.52m OD. It probably represents a demolished floor and was considered to be part of the demolition layer [123] for the service wing.

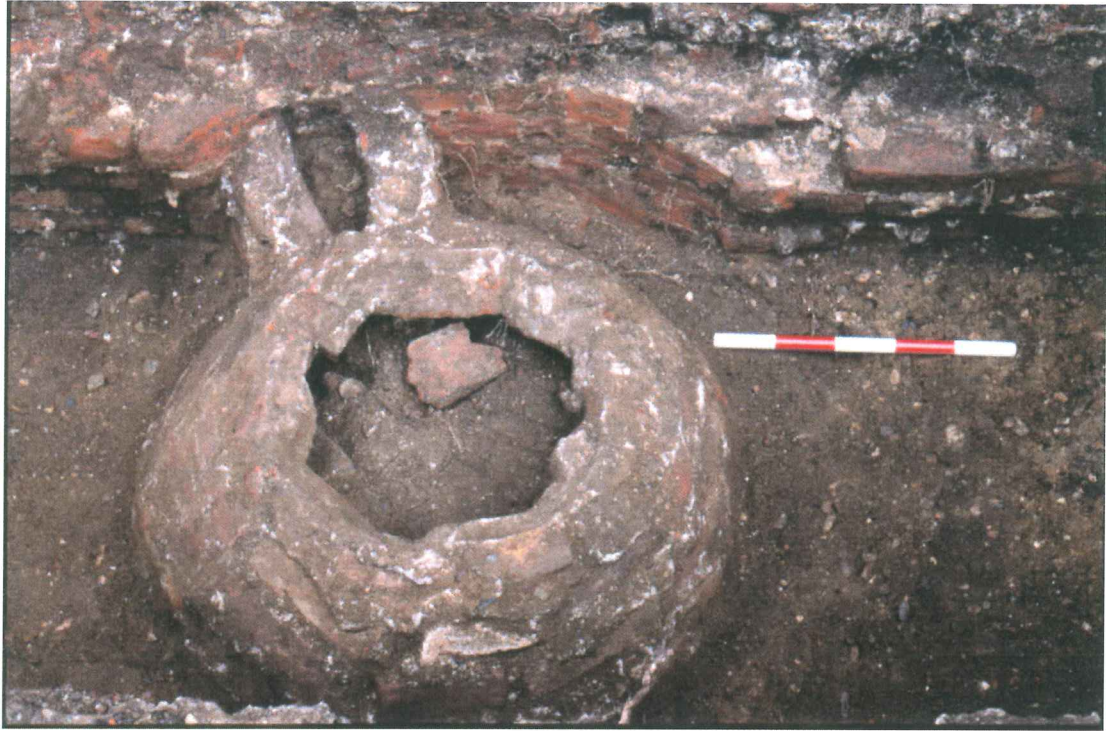
Plate 1: 19th century soakaway [112]

7.4.3 To the north in trench PL a 19th century domed brick soakaway [112] (fabric 3034 nr. 3035, 3032, 3033) was excavated through earlier deposits and structures, possibly contemporary with a similarly constructed structure [18] uncovered to the southwest during the evaluation. The exposed elements of the soakaway had a diameter of approximately 0.97m; it was excavated to a depth of approximately 0.47m, and had a highest level of 4.38m OD. The position of the soakaway is problematic. Structure [18] appears to have been constructed after the demolition of the service block and privy shaft in the later 19th century in order to drain the roof of the palace through feeding pipe [19]. However the construction of soakaway [112] entailed cutting into the foundations of the extant building, with a reasonable amount of effort expended in neatly rounding off the Tudor brickwork to form a circular cut [116] for the soakaway. If the service wing had already been demolished it is difficult to see why the soakaway would have been constructed so close to the foundations. A demolition layer [114] of mortar and CBM fragments with a maximum thickness of 0.27m and maximum height of 4.21m OD overlaying the top of soakaway [112] was interpreted as belonging to the destruction phase of the west wing in the late 19th century, so it is thought that the soakaway [112] was constructed in the mid- to late 19th century, just prior to the demolition of the west wing.

- 8.4 A domed brick soakaway was cut into the earlier (Tudor) foundations probably during the late 18th or 19th centuries. The cement-like mortar and brick fabrics used in construction indicate a mid to late 19th century date as more probable.
