16-20a BARNET HIGH STREET

EVALUATION

Pre-Construct Archaeology Ltd Unit 54 Brockley Cross Business Centre 96 Endwell Road London SE4 2PD An Archaeological Evaluation at 16-20a High Street, High Barnet, London Borough of Barnet.

Site Code: HTB 04

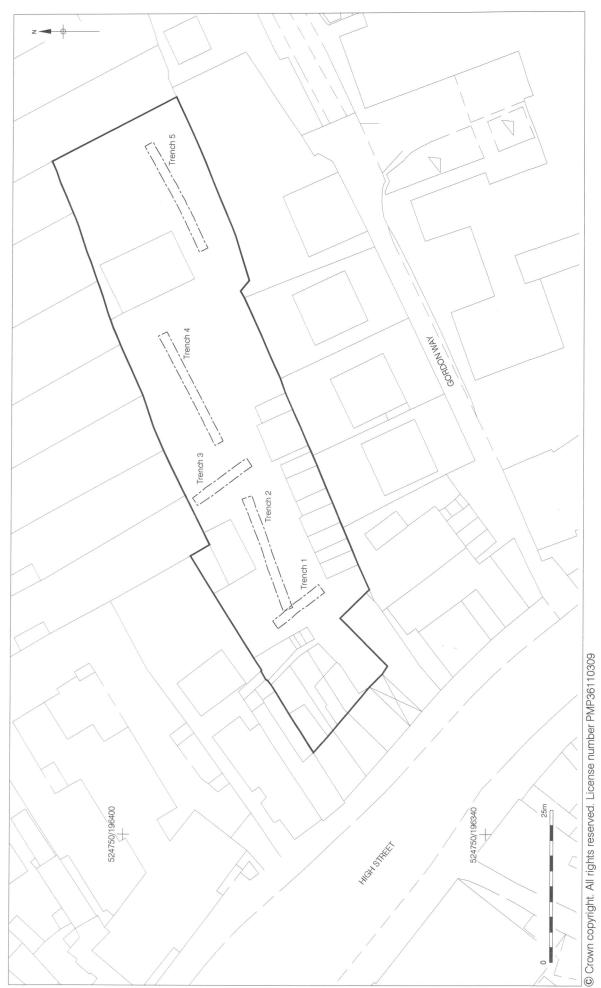
- 6.1 The archaeological evaluation comprised of five trenches spread over the area of the proposed development (fig.2).
- 6.2 The evaluation trenches were excavated to the following dimensions:

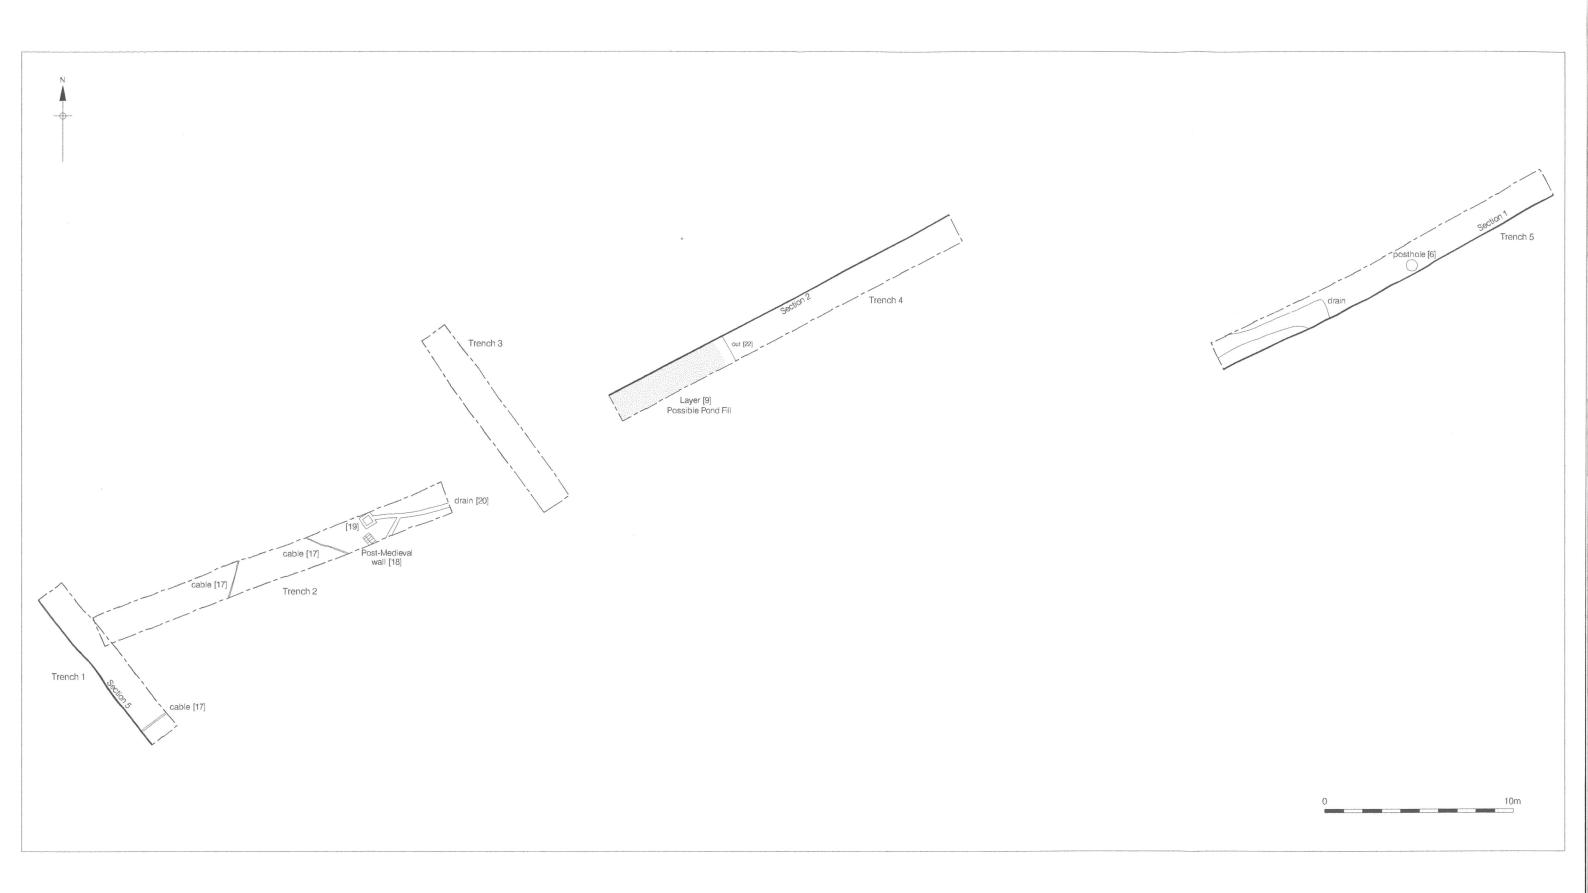
- 7.4.1 No archaeological features of significance were observed in Trench 4. In addition, extensive post-medieval truncation had removed all trace of earlier sub-soils along the whole trench. The trench was aligned east-west, with a pronounced slope to the east. (see Figs 3 & 4).

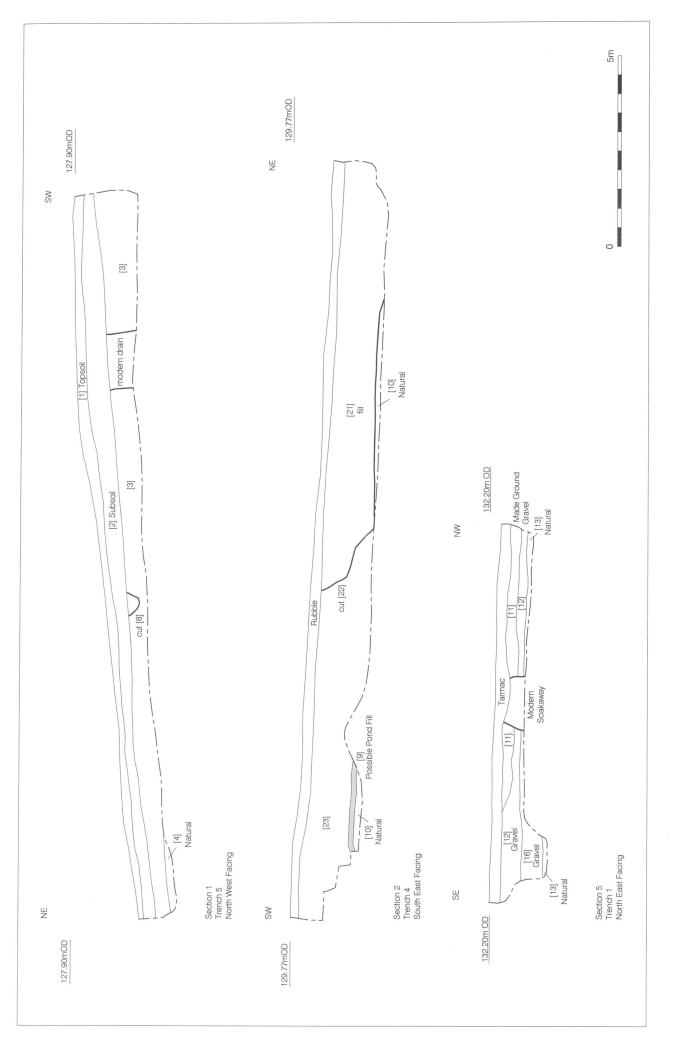
- 7.1.1 No archaeological features of significance were observed in Trench 1. The trench was aligned north-south and was 10m long (see Figs 4 & 5).
- 7.1.2 Natural light orange/grey clay [13] was encountered at height 131.24m OD. This was overlain by natural gravels with a slightly brownish/orange grey sandy matrix [16] (0.4m thick, height 131.0m OD). The matrix becomes slightly more clayey towards the upper levels, where it would have graded into subsoil.
