ST MICHAEL'S AND ALL SAINTS CHURCH BARNES LONDON BOROUGH OF RICHMOND HISTORIC BUILDING SURVEY

**Historic Building Survey Of The Southern Boundary Wall At St
Michael's & All Angels Church, Elm Bank Gardens, Barnes, London
Borough Of Richmond-Upon-Thames**

Site Code: ELB 05

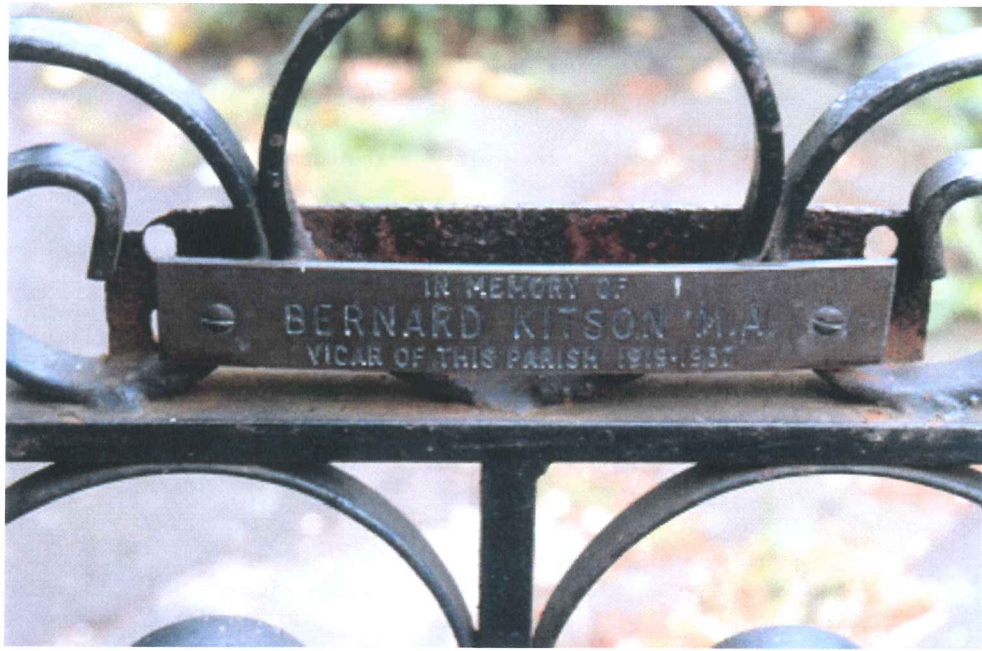
Plate 3: The Memorial Garden in the Southern Churchyard

- 4.7 The current boundary wall is in its present form from no earlier than 1937, as the memorial garden gate hosts a commemorative plaque in memory of Bernard Kitson MA, the vicar of the parish from 1919 to 1937 (plate 3).

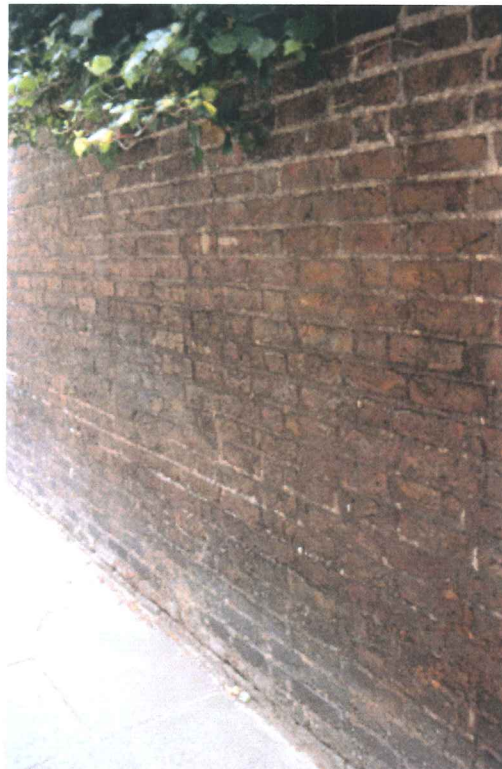
Plate 4: Southern Elevation of the
Boundary Wall - Eastern Section

- 5.3 The eastern section of the wall [1] is constructed in a variant of Flemish bond, with every three stretchers interspersed with one header brick. The coursing is laid in such a fashion so that the middle stretcher in a group of three is overlain and underlain by a header brick. The buttresses are constructed to a width of 1 ½ bricks, with alternating headers and stretchers on each course, the top three courses tumbled in to the main wall itself in an arc. The buttresses raise to a height approximately three courses below the wall coping, which is constructed of similar bricks laid as headers on edge. The mortar appeared to be a 'compo' mixture of lime, sand and cement with abundant gravel inclusions. It appeared consistent throughout the wall construction except where areas had been repaired and re-pointed on the southern elevation. 'Penny struck' pointing was applied inconsistently to the north and south elevations. Changes in mortar colour and consistency were noted, but probably reflect different 'lifts' of the wall (a number of courses built in one sitting) rather than different phases (Fig. 4). The exception to this was small area of the wall [3] where it had been finished off to meet the later 20th century low wall and ironwork (Fig. 4). Brick fabrics and sizes observed in wall are given below and are described using the Museum of London system of fabric classification. On the southern elevation, the bottom two to three

courses (not visible in the northern elevation due to ground build-up) were weathered to a greater degree and dirtier than the remainder of the wall (plate 4). This initially gives the impression that the brickwork may be earlier, but closer examination revealed the same bond, fabrics and dimensions as used higher up. This suggests that they are from the same phase, and have been subject to greater abrasion, from flash flooding, build up of mud, dirt etc. as may be expected in a narrow passage way.
