**AN ARCHAEOLOGICAL WATCHING BRIEF
ON STAGSHAW ROUNDABOUT
(B6318/A68 JUNCTION)
SIGNING IMPROVEMENTS, CORBRIDGE,
NORTHUMBERLAND**

**An Archaeological Watching Brief on Stagshaw Roundabout
(B6318/A68 Junction) Signing Improvements, Corbridge, Northumberland**

Site Code: SSR 10

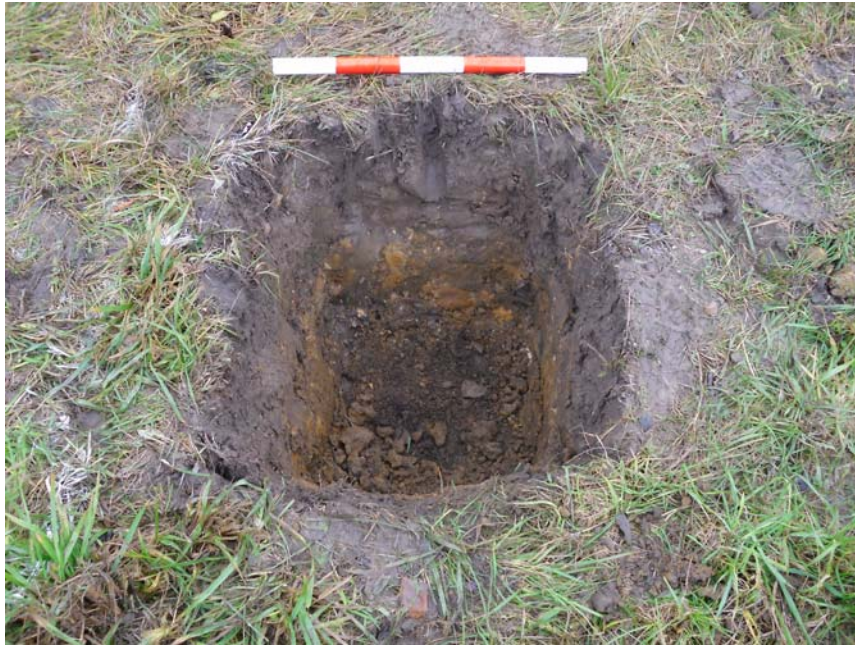
Figure 3. Foundation Pit 15, looking east (scale 0.5m)

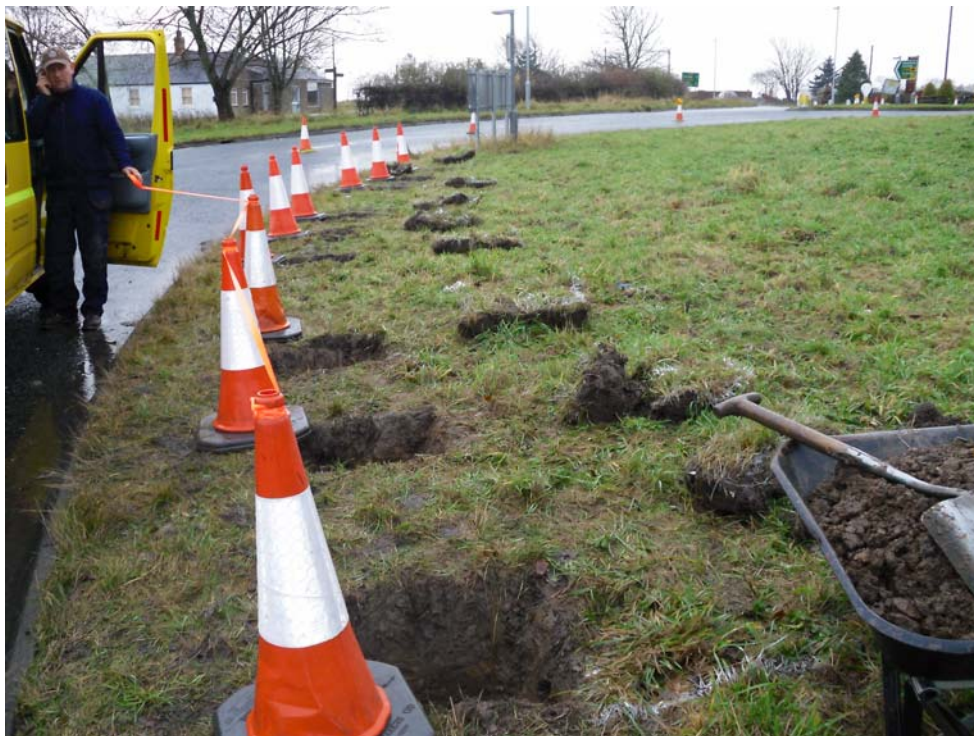
Figure 4. Overview of FPs18-10, looking south.

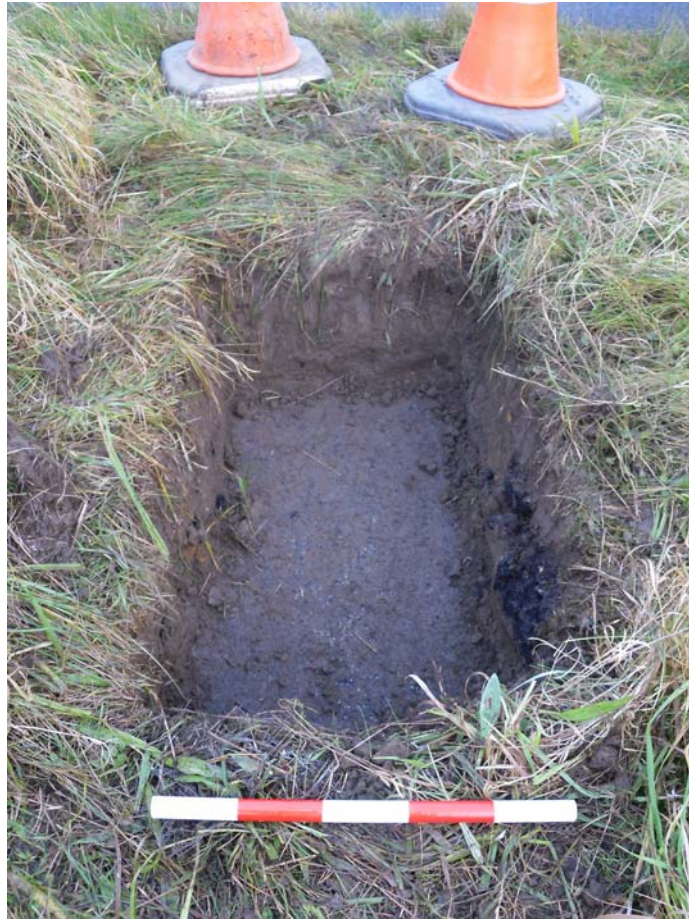
5.3.4 Overlaying 'made ground', [2], the former road surface, [4], and sub-soil, [5], was topsoil with turf line, [1], forming the current ground surface at all locations. Topsoil generally comprised loose mid brown clayey silt with average thickness of 0.25m, although in FP 1 it continued below the basal limit of excavation, 0.50m below existing ground level and was thus the only deposit to be recorded at that location.

Figure 5. Foundation Pit 25, tarmac surface [4], looking north-east (scale 0.5m)

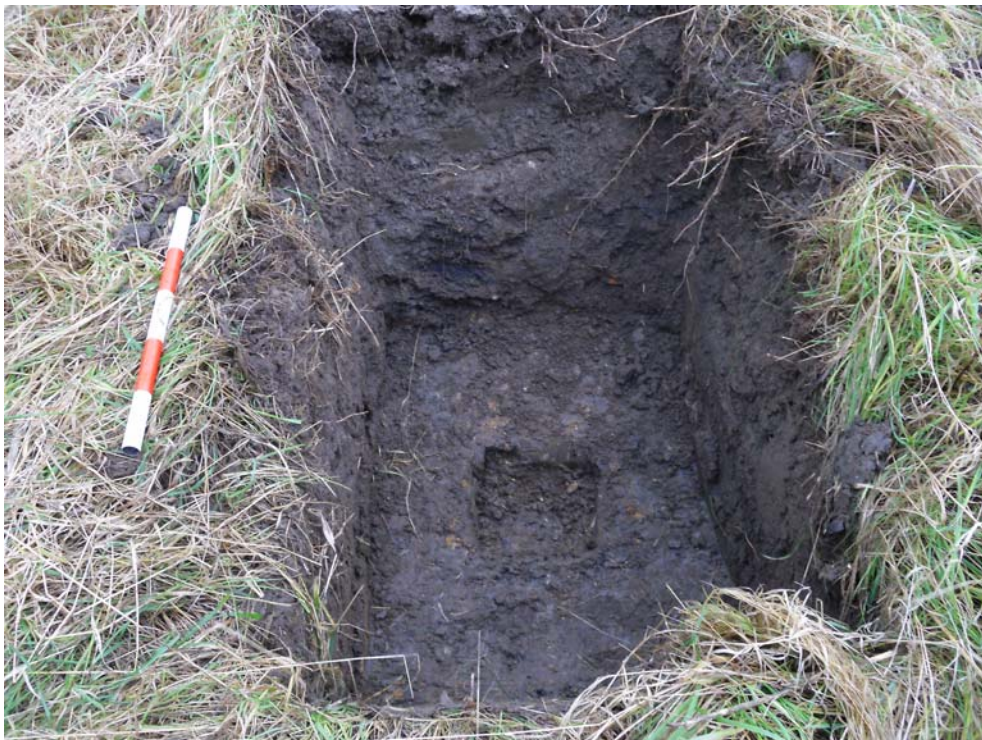
5.2.1 In FPs 27 and 28 - these sited on the northern highway verge of the B6318 to the west of the roundabout junction - a relatively sterile sub-soil, [5], comprising mid to dark greyish brown silty clay with occasional fine and medium stones, was recorded as the basal deposit. It was at least 0.60m thick, continuing below the basal limit of excavation in each foundation pit. This deposit has been interpreted as a sub-soil or uncertain period of origin.

Figure 6. Foundation Pit 28, looking west (scale 0.5m)
