LIVERPOOL HOUSE, SUNDERLAND
 ARCHAEOLOGICAL RECORDING

ARCHAEOLOGICAL RECORDING OF LIVERPOOL HOUSE, 187-193 HIGH STREET WEST, SUNDERLAND, TYNE AND WEAR, SR1

SITE CODE: LHS05

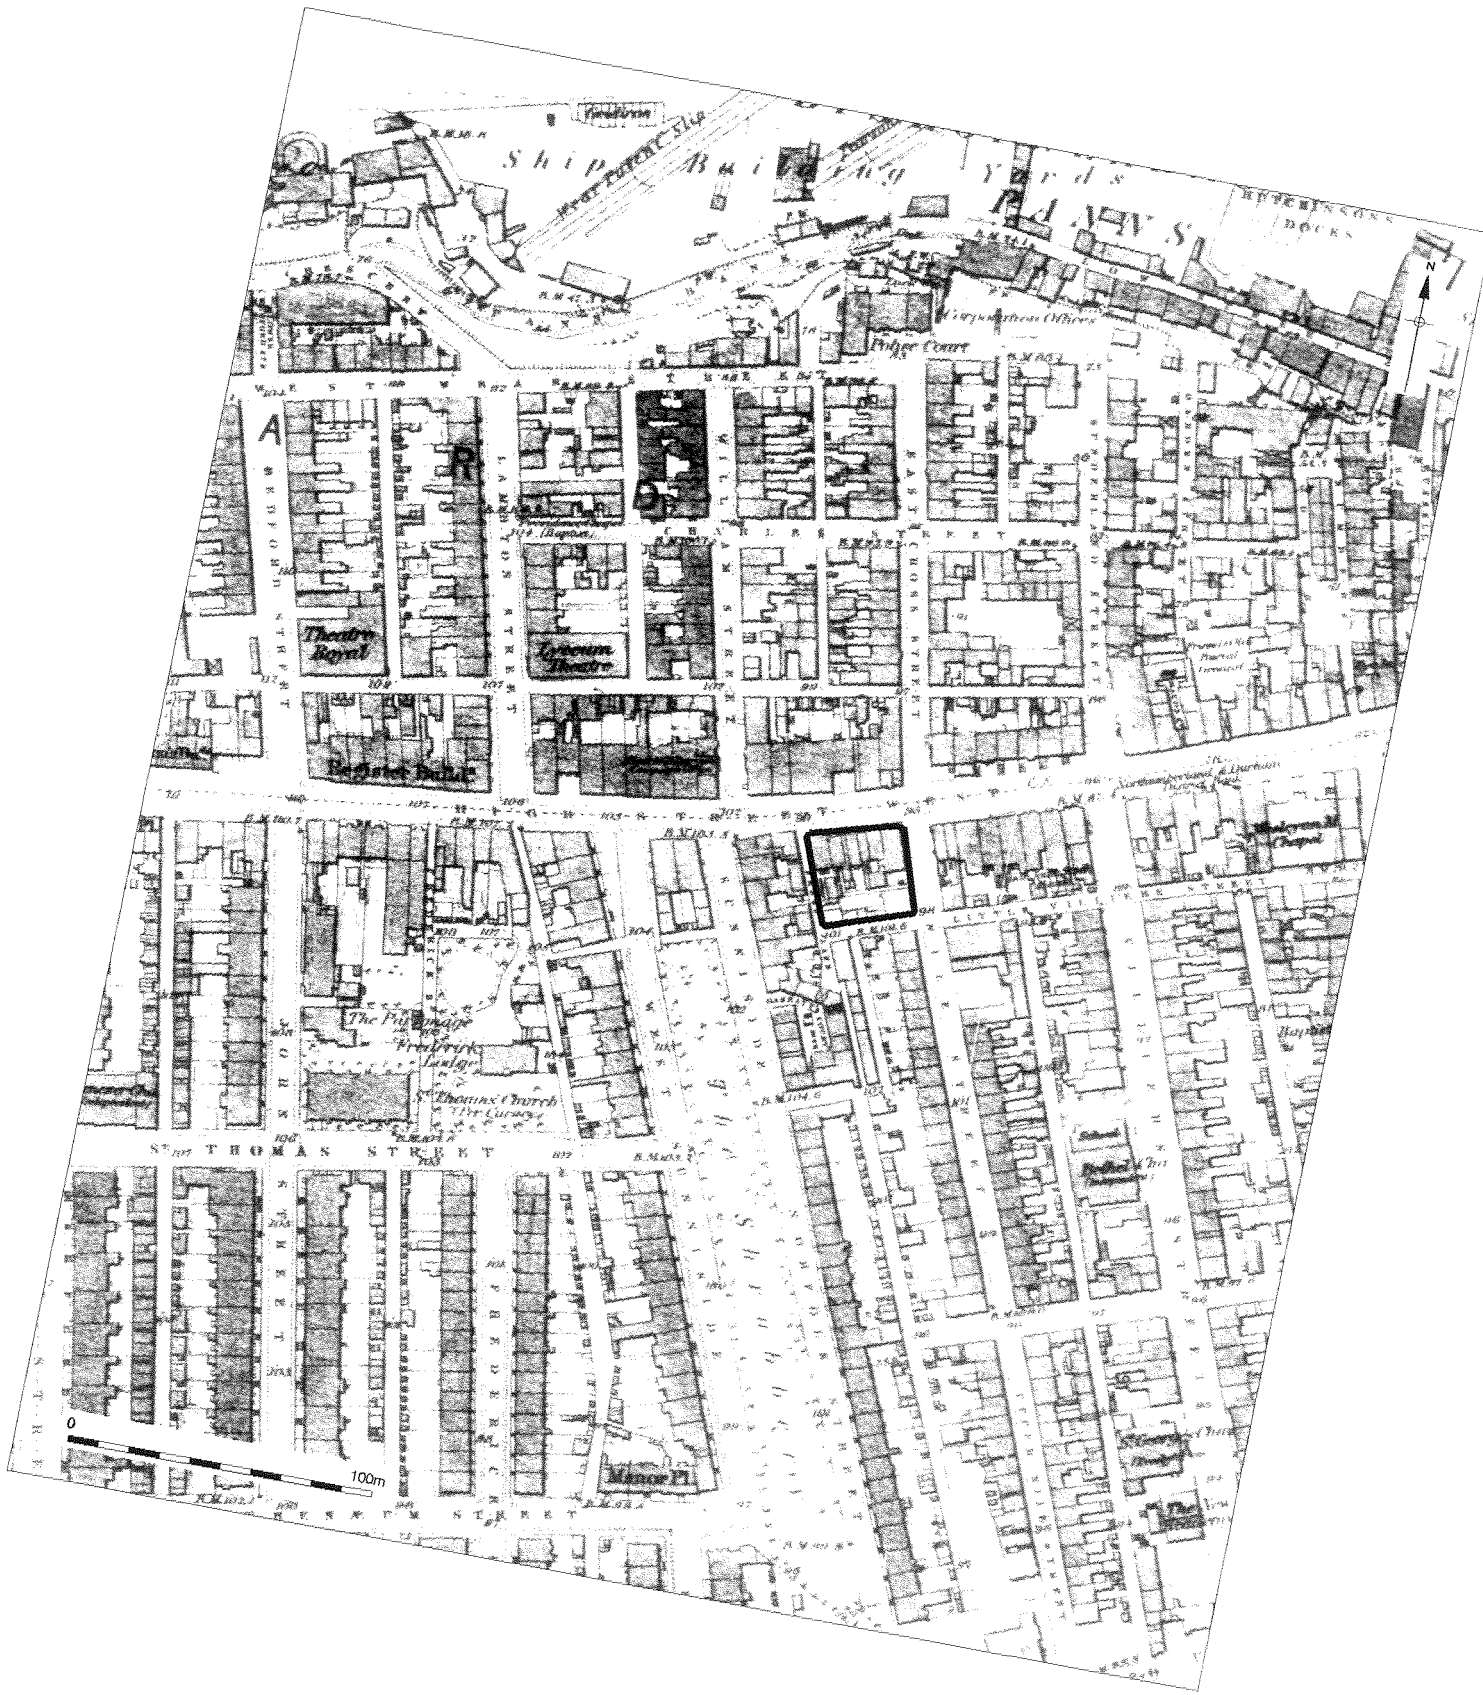
Figure 5
OS Map, 1855
1:25,000

- 4.3 By the time of the First Edition Ordnance Survey 1:2500 in 1855 (Fig 5), the complex has been further developed and a series of alleyways between the buildings, a courtyard and outbuildings can also be seen.

- 6.2 The first edition Ordnance Survey map of 1855 (Fig 5) shows this building still in place and other buildings spreading to the east of it. The property boundaries and alleyways at this time are those that are echoed in the dimensions and internal divisions of Liverpool House. The southern limit of the High Street West fronting buildings is reflected in the current plan of Liverpool House. By this time, the stable block and loft in the southwest corner of the complex are also visible on the Ordnance Survey map. This phase, Phase 2, is characterised by the development of this series of outbuildings. They form part of a group of buildings on the other side of both Press Lane and Little Villiers Street as an urban industrial complex through an arch to the southwest of the building.

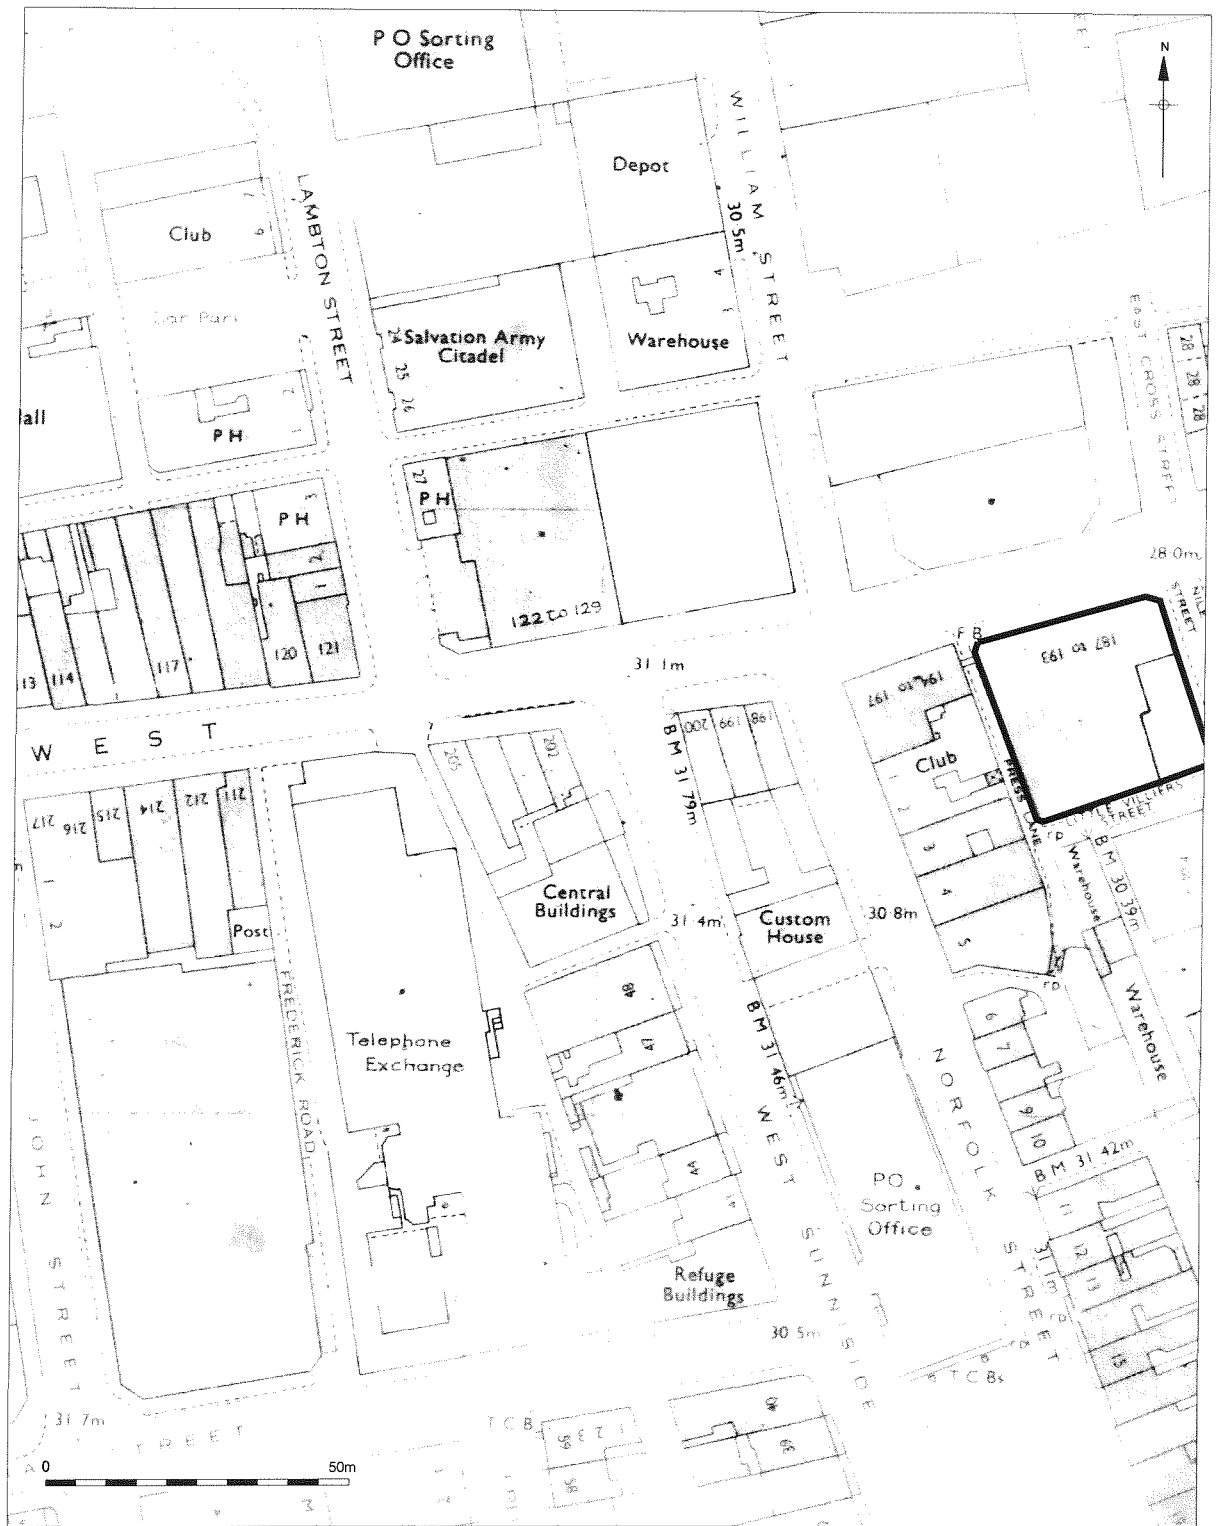
Figure 11
 OS Map, 1988
 1:1,250

- 4.5 Little further development of the site can be discerned until the Ordnance Survey 1:1250 Edition of 1988 (Fig 11) that shows the demolition of the southeast portion of the building to make way for a car park.

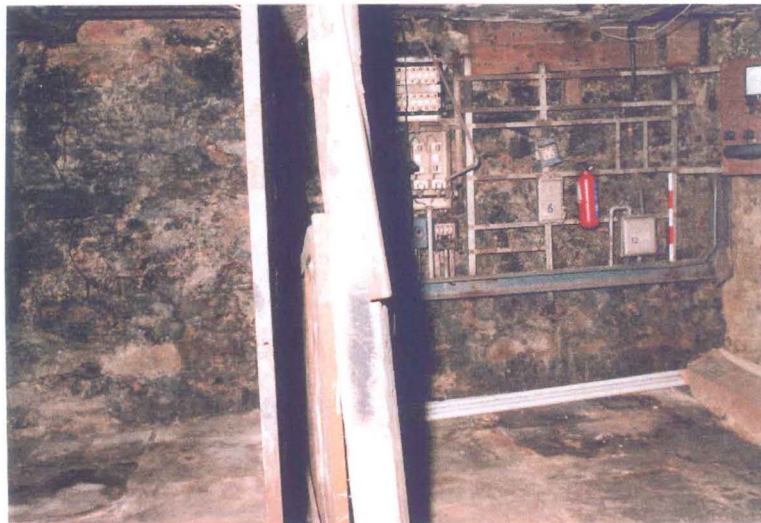
Plate 2 Stone Basement, Room B01

5.2.1 At the west end of the basement, room B01 (Plate 2) is largely built in stone (3) and its north wall is curved, echoing the floors above (Fig 14). The north stone wall shows evidence of a lightwell blocked with mixed bricks (7). The south wall of the room is built in modern Fletton brick and appears to block a passage leading south, a doorway here is covered with a plywood board sheet. The east wall is built in rendered brick (2) and has a doorway knocked through it leading to room B02. The ceiling timbers of B01 bear the remainders of early-twentieth century lath and plaster. The floor (6) is made up of stone flags although these do not show any wear to determine likely uses.

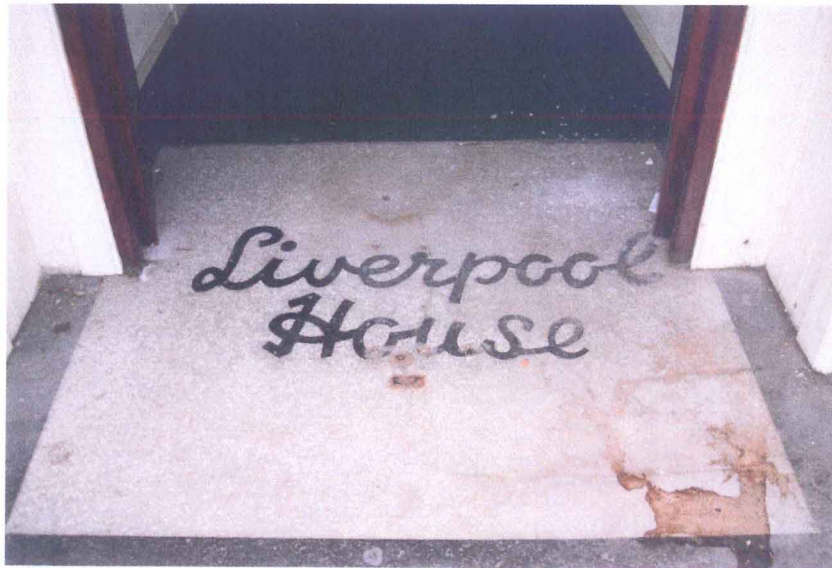
Plate 3 'Liverpool House' tiled slab

- 5.3.4 The doorway at the north end of GF02 is the main entrance into Liverpool House and immediately in from the pavement is a large tiled slab bearing the inscription 'Liverpool House' (39) (Plate 3)

7.6.5 The 'Liverpool House' tiled slab in the doorway of the building has suffered some cracking. If it can be reused or, if not reusable, replicated it could form a valuable reference in any new scheme to the former use of the building and enhance the character of the Conservation Area.

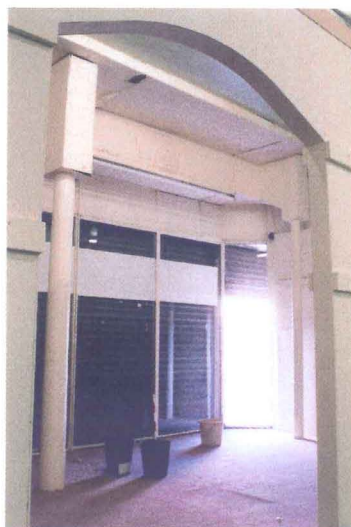
Plate 4 North end, Room GF02

- 5.3.5 The north end of GF02 (Plate 4) has inserted display areas either side of lobby, these built in light timber and plywood board. The majority of the walls are either covered by plywood board or render. The floor is carpeted and the ceiling is plastered, containing two historic skylights, now infilled with corrugated tin. To the northeast of the room is a lift shaft, this now surrounded by plywood boarding. The room is divided to the south from GF08 by a light timber and plywood wall and there is access from the east of the room to GF09.

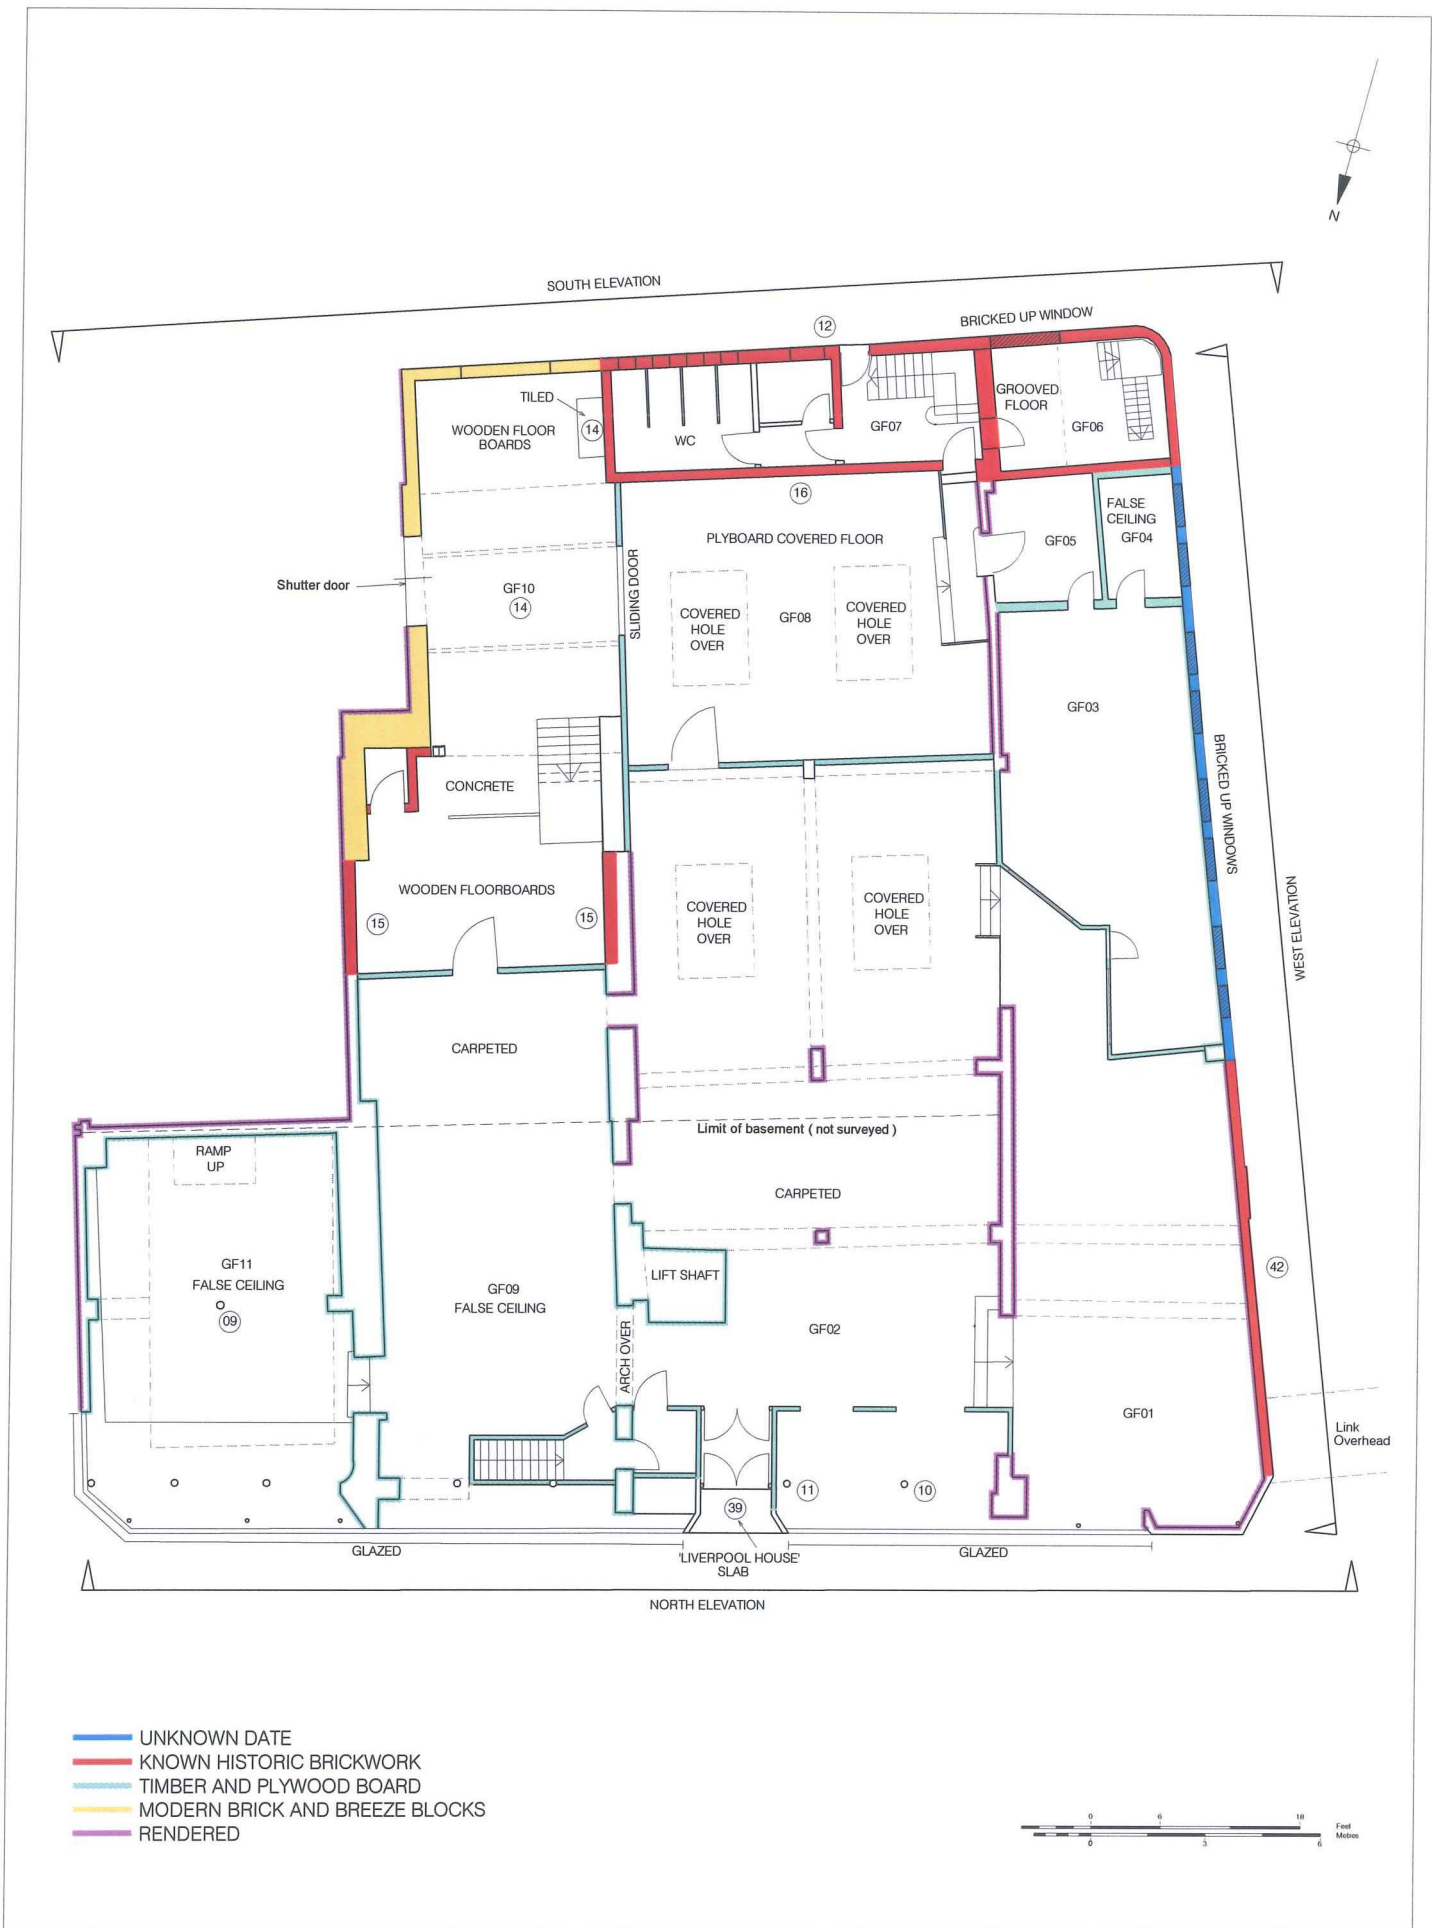
Figure 14
 Ground Floor Plan
 showing areas of construction and important features (ref. Appendix 1)
 1:200

- 5.3.1 Historically, the ground floor (Fig 14) was the main shop floor of the building. Its succession of fronts (see below) were supported on a number of cast-iron and steel columns (eg. 9, 10, 11).
- 5.3.2 In the northeast corner, room GF01 has rendered walls to its west and separating it from GF02. It is carpeted and the roof is plastered. By the glazed front to the room's north are two steel support columns. The capitals and bases of these are not visible.
- 5.3.3 To the south, GF01 is separated from room GF03 by a modern, lightweight timber and plywood board dividing wall, creating GF03 as an office. To the south of GF03, rooms GF04 and GF05 are similarly divided off, GF04 having a rendered wall to the west and light timber wall to the east with a false ceiling, while GF05 has a rendered east wall and plastered ceiling. A door leads east from GF05 to room GF08.

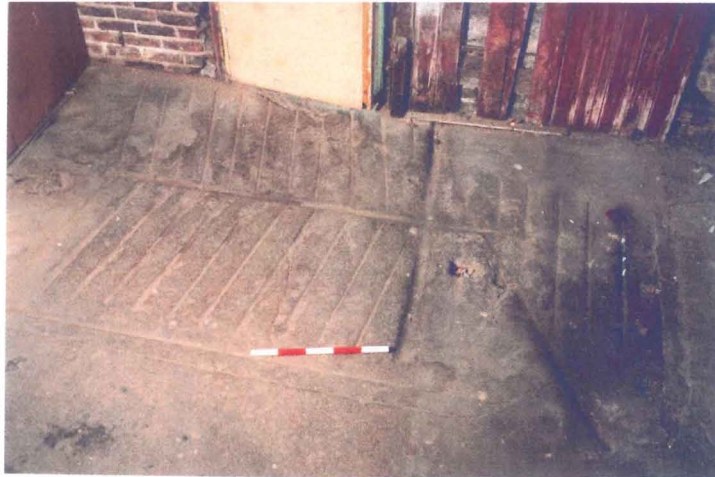
Plate 5 Floor of Stable and Loft Structure, southeast

- 5.3.10 In the extreme southwest of Liverpool House, rooms GF06 and GF07 make up a stable block and loft dating from the mid-nineteenth century (12) (Plate 5). GF07 is now a WC with concrete floor and rendered brick walls on all sides. There are stairs to a second floor, similarly constructed in concrete and brick and recently divided with timber and plywood floors. From GF07, GF06 is reached via a doorway in its west wall, the threshold of which is a well worn, deep wooden step. Inside GF06, the stone

floor contains a number of grooves relating to an (unknown) industrial function. The brickwork of the structure is visible here, it being red brick measuring 229-230mm x 104-111mm x 53-60mm laid in stretcher bond. There is a large bricked up window in the south wall and a section of the wall has been reconstructed in Fletton brick. A wooden staircase leads to the loft of the structure (1F03). The floor 1F03 is of timber planks and there is a bricked up loading hatch with a wooden hinged door in the south wall.

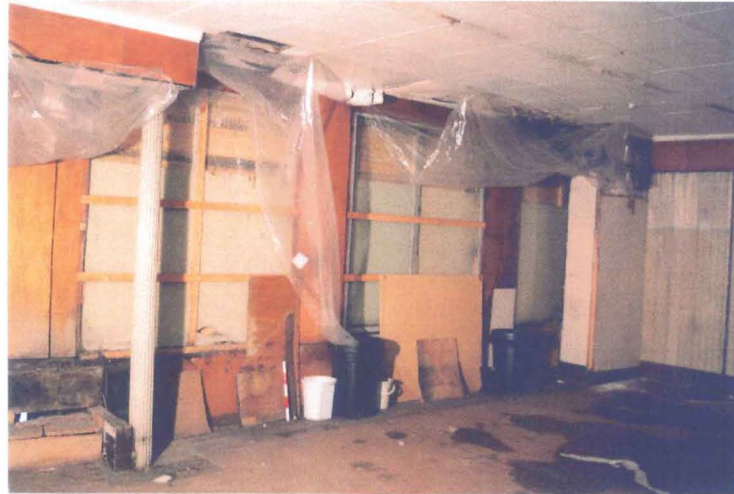
Plate 6 Historic shop front, Room 1F07

this were covered and could not be assessed. The west side of this north front appears to be the original front of Liverpool House, being a wooden front supported in the centre of the room by a fluted cast-iron column with a moulded capital (26) (Plate 6). To the west of this, the continuing shop front has been removed (27). Both sides of the central ceiling beam have a cornice (28) running around the entirety of the room, broken only on the north side (27). There is an entrance to the lift shaft in the west wall.

- 7.9.3 It is recommended that the late 19th century elements of the shop front that are to be removed should be recorded to produce a drawn record showing just the late 19th century elements at a scale of 1:100.

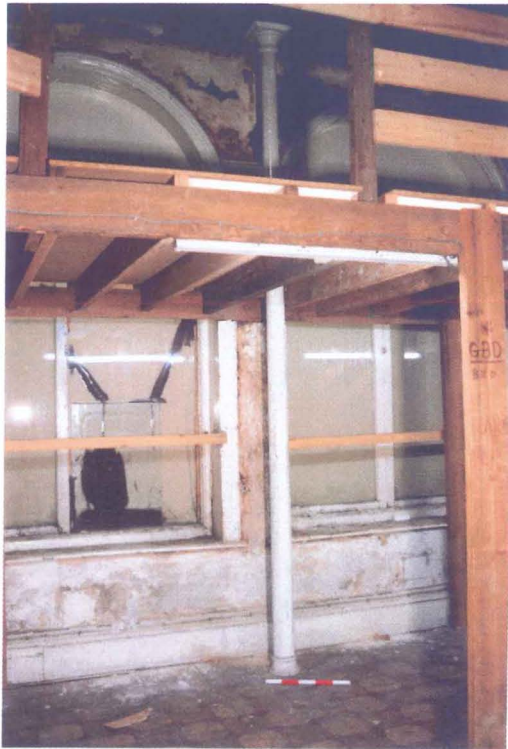
Plate 7 Historic windows, Room 1F02

5.4.4 Room 1F02 is open to double height with a plastered ceiling and a lino floor with floorboards visible beneath. All of the walls are built in brick, but either painted or rendered and not accessible for further analysis. Around the entirety of the room, a skirting board, picture rail and cornices survive (30, 31, 32, 33). As this is the only room in the building where such mouldings survive, it can be assumed that this was a principle room at some point in Liverpool House's existence. In the northwest of the room, there is a blocked up fireplace (24). The north wall of the room holds the fenestration, four large round arched windows (Plate 7), evident on the early illustrations and photographs of Liverpool House (Fig 13). At this wall, and in the centre of the room, the ceiling beams are supported on cast-iron columns (22, 23). Around the north, west and south walls of the room, a timber mezzanine level has been inserted.

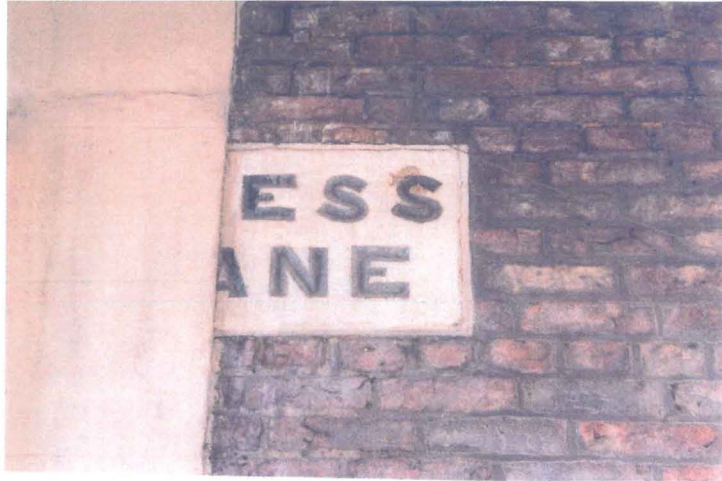
Plate 8 Early-nineteenth century street sign

5.8.1 This nineteenth-century building can be further seen on the west elevation where, at its north end, there is a single-storey's height of brown brick (42), holding a classically styled sandstone door and an early nineteenth century street sign (50) bearing most of the inscription 'Press Lane' (Plate 8), the start of each word truncated by the 1960s shop front as it 'wraps around' onto the west elevation from the north. Above this, the wall is constructed in modern red-brick although it was not possible to assess whether this was a replacement or a 'skin' reinforcing older brickwork. A link corridor stretches west away from this wall joining Liverpool House to the adjacent building. The roof at this point is double gabled.
