**AN ARCHAEOLOGICAL EVALUATION AT
YARM MEDICAL CENTRE,
1 WORSALL ROAD, YARM,
STOCKTON-ON-TEES**

MARCH 2011

Site Code: YAR 11

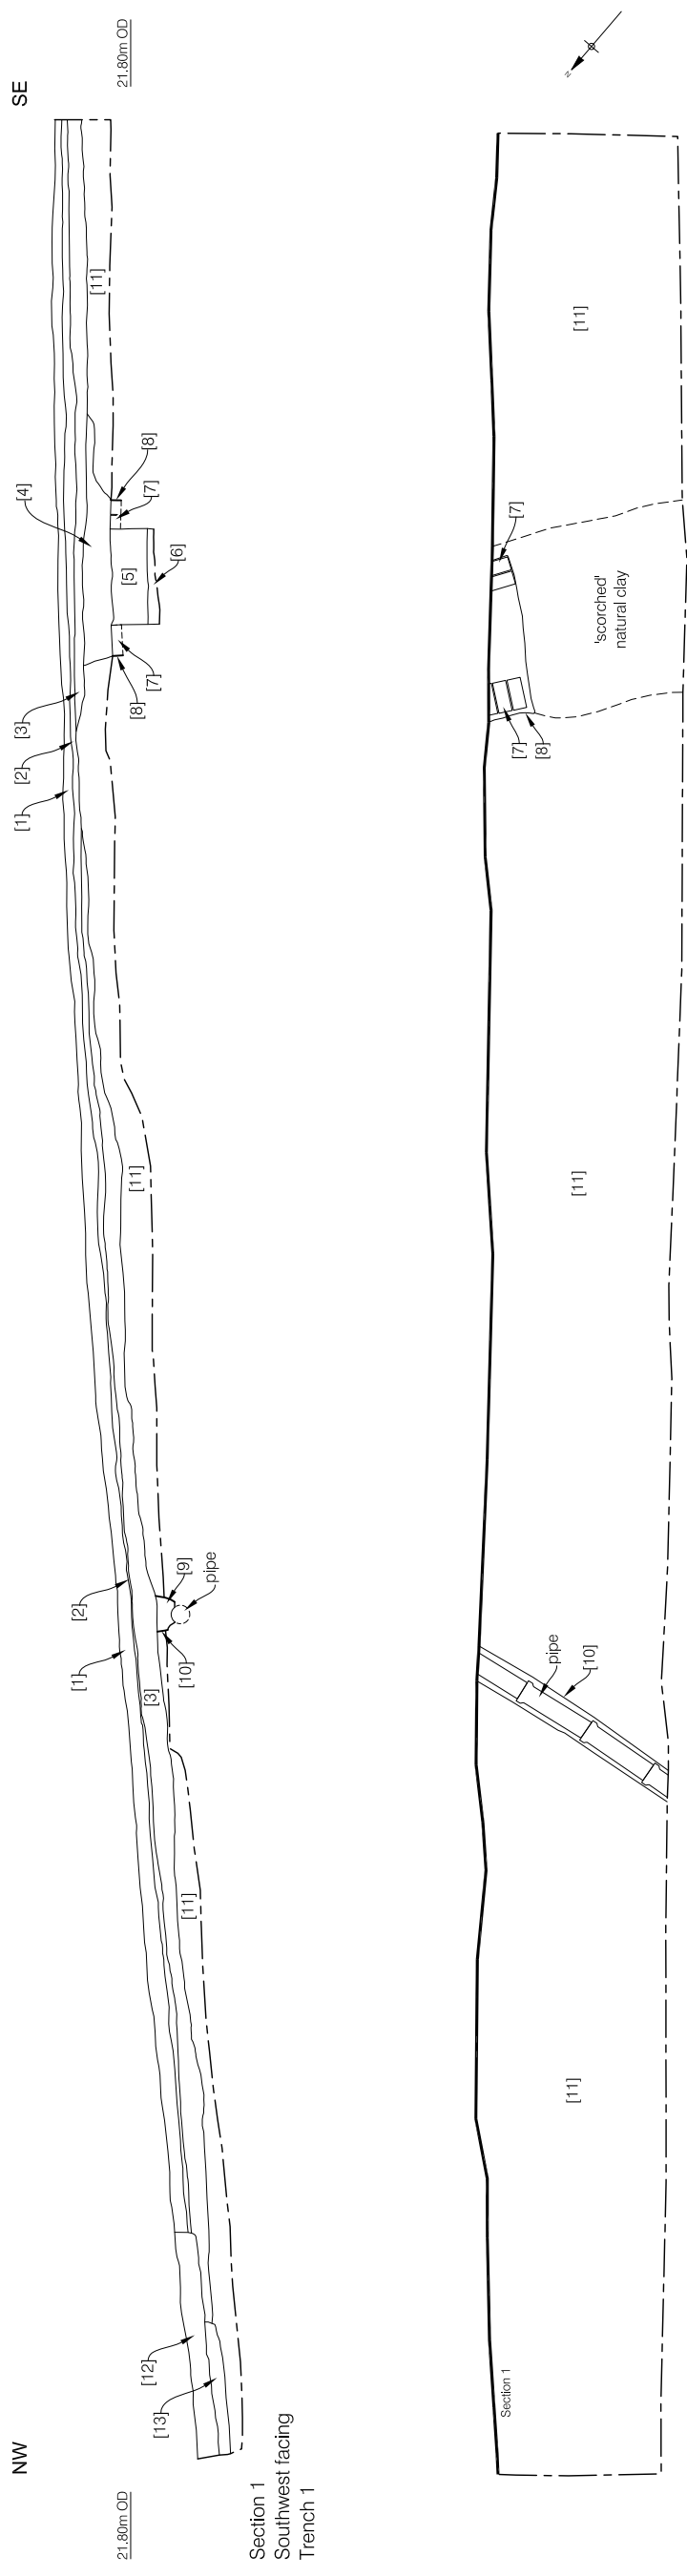
Trench 1: Plan and southwest facing section

5.1.1 Phase 1 represents natural geological deposits. Such material was exposed only along the base of Trench 1. The deposit, [11], comprised stiff light to mid pinkish brown clay with few inclusions. This material is the locally known 'boulder clay' of glacial origin. It was recorded at a maximum height of 17.21m OD at the south-eastern end of the trench, sloping down to a minimum height, on its upper surface, of 15.95m OD at the north-western end of the trench. This fall reflects the natural topography of the site and wider area.

5.2.2 Towards the south-eastern extent of Trench 1, the south-western end of a brick-lined structure, [7], was recorded, adjacent to and continuing beyond the eastern limit of excavation. It was housed within a square-ended construction cut, [8], which had been excavated into the natural clay sub-stratum.

5.2.3 The remains of the structure comprised two parallel NE-SW aligned brick walls c. 0.80m apart and constructed using unfrogged red bricks (250mm x 120mm x 80mm) laid in alternate header and stretcher courses, bonded with soft clay (Figure 3). The structure was 1.30m wide (NW-SE) by at least 0.38m long (NE-SW), continuing beyond the eastern limit of excavation as described, and was c. 0.40m high (four courses of brick) within construction cut [8]; it was recorded at a maximum height of 16.96m OD. Its interior was filled by a weakly cemented fire debris deposit, [6], comprising cinders and slag, overlain by a dump of coarse sand, [5], with a combined thickness of 0.46m. The fire debris likely accumulated when the structure fell into disuse and was probably derived from an associated process in the manufactory.

- 5.2.4 Structure [7] is interpreted as representing the lowermost surviving remains of an element of the 19th century brick and tile works on Worsall Road. Given the limited degree to which it was possible to examine the structure, a definitive interpretation of its function is impossible, although it was most likely part of a kiln or flue within the manufactory. The area of natural clay to the south-west of the structure had been scorched bright pink indicating that it had been exposed to very high temperatures. It is clear that this portion of the structure survived only because of its subterranean setting and all that all associated remains at or above the contemporary ground level had suffered horizontal truncation, probably when the buildings were demolished during the second half of the 19th century or, possibly less likely, when the existing medical centre and its car parking area were constructed during the 20th century.

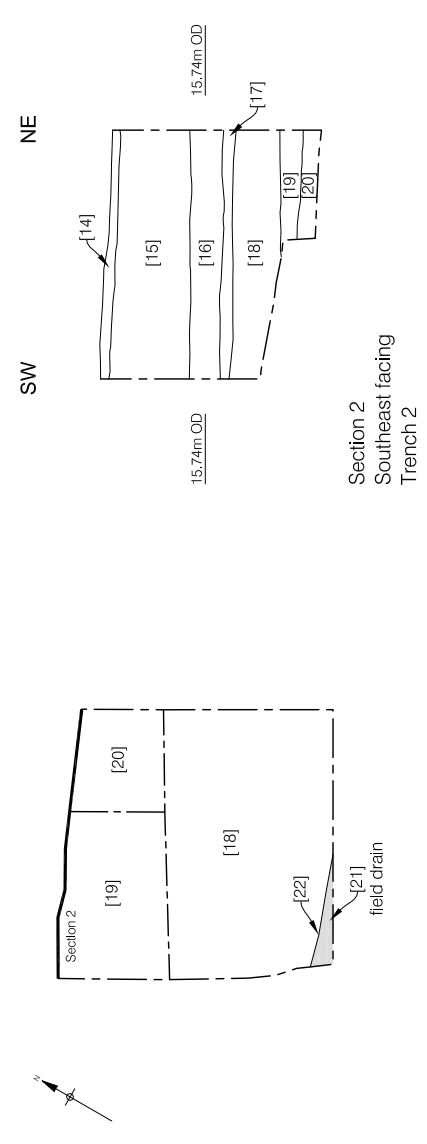
Trench 2: Plan and southeast facing section

- 5.2.6 The earliest strata recorded in Trench 2 comprised a series of deposits, [20], [19], [18], [17] and [16], which have been interpreted as dumped infill material of 19th century date (Figure 3). The deposits had varying compositions of clay, silt and sand and were between 0.10m and 0.38m thick, with a maximum combined thickness of at least 1.10m, recorded at a maximum height of 15.87m OD. A fragment of clay tobacco pipe stem, of probable 19th century date, was recovered from the lowermost deposit, [20].

- 5.2.9 Two east-west aligned ceramic field drains, [22] and [30], were recorded truncating the upper strata of dump deposits, [16] and [26], in Trenches 2 and 3, respectively. These were likely to be of later post-medieval/early modern date, installed to facilitate drainage of the site following the abandonment of the brick and tile manufactory.

- 5.2.8 The dump deposits recorded in Trenches 2 and 3 potentially represent infilling of clay extraction pits to the east of the brick and tile manufactory, following abandonment and demolition of the works. A large feature – likely a clay extraction pit - depicted on the Ordnance Survey 1st edition map of c. 1856 to the east of the works is represented today by a pond in the grounds of the property to the immediate east of the site. It is considered highly probable that extraction would have taken place across as wide an area as possible in the grounds of the works, including the eastern portion of the medical centre site. Disuse of the works in the later 19th century would likely have required infilling of extraction areas within the site for the purposes of ground levelling.

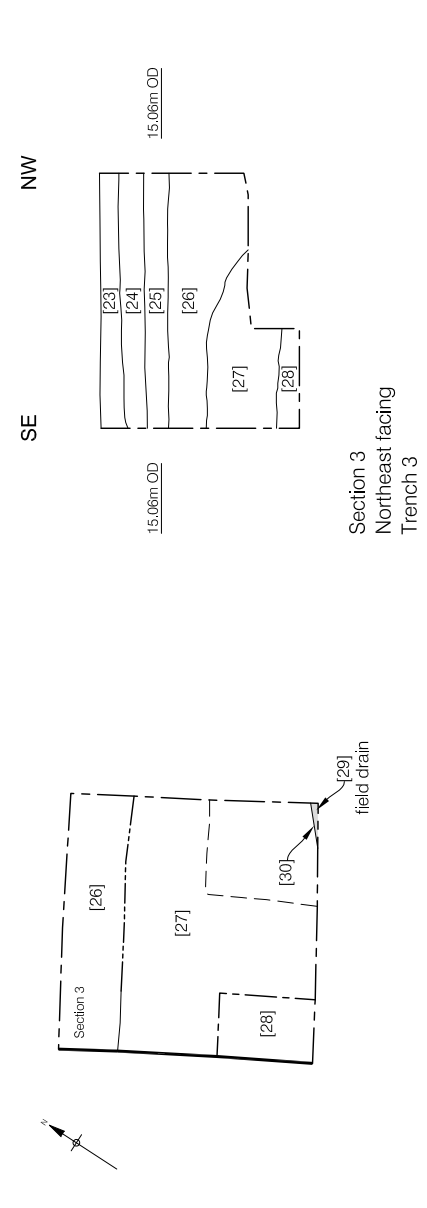
Trench 3: Plan and northeast facing section

- 5.2.7 The earliest strata recorded in Trench 3 were similar dump deposits, [28], [27] and [26], to those recorded in Trench 2, again with varying compositions of silty sand and silty clay (Figure 3). These deposits were between at least 0.20m and 0.66m thick, with a maximum combined thickness of at least c. 1.10m, recorded at a maximum height of 15.00m OD. Fragments of roof pantile and brick of probable 19th century date were noted throughout the uppermost deposit, [26].

- 5.3.2 A clayey silty sand layer, [25], up to 0.21m thick, was recorded extending across Trench 3. This directly overlay the uppermost Phase 2 layer, [26], and sealed field drain, [30], and is interpreted as a modern levelling deposit.

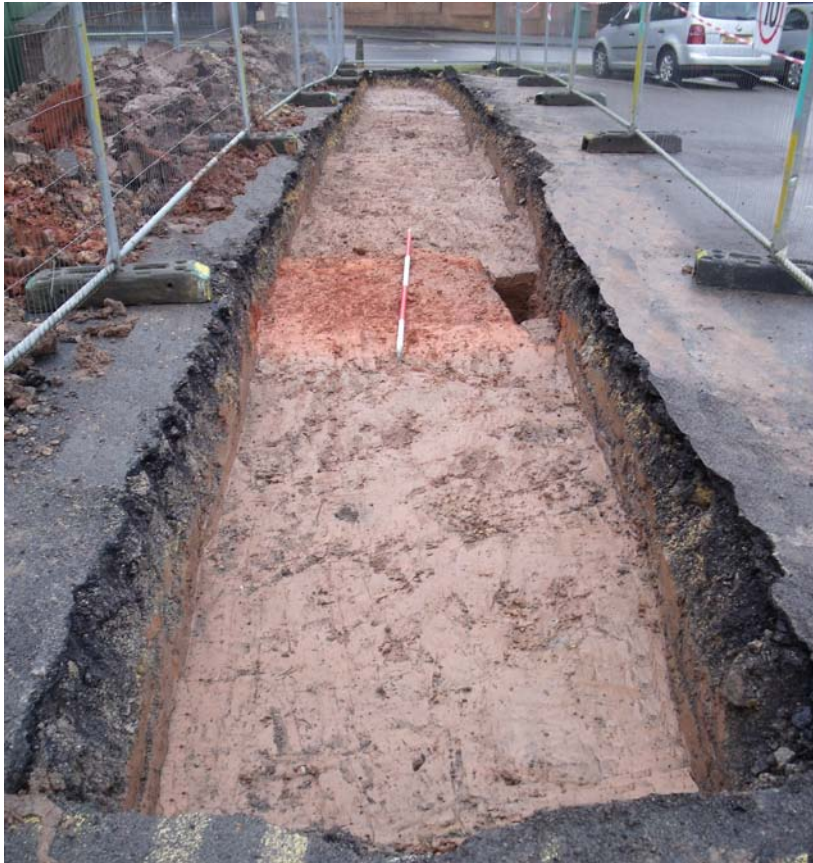
Figure 4 Trench 1 overview, looking north-west (scale 2m)

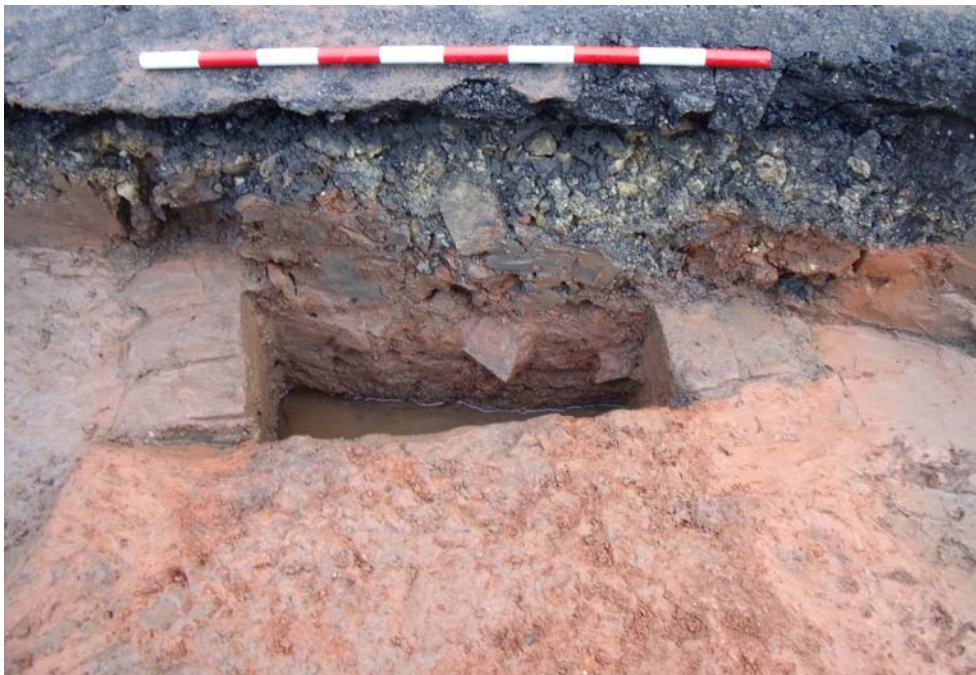
Figure 5 Trench 1, structure [7] in Section 1, looking north-east (scale 1m)

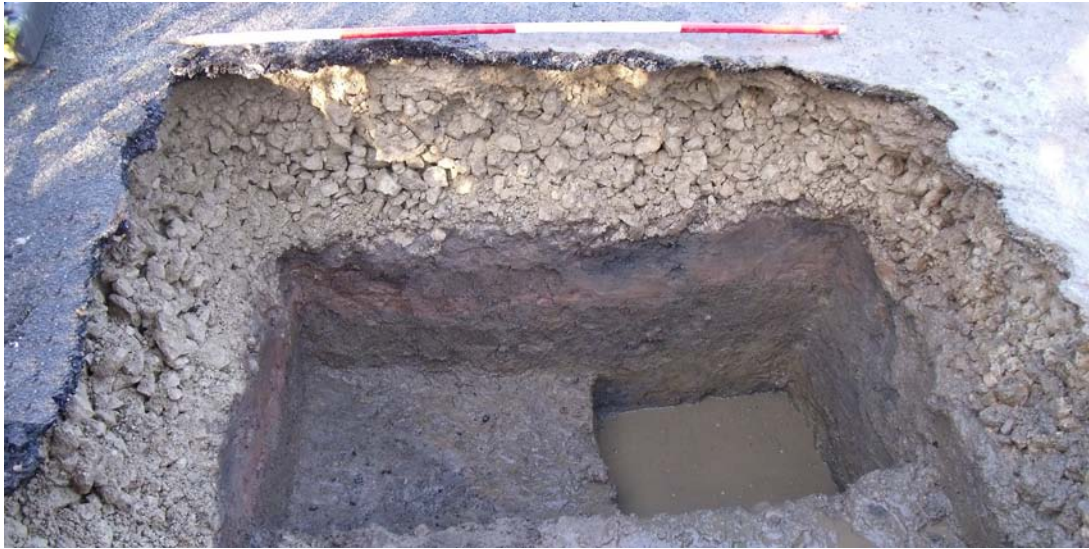
Figure 6 Trench 2, Section 2, looking NNW (scale 2m)

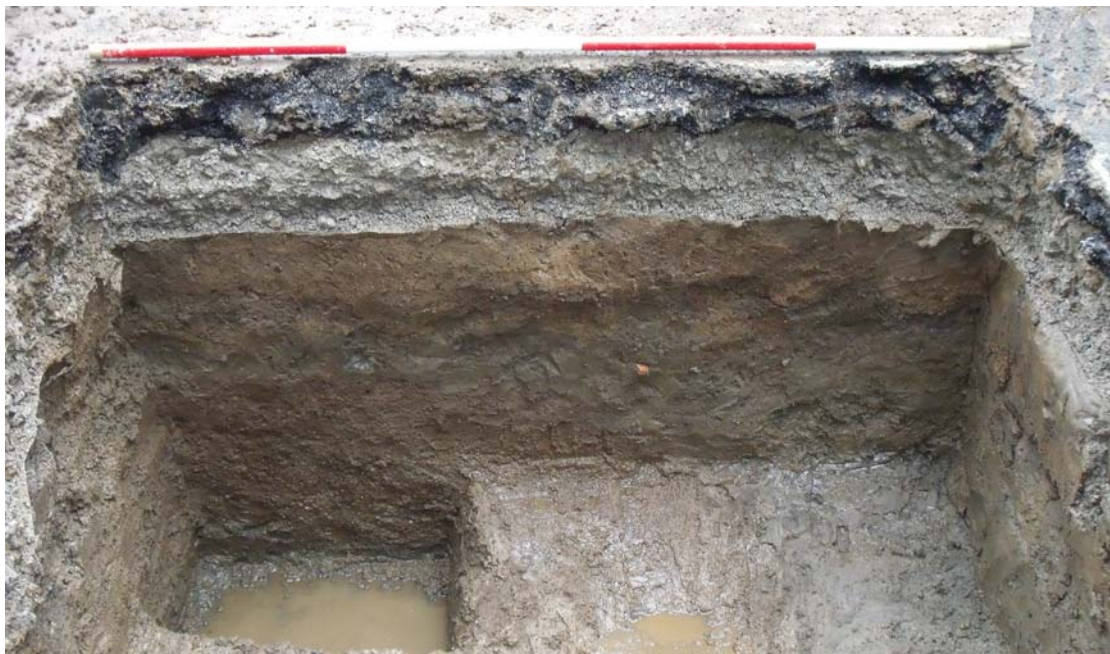
Figure 7 Trench 3, Section 3, looking WSW (scale 2m)
