**HISTORIC BUILDING RECORDING:
THE FORMER UNION WORKHOUSE BUILDINGS,
NEWCASTLE GENERAL HOSPITAL,
WESTGATE ROAD, NEWCASTLE-UPON-TYNE,
TYNE AND WEAR**

APRIL 2011

**Historic Building Recording: The Former Union Workhouse Buildings,
Newcastle General Hospital, Westgate Road, Newcastle-upon-Tyne,
Tyne and Wear**

Site Code: NEG 11

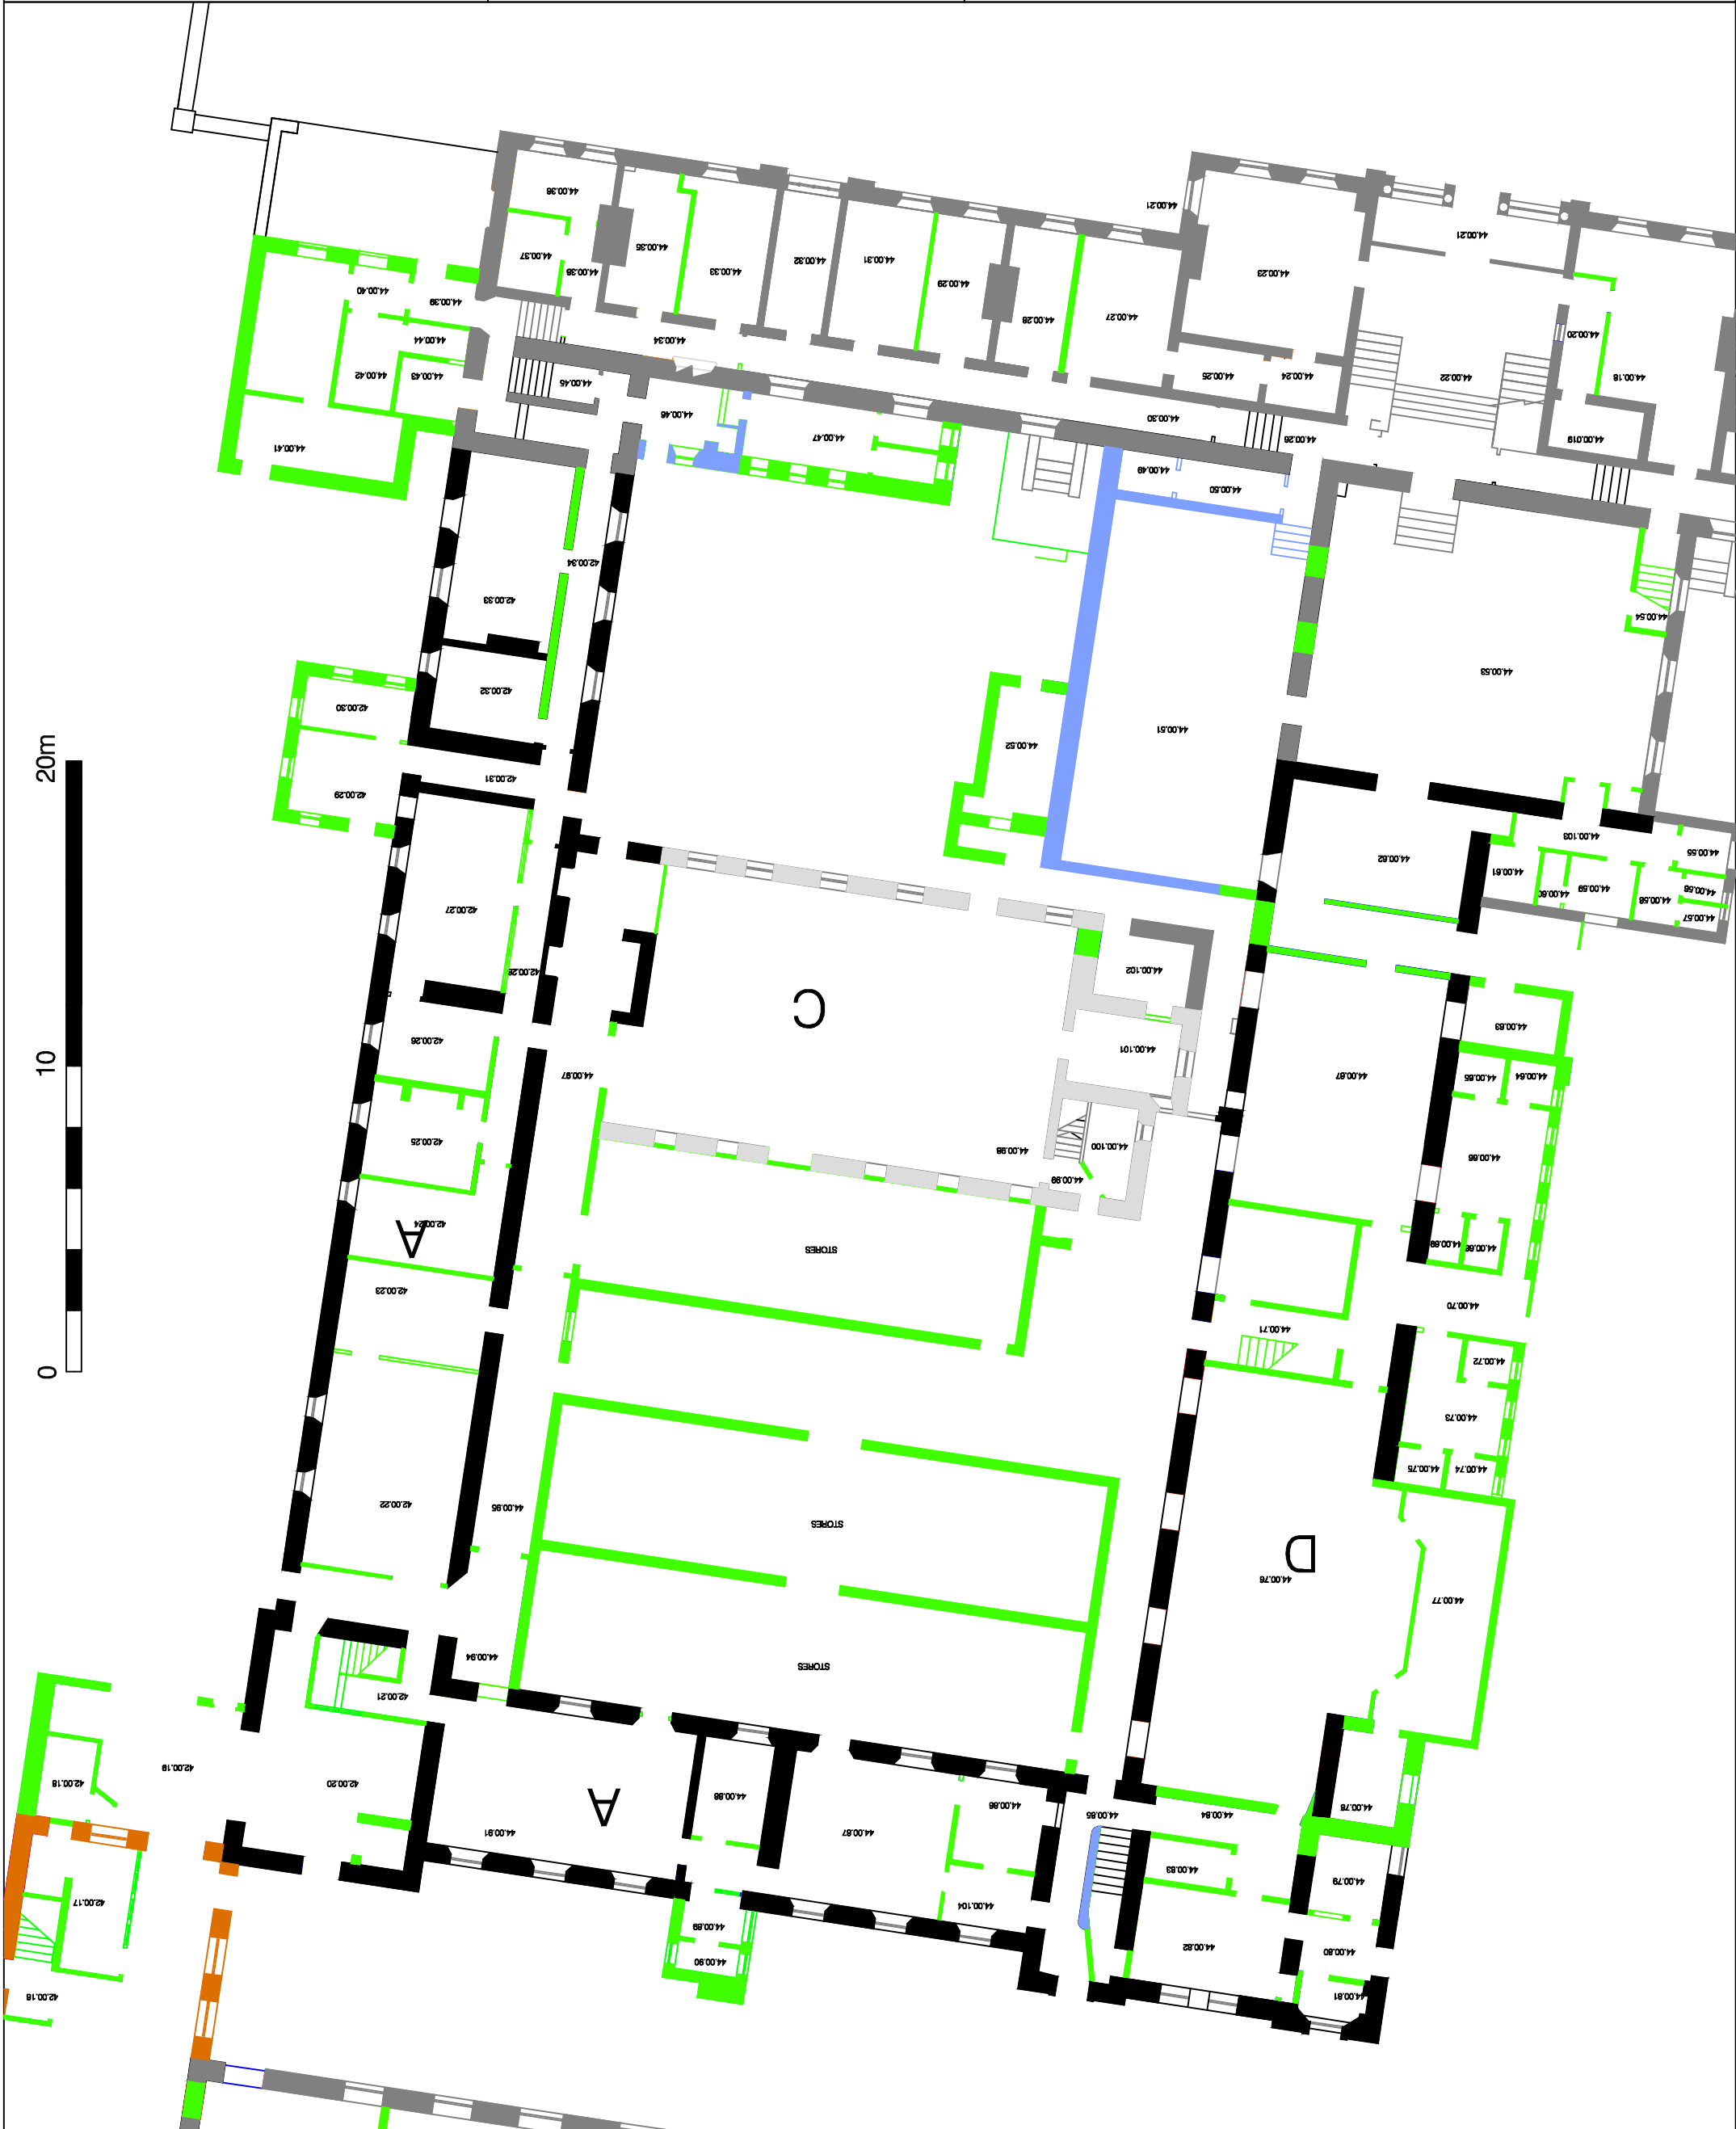
Figure 3

Buildings A, C and D
Ground Floor

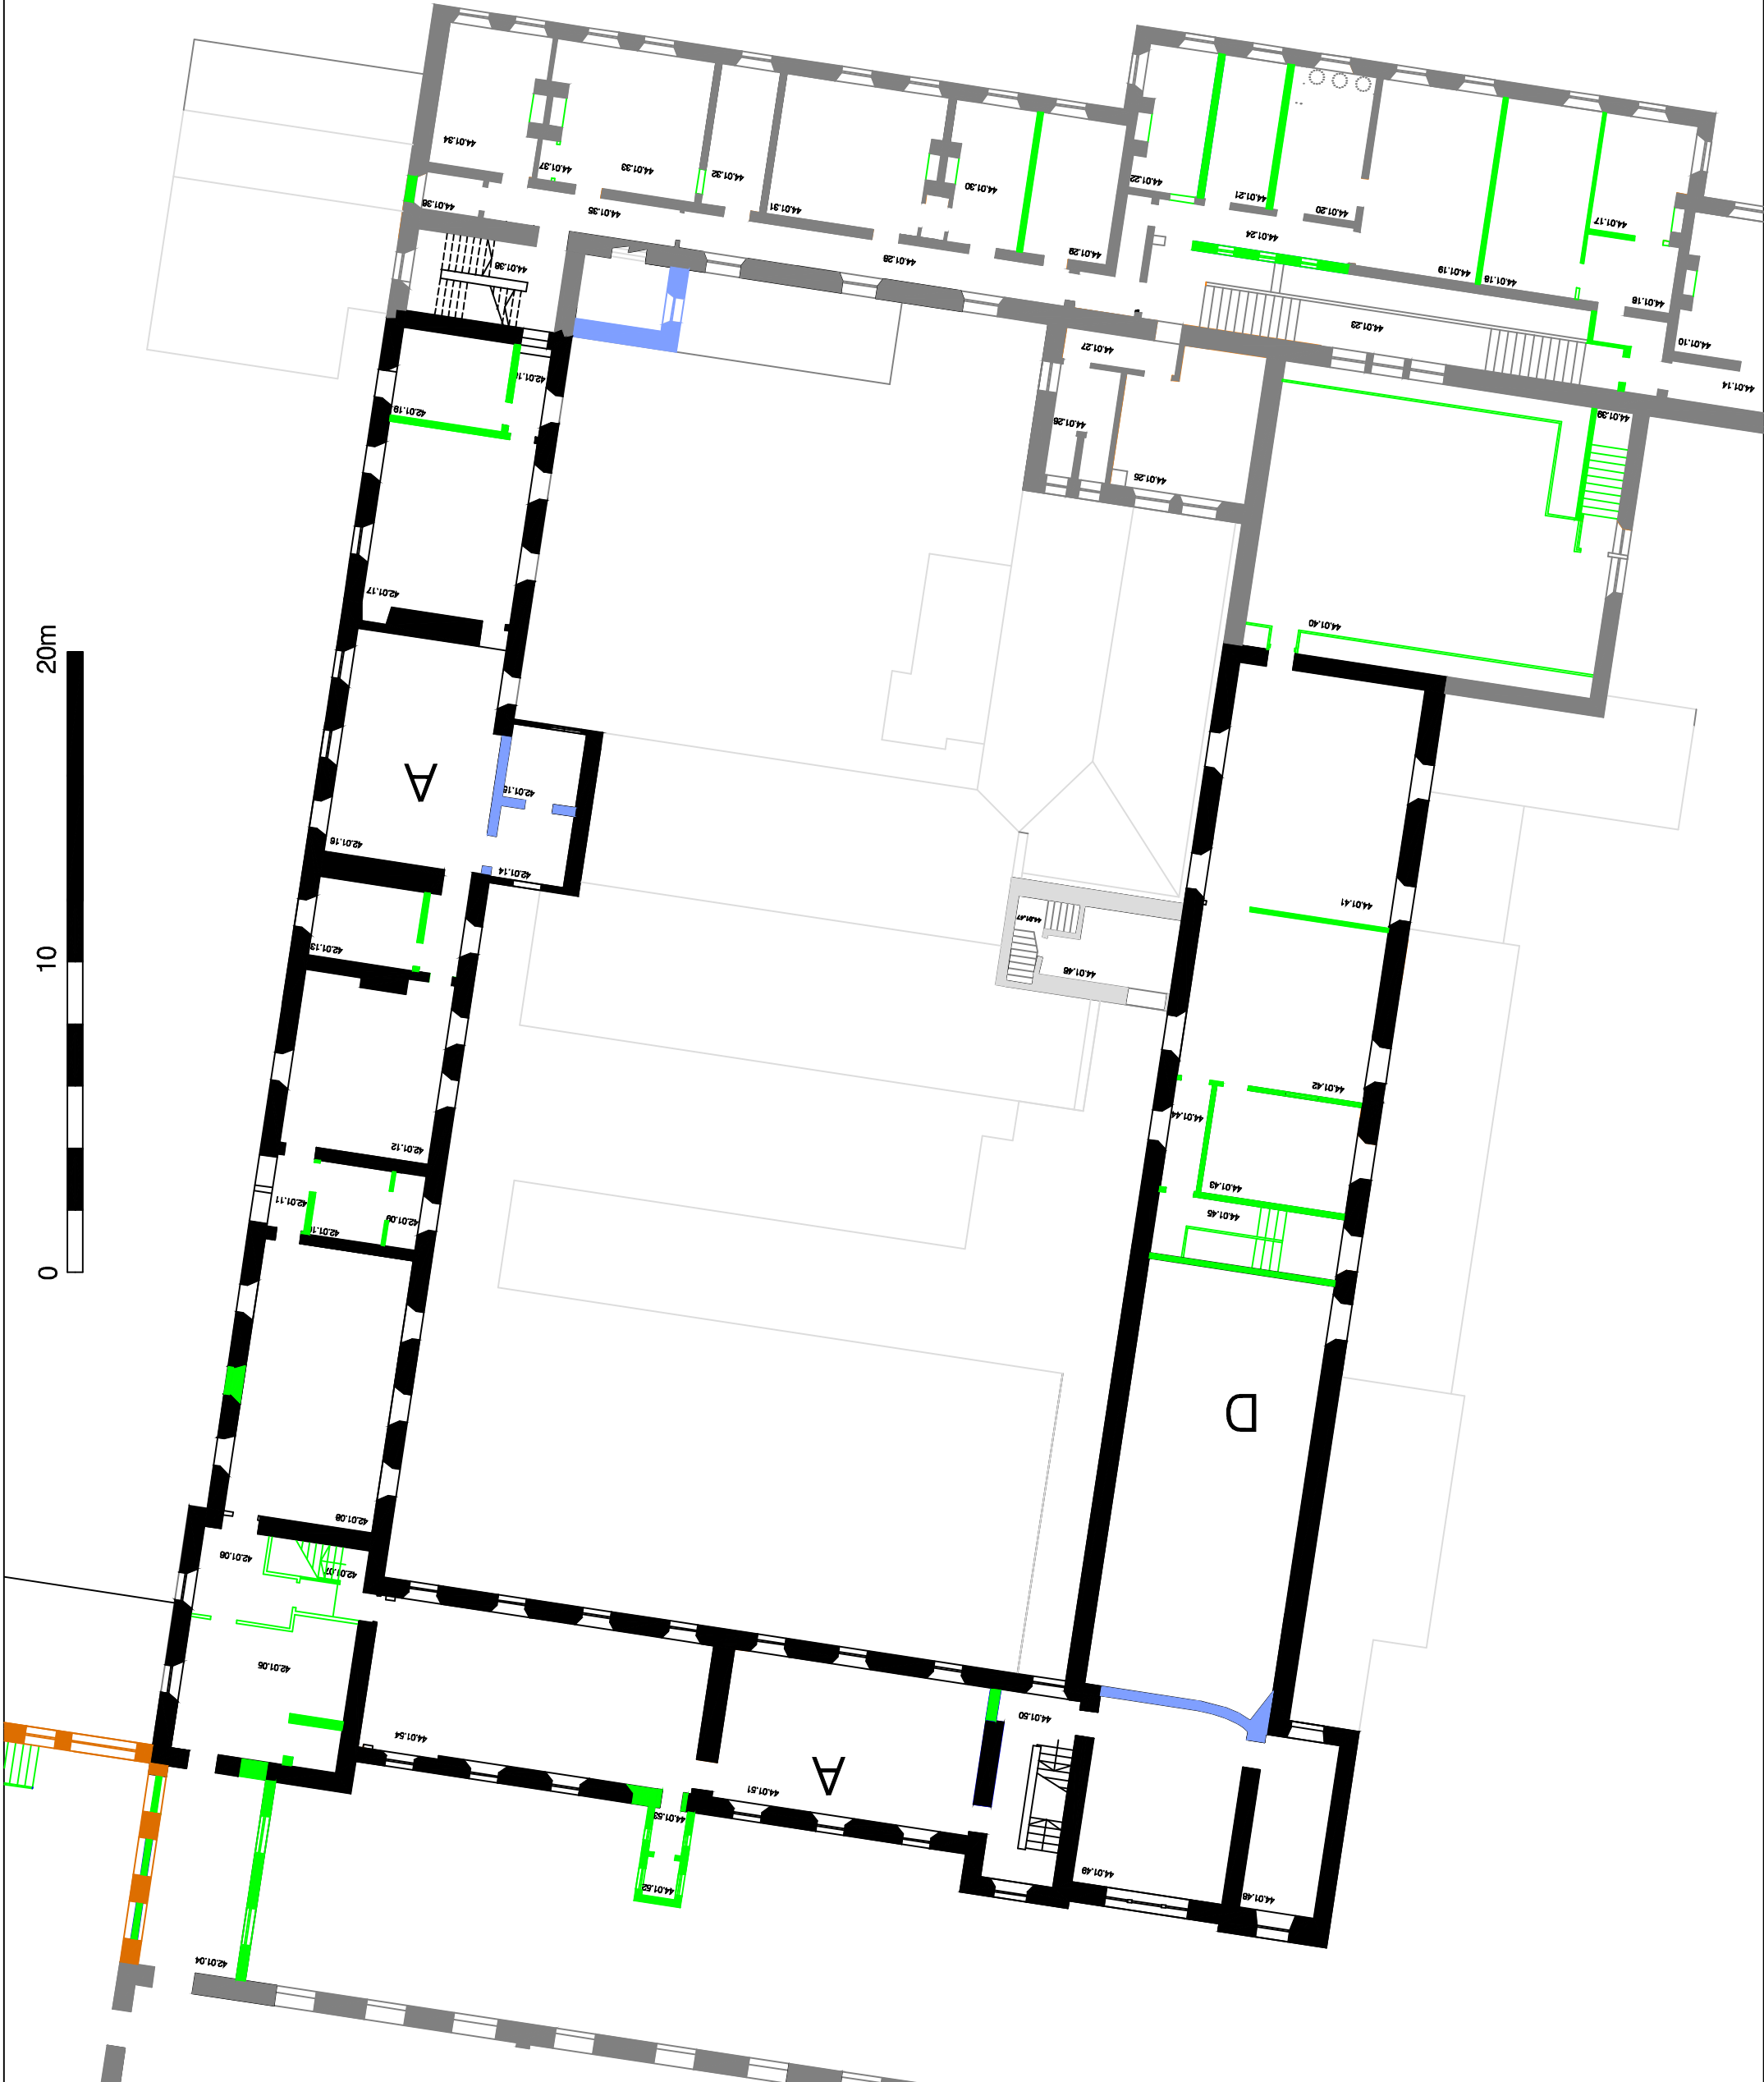
Figure 4

Buildings A and D
First floor

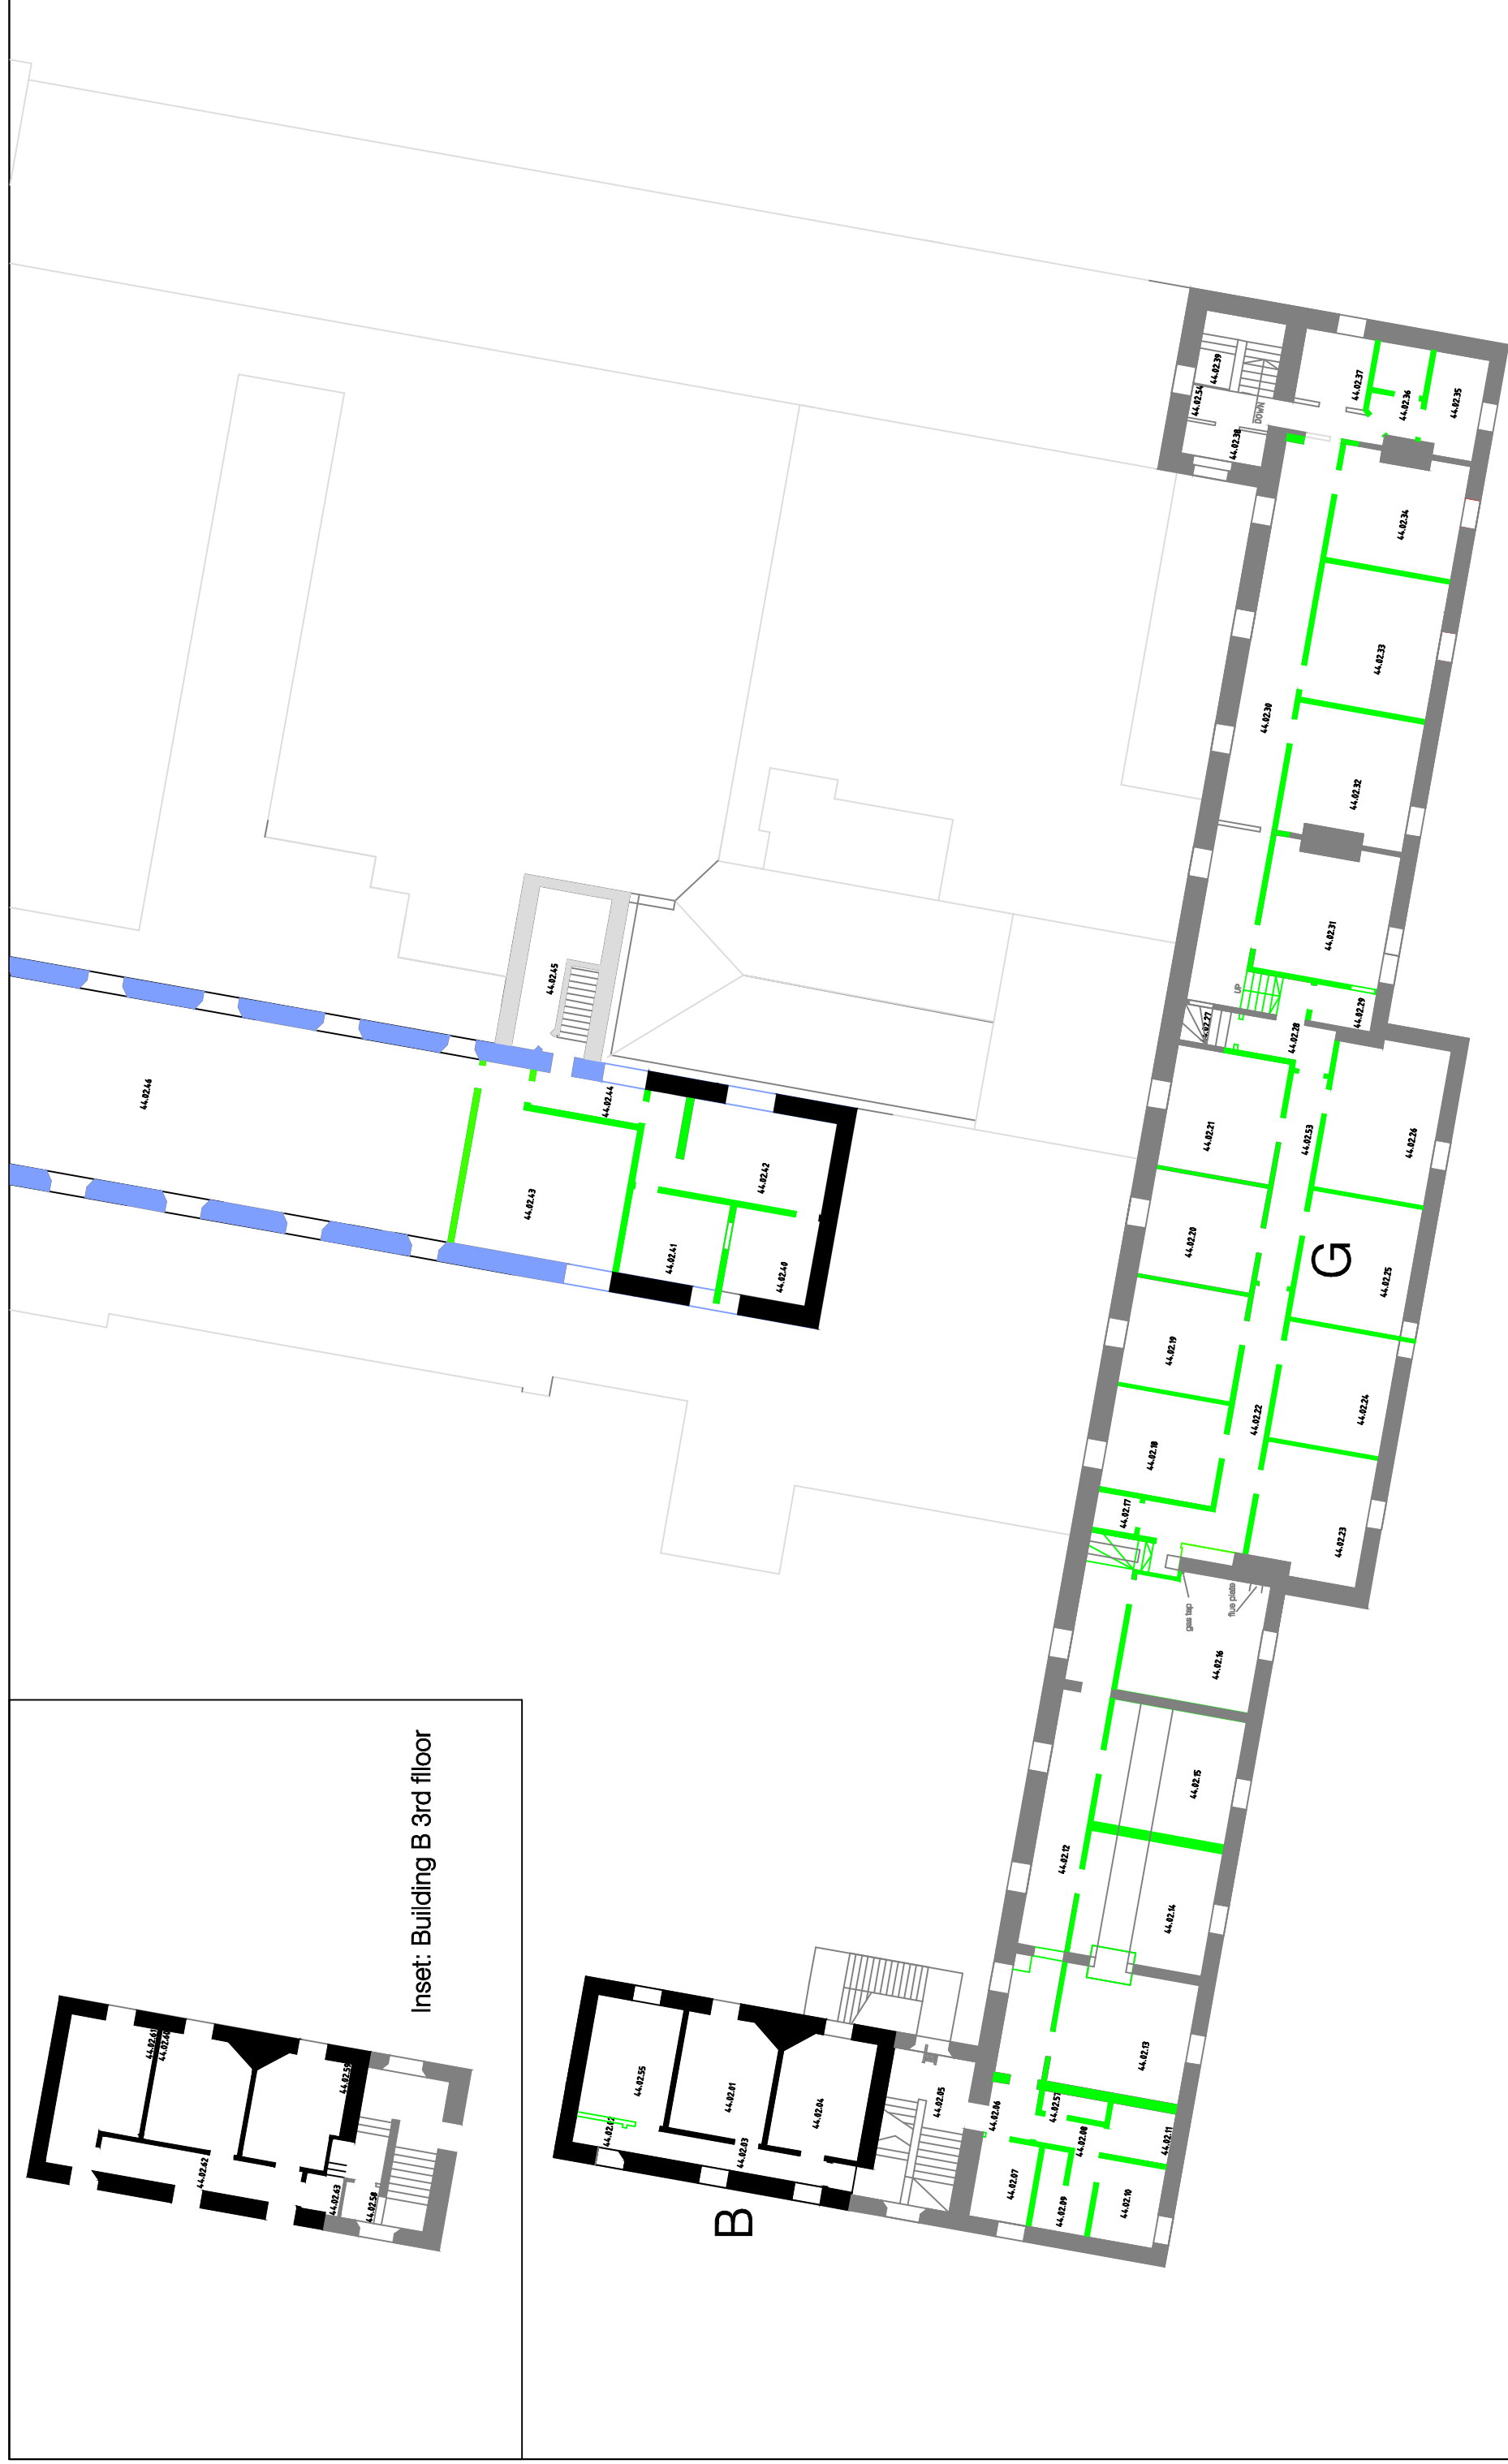
<p>Newcastle General Hospital</p> <p>Archaeological Recording of Former Union Workhouse (NEG 11)</p> <p>Based on digital plans supplied by Newcastle General Hospital with additional survey by NCAS and information from archive plans</p>	<p>Figure 10</p> <p>Buildings B and G</p> <p>Second Floor</p> <p>Scale 1:200@A3</p>
---	---

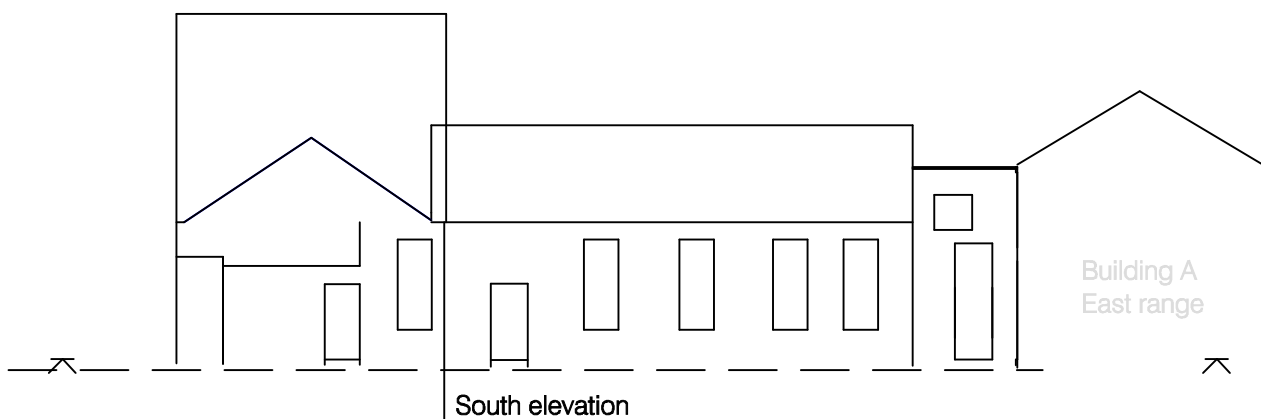
Figure 11

Building C: Elevations
Newcastle General Hospital

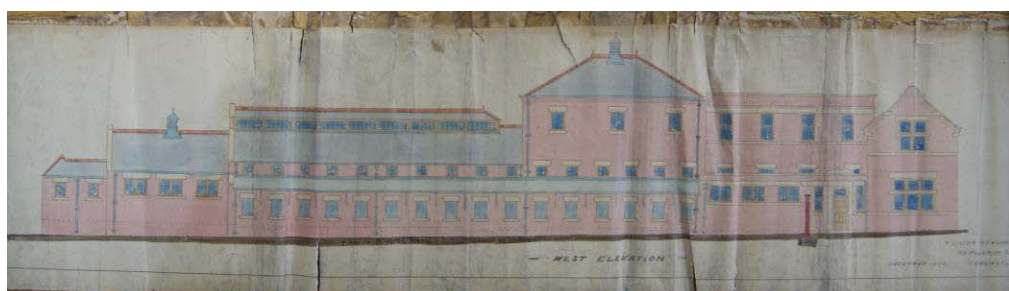
Plans and elevations (part) relating to the 'New Vagrants Buildings' (Building 17) by W. Lister Newcombe, 1901. These drawings are in very poor condition.
(TWAM T186/9774. Reproduced with the permission of the Chief Archivist Tyne and Wear Archives and Museums)

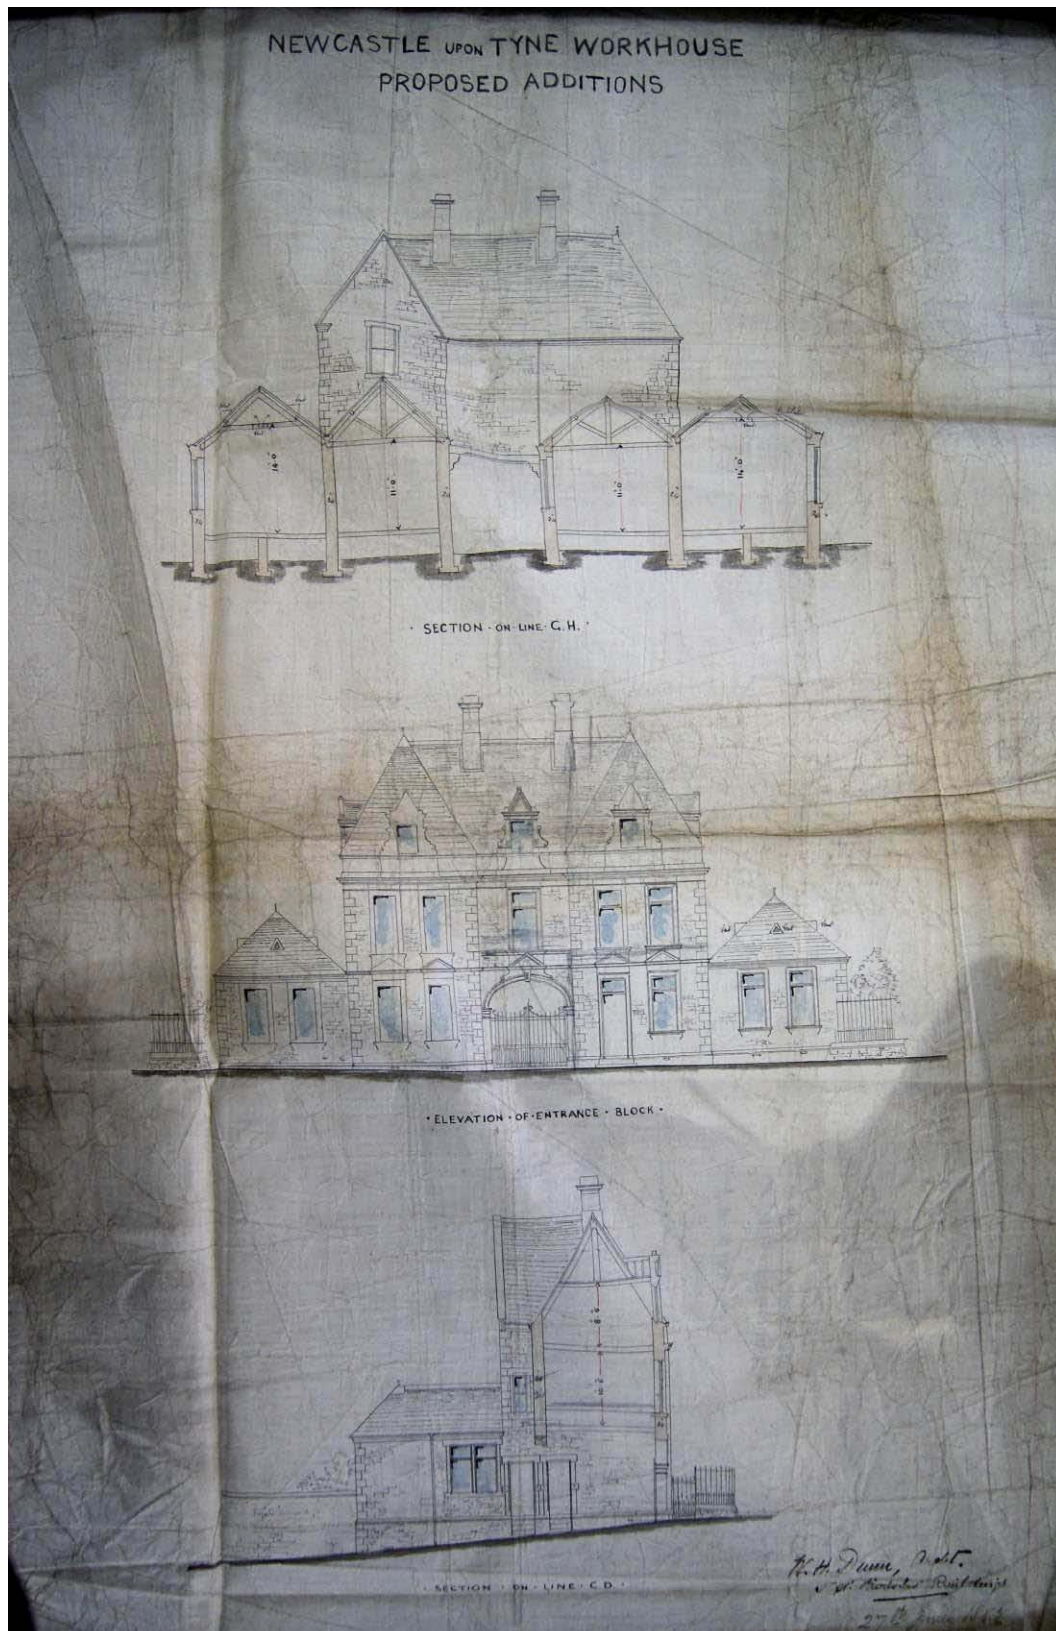
Elevations and cross-sections of the 1882 Gatehouse by W.H. Dunn, 1882.
(TWAM T186/9774. Reproduced with the permission of the Chief Archivist Tyne and Wear Archives and Museums)

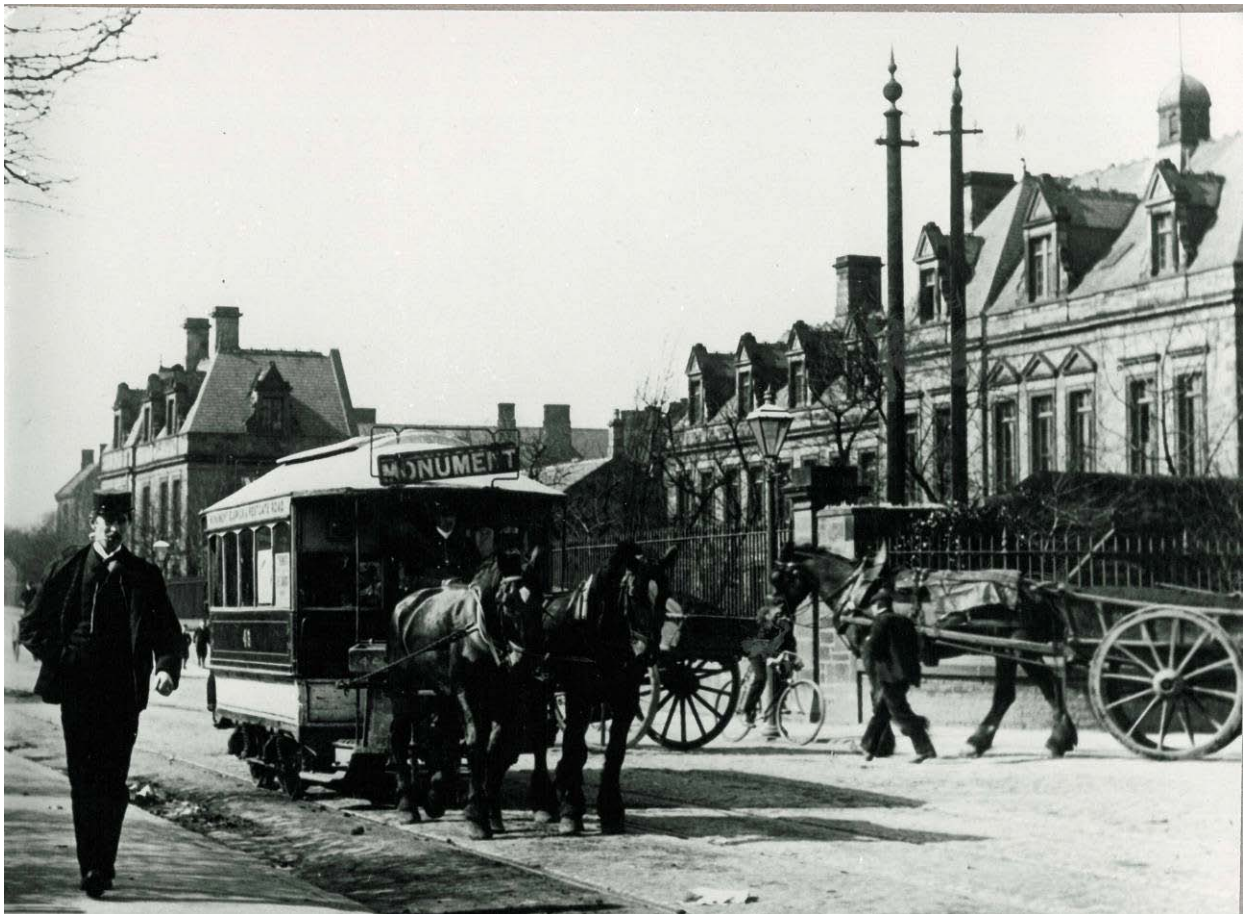
Year: 1901. Looking NW across Westgate Road, showing W end of Building G (Administration Block) and the three-storey central block of the Gatehouse
(Reproduced with the permission of Newcastle Libraries and Information Service)

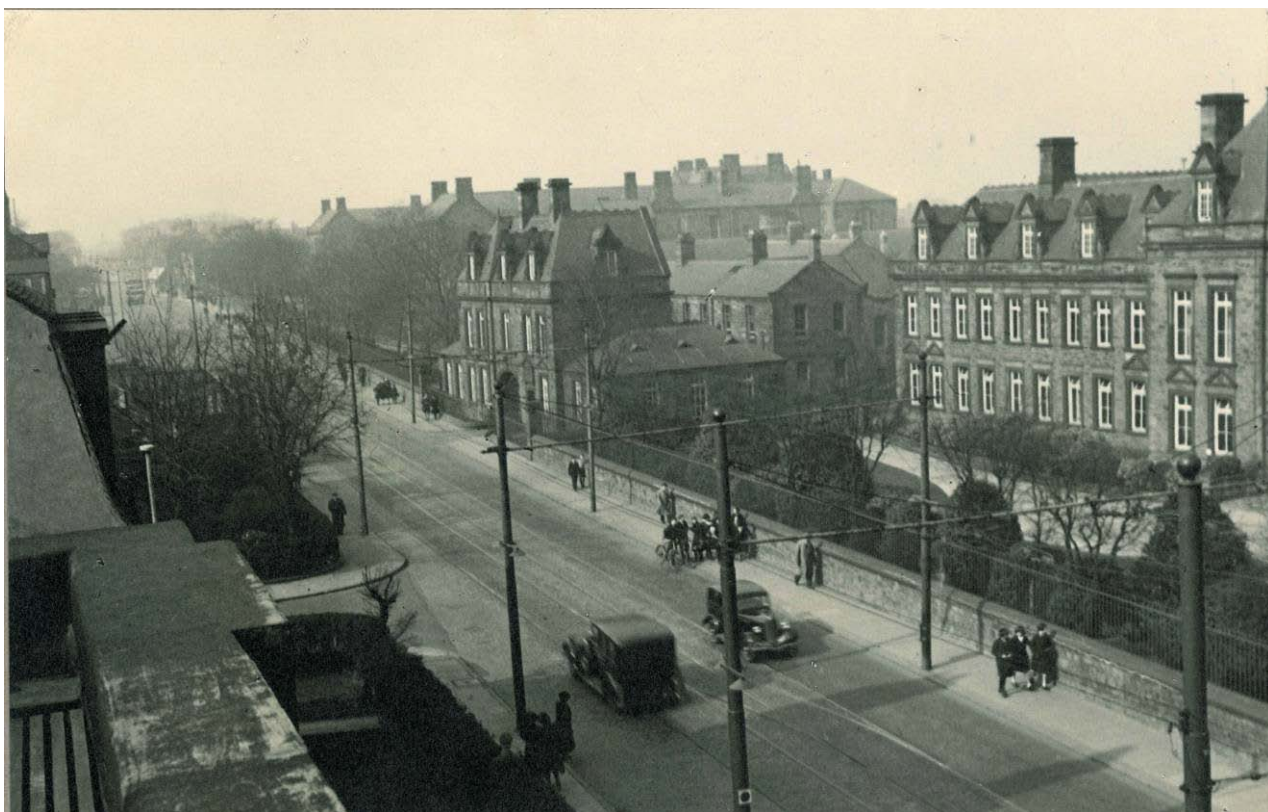
Year: 1938. Looking NW across Westgate Road, showing W end of Building G (Administration Block) and the Gatehouse with the surviving E wing (Building H)
(Reproduced with the permission of Newcastle Libraries and Information Service)

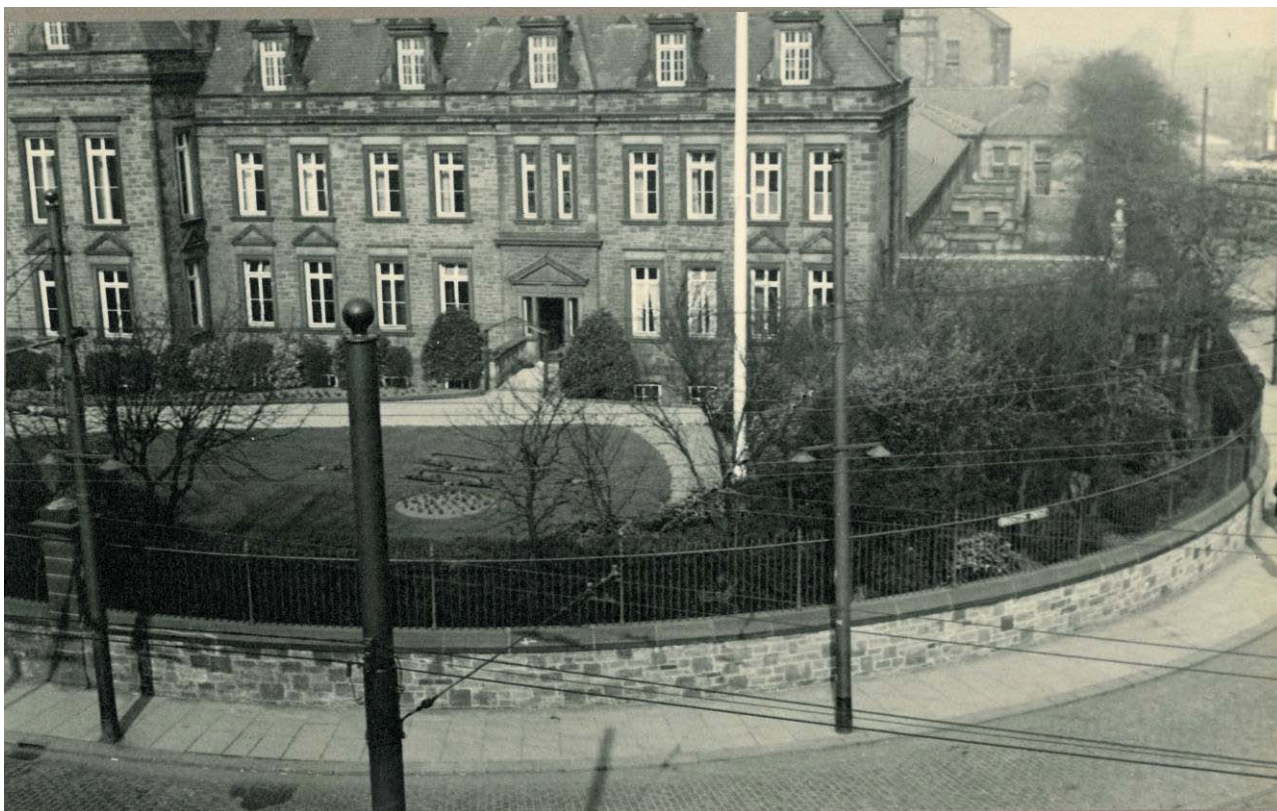
Year 1938. Looking N across Westgate Road to the junction with Brighton Grove, showing E end of Building G (Administration Block)
(Reproduced with the permission of Newcastle Libraries and Information Service)

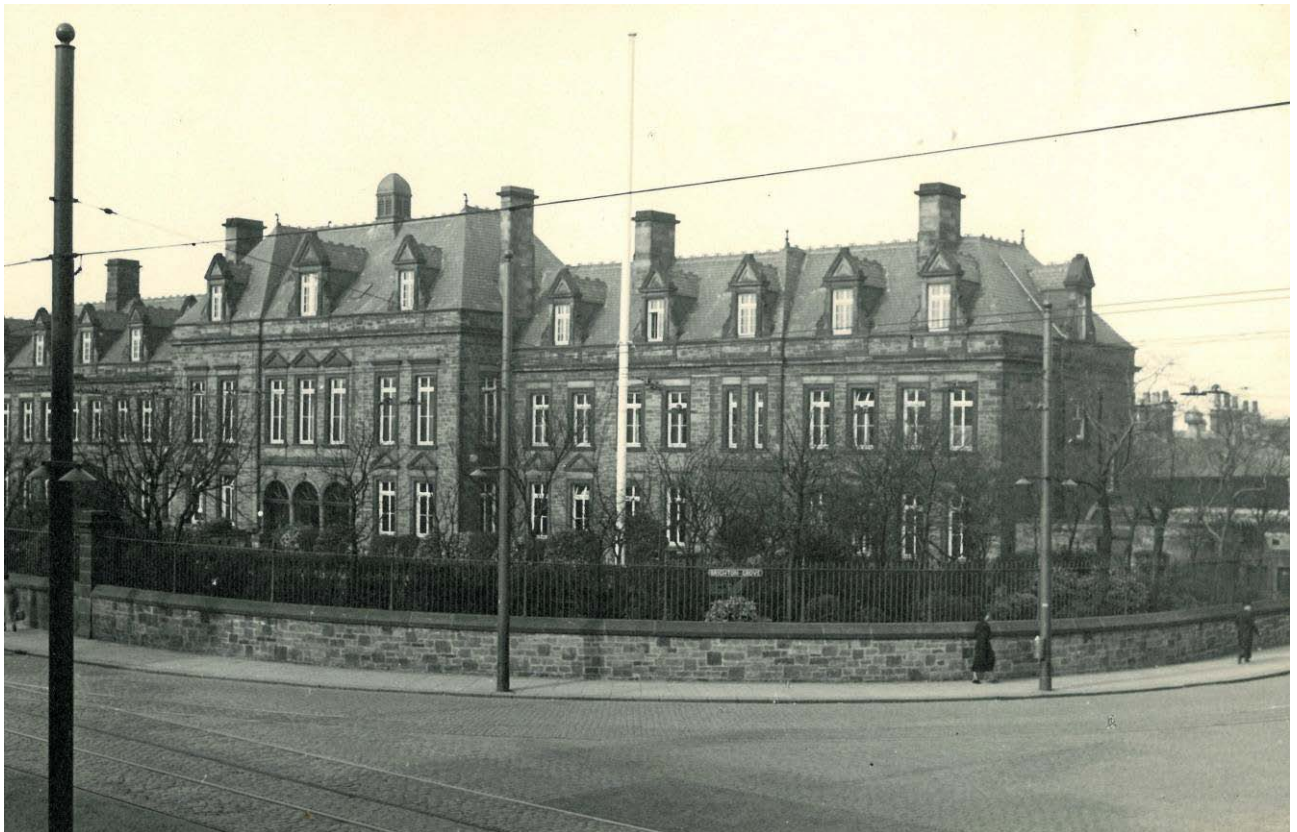
Year: c. 1950. S façade of Building G (Administration Block) looking across junction of Westgate Road and Brighton Grove (the railings have now gone)
(Reproduced with the permission of Newcastle Libraries and Information Service)

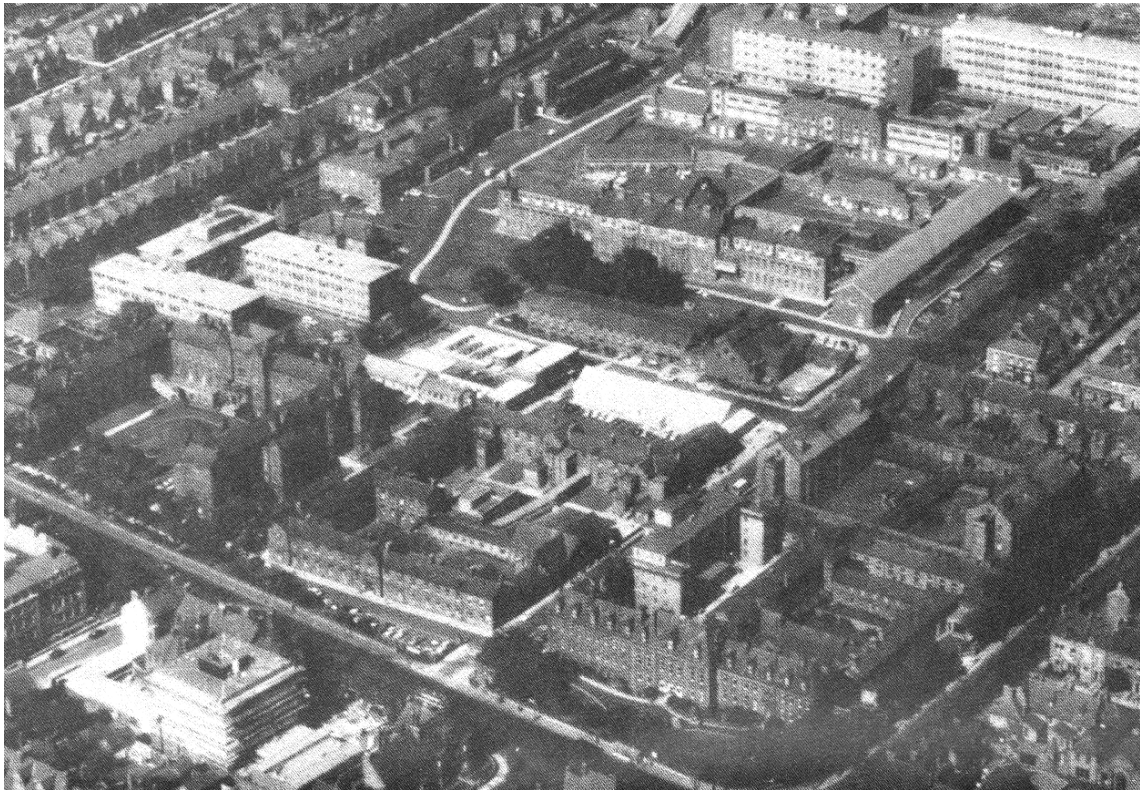
Year: 1964. The Hospital site from the SE – the recorded Workhouse buildings are at the bottom right, the Schools and Infirmary Hospital to the west (*from Hurrell 1984*)

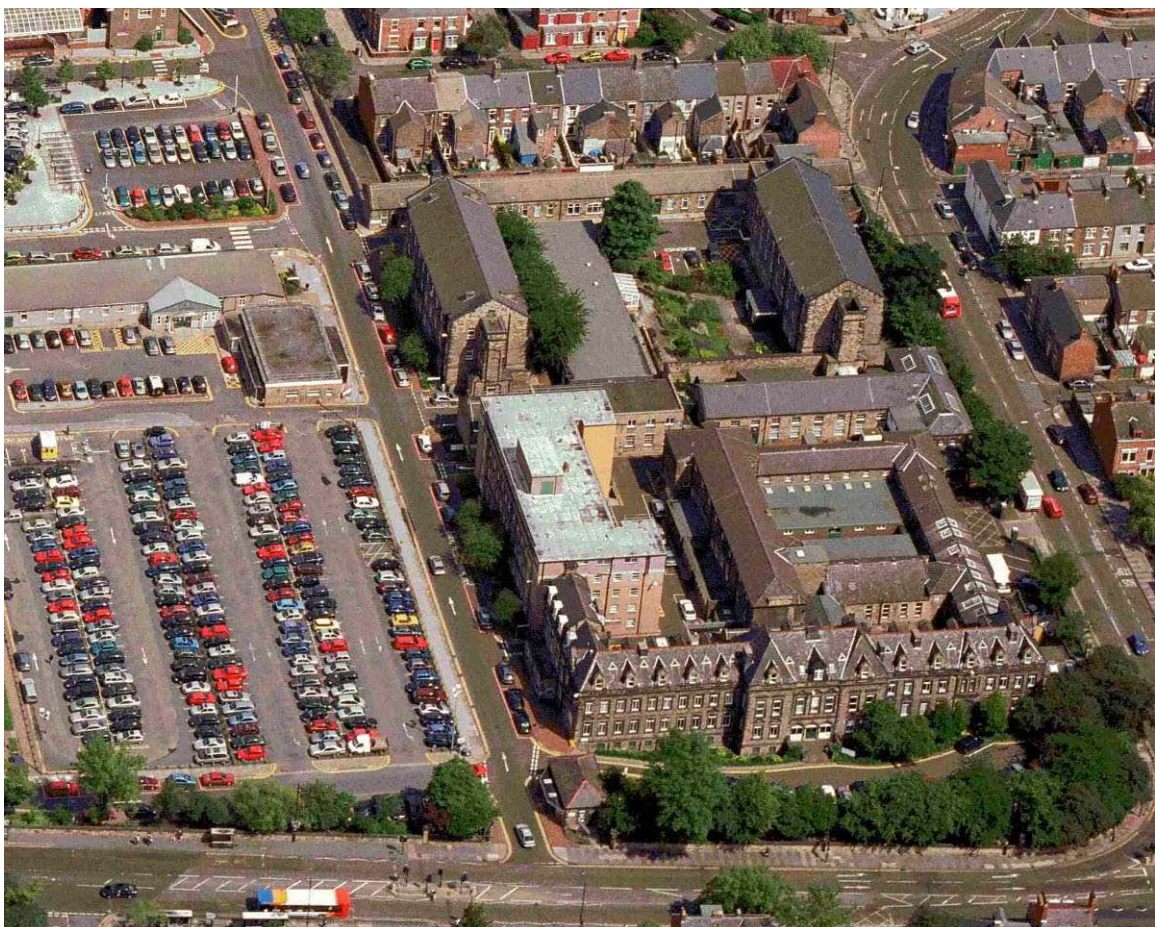
Year: c. 2002. The recorded Workhouse buildings looking N before demolition of Block C and the former Bakehouse range (*courtesy of NGH Estates Department*)
