GARN BODUAN AND TRE'R CEIRI, EXCAVATIONS AT TWO CAERNARVONSHIRE HILL-FORTS

By A. H. A. HOGG

Two forts, Garn Boduan and Tre'r Ceiri, are described in detail, including the results of selective excavations. Garn Boduan shows two periods of Iron Age construction, followed by a small fort of late-Roman or post-Roman date. Tre'r Ceiri seems to have been founded shortly before the Roman conquest and to have continued in use until the 3rd or 4th century. The bearing of this and other evidence on the history of the hill-forts of Caernarvonshire is discussed.

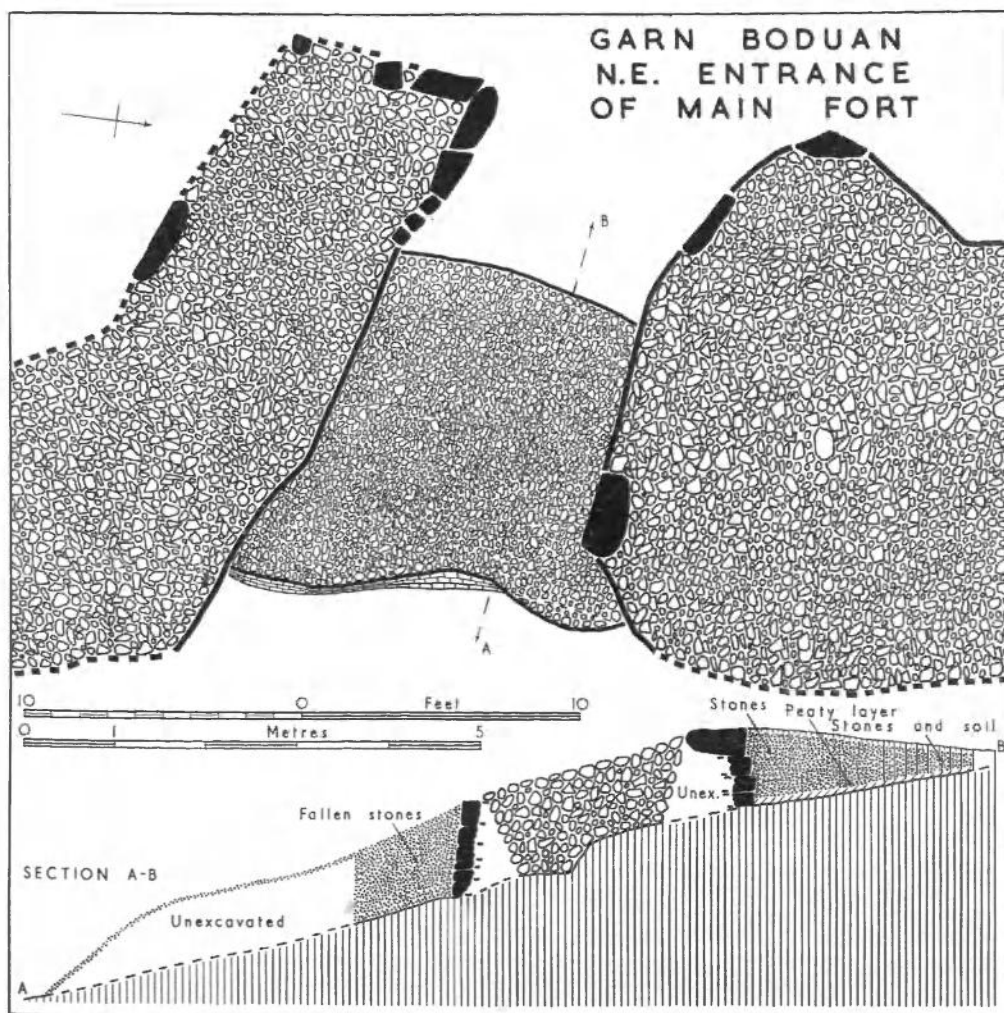
Fig. 4. N.E. Entrance

The N.E. gateway was set slightly obliquely to the line of rampart, which was clubbed on the N. side and inturned for a short distance on the S. The walling was largely of laid blocks, with some upright slabs. On excavation, it was found that the gate-passage had been blocked by a well-built wall of similar character but without uprights. The inner face was in good condition, but part of the outer had tilted forward. The blocking wall was apparently erected while the gateway was in working order. There was no deposit on the rock floor of the gate-passage, and no accumulation of debris had formed against the foot of the flanking walls where the faces of the blocking wall met them. Further, there was sufficient time for some inches of peaty material to form on the rock surface within the fort on the upper side of the blocking wall before either it or the flanking walls collapsed in ruin. It is almost certain, therefore, that the blocking represents an episode in the last period of occupation of the hill-fort, not a modification made during the late- or post-Roman use of the Small Fort.

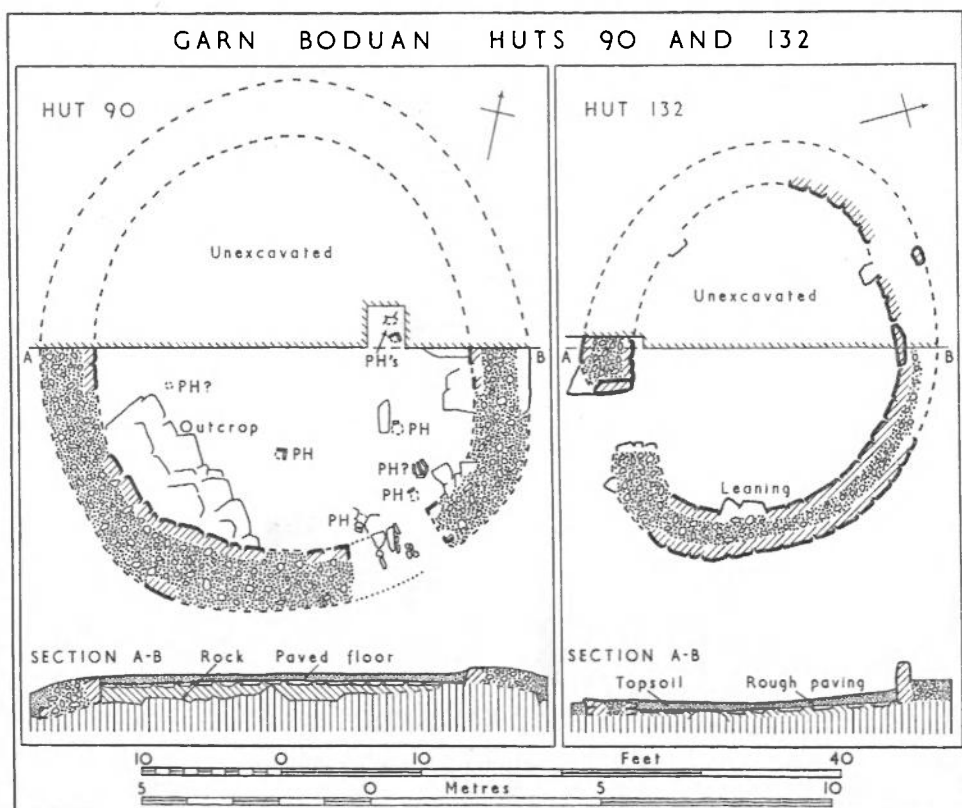
Fig. 5. Huts 90 and 132

About 170 huts, all circular or nearly so, stood within the ramparts. Four of these were excavated, but produced no relics. Holes in the floor showed that the roof of Hut 90 (26 ft. in diameter, Fig. 5 and p. 26 below) had been

supported on a ring of six or seven slight posts set about 6 ft. from the wall face, but the other huts provided no evidence as to their roof construction.

The floor was partly natural outcrop, but was mostly roughly paved with small stones. Two post-holes 11 ins. deep, 4 ft. apart, were found just within the entrance, and another hole, shallower and doubtful, 2 ft. N. of the more easterly. Within the hut five further holes were found, presumably part of a

ring of 7 or 8 set about 6 ft. from the wall. Describing these in anti-clockwise order starting with the most westerly: doubtful, 9 ins. deep; 11 ins. deep with packing; similar to last; (just N. of section line) similar, 7 ins. deep; (1 ft. N. of last) doubtful, 7 ins. deep. All holes indicated timbers 5 or 6 ins. in diameter. There were slight traces of burning against the wall just E. of the entrance, but no definite hearth was found. The only relic was a small flake of poor-quality flint.

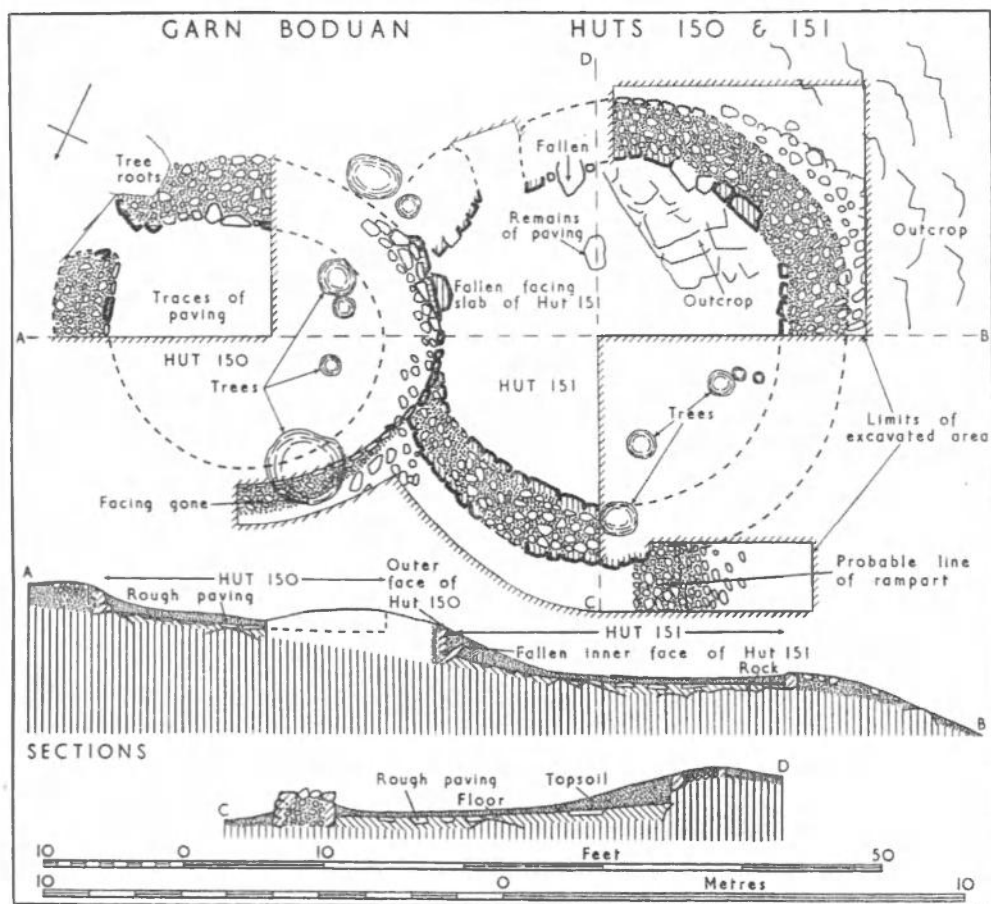
Fig. 6. Huts 150 and 151

Huts 150 and 151, however, gave information of some interest (Fig. 6 and p. 27). Hut 151 (24 ft. in diameter) appeared to be structurally contemporary with the Period I rampart; after it had fallen into ruin, Hut 150 (19 ft. in diameter) was built over it (Pl. IA).

Only the interior of the S.E. quadrant of the smaller hut (150) was cleared, the remainder being inaccessible owing to standing or fallen trees. The inner wall-face proved to be of very rough and badly ruined laid stone, and the floor showed slight rough paving. No post-holes were found; a single slingstone, and a broken rubbing stone in the wall material, were the only relics.

Three quadrants of Hut 151 were cleared, together with part of the external face. Trees rendered the N.W. quadrant inaccessible. The walling, 4 to 5 ft. thick, was mostly faced with laid blocks, with a few upright slabs on the interior. On the N. side the faces stood about 2 ft. high; the blocks in the inner face were the more massive. The floor was slightly and roughly paved, and was very irregular, a mass of outcrop in the S.W. quadrant rising in places a foot above the general level. There were no post-holes in the area cleared. Twenty-six slingstones were found.

The exterior of Hut 150 on the W. was found to have been built over the ruins of Hut 151; a fallen orthostat is shown in section (Fig. 6), and its edge is visible in Plate 1A a short distance below the upright scale. It is certain, therefore, that Hut 150 was built a considerable time after 151.

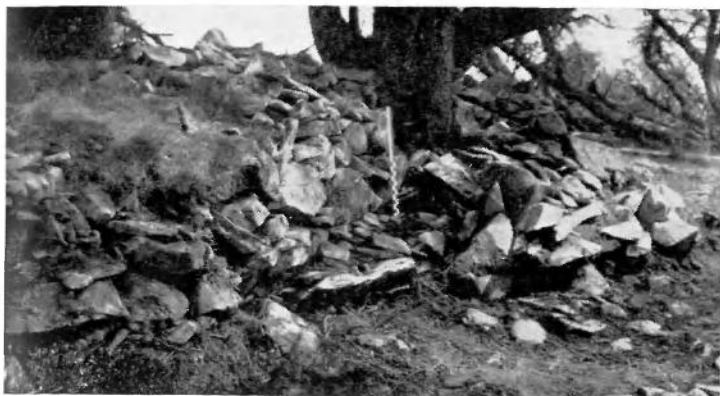
A. Garn Boduan.

W. wall of Hut
150, over ruins of
Hut 151

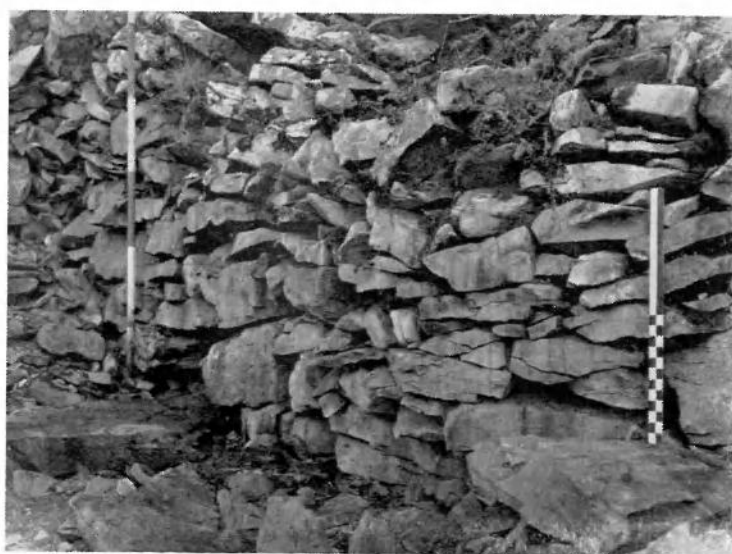
B. Garn Boduan.
Outer face of Period
II rampart, Cut 1

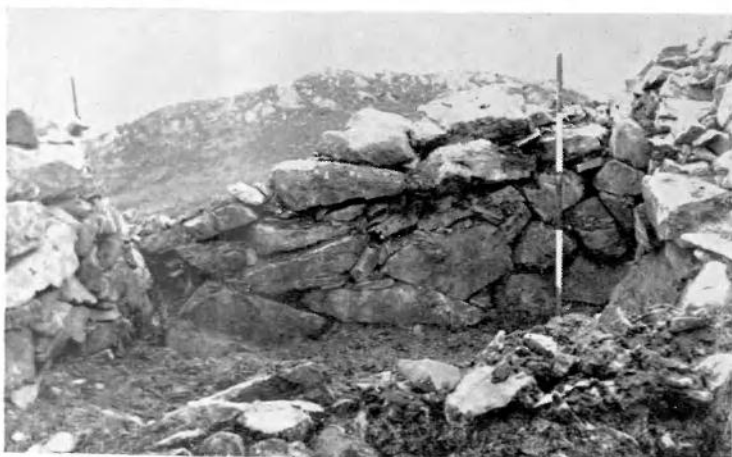
C. Garn Boduan.

Blocking of N.E.
Gateway, from
inside fort

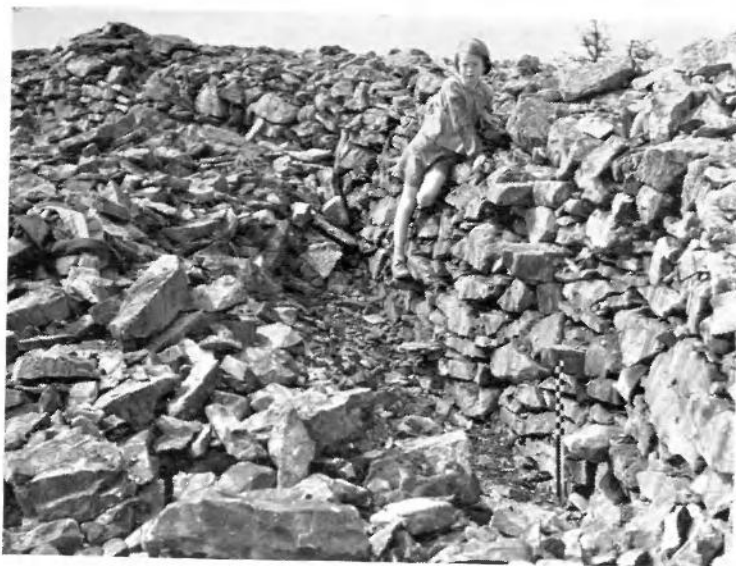
A. Garn Boduan.
Steps within small
fort

Access to the top of the rampart was provided by flights of steps formed of long stones projecting from the inner face (Pl. II A).

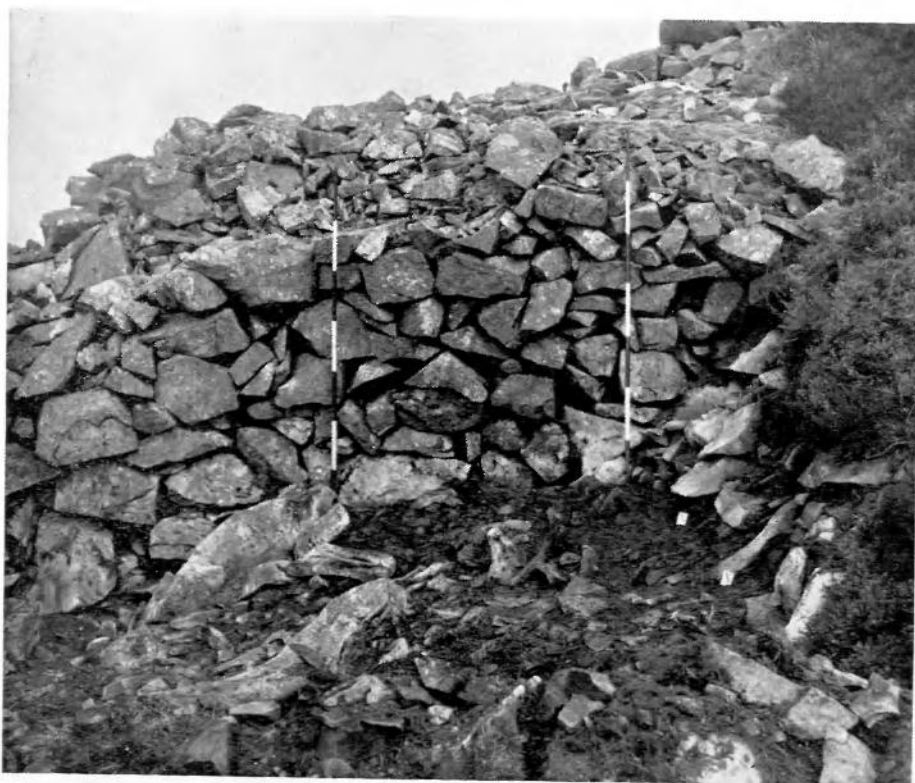
B. Tre'r Ceiri. Outer rampart built across original trackway at W. Gate, from inside

Although the inner and outer walls nowhere intersect, it seems certain that the outer rampart is later, as the N. side of the main gate through it is built across the terrace which seems to represent the original line of the track descending from the W. gateway in the inner rampart (Pl. IVB); the old line of the track continues outside the outer rampart, but seems to have been replaced by a new terrace way leading to the S.W.

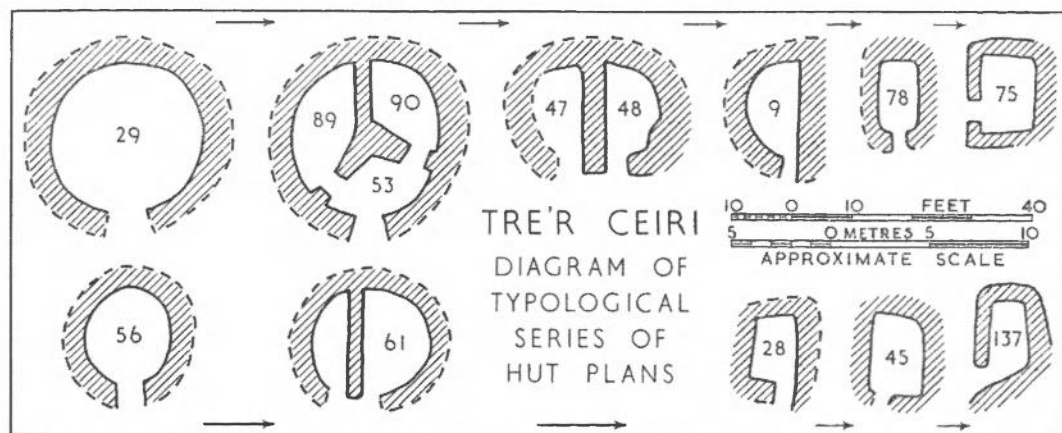
Fig. 11. Typological Series of huts

The interior of the main enclosure is occupied by about 150 huts. These show a great variation in size and shape, but can be arranged in a typological series suggesting development from a simple round hut, evolving through a round hut with central partition into D-shaped huts, and thus into small irregular or rectangular enclosures (Fig. 11).

There is structural evidence that this typological series corresponds, to some degree at least, with a chronological one. Slight excavations made in 1939¹ showed that Hut 37 had been reduced from a round to a roughly rectangular hut by the insertion of a blocking wall. Further, an examination of the three compartments 53, 89 and 90 in 1956 showed that they formed a round hut apparently built with a partition, and that the adjacent irregular enclosures were later. In Hut 61 the partition was probably of one build with the surrounding wall, but the evidence was not conclusive (see pp. 34-6 below).

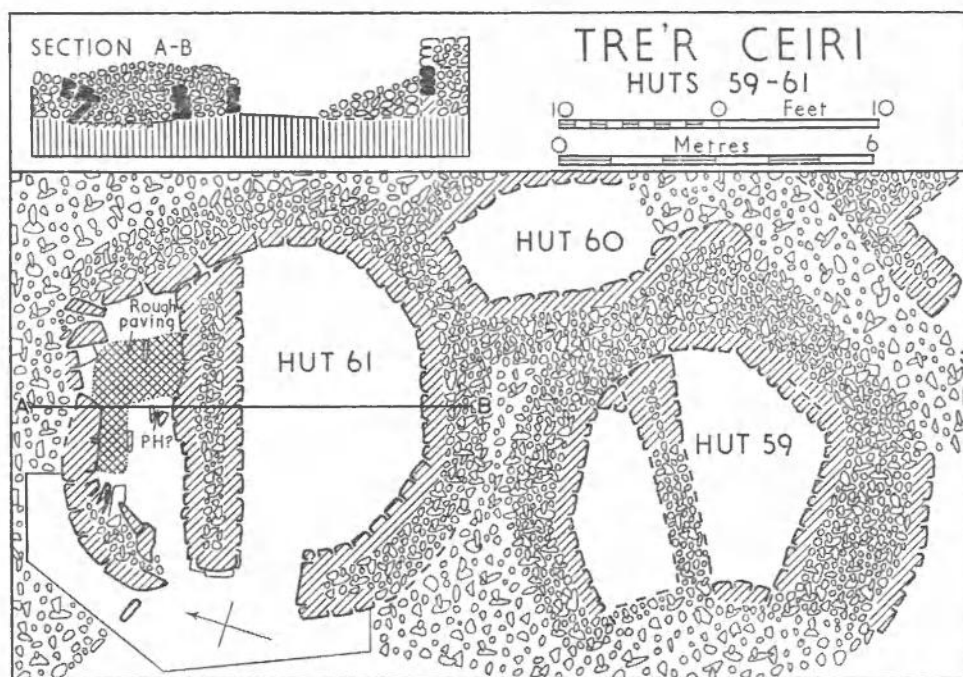
Fig. 14. Huts 59-61

The floor of the hut was mostly formed by a thin layer of clay, but part was covered by an L-shaped patch of rough paving, above which two smallish stones set on edge projected a few inches, possibly to retain the edge of a couch. Two stones near the middle of the partition wall may have formed the packing of a shallow post-hole, but it is more likely that their position was fortuitous. No occupation soil was found on the floor.

The walls, mainly of laid stones, were about 4 ft. thick, and the original masonry stood to a height of about 2 ft., to which a further 2 ft. of modern rebuilding had been added. There were indications that the outer face existed throughout most of the circuit, but it was not followed up.

The entrance was on the W. Its N. side was badly ruined, but it seems originally to have been a gap about 9 ft. wide, divided by the partition wall. The end of this was set back about 2 ft. from the outer face of the house wall, leaving openings 3 ft. 6 ins. wide on the S. and about 2 ft. wide on the N. The building thus formed in effect two separate D-shaped compartments set back-to-back, with separate entrances from a single shallow porch.

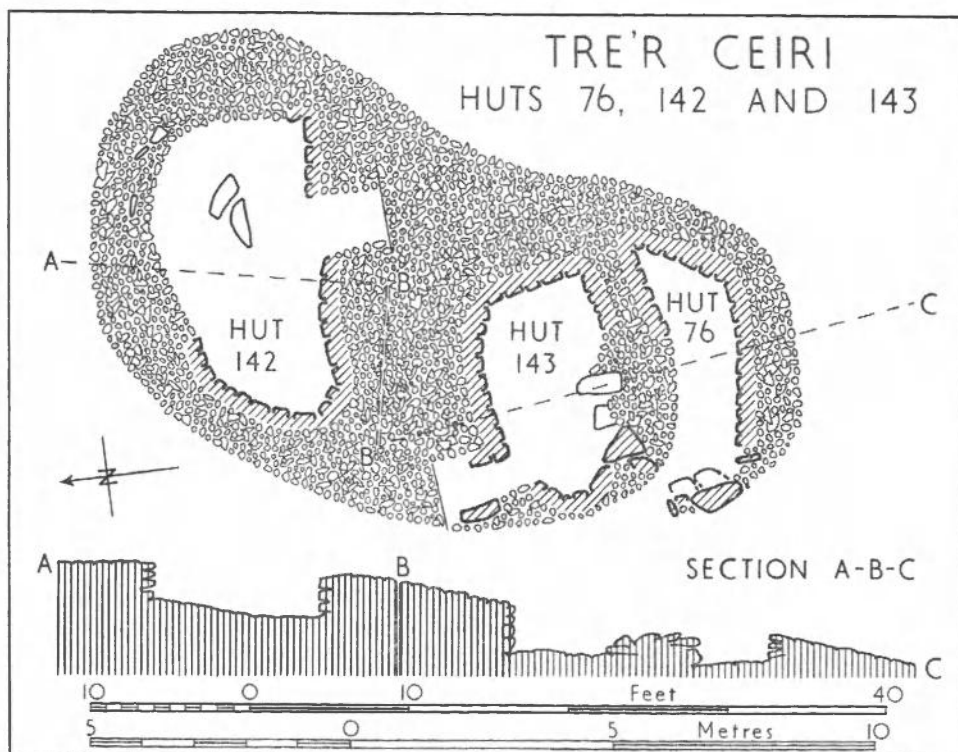
Fig. 15. Huts 76, 142, 143

Huts 76, 142 and 143 (Fig. 15) (250 ft. S.W. of the Cairn). These were three untouched examples of irregular huts, typologically the latest in the sequence of development from the divided round hut. The only information obtained from the excavation was the detail of their plan. Much of their walling was ruinous, but where best preserved it stood about 2 ft. high, of rather irregular laid masonry. In 142 a large slab had been set upright against

the wall, presumably to forestall collapse. The floors were ill-defined and carried no occupation material. In the section, the fallen rubble is omitted for clarity.
