Archaeological Evaluation On Land At Walnut Close Much Hadham Hertfordshire

Grid reference: TL 426 186

Planning Application No: 3/15/1011/FUL
HER no:

Prepared by:
ARCHAEOSERV
(Dennis Payne Archaeological Services)

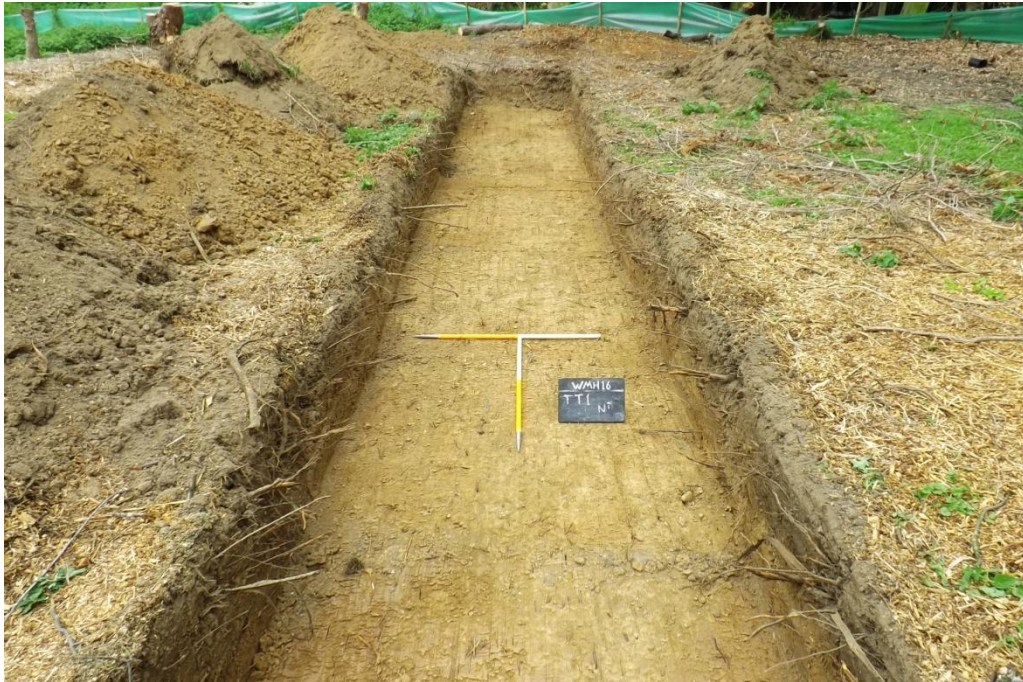
Trench 1. was located in the north-east of the site on a north-south alignment; the top soil was 0.24m deep and the subsoil 0.26m deep the natural (1002) horizon was exposed at 0.50m depth.

Plate 3. Trench 1. from the south

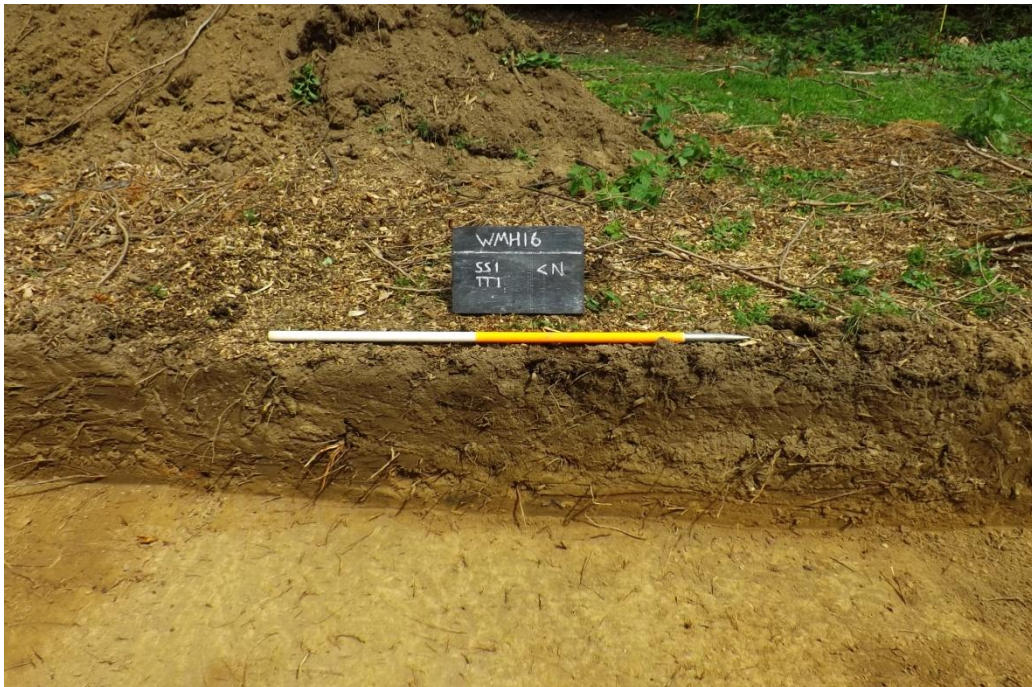
All trenches were 12m in length by 1.80m in width. The deposit model was: Top soil, (1000); Subsoil (1001); natural (1002) exposed at horizon. The top soil was a mid-dark brown soil; the subsoil a mid-orangey brown silty sand with occasional small stones; the natural was a mid-orangey brown silty clay with common stones and flint nodules.

Plate 4. Trench 1. sample section 1. from the west

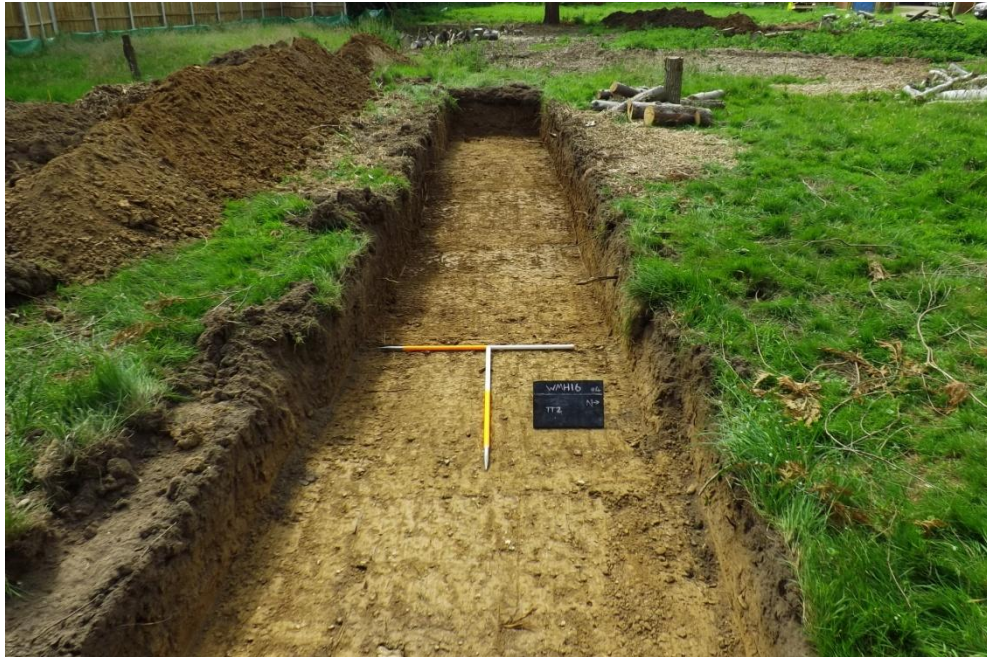
Trench 2. was located in the south-east of the site on an east-west alignment; the top soil was 0.20m deep and the subsoil 0.40m deep the natural (1002) horizon was exposed at 0.60m depth.

Plate 5. Trench 2 from the east

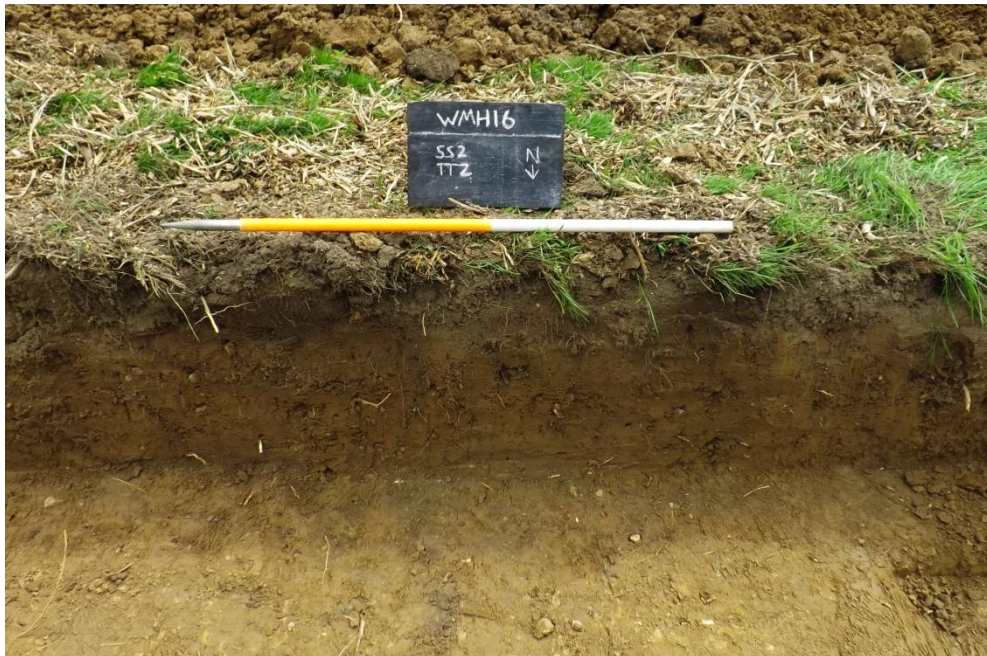
Plate 6. Trench 2 sample section 2 from the south

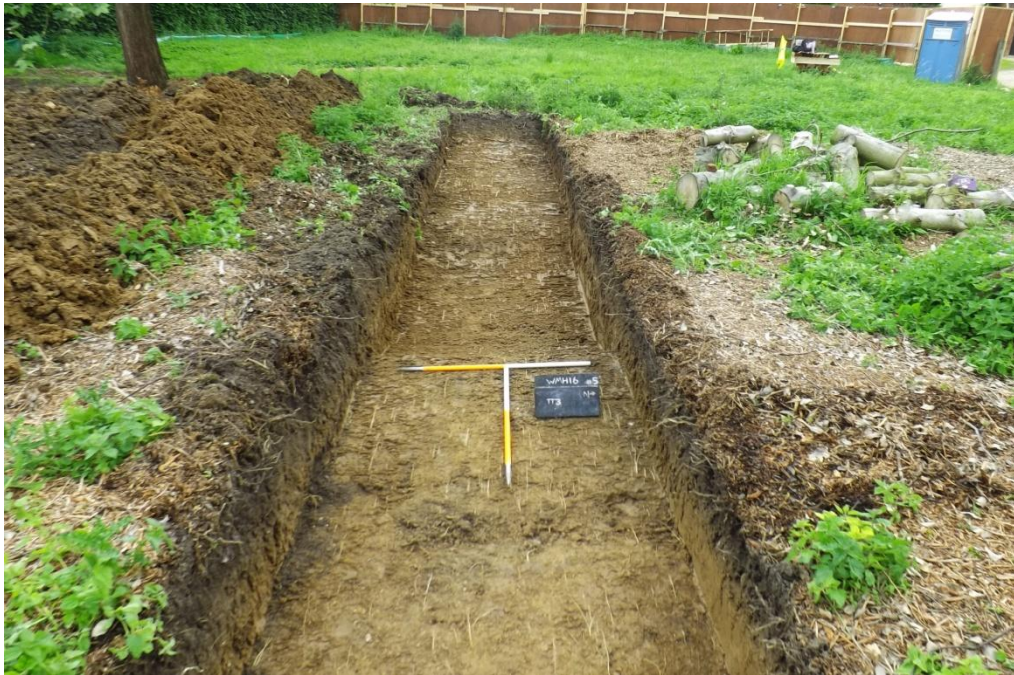
Trench 3. was located in the south-east of the site on an east-west alignment; the top soil was 0.19m deep and the subsoil 0.20m deep the natural (1002) was exposed to a depth of 0.20m.

Plate 7. Trench 3 from the east

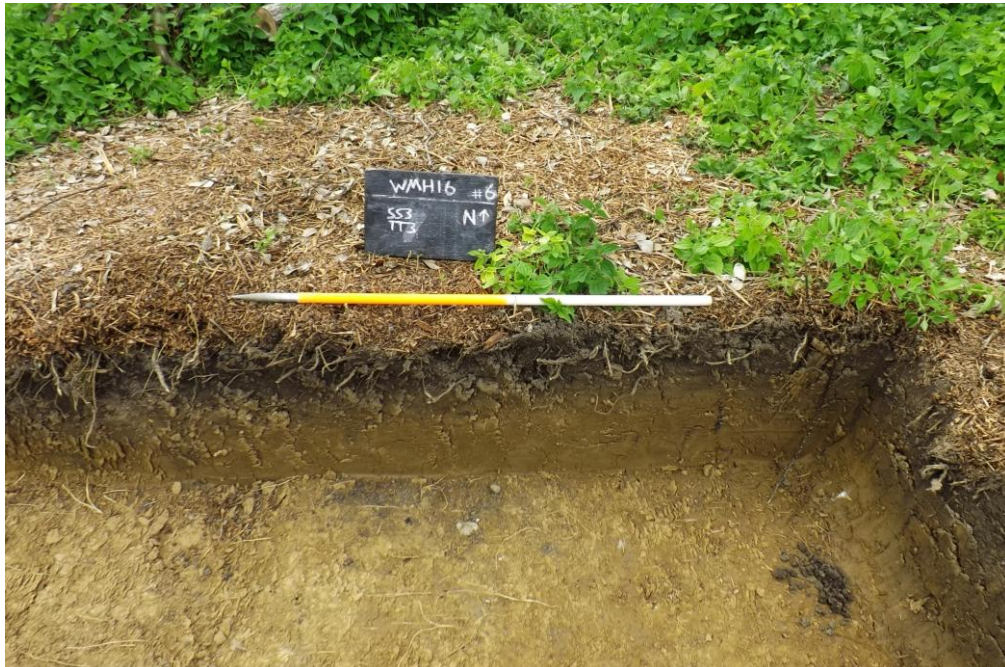
Plate 8. Section 3, Tr 3 from the south

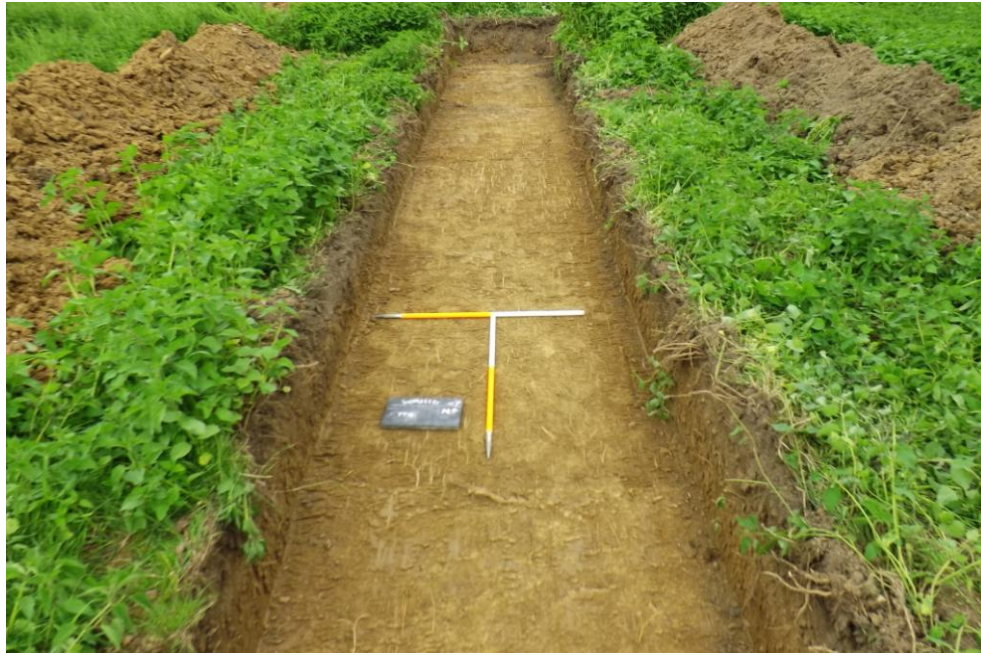
Trench 4. was located in the south of the site on a north-south alignment; the top soil was 0.20m deep and the subsoil 0.20m deep the natural (1002) horizon was exposed at 0.40m depth.

Plate 9. Tr 4. from the south

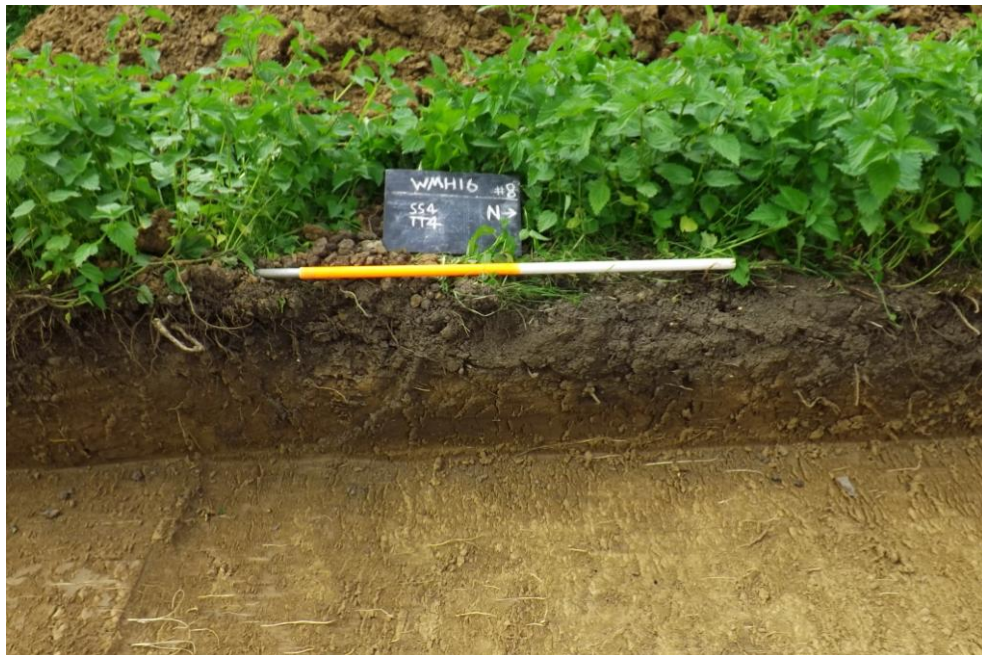
Plate 10. Sample section 4, Tr4. from the east

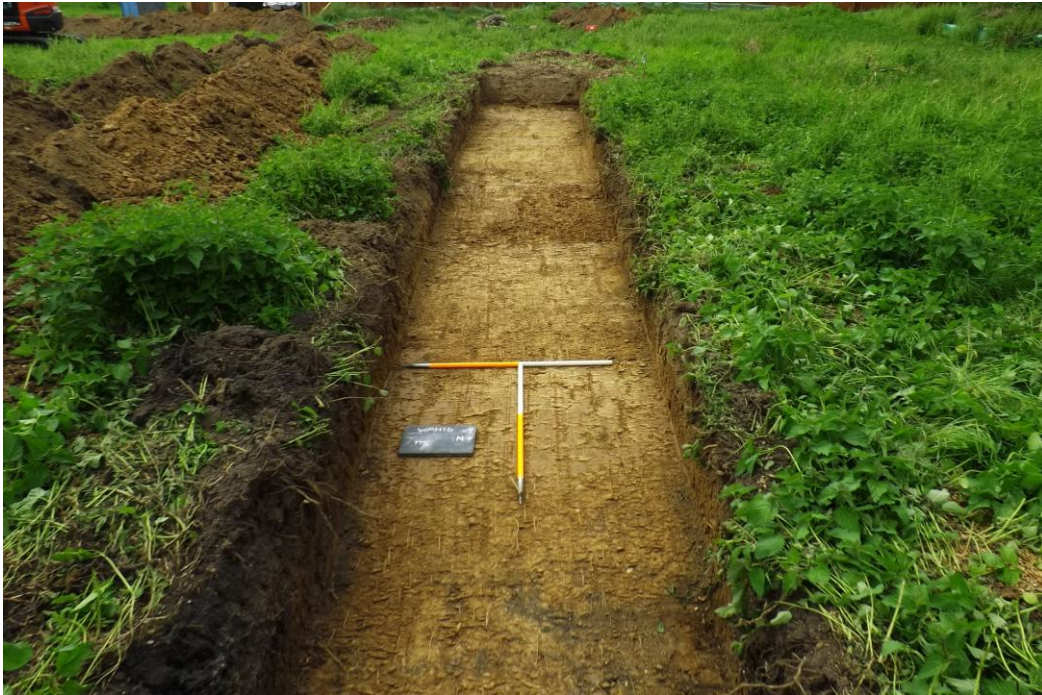
Trench 5. was located in the north of the site on an east-west alignment; the top soil was 0.05m deep and the subsoil 0.20m deep the natural (1002) horizon was exposed to a depth of 0.15m.

Plate 11. Tr 5. from the east

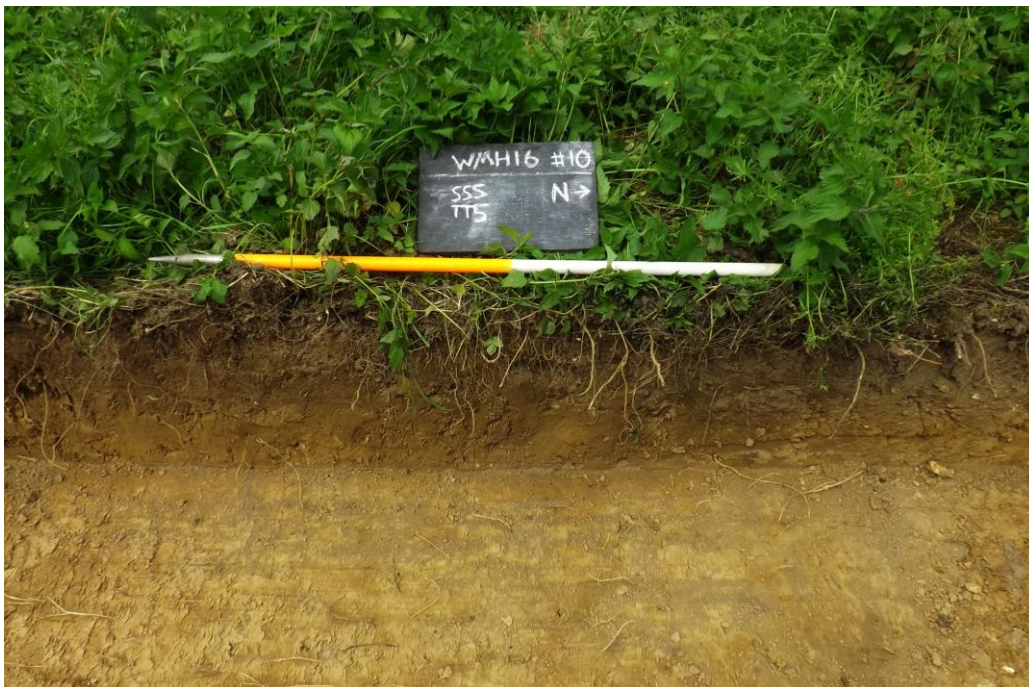
Plate 12. Sample section 5, Tr5. from the east

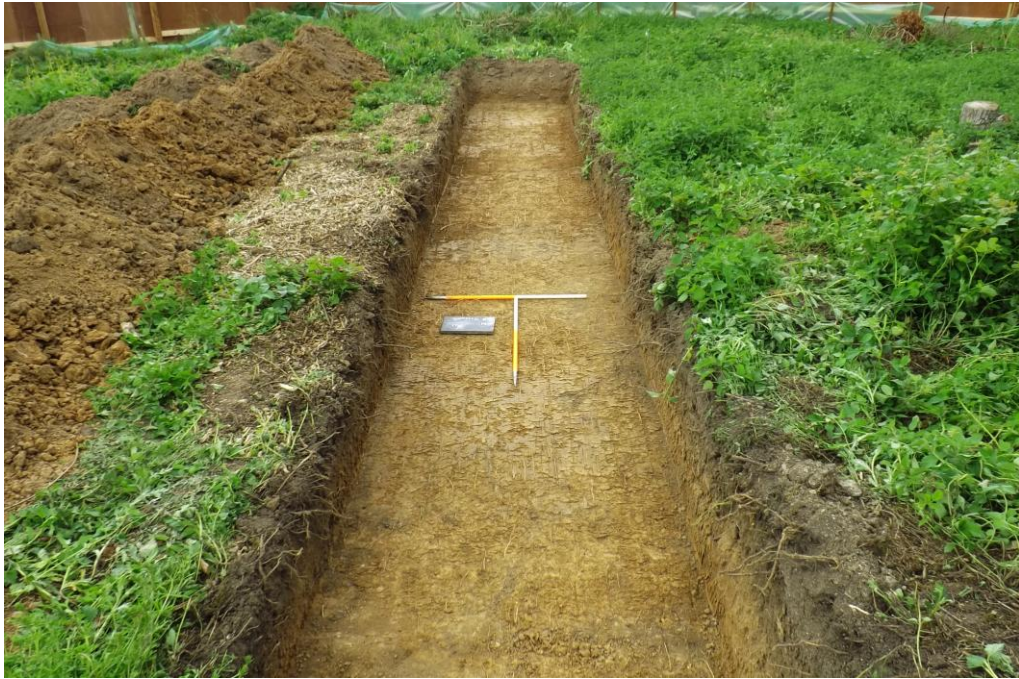
Trench 6. was located in the south-east of the site on an north-west alignment; the top soil was 0.10m deep and the subsoil 0.25m deep the natural (1002) horizon was exposed to a depth of 0.15m.

Plate 13. Tr6. from the east

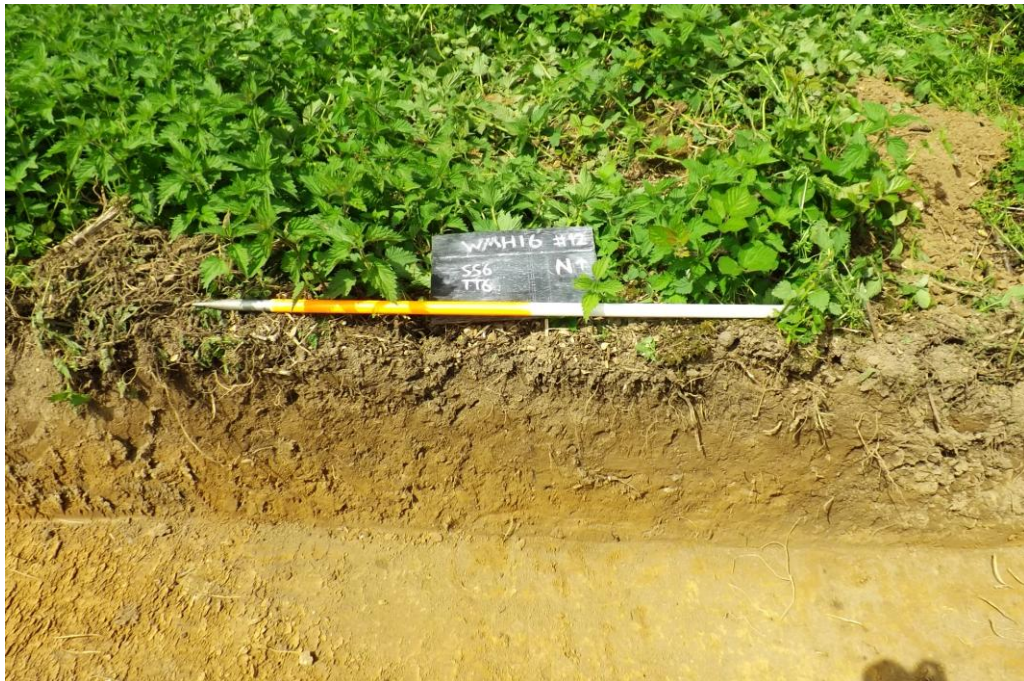
Plate 14. Sample section 6, Tr 6. from the south

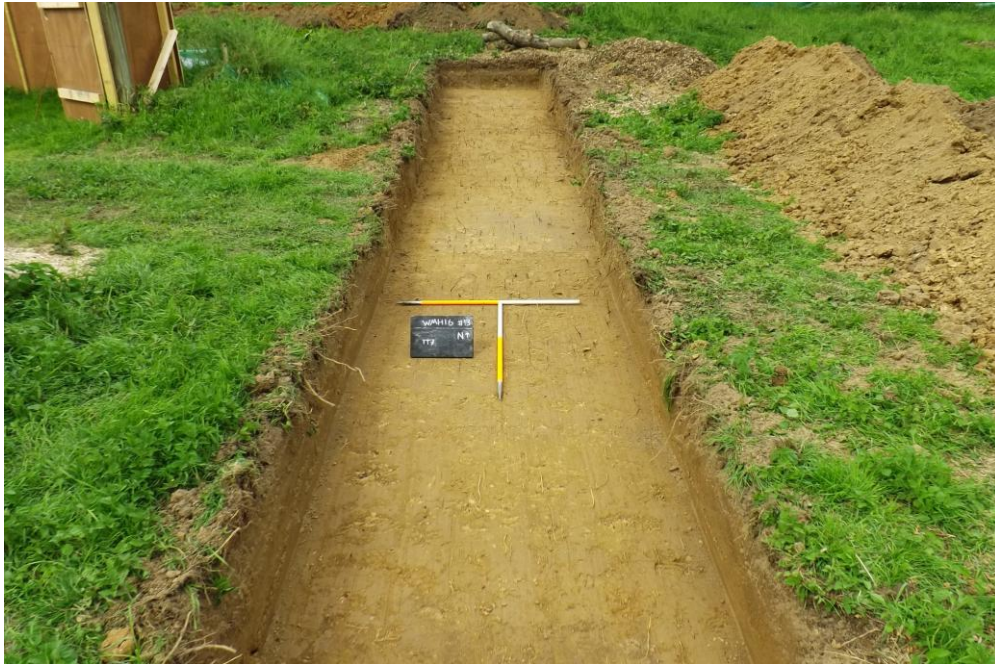
Trench 7. was located in the west of the site on a north-south alignment; the top soil was 0.05m deep and the subsoil 0.30m deep the natural (1002) horizon was exposed at 0.35m depth.

Plate 15. Trench 7. from the south

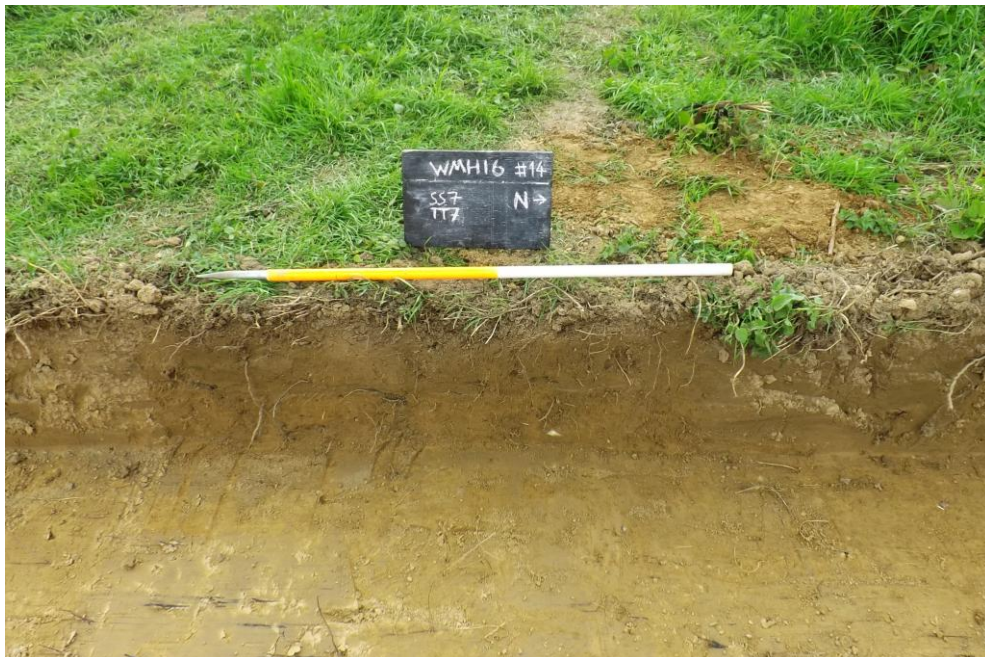
Plate 16. sample section 7, Tr 7, from the east

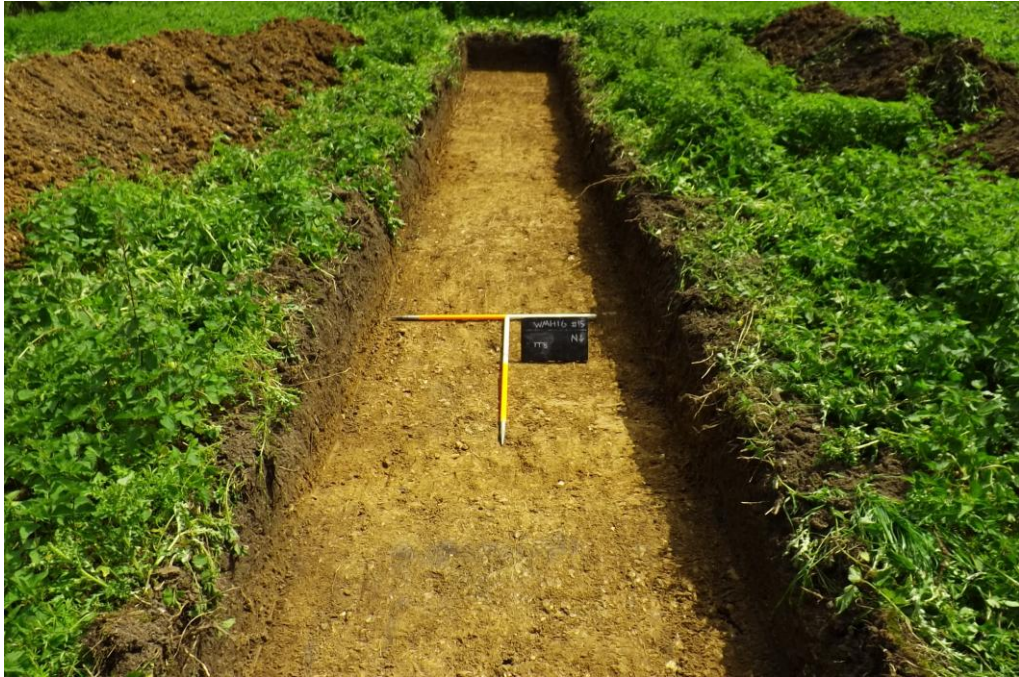
Trench 8. was located in the south-west of the site on a north-south alignment; the top soil was 0.10m deep and the subsoil 0.20m deep the natural (1002) horizon was exposed to a depth of 0.20m.

Plate 17. Trench 8. from the north

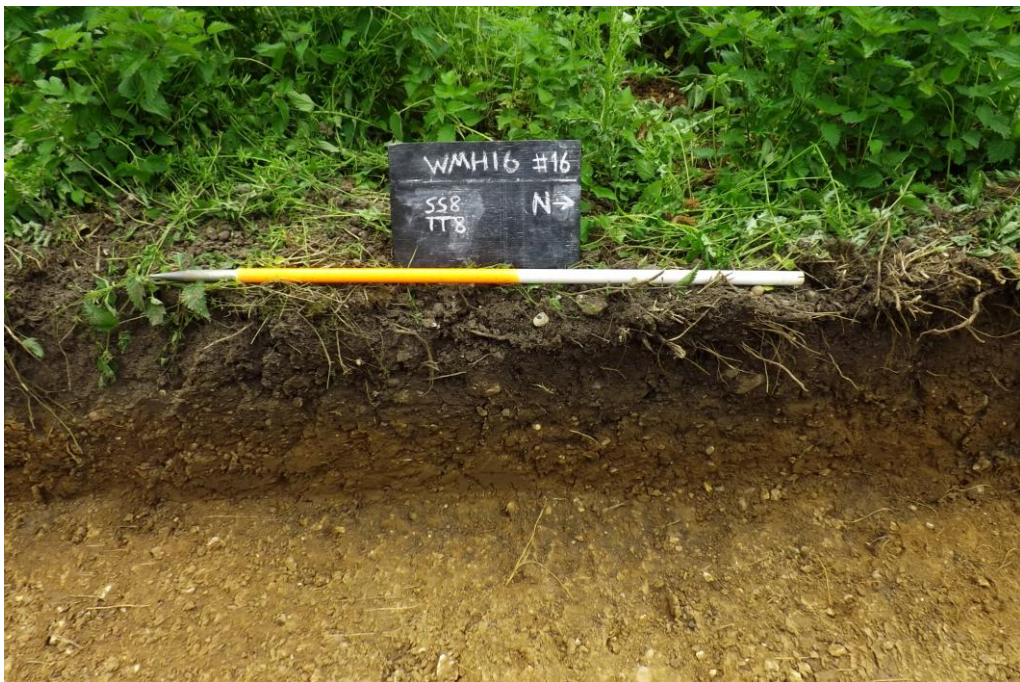
Plate 18. sample section 8. from the east
