Church Farm Barn, The Street

Thorndon, Suffolk

Archaeological Monitoring Report

Planning Application No: 2043/06

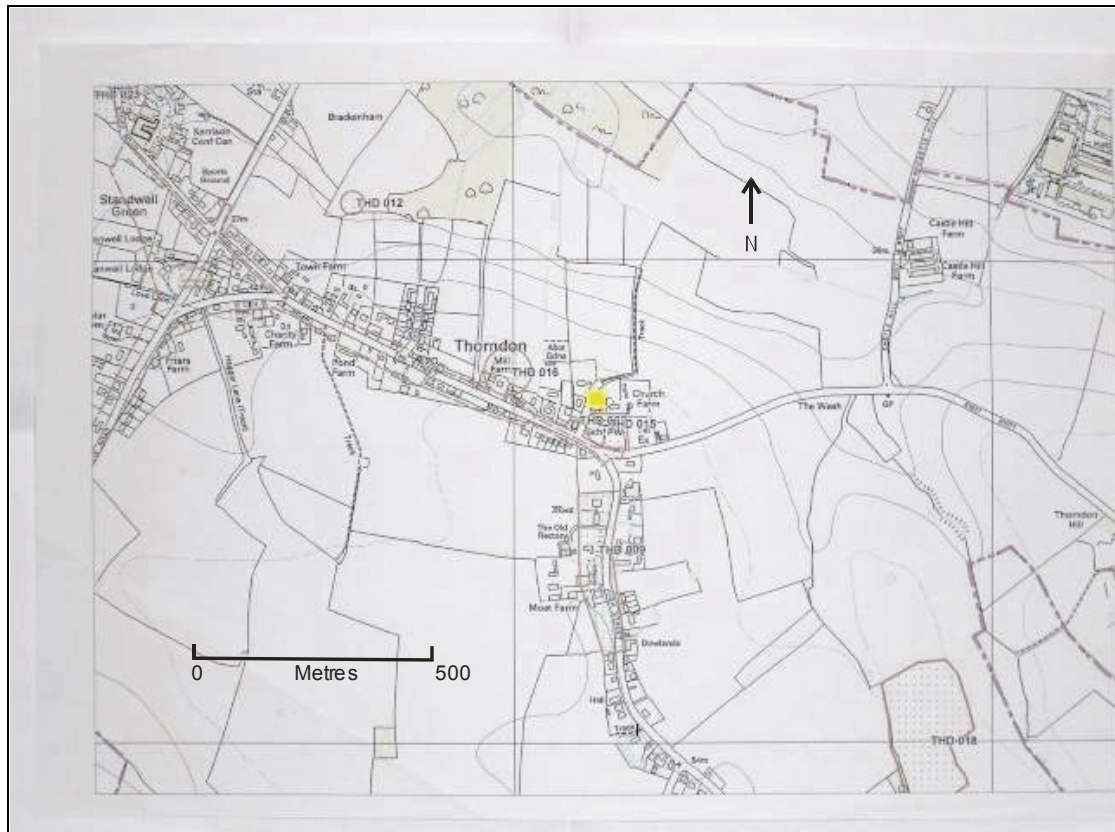
Figure 1 Site in yellow located on the modern Ordnance Survey.

Thorndon is located 6 km south of Eye and 14 km north-east of Stowmarket in Suffolk. The site is located on a north-facing, gentle slope on the eastern edge of Thorndon (fig. 1), on soils developed from a chalky, pebbly, sandy clay over a formation of fine-to coarse grained sands and silts (BGS: Eye, sheet 190). A spot height for the site has a value of 50.10m OD. The site runs down a small river valley, which is a tributary of the River Dove, and is immediately to the north of the medieval church of All Saints. Before development the site was a disused barn orientated north-south and connected to an east-west orientated range of outbuildings on the barns north side forming a T shaped plan. These building were located in disused yard and garden of Church Farm House (fig 4).

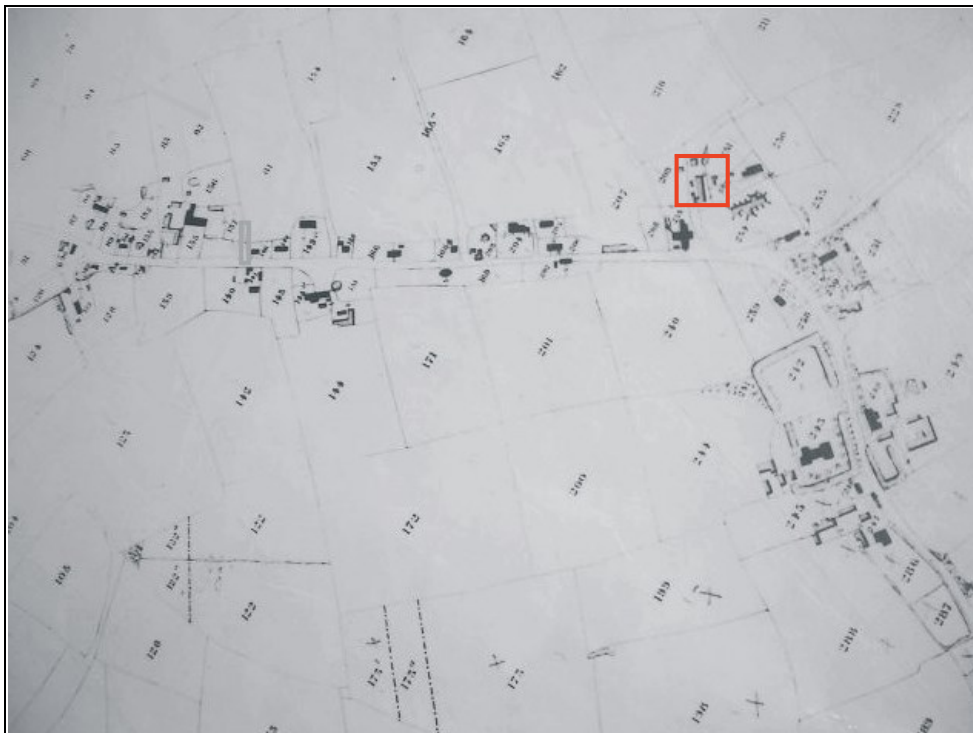
Figure 3 The Tithe map of Thorndon, dated 1845
(site highlighted in red, scale 1 inch to the mile)

The Tithe map of Thorndon showing the barn in its extended form shows two, possibly three, moated enclosures. One of these contains the rectory and could indicate that other principal buildings such as a manor house or hall may have also

moved away from the church in the post-medieval period or even at an earlier date, thus providing a potential site for earlier buildings at Church Farm.

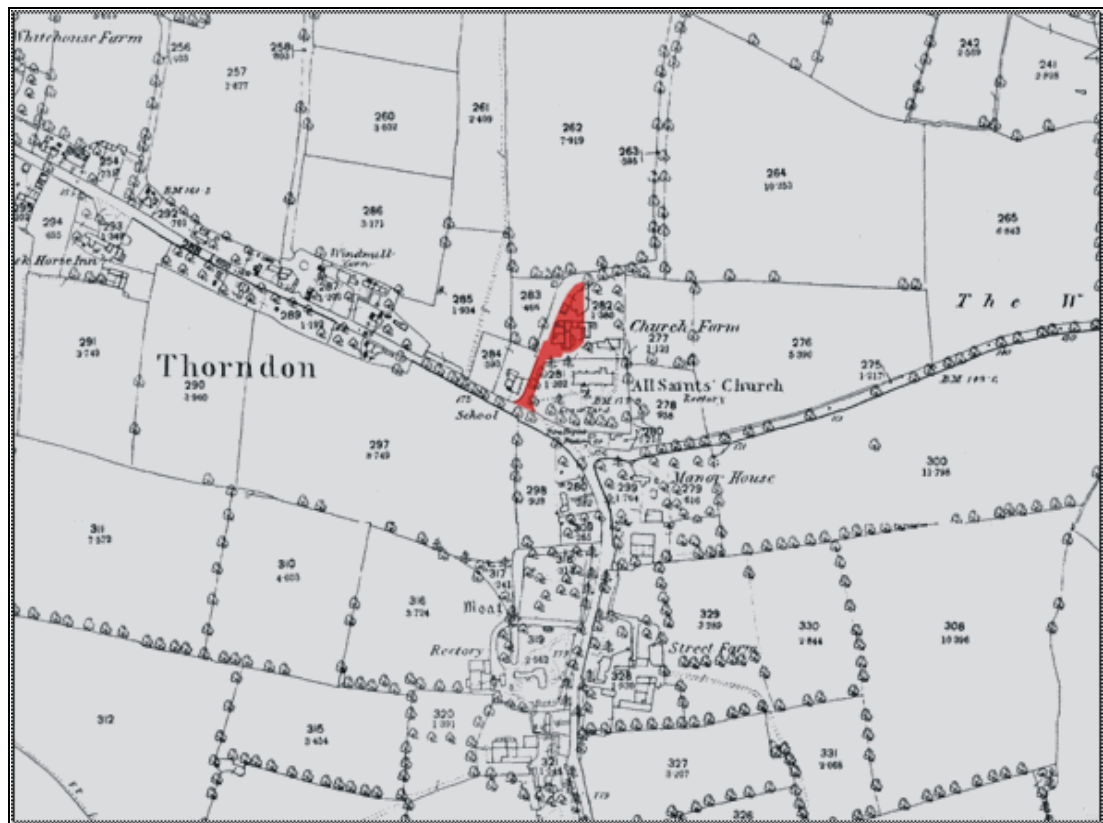
Figure 4: The 1880's Ordnance Survey,
(site marked in red; scale 1:63360)

The excavation of the footings was monitored on the 28th August 2008, 6th November 2008, 10th November 2008, 17th-19th November 2008, 22nd January 2009, and 10th-11th June 2009. Four separate areas were excavated and assigned trench numbers (fig 4). The trenches were inspected by the observing archaeologist Dennis Payne.

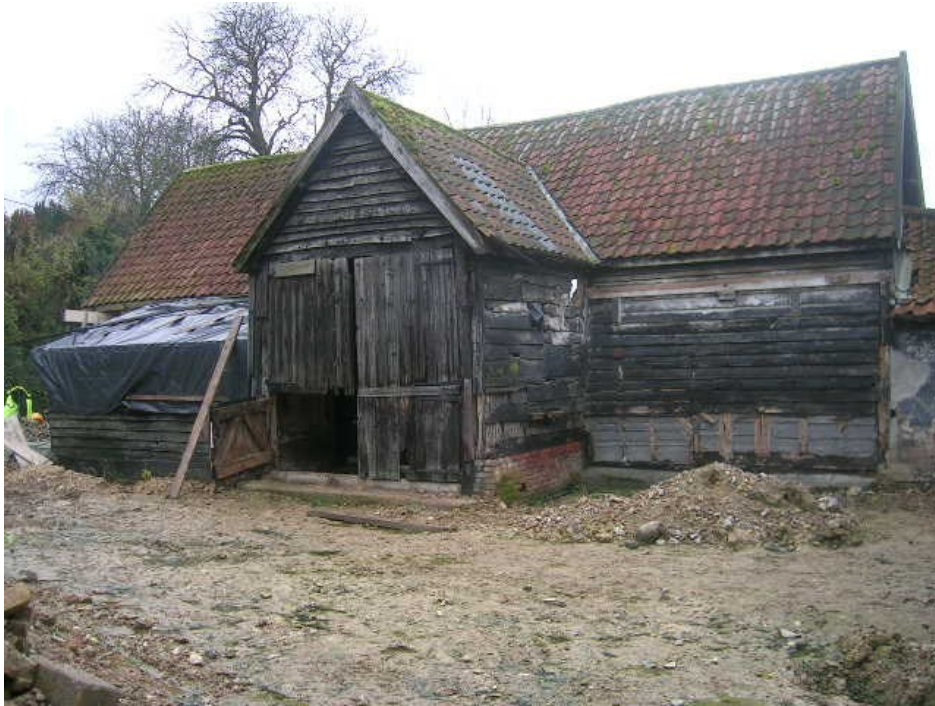
Plate 1 Church Farm Barn. looking west, showing porch

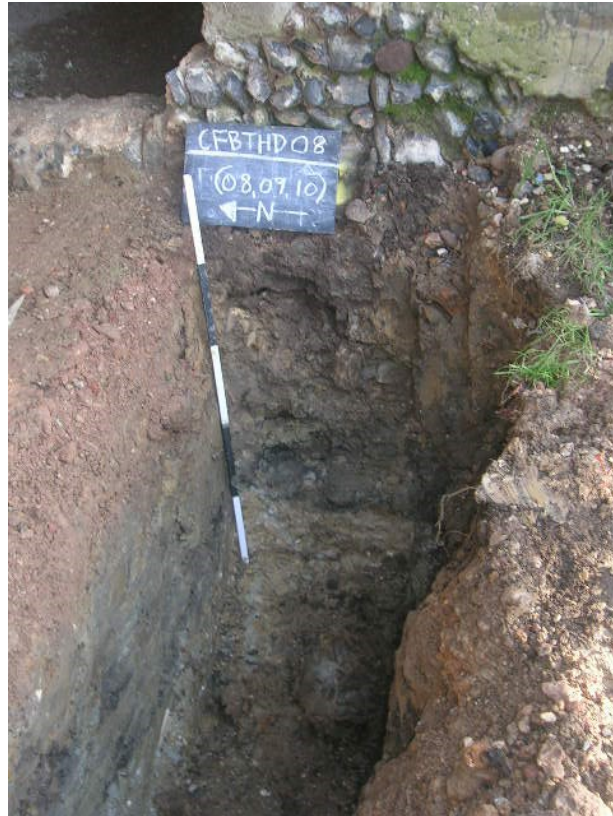
Plate 2 Section 2, Trench 1 Section 2 showing flint wall.
