**TREE-RING ANALYSIS OF TIMBERS FROM
CHURCH FARM HOUSE,
CHURCH STREET, OCKBROOK,
DERBYSHIRE**

July 2008

**ALISON ARNOLD
ROBERT HOWARD**

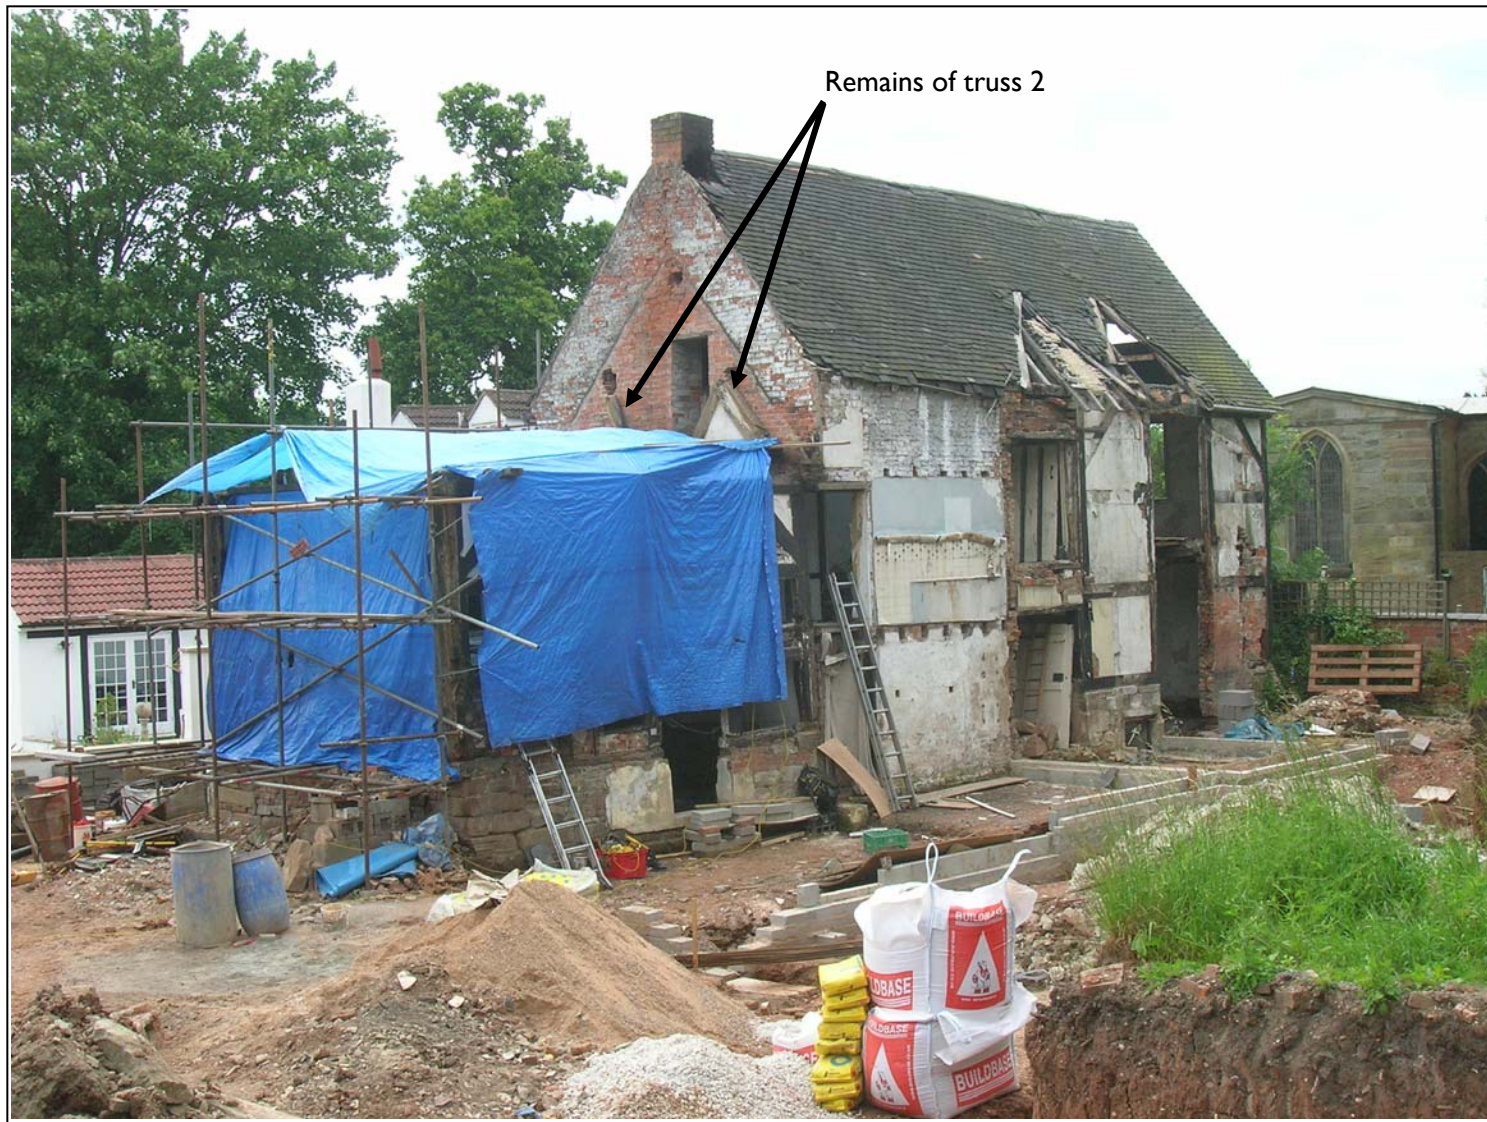
Figure 2: Church Farm House; photograph taken from the north with Building A to the left, note the truncated remains of truss 2 (arrowed)

Church Farm House is located on the east side of Church Street in the parish of Ockbrook, approximately four miles to the east of the City of Derby (Figs 1 and 2). As can be seen clearly from the rear of the building (Fig 2), this structure was once two separate cottages, with these cottages thought to date to the seventeenth century.

The building to the north (Building A) is a single bay structure of two storeys, with square panel timber framing and corner bracing to the top. Unfortunately, the roof has been removed with only the truncated remains of one truss remaining (Truss 2). These remains consist of the west principal and east and west struts and can just be seen in Figure 2.

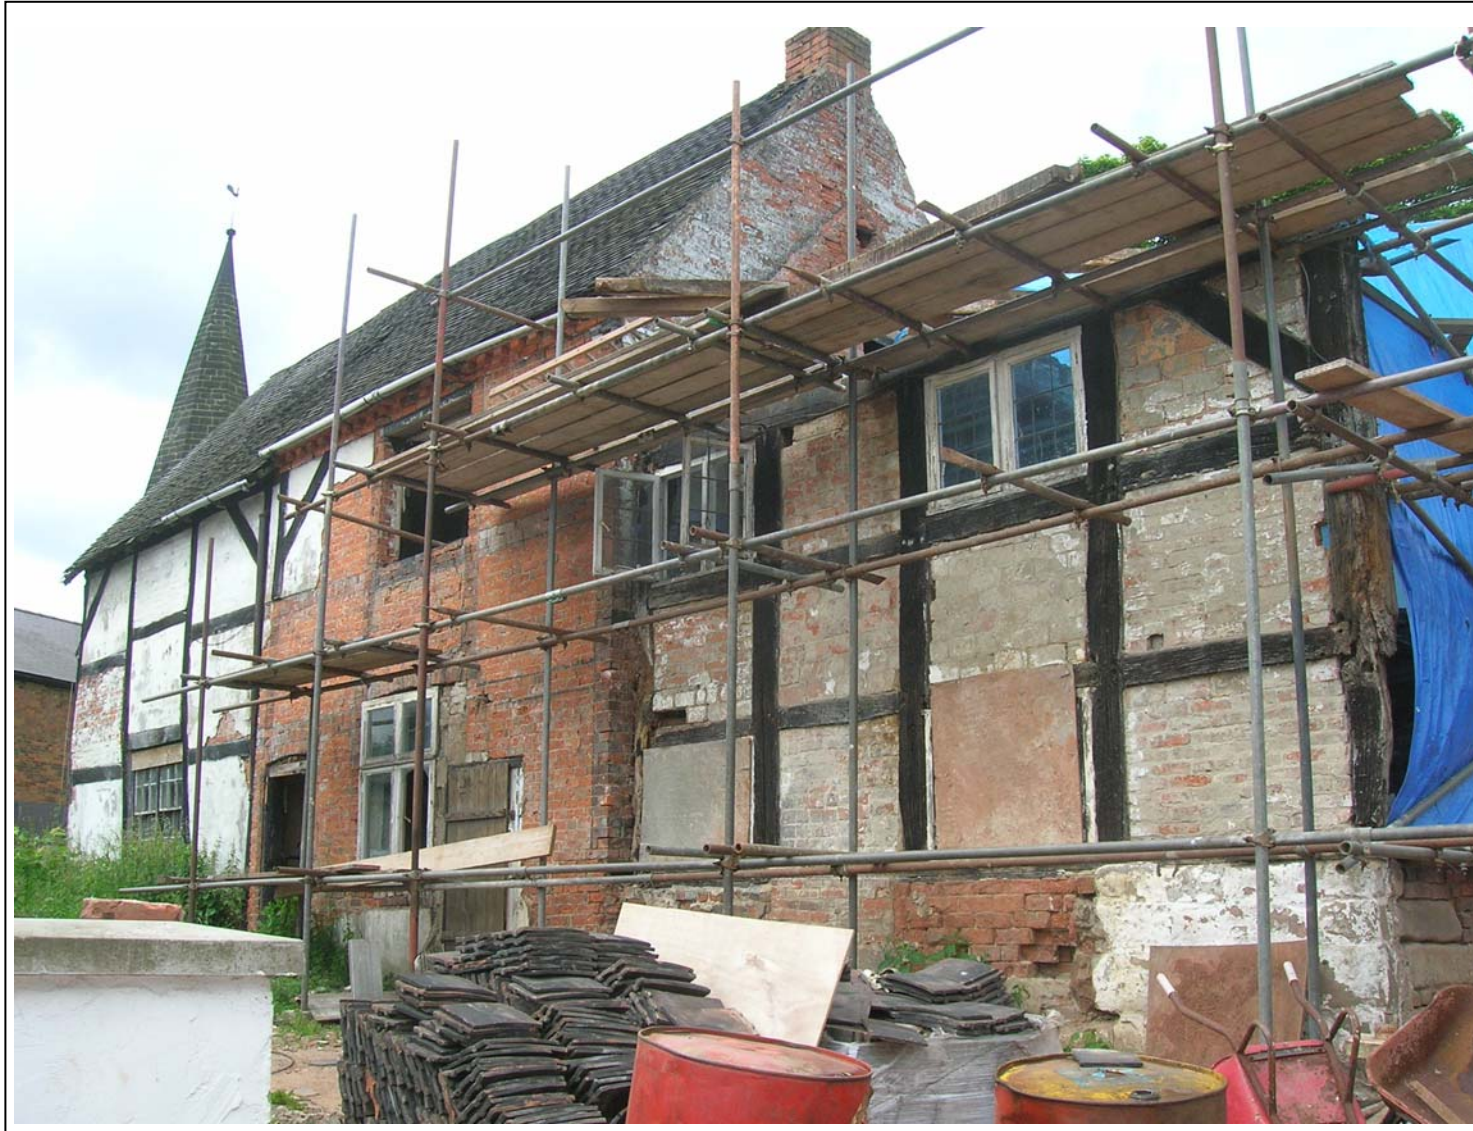
Figure 3: Church Farm House; the rear of the building, Building A to the right

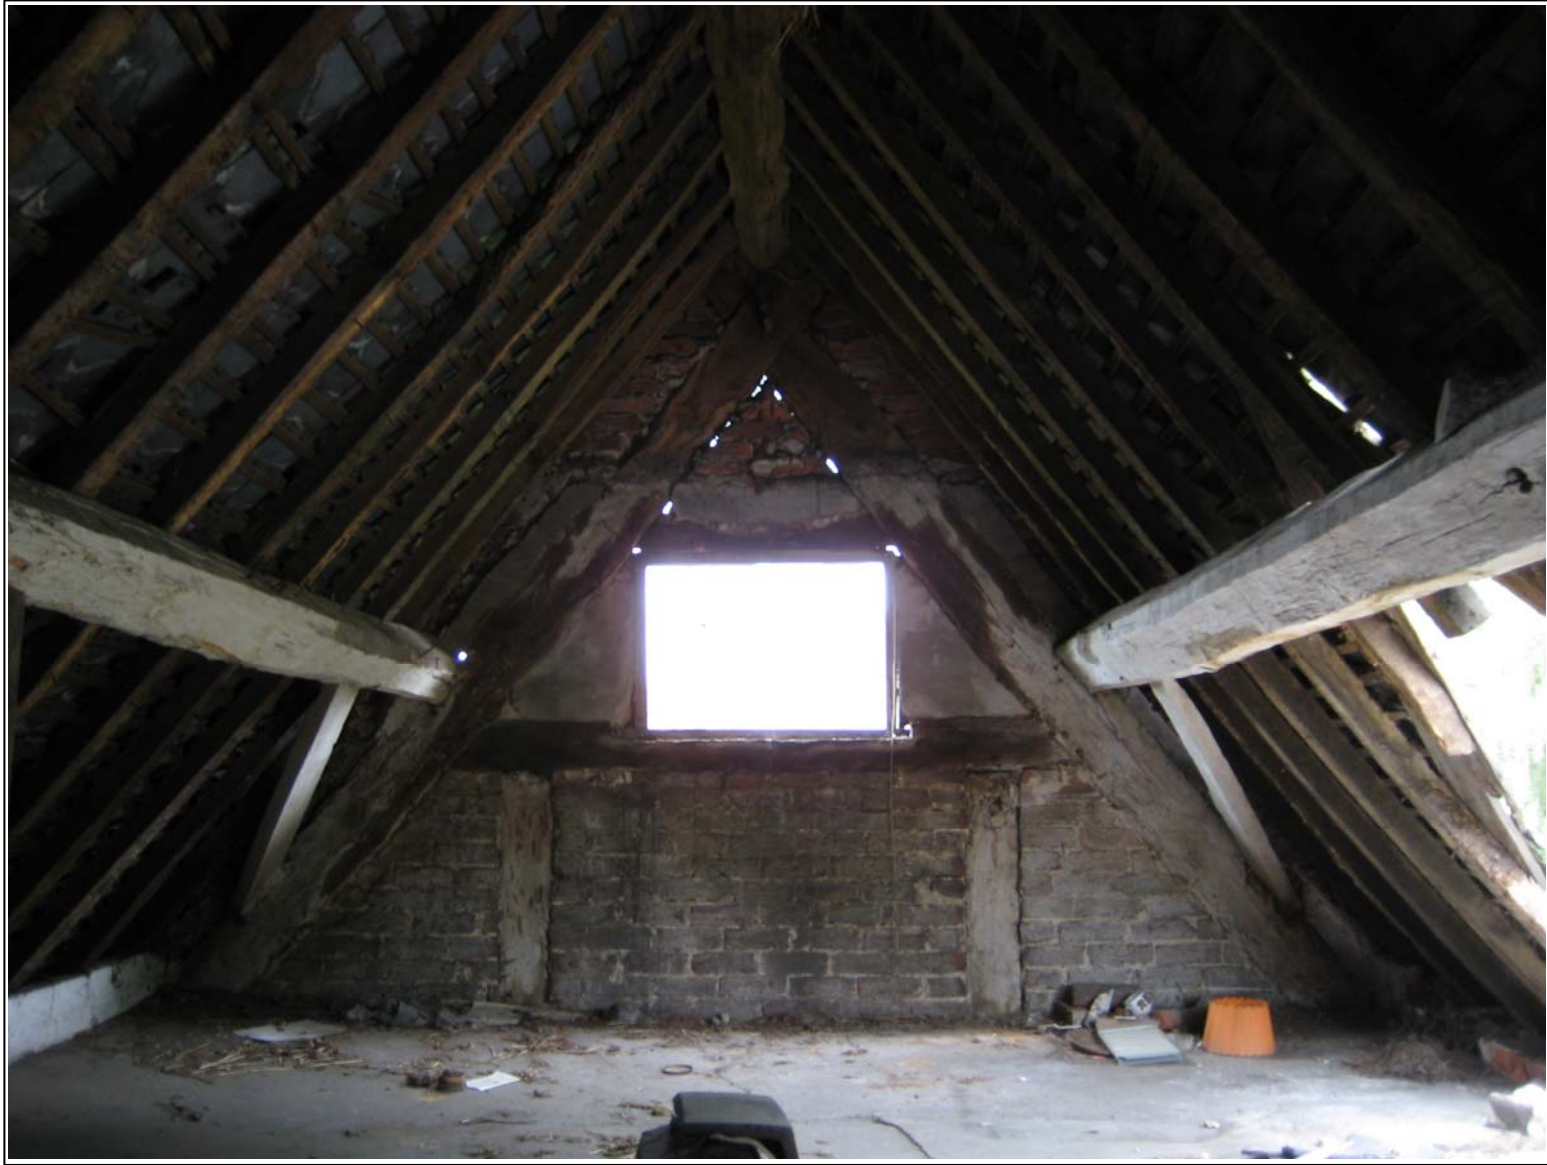
Figure 4: Church Farm House; Building B, truss 4, taken from the north

The building to the south (Building B) is also of one bay with two storeys plus attic and cellar. The exterior has similar square panel timber framing and corner bracing to Building A. The roof is of two trusses which consist of principal rafters, tiebeams, collars, and queen posts (Fig 4).

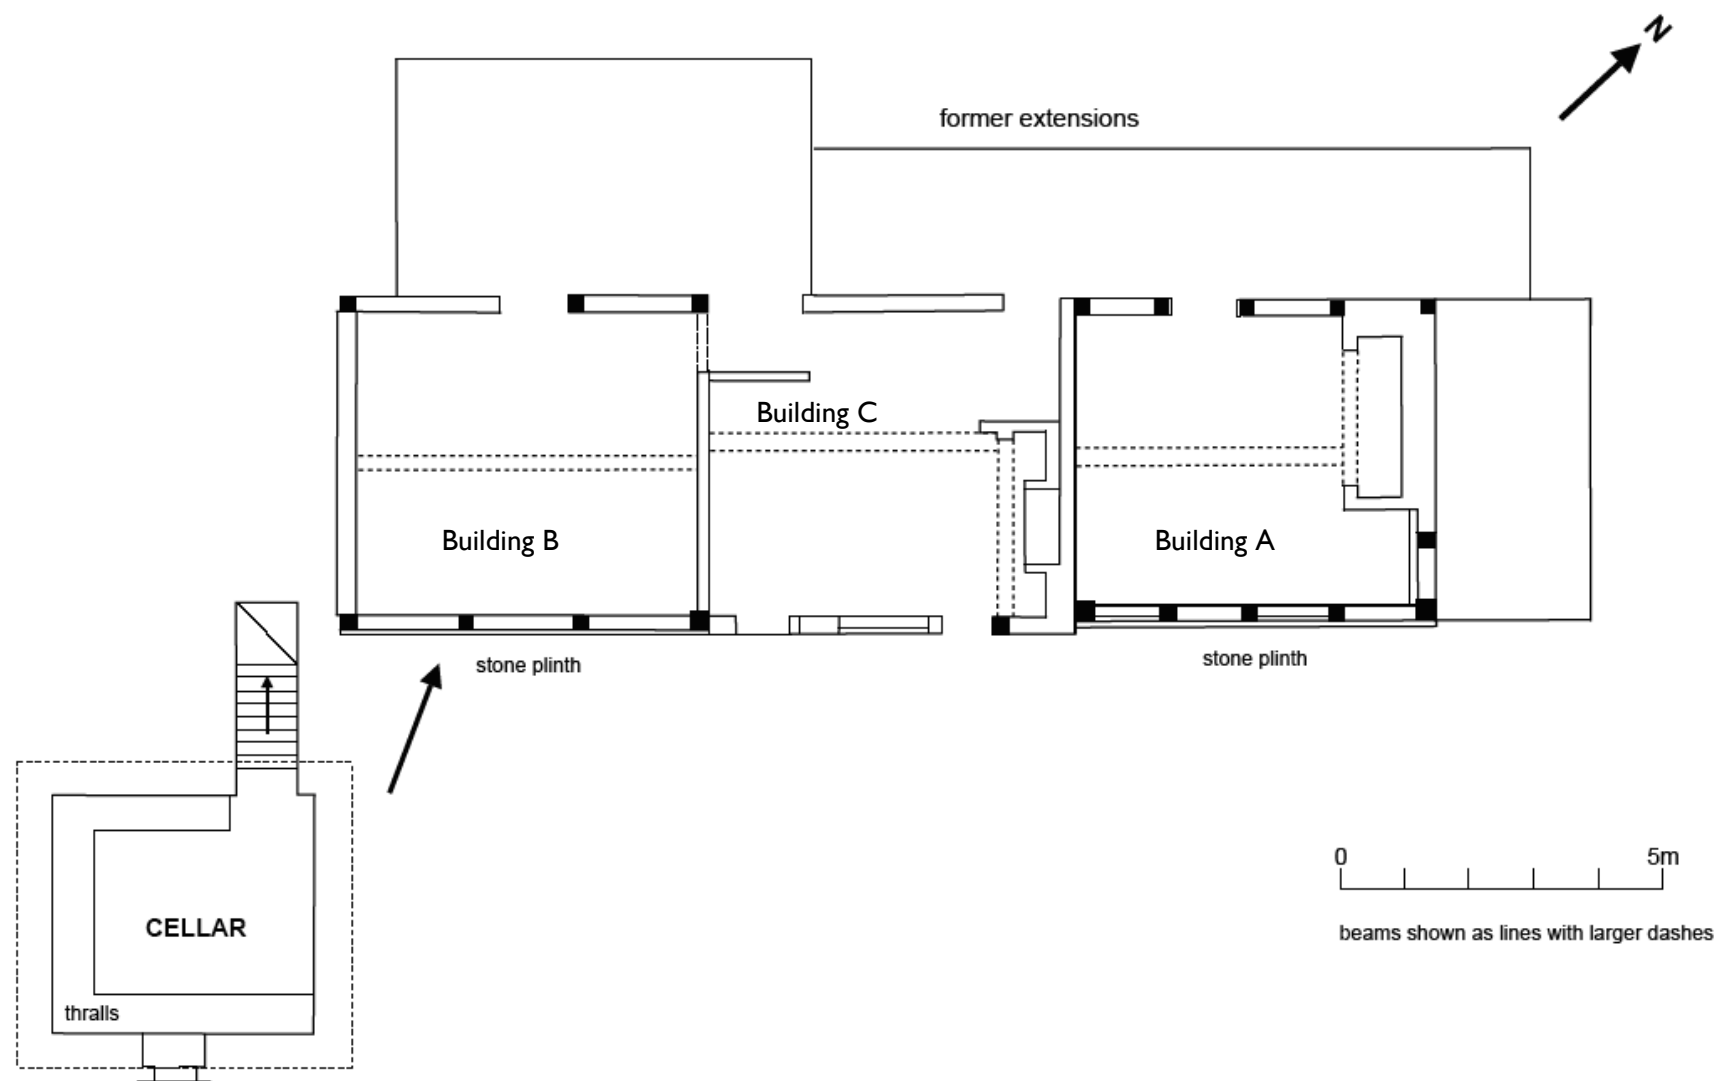
Figure 5: Church Farm House; ground plan and cellar plan (Richard Sheppard)

These two cottages were converted to a single dwelling by the construction of a brick infill (Building C). This is thought to have occurred in the eighteenth century. There were further nineteenth and twentieth-century additions and alterations which have recently been removed (Fig 5).

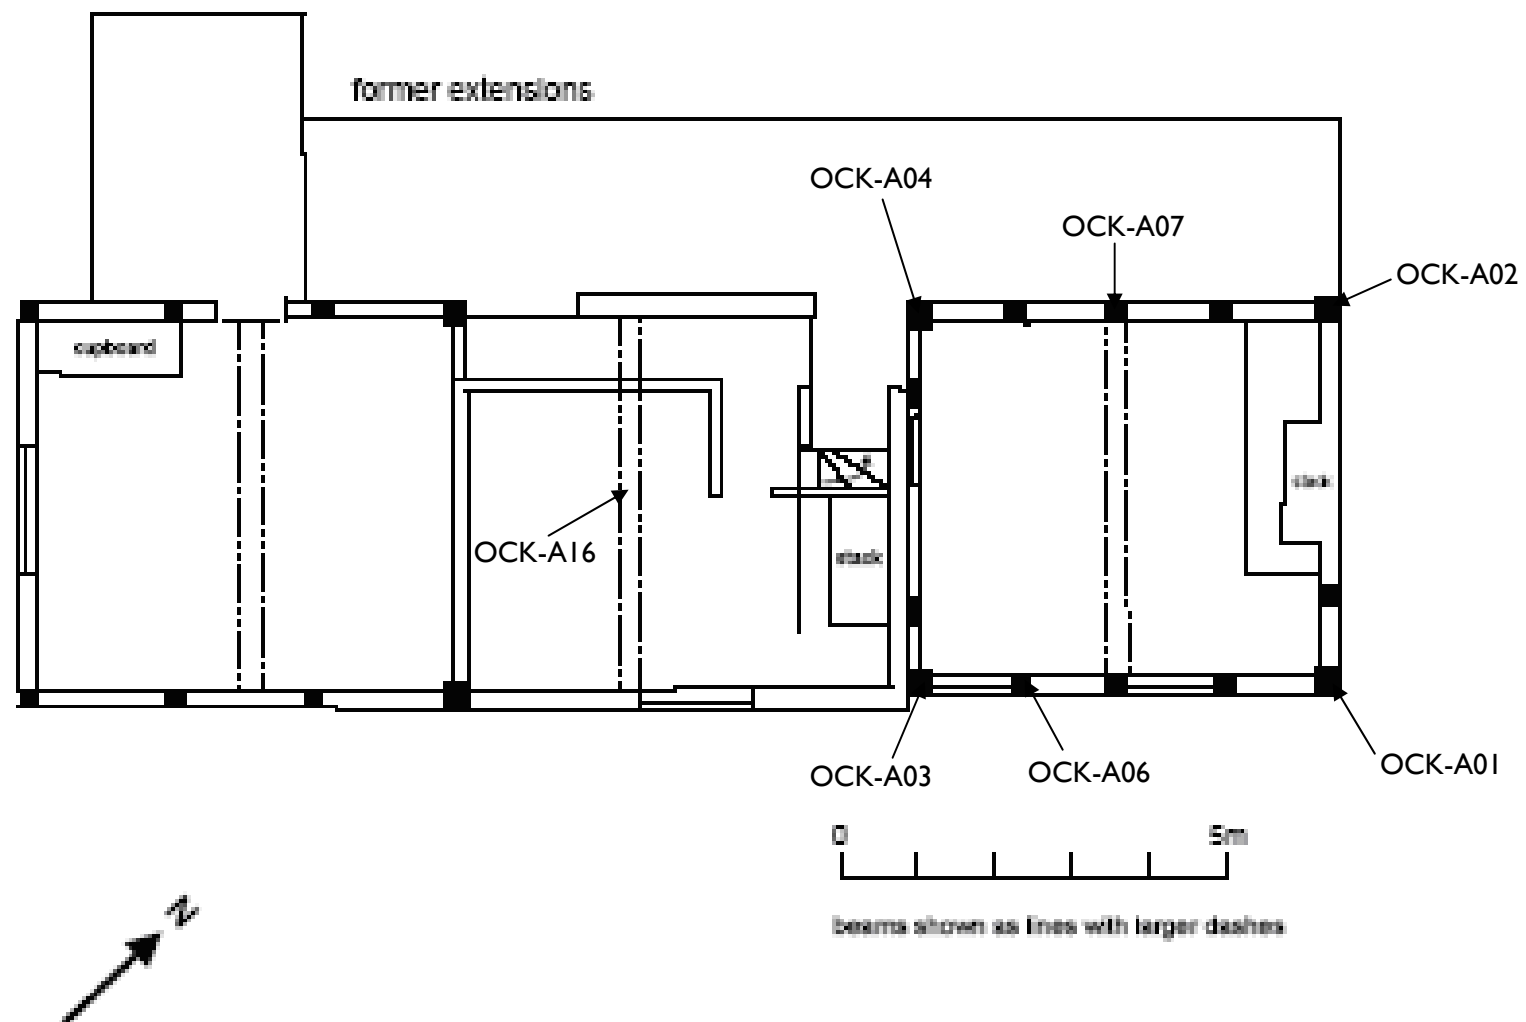
Figure 6: Church Farm House; first-floor plan, showing the location of samples OCK-A01–4, OCK-A06–07, and OCK-A16 (Richard Sheppard)

A total of 16 samples were taken from Church Farm House. Each sample was given the code OCK-A (for Ockbrook, site 'A') and numbered 01–16. It had been suggested that Buildings A and B were of different dates, with Building A being slightly older (*pers comm.* Richard Sheppard) and, therefore, were to be treated as separate phases. In accordance with this, seven samples were taken from the structural and framing timbers and from one of the roof struts of Building A (OCK-A01–07). A further eight samples were taken from the roof of Building B (OCK-A08–15), and finally a single sample was taken from a ceiling beam on the first floor of Building C (OCK-A16). The location of each sample was noted at the time of sampling and these have been marked on Figures 6 and 7. Further details can be found in Table 1.

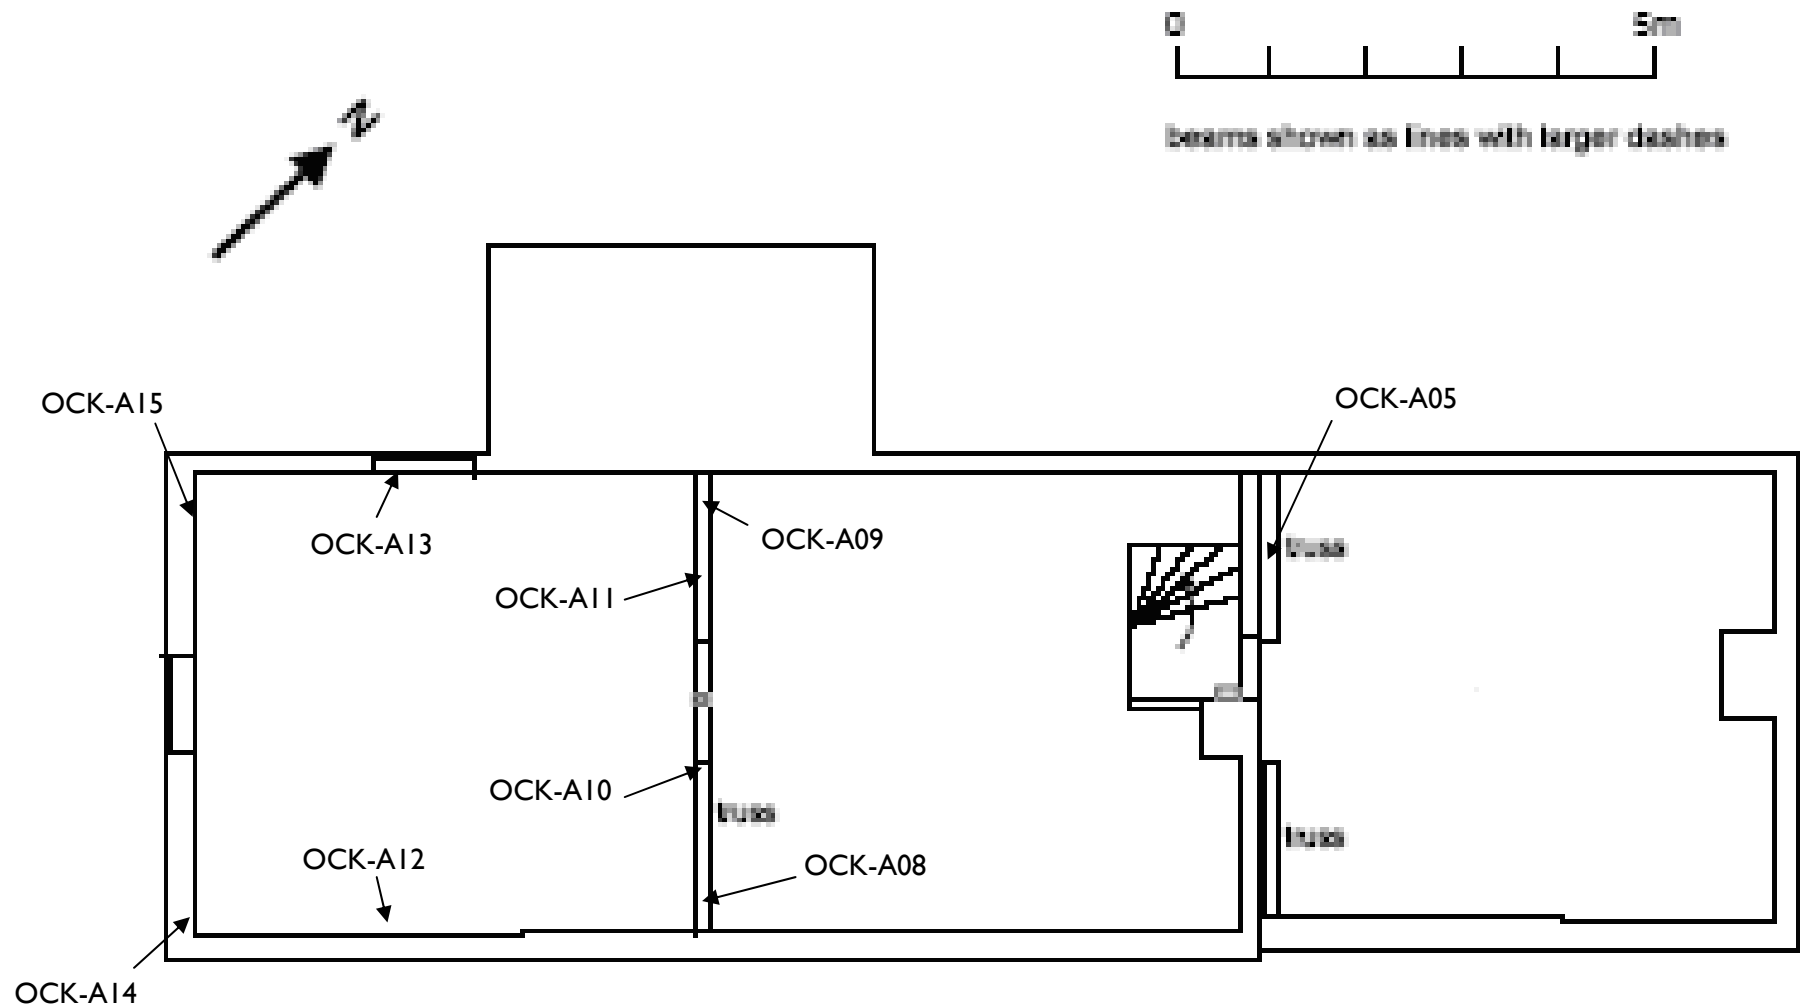
Figure 7: Church Farm House; Attic/garret level, showing the location of samples OCK-A05 and OCK-A08-15 (Richard Sheppard)

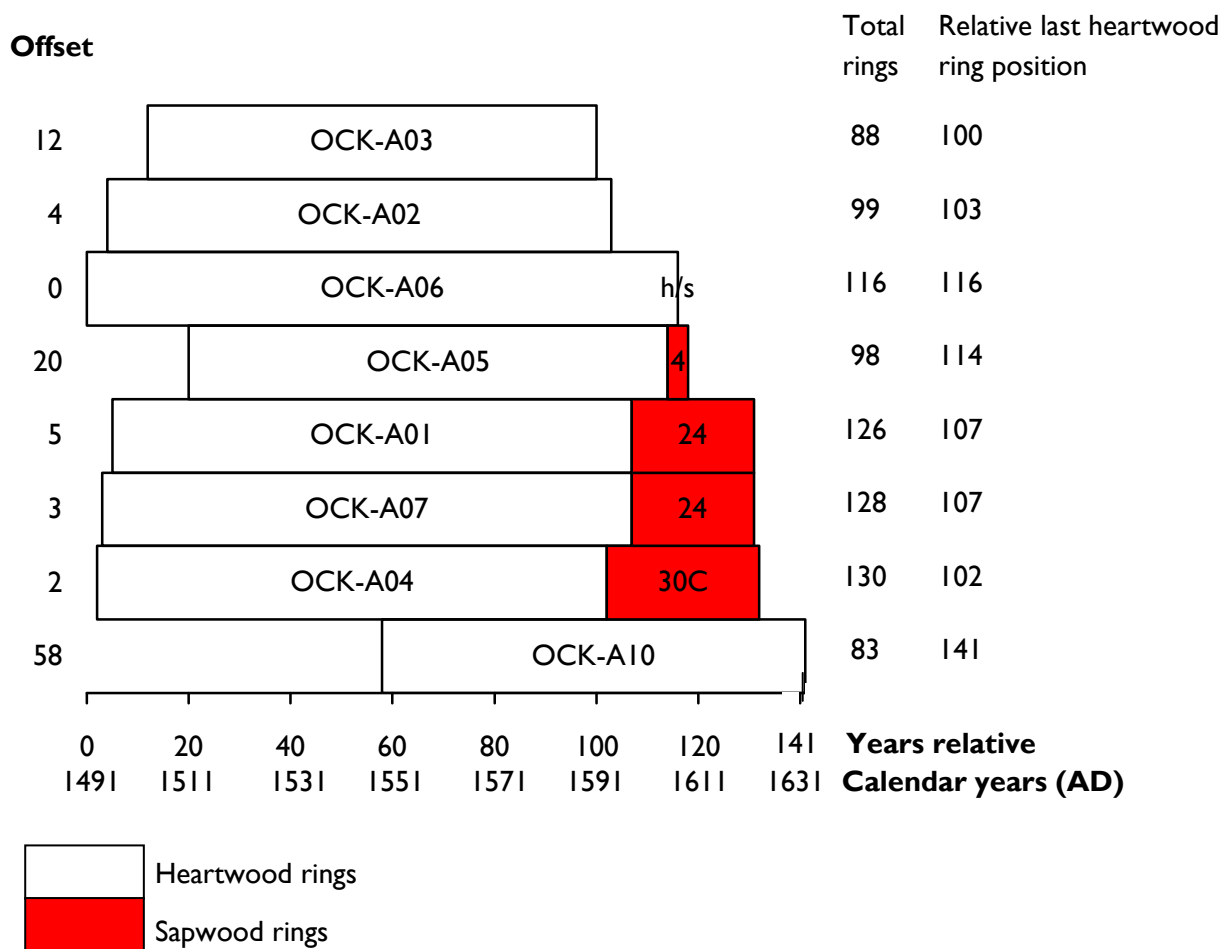
C = complete sapwood retained on sample, last measured ring is the felling date
h/s = the heartwood/sapwood boundary is the last-measured ring on the sample

Figure 8: Bar diagram of samples in site sequence OCKASQ01

Firstly, eight samples grouped and were combined at the relevant offset positions to form OCKASQ01, a site sequence of 141 rings (Fig 8). This site sequence was then compared against a series of relevant reference chronologies for oak where it was found to match consistently and securely at a first-measured ring date of AD 1491 and a last-measured ring date of AD 1631.

Seven of these samples are from Building A. One of these (OCK-A04) has complete sapwood and the last-measured ring date of AD 1622, the felling date of the timber represented. A further four have the heartwood/sapwood boundary ring, interpretation of which suggests that these were also felled in AD 1622. The remaining two samples from Building A do not have the heartwood/sapwood boundary ring. However, with last measured ring dates of AD 1590 (OCK-A03) and AD 1593 (OCK-A02), they would be estimated to have been felled at the earliest in AD 1606 and AD 1609, respectively, making it possible that they were also felled in AD 1622.

The eighth sample in this site sequence (OCK-A10) is taken from Building B. This sample does not have the heartwood/sapwood boundary ring and so an estimated felling date cannot be calculated for it, except to say that with a last-measured ring date of AD 1631, this would be estimated to be AD 1647 at the earliest.

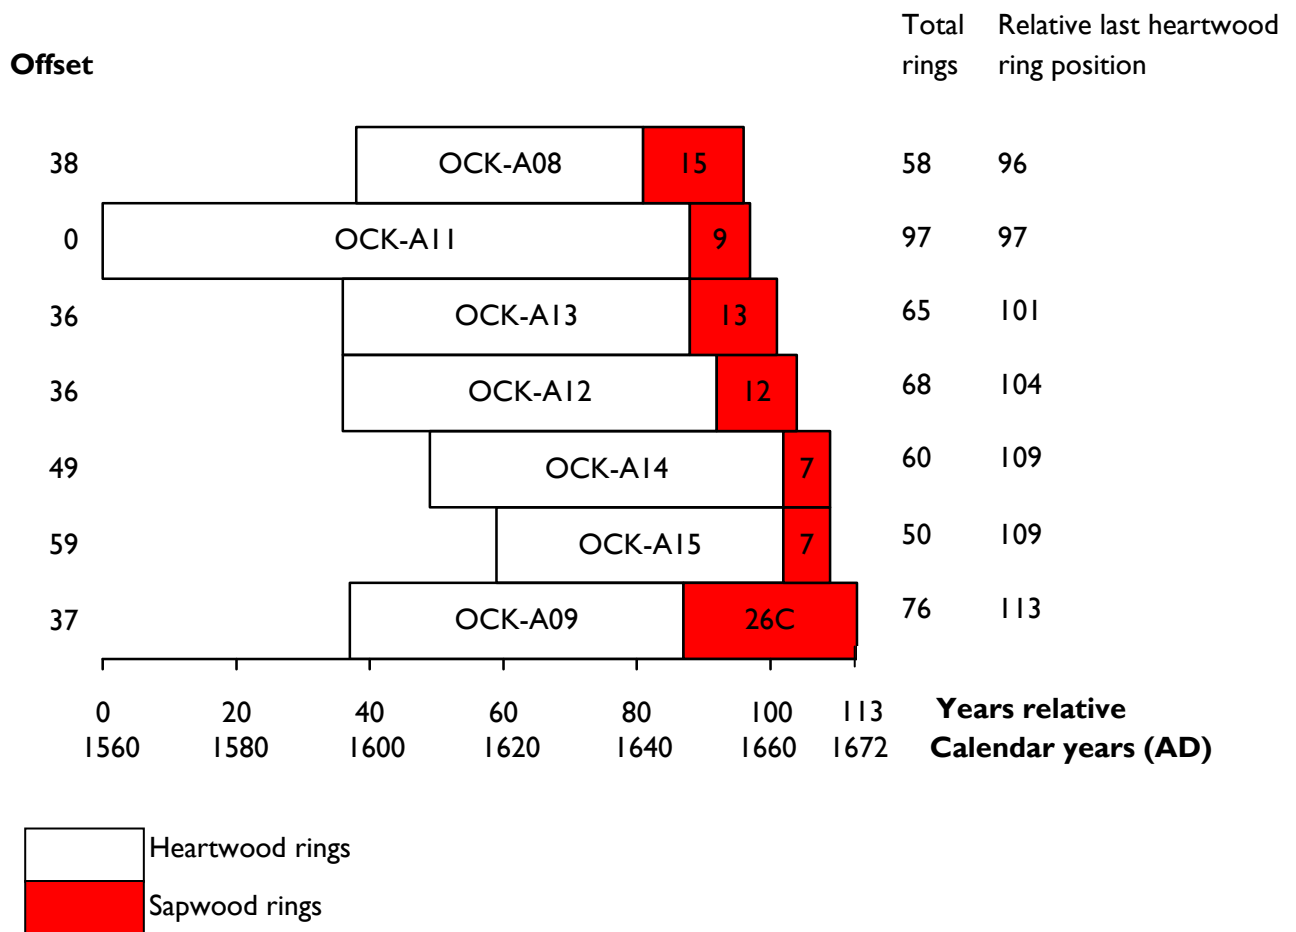
C = complete sapwood retained on sample, last-measured ring is the felling date.

Figure 9: Bar diagram of samples in site sequence OCKASQ02

Secondly, seven samples, all taken from Building B, grouped and were combined at the relevant offset positions to form OCKASQ02, a site sequence of 113 rings (Fig 9). Attempts to date this site sequence by comparing it against the reference chronologies resulted in it matching at a first-ring date of AD 1560 and a last-measured ring date of AD 1672.

One of these samples, OCK-A09 has complete sapwood and the last-measured ring date of AD 1672, the felling date of the timber represented. The other six samples in this site sequence all have the heartwood/sapwood boundary ring. Interpretation of this suggests that it is likely that these samples were also felled in AD 1672.
