**TREE-RING ANALYSIS OF TIMBERS FROM
THE WHITE SWAN PUBLIC HOUSE,
MARKET PLACE,
LEEK,
STAFFORDSHIRE**

**A J ARNOLD
R E HOWARD**

TREE-RING ANALYSIS OF TIMBERS FROM THE WHITE SWAN PUBLIC HOUSE, MARKET PLACE, LEEK, STAFFORDSHIRE

SUMMARY

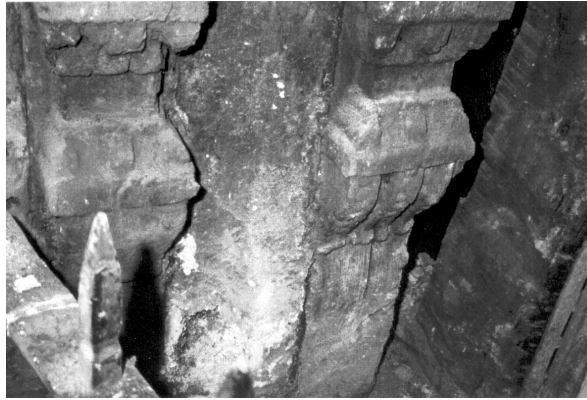
Decorative detail from the video

The window openings are framed as part of the main construction; the studs run the full height of the storey, and have short lengths of timber inserted between, which is the reverse of the technique employed in the seventeenth century; and no provision is made for an attic window, which certainly existed at the time of the 'restoration', and is a standard feature where the attics were an essential part of the accommodation. In addition some very fine ornamental brackets and the mullions of a timber-framed window existed to the right of the present main doorway, all of which have been replaced in rendered brick. What could be told from the video was that the eastern part of the building had been built / rebuilt in the early seventeenth century using close-studding with mid-rails.

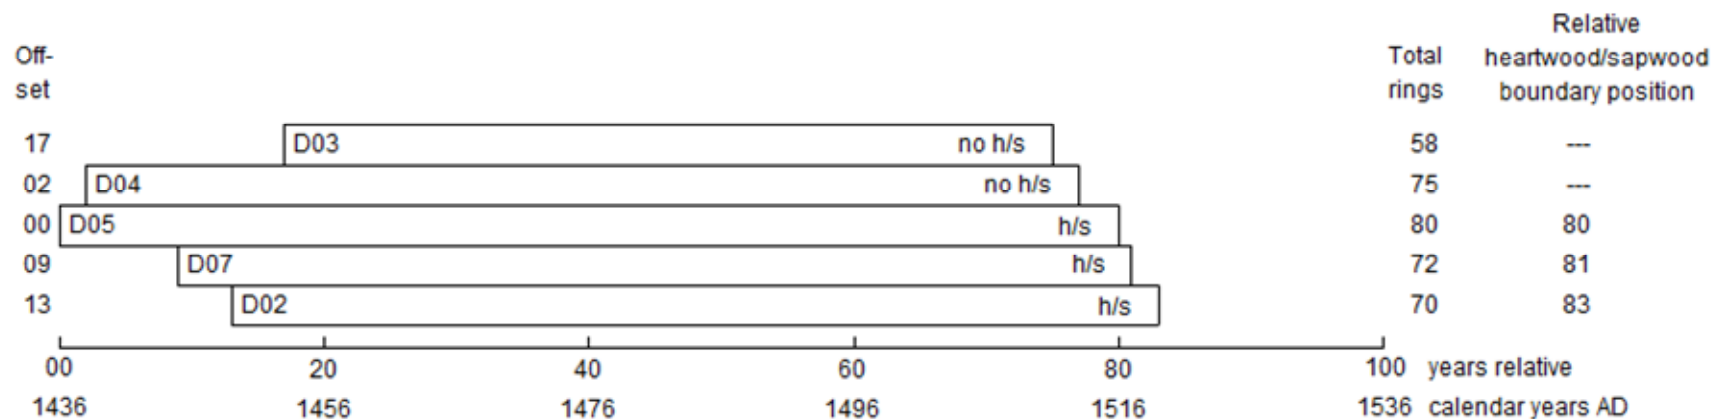
Figure 4: Bar diagram of the samples in site chronology LEKDSQ01

White bars = heartwood rings

h/s = heartwood/sapwood boundary (only the sapwood rings are missing)

At a minimum value of $t=4.0$ a single group comprising five samples could be formed, the samples cross-matching with each other at the positions indicated in the bar diagram Figure 4. The cross-matching samples were combined at these indicated off-set positions to form LEKDSQ01, a site chronology of 83 rings. Site chronology LEKDSQ01 was then satisfactorily dated by comparison with a large number of relevant reference chronologies for oak as spanning the years 1436 to 1518. The evidence for this dating is given in the t -values of Table 2.

None of the five dated samples in site chronology LEKDSQ01 retains complete sapwood, that is, none of them has the last growth ring produced by the trees represented before it was cut. It is thus not possible to give a precise felling date for any of the timbers. Three of the dated samples, however, retain the heartwood/sapwood boundary (h/s in Table 1 and the bar diagram), and it is thus possible to give an estimated felling date range for the timbers. Given that the average date of the boundary on the three samples where it exists is 1516, it is estimated that the timbers represented were felled in the period 1531–56, such an interpretation based on a 95% probability that the trees represented had 15–40 sapwood rings.
