**Dendrochronology, timber analysis, and historic building consultants**

**TREE-RING ANALYSIS OF TIMBERS FROM  
'PARKER'S FIELD',  
NORTH PETHERTON,  
BRIDGWATER,  
SOMERSET**

**July 2011**

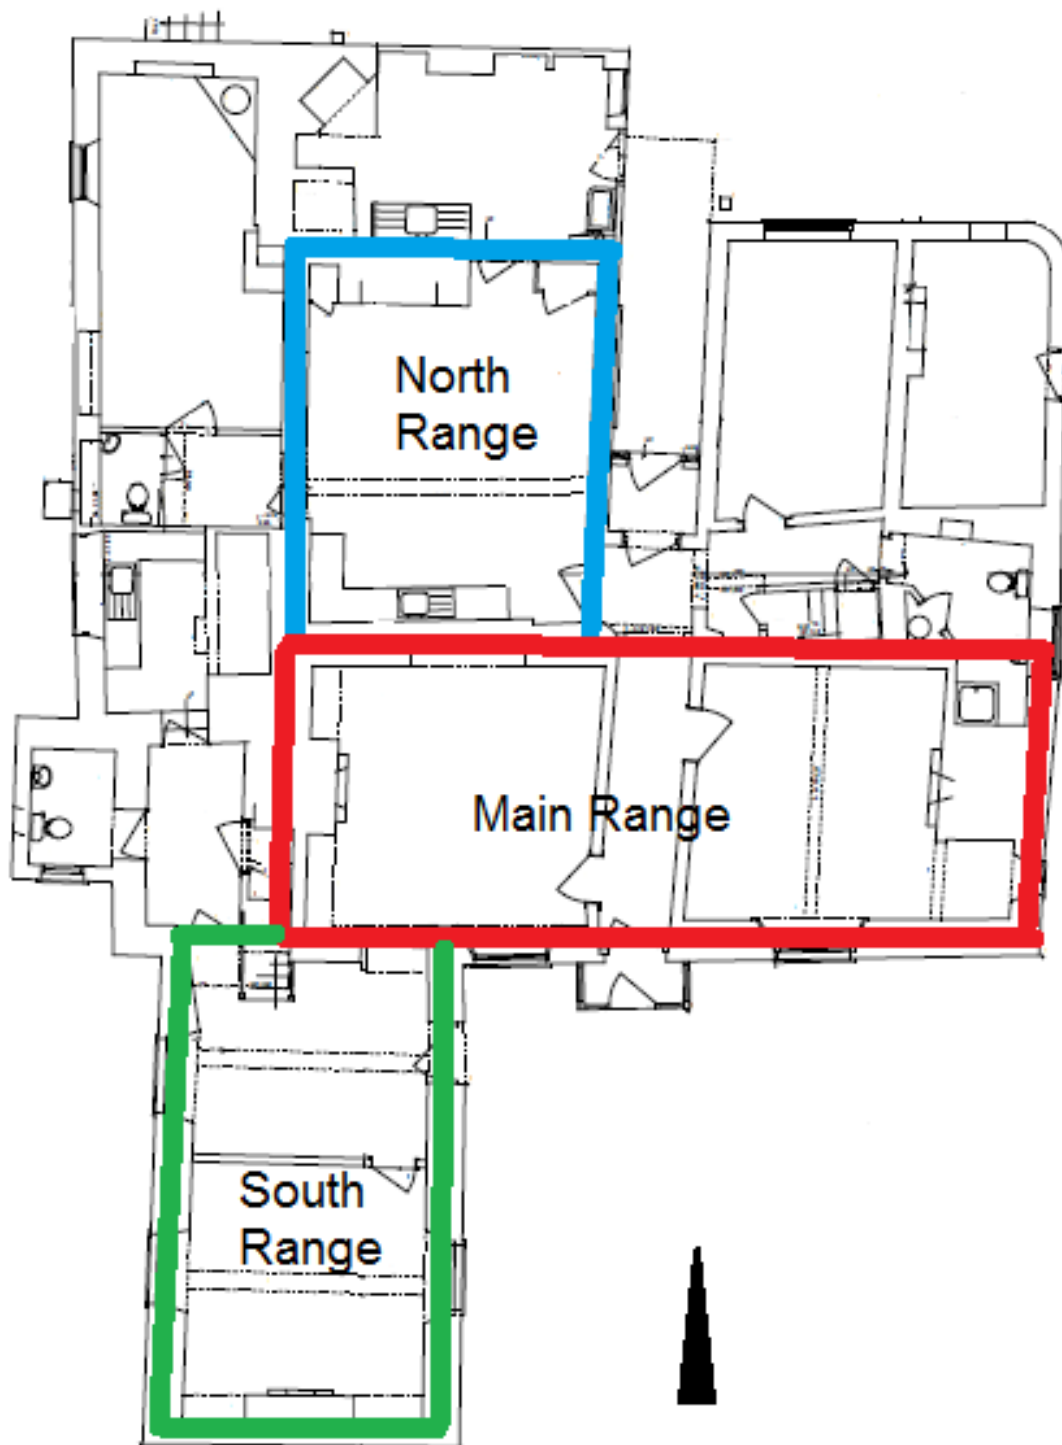
*Figure 3: Ground-floor plan, showing the layout of the building (Quentin Alder Architects)*

The building known as 'Parker's Field' is located at the edge of the village of North Petherton in Somerset (Figs 1 & 2; ST 298 331). It is a two storey structure with the main (and oldest) range aligned east-west. At a later date, a southern range was added at the west end and then later still a short northern range was also added. There are further additions and alterations which probably date to the late-nineteenth and twentieth centuries (Fig 3).

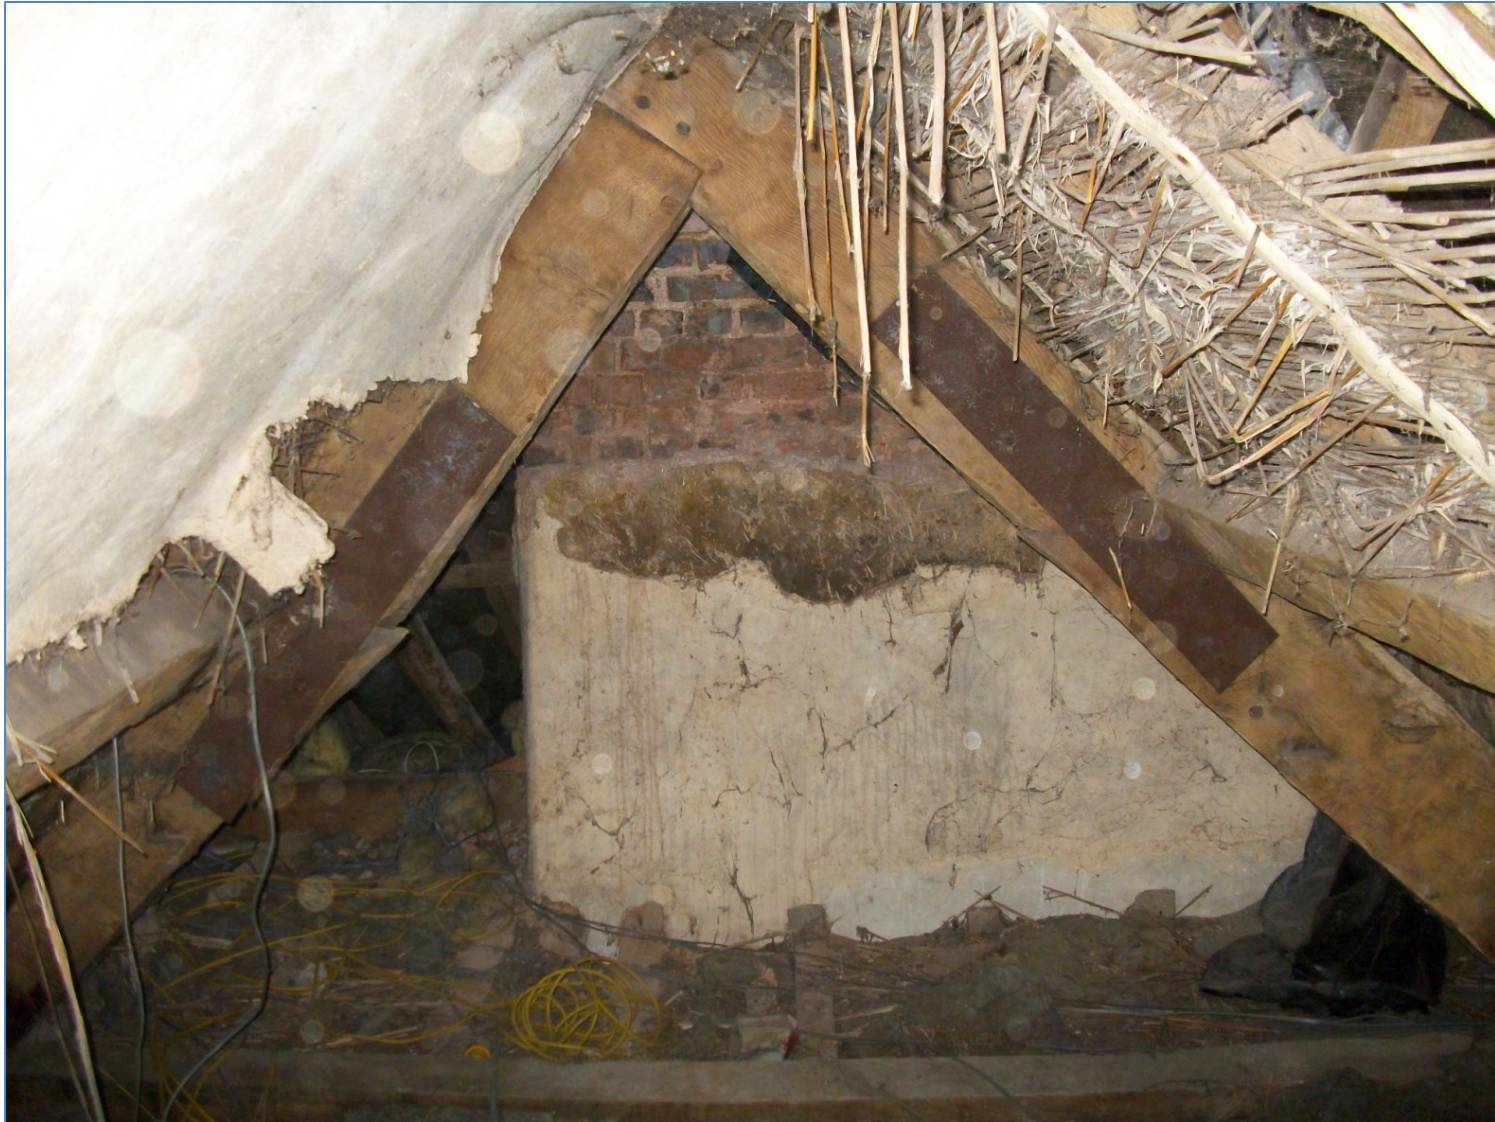
**Figure 4: Main range roof, truss 4 (east face)**

This consists of four trusses of principal rafters, lapped and pegged at the apex, two sets of purlins to each slope, tiebeams, and posts (Fig 4).

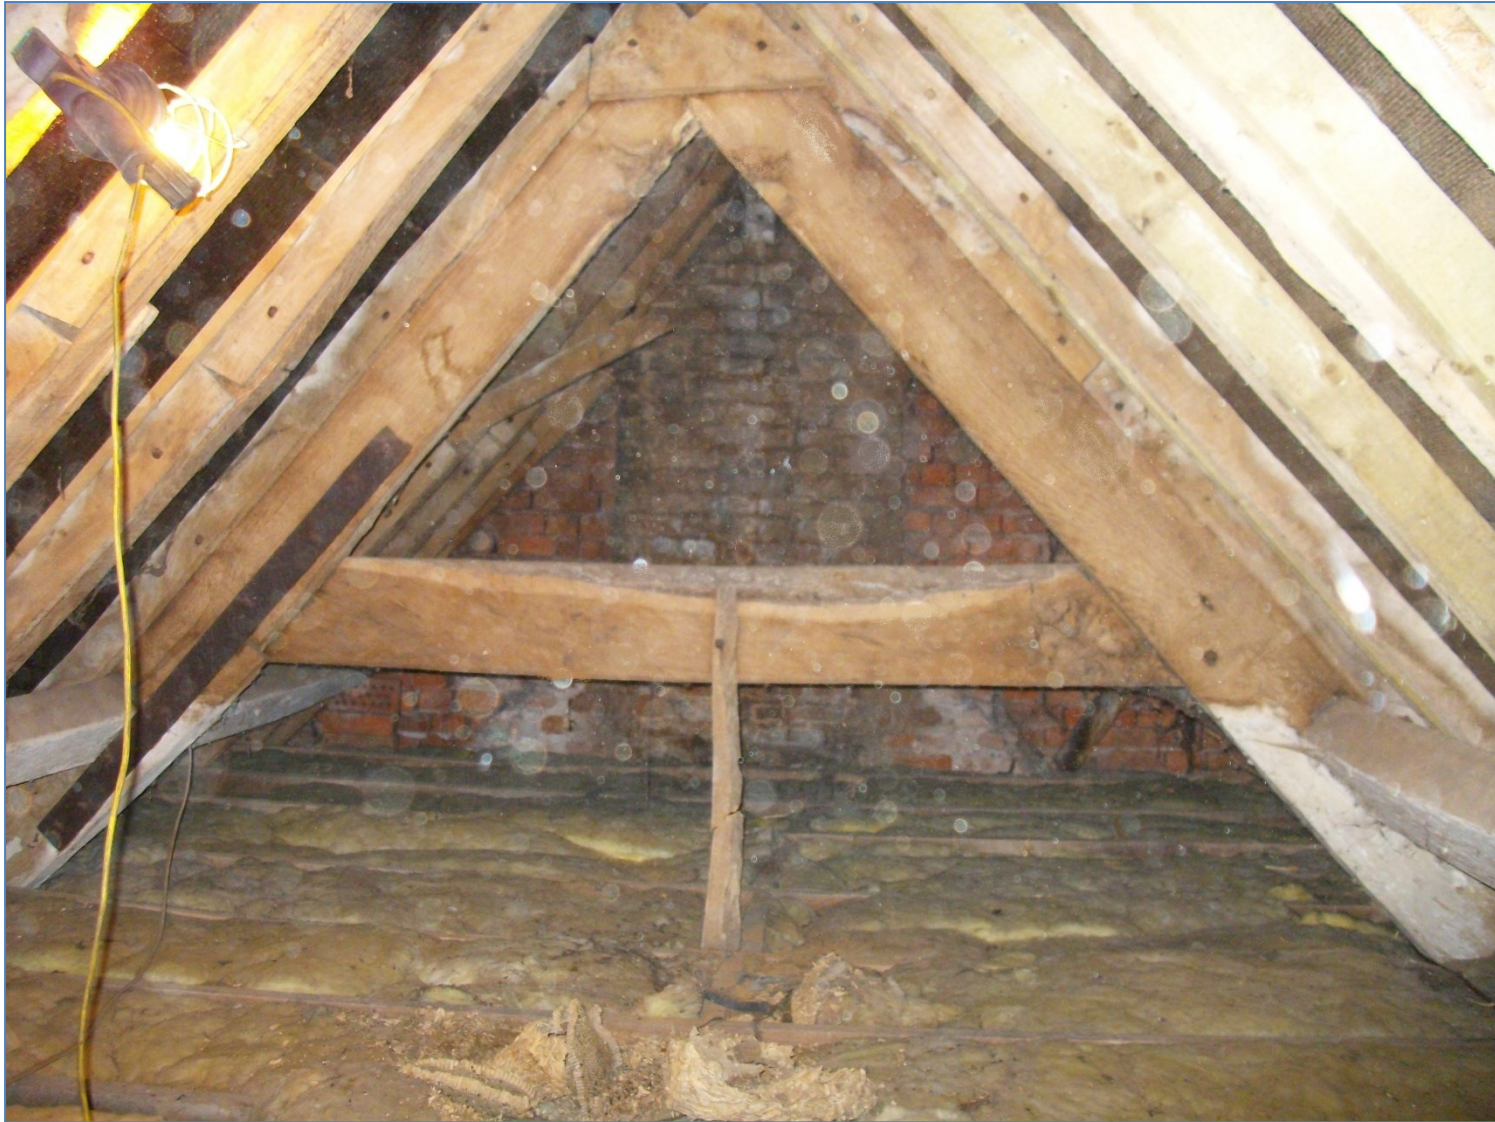
**Figure 5: South range roof, truss 6 (north face)**

The roof above this part of the building consists of three trusses of principal rafters, collars, and through purlins. The ridge purlin is set in a short horizontal timber nailed across the apex of the principal rafters (Fig 5). On the ground-floor are two chamfered ceiling beams (Figs 6 and 7).

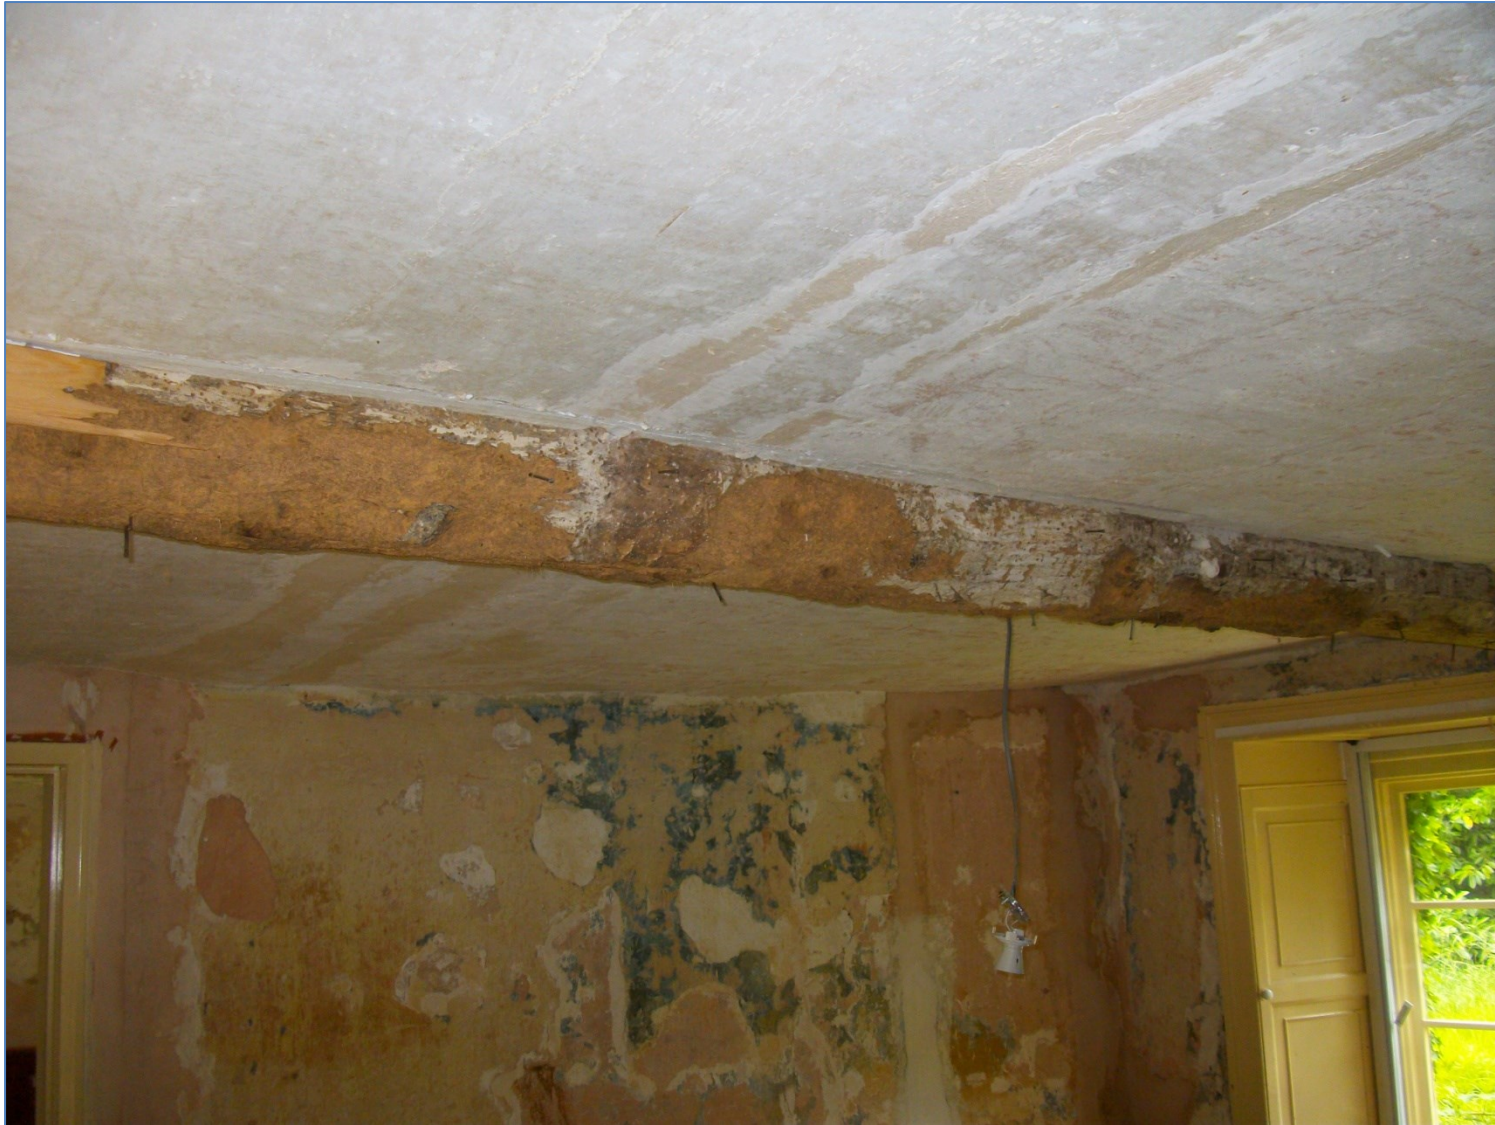
*Figure 6: South range; ground-floor ceiling beam (northern one)*

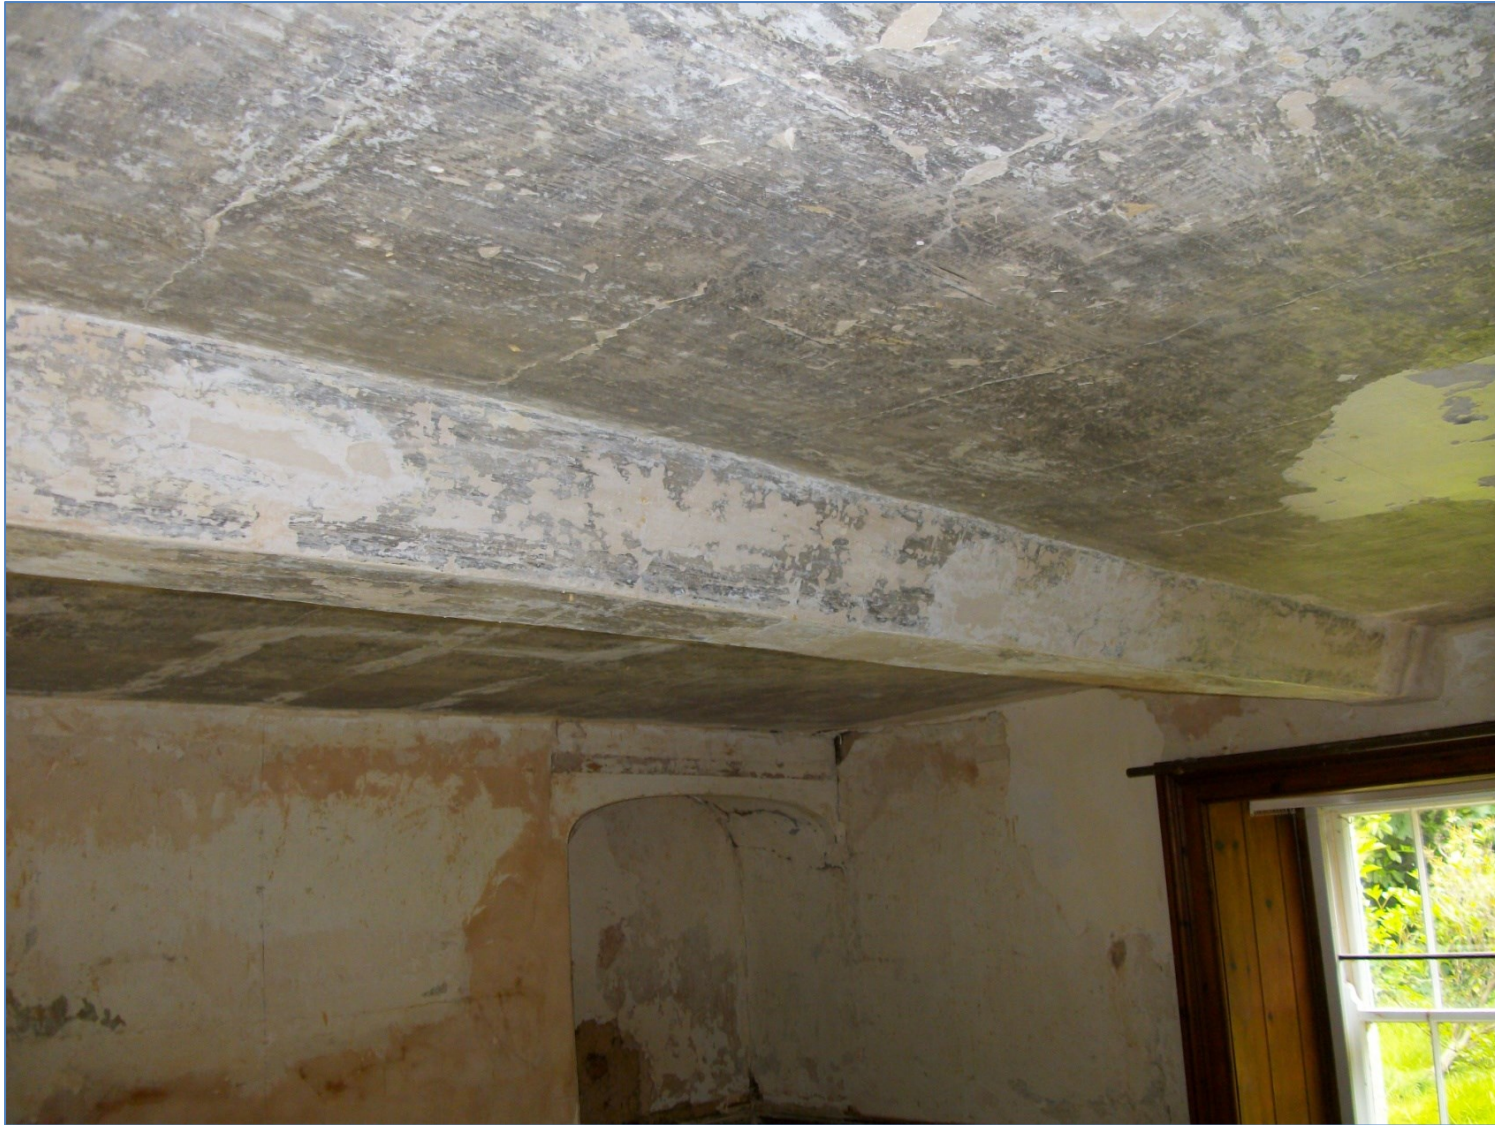
***Figure 7: South range; ground-floor ceiling beam (southern one)***

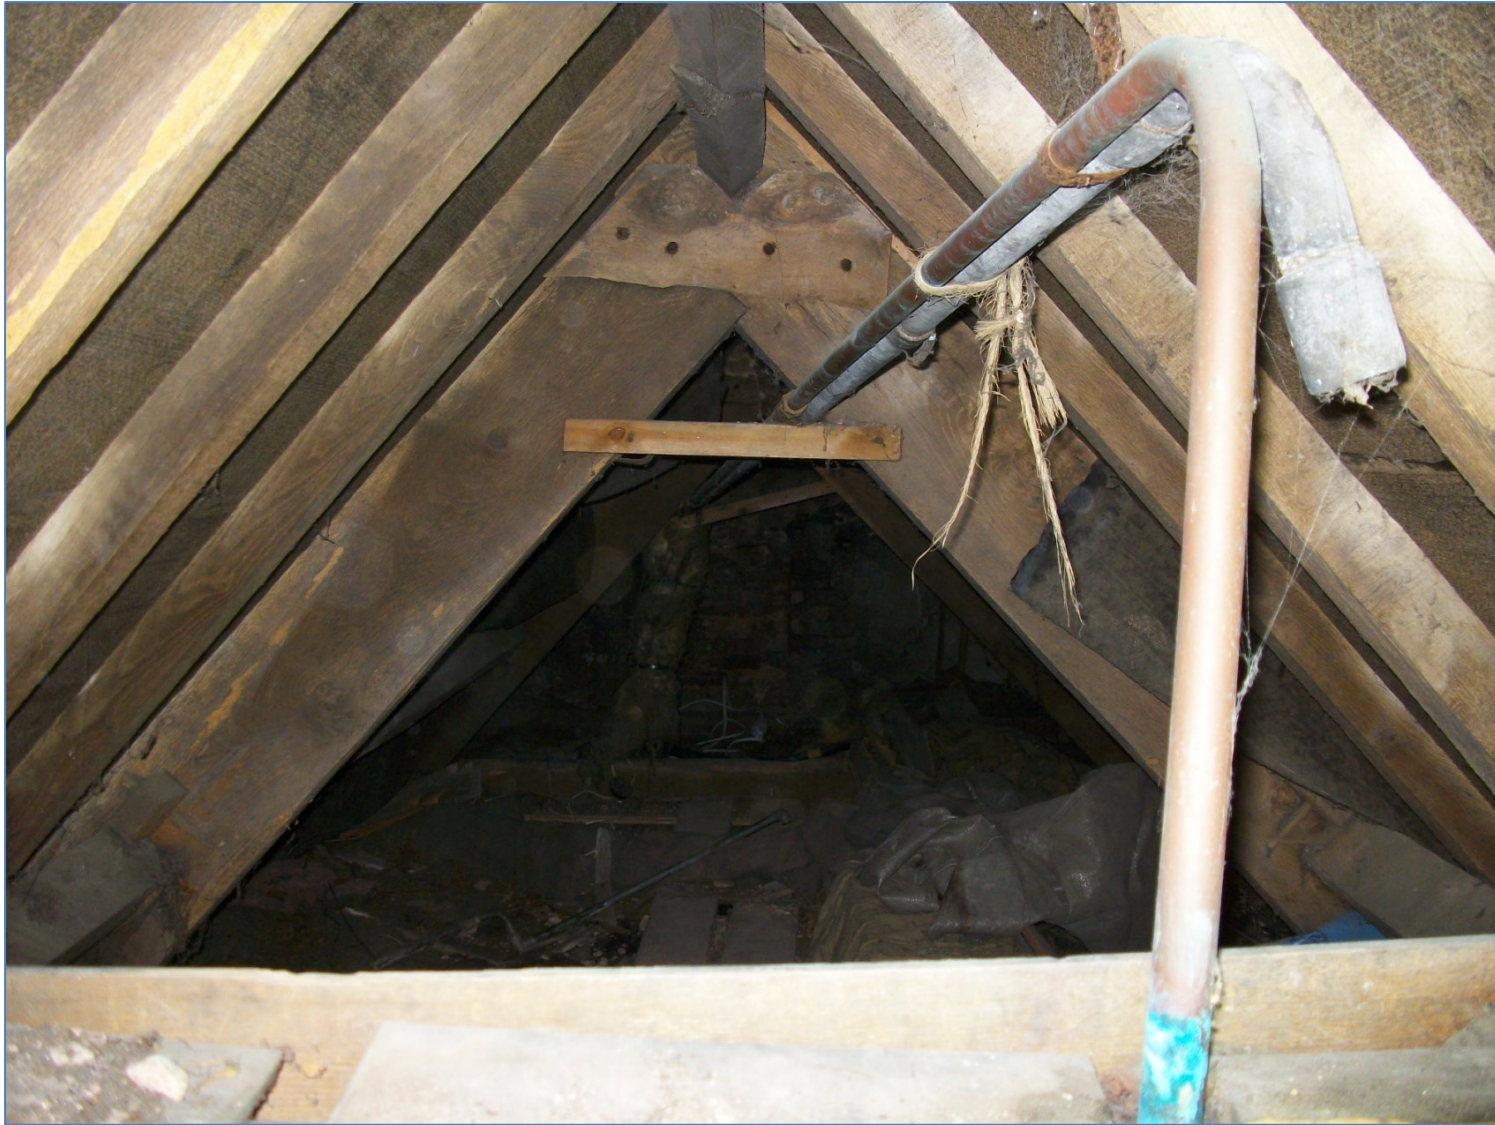
**Figure 8: North range roof, truss 8 (south face)**

This roof is constructed of much 'squarer cut' beams and is of a not so ancient appearance. There are two trusses of principal rafters, collars, ridge purlin, and two sets of through purlins (Fig 8). On the ground floor, in the kitchen is a ceiling beam of historic appearance (Fig 9).

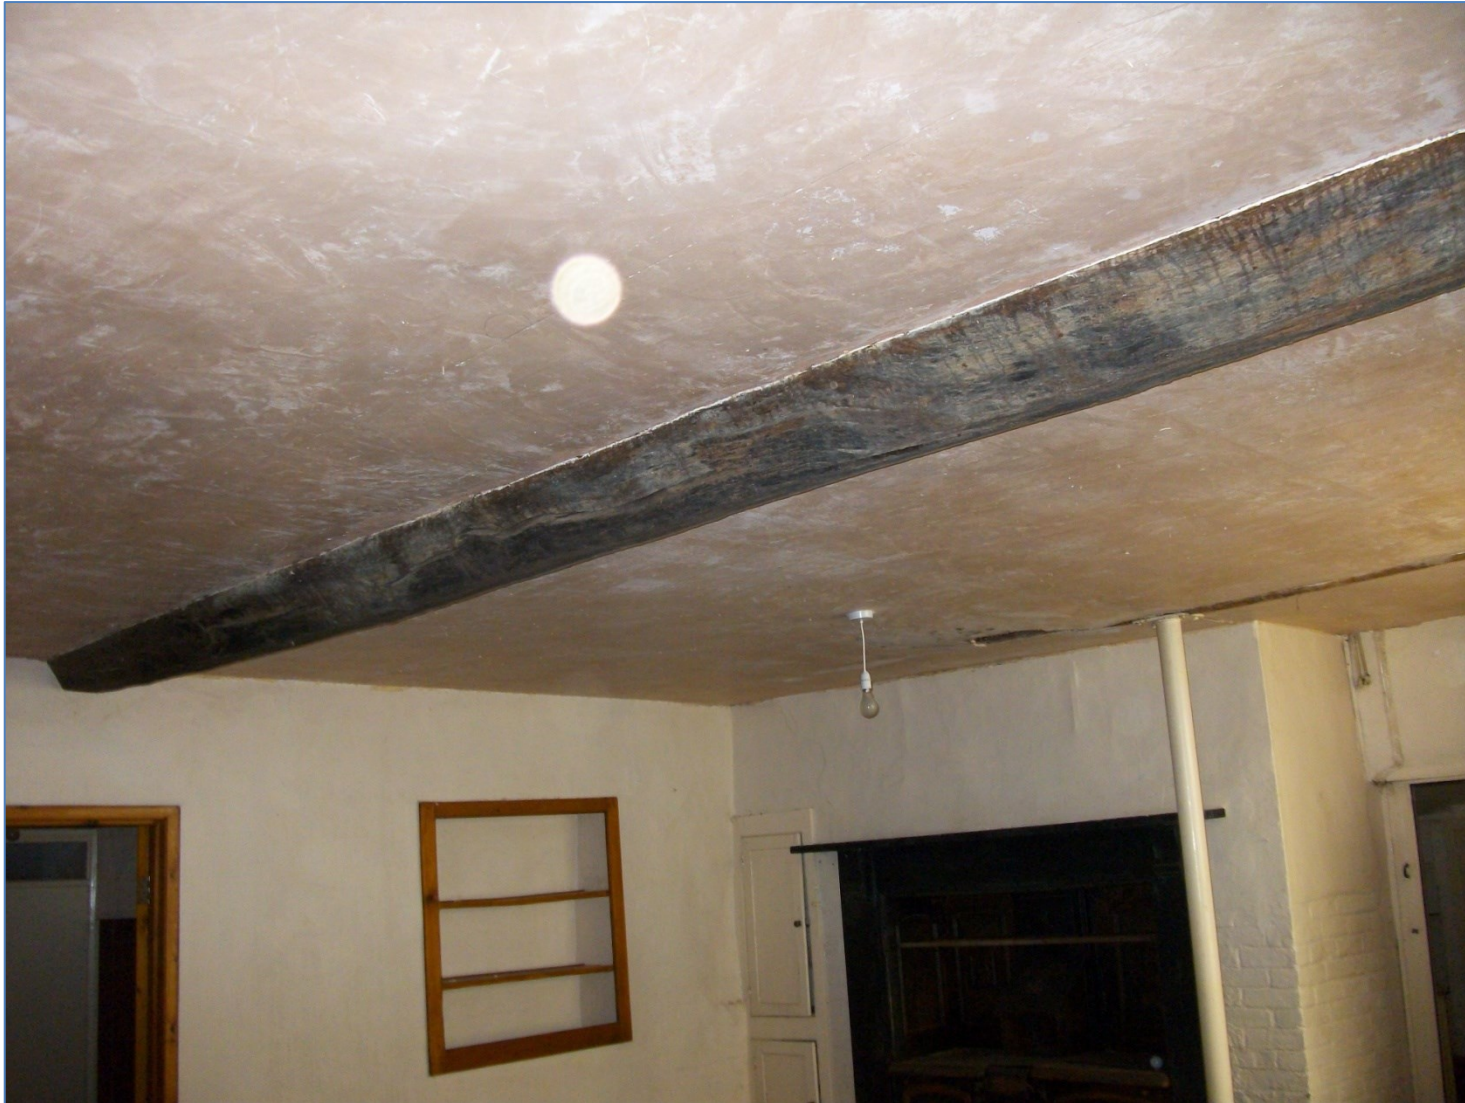
**Figure 9: North range; ground-floor ceiling beam**

The sample taken from the ground-floor ceiling beam in the kitchen of this range has a last-measured ring date of 1587. Without the heartwood/sapwood boundary it is not possible to calculate an estimated felling date for the timber represented except to say that it would be after 1602.

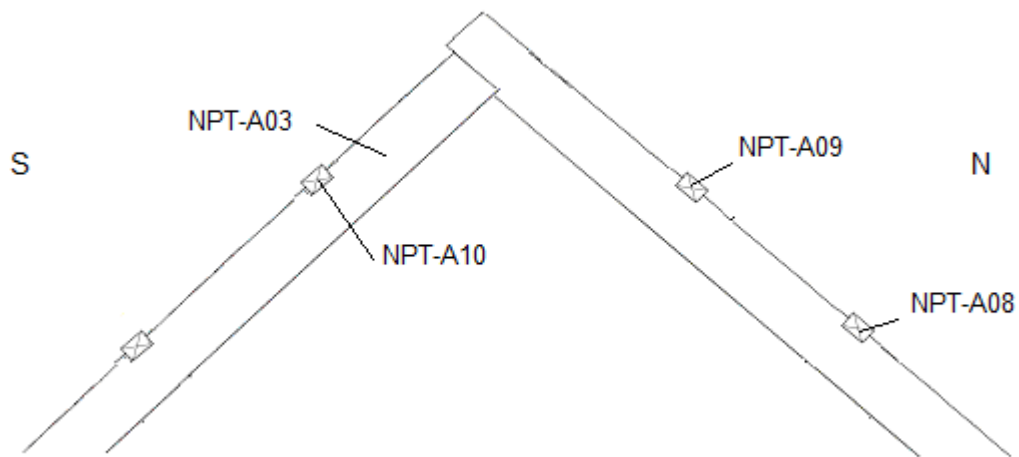
**Figure 12: Sketch of truss 2, showing the location of samples NPT-A03 and NPT-A08-10**

A total of 28 timbers was sampled with each sample being given the code NPT-A and numbered 01-28; samples NPT-A01-11 being taken from the main range roof, NPT-A12-20 from the south range roof, NPT-21-5 from the north range roof, and NPT-A26-8 from ground-floor ceiling beams (NPT-A26 from the north range and NPT-A27-8 from the south range). Trusses have been numbered from north-south and east-west (Fig 10). The location of samples was noted at the time of sampling and has been marked on Figures 11-20. Further details can be found in Table 1.

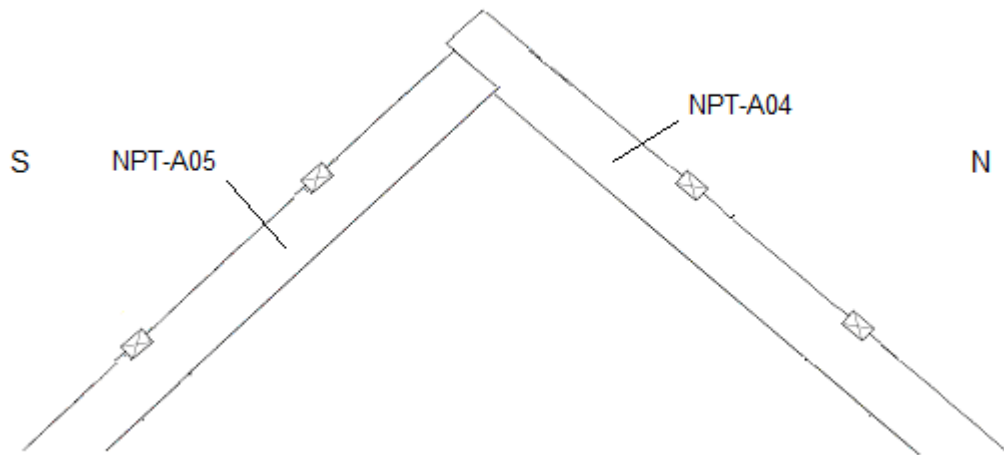
**Figure 13: Sketch of truss 3, showing the location of samples NPT-A04 and NPT-A05**

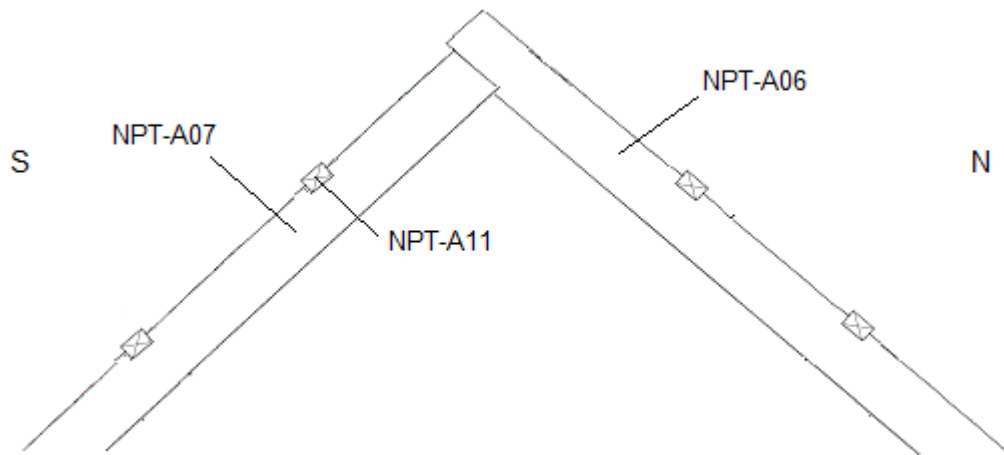
**Figure 14: Sketch of truss 4, showing the location of samples NPT-A06, NPT-A07, and NPT-A11**

Eight of the samples taken from the roof of this part of the building have been successfully dated. One of these samples (NPT-A06) was taken from a timber which retained complete sapwood but due to the extremely friable nature of these outer rings, it is estimated that 3-4 of these rings were lost during the sampling process. Adding the estimated 3-4 lost sapwood rings to the last-measured ring date of 1628 gives a felling date for the timber represented of c 1632. Five further samples have the heartwood/sapwood boundary ring, which in all cases are broadly contemporary and suggestive of a single felling. The average of these is 1612, allowing an estimated felling date to be calculated for the five timbers represented to within the range AD 1630-52 (this allows for sample NPT-A04 having a last measured ring date of 1629 with incomplete sapwood), consistent with these timbers also having been felled in c 1632. The final two dated main range roof samples do not have the heartwood/sapwood boundary ring date and so an estimated felling date cannot be calculated for them. However, with last measured heartwood ring dates in the late-sixteenth century it is likely that these were also felled at the same time as the rest of the timber utilised.

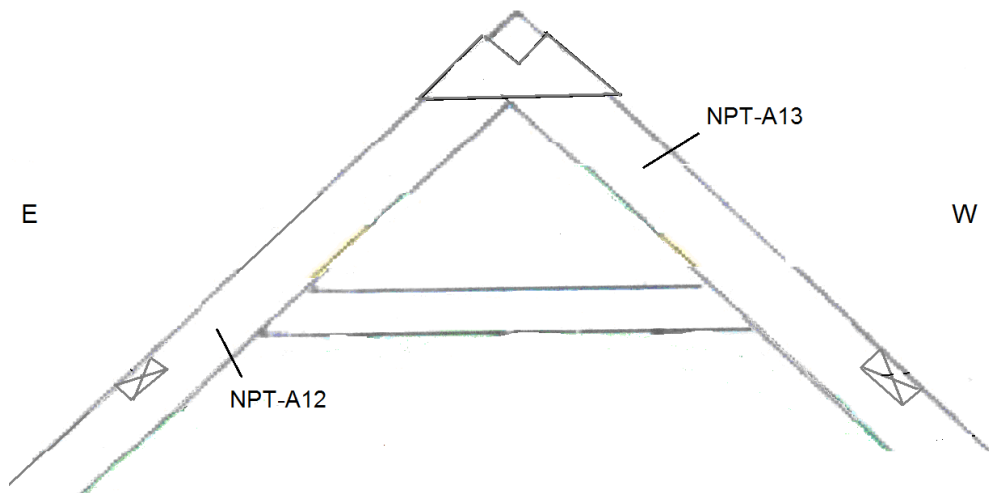
**Figure 15: Sketch of truss 5, showing the location of samples NPT-A12 and NPT-A13**

in this site sequence (NPT-A13) also has complete sapwood and compacted rings but in this case the problem is much worse and the whole of the sapwood is affected; an estimated 38 rings. The addition of these 38 rings to the last-measured ring of 1579 on this sample gives the timber represented a felling date of c 1617.

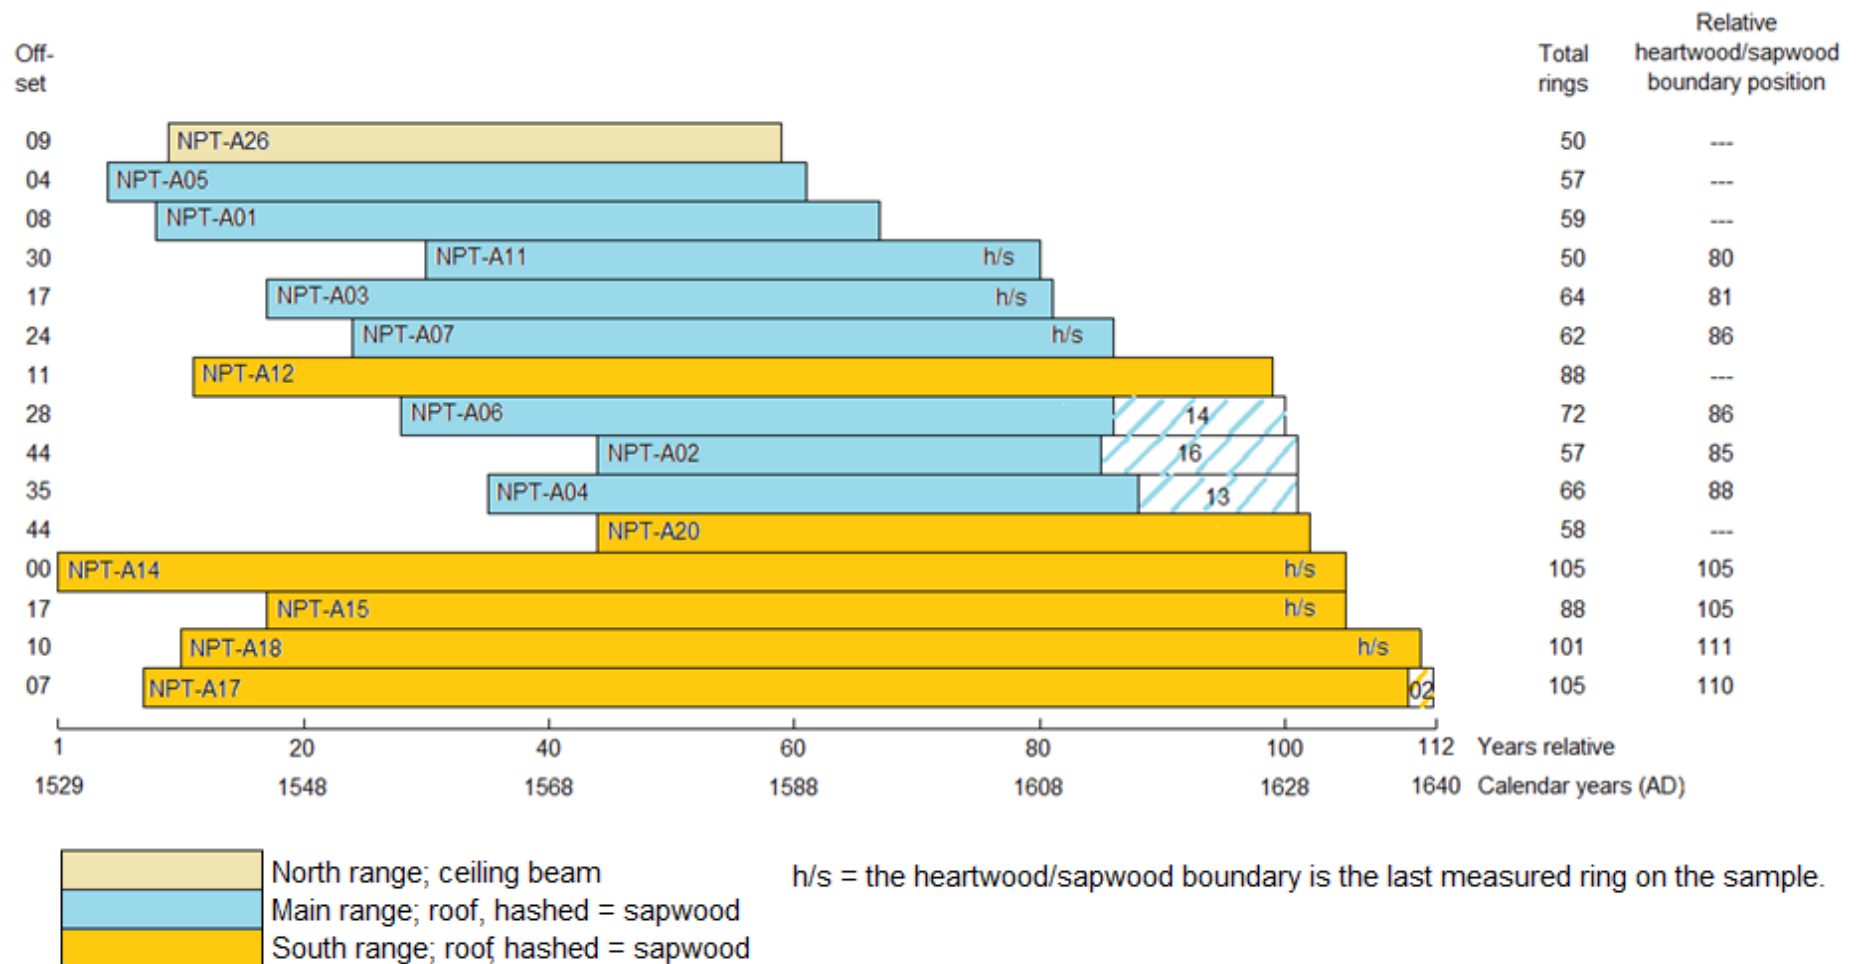
Figure 21: Bar diagram of samples in site sequence NPTASQ01

Firstly, 15 samples (eight from the main range roof, six from the south range roof, and one of the ceiling beams) matched each other and were combined at the relevant offset positions to form NPTASQ01, a site sequence of 112 rings (Fig 21). This site sequence was then compared against a series of relevant reference chronologies for oak where it was found to match consistently and securely at a first-measured ring date of 1529 and a last-measured ring date of 1640. The evidence for this dating is given by the *t*-values in Table 2.
