**56 POTTER STREET,
MELBOURNE,
DERBYSHIRE;**

TREE-RING ANALYSIS OF TIMBERS

**A J ARNOLD
R E HOWARD**

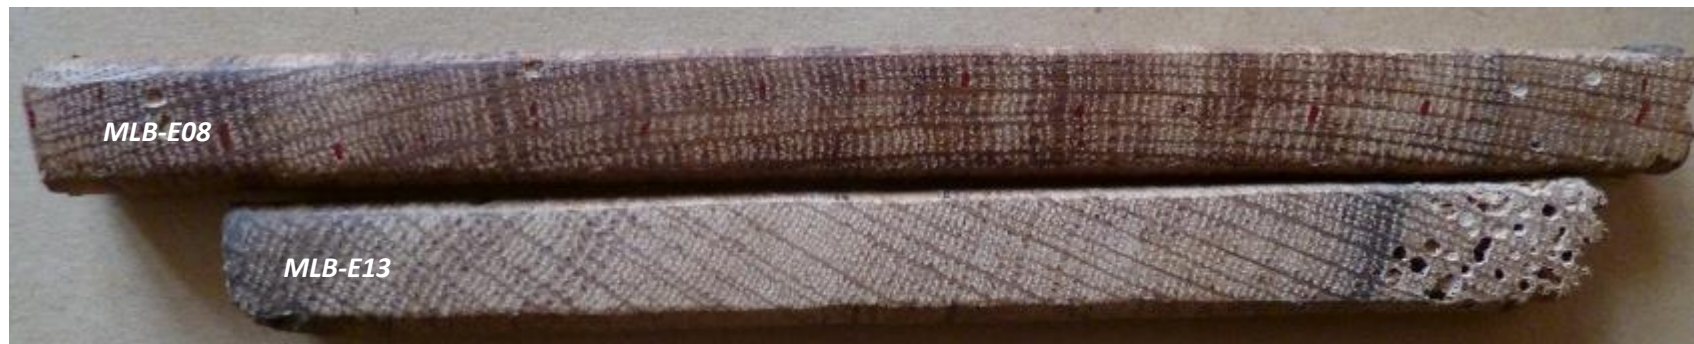
Figure 4: Graphic representation of the cross-matching of samples MLB-E08 and E13

When cross-matched at the correct positions, as here, the variations in the rings of two samples correspond with a high degree of similarity. As the ring widths of one sample increase (represented by peaks in the graph), or decrease (represented by troughs), so too do the annual ring widths of the second sample. This similarity in growth pattern is a result of the two trees represented having grown in the same area *at the same time*. The growth ring pattern of two samples from trees grown at different times would never correspond so well.

Tree-ring dating relies on a few simple, but quite fundamental, principles. Firstly, as is commonly known, trees (particularly oak trees, the timber most commonly found preserved in archaeological excavations) grow by adding one, and only one, growth-ring to their circumference each, and every, year. Each new annual growth-ring is added to the outside of the previous year's growth just below the bark. The width of this annual growth-ring is largely, though not exclusively, determined by the weather conditions during the growth period (roughly March–September). In general, good conditions produce wider rings and poor conditions produce narrower rings. Thus, over the lifetime of a tree, the annual growth-rings display a climatically influenced pattern. Furthermore, and importantly, all trees growing in the same area at the same time will be influenced by the same growing conditions and the annual growth-rings of all of them will respond in a similar, though not identical, way (Fig 4)
