**TREE-RING ANALYSIS OF TIMBERS FROM
'PENY'S HEY',
43 HEY LANE,
LOWERHOUSE,
HUDDERSFIELD,
WEST YORKSHIRE**

**A J ARNOLD
R E HOWARD
M HURFORD**

Summary

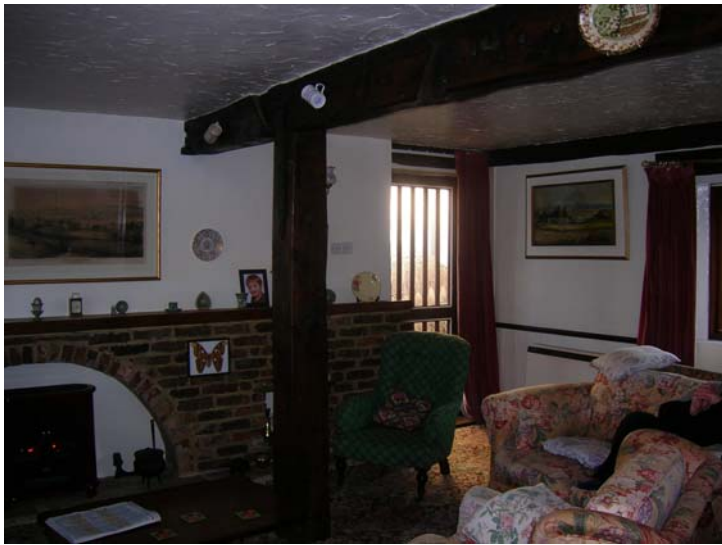
Figure 4a-c: View of ground-floor timbers

4a above: view of the ceiling beam and vertical post in the living room

The timbers presently within Peny's Hey comprise what are now single oak bridging beams (they may originally have been purlins and are reused here) to two of the ground-floor ceilings, that of the living room and the kitchen (at the east end and middle of the building respectively), as well as a series of door and window lintels, wall plates or posts. There is also a bressummer to the fireplace in the dining room at the west end of the house (Fig 4a-c). To the upper floors the timbers comprise a single principal rafter truss with tiebeam, vertical queen posts, and diagonal struts, at the west end of the building, there also being single purlins to each pitch of the roof at the west end (Fig5 a/b). A number of these timbers showed evidence, by way of redundant mortices and pegholes, of having been salvaged and reused in their present position. All the roof timbers to the middle and east end of the house are modern replacements.

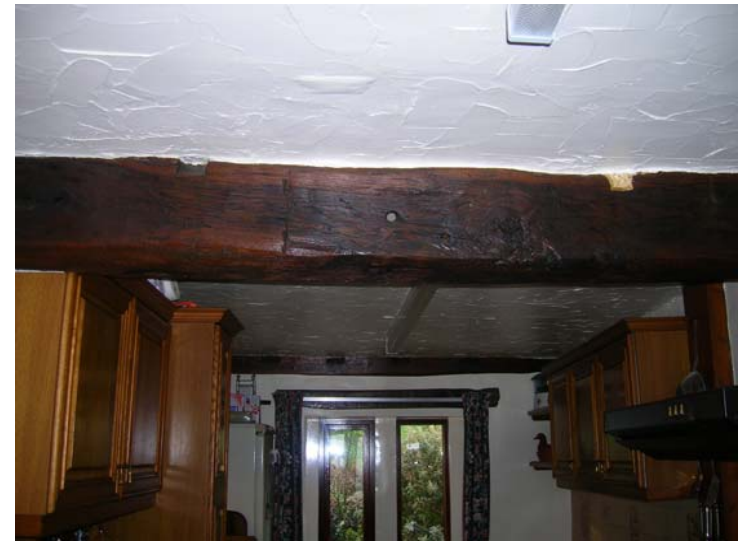
4b above: view of the ceiling beam in the kitchen

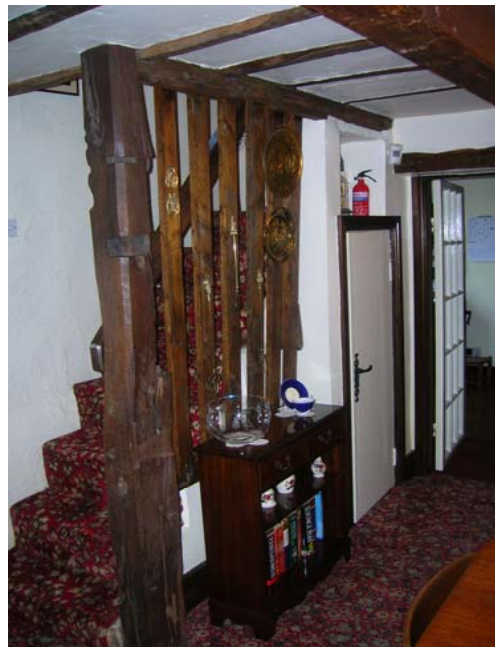
4c left: view of the vertical post in the dining room

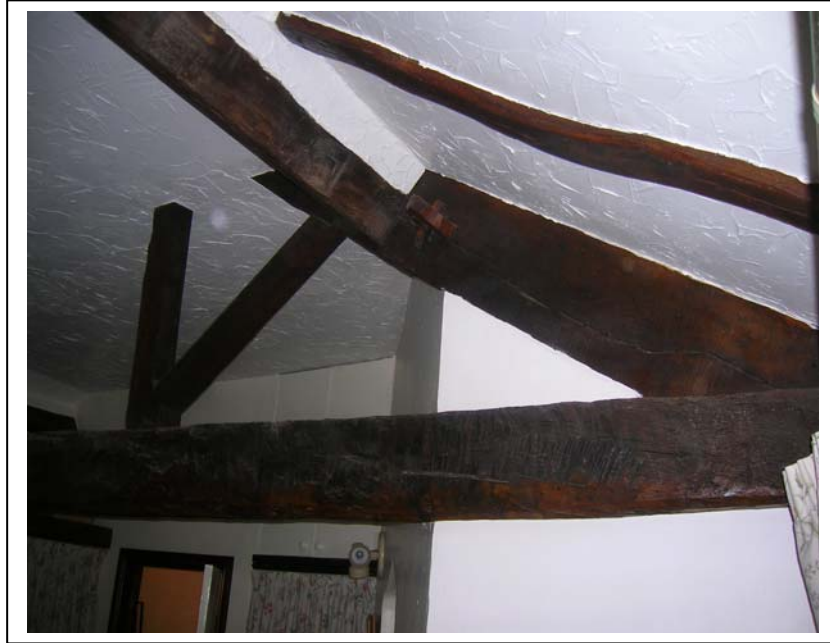
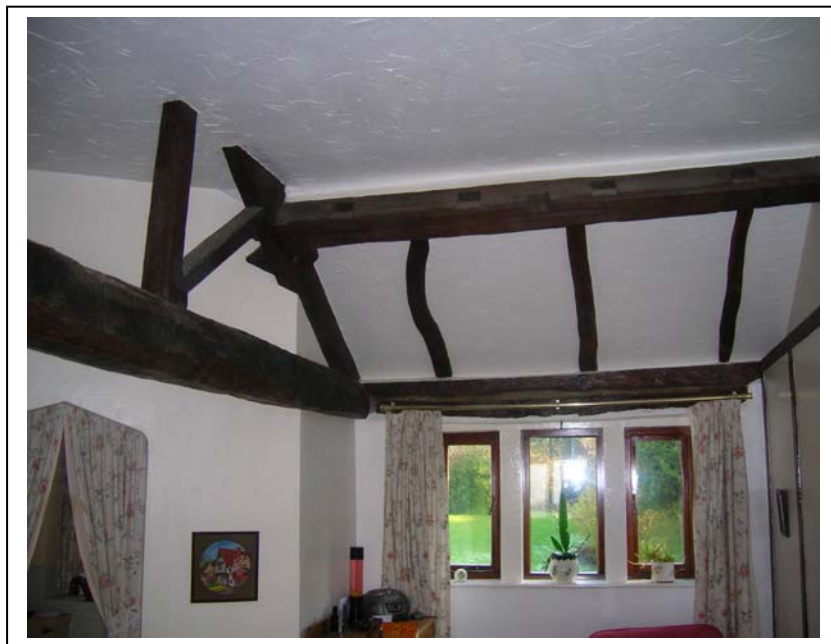
Figure 5a (top): Views of the principal rafter truss
Fig 5b (bottom): View of the south-west purlin

The sapwood of the remaining three dated samples, HUD-B01, B08 and B09 is much later, though the actual felling date of the trees represented by these is a little less precise. One sample, HUD-B09, is from a timber, the south-west purlin of the roof, which retains complete sapwood. However, a small portion of the sapwood, about 5mm, was lost during coring. It is estimated that this loss represent no more than 5-7 rings, and thus, given that the last extant sapwood ring on
