**TREE-RING ANALYSIS OF TIMBERS FROM
EDEN FARM BARN,
KIRKANDREWS ON EDEN,
NR CARLISLE,
CUMBRIA**

**A J ARNOLD
R E HOWARD**

SUMMARY

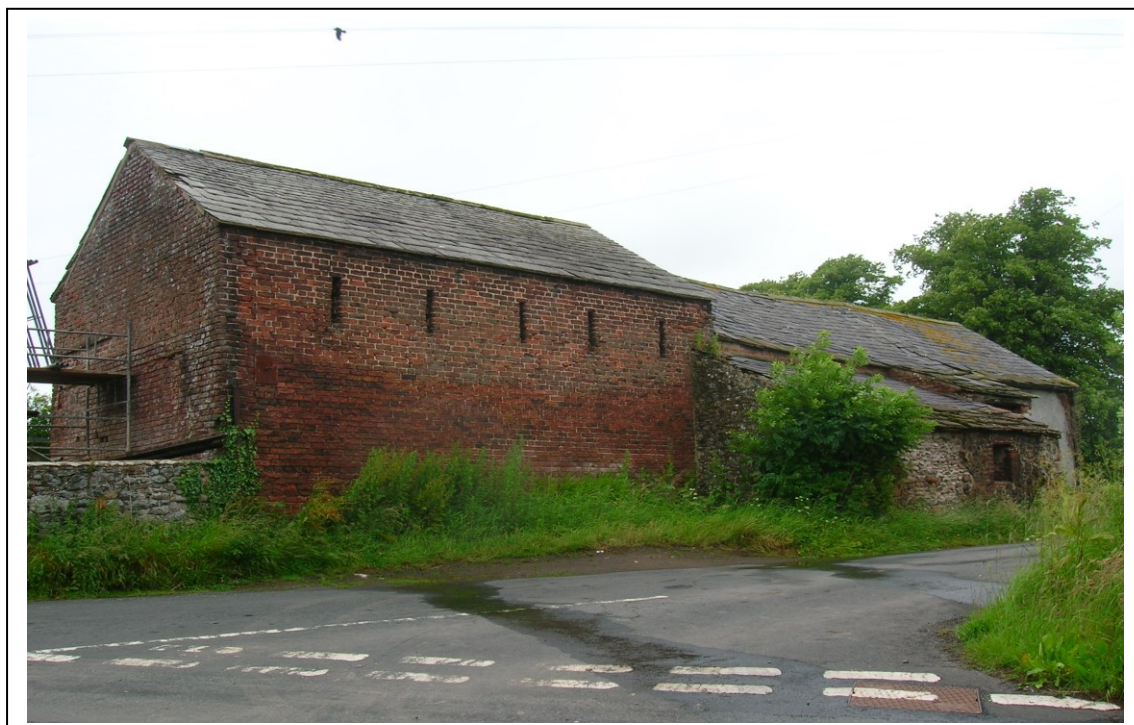
(viewed from the south-west)
