**KENARDINGTON MANOR,
KENARDINGTON,
KENT;**

TREE-RING ANALYSIS OF TIMBERS

**A J ARNOLD
R E HOWARD**

SEPTEMBER 2012

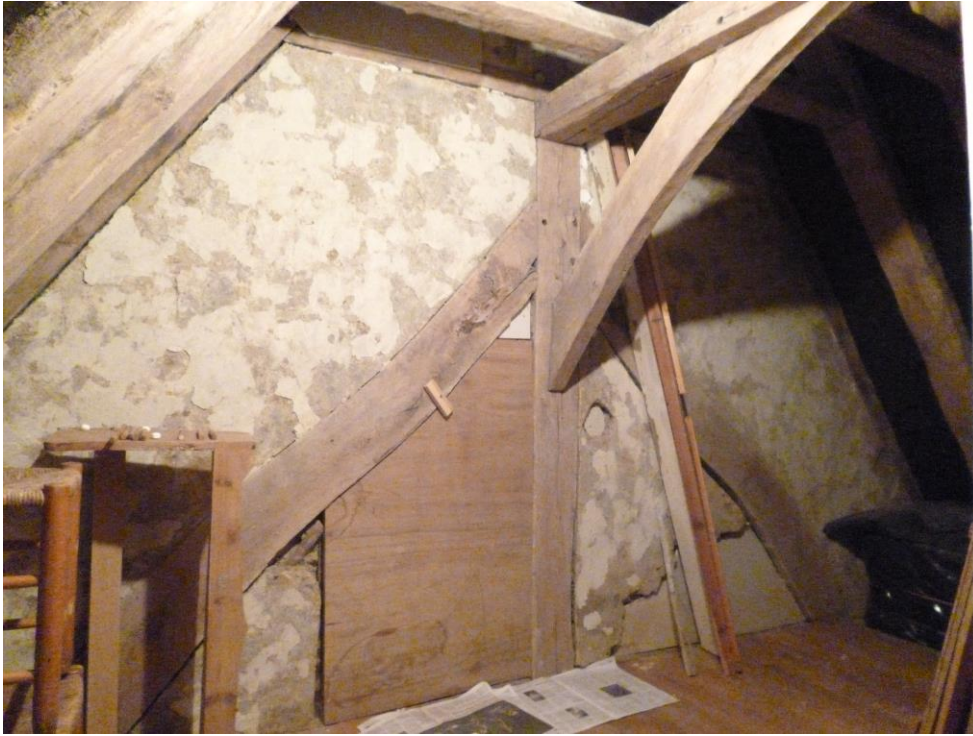
Figure 2a (top): View of the west face of truss 1

Note the ogee down-braces from the crown-posts to the tiebeams as well as the up-braces from the crown-posts to the collar purlin

The four east-most crown-post trusses at Kenardington Manor appear to be plain (ie, without any moulding or other decoration)(Fig 2a/b) while the fifth, west-most, truss has moulded decoration to the tiebeam, and the crown post has been given some embellishment as well (Fig 2c). The tiebeam of this truss, furthermore, is 'cranked', ie, it has a distinct angle, or bend, at its mid-point from whence rises the crown-post, whereas the tiebeams of the other four trusses appear to be straight. Truss five is also different from the others in that there are no down-braces from the crown-post to the tiebeam, such ogee braces being present on the first four trusses. All the trusses have up-braces from the crown-post to the collar purlin, with the fifth truss also having braces between its crown-post and collar.

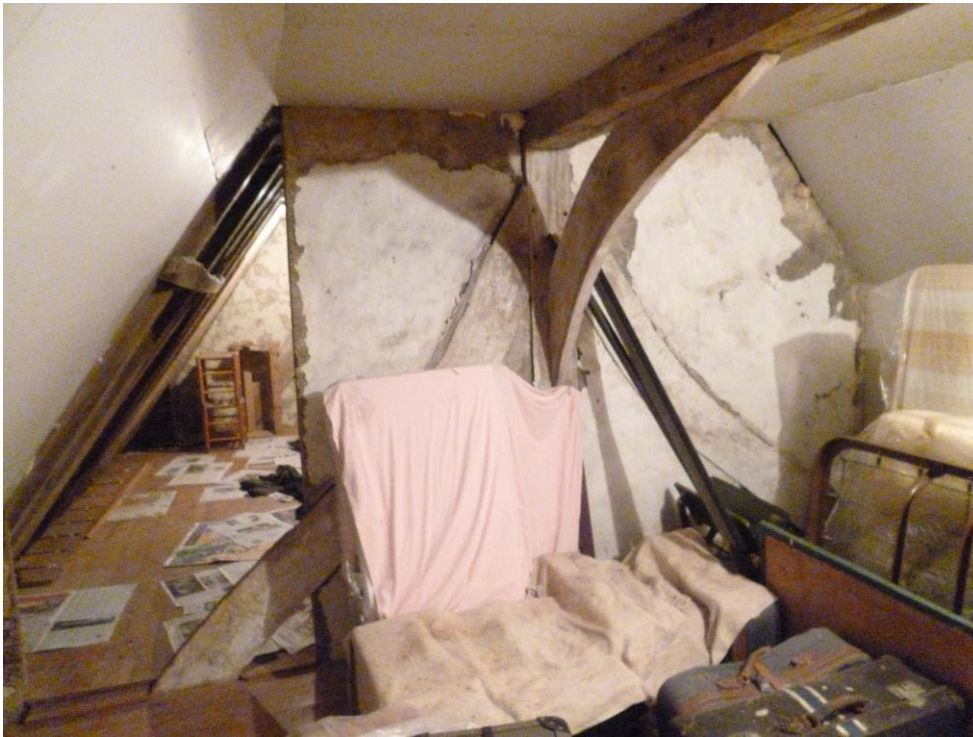
Figure 2b (bottom): View of the west face of truss 2

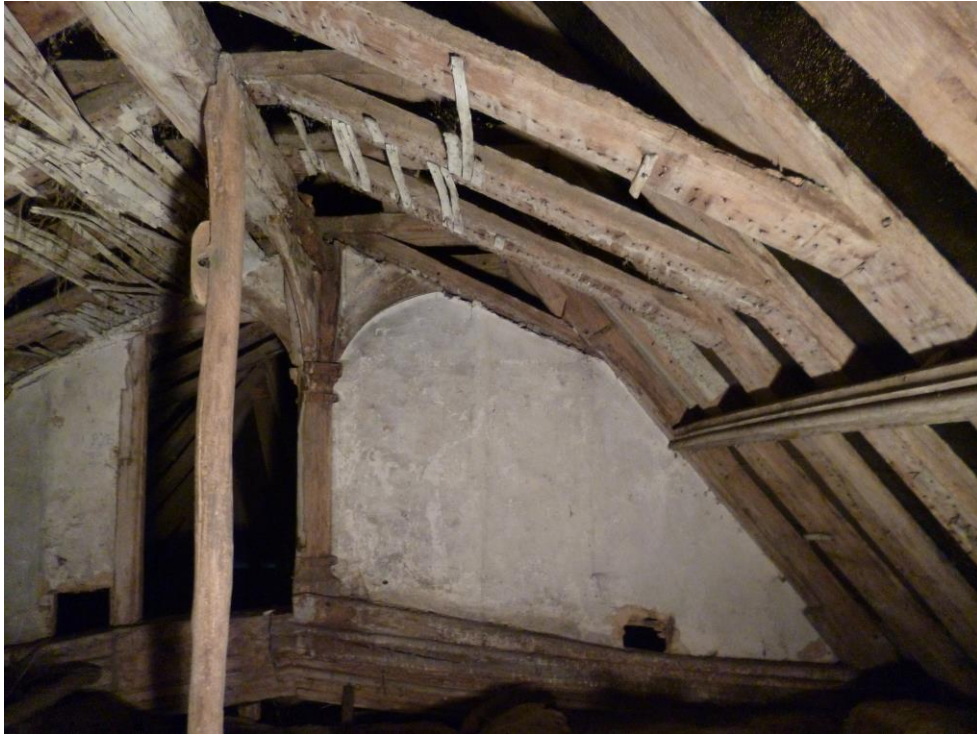
Figure 2c (top): View of the west face of truss 5. Note the cranked and moulded tiebeam and the decorated crown post of this truss, as well as the absence of down-braces. Note also the moulded purlin in this bay as well as the soulaces between rafters and collars

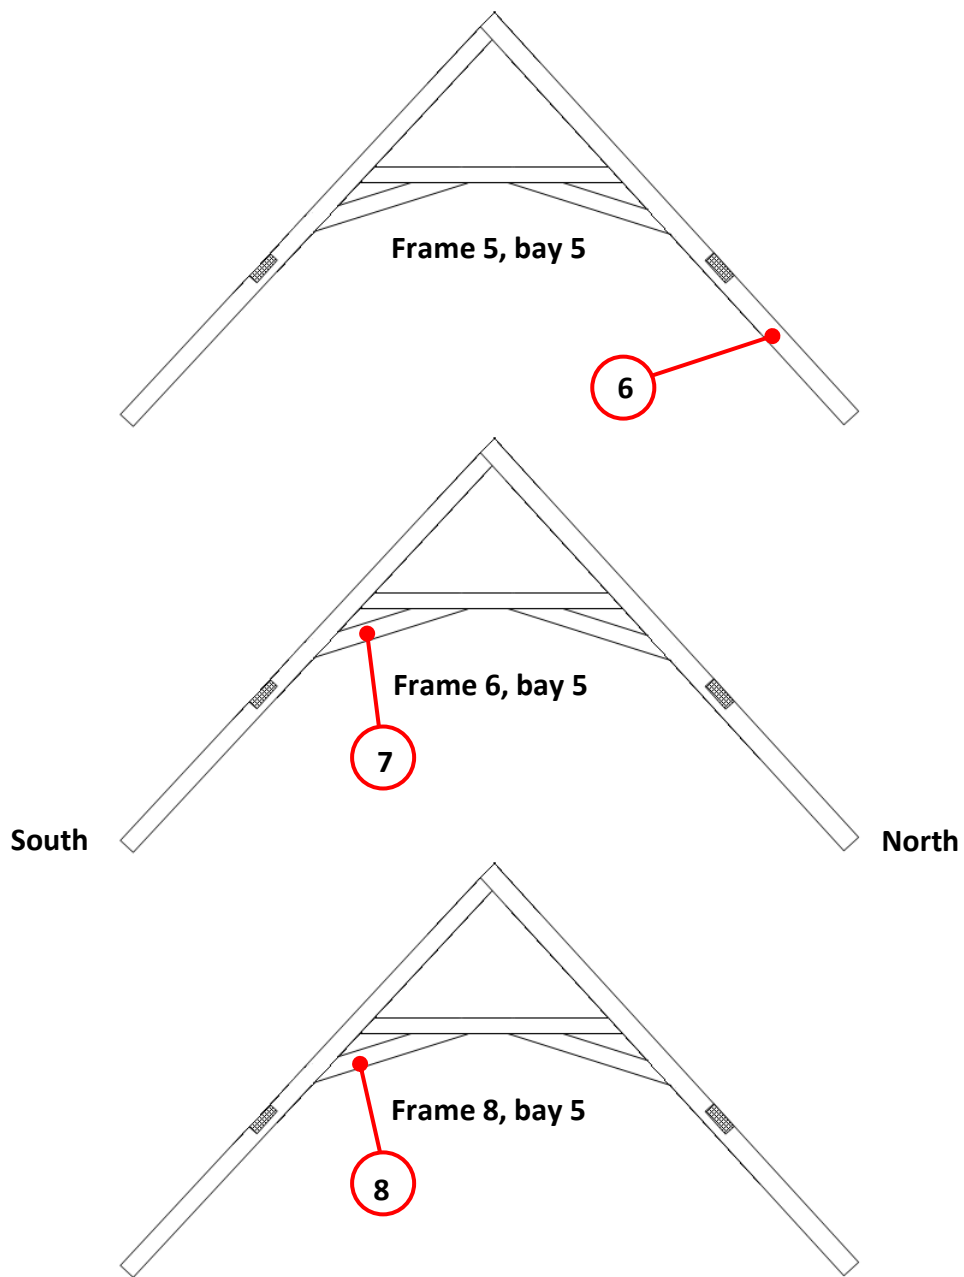
Figure 4b: Schematic representation of the trusses and frames to show sampled timbers

The positions of the sampled timbers were located and recorded at the time of coring, the details of these samples being given in Table 1. These details include the specific timber sampled and its location, the total number of rings each sample has, and how many of these, if any, are sapwood rings. The individual date span of each dated sample is also given. In this Table the trusses, bays, and individual timbers, have been located on a site north–south/east–west basis as appropriate, the front of the house taken to site-north. The positions of the samples have also been recorded on simple schematic plans or drawings of the trusses and on photographs. These are reproduced here as Figures 3 and 4a-d.

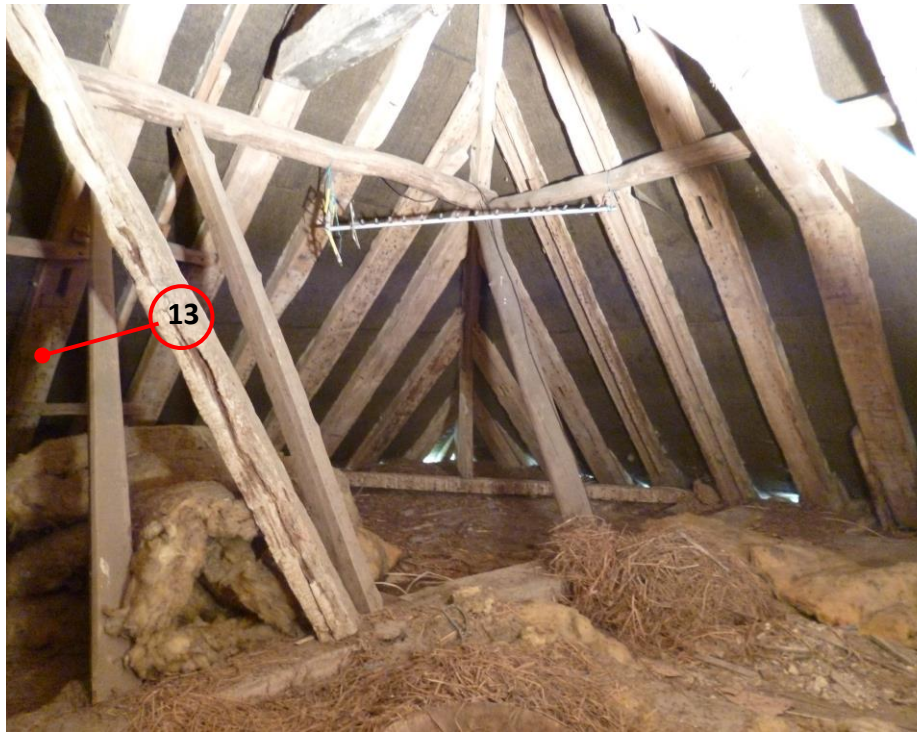
Figure 4d: Photograph of the west hip end to show sampled timber
