**PORCH HOUSE,  
1 WATERSIDE,  
CASTLE COMBE,  
CHIPPENHAM,  
WILTSHIRE**

**TREE-RING ANALYSIS OF TIMBERS**

**NOVEMBER 2012**

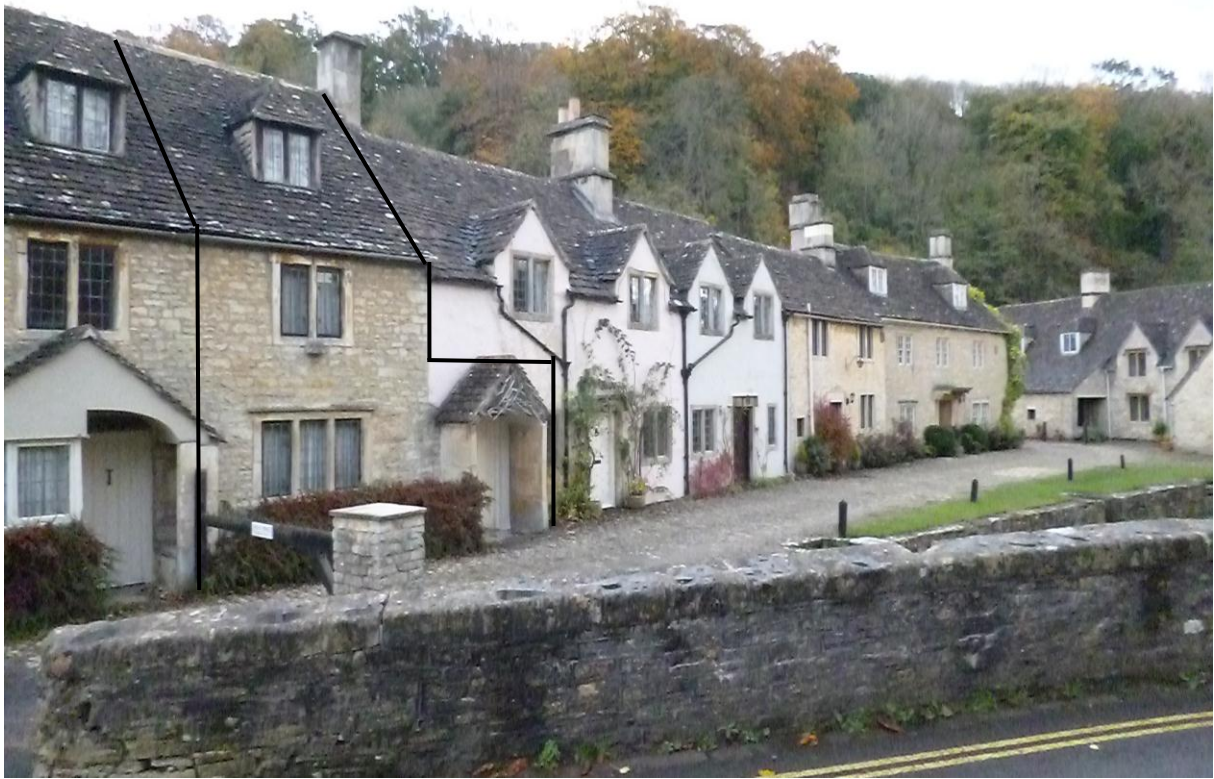
Figure 2: Porch House, 1 Waterside, Castle Combe, outlined, showing the entry from number 2

Porch House (number 1 Waterside, close to the river Bybrook) in Castle Combe, Wiltshire (ST 841 766, Figs 1a/b) (popularly believed to be the prettiest village in England), presents itself as a very fine, two-storey with attic-floor cottage built of Cotswold stone beneath a stone tile roof. The attic floor rooms are lit by a gabled dormer window. Number 1 forms part of a terrace of other cottages to Waterside, notably numbers 2 and 3, a pair of cottages with rough rendered stone, and a similar stone tiled roof, and listed as being of later-eighteenth century date. The left hand, gabled, door of number 2 is now part of 1 Waterside over which, at first floor level and above, there is a flying freehold (Fig 2). There is a substantial chimney between numbers 1 and 2, with some interesting stonework at ground floor level.

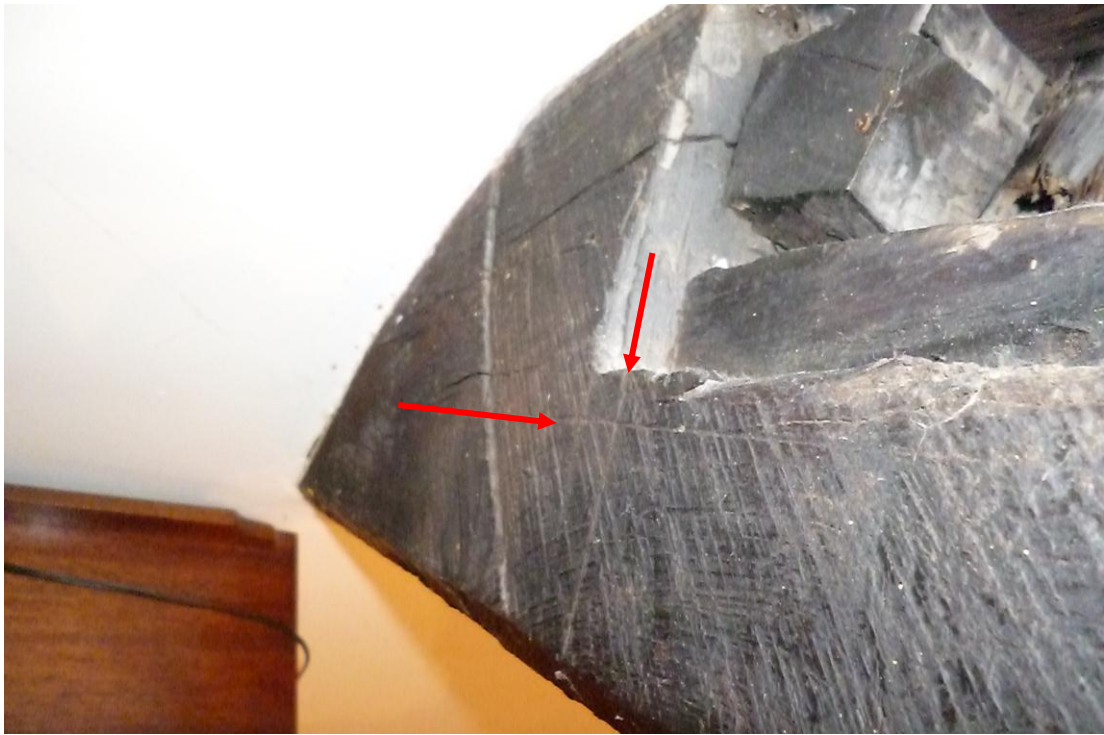
**Figure 4a:** Scribed marking-out lines for the cutting of the mortice joint in the front principal rafter

The carpentry of the timbers appears to be of some quality, the mortices, for example, being marked-out with scribe lines (Fig 4a), and the joints being numbered for ease of assembly (Fig 4b). It would appear that many of the baulk timbers have been carefully half-sawn from whole trees using a quality saw, this action having left very fine, evenly spaced, saw-marks on the one face of such timbers (Fig 4c). The other, apparently outer, faces of the trees have been cut reduced or trimmed using an adze or axe (Fig 4d). One feature of note is the compass-scribed circle seen to the north face of the east, or rear, principal rafter, just below the mortice for the purlin (Fig 4e). It is possible that this was the first stage in the marking out of a never completed 'floret' or rosette, patterns which are quite often seen on medieval timbers. The meaning of these marks is unknown, and indeed, it is probable that they are of no significance other than being something of a 'doodle', or a marking-out exercise undertaken by a carpenter during a possibly moment of relaxation or idleness.

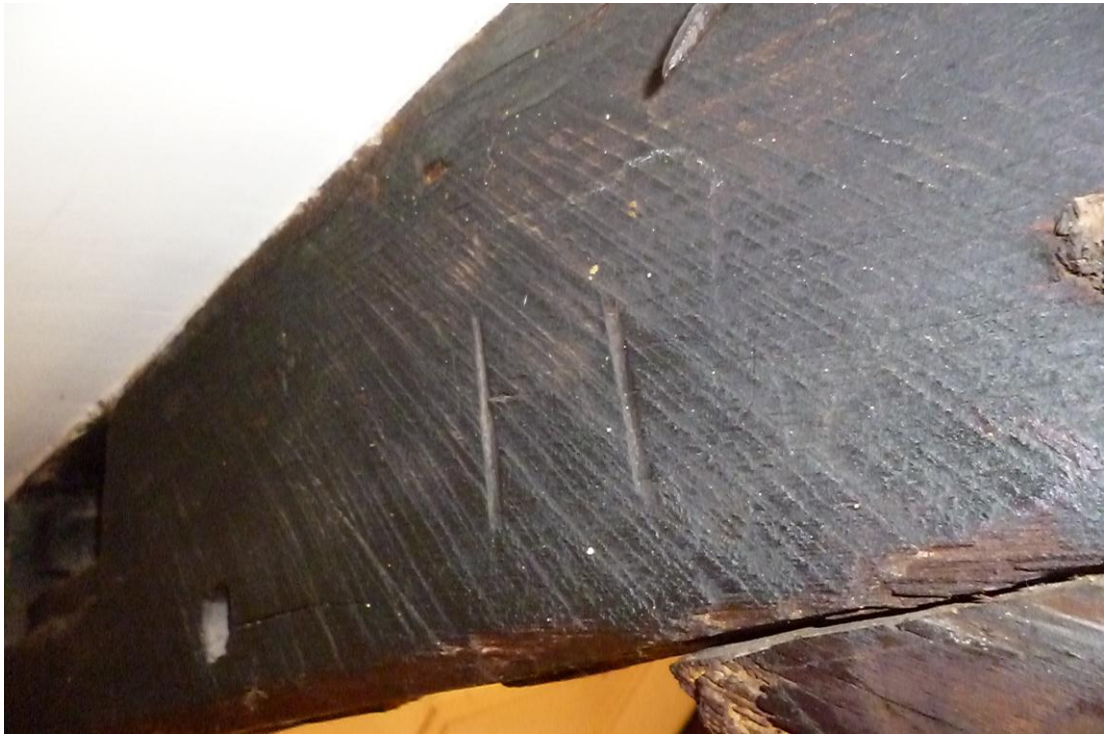
**Figure 4b:** Assembly mark for a mortice and tenon joint between collar and rafter

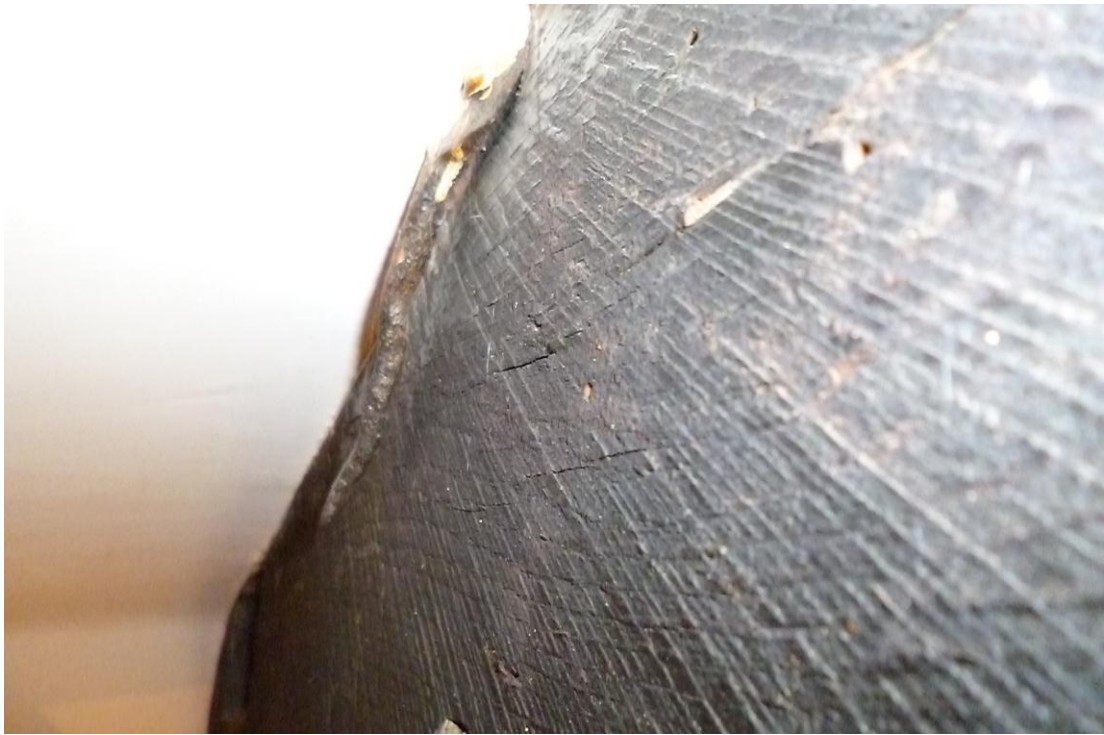
**Figure 4c:** Saw marks to the face of one timber forming parallel lines

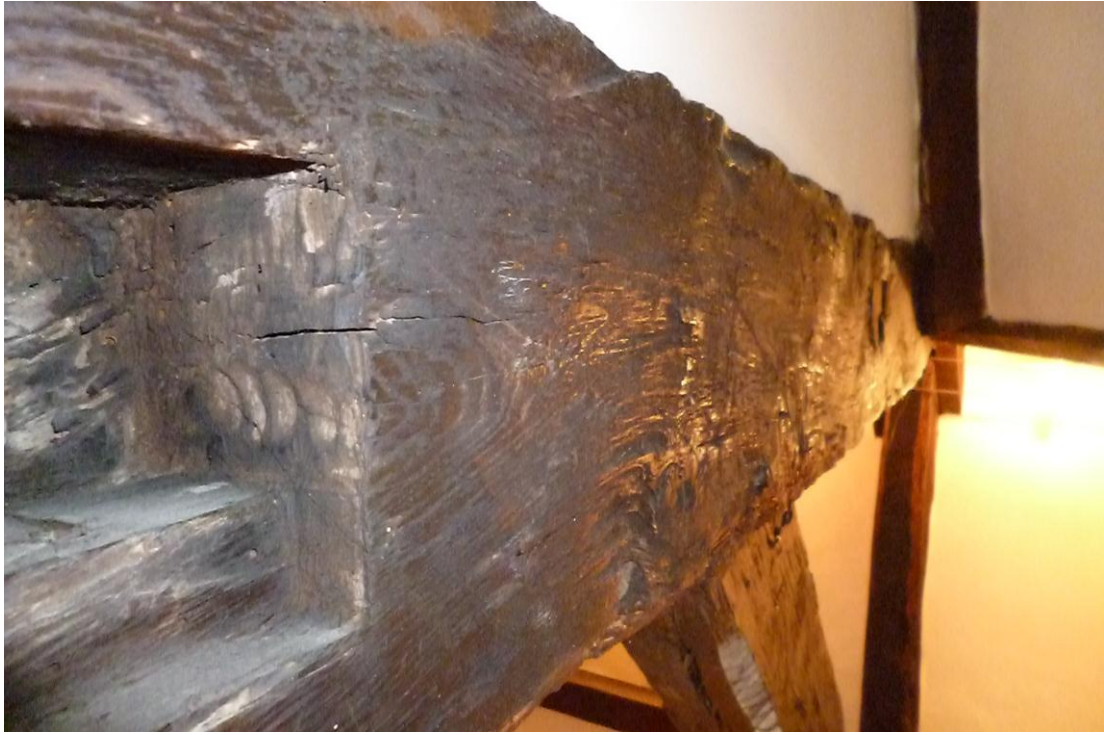
**Figure 4d:** Adze marks to the face of timber forming characteristic 'scallop'

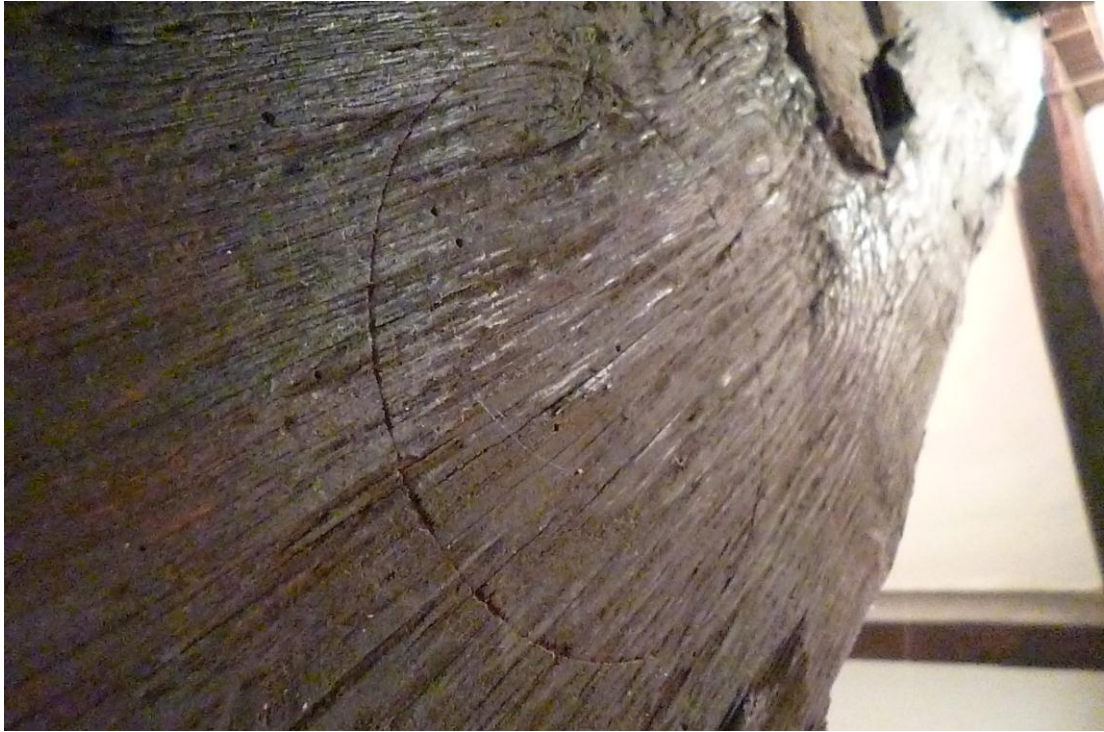
**Figure 4e:** Circular 'compass' mark to timber, possibly the beginnings of a decorative 'florets' inscription, and as it might have looked, completed, below

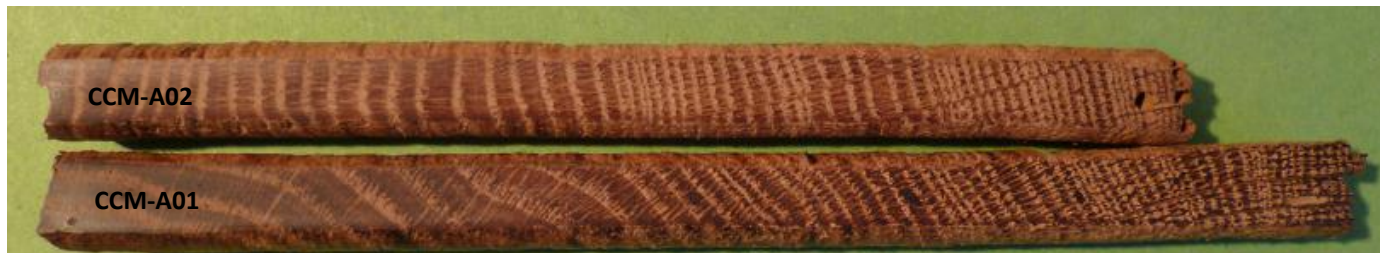
**Figure 5:** Graphic representation of the cross-matching of samples CCM-A01 and A02

When cross-matched at the correct positions, as here, the variations in the rings of the two samples correspond with a high degree of similarity. As the ring widths of one sample increase (represented by peaks in the graph), or decrease (represented by troughs), so too do the annual ring widths of the second sample. This similarity in growth pattern is a result of the two trees represented having grown in the same area *at the same time*. The growth ring pattern of two samples from trees grown at different times would never correspond so well.
