**CANNINGTON COURT,
CANNINGTON,
NEAR BRIDGWATER,
SOMERSET,**

TREE-RING ANALYSIS OF TIMBERS

APRIL 2013

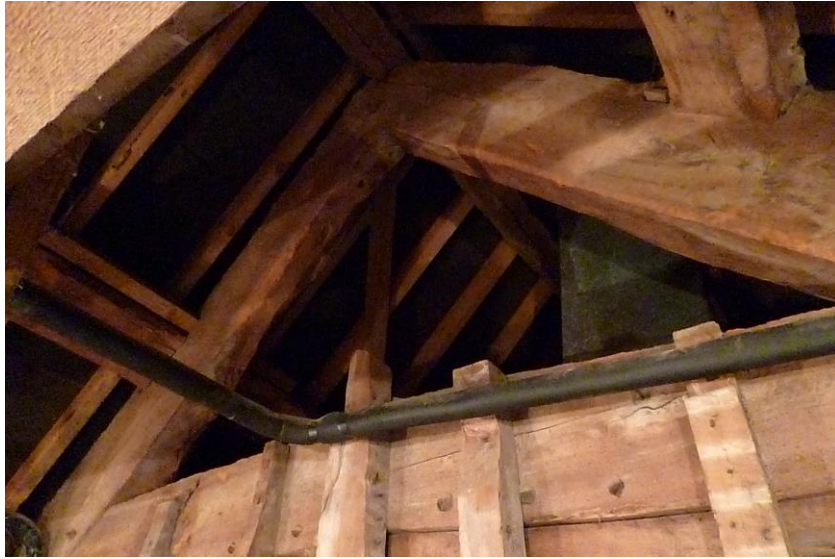
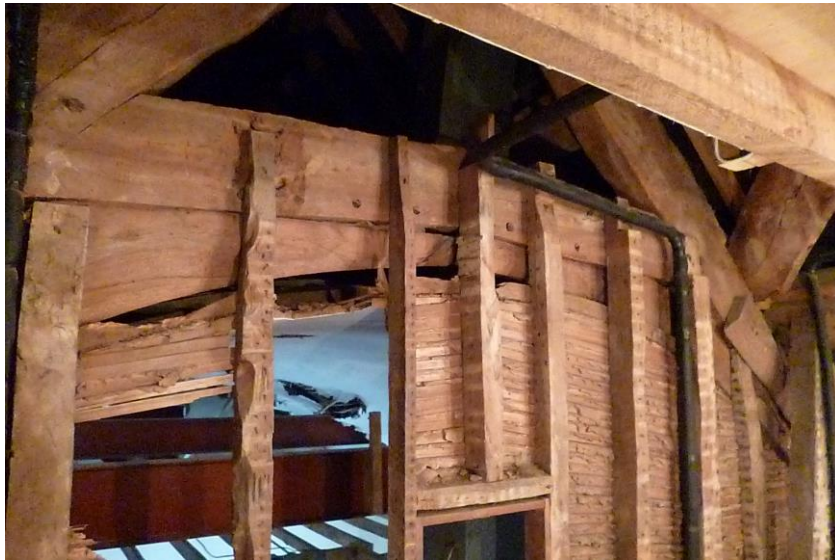
Figure 3a–c: Views of the elm trusses to the west range (top and middle) and an example of a carpenter’s assembly marks (bottom)

With the aim of fulfilling the application of tree-ring dating to this project, an inspection was made of the arch-braced roof trusses to the west and south ranges. It was seen at this time that although a considerable quantity of timber was to be found to the roof of the west range in the form of several arch-braced principal rafter trusses with collars and tiebeams (Fig 3a/b), and with double purlins, wind-braces, and struts, all the beams, without exception, were of elm (it was noted at this time that all timbers were carefully carpentered and the beams appear to display a full set of carpenter's assembly marks, Figure 3c). Currently, probably due to the variation and erratic nature of the annual growth rings of this tree, it is not possible to reliably date elm, and no samples were obtained from this roof.

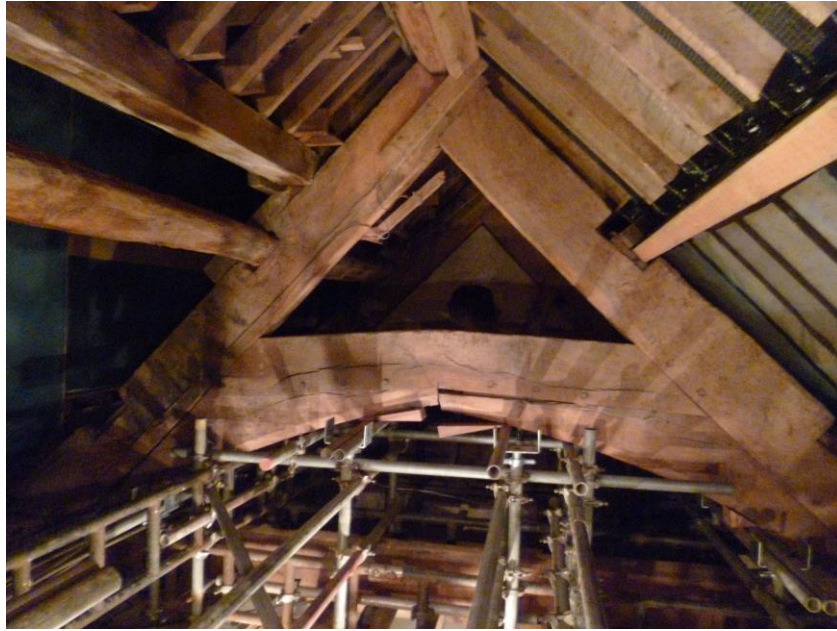
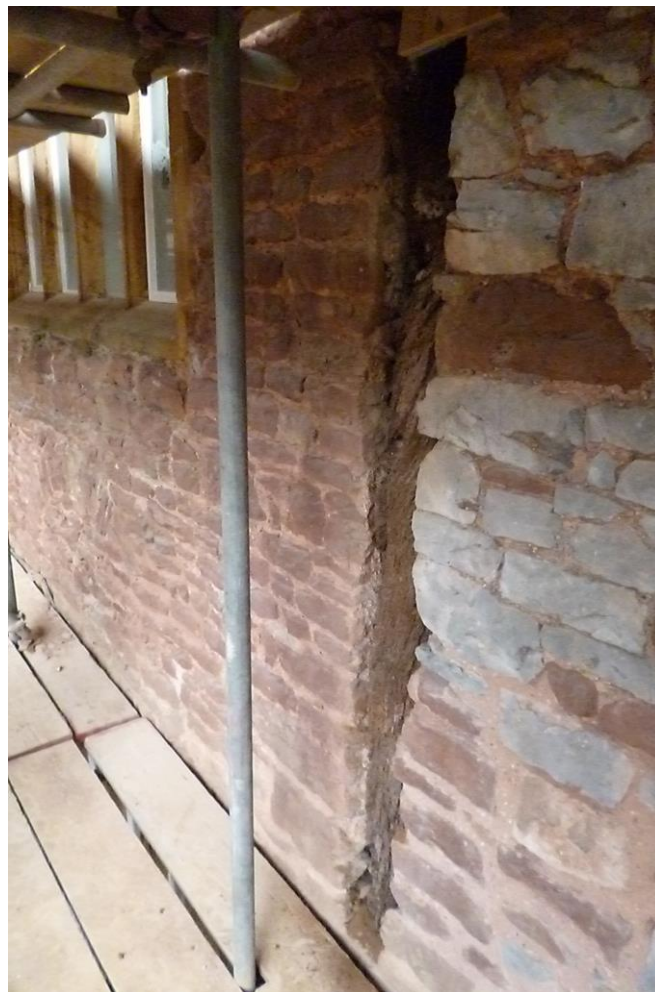
Figure 3d/e: Views of a truss of the sampled south range roof (top) and a post buried in the south wall of the north range (bottom)

Fortunately, the four arch-braced trusses of the south range, were, by contrast, all of oak and appeared to contain sufficient numbers of rings, Figure 3d.

In addition to the roof timbers of the west and south ranges, a small number of timbers were exposed in the south face of the north range (the wall facing onto the courtyard). An examination of these timbers showed them to be heavily decayed and rotted, Figure 3e. Despite this, an attempt was made to core one of the timbers, the resultant sample, unfortunately, breaking into a number of small pieces. It was observed from these pieces that the timber was derived from a fast-grown tree and had insufficient rings (ie, less than 50) for reliable analysis.

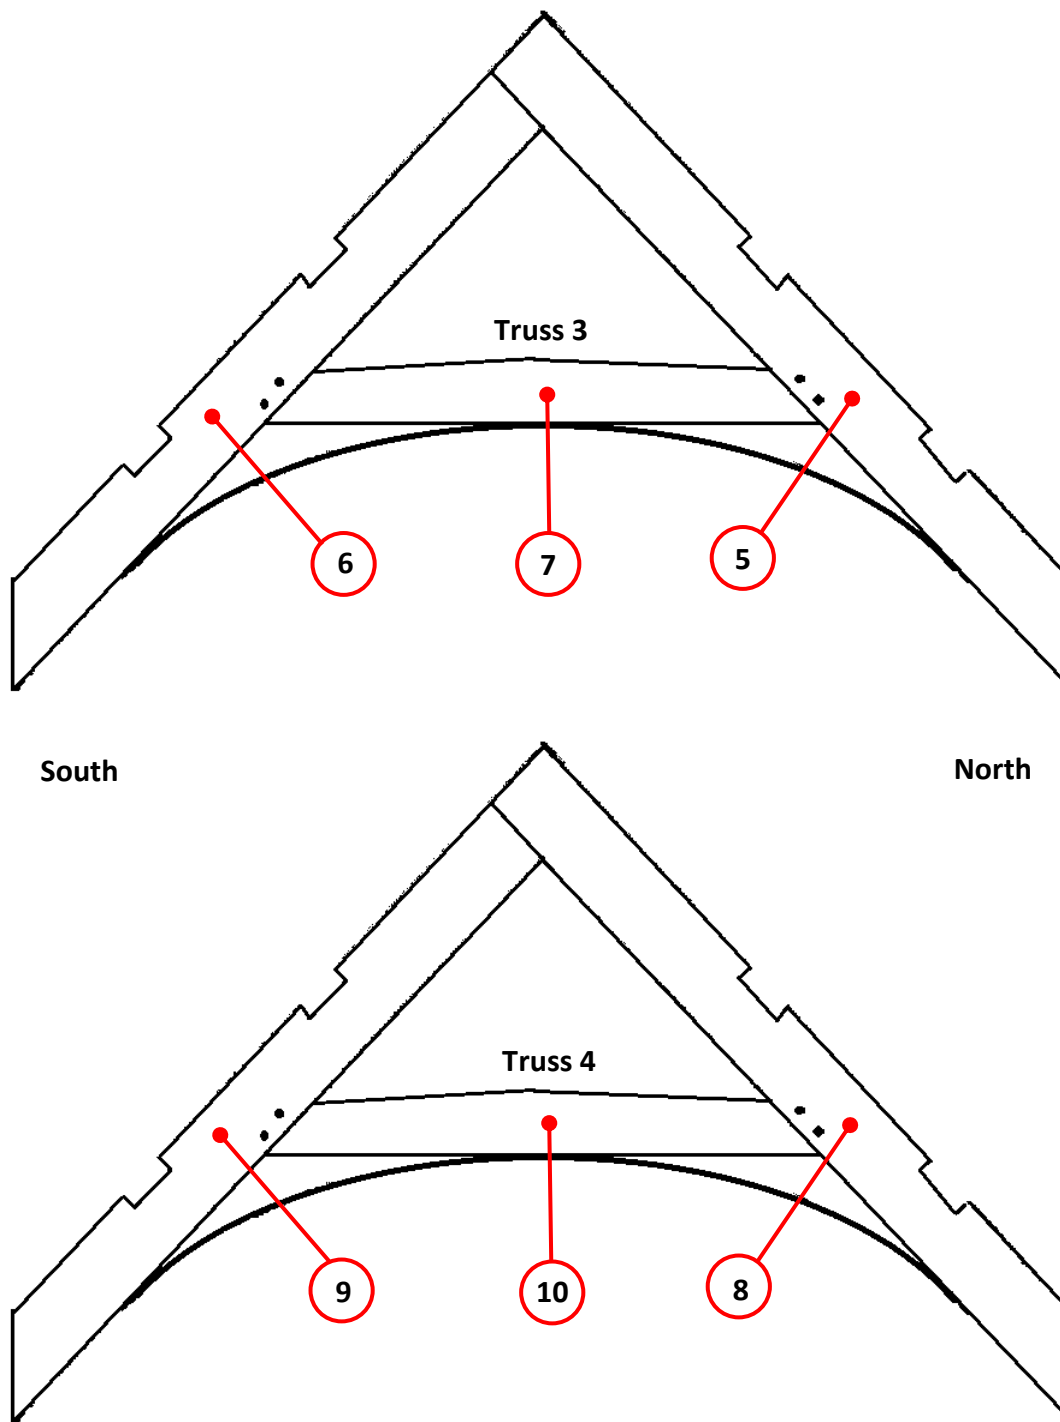
Figure 5c/d: Simple schematic drawings of the south range roof trusses to locate the sampled timbers

drawings shown here as Figures 5a–d. Details of the samples are given in Table 1, including the timber sampled and its location, the total number of rings each sample has, and how many of these, if any, are sapwood rings. The individual date span of each dated sample is also given. In this report, the ranges of the building are described by compass point as lying either north, south, east, or west around the courtyard, with the sampled roof trusses of the south range being numbered west–east, 1–4, with individual timbers identified on a north–south basis as appropriate.
