**1-5 BRIDGE STREET,
BIDEFORD,
DEVON,
TREE-RING ANALYSIS OF TIMBERS**

**A J ARNOLD
R E HOWARD**

APRIL 2012

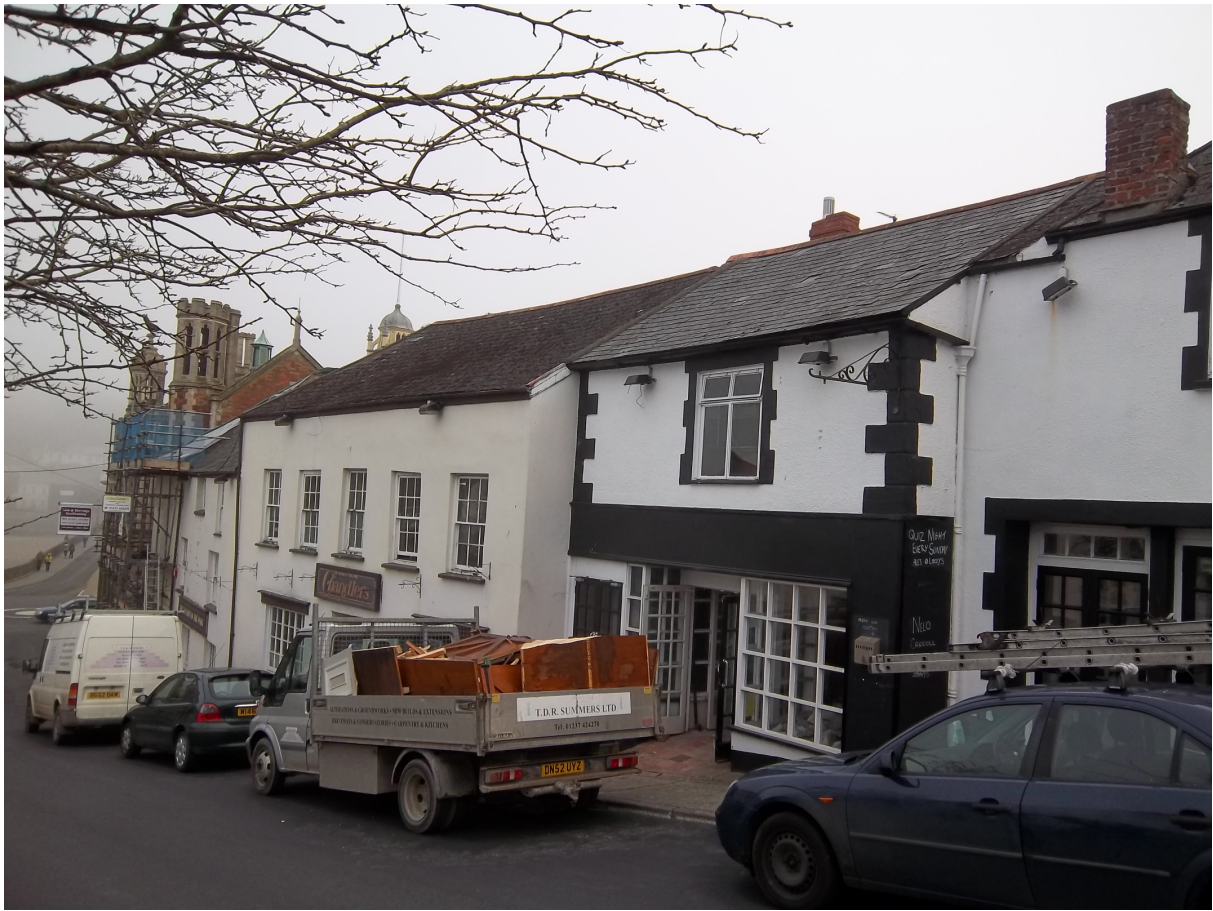
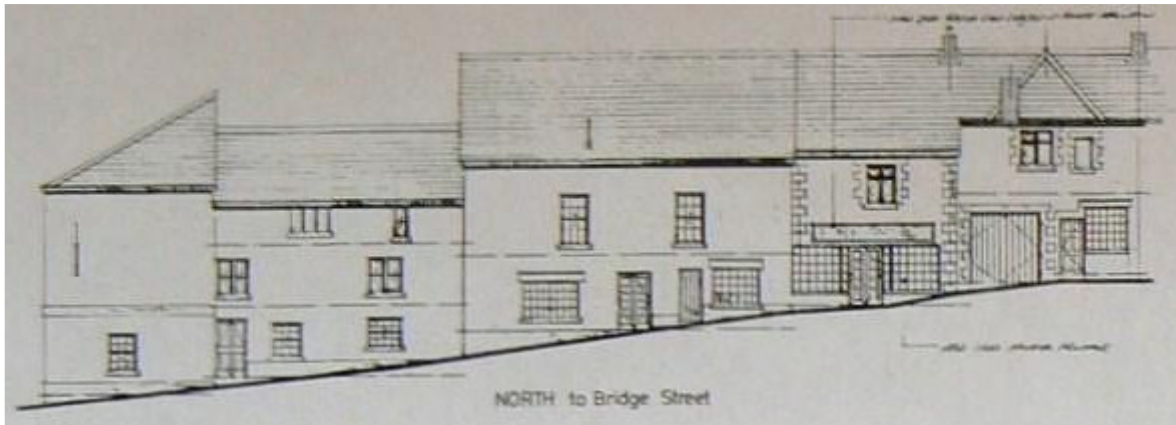
Figure 2a/b: View of numbers 1–5, looking down Bridge Street towards the river Torridge (top), with drawn elevation to Bridge Street (bottom)

The buildings that now comprise numbers 1–5 stand on the south side of Bridge Street (SS 453 264, Figs 1a/b and 2a/b) as it rises steeply away from the west bank of the river Torridge. Parts of the building, particularly number 1 Bridge Street (see plan Fig 3), were formerly the Royal Mail public house, the pub gradually extending along the street to incorporate numbers 2 and 3, and then number 4 and 5 Bridge Street, into its premises (number 5 previously having been a shop). The pub had been closed, and the buildings unoccupied, for some considerable time before recently being purchased. Although a full drawn survey and record has not been undertaken as part of this programme of tree-ring dating, the description for number 1 Bridge Street lists it as being of early seventeenth century date (though remodelled externally in the mid-nineteenth century), and as having an early seventeenth century broad-rib ceiling divided by inserted partitions.

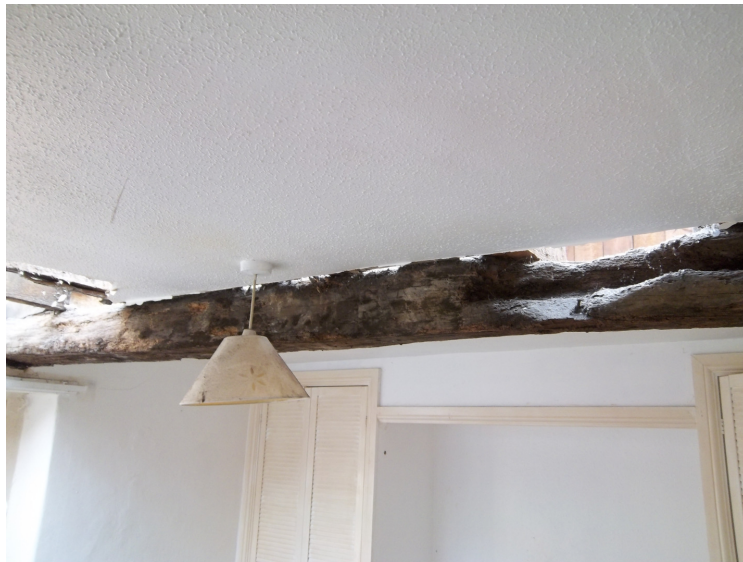
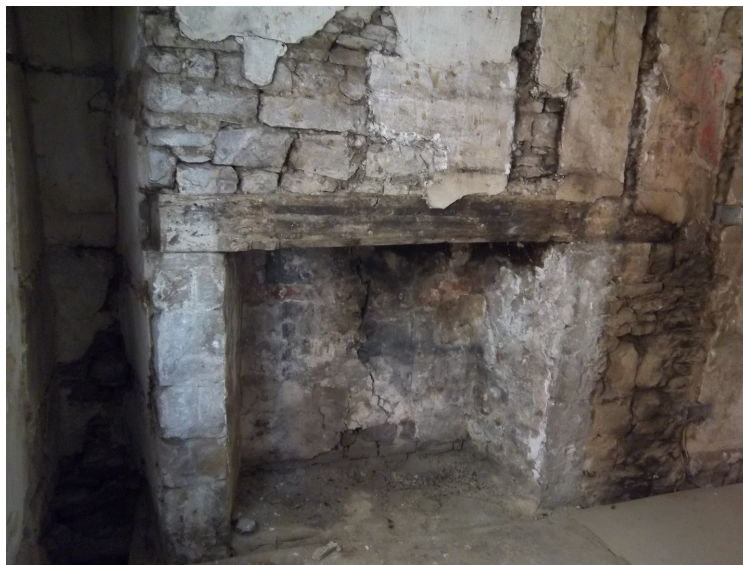
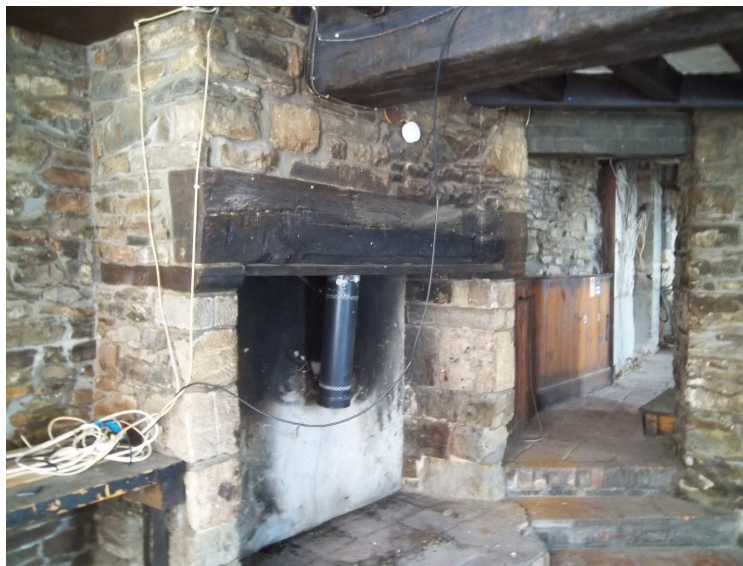
Figure 4a–c: View of the second-floor ceiling beam, (top) and first- and ground-floor fireplace lintels (middle and bottom) to 1 Bridge Street (respectively samples BID-A01–A03)

Within, apart from a single beam to the second-floor ceiling of number 1 Bridge Street (Fig 4a), and single lintels to the first- and ground-floor fireplaces (Figs 4b/c), there are no oak timbers to the lower rooms of this part of the building. The ground-floor ceilings of numbers 1, 2, and 3 Bridge Street, however, are formed of a series of large pine beams from which run smaller joists, also of pine (Fig 4d). There are no lower timbers to 4 Bridge Street while the ground-floor ceiling of number 5 (Fig 4e) comprises five main oak beams without any smaller common joists.

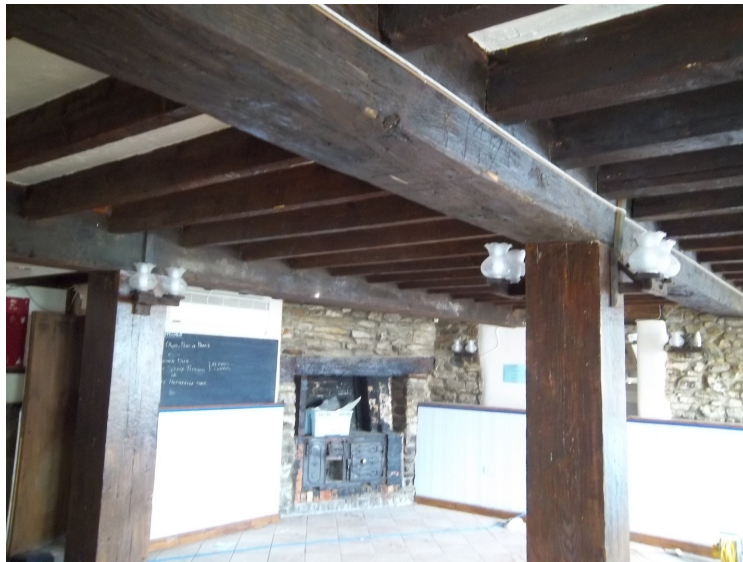
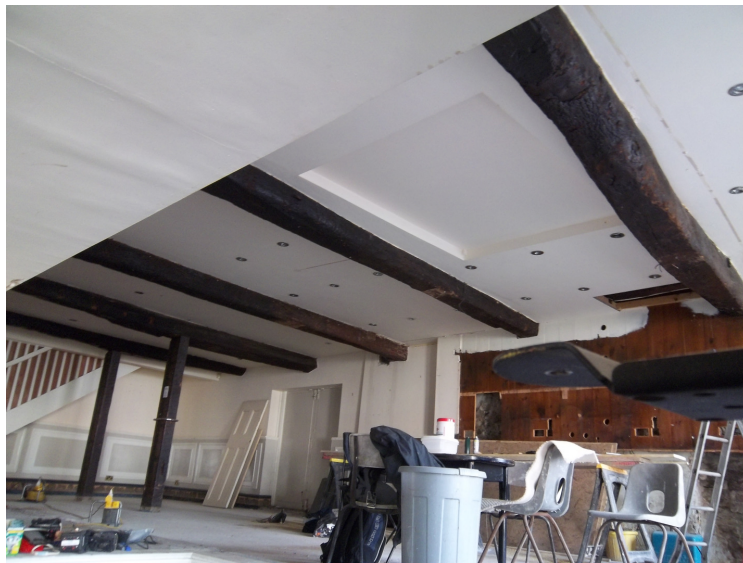
Figure 4d/e: View of the ground-floor pine ceiling beams to 2 Bridge Street (top), sampled as BID-P25–P27 and the ground-floor ceiling beams to 5 Bridge Street (bottom), sampled as BID-A20–A24

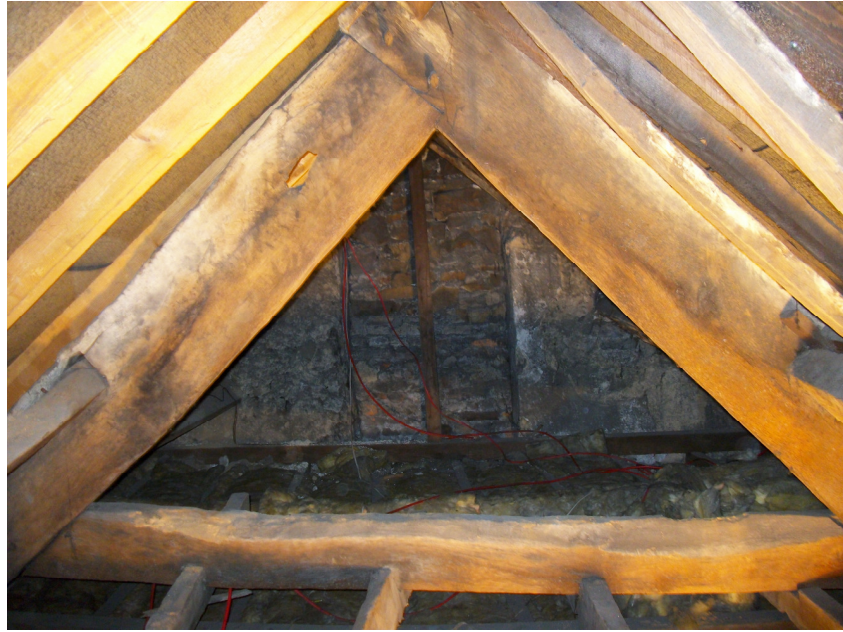
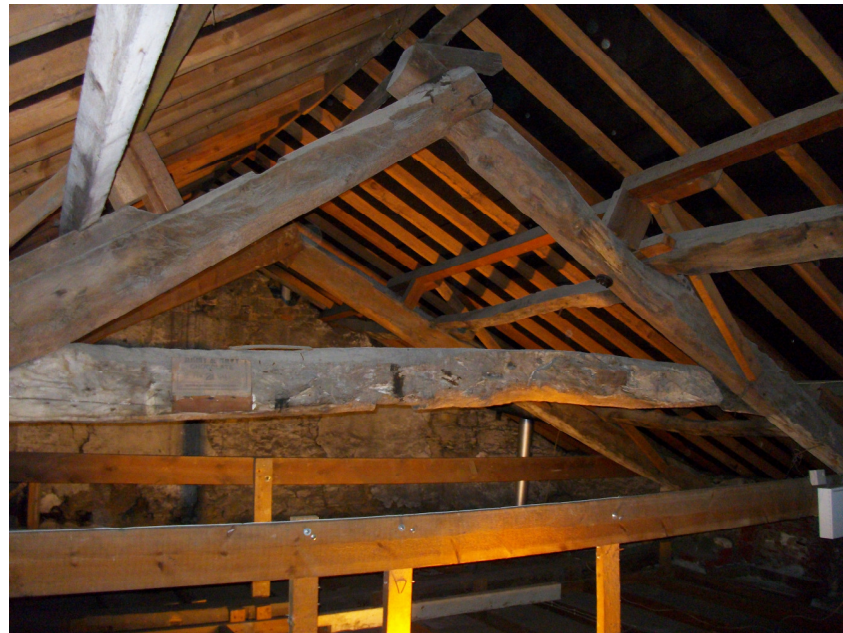
Figure 4f/g: View of the roofs to 2 Bridge Street (top) sampled as BID-A04–A11, and 3 Bridge Street (bottom), sampled as BID-A12–A19

The east–west roof to number 2 Bridge Street (Fig 4f) comprises two principal rafter trusses, the trusses having collars but no tiebeams. The collars are pegged to the principals with slightly unusual notched-lap tennons. The principal carry single through-purlins to each pitch of the roof. There appear to be no original, or early, common rafters, these all appearing to be modern, late-twentieth century timbers.

The east–west roof to number 3 Bridge Street (Fig 4g) also comprises two principal rafter trusses, again with collars, but no tiebeams. The collars in these trusses are face-lapped to the principals and fixed with nails. There are two sets of purlins to each pitch of this roof, these being carried on the backs of the principal rafters. There is some evidence, by way of redundant mortices and peg holes, and by the way that some of the joints are ill-fitting, that some timber in this roof may have been reused, or that the roof has been reconfigured and more recent repair pieces have been inserted. The timbers appear to present a less integral structure. There again appear to be no original, or early, common rafters, these all appearing to be modern replacements

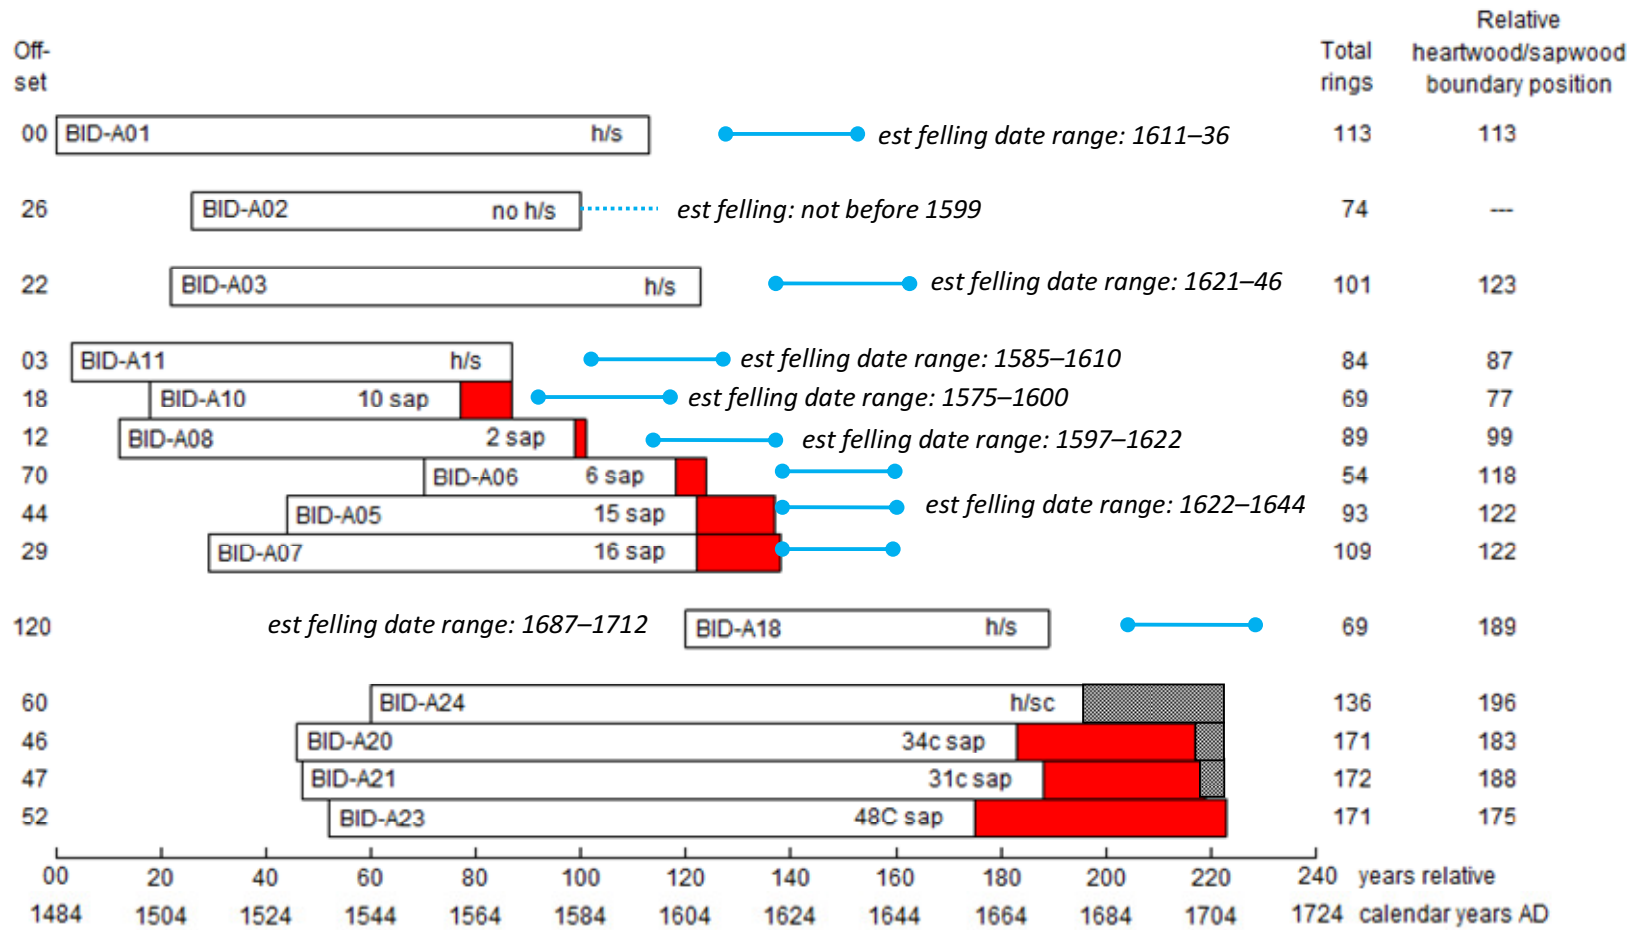
Figure 5: Bar diagram of the samples in site chronology BIDASQ01

Blank bars = heartwood rings. Filled bars = sapwood rings. Hatched bars = sapwood rings estimated from lost core portion. Extended lines = estimated felling date range based on 15–40 sapwood rings. h/s = heartwood/sapwood boundary
 C = complete sapwood is retained on the sample, the last measured ring date is the felling date of the timber
 c = complete sapwood is found on the timber, but part or all has been lost from the sample in coring

The 14 samples of site chronology BIDASQ01 are shown here in the form of a bar diagram (sorted by sample location and in last measured ring date order) at positions where the ring variations of each sample cross-match with each other. This similarity is produced by the trees represented sharing periods of growth in common (ie, where the bars overlap). The samples are combined at these offsets to form a 'site chronology' (BIDASQ01) which is compared with a large database of reference chronologies for all time periods for all parts of England, cross-matching only with a date span of 1484–1706 (see Table 2).

Although many of the samples have periods of growth in common, and cross-match with each other, interpretation of the sapwood on the individual cores suggests that some of the trees represented were felled at different times. Sample BID-A01, for example, from the main second-floor ceiling beam of 1 Bridge Street, has the heartwood/sapwood boundary ring (meaning that the outer sapwood rings are missing, but *only* the sapwood rings are missing), this boundary ring being dated to 1596. Given that the 95% confidence limit for the amount of sapwood that oaks trees have lies between 15 and 40 rings, it can be calculated that the tree has an estimated felling date of between 1611 at the earliest (1596+15) to 1636 at the latest (1596+40). This calculation has been done for a number of other timbers, as shown in the figure above.

The first group comprises 14 oak samples, the majority of them from either number 1, 2, or 5 Bridge Street, with only one sample (BID-A18) being from number 3 Bridge Street. The 14 cross-matching oak samples were combined at their indicated off-set positions (see bar diagram Fig 5) to form BIDASQ01, a site chronology with an overall length of 223 rings. This site chronology was then satisfactorily dated by repeated and consistent comparison with a large number of relevant reference chronologies for oak as spanning the years 1484 to 1706. The evidence for this dating is given in the *t*-values of Table 2.

Site chronologies BIDASQ01 and BIDASQ02 are composites of the data of the relevant cross-matching samples as seen in the bar diagrams Figures 5 and 6. This composite data produces 'average' tree-ring patterns, where the overall climatic signal of the growth is enhanced, and the possible erratic variations of any one individual sample are reduced. These 'average' site chronologies are then compared with several hundred reference patterns covering every part of Britain for all time periods. Each site chronology dates only at the time periods indicated, each table giving only a small selection of the very best matches as represented by 't-values' (ie, degrees of similarity).
