**ALL SAINTS CHURCH,
NORTH STREET,
YORK;
TREE-RING ANALYSIS OF TIMBERS FROM
THE WESTERN END OF THE NORTH AISLE ROOF**

SEPTEMBER 2013

SUMMARY

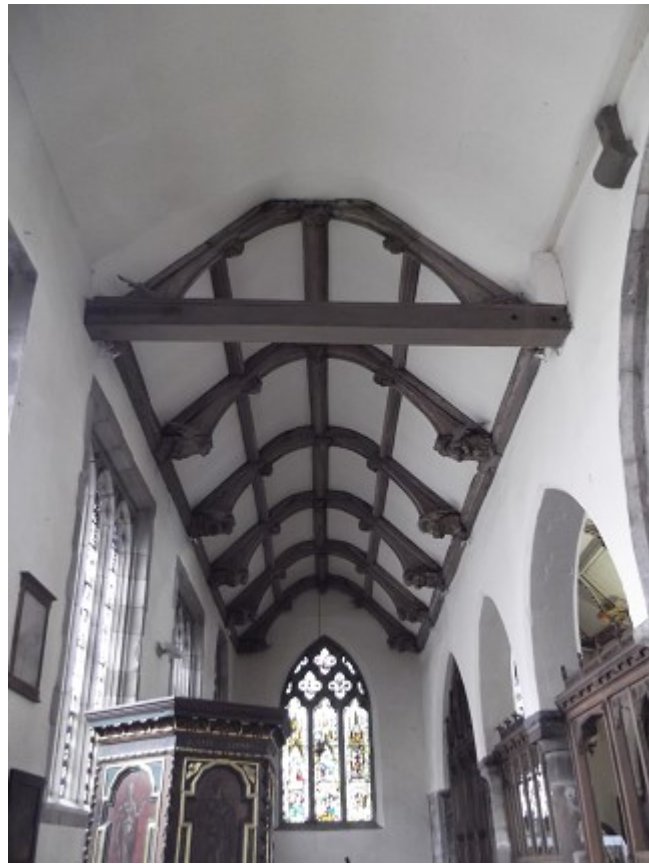
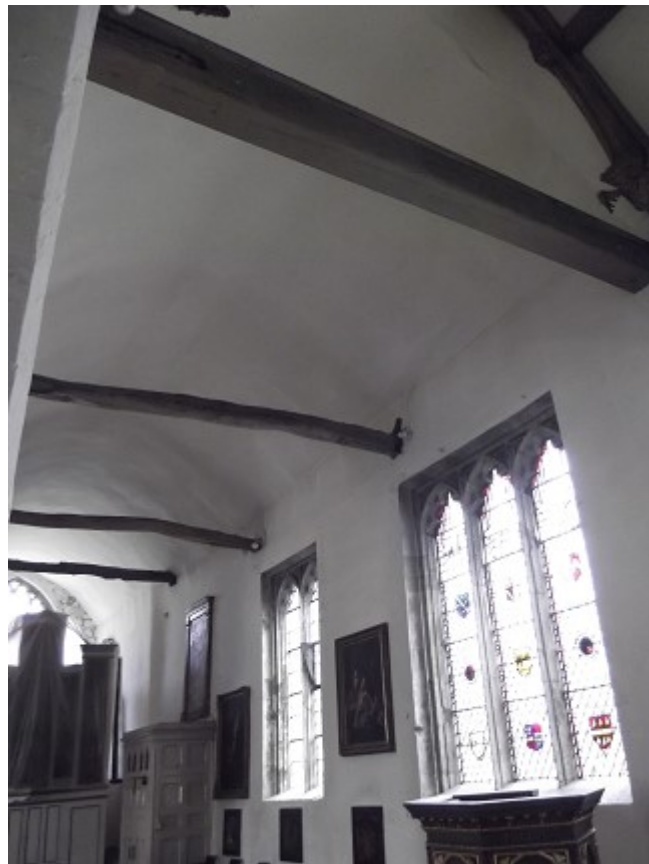
Figure 3a/b: Internal views of the north aisle looking west to east (top) and east to west (bottom). It is above this latter area that the samples analysed here have been obtained

In essence the north aisle roof comprises three parts (Fig 2), with solid brick partition between each part. To the eastern end (not quite one half of the whole north aisle) the roof comprises six hammer beam trusses (Fig 3a), the trusses carrying a ridge beam with a single purlin to each pitch of the roof. The western part (again not quite half of the whole) is without principal trusses, the barrel vaulted roof (cealed from below and not visible from within the church, Fig 3b) comprising about 28 coupled common rafter trusses with collars, the rafters (possibly in two sections) falling to wall plates to the north and south walls of the aisle. A number of these timbers show clear evidence, by way of redundant mortices and peg holes, of being reused in their present locations. There are in this part of the aisle, however, three slender cross-beams which appear to tie the aisle walls together, but probably do not act as tiebeams to any of the rafter frames. The remaining portion of the north aisle, the west chapel, comprises a small section at the far west end. Access to this roof not being possible, it is not clear what form this section of roof takes. These divisions can again be seen in the externally roof lines of the north aisle (Fig 4a/b).

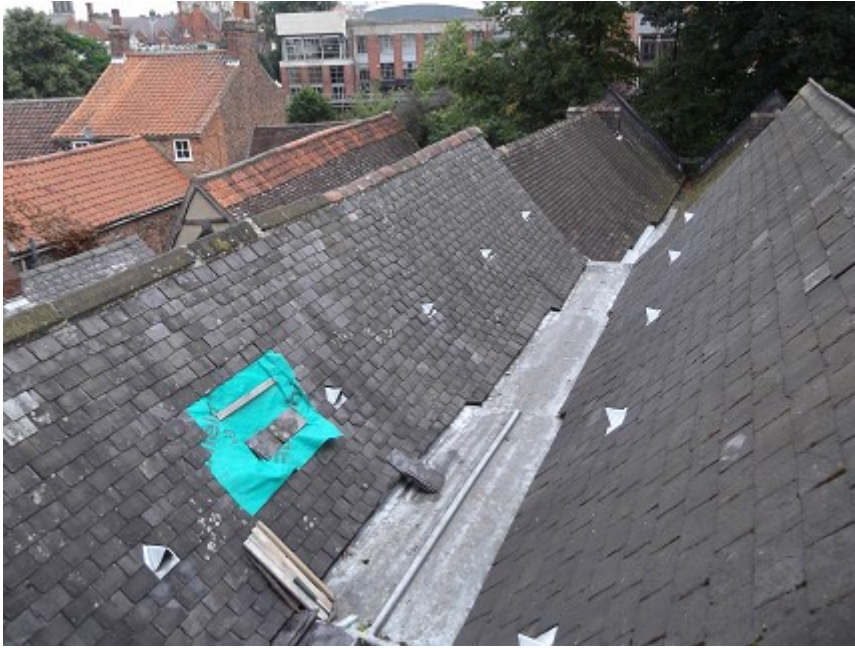
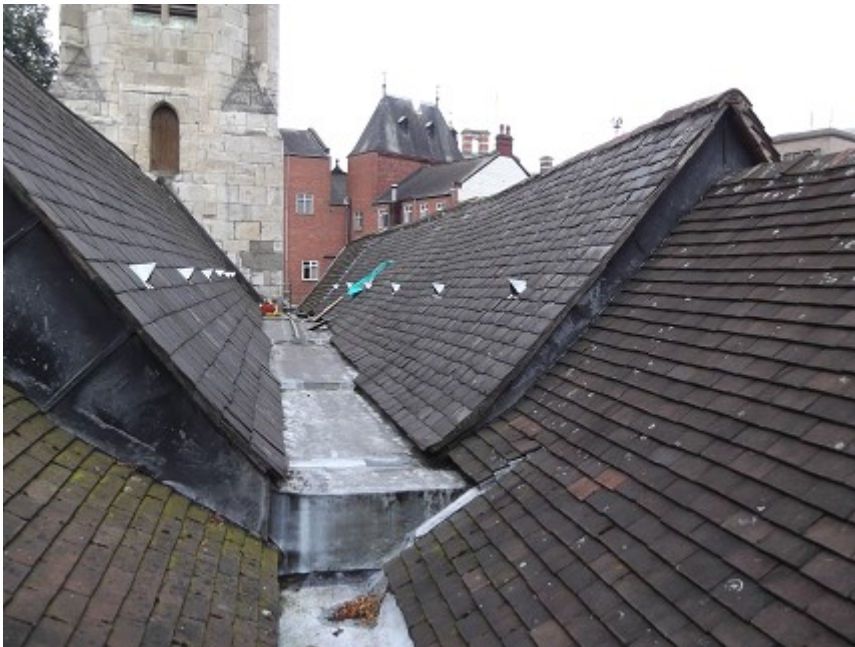
Figure 4a/b: Views of the north aisle roofscape looking west to east (top) and east to west (bottom)

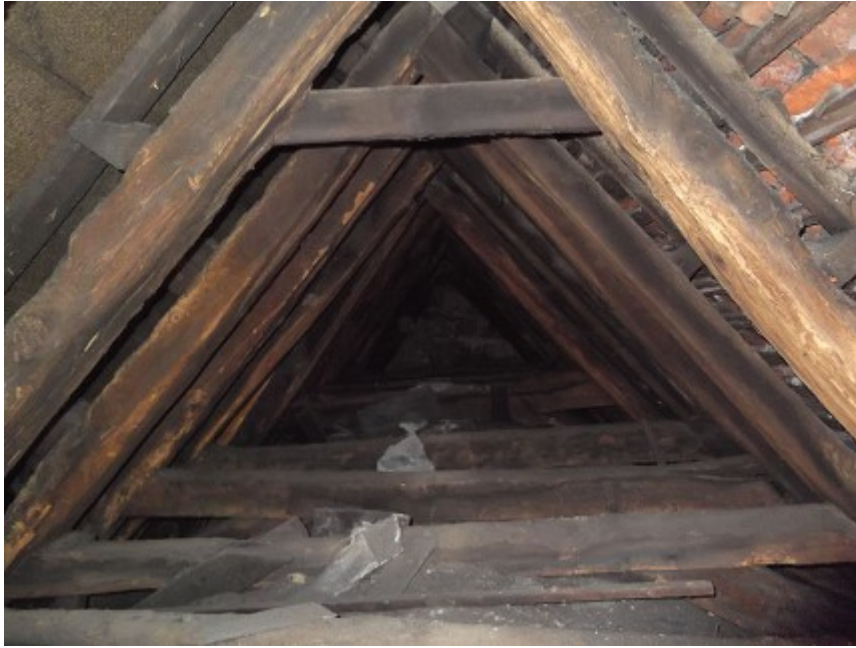
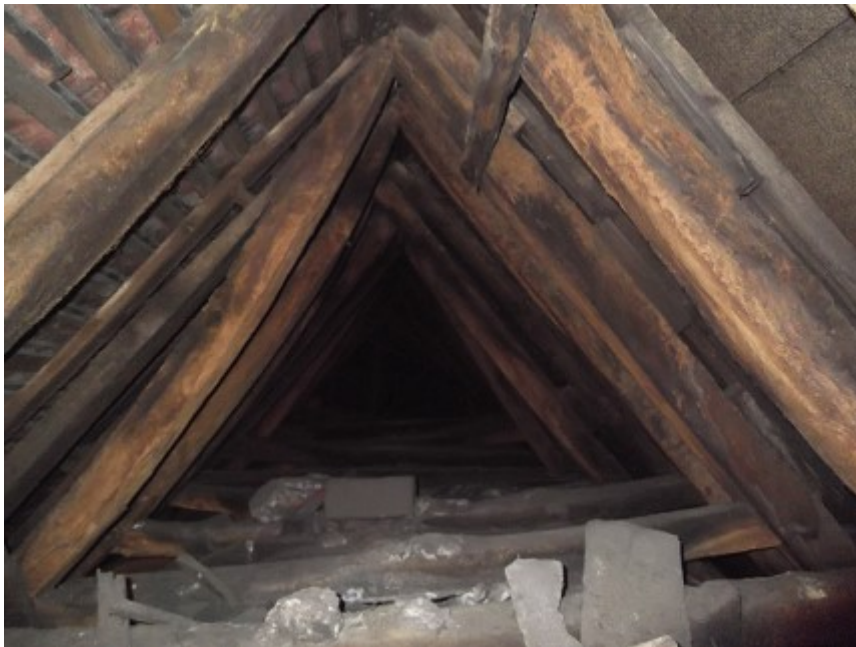
Figure 5a/b: Views of the roof trusses to the west end of the north aisle looking west to east (top) and east to west (bottom)

At the time of sampling access was only available to the coupled common rafter frames of the larger western portion of the roof (Fig 5a/b), and with the aim of fulfilling the sampling brief for this project, core samples were obtained from ten different timbers here. Each sample was given the code YRK-N (for York – site 'N'), and numbered 01–10. Details of the samples are given in Table 1, including the timber sampled and its location (the frames being numbered from east to west), the total number of rings each sample has, and how many of these, if any, are sapwood rings. The individual date span of each dated sample is also given. Although there were other timbers potentially available for sampling in this part of the aisle, the three slender cross beams for example, these all appeared to have insufficient rings for dating and were not sampled.

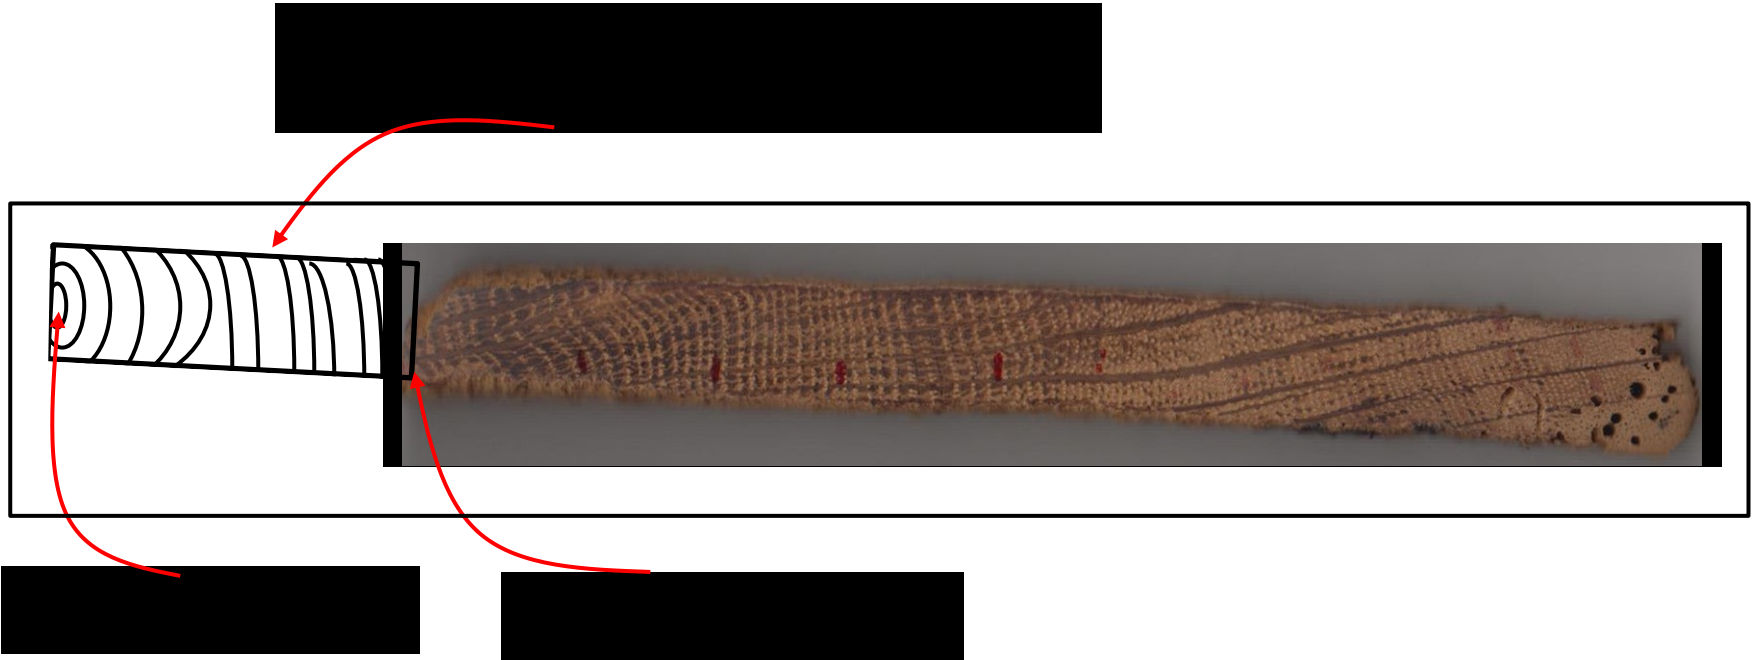
Figure 8: Estimating the start of growth of the tree represented by sample YRK-N06

It may be of interest to note the date at which at least one of the trees might have started growing, and the age it had reached when felled. As may be seen from Table 1 and the bar diagram Figure 7, the first, or earliest, extant ring on any sample, YRK-N06, is dated to 960. This ring, however, is not the centre ring of the tree (ie, its first growth ring) but is, roughly estimated, 20 or even 30 years from it (see Fig 8). If this estimate is correct, this would suggest that the tree represented by the sample began growing (in round terms) about 930–940. Samples with rings from such an early date, while not unknown to tree-ring studies, are not particularly common, with some other examples of early rings, as it happens, being found on a few timbers from the Chapter House roof at York Minster.

Given that the tree is one of a group estimated to have been cut in 1166–91, if it had begun growing in 930, it could have reached about 250–260 years of age when felled, again a fairly uncommon figure in tree-ring analysis.
