**TREE-RING ANALYSIS OF TIMBERS FROM
CRAG HOUSE FARM BARN,
OTLEY OLD ROAD,
COOKRIDGE
LEEDS**

March 2012

SUMMARY

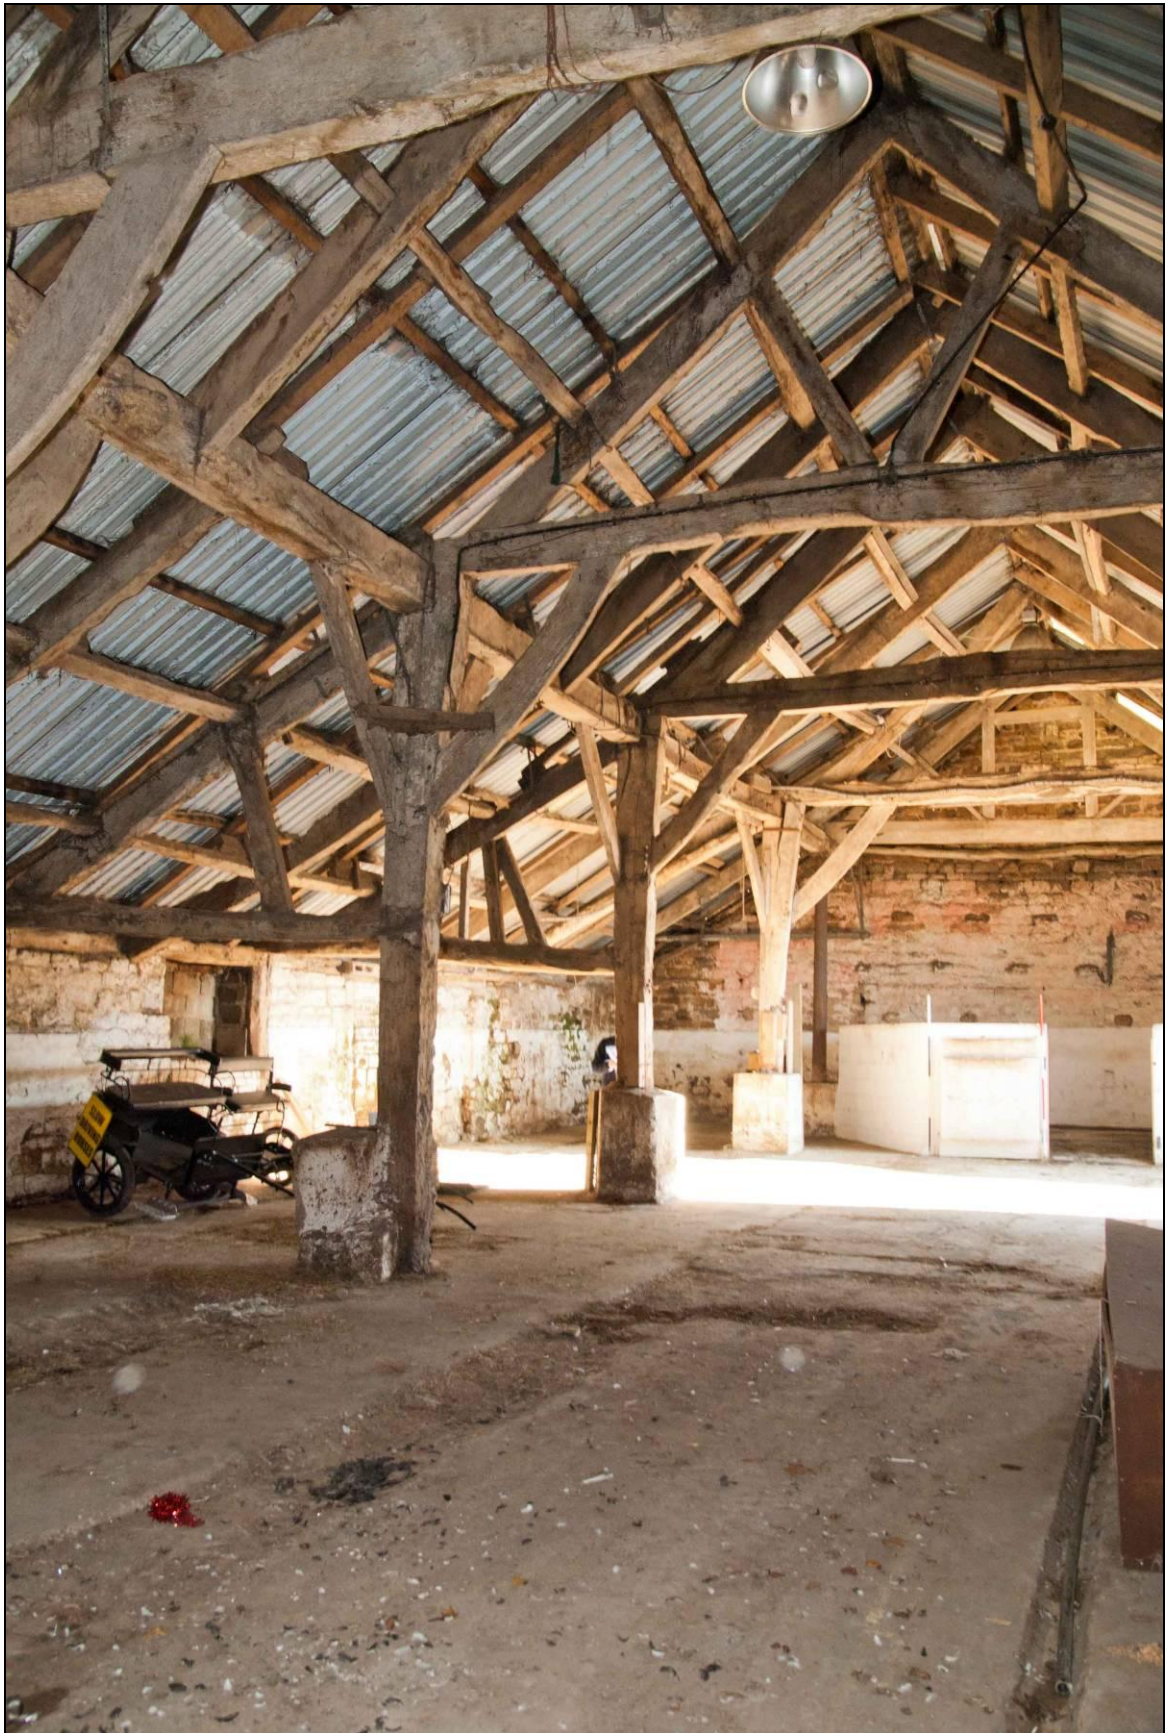
Figure 4: Crag House Farm barn, photograph taken from the south-west (Archaeological Services WYAS)

The barn is of five bays and is fully aisled on the north side and for three bays on the south side (Fig 3). The roof has four trusses consisting of posts, tiebeams, principal rafters, and braces which run from the post to the tiebeam and to the aisle plate. Additionally, truss 3 has V-struts from tiebeam to principal rafters and truss 4 has a king post. Between these main trusses are intermediate sets of principal rafters. There are two sets of purlins to each slope; these are trenched to the main principal rafters and through purlins to the intermediate ones. The ridge is similarly arranged (Fig 4).
