**TREE-RING ANALYSIS OF TIMBERS FROM  
STONELOWE HALL,  
LONGSDON,  
NEAR LEEK,  
STAFFORDSHIRE**

**A J ARNOLD  
R E HOWARD**

## SUMMARY

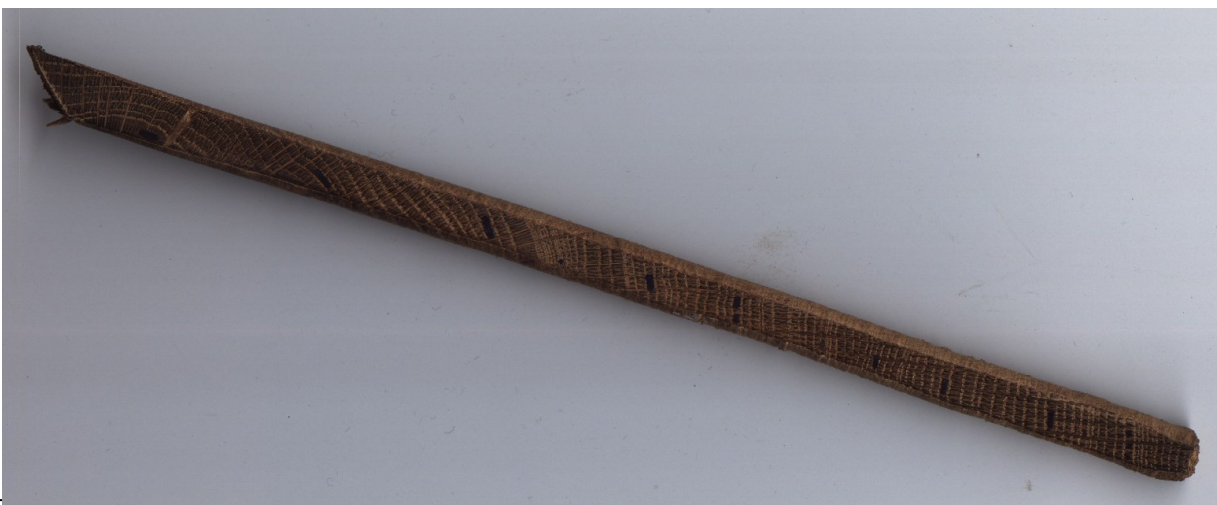
**Sample STL-A13 from the tiebeam of truss E in the hall range**
