**TREE-RING ANALYSIS OF TIMBERS FROM  
64-72 GOODRAMGATE (LADY ROW),  
YORK**

**Dec 2011**

**ALISON ARNOLD  
ROBERT HOWARD**

**Dendrochronological analysis was undertaken on samples taken from timbers of the roof and north truss of number 64. This resulted in the construction of two site sequences.**

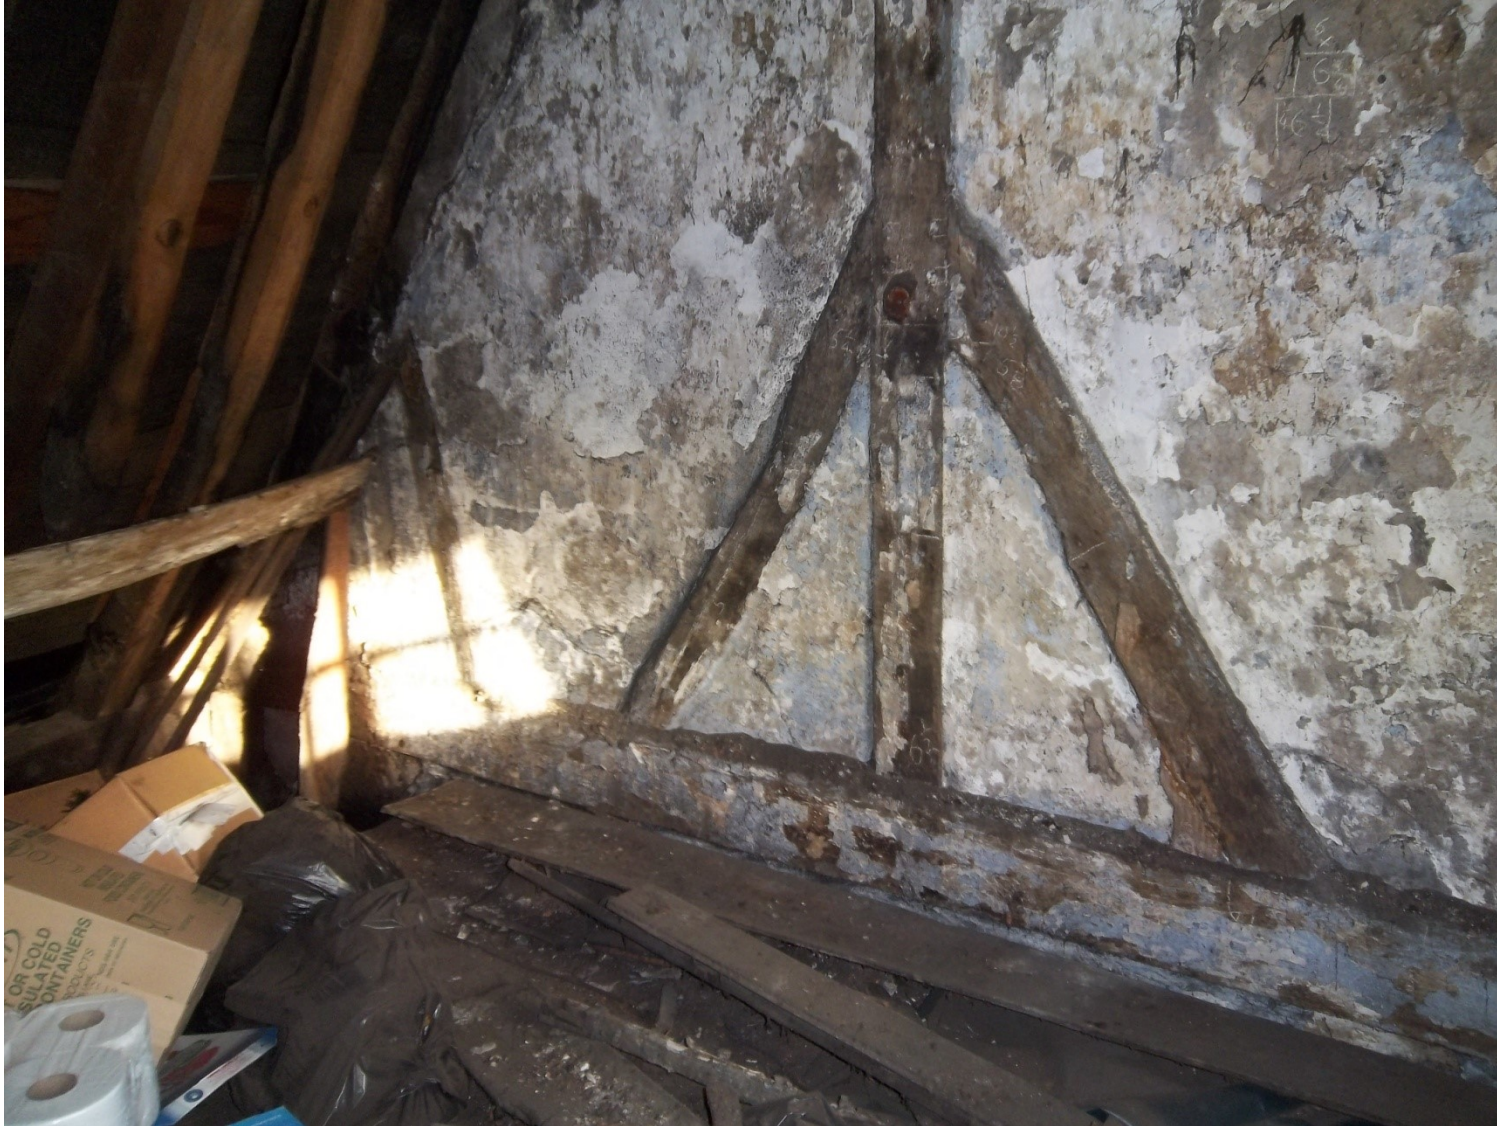
**Figure 5: Truss 3 (north face)**

Briefly, the range is of two storeys, with the first floor jettied to the street frontage, and is thought to have originally consisted of 11 bays (Fig 4). Within the roof, there are eight surviving trusses of tall, un-jowled crown posts with braces to the tiebeams and collar purlins and raking struts between the tiebeams and the principal rafters (Fig 5).

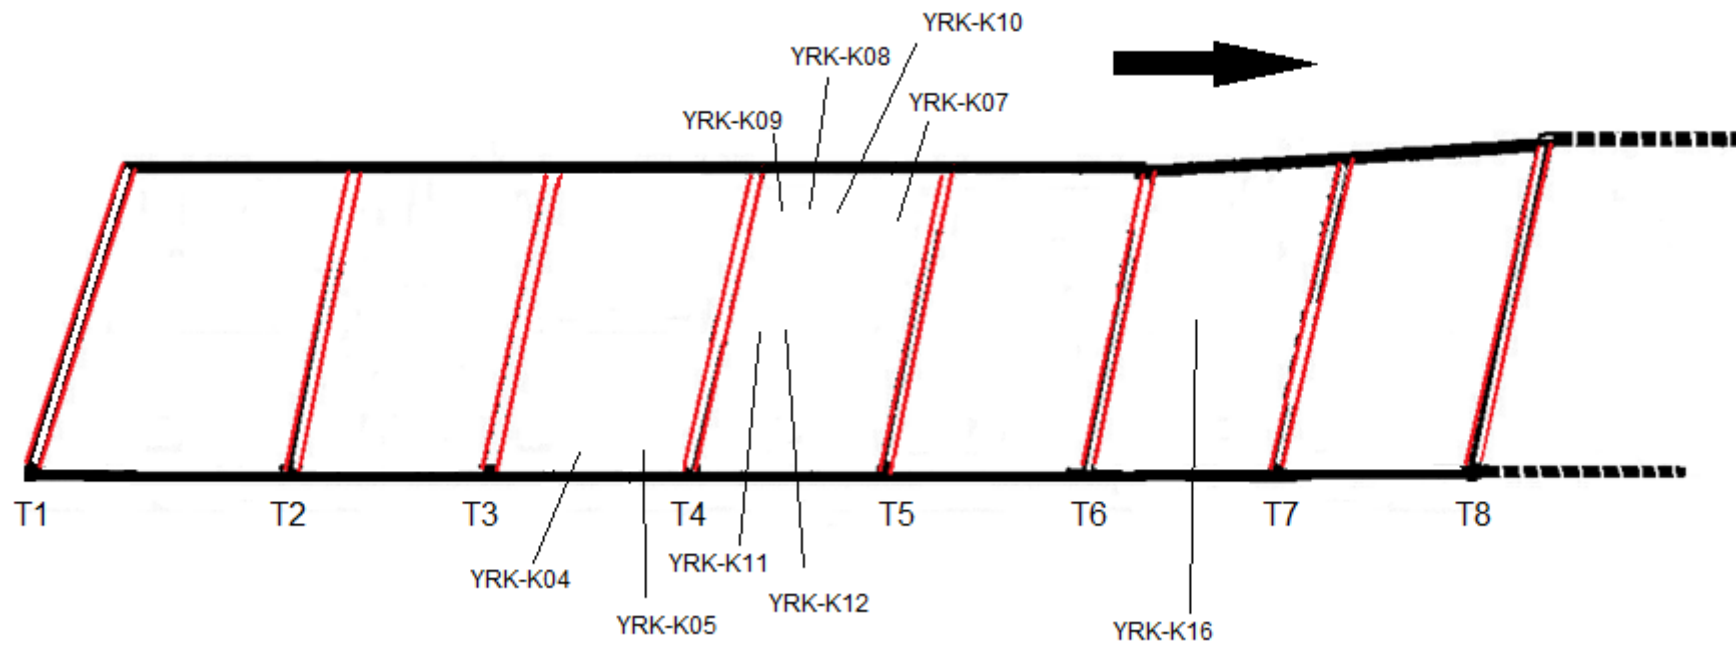
Figure 11: Sketch plan, showing the location of samples YRK-K04, YRK-K05, and YRK-K07–12

A total of 18 timbers was sampled with each sample being given the code YRK-K and numbered 01–18; samples YRK-K01–16 being taken from the roof and YRK-K17–18 from the north end wall of number 64 at first floor level. The location of samples was noted at the time of sampling and has been marked on Figures 6–11. Further details can be found in Table 1. Trusses have been numbered from south to north (Fig 4). It was not possible to gain access to all parts of the roof, therefore, sampling was restricted to accessible trusses.

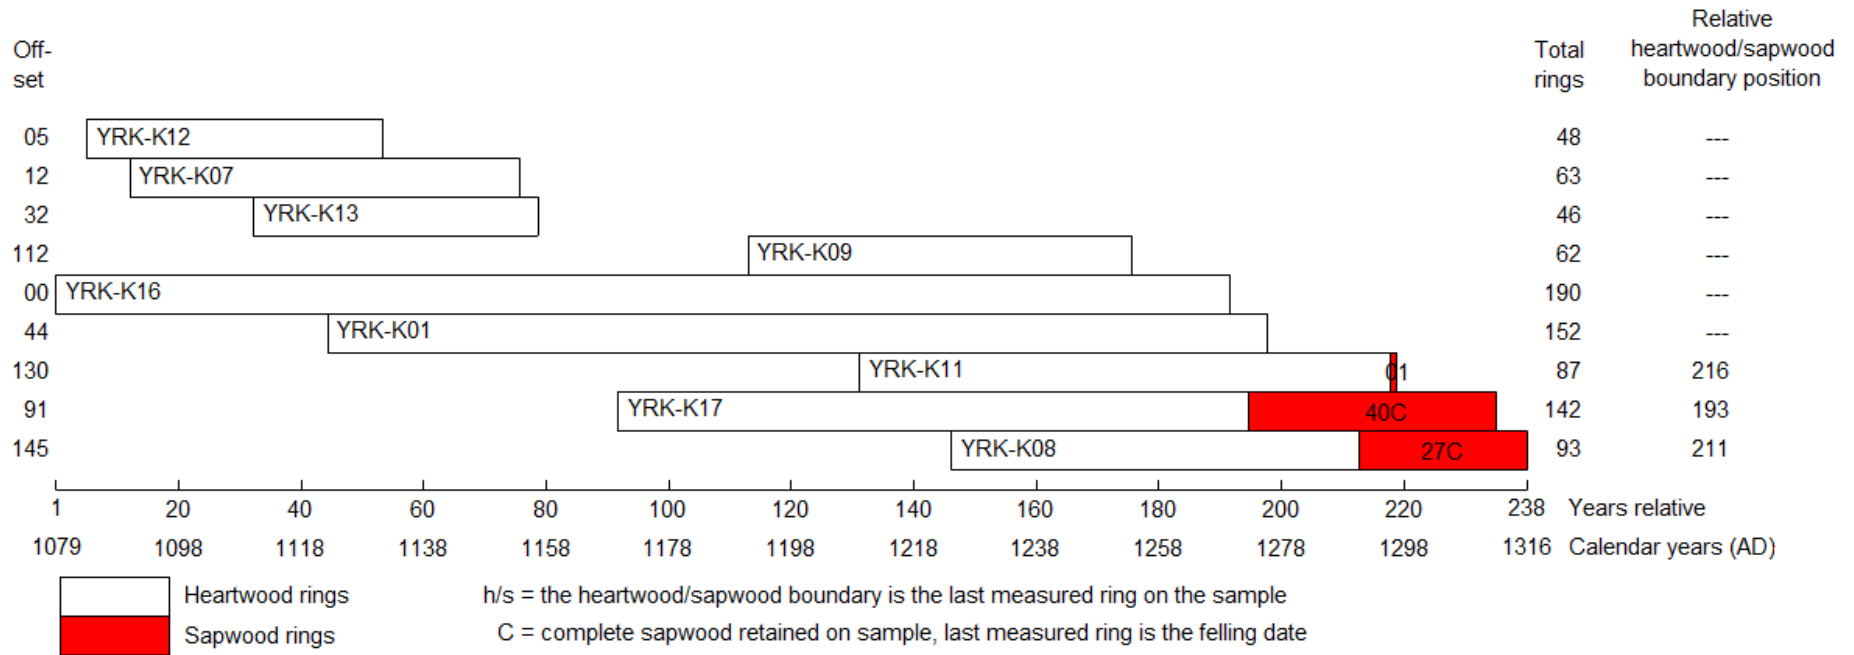
**Figure 12: Bar diagram of samples in site sequence YRKSQ01**

Firstly, nine samples (eight from the roof and one from a stud post in the north end wall of number 64) matched each other and were combined at the relevant offset positions to form YRKKSQ01, a site sequence of 238 rings (Fig 12). This site sequence was compared against a series of relevant reference chronologies for oak where it was found to match consistently and securely at a first-measured ring date of 1079 and a last-measured ring date of 1316. The evidence for this dating is given by the *t*-values in Table 2.

Three of the dated samples have last-measured heartwood ring dates in the twelfth century (Fig 12) but are still thought to have probably been felled in c 1316. For this to be the case these timbers would have to represent the inner portions of much longer lived trees, over 200 years old at felling. It is known that trees of this age were used in this building as evidenced by sample YRK-K16 which has 190 years worth of measured growth without the heartwood/sapwood boundary.

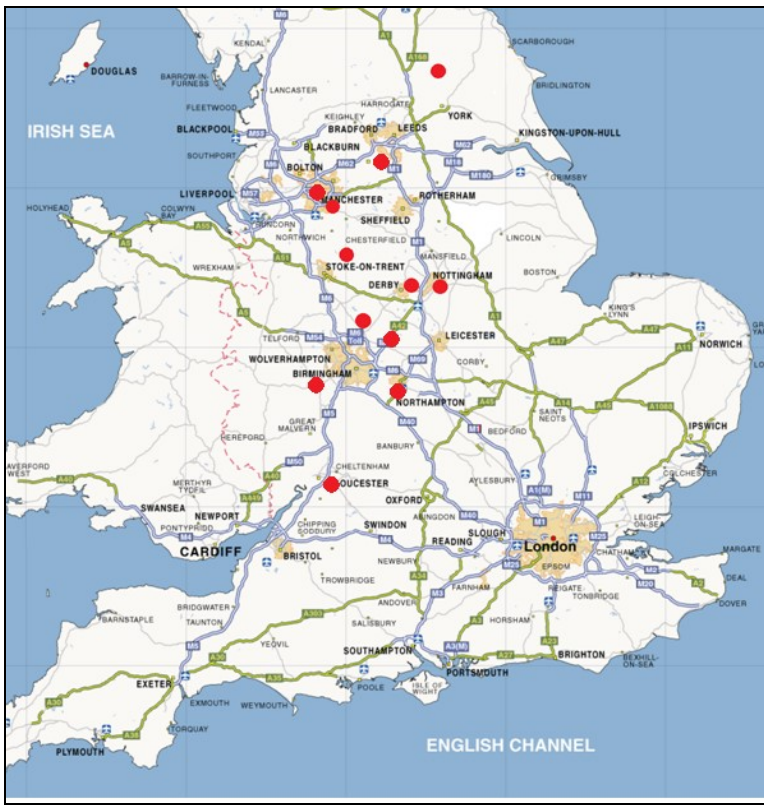
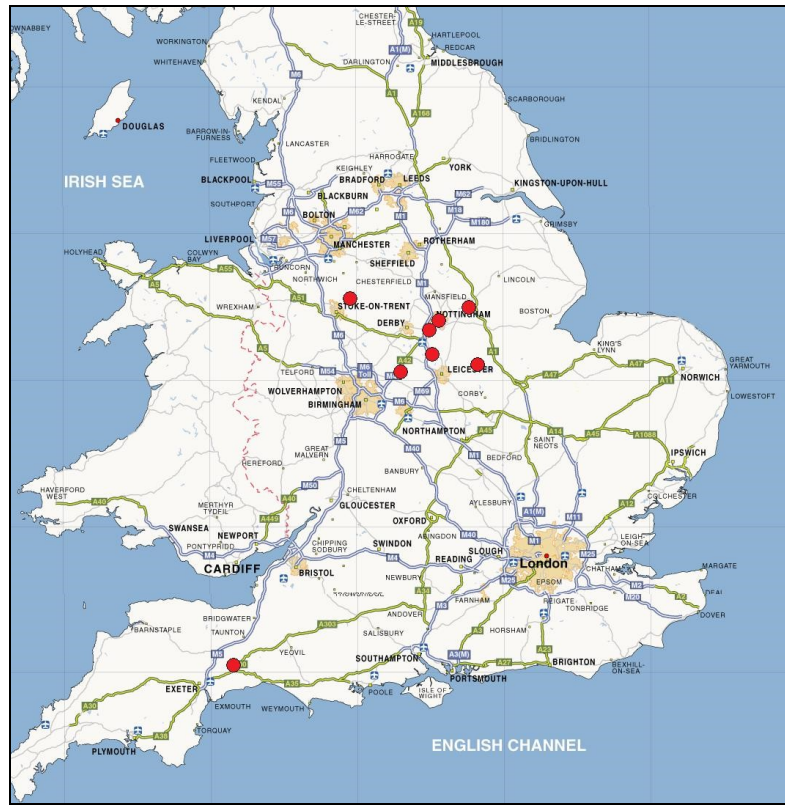
Figure 14: Maps plotting the reference chronologies with the best matches with a) site sequence YRKKSQ01 and b) site sequence YRKKSQ02

With the possibility being raised that the timber used at Goodramgate was not simply supplied by the nearest woodland an attempt to identify the origin of the wood by looking at the location of the highest matching reference chronologies was made (dendroprovenancing). The reference chronologies producing the highest *t*-value matches for site sequences YRKKSQ01 and YRKKSQ02 can be seen in Tables 2 and 3 and in Figure 14. In the case of YRKKSQ02 the best matches (with the exception of a site in Awliscombe in Devon) are clustered around the Nottinghamshire and Derbyshire area whereas the highest matches with YRKKSQ01 are more diverse, although generally they could be said to be in the north-west of the country. The fact that this site sequence has less

affinity to one particular area may be to do with the fact that there are more components in this sequence (nine compared to two) and that these components possibly come from a number of locations. However, caution should be taken when trying to identify timber source in this way. It has been suggested (Bridge 2000) that although it is likely that sites closest in origin to the source of the timber will give the best matches this may be an over-simplification and that of equal, if not greater, importance may be the site environment, such as soil type or geomorphology. This might explain the occurrences of seemingly anomalies matches sometimes, such as site sequence YRKSQ02 and the Devon site.
