**TREE-RING ANALYSIS OF TIMBERS FROM
THE OLD RECTORY,
BLAKENEY,
WIVETON ROAD,
NORFOLK**

**TREE-RING ANALYSIS OF TIMBERS FROM THE OLD RECTORY, WIVETON ROAD, BLAKENEY,
NORFOLK**

**ALISON ARNOLD
ROBERT HOWARD**

Dendrochronological analysis was undertaken on samples taken from timbers of the main and cross-wing roofs and from two timber ceilings, resulting in the dating of a single site sequence.

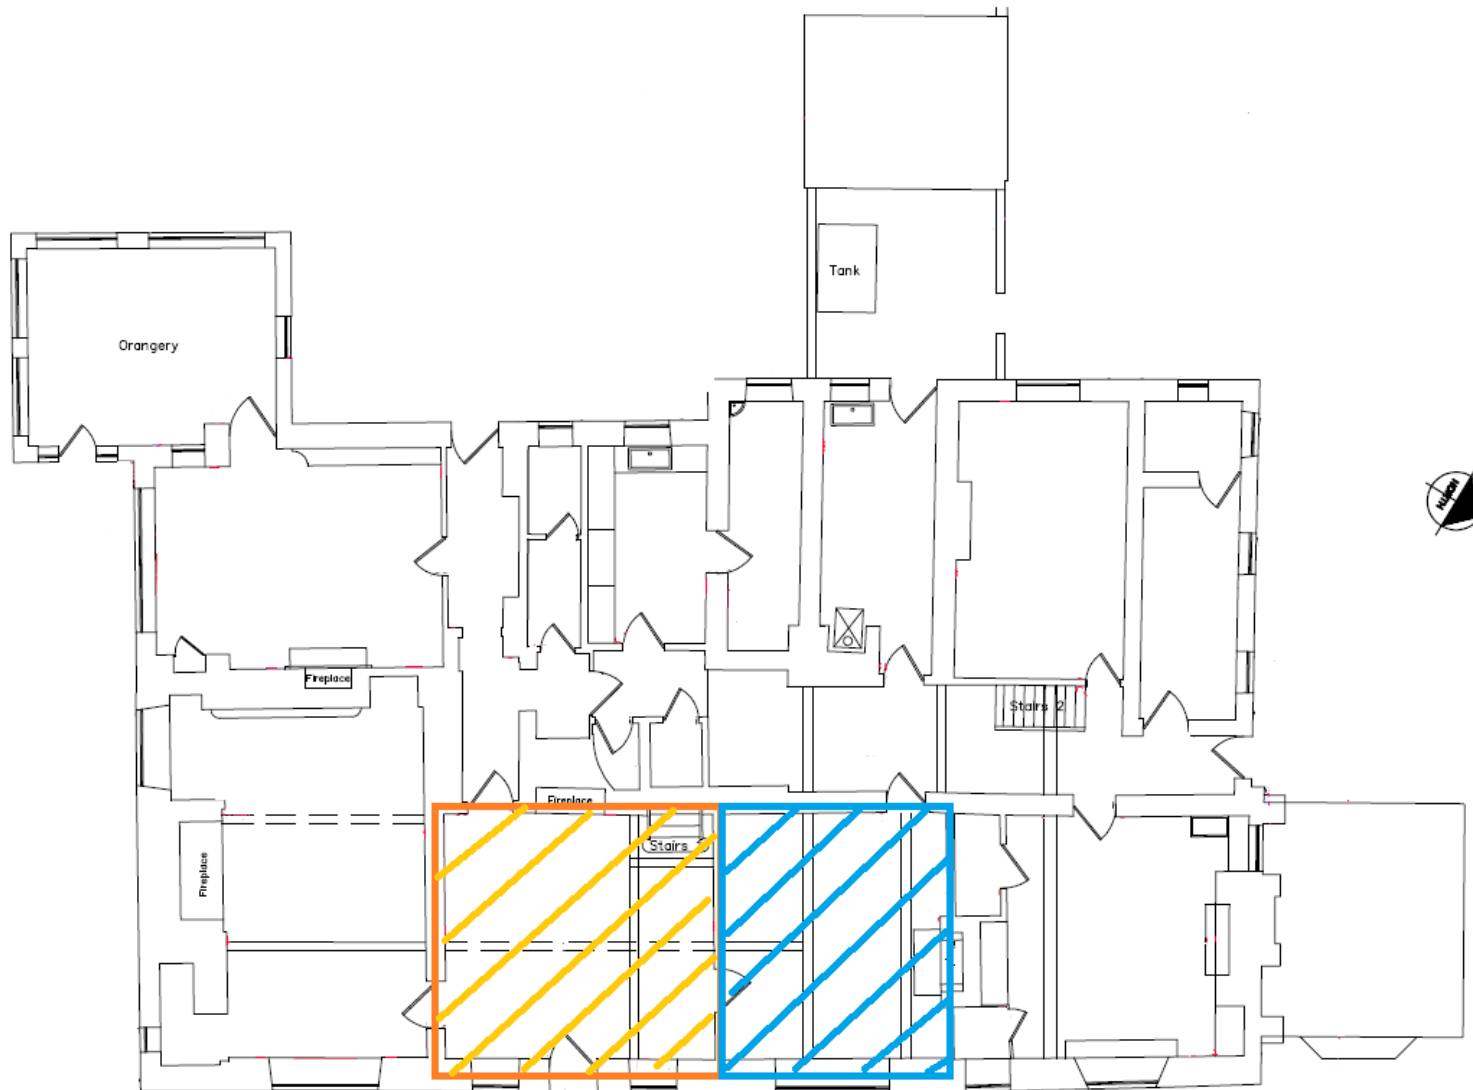
Figure 4: Ground-floor plan, showing the entrance hall (orange) and dining room (blue), (plan supplied by The Whitworth Co-Partnership)

Within this range, at ground-floor level, are the entrance hall and dining room. Both of these rooms have exposed timber ceilings (Figs 8 and 9). That of the entrance hall is more heavily moulded and with painted main joists. This ceiling is interrupted by an inserted panelled screen.

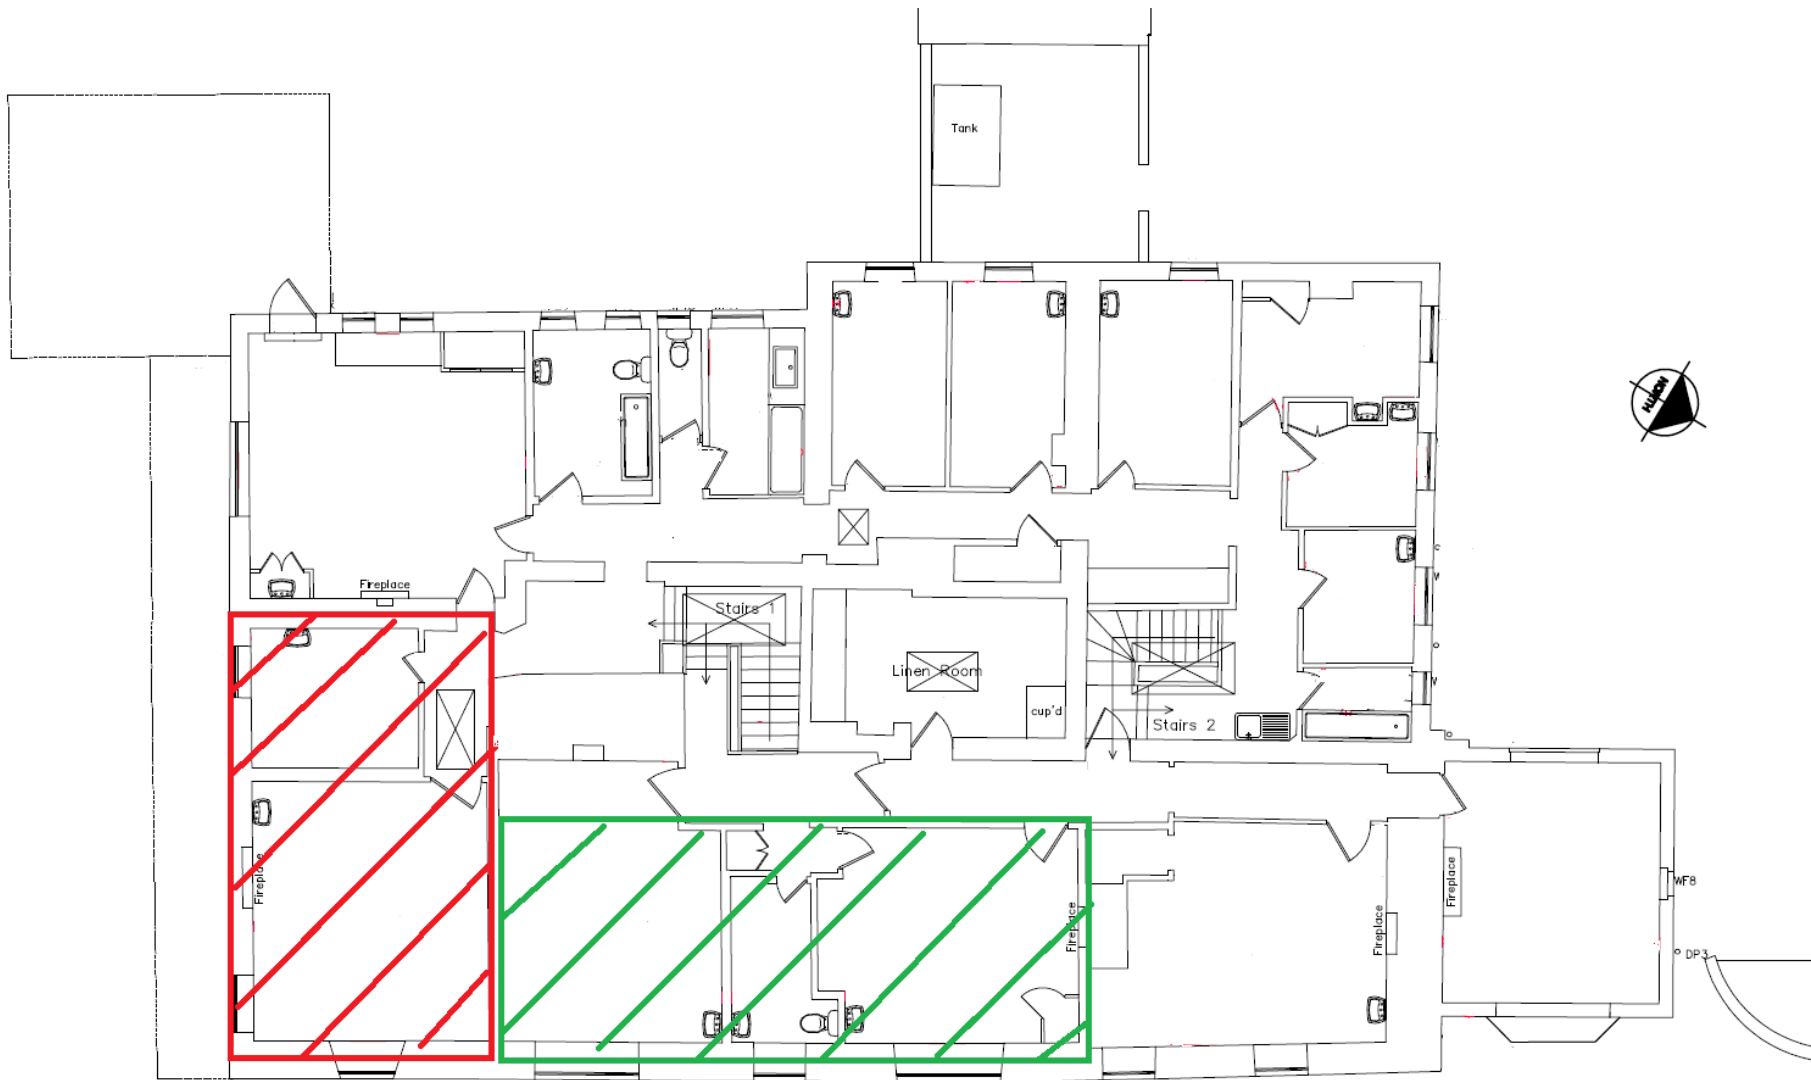
Figure 5: First-floor plan, showing the main range roof (green) and cross-wing roof (red), (plan supplied by The Whitworth Co-Partnership)

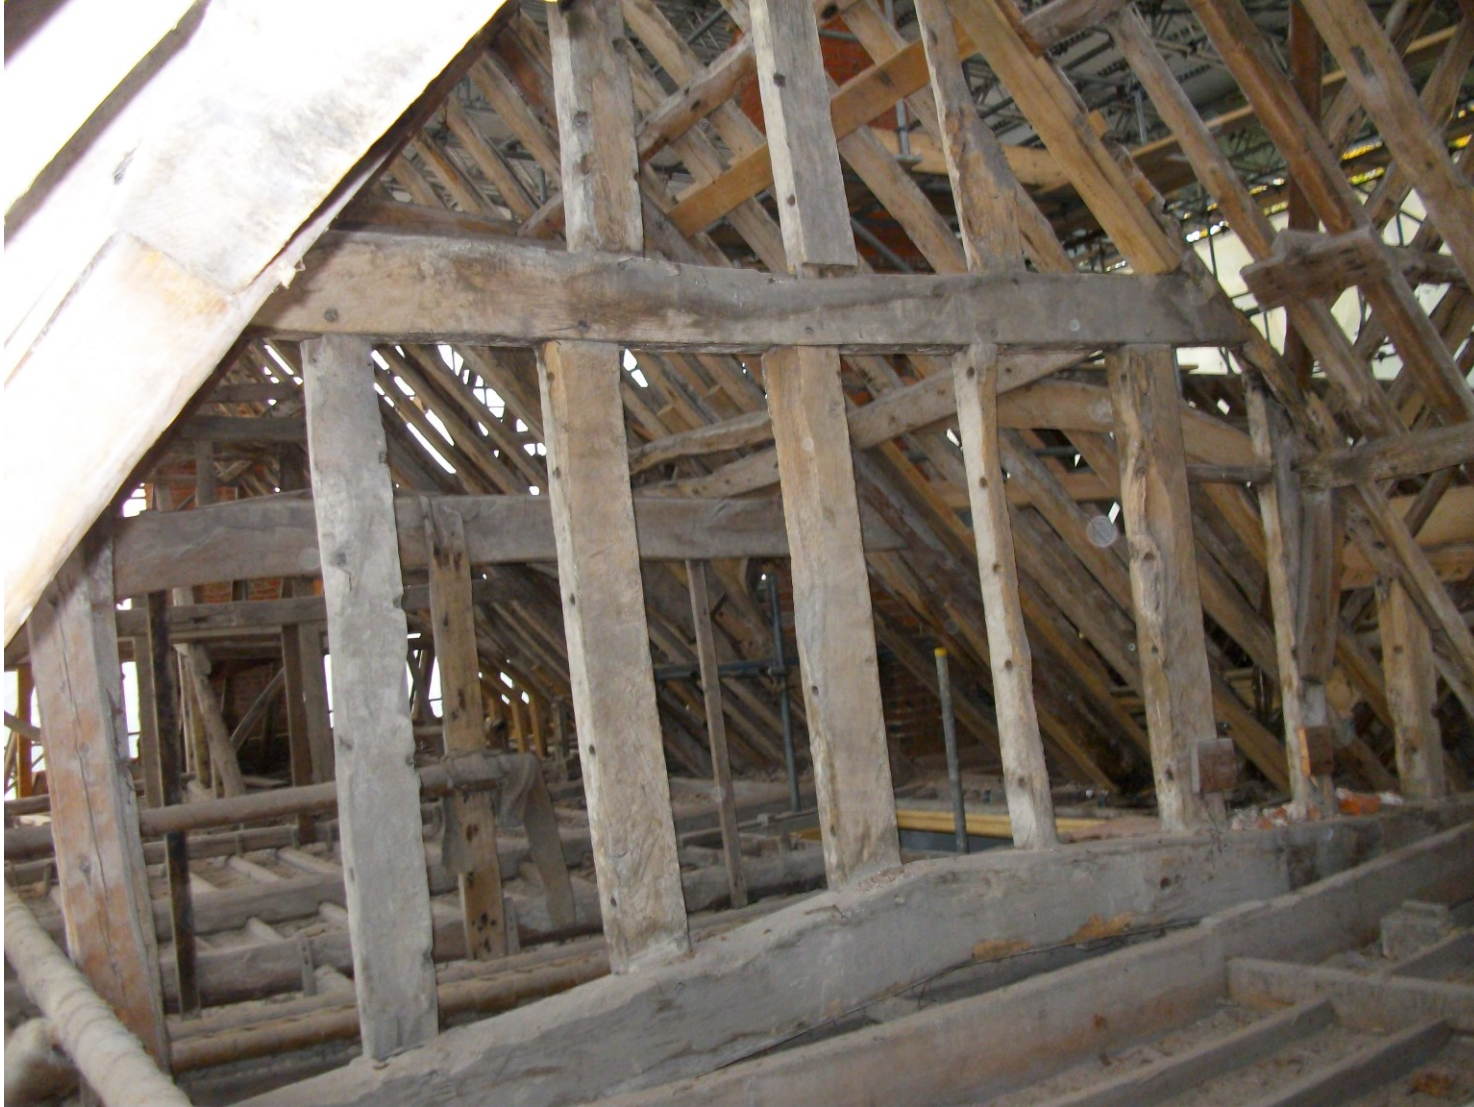
Figure 6: Main range roof; truss 1 (photograph taken from the north)

The main range roof consists of five trusses (numbered from north to south). Each truss consists of principal rafters, collars, and tiebeams; windbraces run from the principal rafter to the purlin. Additionally, trusses 1 and 5 are studded above and below the collar, suggesting these two trusses were originally 'closed' (Fig 6). Truss 3 has a cranked collar and is archbraced (Fig 7).

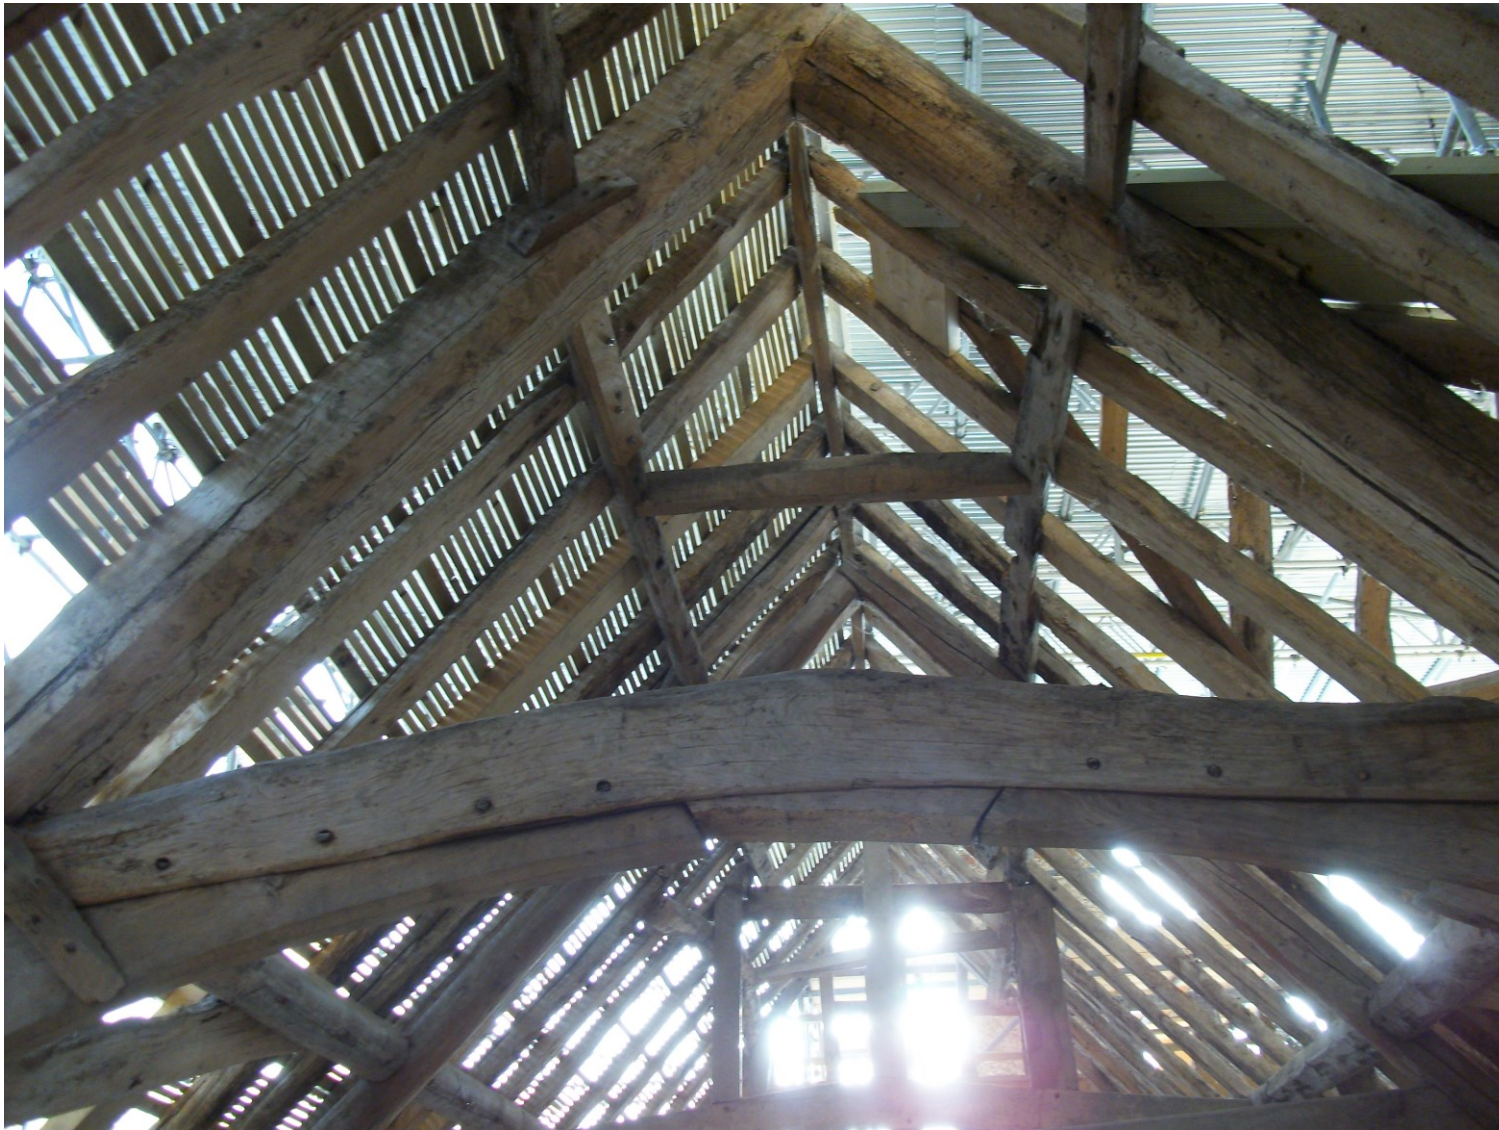
Figure 7: Main range roof; truss 3 (photograph taken from the south)

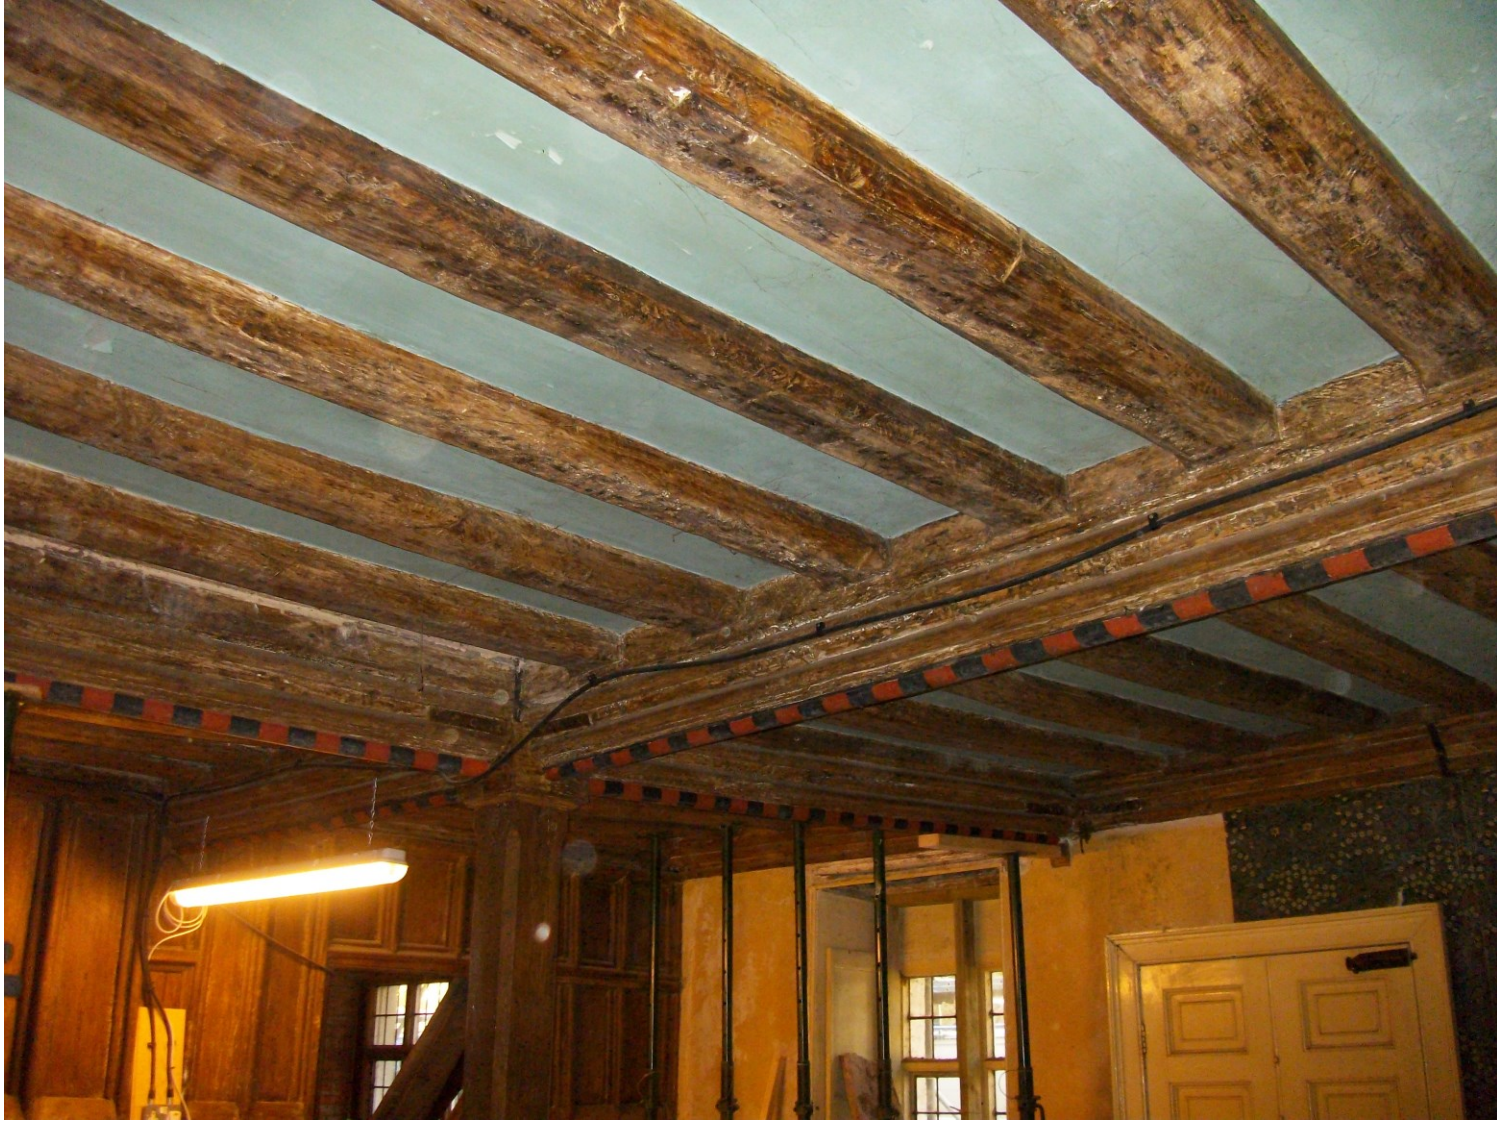
Figure 8: Main range; entrance hall, ceiling, photograph taken from the south-west

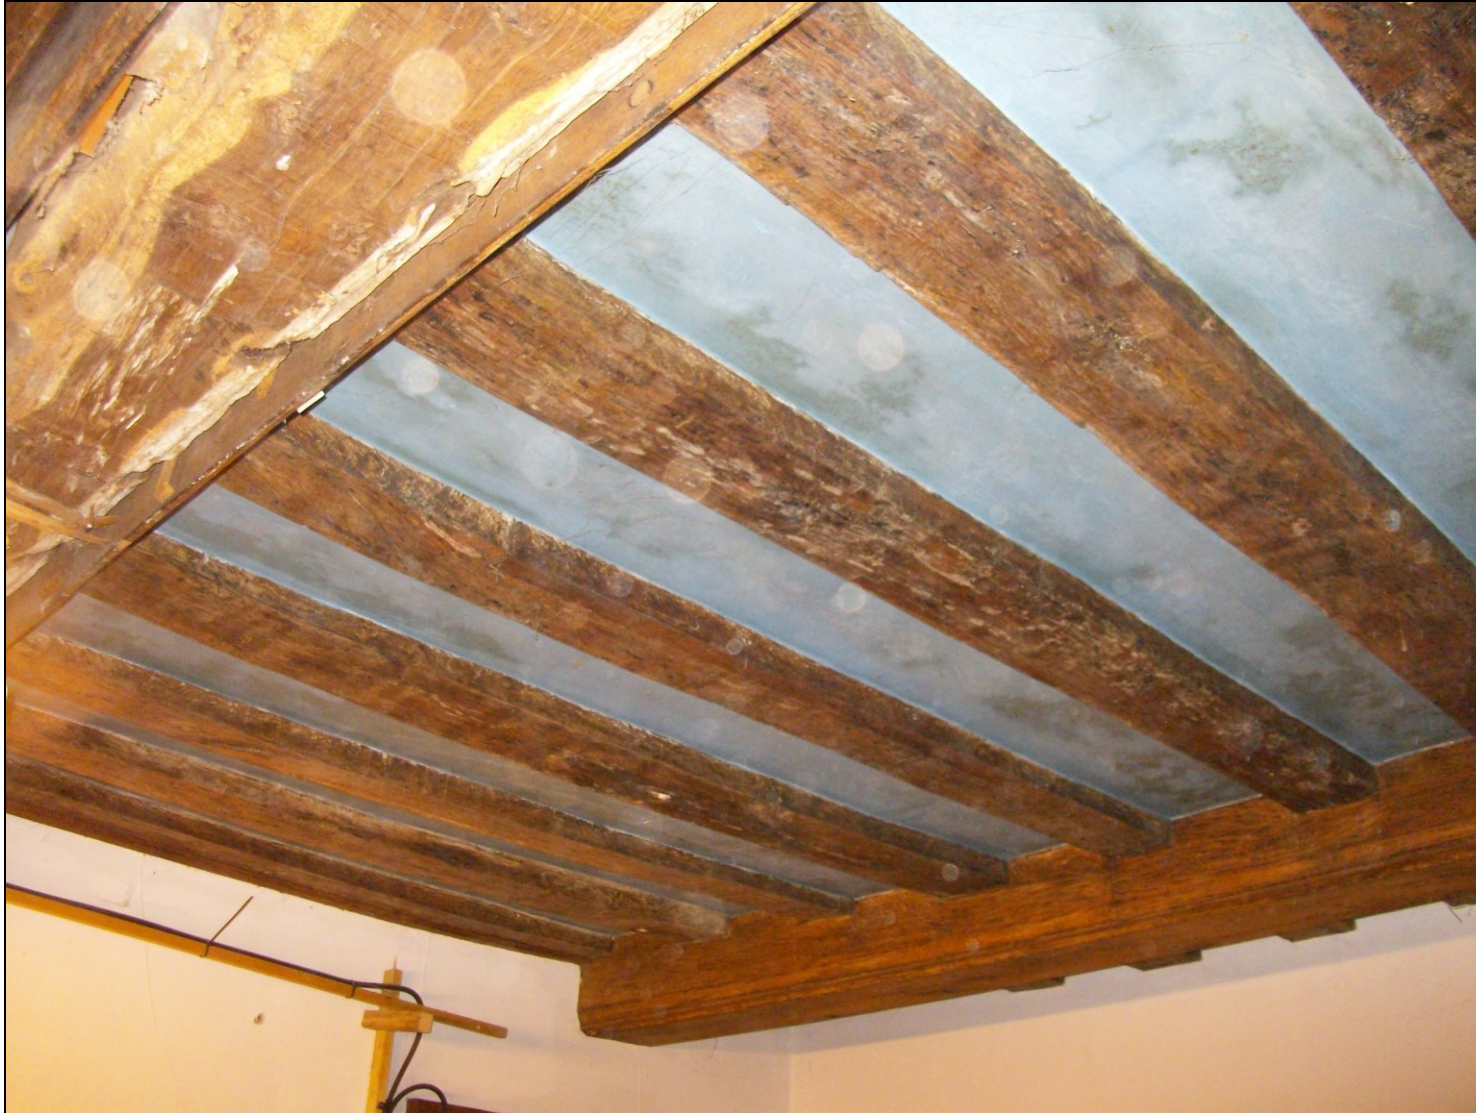
Figure 9: Dining room, ceiling, photograph taken from the south-east

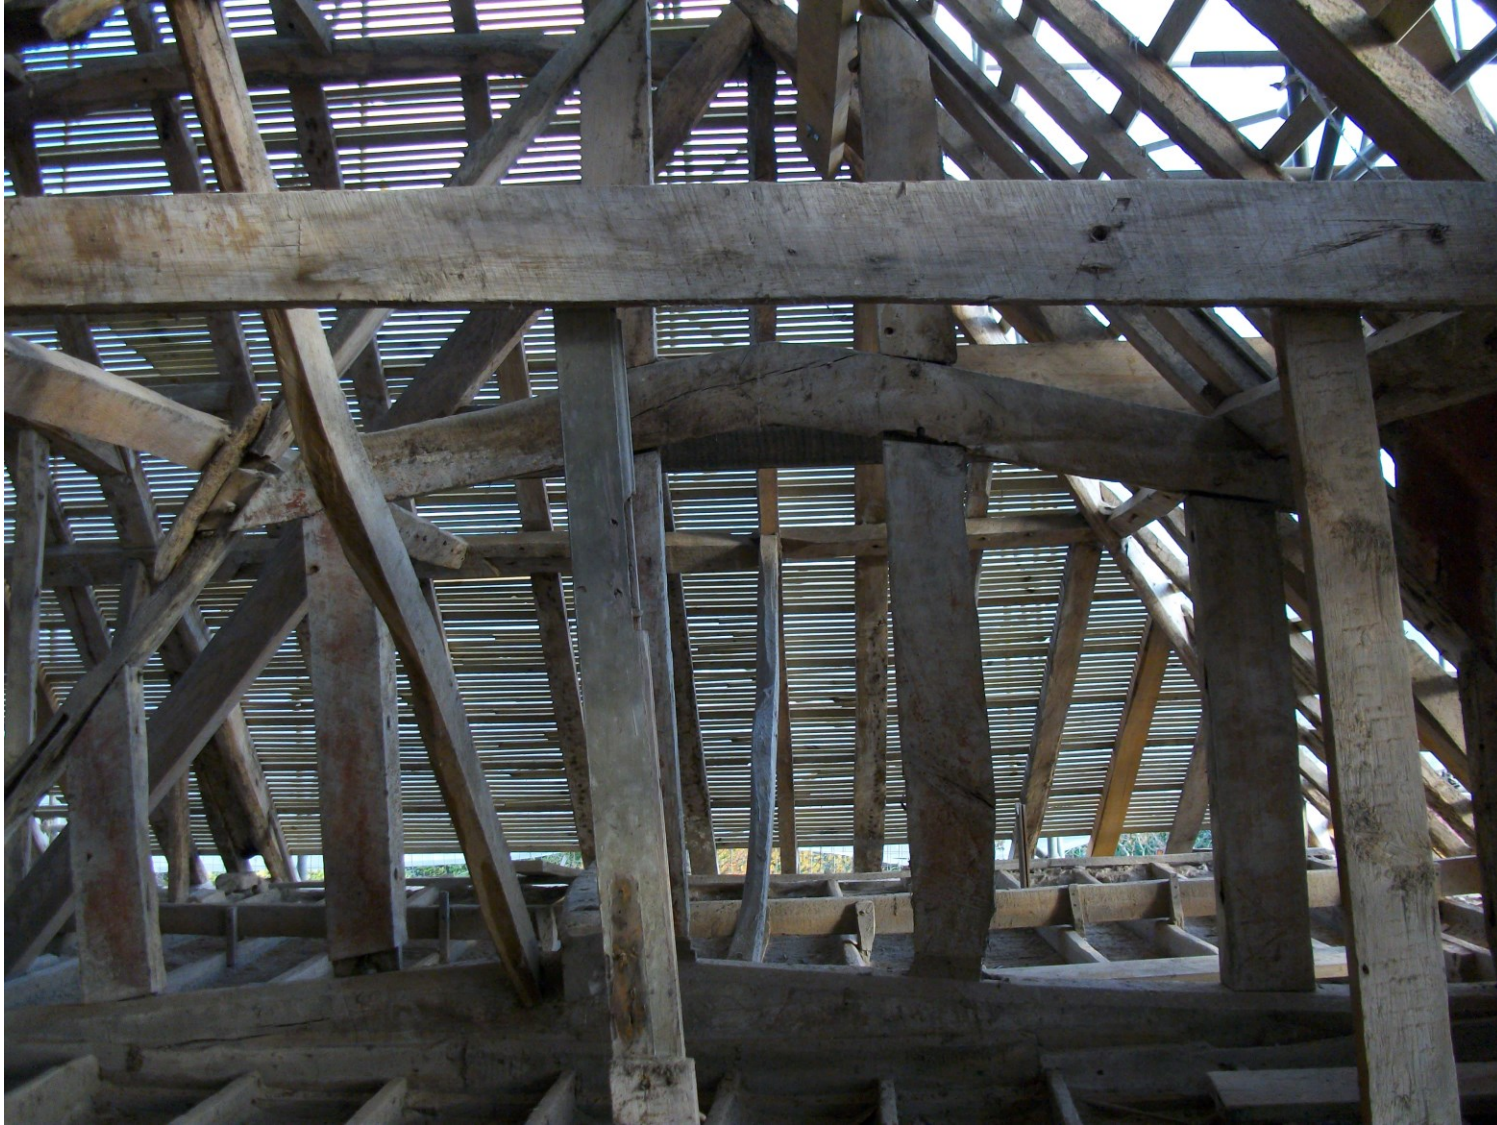
Figure 10: Cross-wing; truss 6 in the background (photograph taken from the west)

This roof does not appear to be so complete with more signs of modification and later repairs. There are three trusses (including the hip truss). Truss 6 is studded above and below the collar and resembles truss 1; the timbers are painted a red colour (Fig 10). This suggests a 'closed' truss and that either the roof space was utilised (perhaps for accommodation or storage) or the timbers were visible from the room below. Truss 7 is a rather cobbled together truss of collar and studs and truss 8 is the hip truss. There is a single, surviving windbrace from the south principal rafter of truss 6 to the purlin.

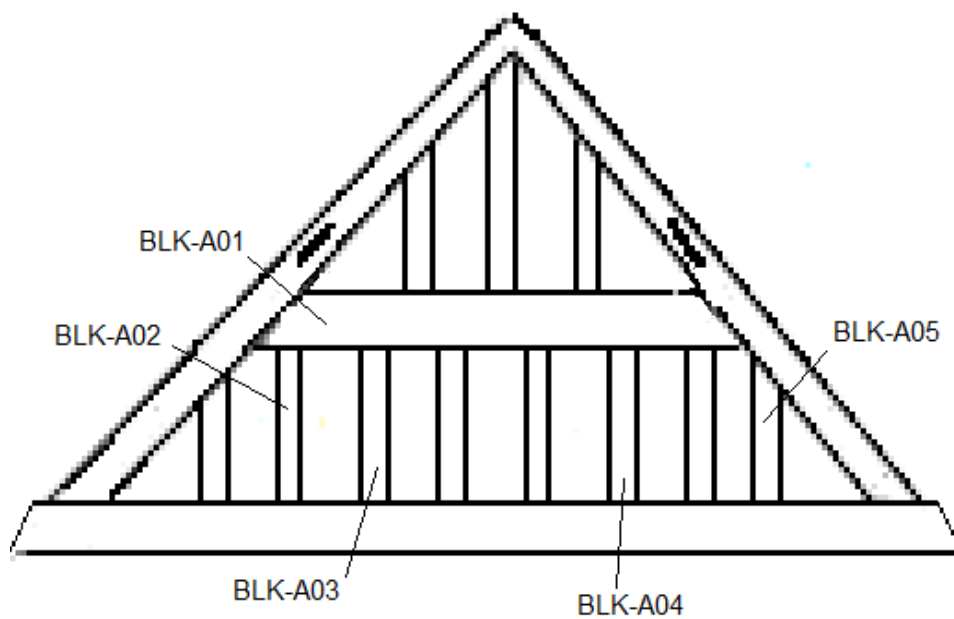
Figure 12: Sketch of truss 1, showing the location of samples BLK-A01–05

A total of 36 timbers was sampled with each sample being given the code BLK-A and numbered 01–36; samples BLK-A01–10 being taken from the main range roof, BLK-A11–20 from the cross-wing roof, BLK-A21–8 from the entrance hall ceiling beams, and BLK-A29–36 from the dining room ceiling beams. The location of samples was noted at the time of sampling and has been marked on Figures 11–16. Further details can be found in Table 1.

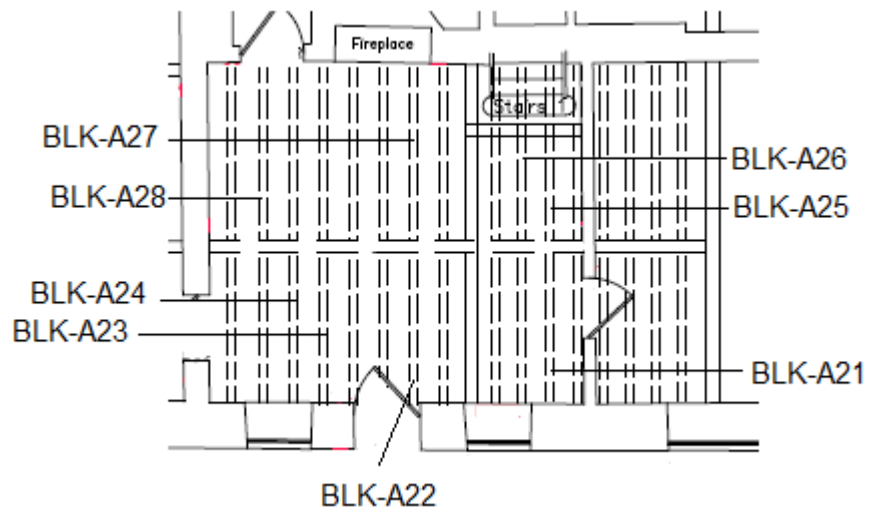
Figure 15: Plan of Hall ceiling, showing the location of samples BLK-A21–8

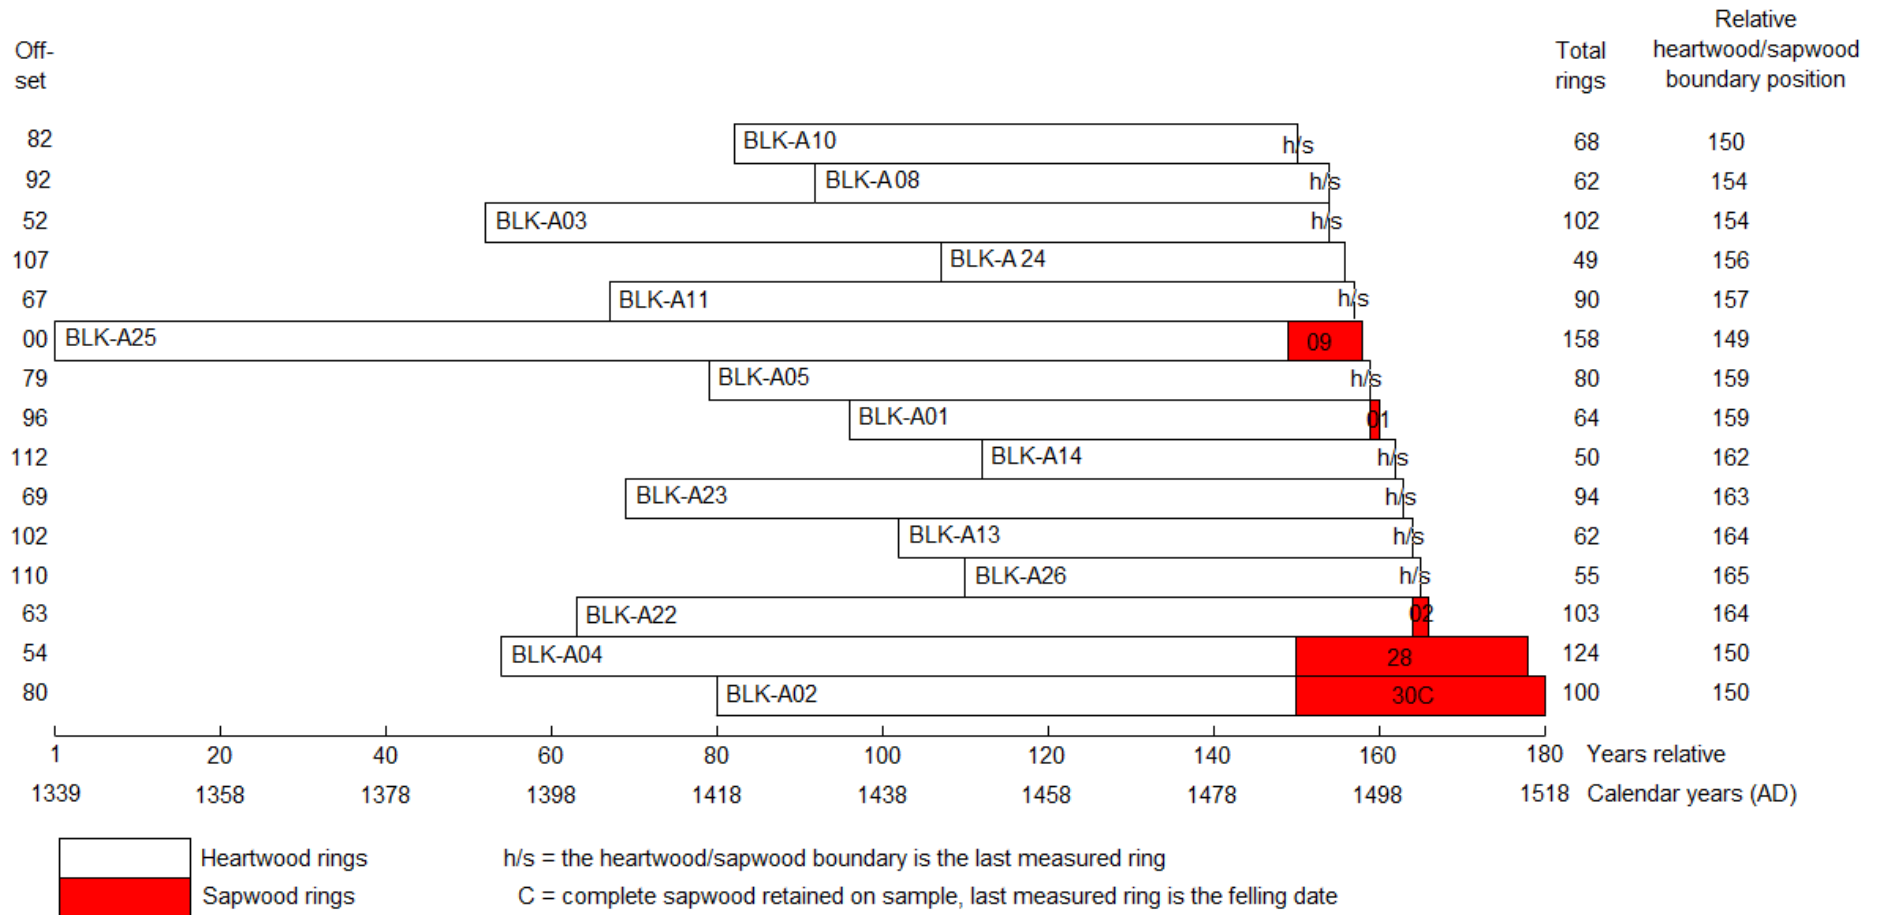
Figure 17: Bar diagram of samples in site sequence BLKASQ01

Firstly, 15 samples (seven from the main range roof, three from the cross-wing roof, and five from the entrance hall ceiling) matched each other and were combined at the relevant offset positions to form BLKASQ01, a site sequence of 180 rings (Fig 17). This site sequence was compared against a series of relevant reference chronologies for oak where it was found to match consistently and securely at a first-measured ring date of 1339 and a last-measured ring date of 1518. The evidence for this dating is given by the *t*-values in Table 2.
