**THE OLD MANOR HOUSE,
1 WEST END,
LONG CLAWSON,
LEICESTERSHIRE;**

TREE-RING ANALYSIS OF TIMBERS

MARCH 2014

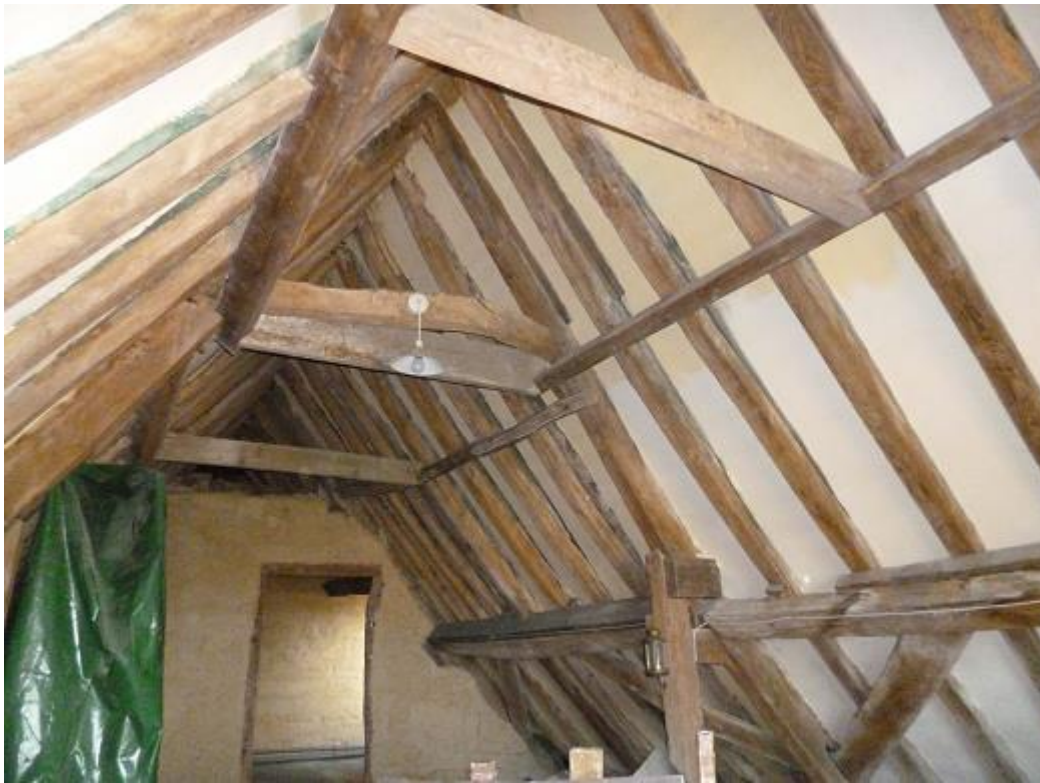
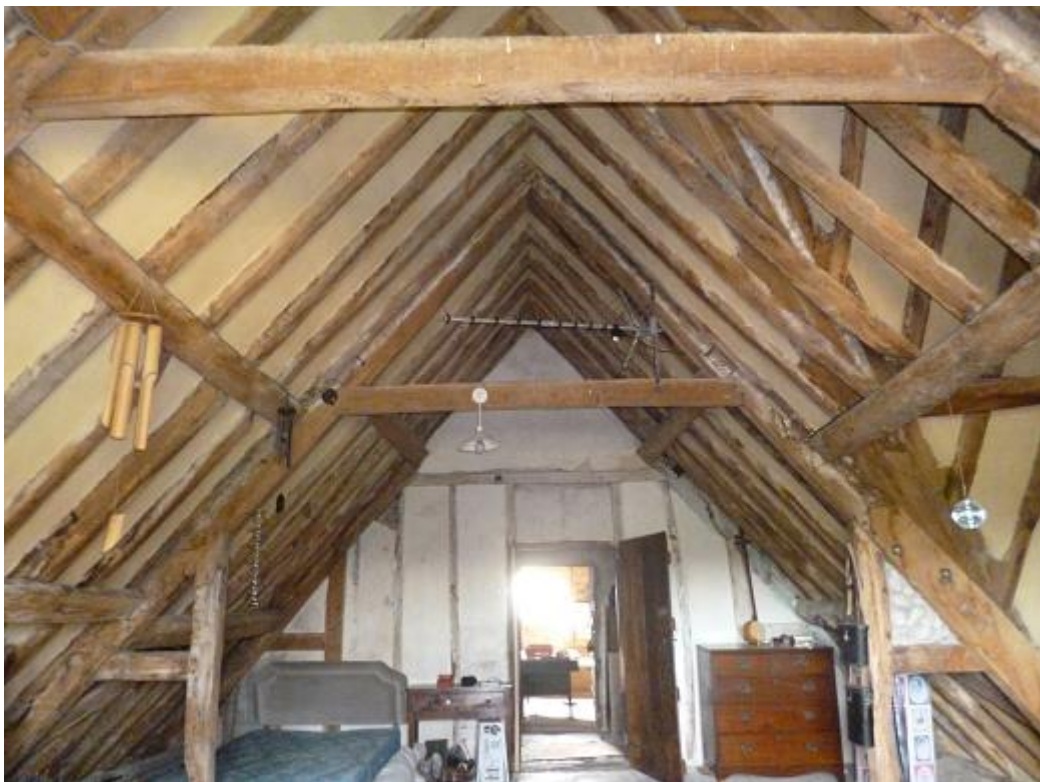
Figure 2a/b: Views of roof to the front wing, looking north to south (top) and to the west end of the rear range, looking west to east (bottom)

Within, particularly to the roofs, the building contains a substantial amount of timberwork, this forming principal rafter with tiebeam and collar trusses to the roofs of both ranges (Fig 2a/b), and the beams to the first and ground floor ceilings. The roof structure appears to be designed as a whole, originally with three full height gables on the south front, recent reroofing works revealing a complete numbering sequence for the principal trusses and spars.

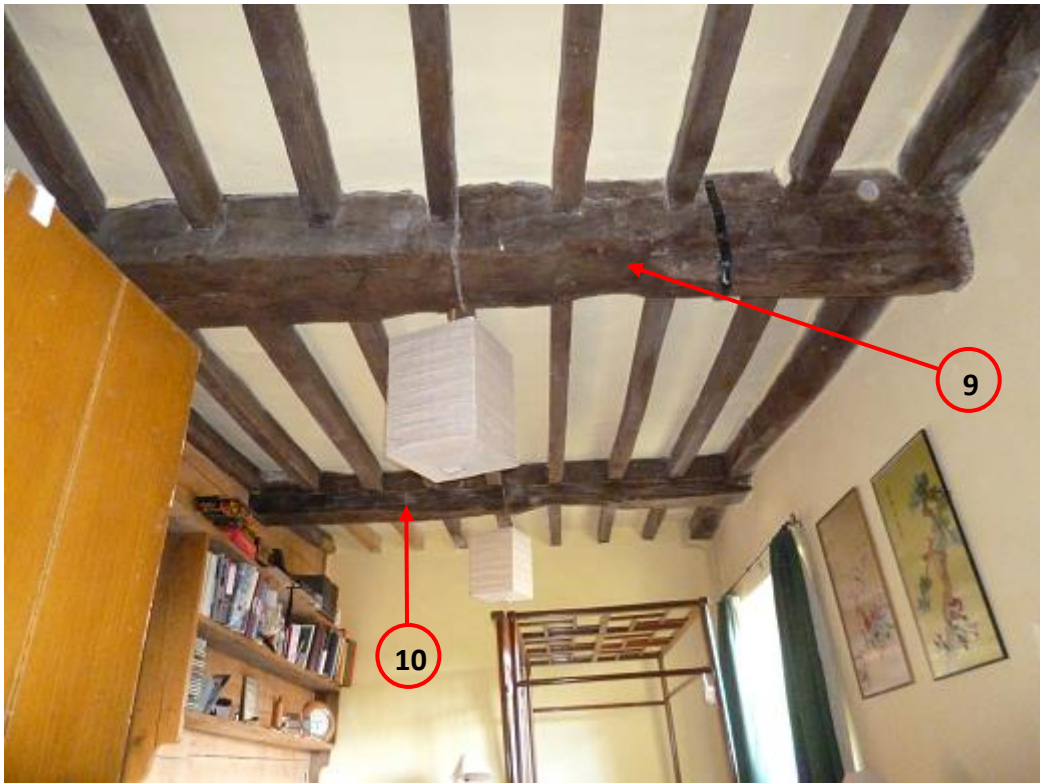
Figure 4a/b: Views of the first floor (top) and ground floor (bottom) ceiling beams to help locate the sampled timbers (see Table 1)

Thus, from the timbers, a further four core samples were obtained, two from the first floor ceiling beams and two from the ground floor ceiling in the kitchen. These additional four samples were then analysed in conjunction with the eight previously obtained. Each sample has been given the code LNG-C (for Long Clawson), and numbered 01–12. The positions of the sampled roof timbers are shown on a simple schematic sketch plan made at the time of sampling, given here as Figure 3, while the ceiling timbers are located on annotated photographs, given here as Figure 4a/b. In this report, the timbers and sample positions are located on a north–south or east–west basis as appropriate, the street entrance of West End deemed to be to the north side of the building. Details of the samples are given in Table 1, including the timber sampled and its location, the total number of rings each sample has, and how many of these, if any, are sapwood rings. The individual date span of each dated sample is also given.

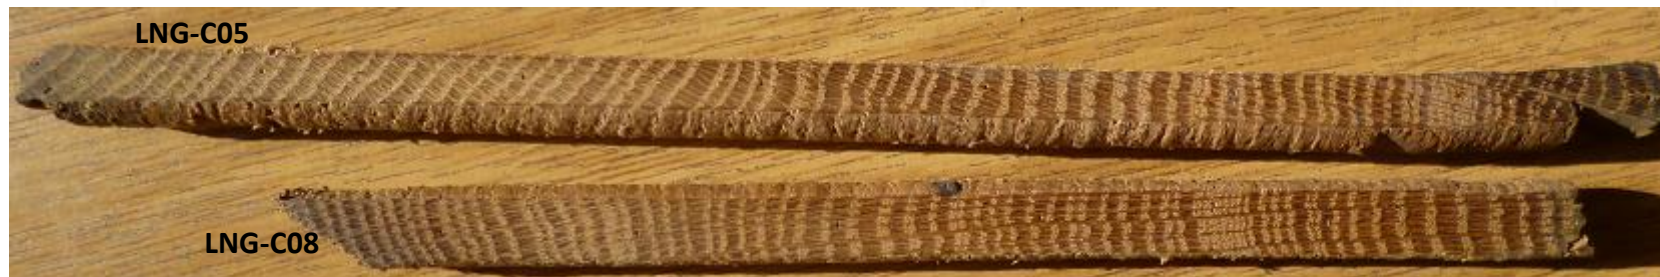
Figure 5: Graphic representation of the cross-matching of two samples, LNG-C05 and C08

When cross-matched at the correct positions, as here, the variations in the rings of these two samples (where they overlap) correspond with a high degree of similarity. As the ring widths of one sample increase (represented by peaks in the graph), or decrease (represented by troughs), so too do the annual ring widths of the second sample. This similarity in growth pattern is a result of the two trees represented having grown at the *same time* in the *same place*. The growth ring pattern of two samples from trees grown at different times would never correspond so well.

Tree-ring dating relies on a few simple, but quite fundamental, principles. Firstly, as is commonly known, trees (particularly oak trees, the timber most commonly used in building construction until the introduction of pine from the late eighteenth century onwards) grow by adding one, and only one, growth-ring to their circumference each, and every, year. Each new annual growth-ring is added to the outside of the previous year's growth just below the bark. The width of this annual growth-ring is largely, though not exclusively, determined by the weather conditions during the growth period (roughly March–September). In general, good conditions produce wider rings and poor conditions produce narrower rings. Thus, over the lifetime of a tree, the annual growth-rings display a climatically influenced pattern. Furthermore, and importantly, all trees growing in the same area at the same time will be influenced by the same growing conditions and the annual growth-rings of all of them will respond in a similar, though not identical, way (see Fig 5).
