**TREE-RING ANALYSIS OF TIMBERS FROM
LING BOB FARM
SCOTLAND LANE
HORSFORTH, LEEDS
YORKSHIRE**

February 2014

Dendrochronological analysis was undertaken on samples taken from timbers of the barn and former farmhouse at Ling Bob Farm, resulting in the construction and dating of two site sequences and the individual dating of two samples.

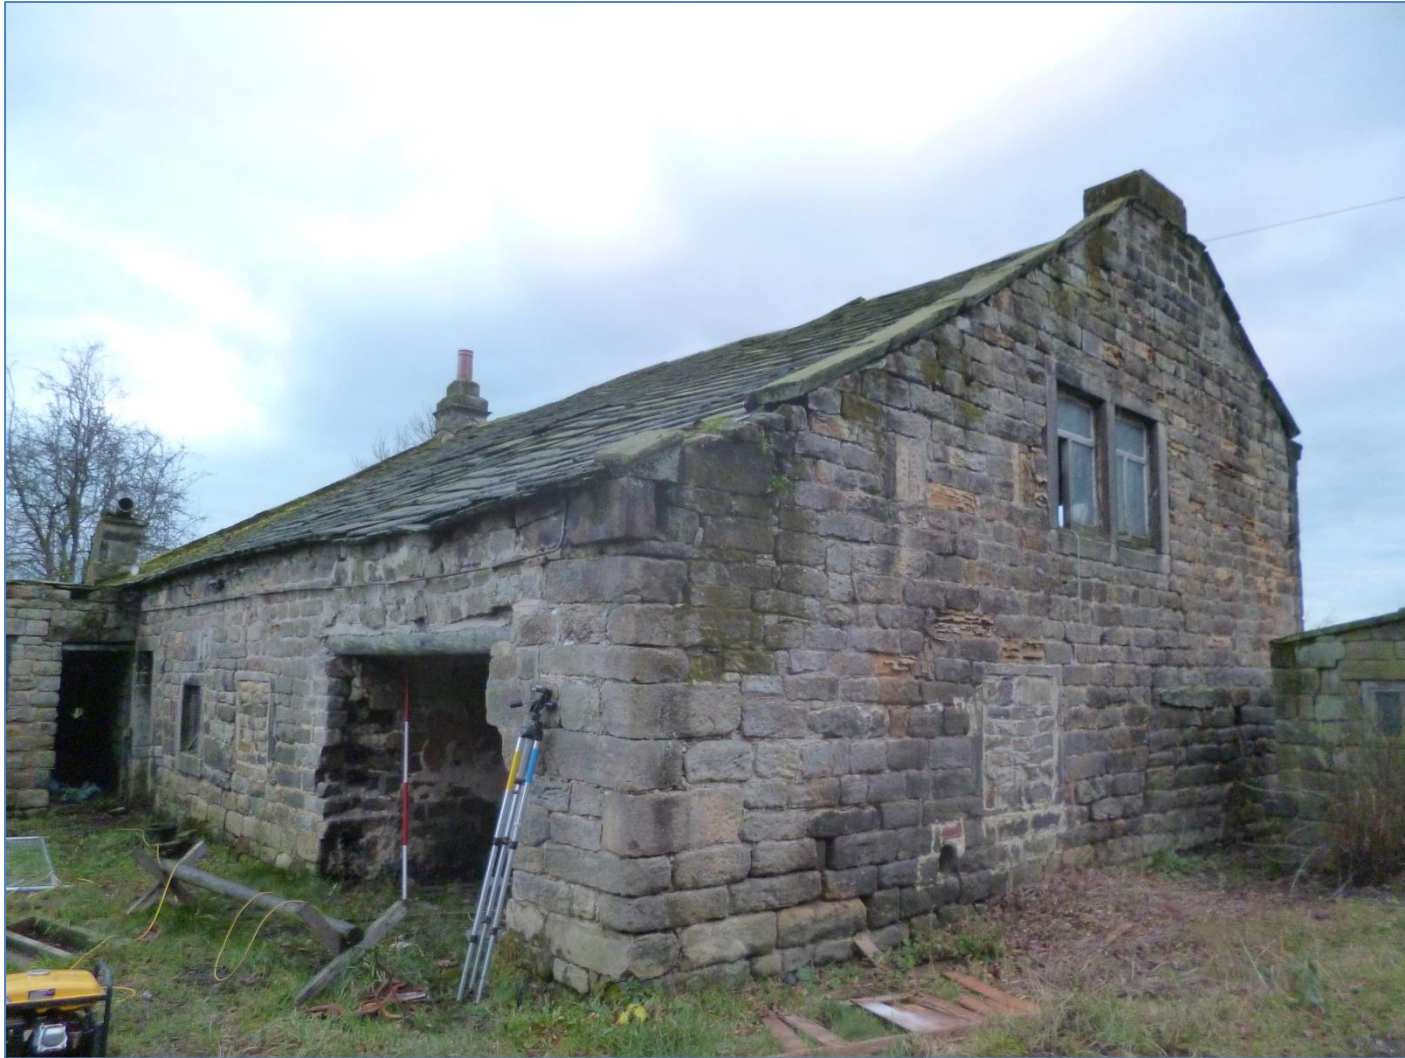
Figure 5: The rear of the former farmhouse, photograph taken from the north-west

The former farmhouse (Farmhouse 1 in listing description and site plan) is located approximately 10m to the north-east of the present farmhouse (Fig 4). It is constructed of coursed, squared sandstone with a stone slate roof and is of end-lobby plan with a continuous rear outshut (Fig 5). The roof over this building consists of two king post trusses with principal rafters and struts. There are empty mortices in the king posts and ridge signifying there was once braces running between these two elements (Fig 6). There are a single tier of purlins to the main roof with a further two to the catslide to the north. The exception is in the westernmost bay where there can be seen to be two slender purlins rather than the heavier single purlin seen in other bays (Fig 6). On the ground floor is an exposed large, chamfered ceiling beam, with a scarf joint c 2m from the chimney breast, thought to indicate the presence of a former firehood. This building is believed to date to the later-seventeenth century but underwent alterations in the nineteenth and twentieth centuries.

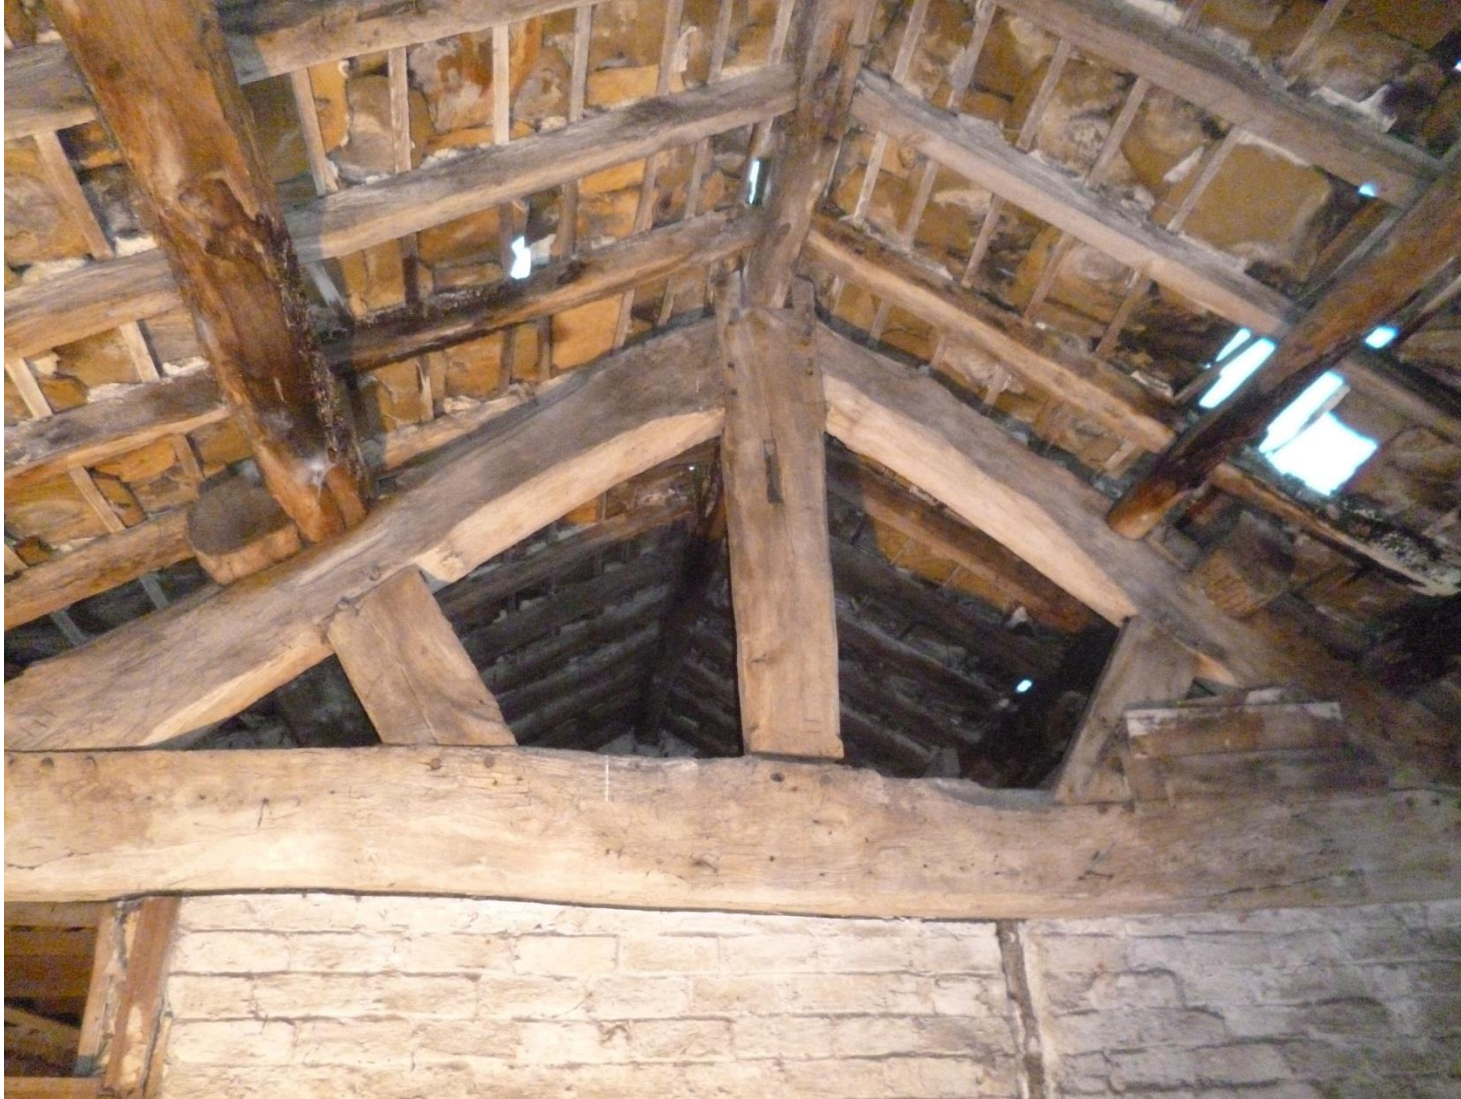
Figure 6: Former farmhouse, truss 2 (photograph taken from the west)

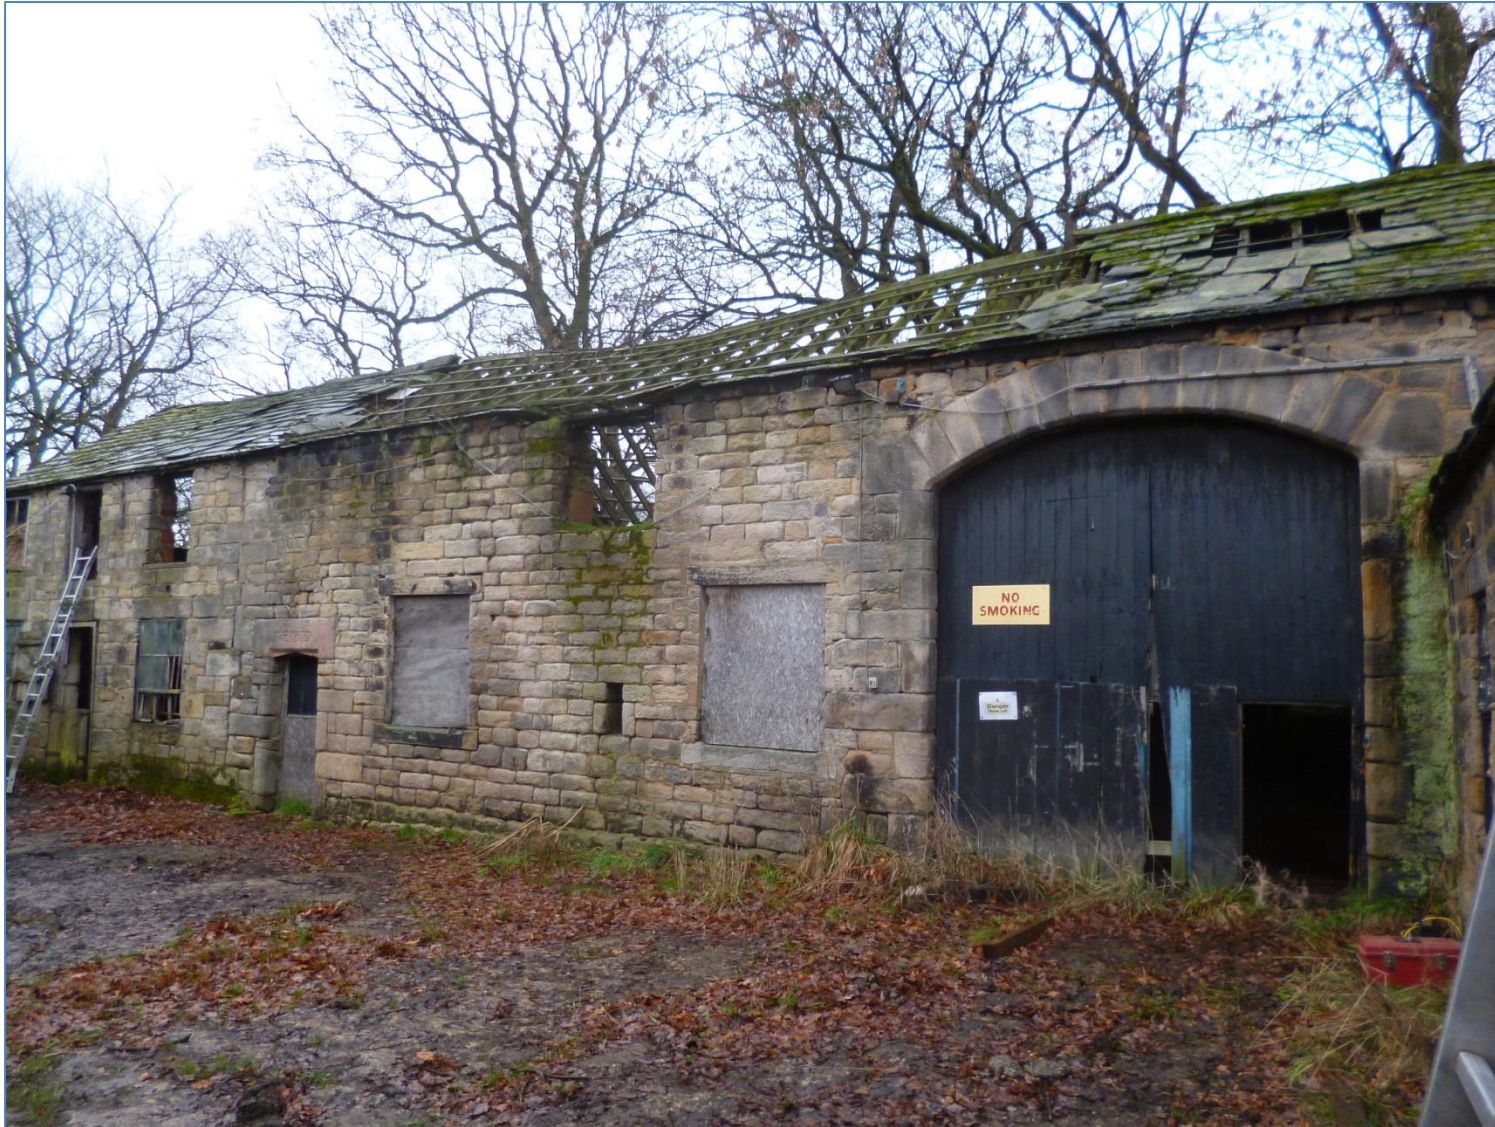
Figure 7: The barn, photograph taken from the east

To the north-west of the present farmhouse is the former stables and barn. This is a long building on a north-south alignment, aisled on the west side. At right angles to the north end of the barn is the arch barn (existing stable range). The stables and barn are again constructed of coursed squared sandstone with quoins, slate roof and has a large, segmental-headed wagon doorway with chamfered surround, near the north end (Fig 7). To the south of this there is a Tudor-arched doorway with chamfered surround, the lintel above it has the date 1680 carved into it. The roof over the northern part of this building consists of a king post truss, with tiebeam, principal rafters, and struts. A post survives on the west side but can be seen to have been cut down and now sits on a brick pillar. From this braces rise up to the tiebeam and a purlin of the aisle (Fig 8). The rest of the roof is in a very fragmentary state (Fig 9).

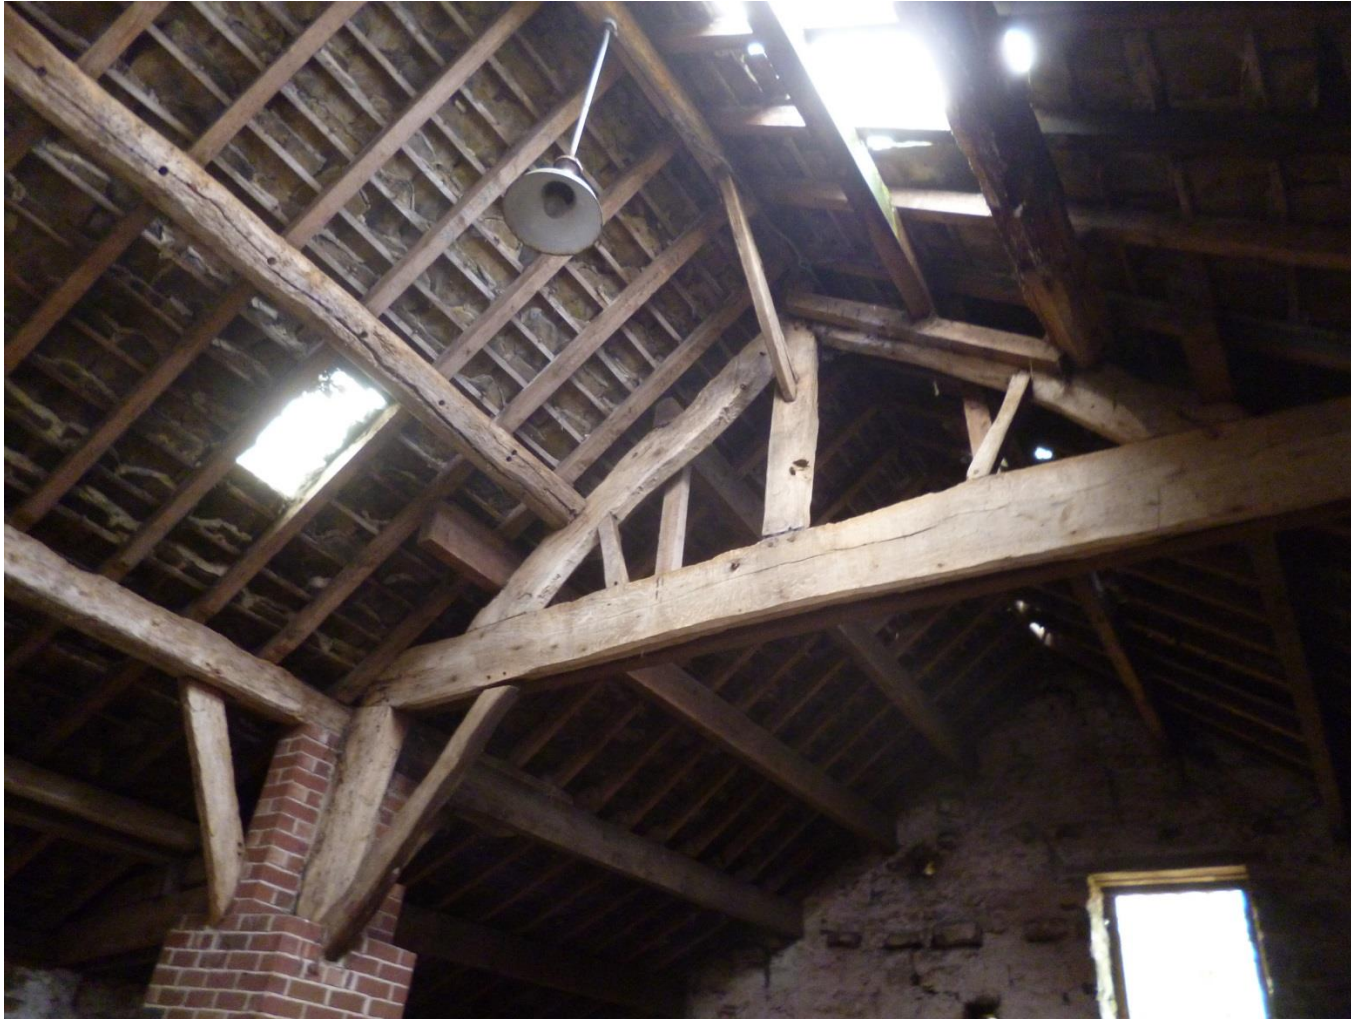
Figure 8: The barn, truss 1, photograph taken from the south

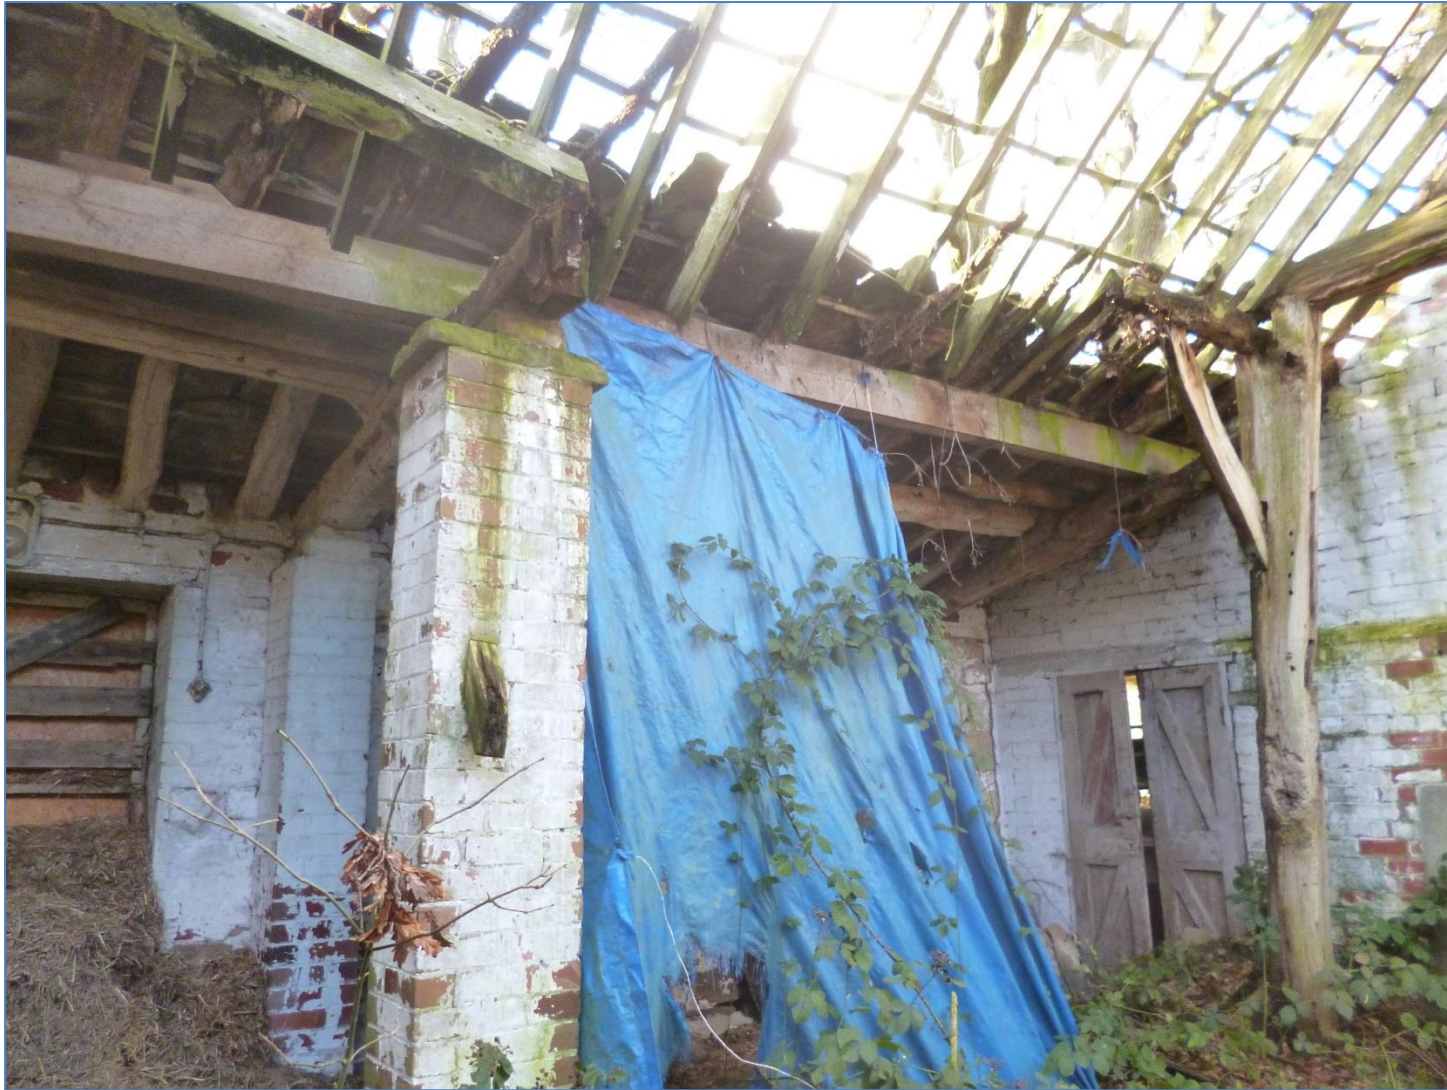
Figure 9: The barn roof, the post of truss 2 in the background, photograph taken from the south-east

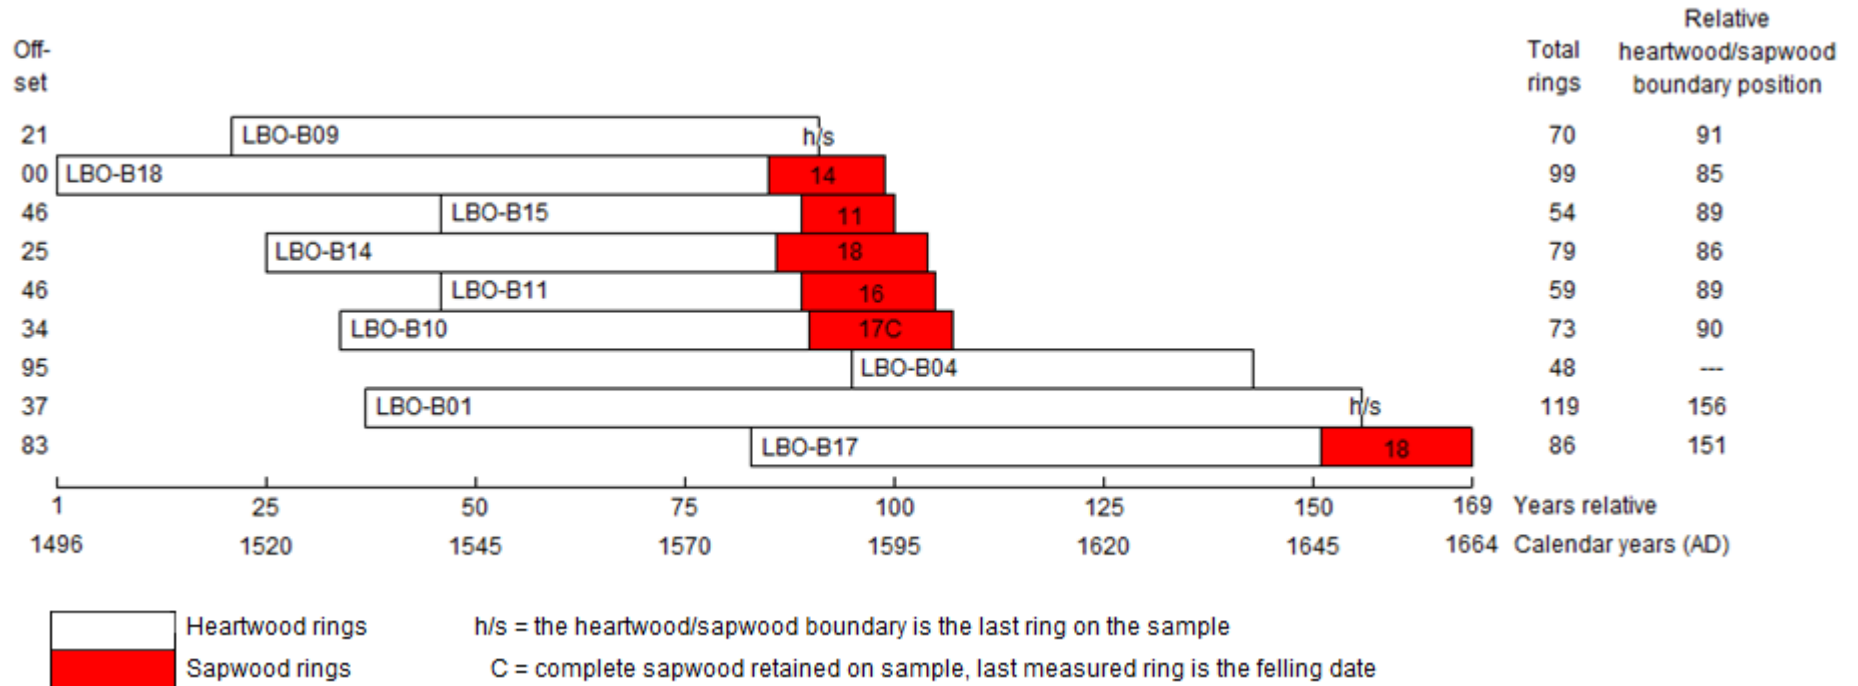
Figure 16: Bar diagram of samples in site sequence LBOBSQ02

Secondly, nine samples grouped to form a site sequence of 169 rings (Fig 16). When compared against the reference material this site sequence matched at a first-ring date of 1496 and a last-measured ring date of 1664. The evidence for this dating is given by the *t*-values in Table 3.

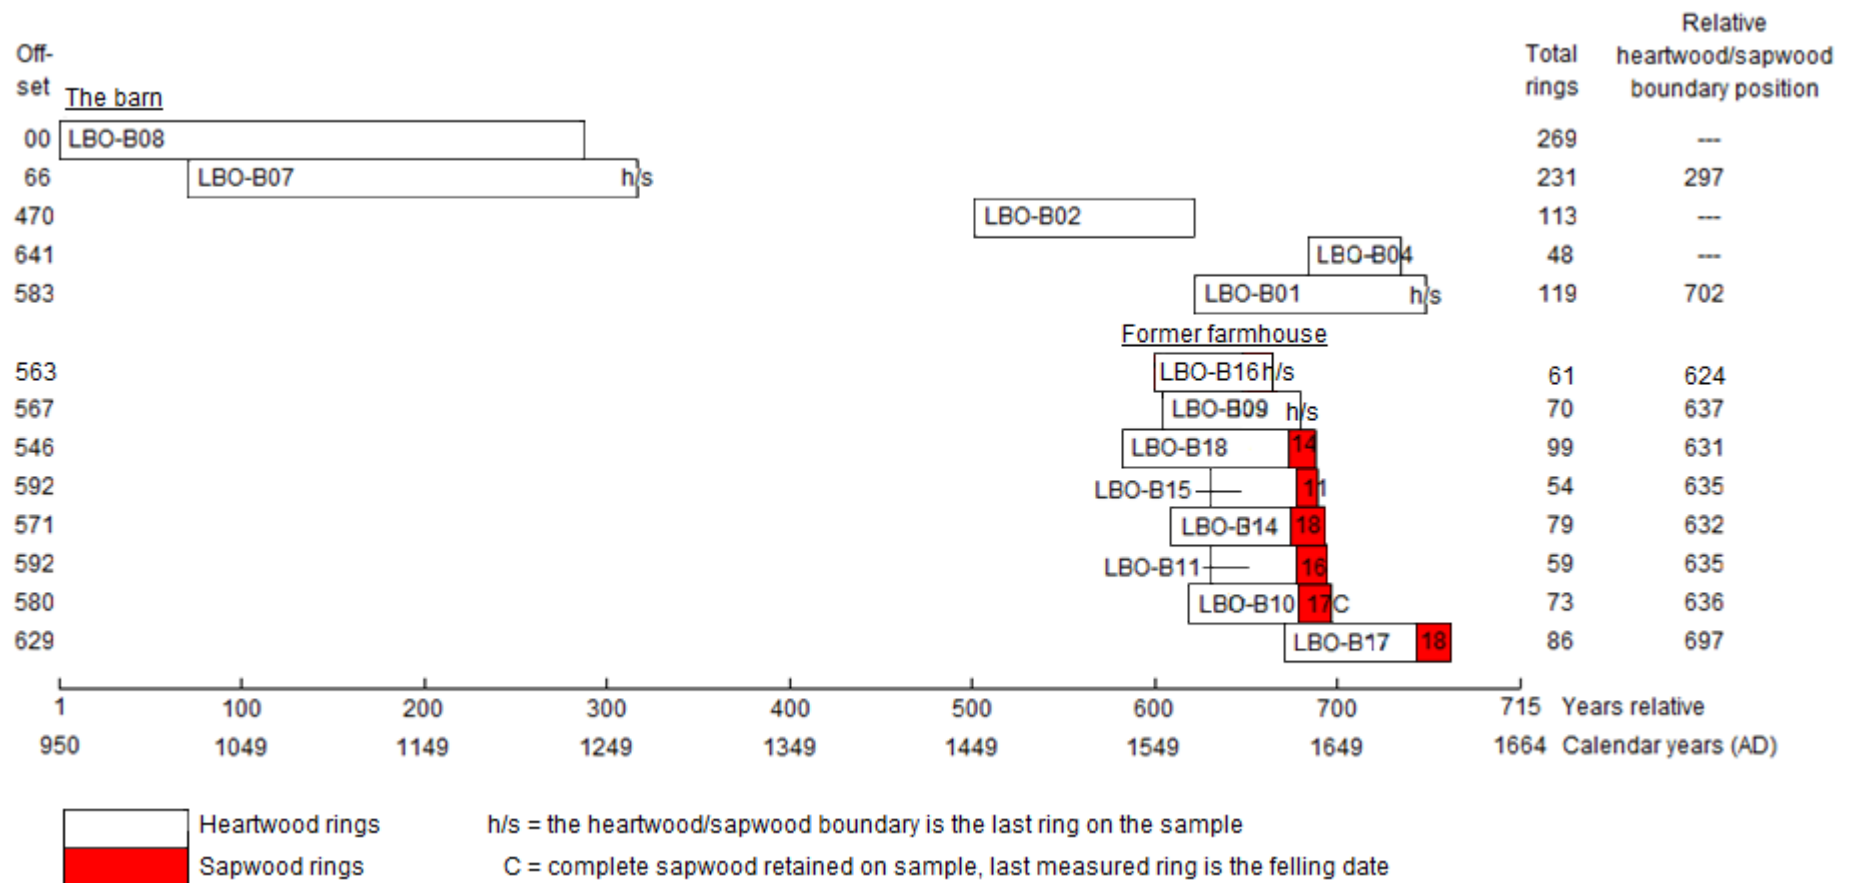
Figure 18: Bar diagram of all dated samples, sorted by area

Eight of the samples taken from the roof of this building have been successfully dated (Fig 18). Sample LBO-B10, taken from the king post of truss 1, has complete sapwood and the last-measured ring date of 1602, the felling date of the timber represented. Six other samples have similar heartwood/sapwood boundary ring dates to each other, suggestive of a single felling. The average heartwood/sapwood boundary ring date of these six samples is 1581, allowing an estimated felling date to be calculated for the timbers represented to within the range 1601–21, consistent with these samples also having been felled in 1602. This felling date range allows for sample LBO-B11 to have the last-measured ring date of 1600 with incomplete sapwood. The final dated sample, taken from a purlin, has the later heartwood/sapwood boundary ring date of 1646, giving an estimated felling date range for the timber represented of 1661–86.

Five of the samples taken from the barn have been successfully dated (Fig 18). Only two of these have the heartwood/sapwood boundary, interpretation of which suggests two separate fellings. Sample LBO-B07, taken from an aisle tie, has the heartwood/sapwood boundary ring date of 1246, allowing an estimated felling date to be calculated for the timber represented of 1261–86. With a last-measured heartwood ring date of 1218 it is possible that sample LBO-B08, again from an aisle tie, was also felled in 1261–86. Additionally, these two samples match each other at $t=12.9$, a value high enough to suggest both timbers were cut from the same tree. At the time of sampling the two beams represented by these samples could be seen to be reused (Fig 19).

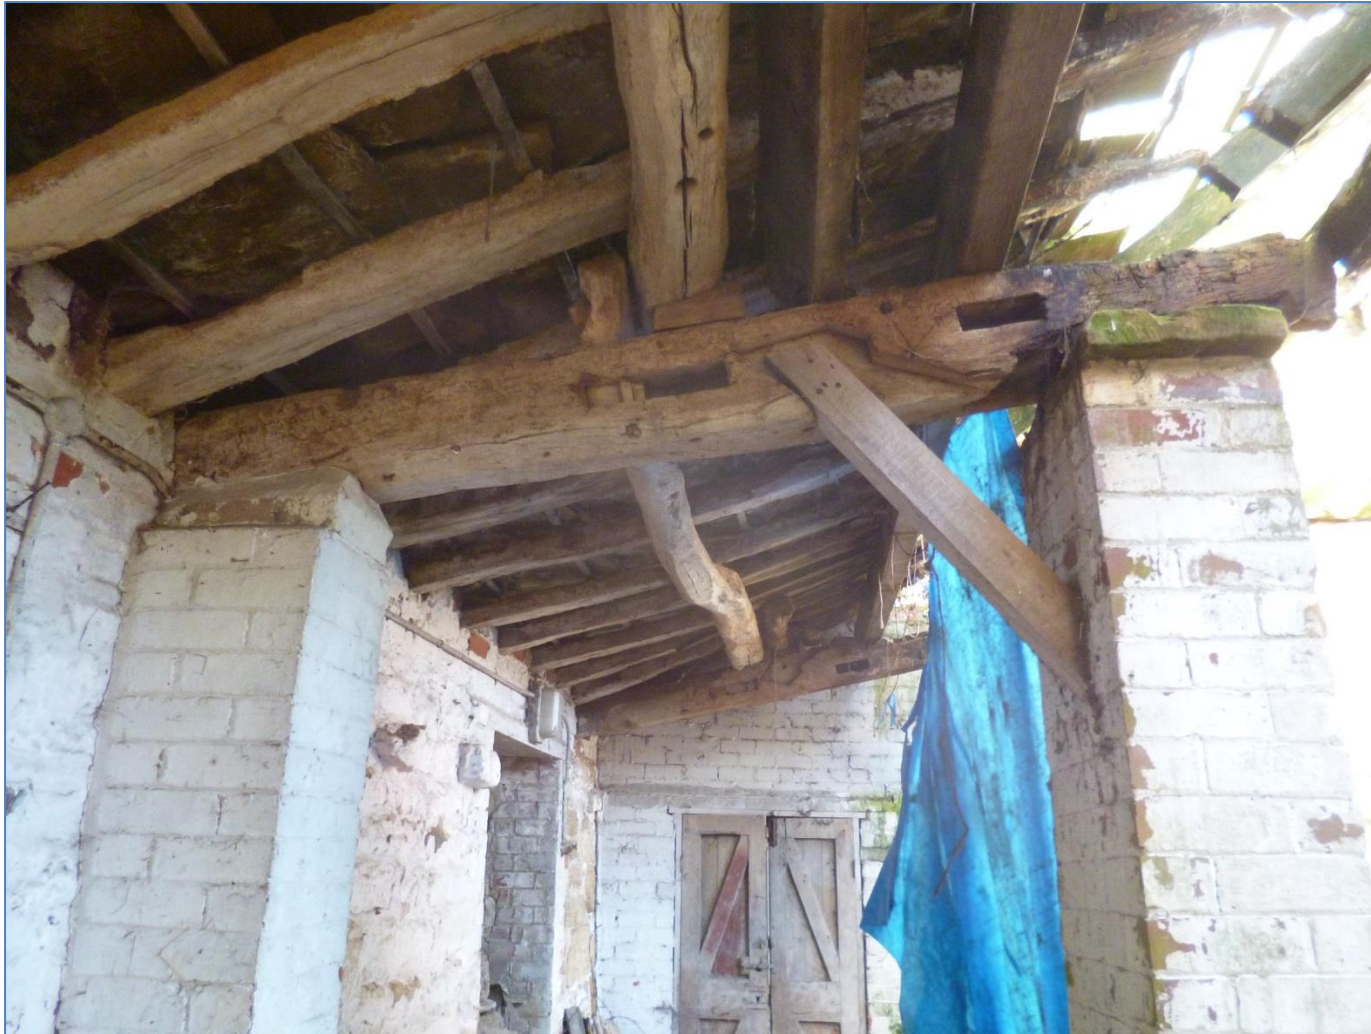
Figure 19: Aisle ties of the barn, the redundant mortices and lap joints clearly demonstrate a previous use for this timber (aisle tie 3) and the one in the background (aisle tie 2), photograph taken from the south

Two of the aisle ties of the barn have been dated to 1261–86; both of these timbers can clearly be seen to be reused. The tiebeam of truss 1, a timber thought to be primary, is now known to have been felled in 1666–91. Two further barn timbers, a king post and a purlin, have *terminus post quem* fellings of 1547 and 1653, respectively. During the sampling of these latter two timbers, the heartwood/sapwood boundary was seen on both beams and it was felt that this point was only just missed off the samples. This would mean that the actual felling dates are probably quite close to the *terminus post quem* dates, suggesting two separate fellings, one in the mid-later sixteenth century and the other in the second half of the seventeenth century, perhaps at the same time as the tiebeam. With at least one, and probably two timbers being dated to the second half of the seventeenth century, the dendrochronology has provided support for the 1680 date carved on the door lintel. However, it has also shown that reused timber from the thirteenth and possibly the sixteenth century was also utilised in its construction.
