**TREE-RING ANALYSIS OF TIMBERS FROM
OLD HOUSE FARM,
PENTRE LANE,
BREDWARDINE,
HEREFORDSHIRE**

May 2013

**ALISON ARNOLD
ROBERT HOWARD**

SUMMARY

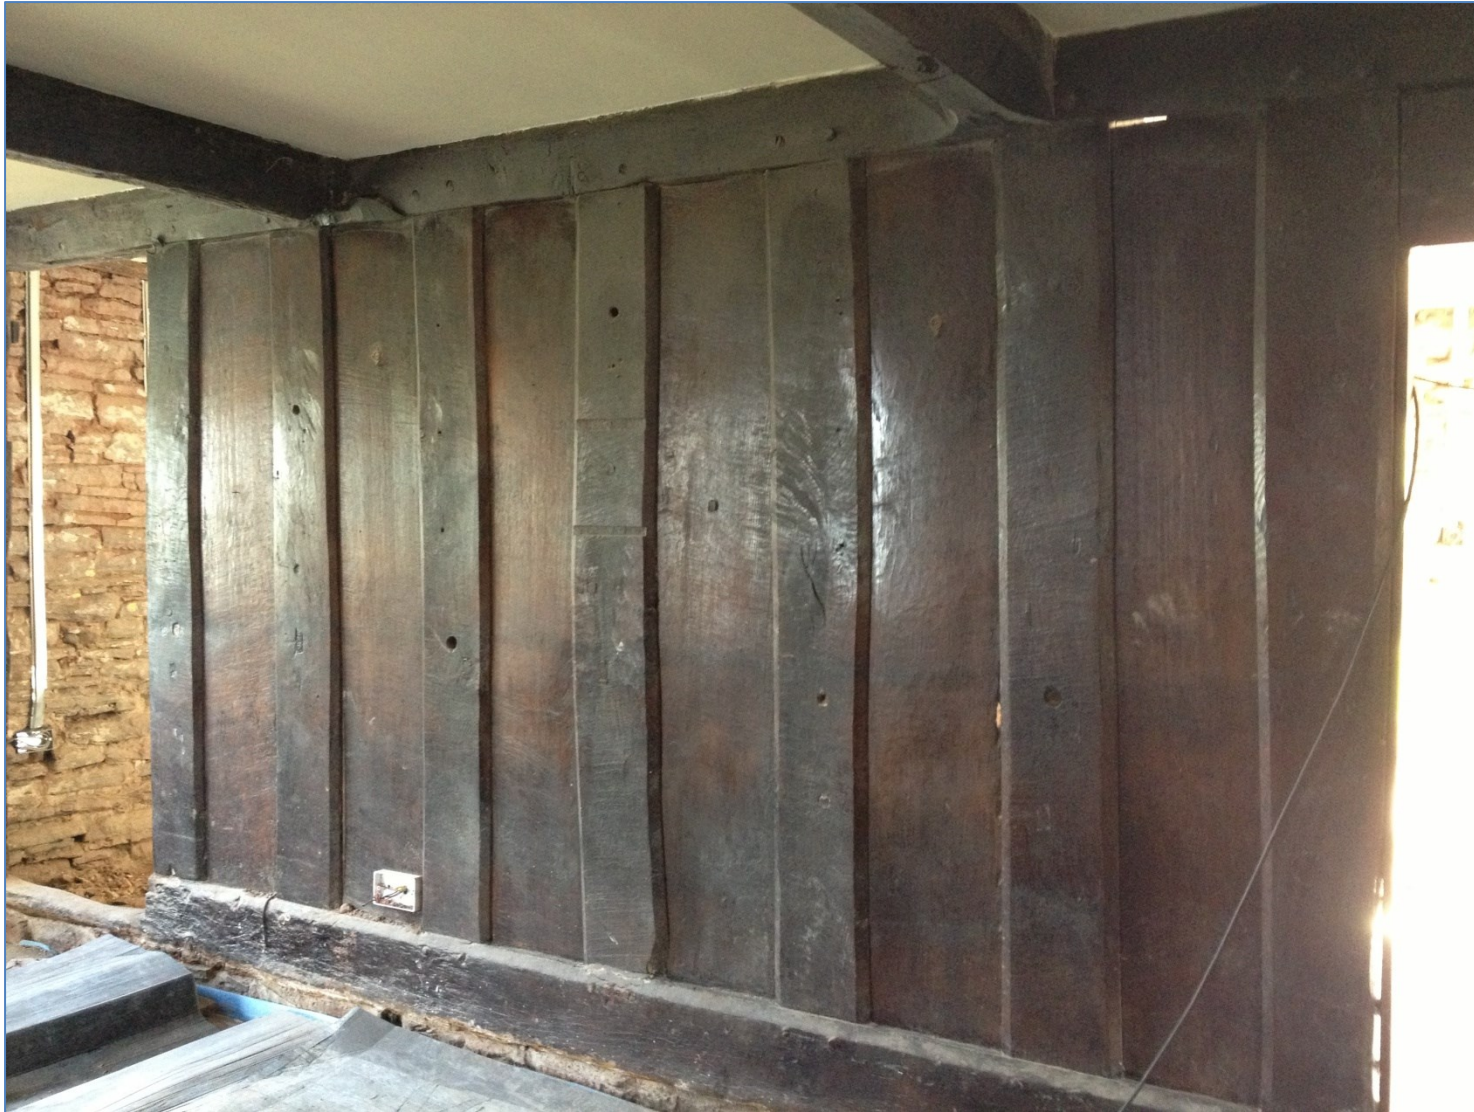
Figure 4: Plank and muntin screen

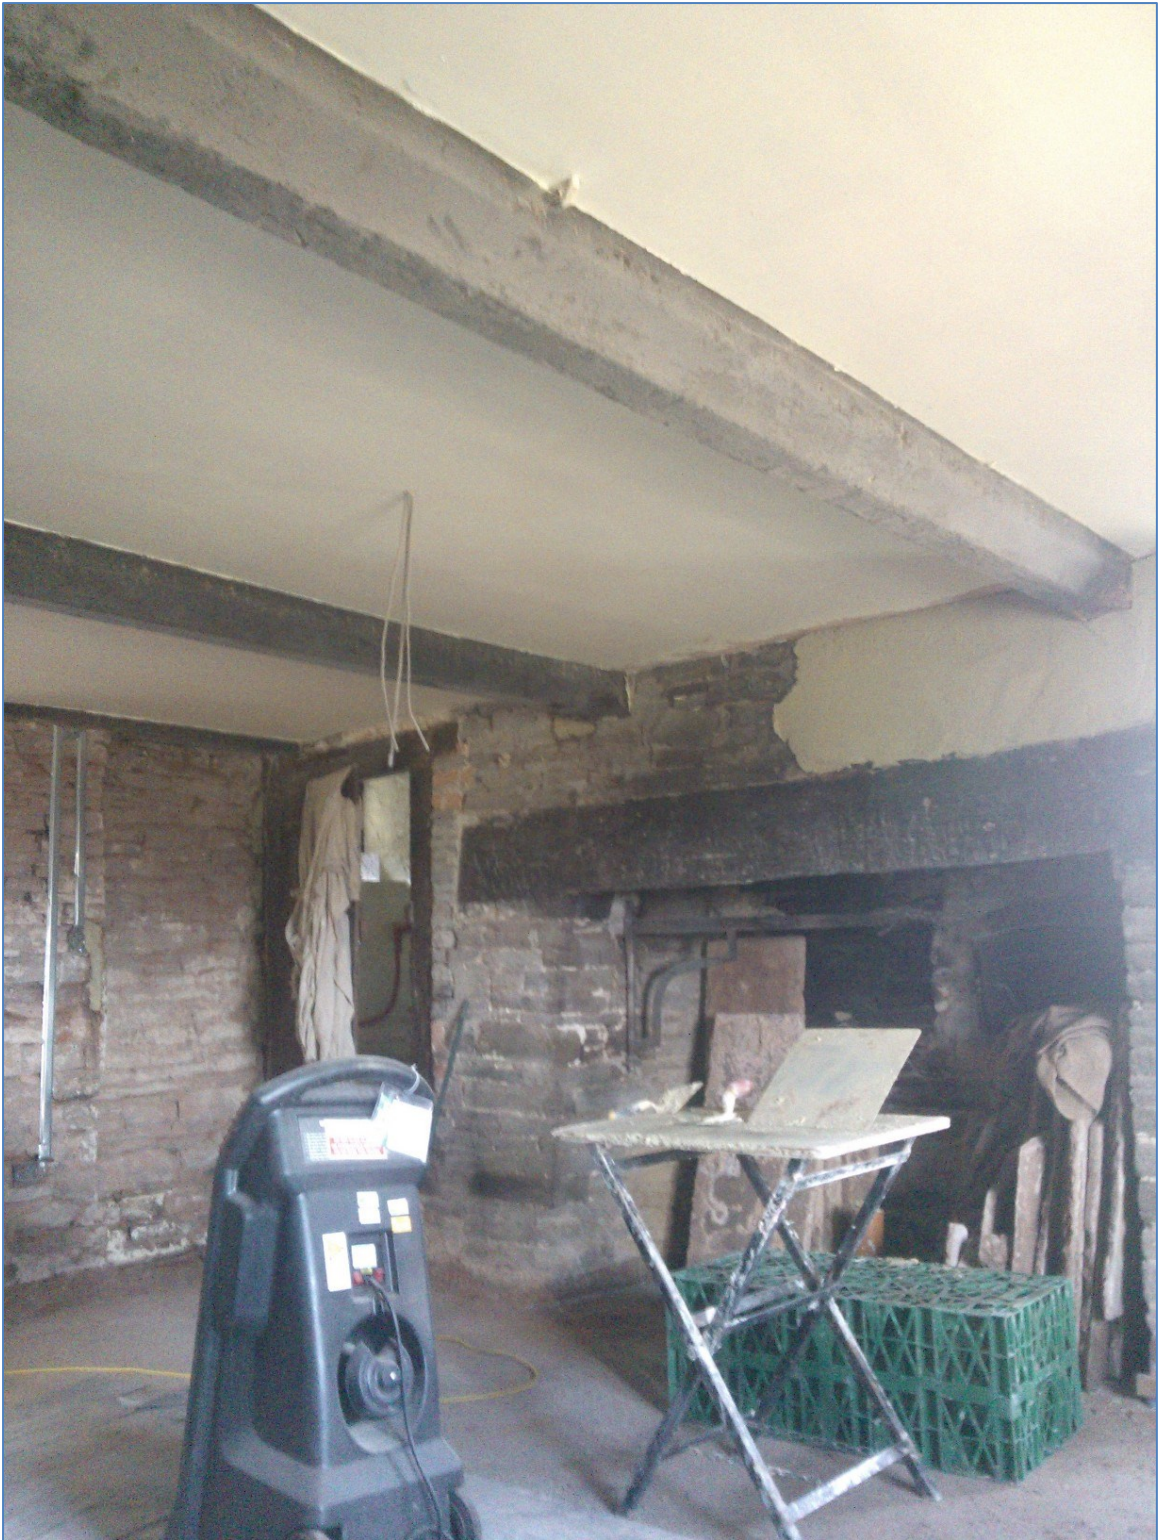
Figure 5: Ceiling beams

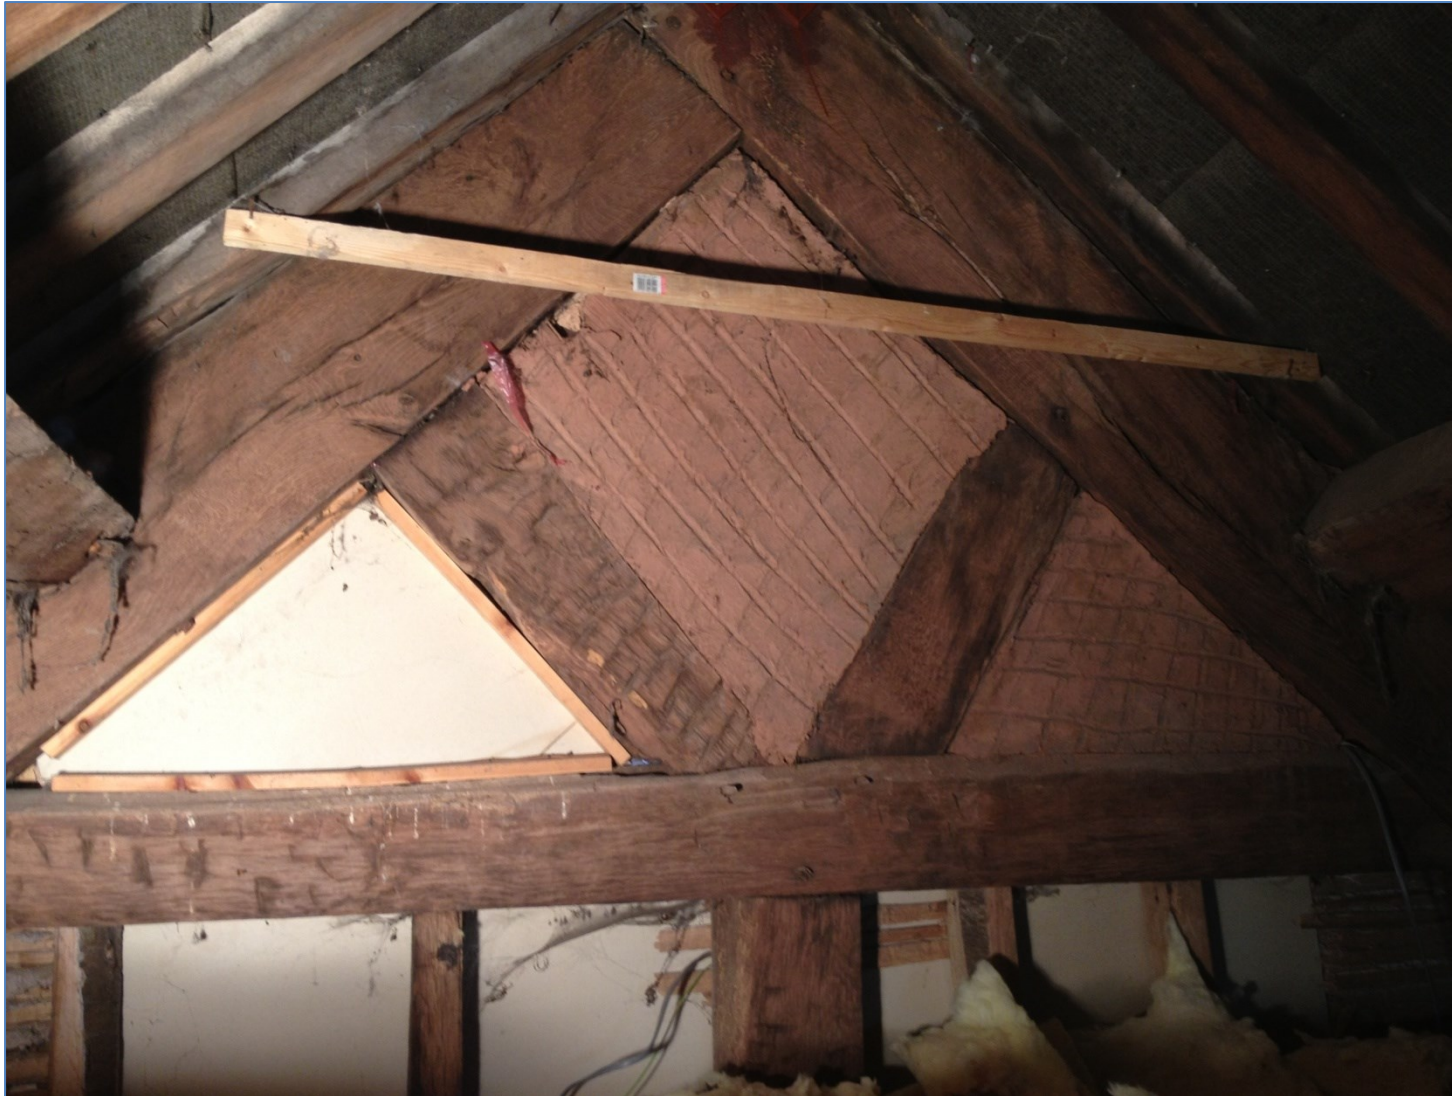
Figure 6: Truss 2 (photograph taken from the north)

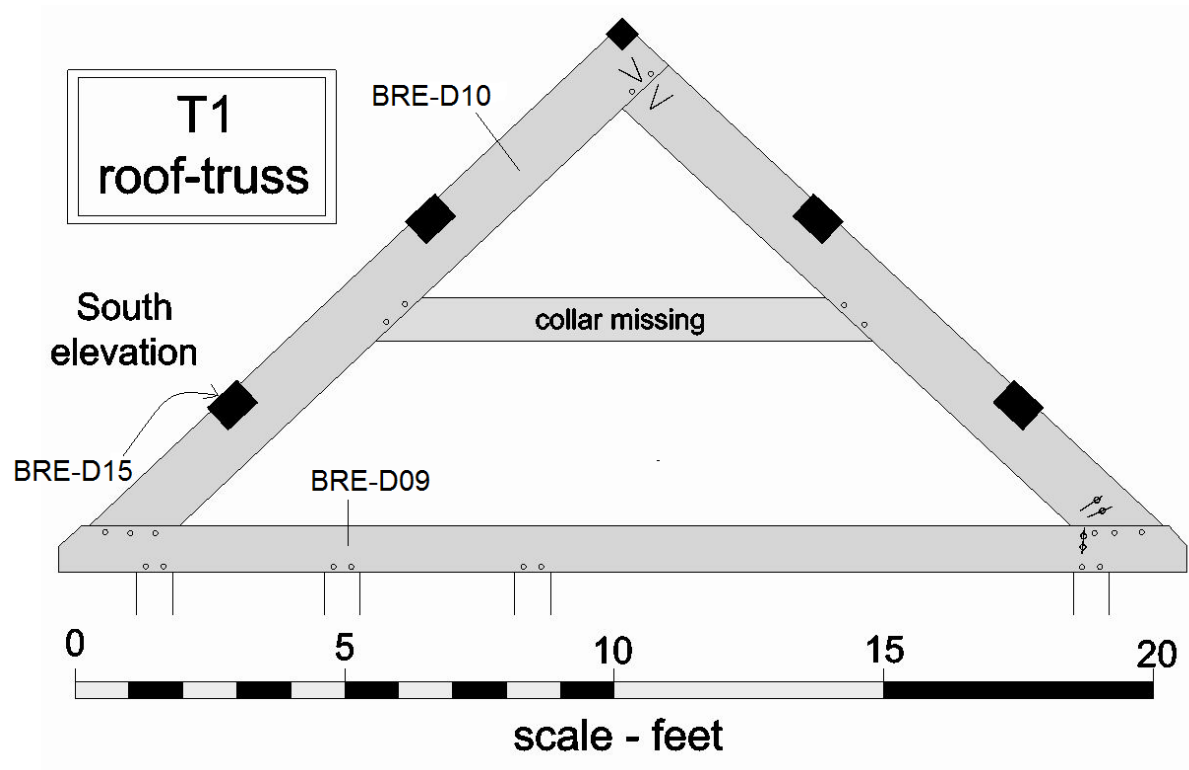
Figure 8: Truss 1, showing the location of samples BRE-D09, BRE-D10, and BRE-D15 (Duncan James)

A total of 17 timbers was sampled with each sample being given the code BRE-D and numbered 01–17; samples BRE-D01–08 being taken from ground floor timbers (lintels, a cill, top beam of the screen, and ceiling beams) and BRE-D13–17 from roof timbers. The location of samples was noted at the time of sampling and has been marked on Figures 7–10. Further details can be found in Table 1.

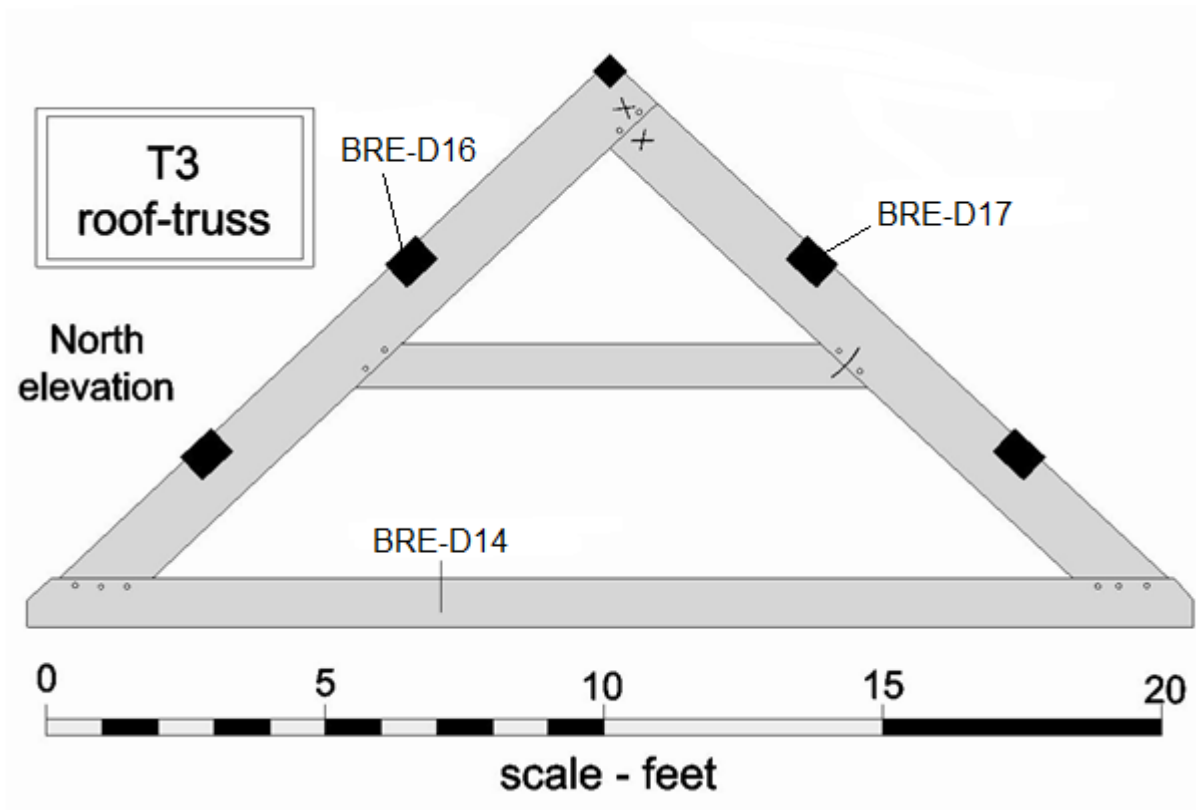
Figure 10: Truss 3, showing the location of sample BRE-D14, BRE-D16, and BRE-D17 (Duncan James)

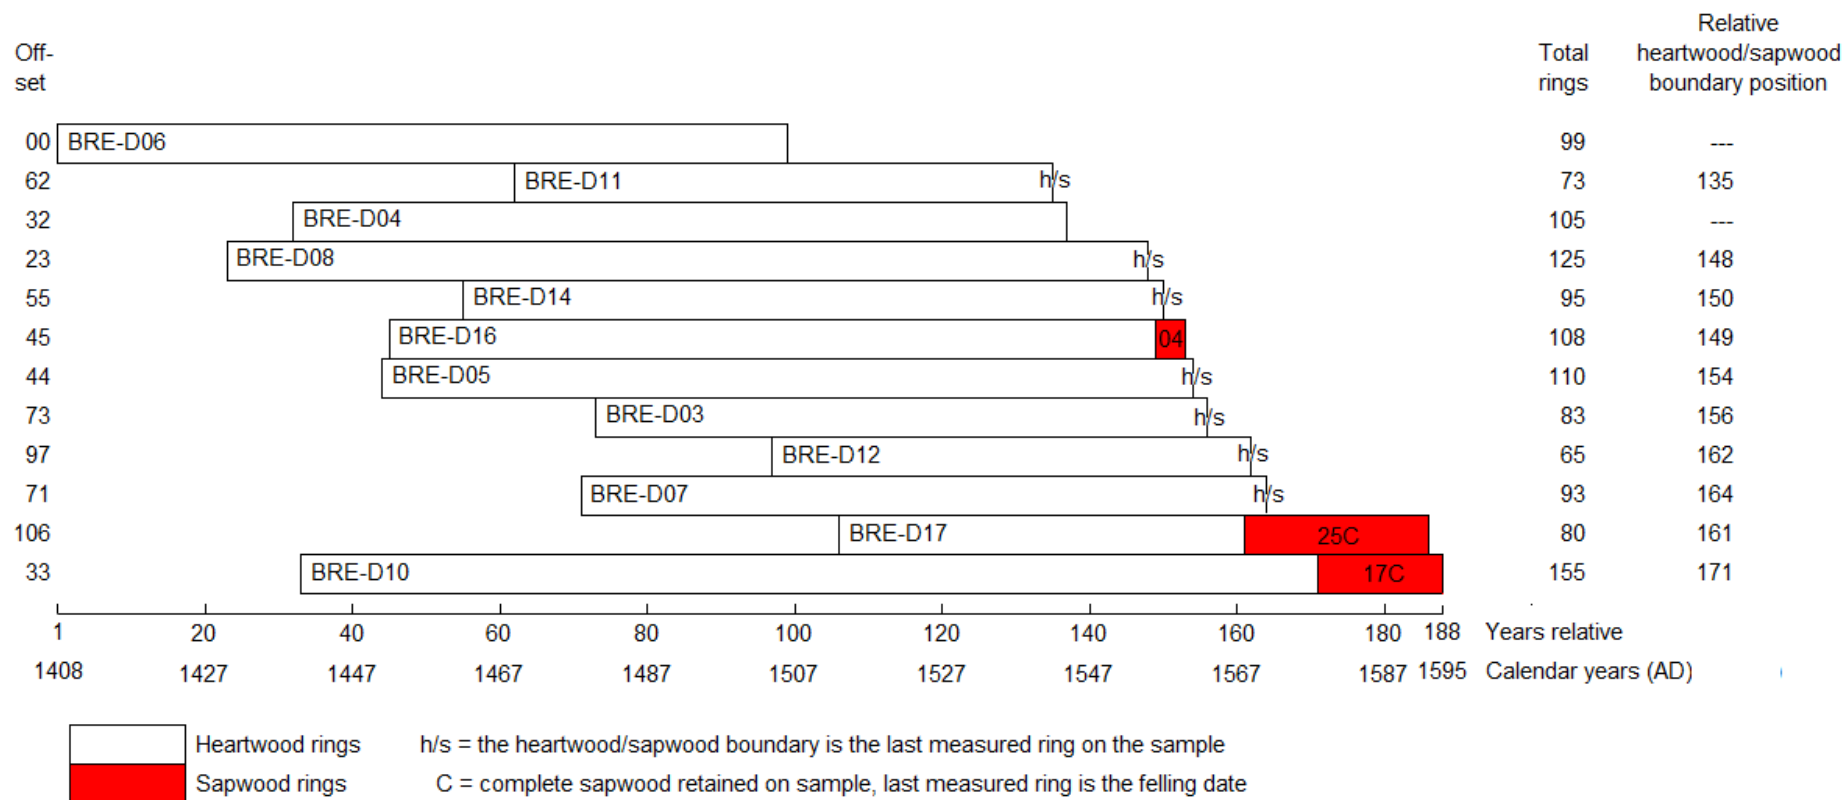
Figure 11: Bar diagram of samples in site sequence BREDSQ01

Twelve of the samples matched each other and were combined at the relevant offset positions to form BREDSQ01, a site sequence of 188 rings (Fig 11). This site sequence was then compared against a series of relevant reference chronologies for oak where it was found to match consistently and securely at a first-measured ring date of 1408 and a last-measured ring date of 1595. The evidence for this dating is given by the *t*-values in Table 2.
