**TREE-RING ANALYSIS OF TIMBERS FROM
HOWLEY HALL FARM,
MORLEY,
WEST YORKSHIRE**

August 2013

**ALISON ARNOLD
ROBERT HOWARD**

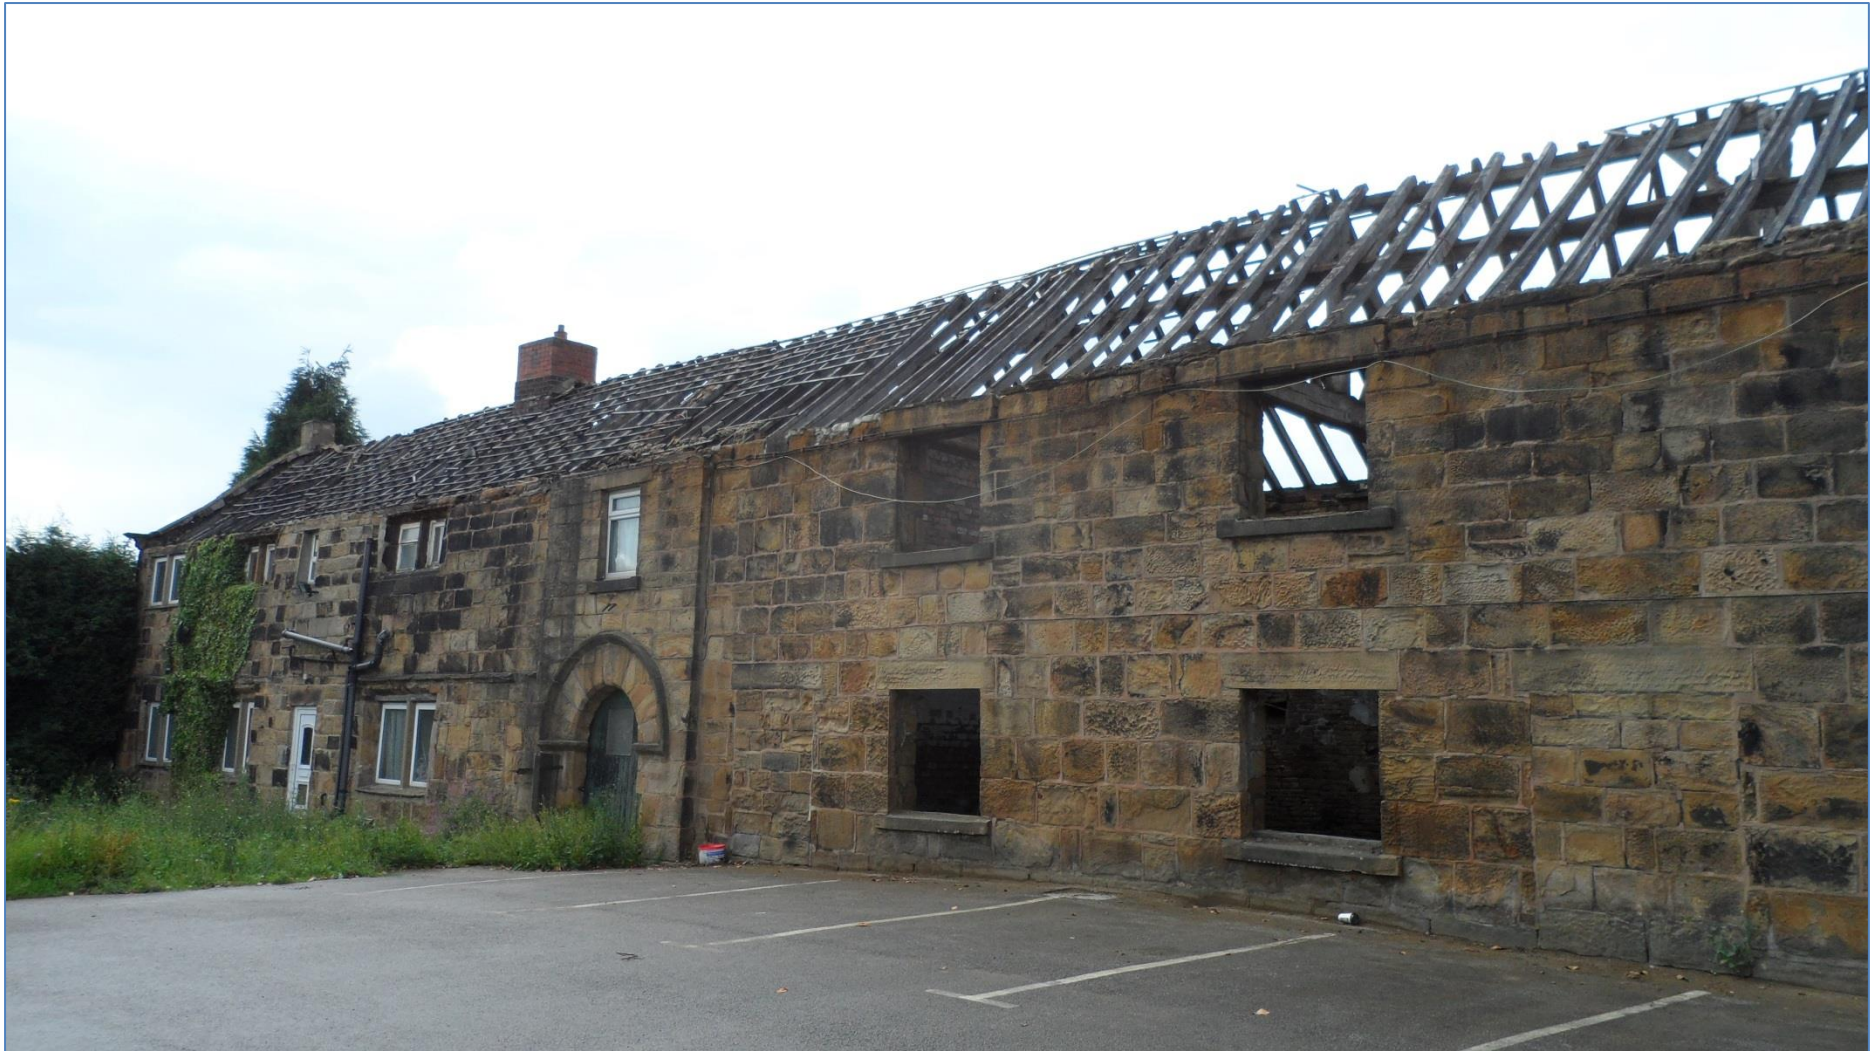
Figure 5: The cottage (to the left) and the mistal (to the right), photograph taken from the east

The cottage consists of five bays and the mistal four; separating them is a short, projecting bay (Fig 5) and there are outshuts to the west of the main building. The roof over both the cottage and the mistal appear to be of the same construction, consisting of principal rafters, king post, struts, tiebeam, and braces rising from the king post to the ridge (Figs 6 & 7). There are single, trenched purlins to each slope. It had been suggested that some of the tiebeams might be reused although once on site no obvious signs of previous use were noticed. However, in contrast to the rest of the timber, one of the principal rafters of truss 6 appears to be adzed (Fig 8) and was thought likely to represent an earlier timber. The first floor frame of the mistal is exposed and consists of closely spaced joists (Fig 9).

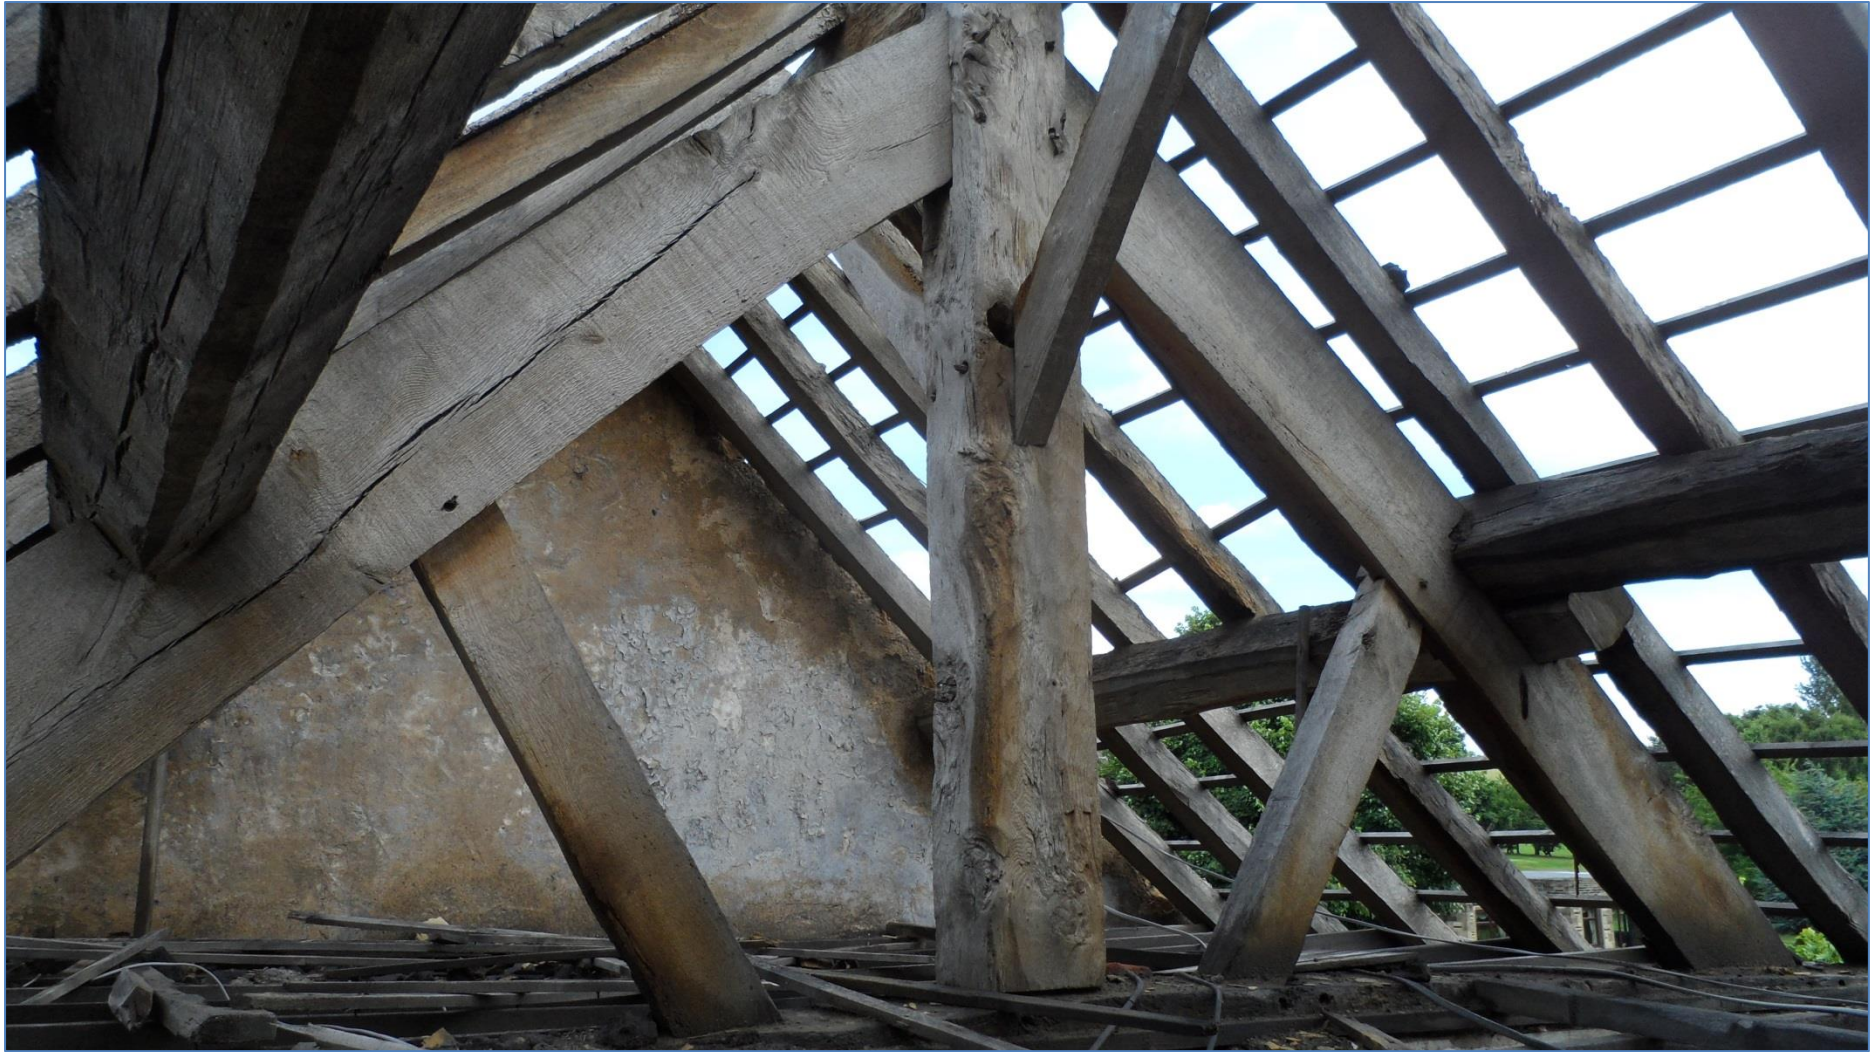
Figure 6: The cottage, truss 5, photograph taken from the south-west

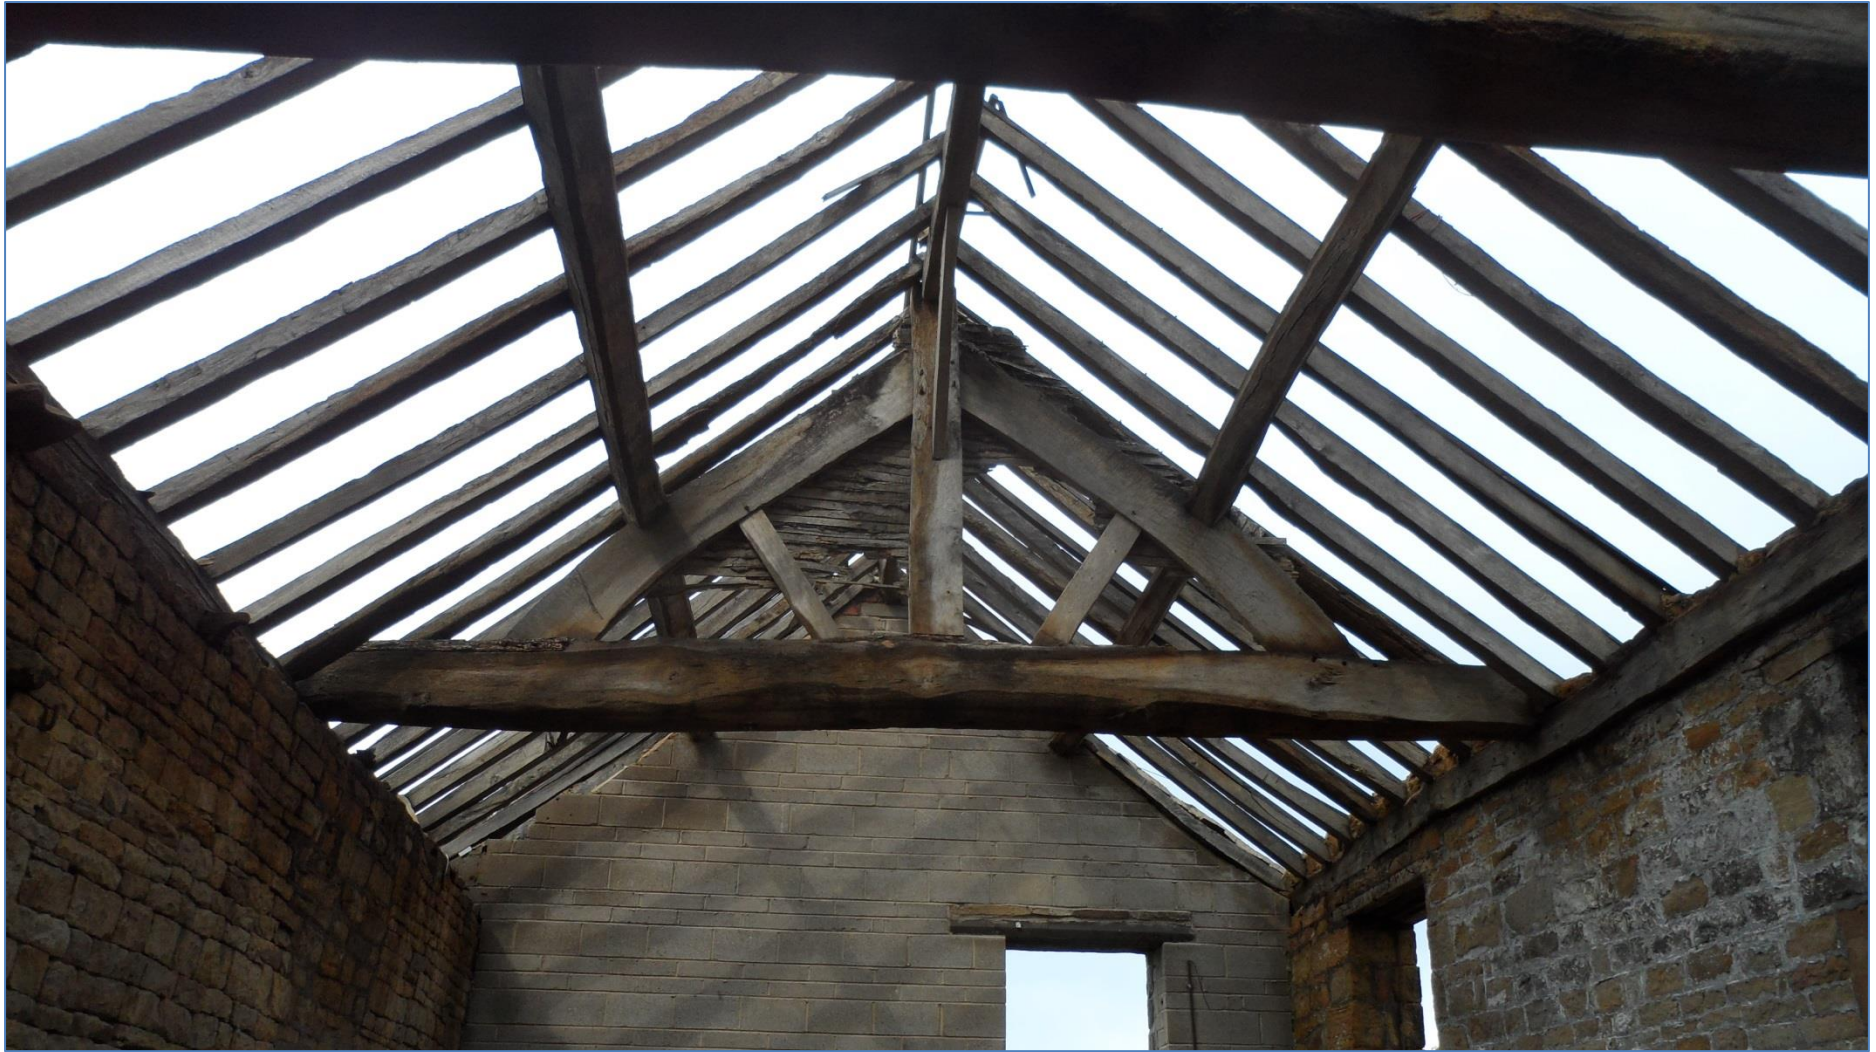
Figure 7: The mistal, truss 1, photograph taken from the south-west

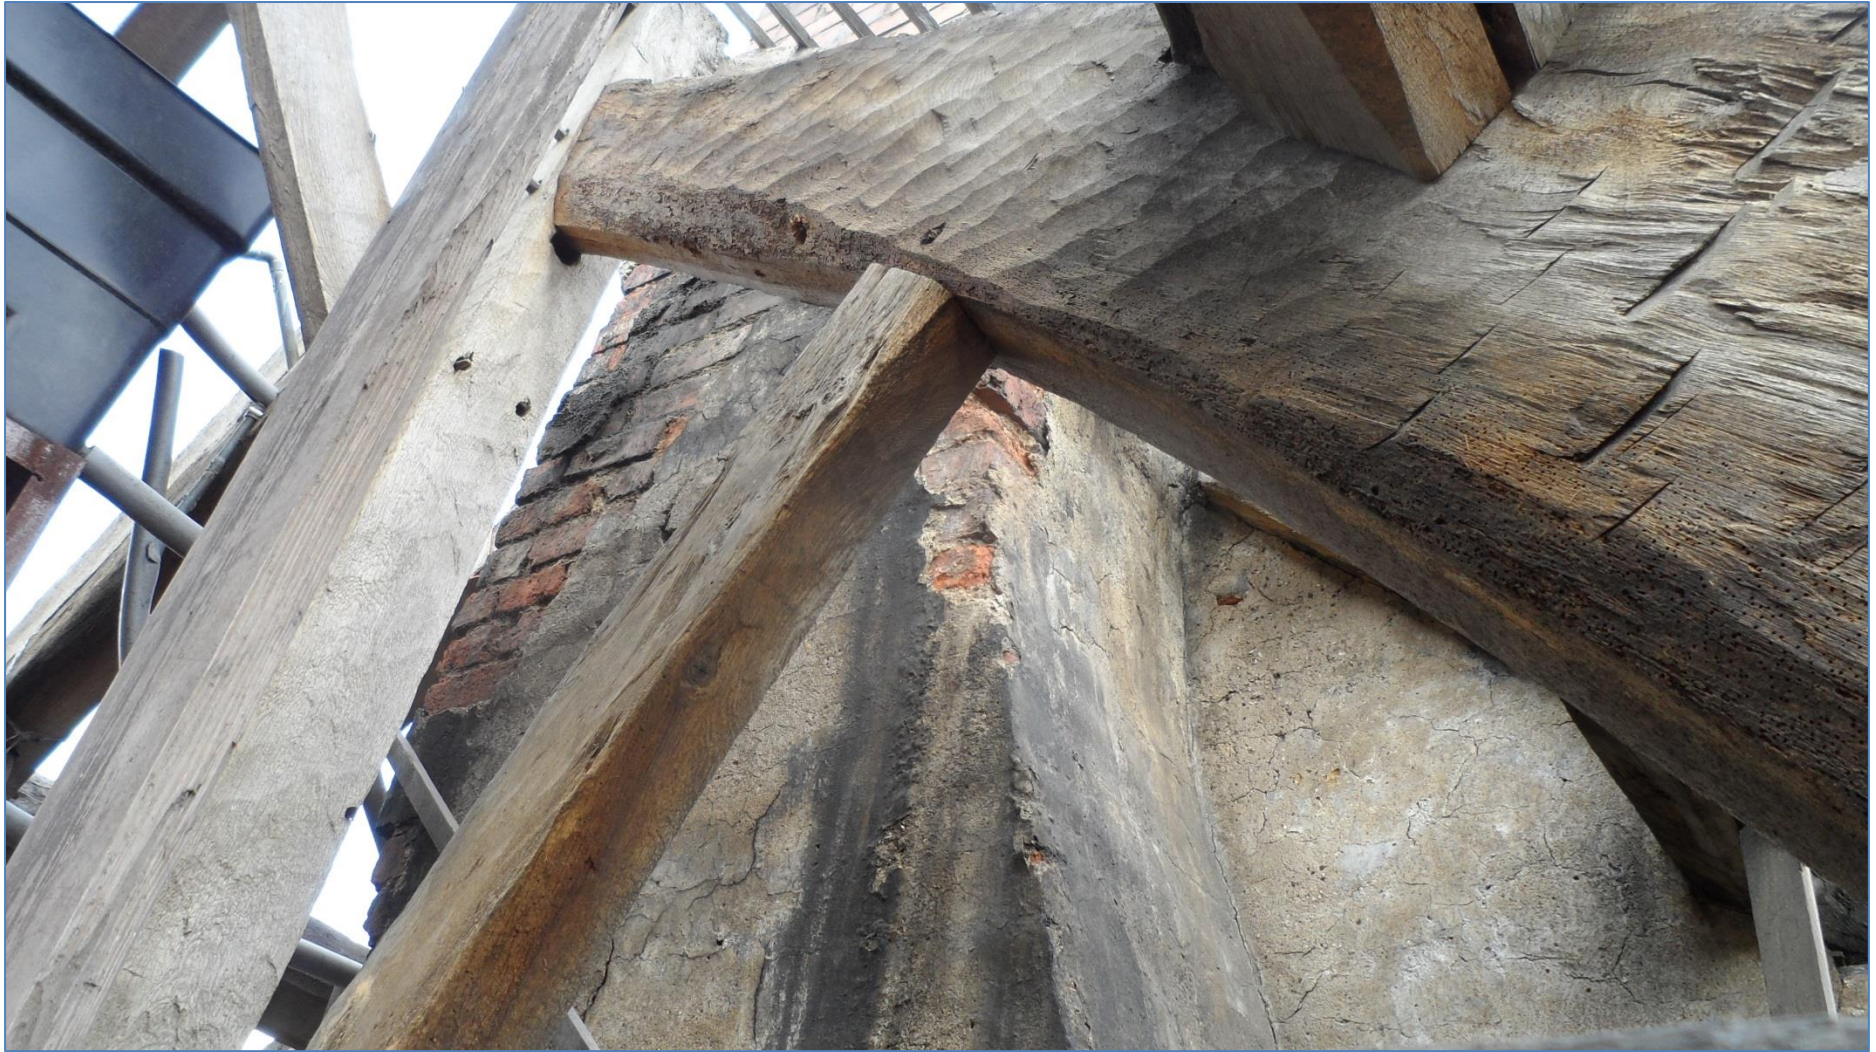
Figure 8: The cottage, east principal rafter of truss 6 with adze marks

Some of the dated timbers were thought to potentially be reused whilst others were believed to be primary. However, this has not been supported by the dendrochronology with all dated timber being of the same date. It is unfortunate that sample HOW-A12, taken from the adzed principal rafter did not match any of the other samples and could not be dated individually. It could be argued that the reason why this sample did not match in with the rest of the timber is because it is of a different date. However, equally, it may simply be that the tree from which this beam was cut experienced non-climatic influences which have unduly affected its growth pattern.

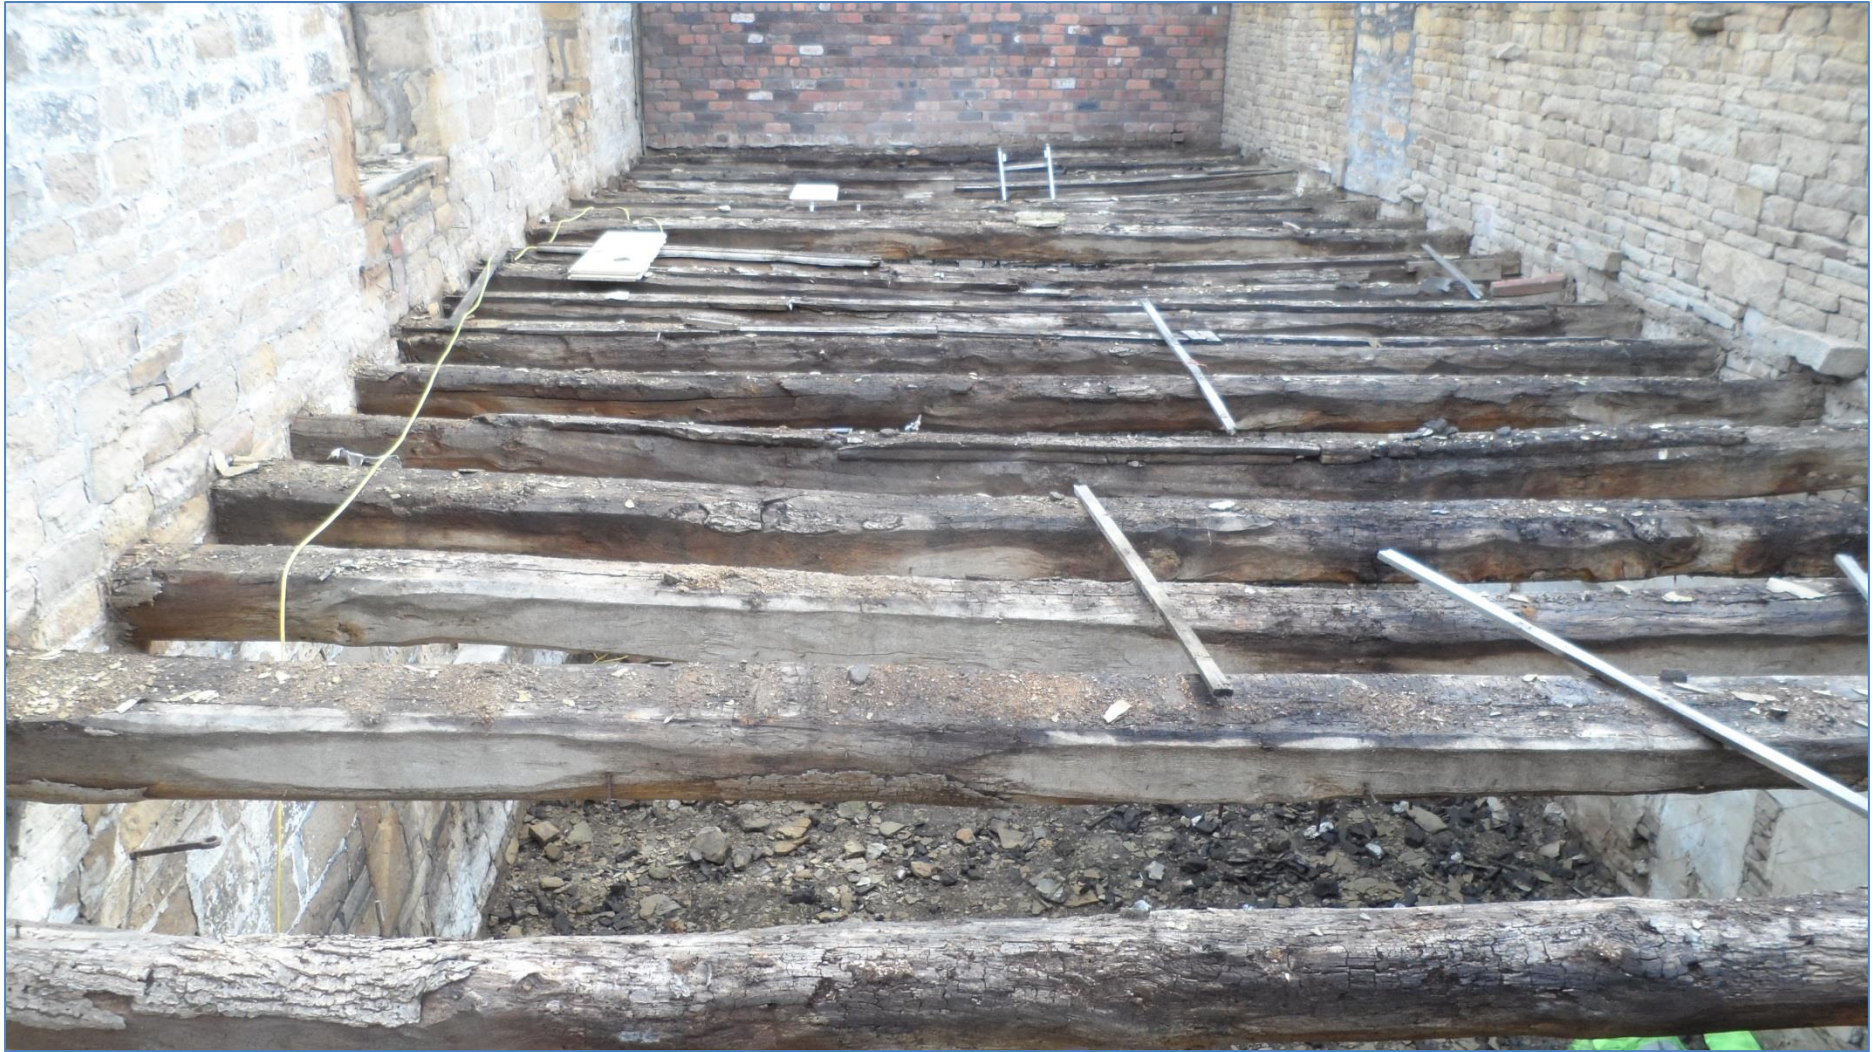
Figure 9: The mistal, first-floor frame, photograph taken from the north-east

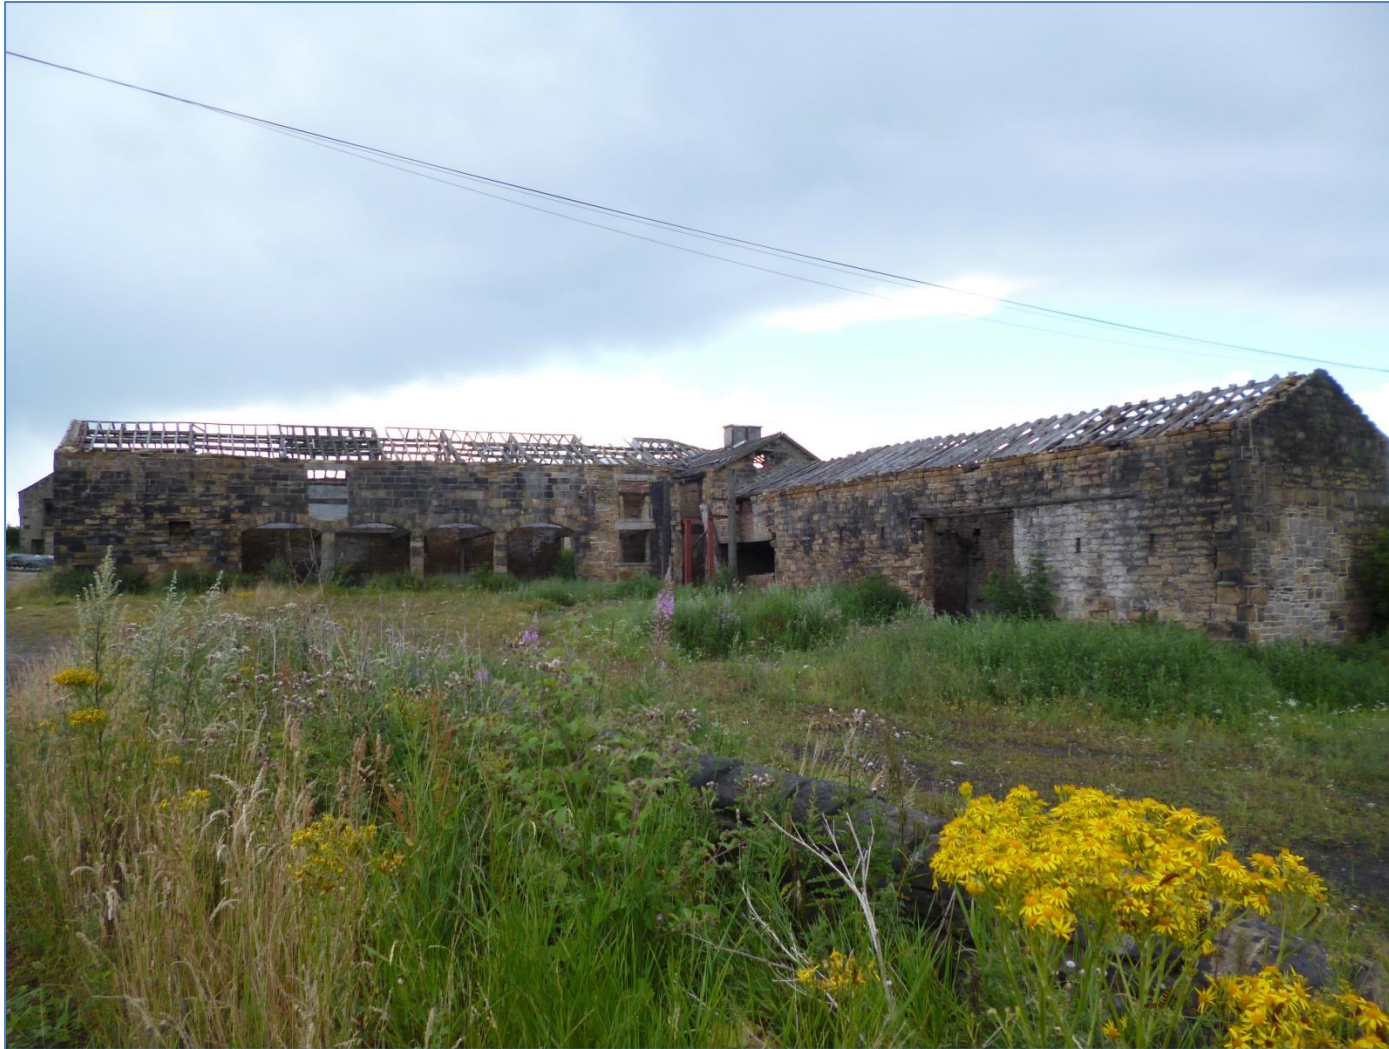
Figure 10: The cartshed (to the left) and barn (to the right), photograph taken from the north-east

Whilst the southern two south-east facing yards appear relatively recent in date, the third, northern yard appears older and comprises a barn and cartshed (Fig 10). The roof over the cartshed consists of seven trusses of principal rafters, tiebeam, king post, and queen posts from which struts run to principal rafters. There are two sets of purlins to each slope (Fig 11). The barn is of seven bays separated by six trusses of principal rafters, king post, tiebeam, and raking struts. Again, there are two sets of purlins to each slope (Fig 12).

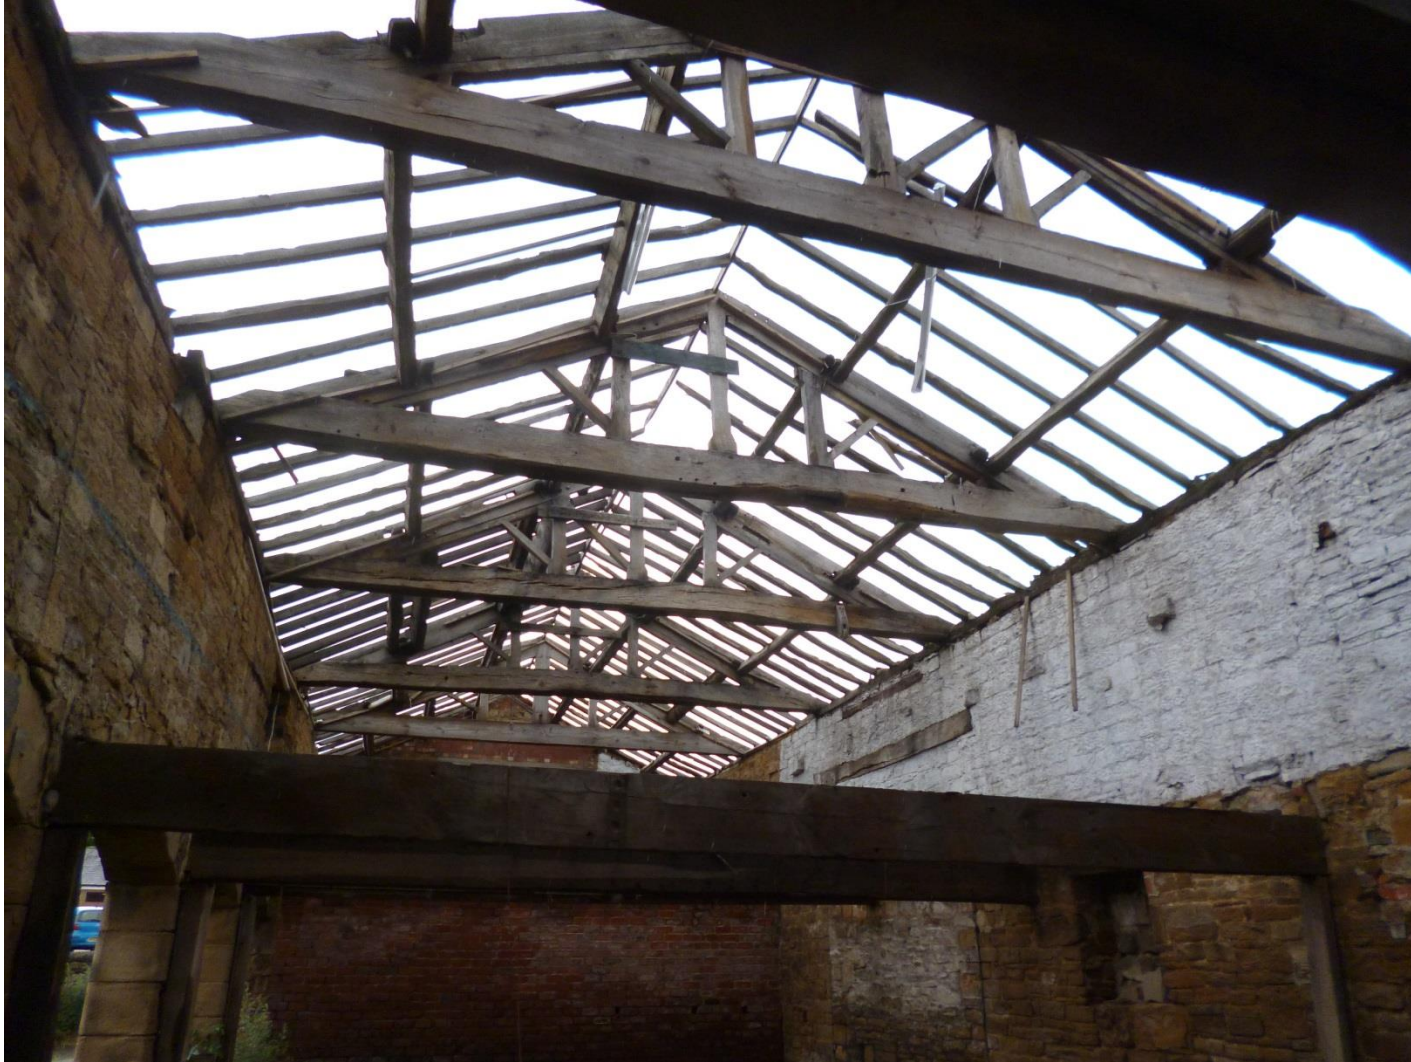
Figure 11: The cartshed, photograph taken from the west

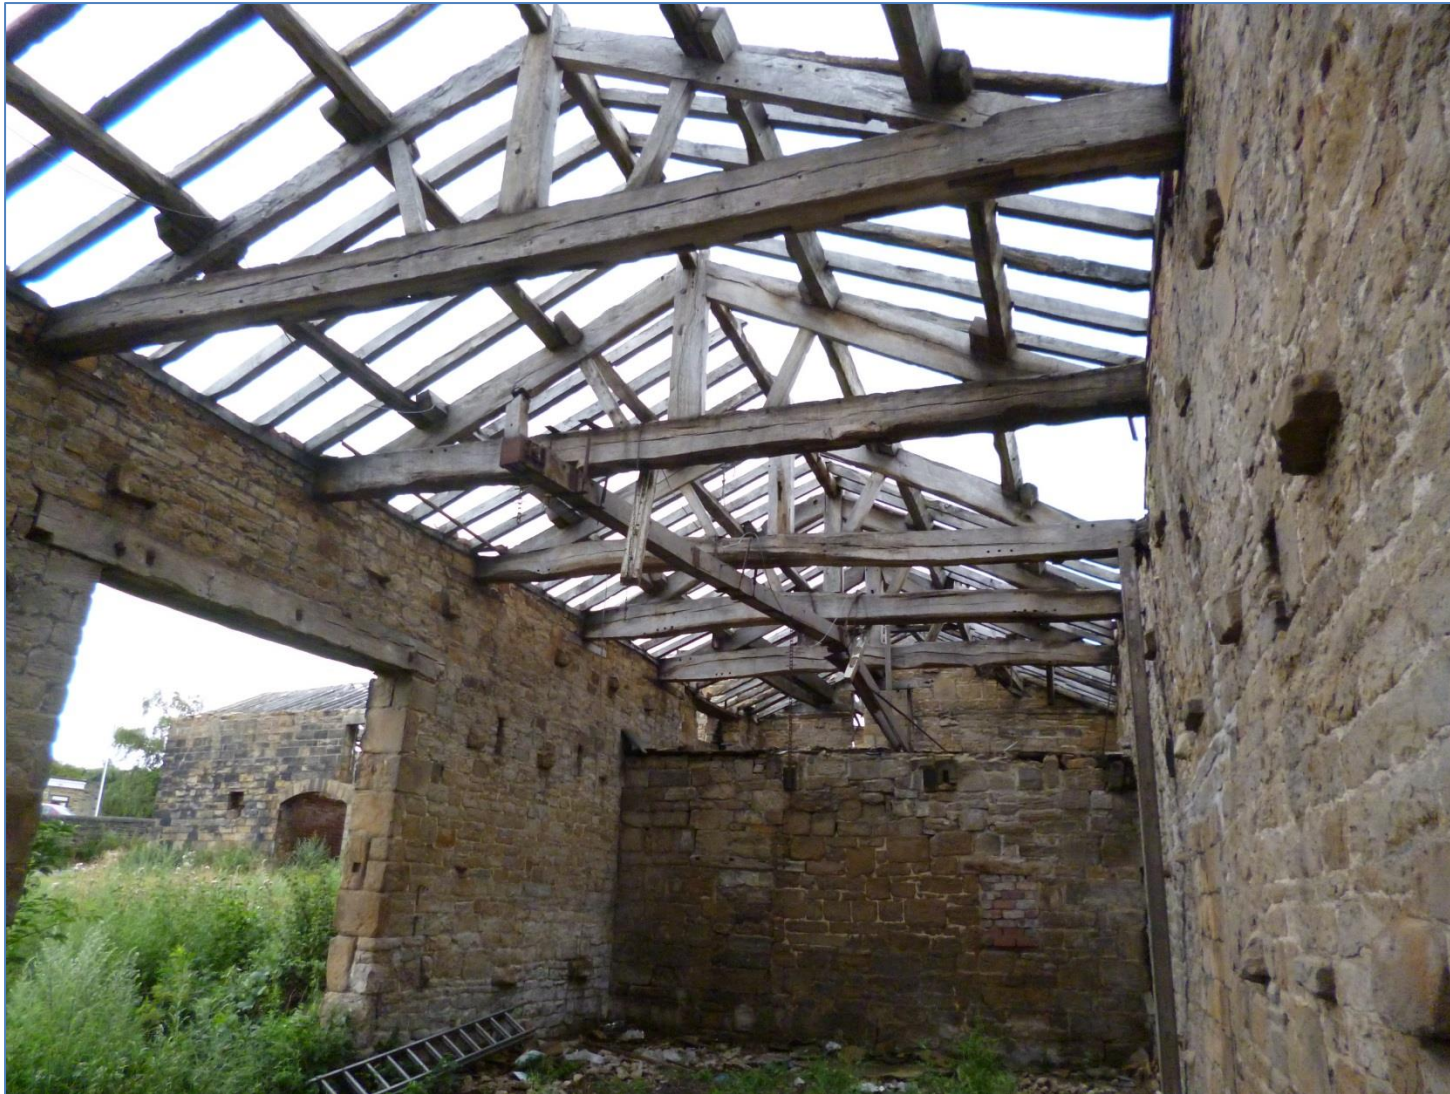
Figure 12: The barn, photograph taken from the north
