WHITESIKE AND BENTYFIELD MINING COMPLEX, ALSTON MOOR, CUMBRIA

DESK-BASED ASSESSMENT,
ARCHAEOLOGICAL SURVEY AND
WATCHING BRIEF
CP. No: 1467/11
18/04/2012

NP ARCHAEOLOGY LTD

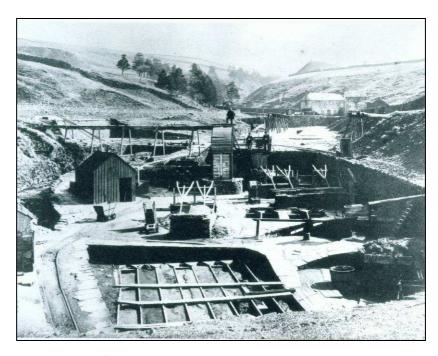
Plate 1: Whitesike Dressing Floor c. 1900

mines driven from the valley to the north. These include the well-preserved Whitesike floor, a good example of a small 19th century washing floor (Plate 1). The ruined remains of a wheelpit at Whitesike and Bentyfield lead mines and ore works provide evidence for a waterwheel that was used to power a crushing mill that broke up the ore prior to processing on the dressing floor. The dressing floor has been damaged by severe stream erosion; however, an area survives that retains stratified deposits 1.5 to 2 metres deep. A second dressing floor retains evidence of timbers, iron pipes and other features (NP Archaeology forthcoming).

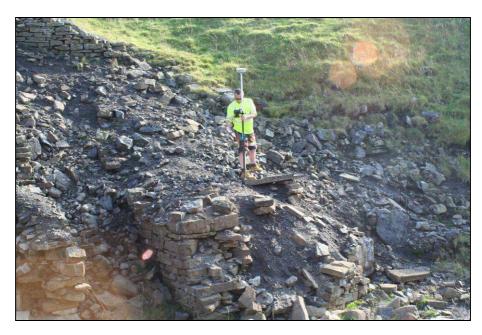
Plate 2: Surveying of the remains of the crushing mill wheel pit, June 2011

- 5.2 Due to the precarious nature of the ground around the site of the crushing mill wheel pit, and the rubble of the decayed remains, it was difficult to obtain accurate surveys of the surviving walls (Plate 2).

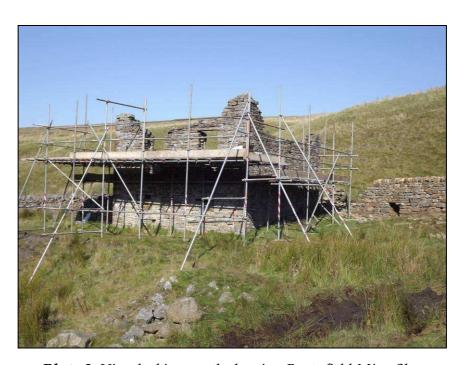
Plate 3: View looking north showing Bentyfield Mine Shop

- 5.6 The building is presently roofless and, at the time of survey, was surrounded externally by scaffolding, which made clearly photographing the external elevations difficult (Plates 3 and 4). The building was formerly of two stories, although most of the stonework for the upper level has either fallen away or been deliberately pushed into the interior. The roof is missing, with the material presumably removed for reuse elsewhere. It is unclear what form the original roof took due to the lack of the full height of the end walls, but it is presumed it would have been gabled, and covered in either slate or stone flagstones.

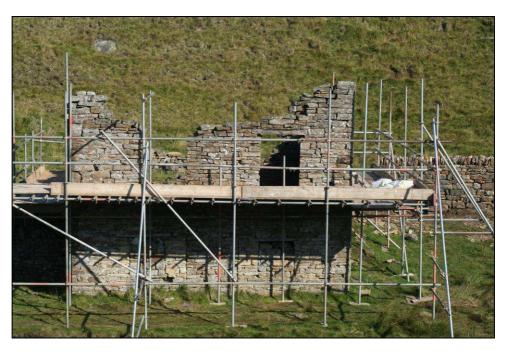
Plate 5: South elevation of Bentyfield Mine shop showing the two first floor windows

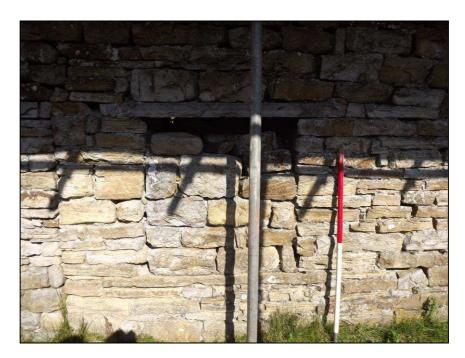
Plate 6: One of the two blocked windows in the south elevation of Bentyfield Mine Shop (Scale = 1m)

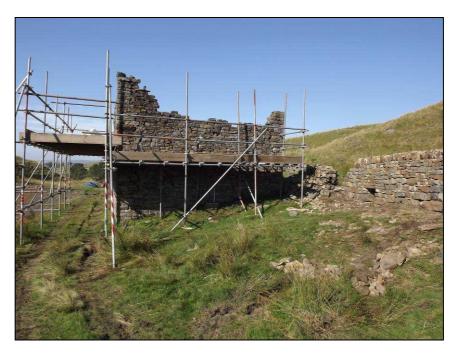
Plate 7: East elevation of Bentyfield Mine Shop

- blacksmiths forge, a common feature of mine shops located close to the level, as repairs to tools could be undertaken promptly, although no clear evidence for a forge was noted internally (Plates 7 and 8).

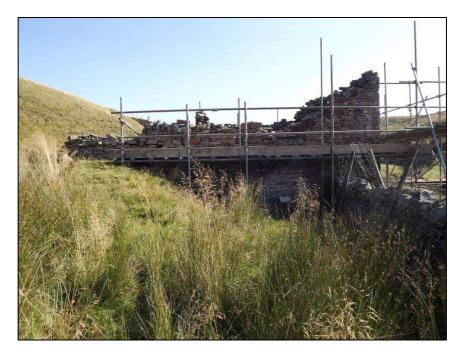
- 5.8 The west elevation contains evidence for a former doorway or opening at ground floor level, although it is now blocked up with masonry (Plates 9 and 10). To its north side there is a vertical break in the masonry where a boundary wall to the rear of the property meets the north-west corner of the building (Plate 11). This boundary wall heads northwards for a short distance before turning eastwards and enclosing an area to the north side of the property (Plate 12). The north wall of the mine shop is now largely lost.

Plate 9: West elevation of Bentyfield Mine Shop

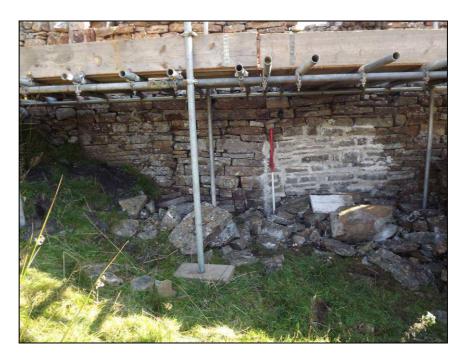
Plate 10: Detail of blocked door or opening, east elevation of Bentyfield Mine Shop (Scale = 1m)

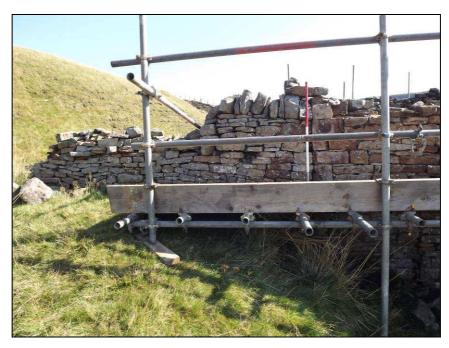
Plate 11: West elevation showing vertical break in masonry between the mine shop and the boundary wall to the north (Scale = 1m)

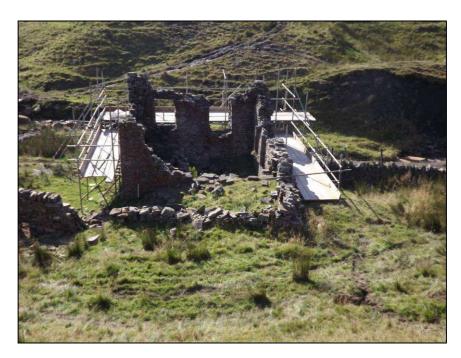
Plate 12: View looking south from the higher ground showing the north side of Bentyfield Mine Shop

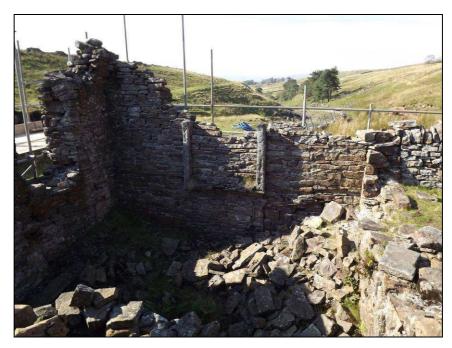
Plate 13: View looking west showing the evidence for a first floor fireplace, Bentyfield Mine Shop

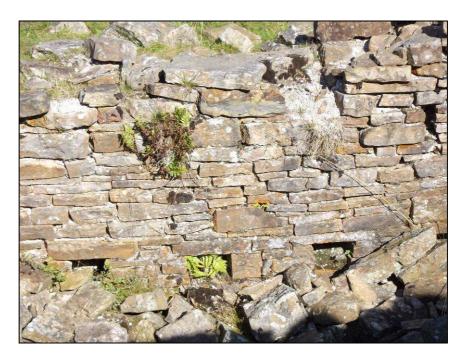
Plate 14: Detail of four visible niches in the north internal wall of the former mine shop

- 6.4.3 The niches noted in the north wall prior to the removal of the internal rubble were clearly visible once the masonry had been cleared. It was noted that at least seven of these niches were present (Plate 24).

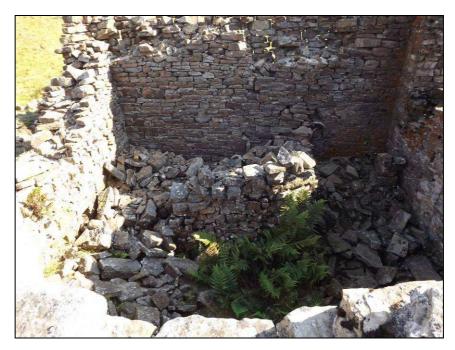
- 5.10 The interior of the building was largely filled with rubble derived from the walls of the mine shop; therefore the ground floor surface was not visible (see watching brief section below). The only feature of note was an L-shaped line of stonework which may have been part of a blacksmiths forge (Plate 15).

Plate 15: View looking east showing an L-shaped line of stonework within the interior of the former mine shop

- 6.4.2 The removal of the rubble did not provide any further information on the L-shaped walls noted to have existed prior to the consolidation works (see Plate 15 above); therefore its function is still unclear. It does not appear, however, to have been original to the structure as no flagstones were noted beneath its base suggesting that the L-shaped feature was inserted after the floor was removed.

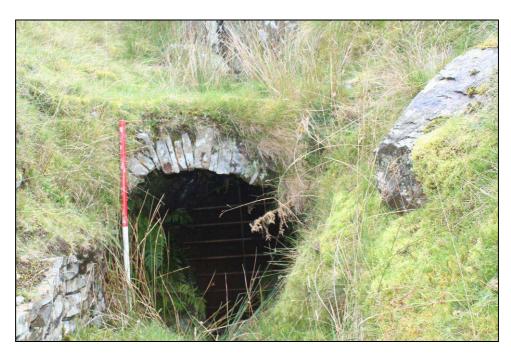
Plate 16: Detail of the entrance to Bentyfield Low Level prior to remedial works in October 2011 (Scale = 1m)

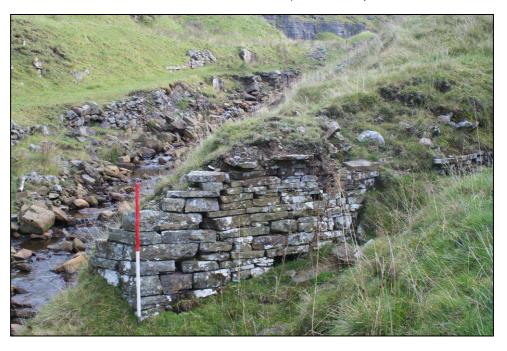
Plate 17: View looking east showing the eastern retaining wall for Bentyfield Low Level (Scale = 1m)

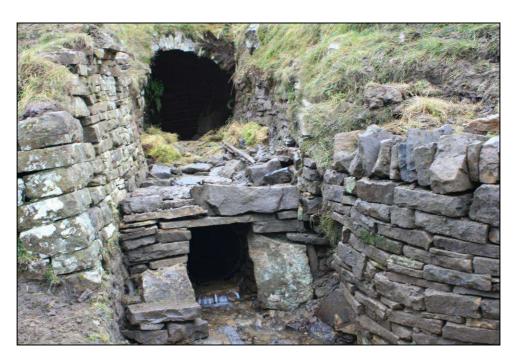
Plate 19: Detail of modern drainage structure inserted into the mouth of Bentyfield Low Level in October 2011

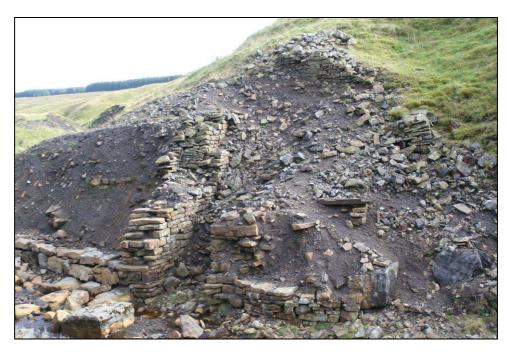
- 6.3.1 The Bentyfield crushing mill wheel pit is located on the south side of the Garrigill Burn, and is orientated roughly north-west to south-east. The walls are heavily degraded through natural hillwash and water erosion (Plates 20 and 21). The walls of the wheel pit were noted to be constructed of coursed masonry, seemingly unbonded, and the pit itself measured *c*.1.31m.
- 6.3.2 Consolidation works at the site of the wheel pit consisted of the construction of new retaining walls to its east side (Plate 22).

Plate 20: View looking south-east showing the remains of Bentyfield crushing mill wheel pit

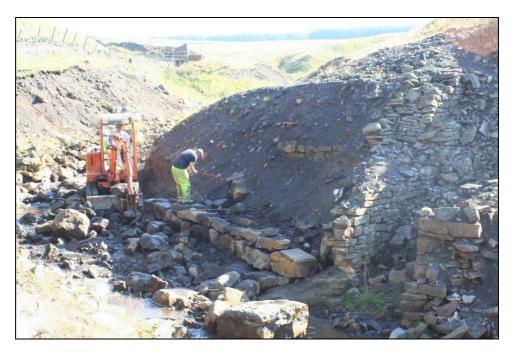
Plate 22: Consolidation works to the east side of Bentyfield crushing mill wheel pit

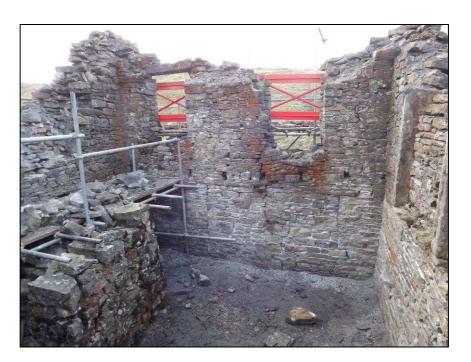
- 6.4.1 The interior of the former mine shop, located at the east end of the survey site, was cleared out by local volunteers in November 2011. Following the removal of the rubble which covered most of the interior of the building, it was possible to note that the original floor surface, presumably stone flagstones, had been removed and the compacted earth surface on which the flags would have been laid was exposed (Plates 23 and 24).

Plate 23: Interior of Bentyfield Mine Shop following removal of rubble

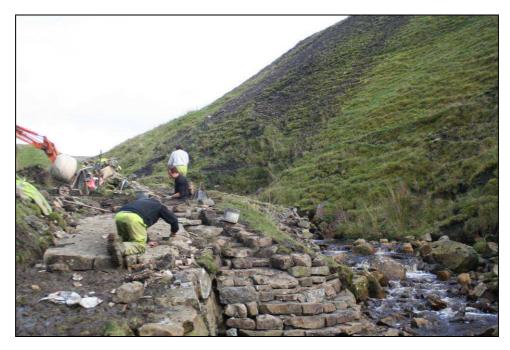
6.5.1 Part of the consolidation works at the Whitesike and Bentyfield Mine Complex involved the construction of a new footpath along the north side of Garrigill Burn, the reconstruction of sections of retaining walls, and the construction of a new footbridge at the east end of the site. A watching brief was maintained during sections of these works but no features of note were revealed, although the footpath itself was constructed on the existing ground surface, with little in the way of ground intervention (Plates 25 to 28).

Plate 25: View looking east showing the construction of the new footpath along the north bank of Garrigill Burn

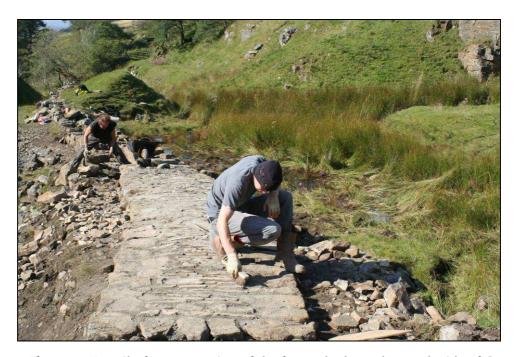
Plate 26: Detail of a new section of the footpath along the north side of Garrigill Burn

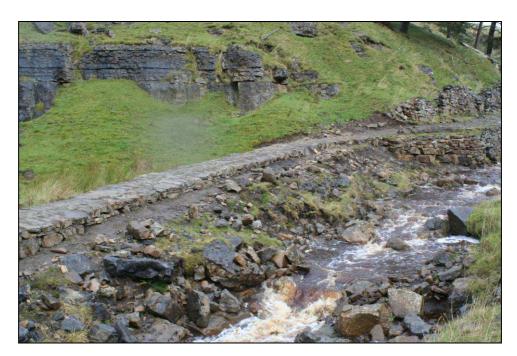
Plate 27: Detail of the newly constructed footpath along the north side of Garrigill Burn, with the former quarry visible left of photograph

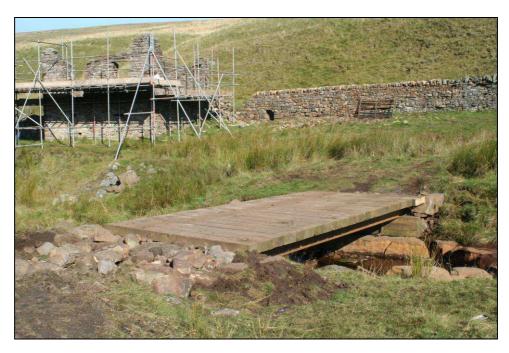
Plate 28: New bridge over the Garrigill Burn located close to Bentyfield Mine Shop

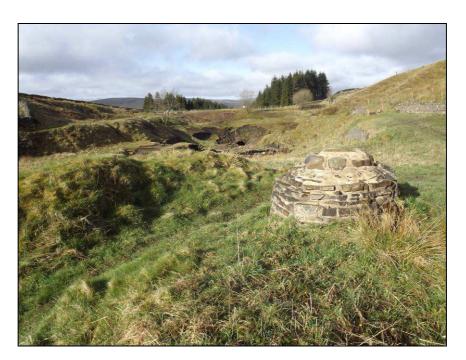
- 6.6.1 During the days on site for the watching briefs, several surviving features of note were observed which related to the mine workings of the Whitesike and Bentyfield Mine Complex. These do not include those already referred to above.
- 6.6.2 Situated on high ground to the north side of Garrigill Burn, and to the north of Whitesike Mine dressing floor, is a circular stone-built mine shaft cap of approximate 1.85m diameter, and which stands to a height of approximately 1m. The stonework of the mine shaft cap has been bonded with what appears to be modern cement, suggesting that this may either be

Plate 29: View looking west showing the mine shaft cap on the north side of Garrigill Burn

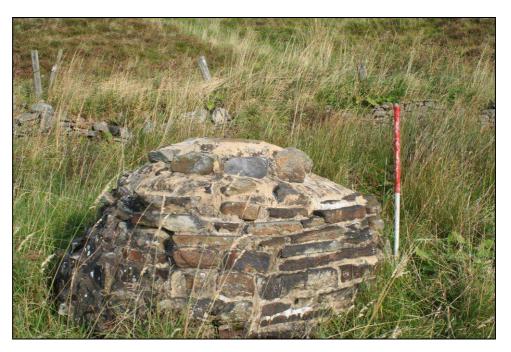
- a recent capping, or the stonework has been replaced or repointed (Plates 29 and 30). A drainage gully was noted to run into the north-east side of the mine shaft cap, which was lined with thin stone slabs. It is possible this gully is a later addition, possibly cut to drain the fields to the north. This site was recorded as 'Feature 5' during the watching brief.

Plate 30: Detail of mine shaft cap (Scale = 1m)

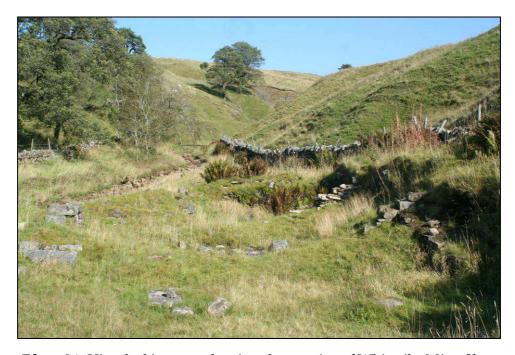
- 6.6.3 Evidence for Whitesike Mine Shop was noted on the south side of Garrigill Burn, in the location of where buildings are shown on historical mapping. The surviving remains consisted of the lower courses of the south and east external walls (*c*.0.80m thick) along with two internal walls extending northwards from the south wall. Very little else survives apart from a spread of building material and a possible section of the north wall which contains a hole in the coursed masonry, possibly associated with a flue for a heater (Plates 31 and 32). This site was recorded as 'Feature 1' during the watching brief.

Plate 31: View looking east showing the remains of Whitesike Mine Shop

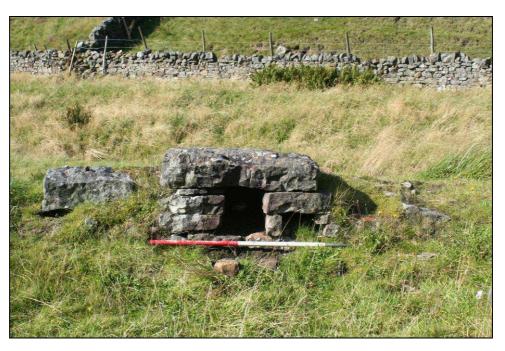
Plate 32: Detail of a section of possible north wall of Whitesike Mine Shop which contains a square aperture (Scale = 1m)

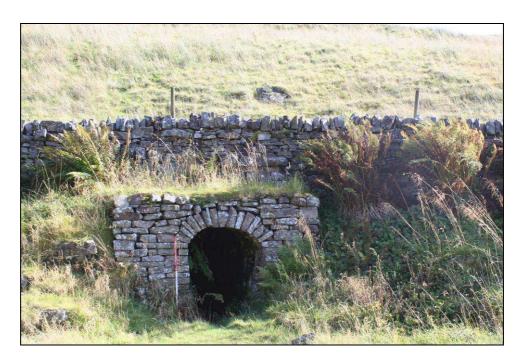
- 6.6.4 Located immediately to the west of the remains of Whitesike Mine Shop is the entrance into Whitesike Level (Plates 33 and 34). This entrance was reputedly reconstructed in 1982, and is therefore in good condition and well intact. The aperture measures *c*.3m in width and stands to a height of *c*.2.15m. The level entrance is constructed of long stone slabs of varying sizes. The site was recorded as 'Feature 2' during the watching brief.

Plate 33: Detail of the entrance to Whitesike Level (Scale = 1m)

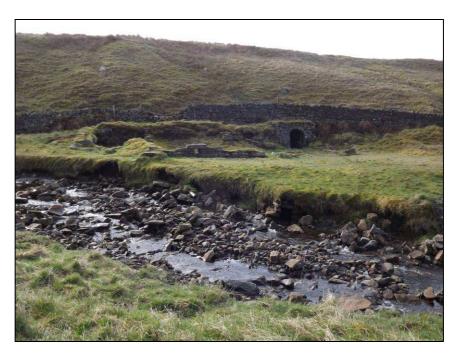
Plate 34: View looking south showing the Whitesike Mine Level adjacent to the remains of Whitesike Mine Shop, south side of Garrigill Burn

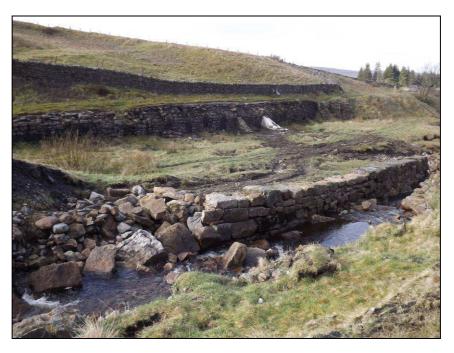
Plate 35: Long masonry wall along the south side of Garrigill Burn, remains of bouse teams at Whitesike Mine

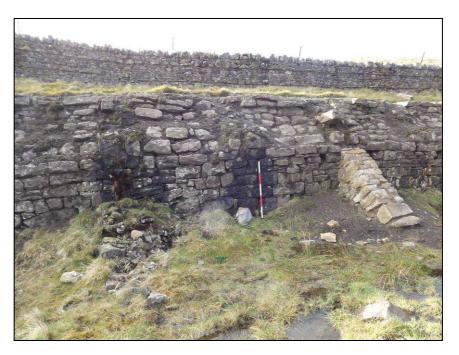
Plate 36: Detail of part of the south wall of the bouse teams or bingsteads, Whitesike Mine (Scale = 1m)

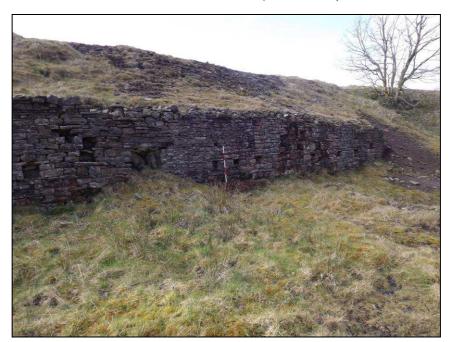
Plate 37: South retaining wall of Whitesike Dressing Floor (Scale = 1m)

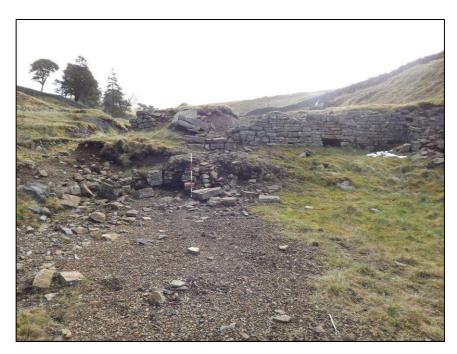
Plate 38: View looking east showing the east wall of the dressing area at Whitesike with what survives of the wheel pit (Scale = 1m)

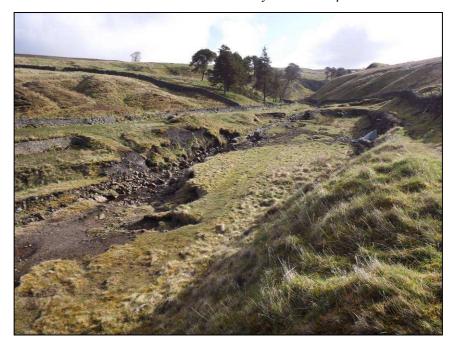
- 6.6.6 Little survives of Whitesike Dressing Floor, which is the area shown in the foreground on Plate 1. The south wall is still relatively extant and contains various square apertures which appear to have related to the timber frames and mechanisms utilised for the dressing processes (see Plate 1) (Plate 37). Part of the wheel pit which is visible on Plate 1 appears to still survive to the east side of the dressing floor area (Plate 38). As a whole, the dressing floor at Whitesike, as shown in *c*.1900, has largely disappeared (Plate 39).

Plate 39: View looking east showing the area of Whitesike Dressing Floor

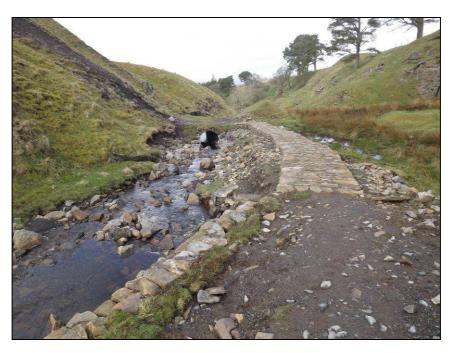
- 6.6.7 The Second Edition Ordnance Survey map of 1899 shows that between Whitesike and Bentyfield Mines, the Garrigill Burn was partly culverted (see Figure 6). During the site visits for the present project, it was noted that these culverted sections have been mostly washed away, apart from a small section close to the site of the Old Limekiln, and the culvert which runs under the road from Alston to Middleton in Teesdale (Plates 40 to 42).

Plate 40: View looking west showing part of the culvert to allow a track to cross the Garrigill Burn

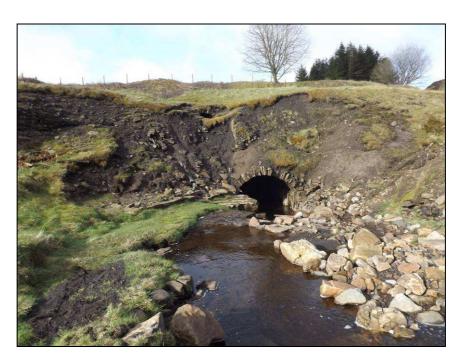
Plate 41: View looking west showing the large culvert under the road from Alston to Middleton in Teesdale

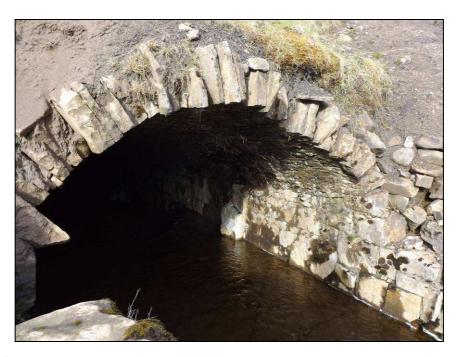
Plate 42: Detail of large culvert under road to west side of Whitesike Mine

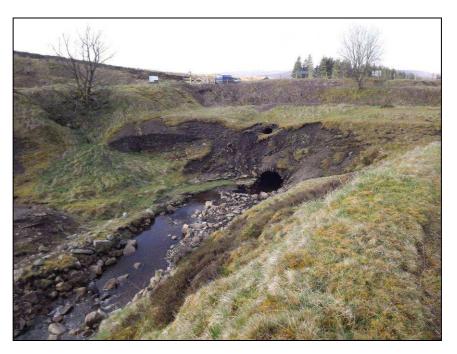
- 6.6.8 An opening was noted to still be visible just above the main culvert which runs over the road to the west side of Whitesike Mine, although the entrance is presently largely obscured by spoil (Plate 43). This may have been mistakenly labelled as a 'Level' on the Second Edition Ordnance Survey map of 1899 (see Figure 7), however it is set within a large area of spoil and may have actually been an access tunnel to allow the tipping of spoil on the other side of the road.

Plate 43: View looking west showing the main culvert under the road

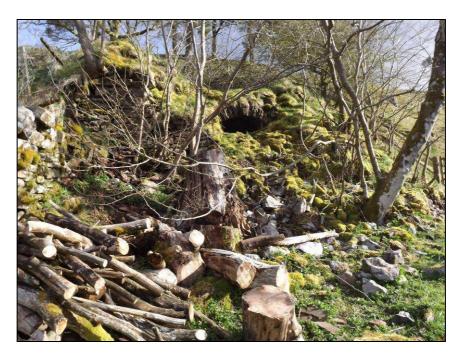
- 6.6.9 The 'Old Limekiln' which is annotated on the Second Edition Ordnance Survey map of 1899, to the east side of Whitesike Mine, and on the north side of Garrigill Burn, was noted to still be partially extant, with the sides and the central arch still visible (Plate 44). This lime kiln is presently recorded in the HER database as No. 19274 'Whitesike Lime Kiln.

Plate 44: Remains of lime kiln on north side of Garrigill Burn close to Whitesike Mine

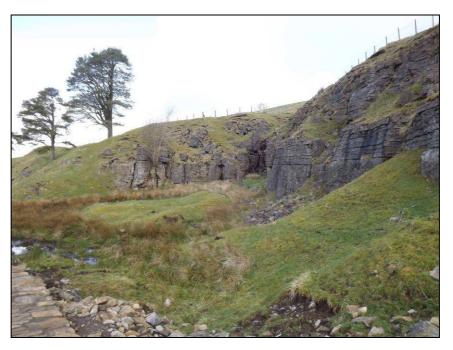
Plate 45: Quarry site on the north side of Garrigill Burn, between Whitesike and Bentyfield Mines
