**TENNANT GILL,
YORKSHIRE DALES
NATIONAL PARK,
NORTH YORKSHIRE**

ARCHAEOLOGICAL SURVEY

DOCUMENT TYPE: Archaeological Survey

CLIENT: Yorkshire Peat Partnership

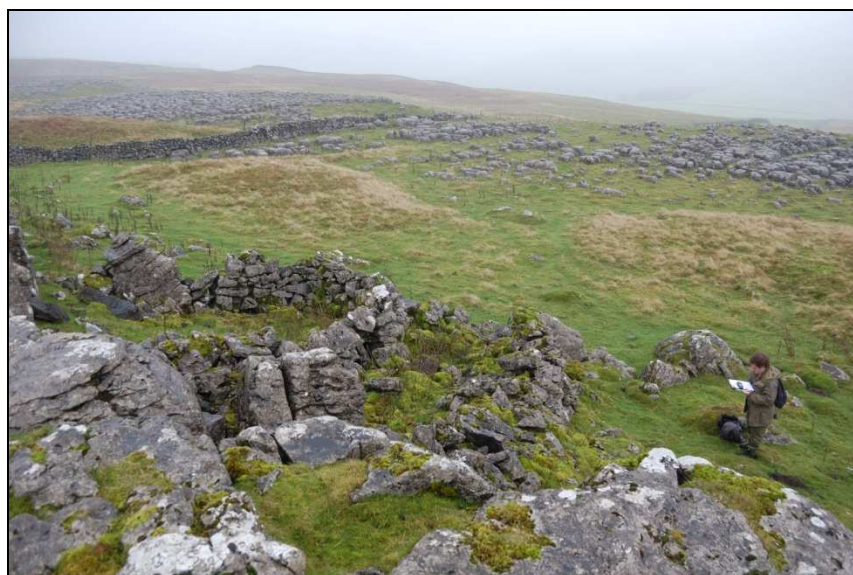
Plate 1: Peat formations below site (100)

- 3.3.4 The lowest peat formation occurs at c.460m OD (Plate 1). In this area, discontinuous areas of peat were observed. These formations, which continue to the north-east and south-west, occur between the limestone pavement to the south-east and the ridge of rock to their north-west. The peat at this point was c.50cm deep at the centre of the mat and thinned out closer to mineral soil vegetation which surrounded these mounds.

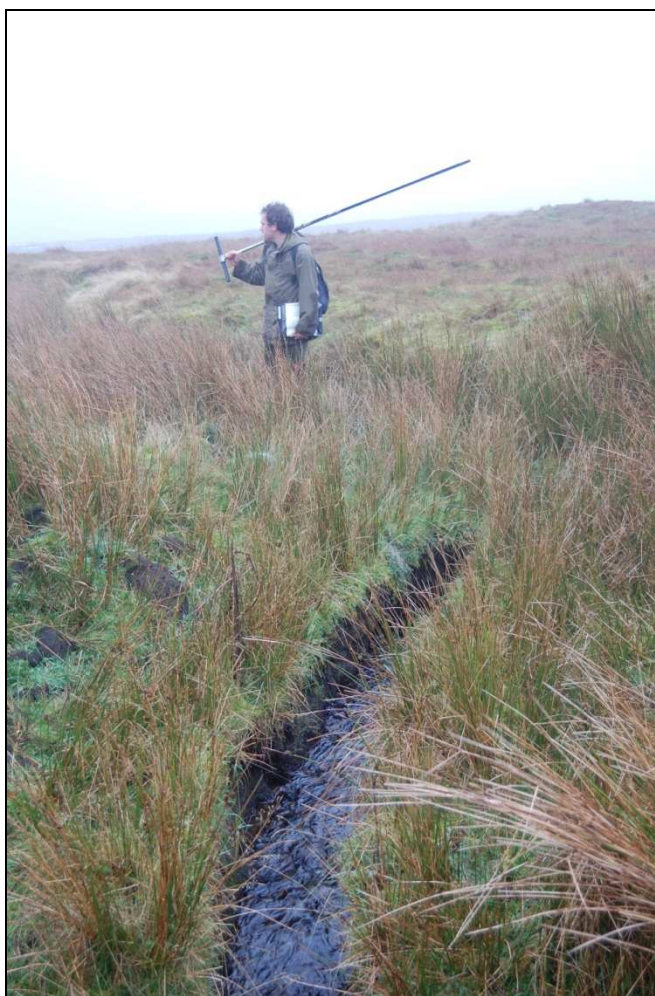
Plate 2: Tennant Gill

- 3.3.6 Further to the north-west it was observed that sections of the Tennant Gill area have been heavily eroded by stream erosion. On the lower slopes the Tennant Gill is channelled within a defined stream bed (Plate 2), albeit it still cuts though thin (c.10-20cm) peat deposits. However, further upstream erosion occurs on a wide scale. At one point along the stream (SD 87976-70003) c.70cm of peat has been exposed. This consists of c.30 cm of a lower heavily humified peat with a c.40cm layer of woody peat overlaying this (Plate 3). The presence of more frequent woody material may be indicative of vegetational change in this area over the course of the bog development.

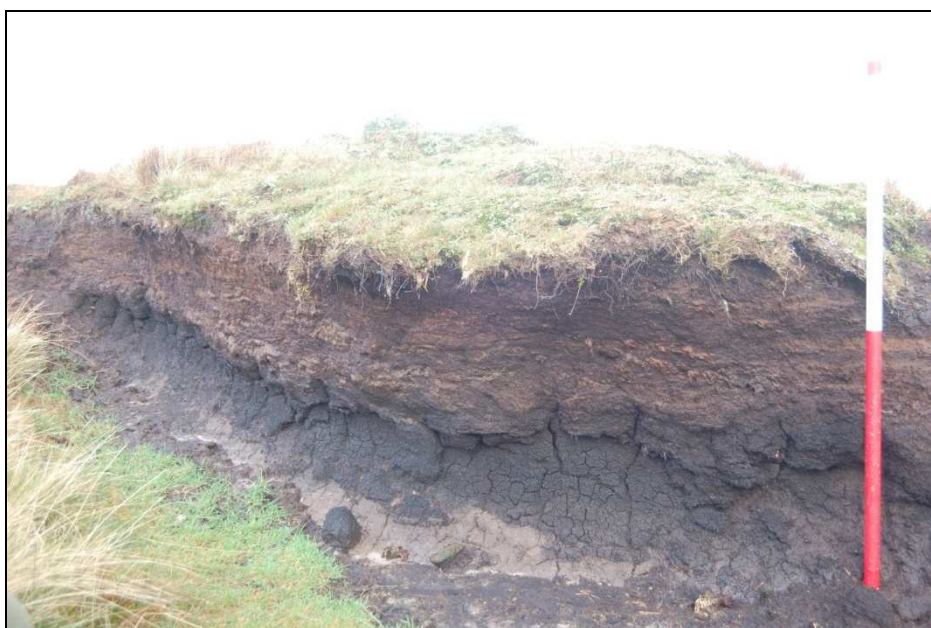
Plate 3: Humified and woody peat

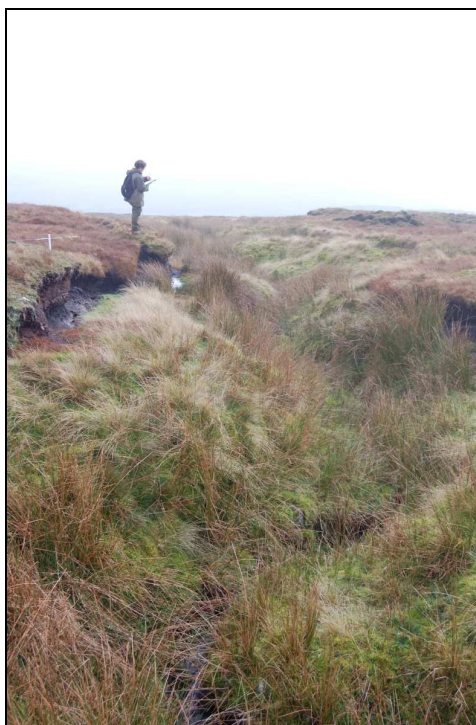
- 3.3.7 Though some areas of the bank now seem stable it was observed that along many areas of the Tennant Gill at this point peat is falling into the stream bed (Plate 4). This erosion can be seen most clearly from the hill side where a deep scar can be seen along the route of the Tennant Gill (Plate 5). This photograph also shows the discontinuous nature of the peat deposits in the north-eastern part of the site where areas of green grass highlight mineral soils, while the redder cotton grass (*Eriophorum vaginatum*) highlights areas where peat deposits are present. From a number of auger points taken in this area it was observed that the peat was not deeper than 80cm.

Plate 4: Tennant Gill bank

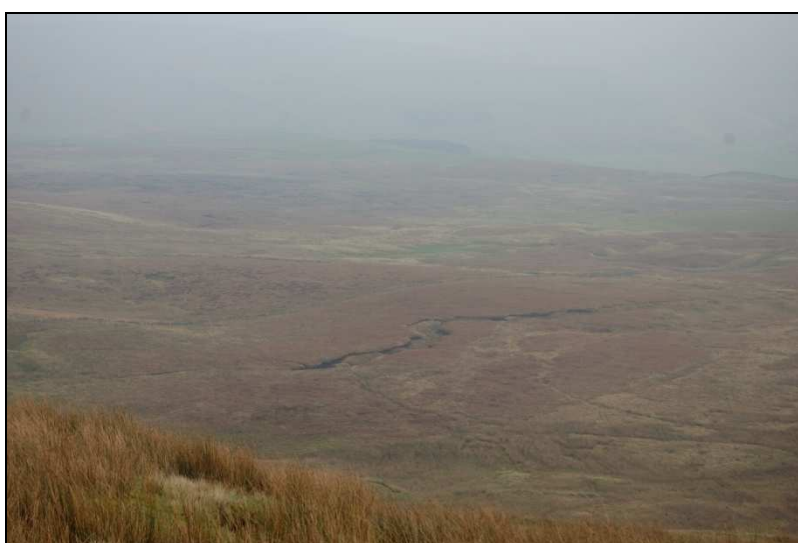
Plate 5: Tennant Gill erosion from hillside, facing east

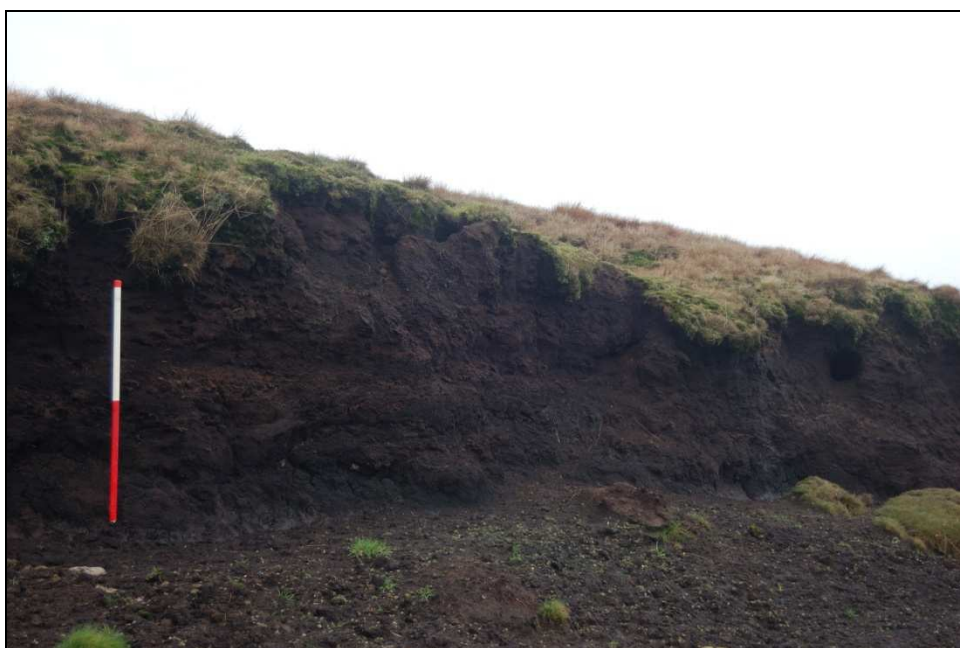
- 3.3.8 Near the summit of the hill an area of near continuous peat was observed as lying above the line of the 607m OD contour. This can be best seen in its exposed state at SD 87192-70247 (Plate 6). Peat up to 2m deep was recorded using the hand auger. The peat consisted of preserved monocotyledonous herbaceous grasses with some sphagnum. The abundant grass growing

Plate 6: Exposed peat above 607m OD

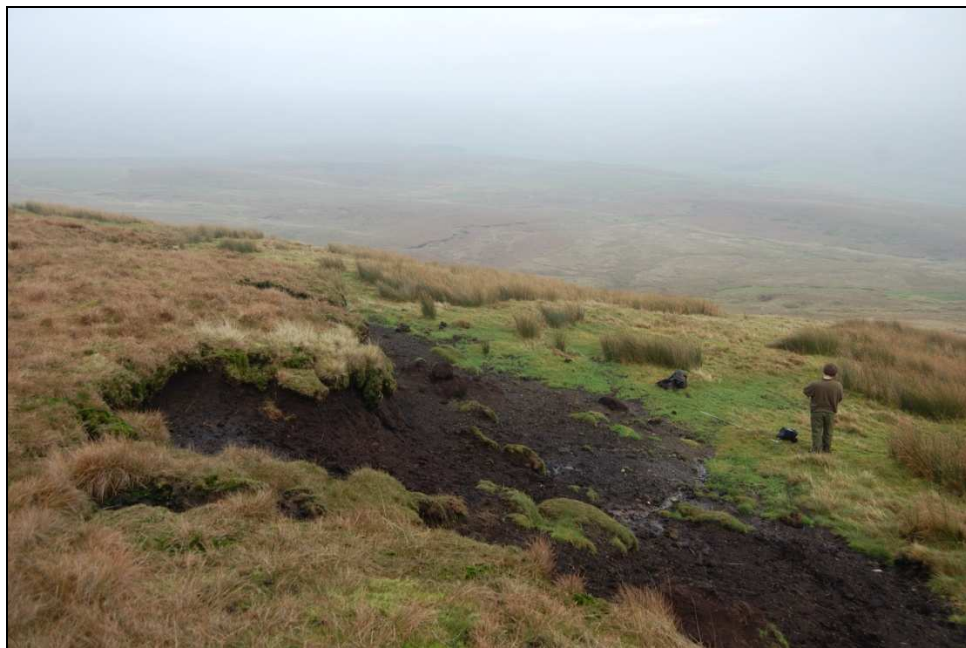
over a mineral soil immediately below this area suggests that the soil here is not persistently waterlogged, thus peat formation is dependent on a combination of high rainfall and poor drainage over areas of iron panned, or poorly drained soil. Drainage of water from the peat at this point was observed at a number of points. Added to this, heavy animal trampling from sheep and digging by rabbits is adding to erosion. This is particularly noticeable where the peat meets the mineral soil plant communities (Plate 7).

Plate 7: Hagged peat

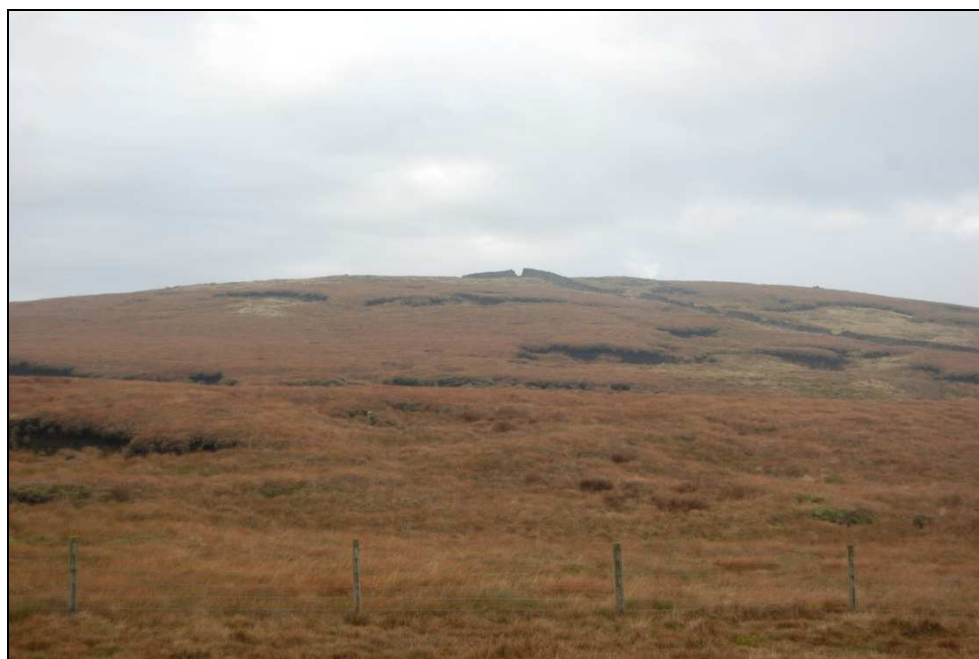
Plate 8: Hill-top peat deposits

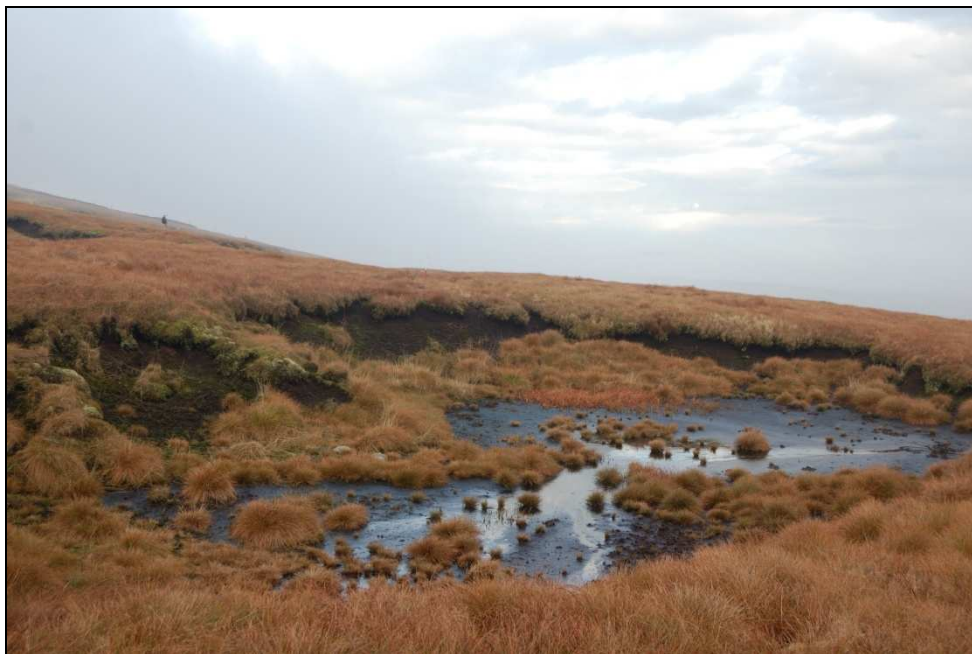
- 3.3.9 Erosion of the peat above the 607m OD contour was observed. It is suggested that this is due to drying out and shrinkage of the peat, causing the surface to break. This can be seen in Plate 8, on the area of the slope immediately below the summit. In this area another large dump of automotive tyres was identified (SD 87090-70302), which are blocking a stream that was flowing into a very large area of eroded peat (Plate 9). Here the mineral soil is exposed over a c.40mx50m area, with this area likely to increase in size unless drainage channels leaving the eroded basin are blocked.

Plate 9: Eroded peat caused by tyre dump

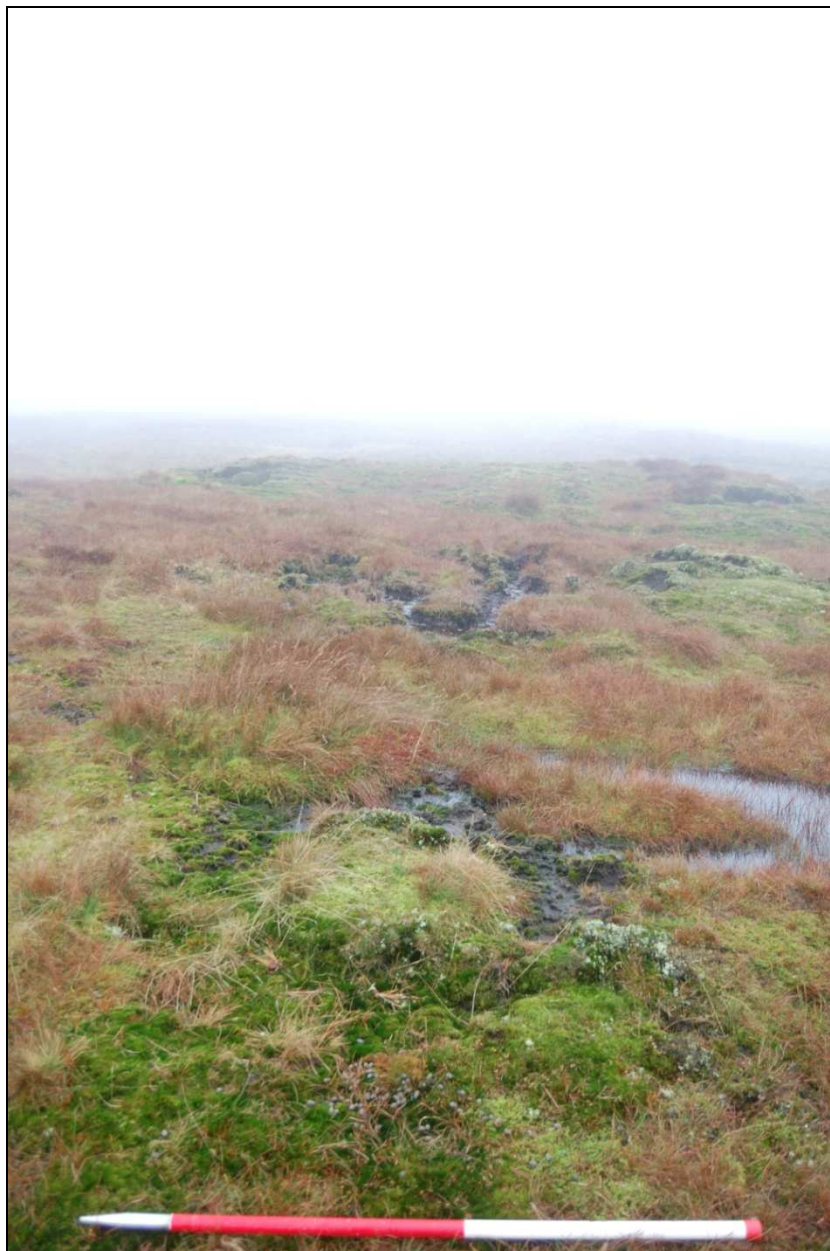
- 3.3.11 Between Far Fell and Middle Fell isolated areas of peat were observed. Around the point SD 87648-69815 an area of exposed peat was observed. An auger depth showed the peat to be up to 1m deep, over a 5cm layer of blue-grey clay, over orange-brown sandy clay. Though not cut by modern drainage channels the peat is becoming degraded. Patchy areas of the c.50x50m area have become exposed (Plate 10) and if left untreated this may become more prominent over time.

Plate 10: Patchy degraded peat

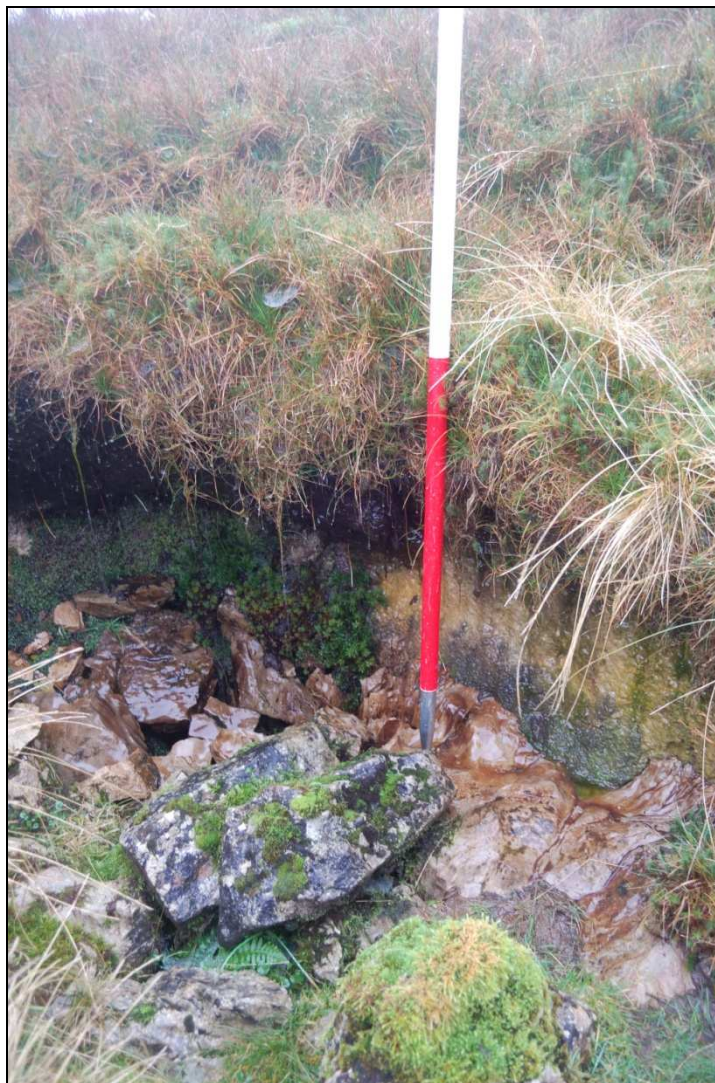
Plate 11: Possible sinkhole

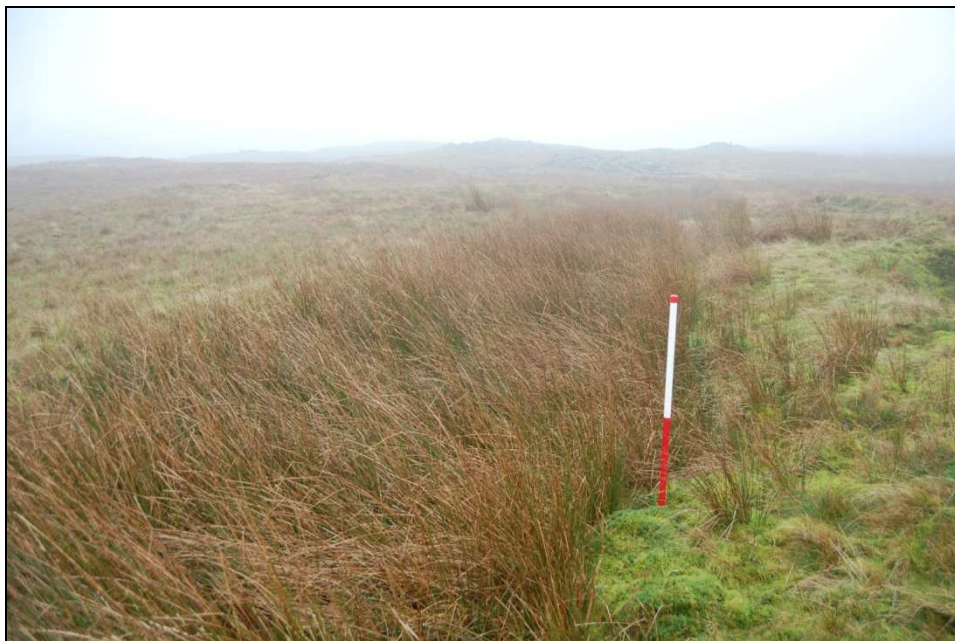
- 3.3.13 Drainage systems in much of the surveyed area have not been maintained and are mostly overgrown, the exception being some portion of the Tennant Gill as discussed above. Between Far Fell and Middle Fell many of the larger drains are almost non-functional as drains. Many are filled with rush growth, mainly the sedge *Sonchus nigricans* (Plate 12). In others areas of Far Fell, near the southern edge of the boundary wall (101), some areas seem to have experienced heavy erosion in the past but are now stable, as evident from heavy sedge growth.

Plate 12: Sedge growth

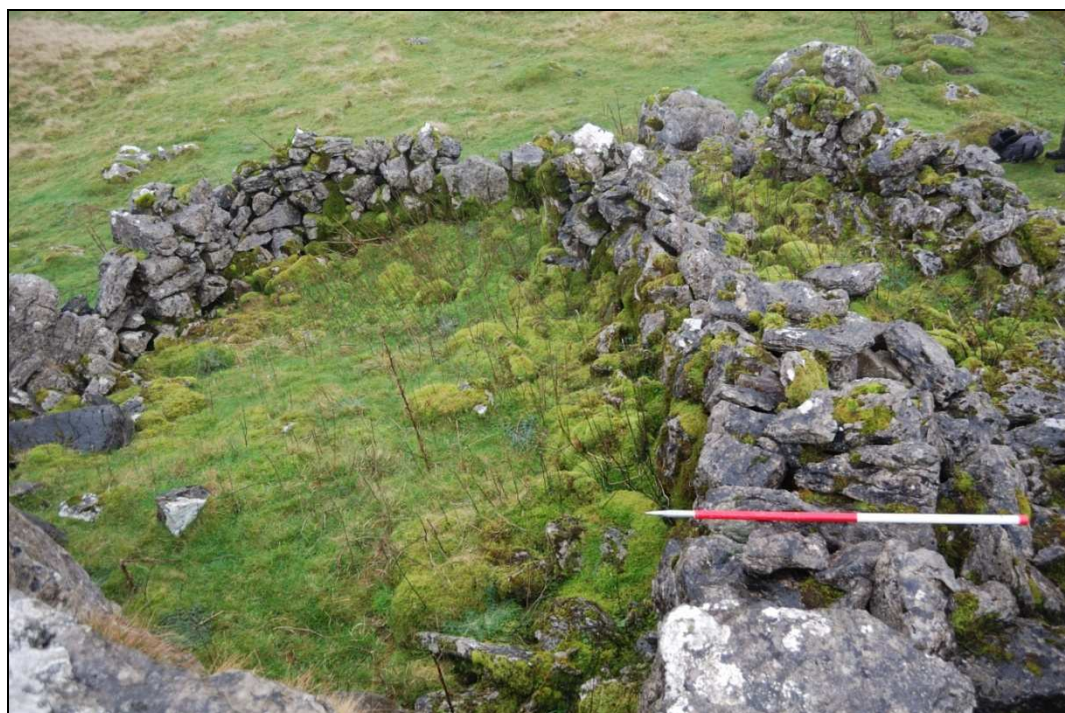
- 3.2.2 The first feature **(100)** recorded was to the north of Tennant Gill at the northern edge of the survey area. It is a semi-circular dry stone enclosure with an outcrop of limestone pavement forming its north-western side. An internal wall divides two thirds of the structure from the other third. It measures 9m by 5.5m. The method of construction and form suggest that this is a fairly modern agricultural structure, possibly a sheep pen. Some of the walls have collapsed but it is in a stable condition.

Site Number	100
Monument Type	Enclosure
Period	Post Medieval
Location	Against exposed section of limestone pavement to the north-west
Easting	388129.63
Northing	470034.60
Elevation	471.56
Existing MYD number	35404
Condition	Stable
Land use	Upland pasture
Risks of proposed work	In an area unlikely to be damaged by machine action as it is near a boundary wall and a rock face too steep for vehicular access.
Description	Semi-circular dry stone enclosure with an outcrop of limestone pavement forming its north-western side. An internal division separates one third from the other two thirds. It measures 9m N-S by 5.5m E-W. The walls survive to a maximum height of 1.6m and are constructed of randomly coursed rough limestone blocks. The method of construction and good preservation suggest that this is a relatively modern feature, probably a sheep fold.

Plate 13: South facing view of enclosure showing internal division

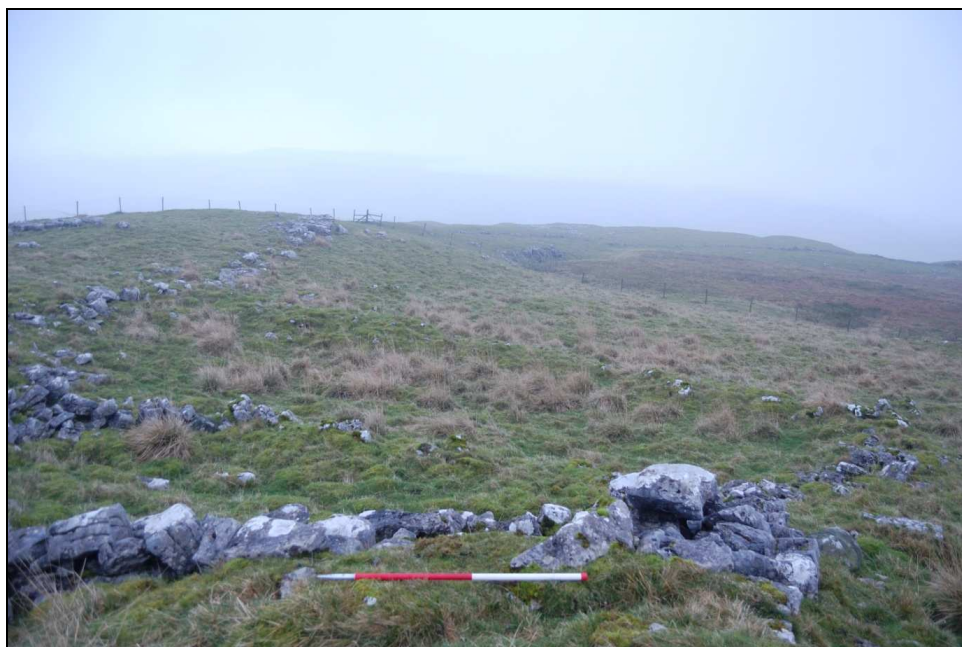
- 3.2.6 At a distance of 17m south of the hut circle is the sub-circular enclosure **(102)**. It is very similar in construction to the hut and survives as low earth and stone banks around 1m wide and up to 0.5m in height. It is around 20m in diameter. As with the hut circle there is a possible entranceway on the southern side, in this case marked by two larger stones. There is a small internal structure similar in construction against the north-western edge of the enclosure up against a vertical section of lime stone pavement.

Site Number	102
Monument Type	Enclosure
Period	Prehistoric
Location	On a plateau overlooking the valley
Easting	388171.77
Northing	469423.65
Elevation	436.32
Existing MYD number	35408
Condition	Stable
Land use	Upland pasture
Risks of proposed work	
Description	Low sub circular enclosure of limestone blocks and earth on a flat area of ground overlooking the valley below. It is built up against a vertical edge of exposed limestone pavement to the west. The banks incorporate and add to natural outcrops of limestone to form an enclosed space 20m in diameter with a small internal structure of the same material up against the limestone pavement. The internal space appears to have been cleared of large stones. A narrow entranceway is possibly marked at the eastern extent of the enclosure by two larger upright stones. This may, however, be an area where the bank has been damaged. The bank is around 1m wide at its base and survives to a height of up to 0.5m. It is 15m south-west of possible hut 103 with which it is likely to be associated.

Plate 15: View looking east from the limestone pavement at enclosure (102)

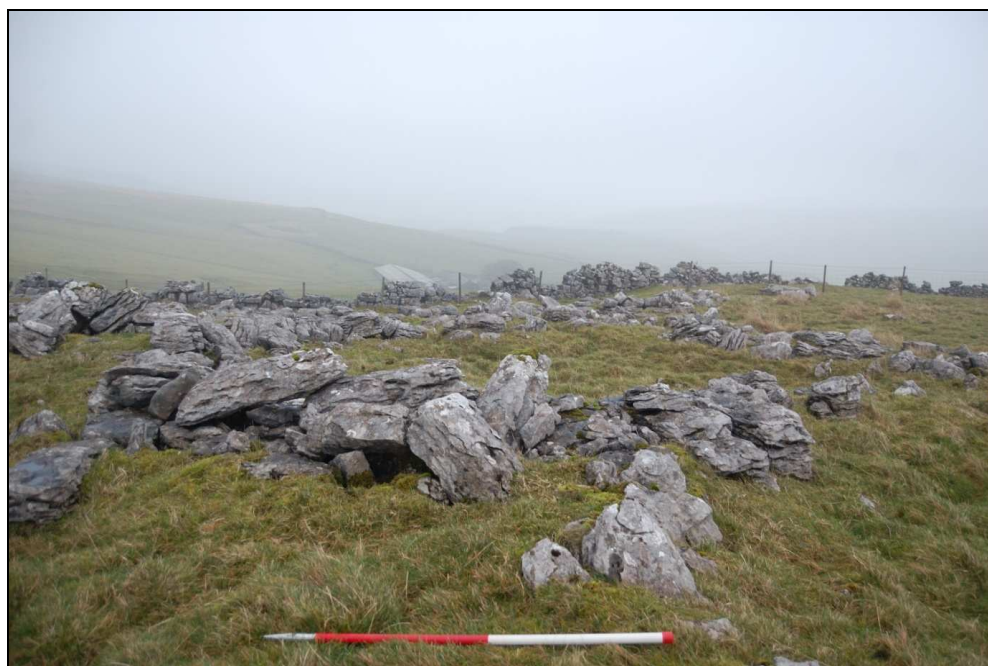
- 3.2.5 The hut circle **(103)** is 8m in diameter and the interior space appears to have been levelled and cleared of stones. There is a possible entranceway to the south. These sites may be prehistoric and are analogous to hut circles found in other upland areas such as Dartmoor.

Site Number	103
Monument Type	Hut Circle
Period	Prehistoric
Location	On a plateau overlooking the valley
Easting	388199.44
Northing	469441.13
Elevation	437.128
Existing MYD number	-
Condition	Stable
Land use	Upland pasture
Risks of proposed work	Although outside the area of peat grips and planned restoration it could potentially be damaged by plant on its way to the area of work.
Description	A subcircular platform surrounded by low limestone and turf banks. The stones seem to have been moved from local areas of exposed stone and placed on top of each other and against <i>in-situ</i> limestone outcrops to form low walls. This encloses a space that has been levelled and cleared. The hut circle is 8m in diameter and the walls are around 0.7m wide. They survive to a height of up to 0.5m. The form, construction and size of this feature are similar to those of hut circles found on other upland sites. Its position overlooking the valley below, but in a sheltered situation close to a subcircular enclosure, makes this a more convincing interpretation.

Plate 16: Hut Circle (103) overlooking the valley and Tennant Gill Farm to the East

- 4.2.1 The survey identified some regionally significant archaeological sites, in the form of a potential hut circle and enclosure, which could be of early date, potentially prehistoric, and a wall which appears to be in all probability of medieval or earlier date. All these sites should be avoided during any peat restoration works.
- 4.2.2 No ecofacts or archaeological horizons were identified during the palaeoenvironmental survey, though the potential for peat deposits to seal important archaeological information remains a possibility in view of the depth of deposits; caution should therefore be exercised during any restoration works on the site.

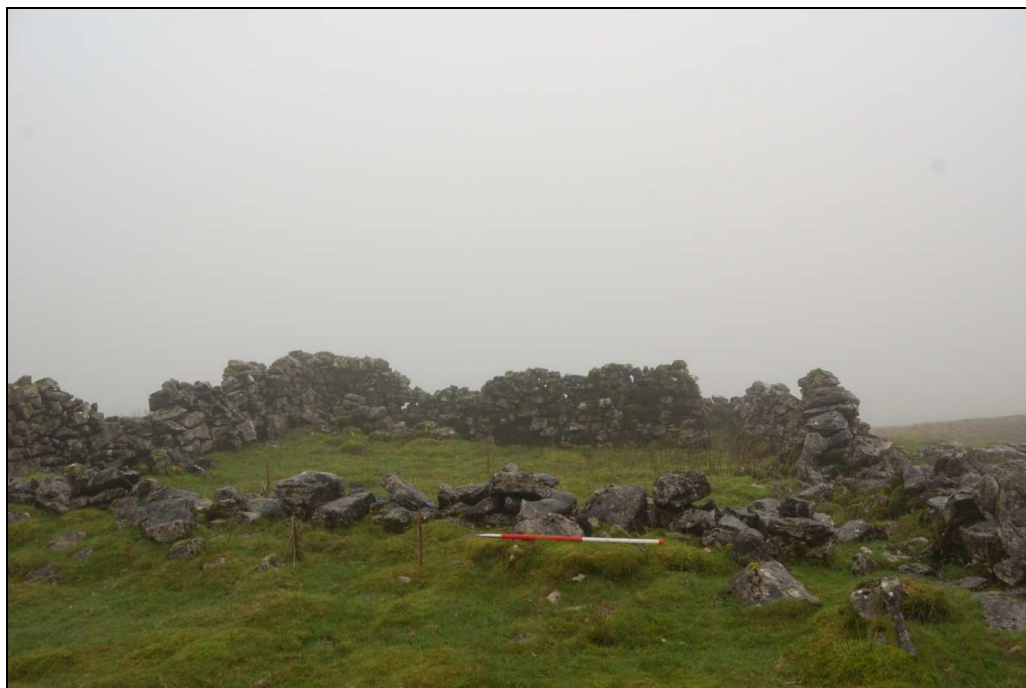
- 3.2.7 Site **(104)** is a rectangular stone building, which is recorded on the Ordnance Survey 1:25000 map. It measures 9m by 8m and is built up against a north-east to south-west boundary wall. A small offshoot from the north-east wall may have been used for corralling animals. An internal dividing wall is flanked on either side by sheep runs. The walls survive to a maximum height of 1.6m. The good condition of the stonework and the fact that this structure respects the field boundary indicate this is a fairly modern agricultural building. It is possible that it also served a domestic purpose but there is no evidence to confirm this.

Site Number	104
Monument Type	Building
Period	Post Medieval
Location	
Easting	387839.24
Northing	469453.44
Elevation	475.34
Existing MYD number	35300
Condition	Fair
Land use	Upland pasture
Risks of proposed work	Upstanding monument. Clearly visible to contractors and therefore avoidable.
Description	<p>Marked on 1:25000 OS Map, this feature consists of a rectangular structure with an internal division to the SE. It is built up against a north-east-south-west boundary wall. It measures 9m north-east-south-west by 8m NW-SE. The walls survive to a maximum of 1.6m.</p> <p>The north-east wall has an offshoot running NW which may have been used for corralling animals.</p> <p>It is unclear whether this building was purely for animal herding or whether it also had a domestic function.</p> <p>An internal door was noted for the internal division. A door exiting externally to the NW near the boundary wall was less obvious but possible.</p> <p>Two sheep runs observed on either side of the internal division.</p> <p>This is likely to be a post medieval feature.</p>

Plate 17: Looking South towards Building (104)

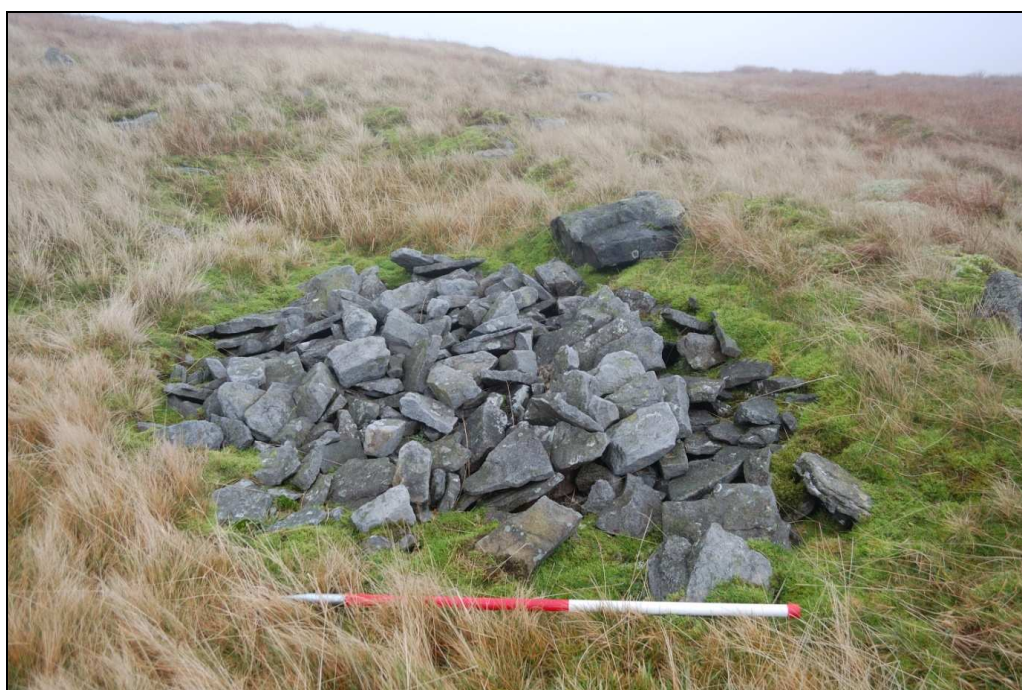
- 3.2.8 The final feature **(105)** recorded in the survey area is a group of three cairns of limestone blocks. They were recorded at the far north-western corner of the area and are in close proximity to a field boundary wall. The fact that they are not covered by soil or vegetation suggests that they are a modern feature associated with the construction of the nearby wall or with later repairs.

Site Number	105
Monument Type	Clearance Cairns
Period	Post medieval
Location	Far north-east of surveyed area. Highest archaeological feature noted during survey.
Easting	386890.88
Northing	470437.91
Elevation	645.93
Existing MYD number	
Condition	Stable
Land use	Upland pasture
Risks of proposed work	May be damaged by movement of plant
Description	Series of piles of stones in close proximity to post medieval field boundary. May be from the original construction of the wall or were gathered to make repairs.

Plate 18: One of a series of three piles of limestone blocks that make up Site (105)
