Exeter City Council Historic Environment Record

Civil Parish & District:	Nation Refere	al Grid nce:	Number:
Exeter	SX 9210 9249		
Subject: Archaeological monitoring and recording on land behind the Pearson Library, Exeter Cathedral, Exeter. Photo attached: Y			
Planning permission no:		Recipient museu	m:
OASIS ID: oakforda1- 509235		Museum Accessi n/a	on no:
Contractor's reference number/code: OA1955		Date fieldwork u 10/10 & 03/12/20

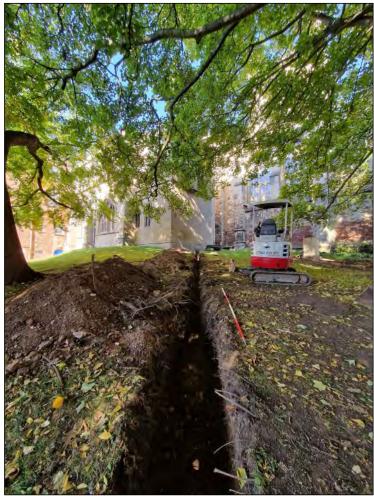
Pl. 1 General view of new service trench showing extensive late 19th century landscaping deposits (103-4). 2m scale. Looking northeast.

Inspection of the trench exposed a mid brown clayey silt (105) at a depth of 0.27-0.85m. This contained frequent mid pinkish white lime mortar, cbm and volcanic trap fragments and roofing slate and has been interpreted as a demolition deposit. This was overlain by a 0.1m thick mid brown clayey silt (104) with frequent white lime mortar flecks. This deposit was in turn sealed underneath a 0.35m thick mid brown clayey silt (103) with rare gravel, charcoal flecks and roofing slate inclusions. These deposits probably represent landscaping following the demolition of the 'Three Chambers' and were in turn located underneath a 0.13m thick mid greyish brown clayey silt (102). These were underneath a 0.14m thick light to mid greys clayey silt (101) with frequent ash and coal flecks, roofing slate and white lime mortar flecks. These deposits have been interpreted as construction deposits associated with the construction of the Pearson in the late 19th century. The sequence was sealed by a 0.13m thick mid brown clayey silt (100) topsoil.

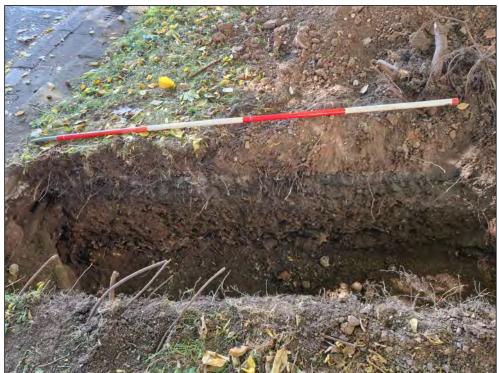
Pl. 2 Section through extensive late 19th century landscaping deposits (103-4) overlying demolition deposit (105). 2m scale. Looking southwest.

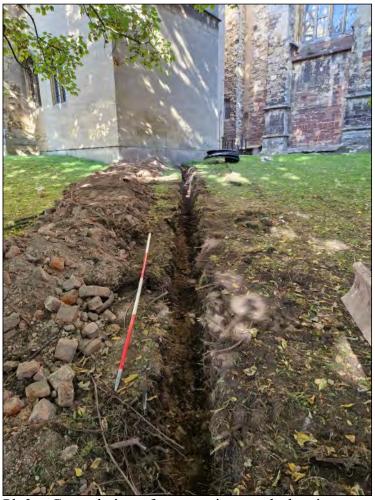
Pl. 3 General view of new service trench showing demolition deposit (105). 2m scale. Looking northwest.
