**Archaeological evaluation and historic  
building recording at Orchard Wyndham,  
Williton, Somerset**

**Report No. 23-02**

**January 2023**

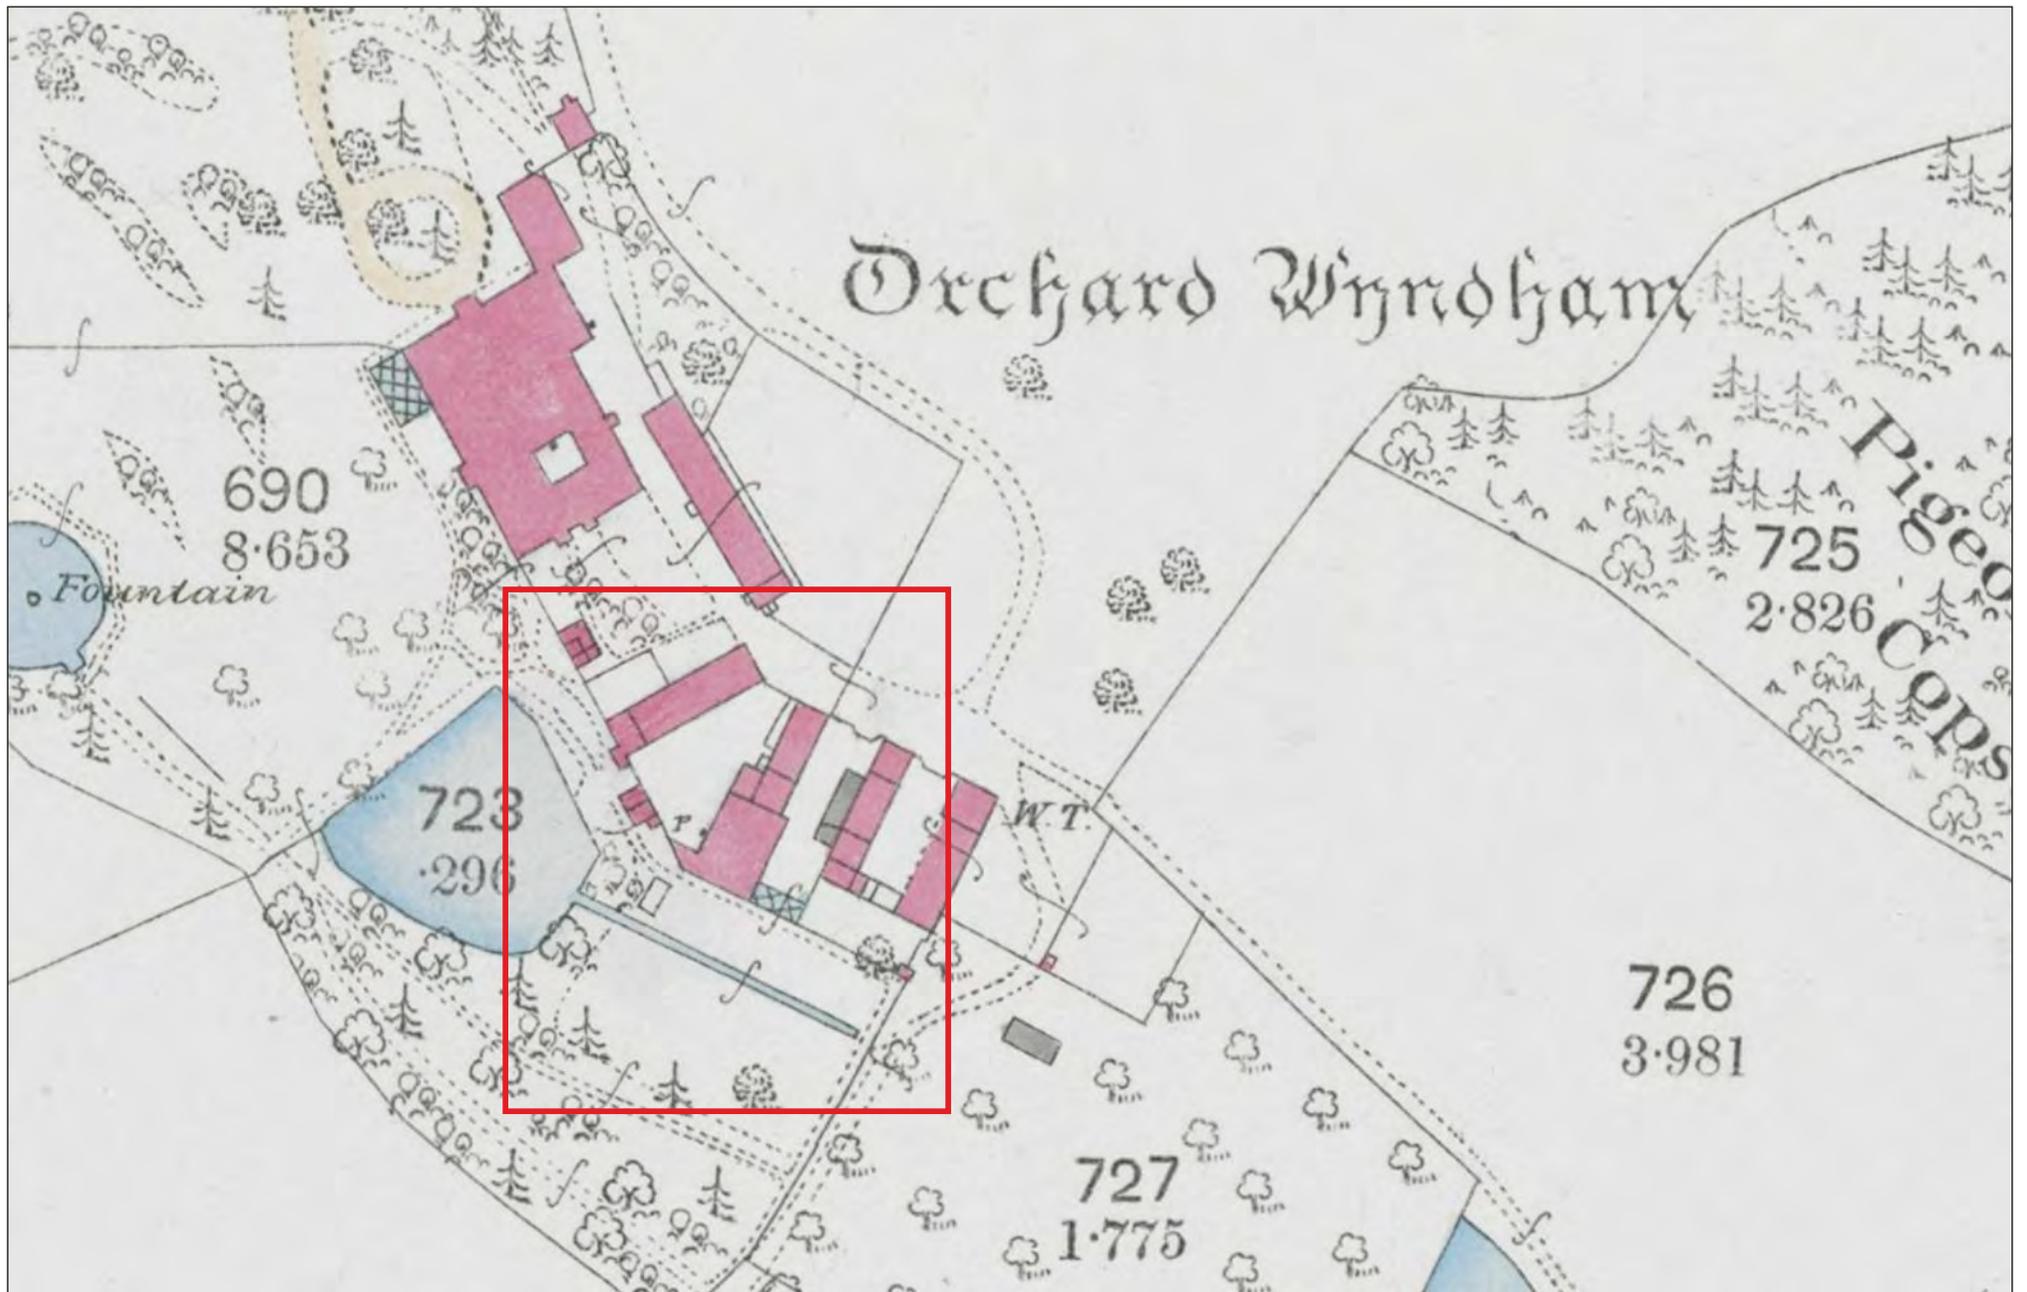
Fig. 3 Detail from the 1888 1st edition Ordnance Survey Map Somerset Sheet XLVIII.5.

The area was mapped by the Ordnance Survey in 1888, when the site was shown in the greatest detail thus far (Fig. 3). The area has drastically changed by this period. The buildings and yards which formerly occupied the areas to the northeast and southeast of the linhay have been demolished and in part replaced with new buildings. The stable yard to the west has been opened up with the demolition of the smaller outbuildings, while a large roughly square building, a carriage house, has been built to the south. On the eastern side of the linhay a large stock yard has been created, with a small rectangular lean-to on the eastern side and a greenhouse occupying the southern edge of the yard. To the east an agricultural stable and large barn are built around a central hay yard, while pigsties are located on the southern side of the yard.

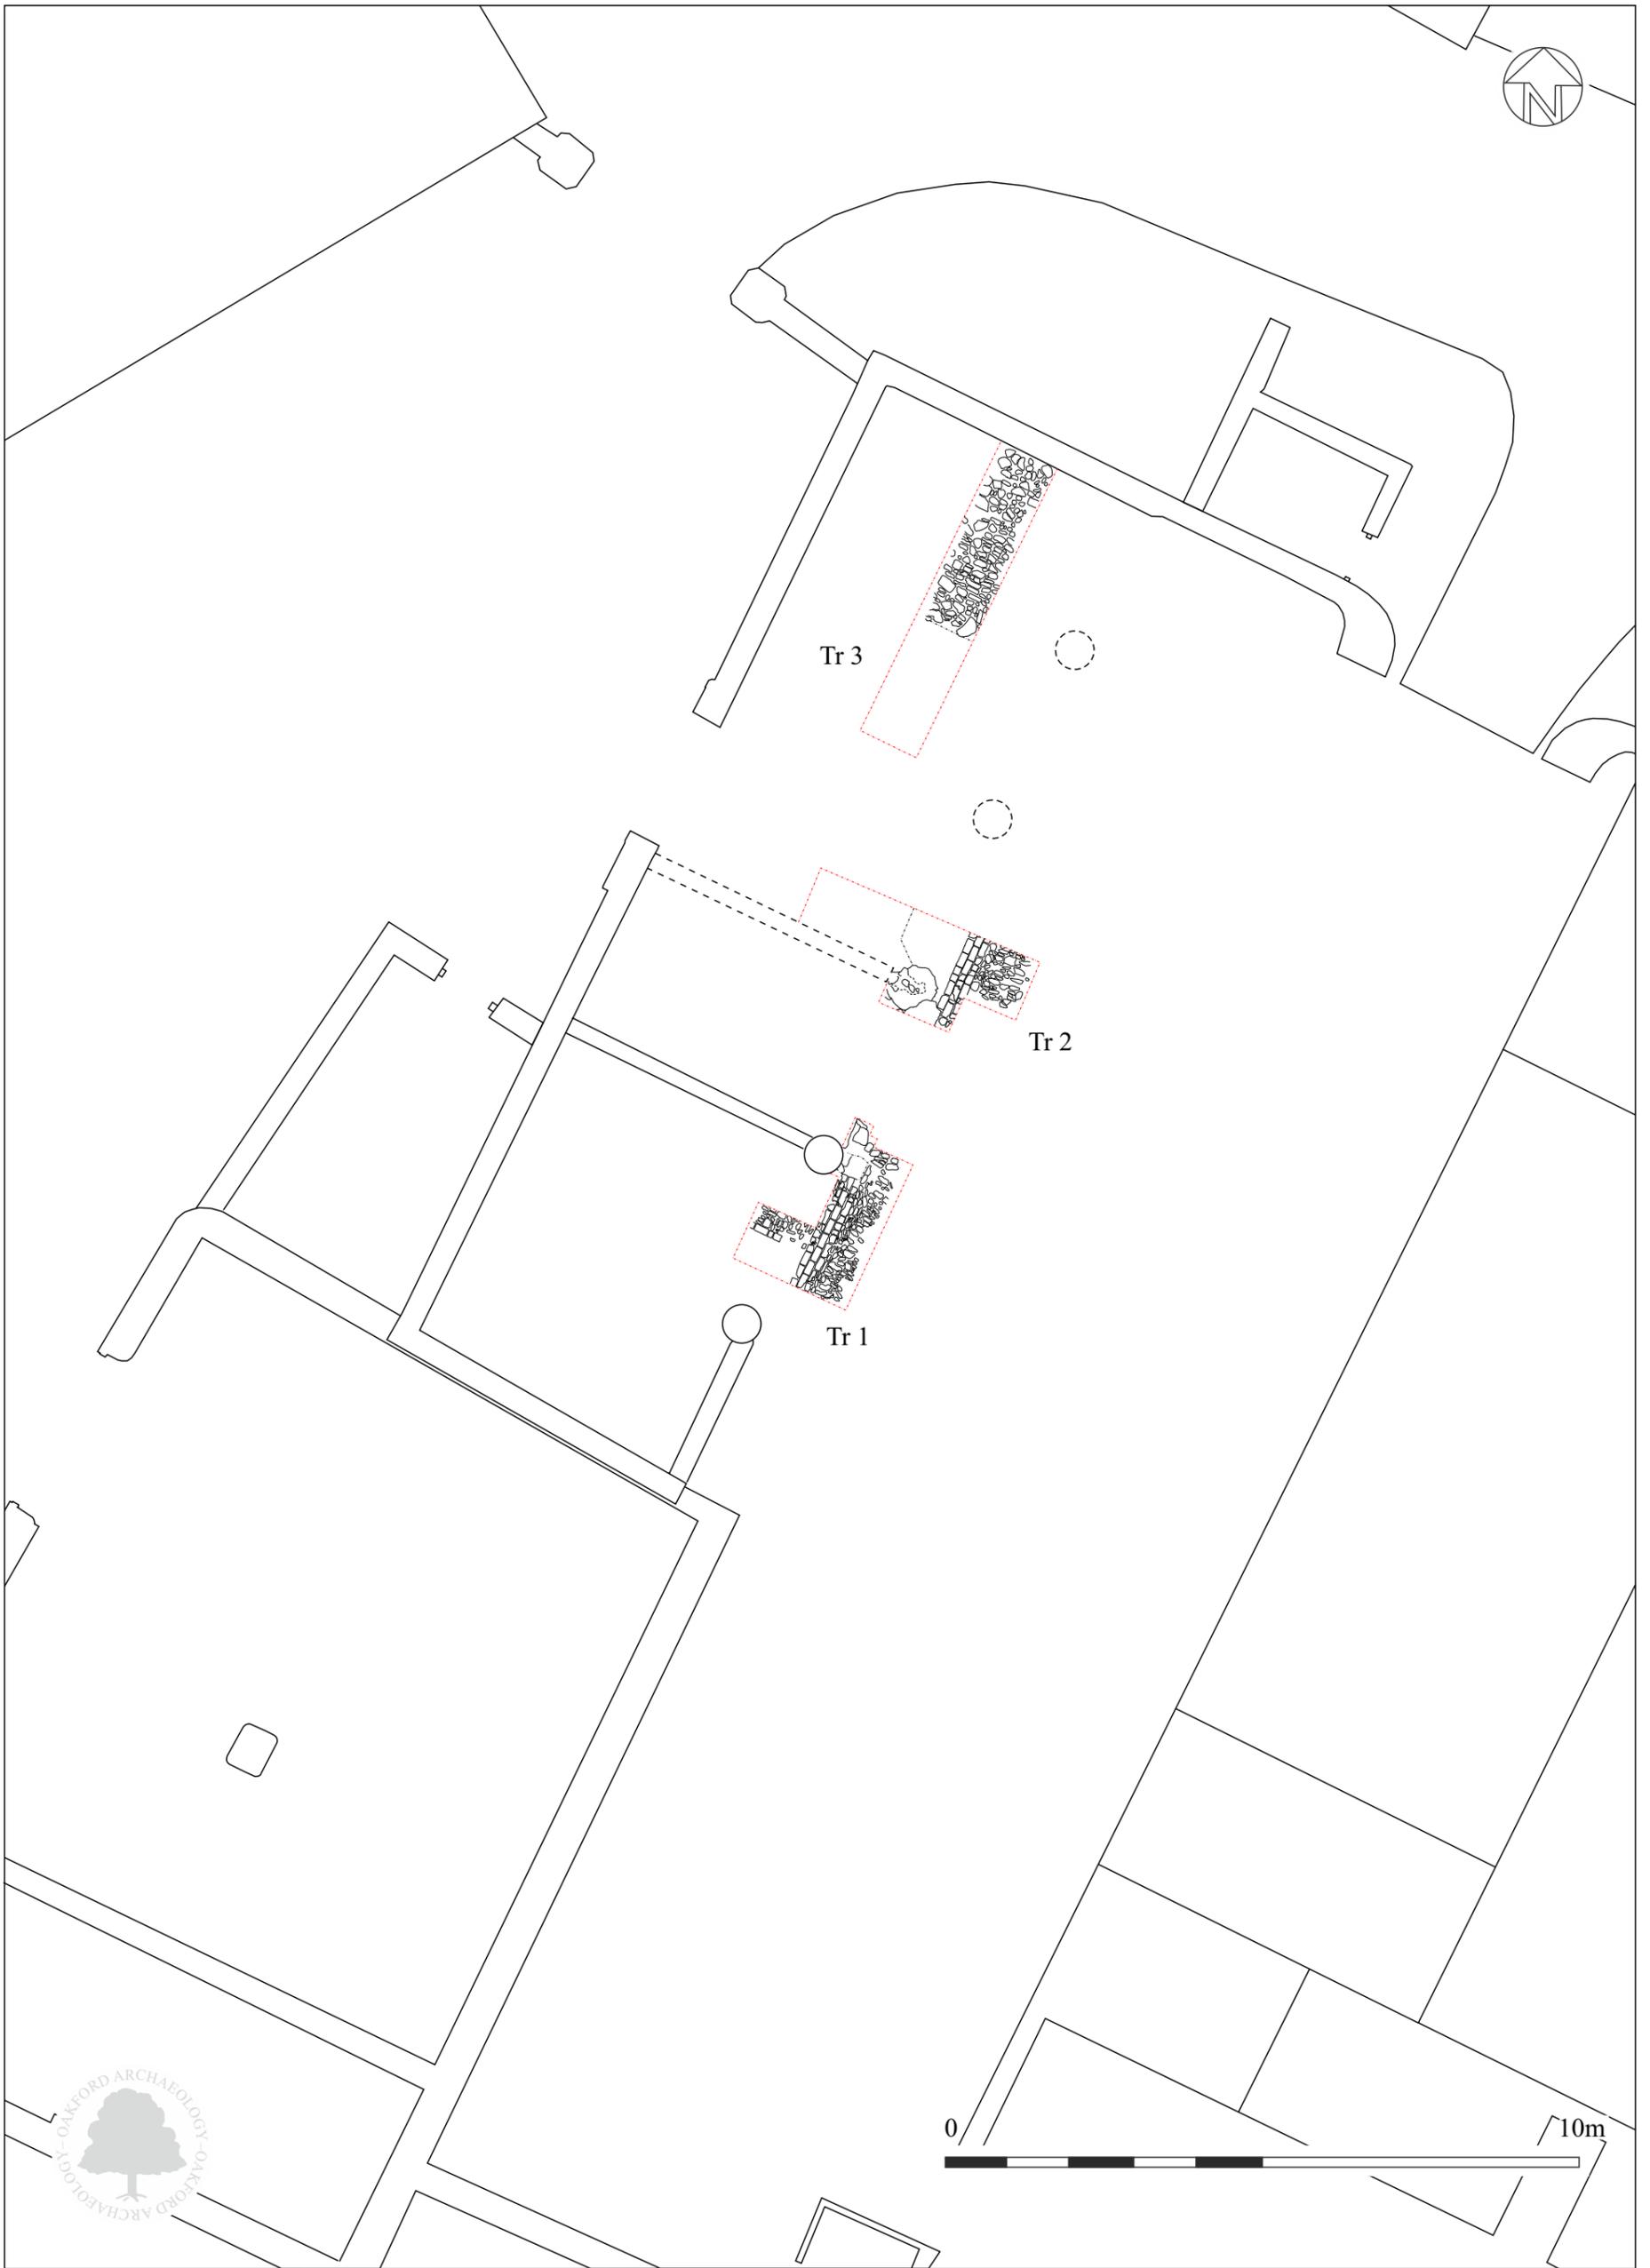
Fig. 6 Plan showing location of trenches and principal features identified.

The work comprised the excavation of three trenches totalling 11.4m in length, with each trench 1m wide. They were positioned to provide a spatial sample of the site and their positions were agreed with the SWHT prior to commencement on site. The positions of trenches as excavated are shown on Fig. 6.

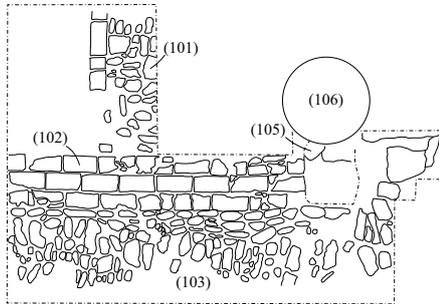
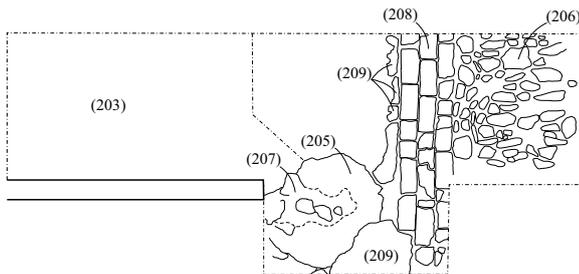
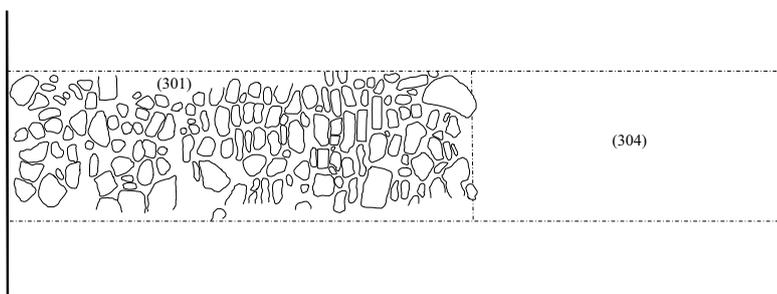
Fig. 7 Trenches 1-3, plans.

This trench measured 2.5m x 1m, was orientated approximately NE-SW and was excavated to a maximum depth of 0.21m. The work exposed a mid reddish brown silty clay (107) at a depth of 0.15m below ground level. This contained frequent stone rubble, and rare inclusions of mid yellowish white lime mortar and cbm fragments. Interpreted as a historic made ground this deposit was in part built up around the pier foundation (105). This was approximately 0.14m high and consisted of stone rubble bonded with mid orange lime mortar. This was underneath the cylindrical stone rubble pier (106) bonded with an identical mid orange lime mortar. Overlying the made ground were the contemporary external cobbled yard (103), consisting of large worn stone and waterworn pebbles, the external open brick drain (102) and the internal cobbled floor (101), consisting of large worn stone and waterworn pebbles. These were sealed underneath a 0.07m thick mid to dark brown clayey silt (100) topsoil. No finds were recovered, and the recorded layer sequence is set out in Table 1, Appendix 2.

The trench measured 3.8m x 1m, was orientated approximately NW-SE and was excavated to a maximum depth of 0.7m. A mid red silty clay (203) colluvial subsoil was exposed at a depth of 0.67m below current ground level. The overlying original soil sequence had been cut (202) and was sealed underneath a 0.52m thick mid reddish brown silty clay (201) with frequent stone rubble, and rare inclusions of mid yellowish white lime mortar and cbm fragments. Interpreted as a historic made ground identical to the one exposed in Trenches 1 and 3, this deposit was in part built up around the pier foundation (205). This was approximately 0.29m high and consisted of stone rubble bonded with mid orange lime mortar. The remains of the former cylindrical stone rubble pier (207) survived above, consisting of stone rubble bonded with an identical mid orange lime mortar. Overlying the made ground were the contemporary external cobbled yard (206), consisting of large worn stone and waterworn pebbles, and the external open brick drain (208). The original cobbled floor within bays 3 and 4 had been replaced with a thin concrete floor (209). No finds were recovered and the context descriptions for this trench are set out in Table 2, Appendix 2.

clay (302) with frequent stone rubble, and rare inclusions of mid yellowish white lime mortar and cbm fragments. Laid into the top of this deposit was an internal cobbled floor (301), consisting of large worn stone with the occasional brick. The southern end of this surface had been truncated by modern activity, and both were in turn sealed underneath a 0.1m thick mid to dark brown clayey silt (300) topsoil. No finds were recovered and the context descriptions for this trench are set out in Table 3, Appendix 2.

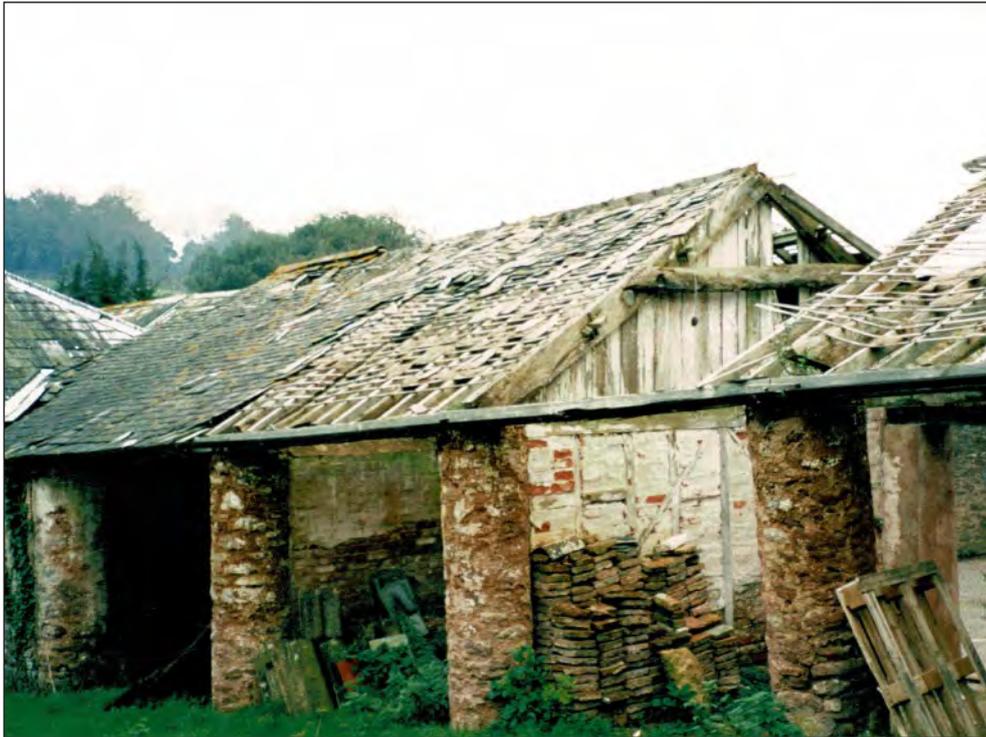
Pl. 9 General view of the south end of the former linhay prior to demolition showing the cylindrical piers and roof structure. Looking southwest.

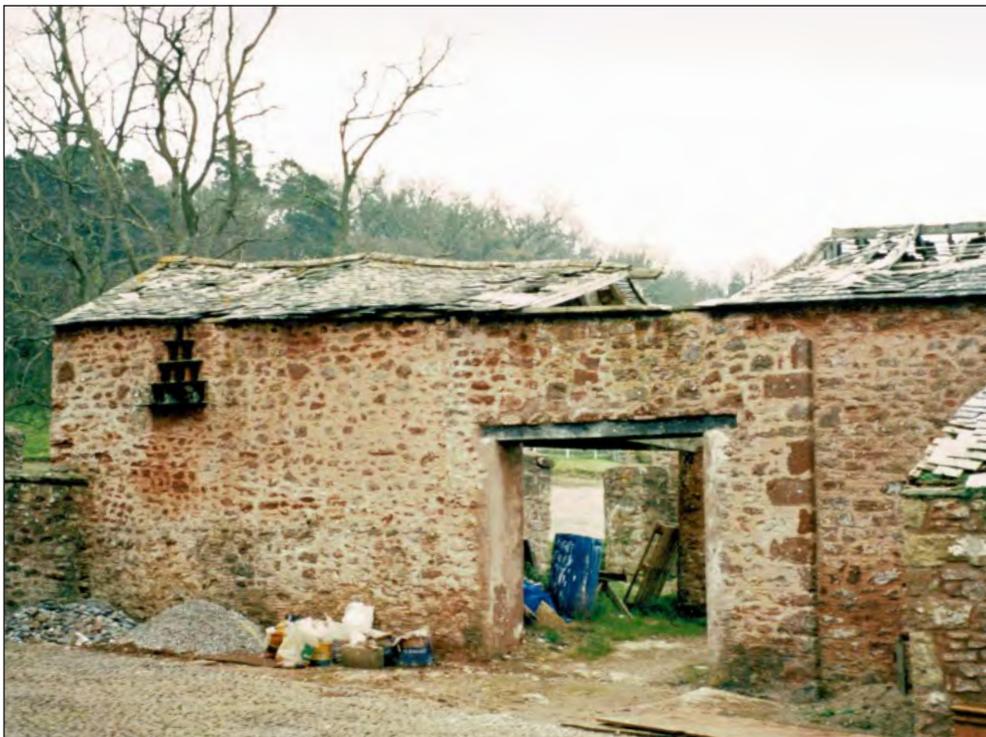
Pl. 10 General view of the former linhay prior to the demolition of the roof structure from the stable yard to the west. Looking northeast.

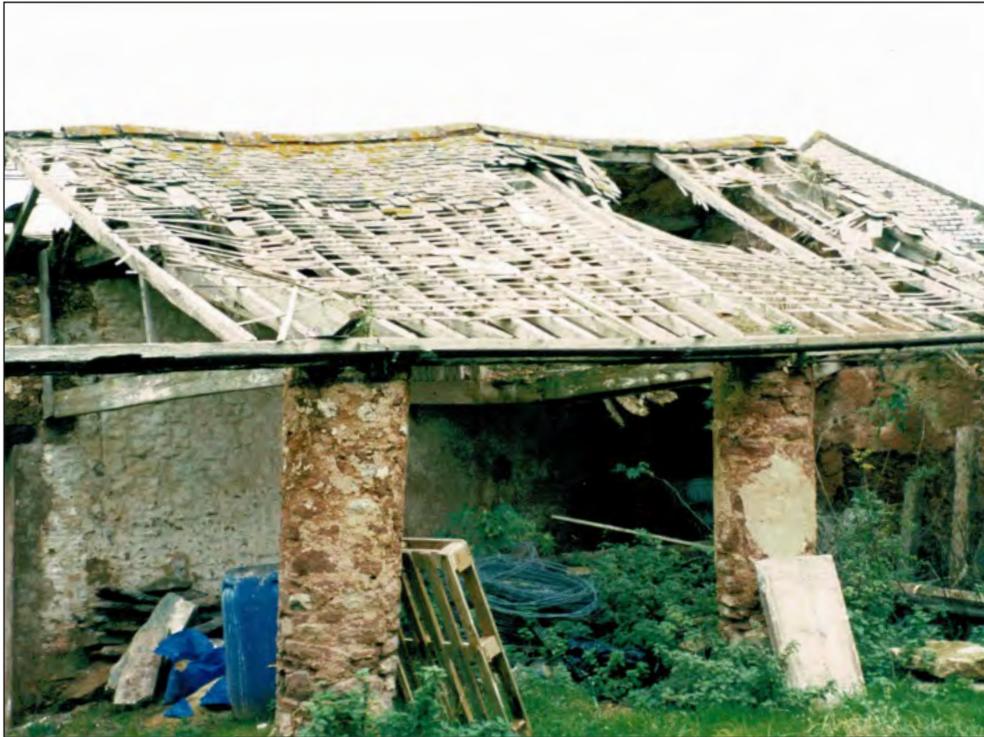
Pl. 11 General view of the north end of the former linhay prior to demolition showing the cylindrical piers and roof structure. Looking northwest.

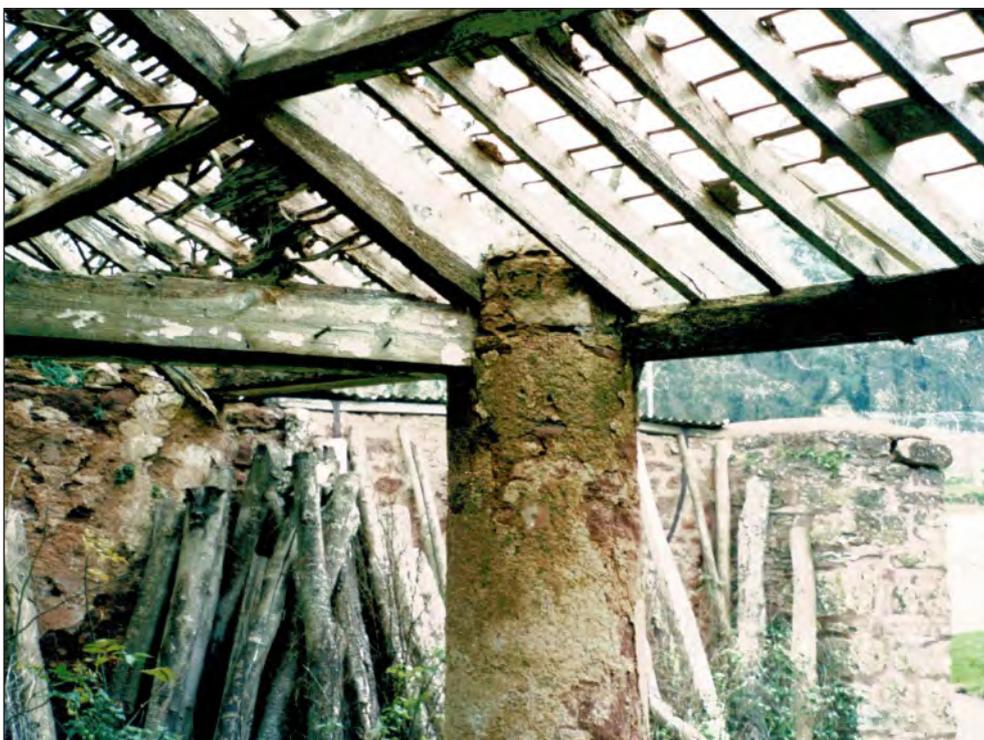
Pl. 12 Close-up of cylindrical pier showing details of the roof construction and tie-beam. Looking northeast.

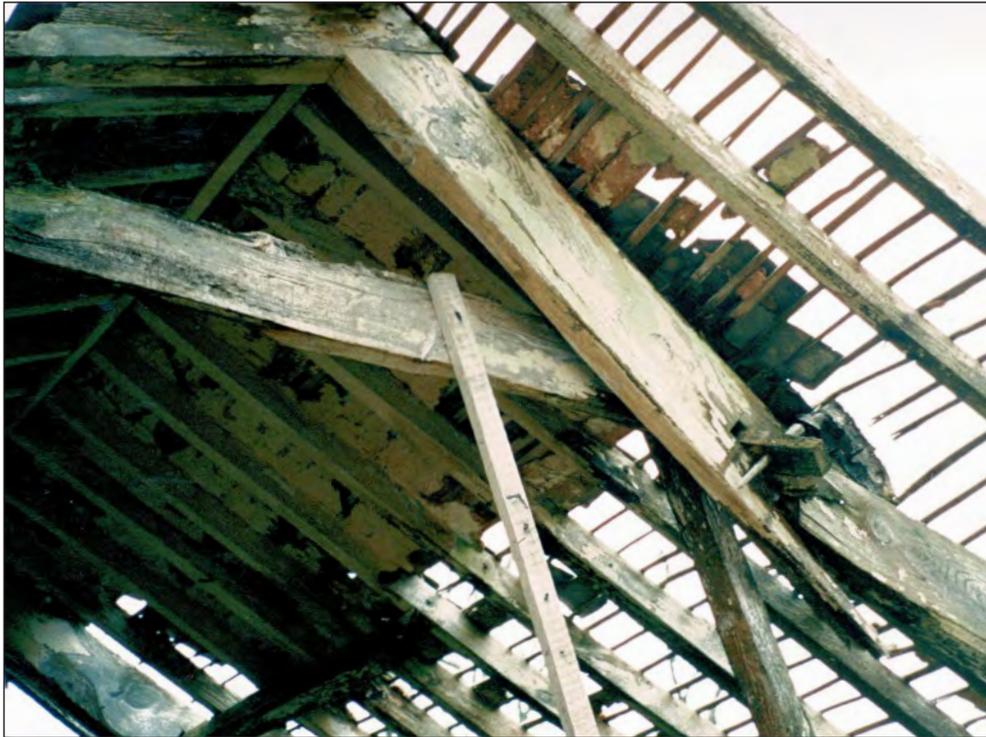
Pl. 13 General view of the roof structure showing possible evidence for torching between the rafters.

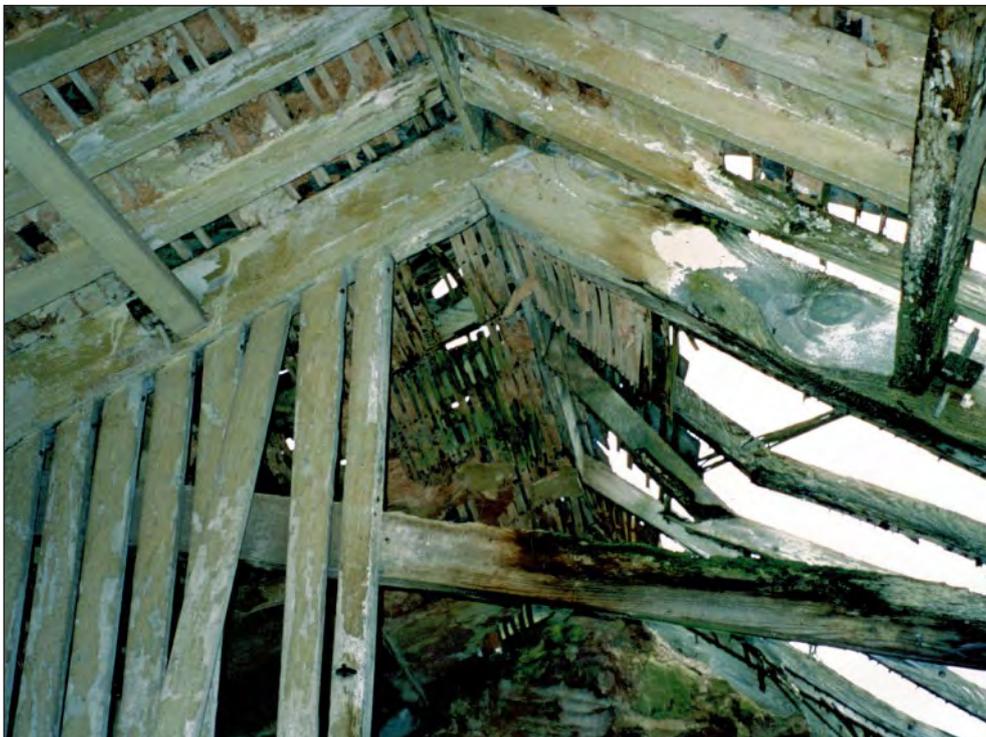
Pl. 14 General view of the roof structure at the southern end showing possible evidence for torching between the rafters. Looking northwest.

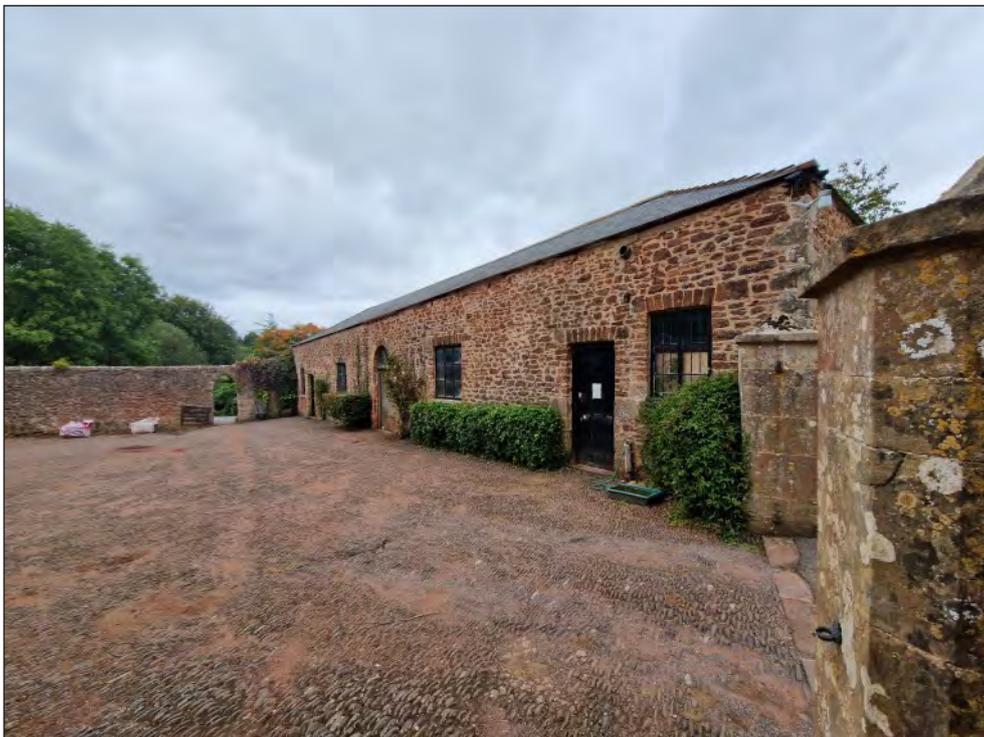
Pl. 18 General view of the stable with the fine cobbling of the yard visible in the foreground. 2m scale. Looking southwest.

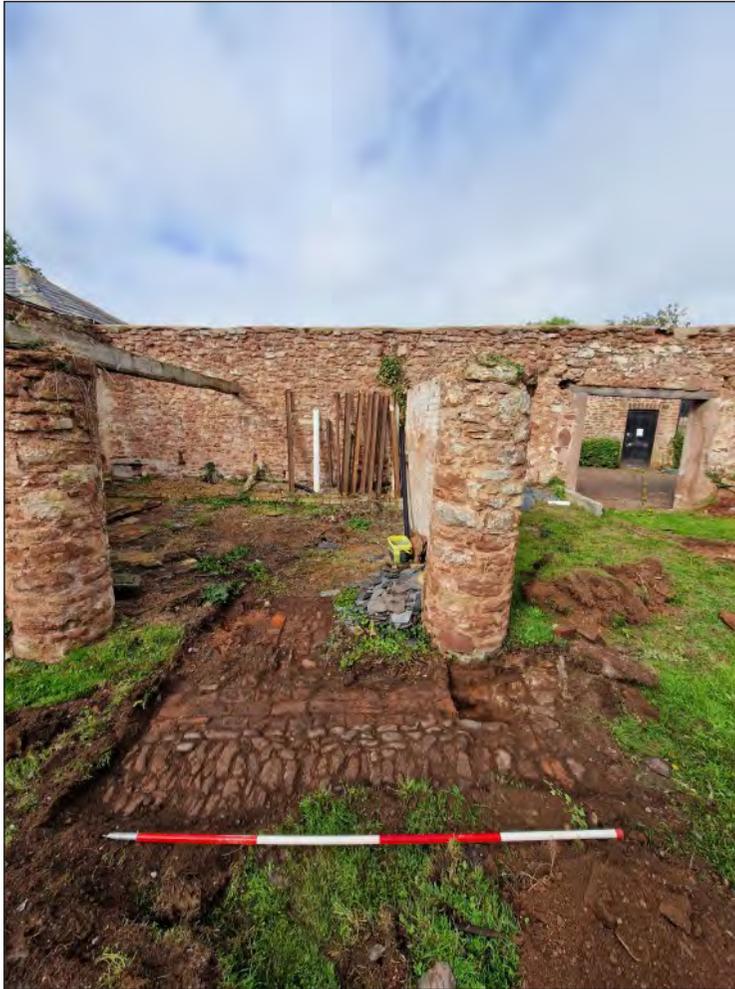
Pl. 23 General view of Trench 1 showing cobbled yard surface (103), brick drain (102) and cobbled surface (101). 2m scale. Looking northwest.

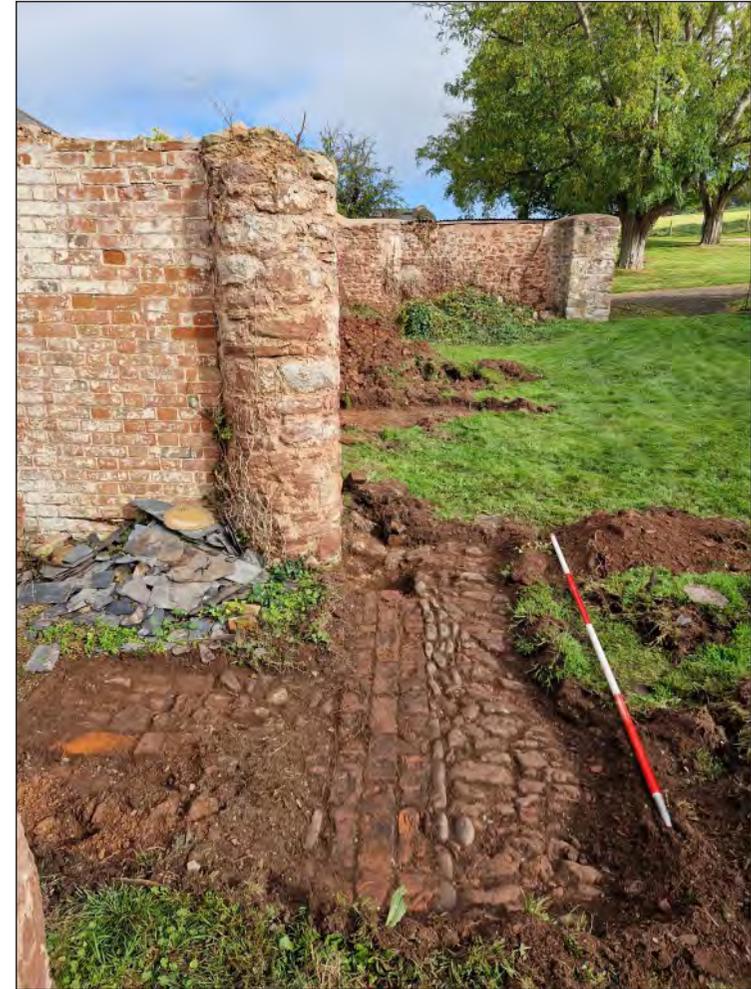
Pl. 24 General view of Trench 1 showing cobbled yard surface (103), brick drain (102) and cobbled surface (101). 2m scale. Looking northeast.

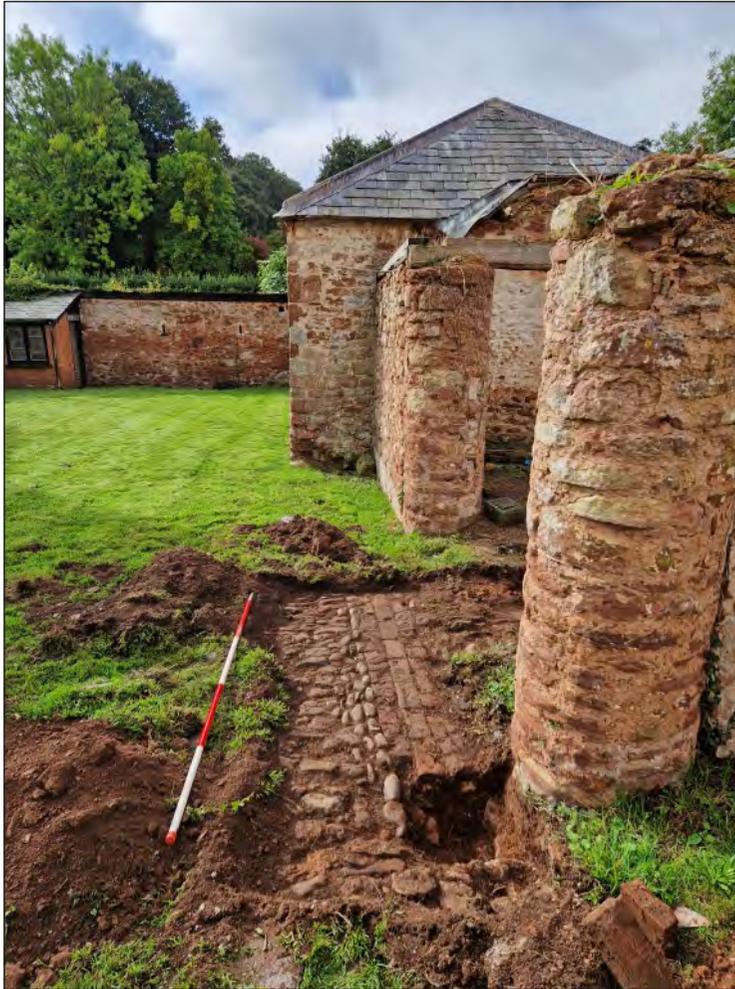
Pl. 25 General view of Trench 1 showing cobbled yard surface (103), brick drain (102) and cobbled surface (101). 2m scale. Looking southwest.

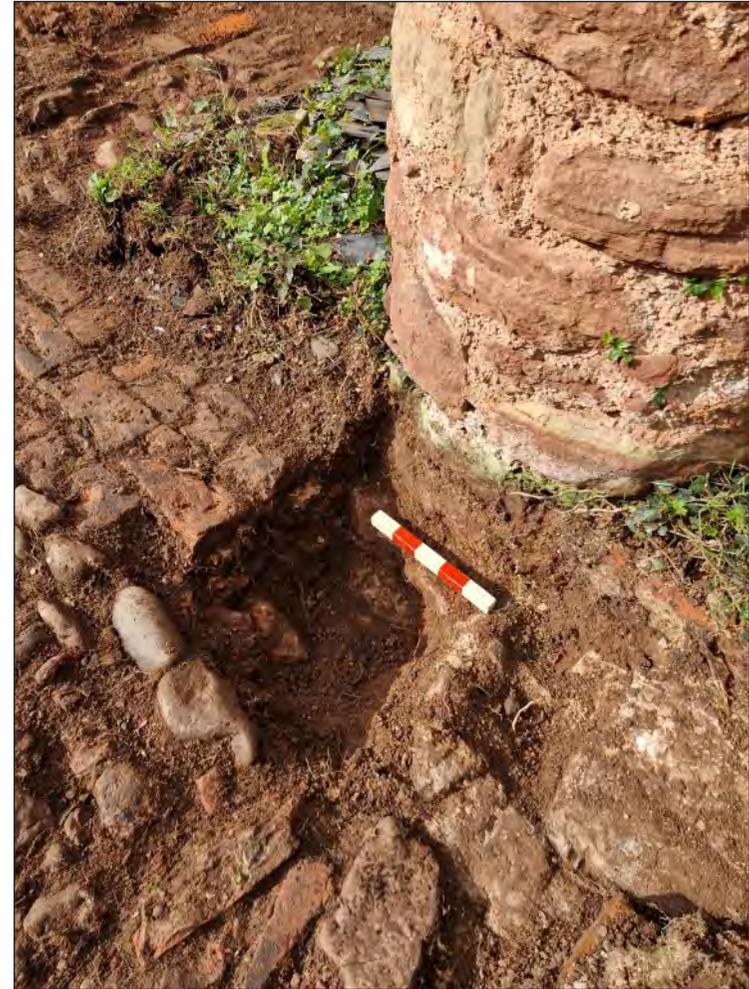
Pl. 26 Close-up of Trench 1 showing pier foundation (106). 0.25m scale. Looking southwest.

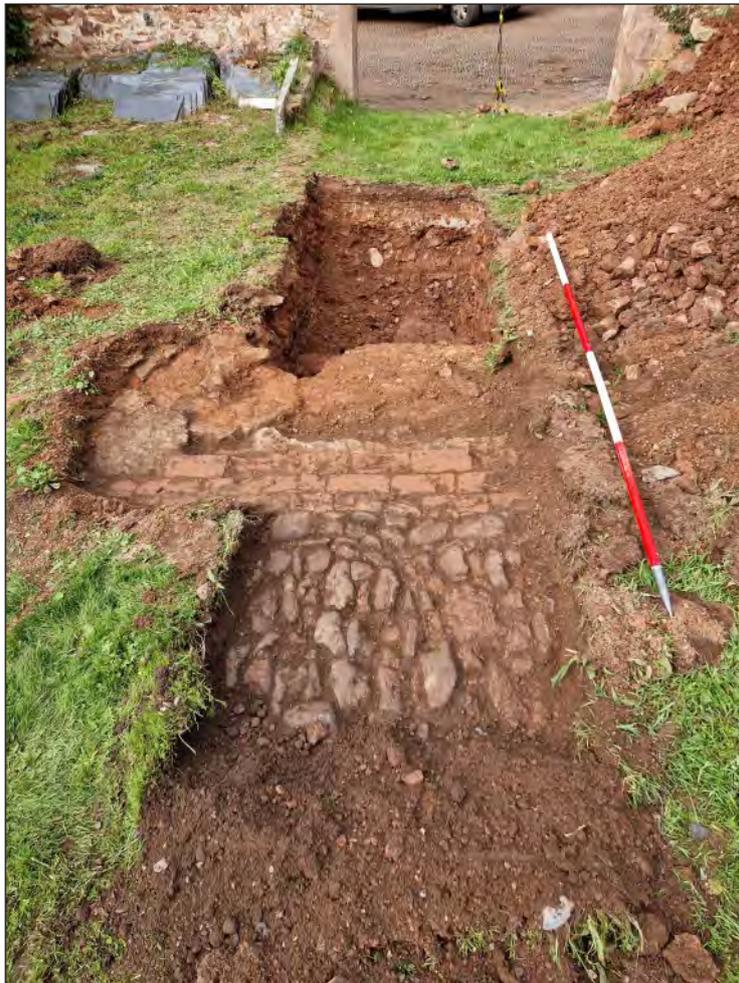
Pl. 27 General view of Trench 2 showing cobbled yard surface (206), brick drain (208), pier foundation (205) and concrete floor (209). 2m scale. Looking northwest.

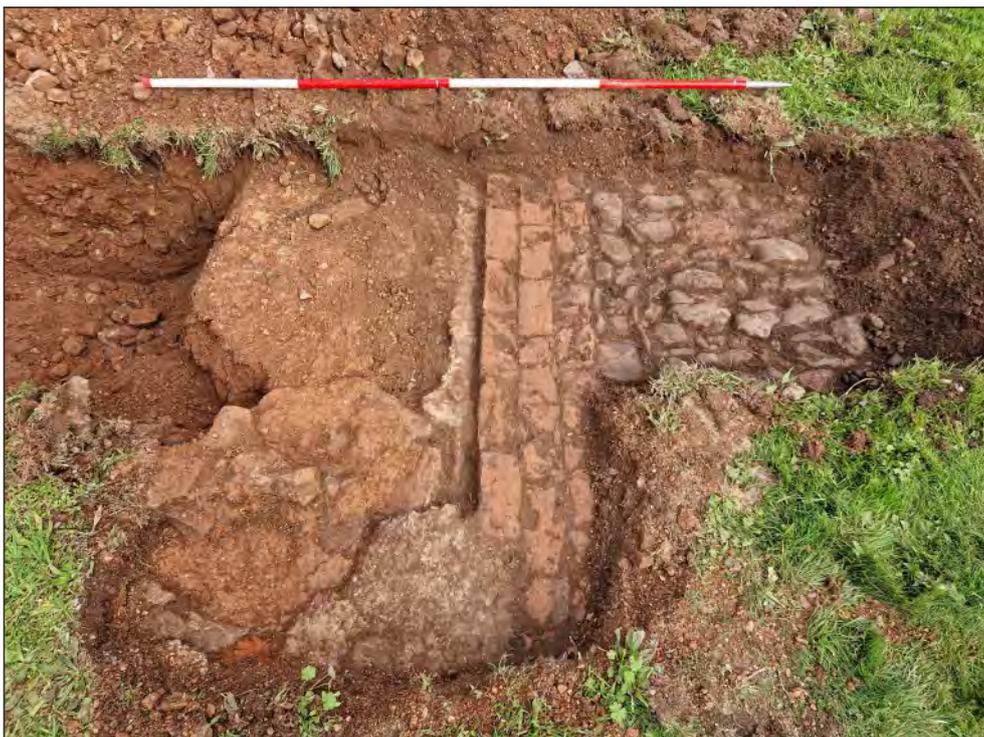
Pl. 28 General view of Trench 2 showing cobbled yard surface (206), brick drain (208), pier foundation (205) and concrete floor (209). 2m scale. Looking northeast.

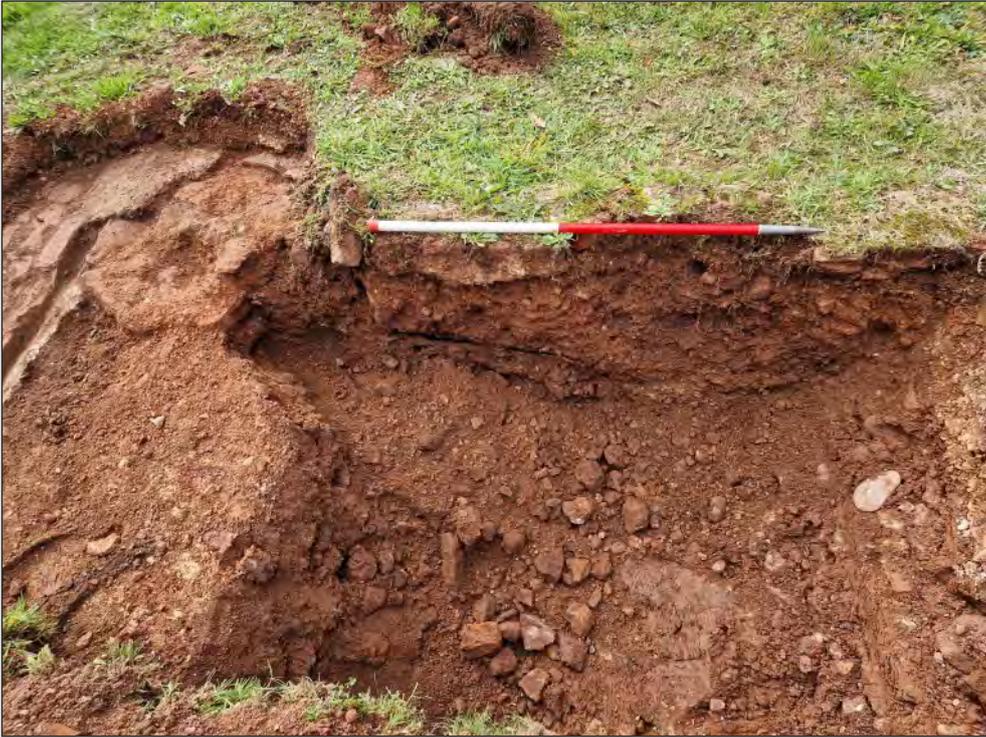
Pl. 29 General view of Trench 2 showing made ground (201) above colluvial subsoil (203). 1m scale. Looking southwest.

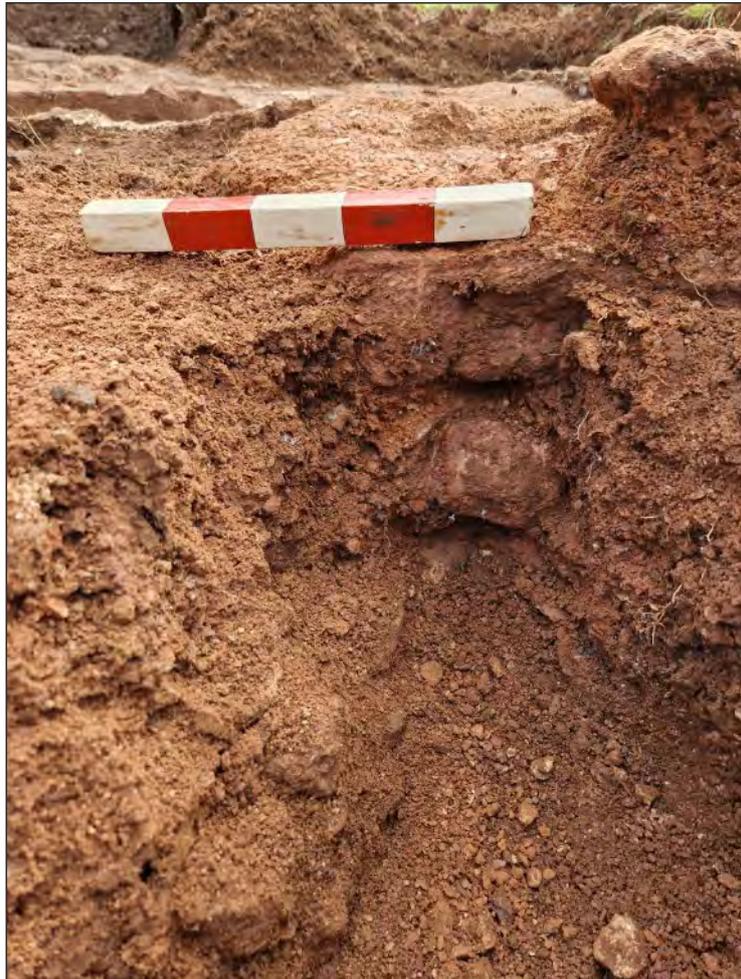
Pl. 30 Close-up of made ground (201) butting-up to pier foundation (205). 0.25m scale. Looking southeast.

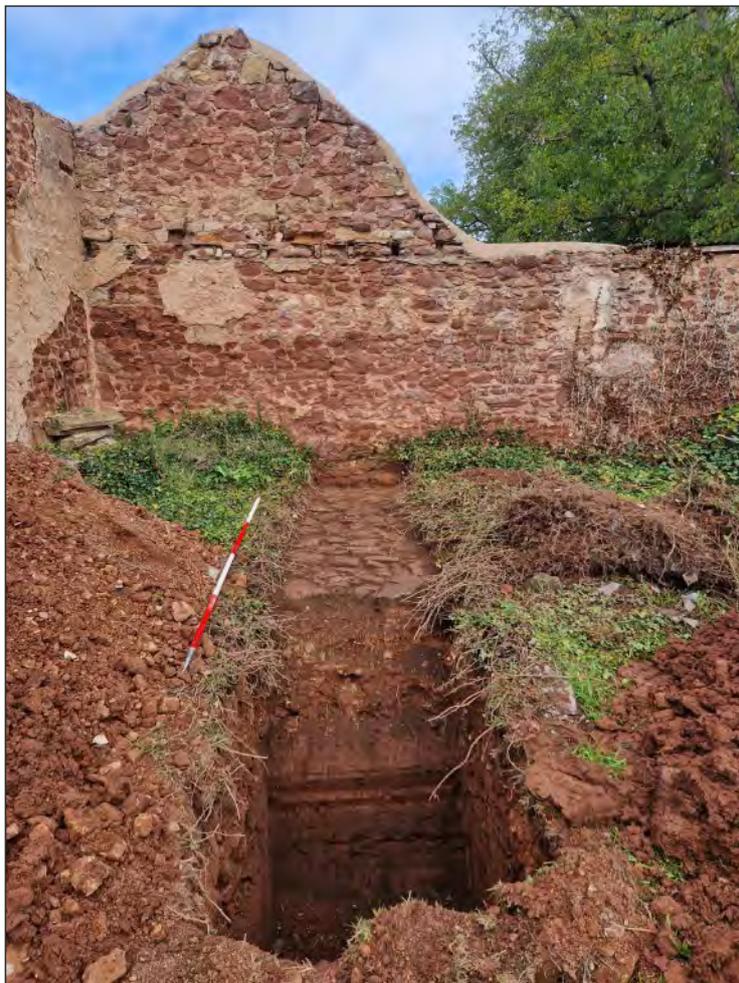
Pl. 31 General view of Trench 3 showing colluvial subsoil (304) in foreground and cobbled surface (301) in background. 2m scale. Looking northeast.

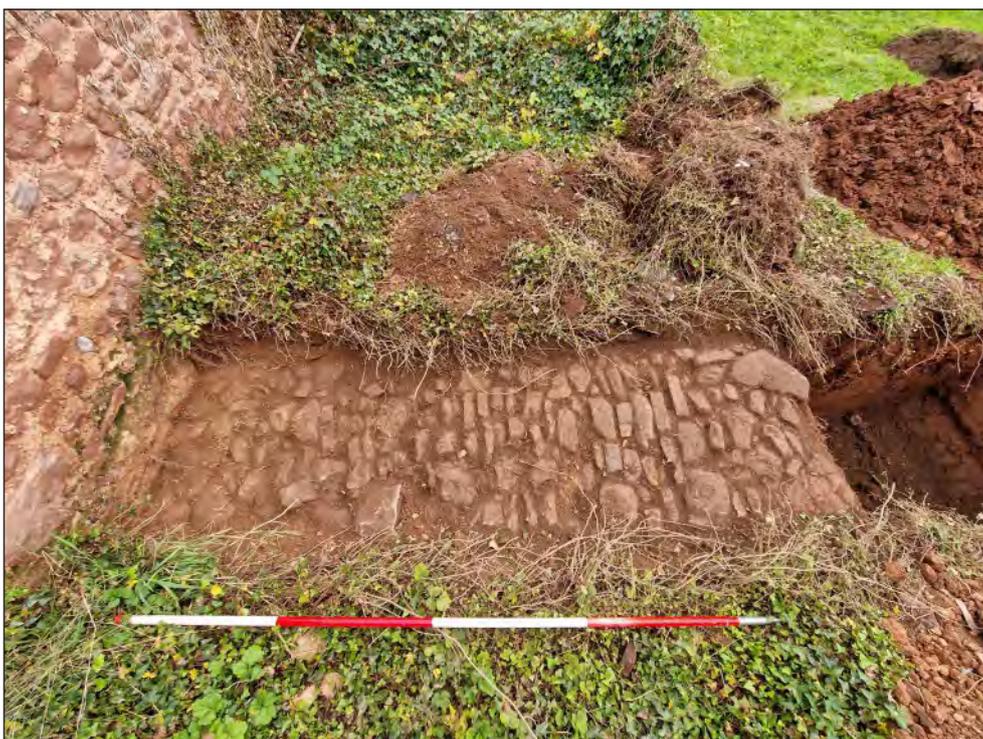
Pl. 32 Close-up of cobbled surface (301). 2m scale. Looking southeast.

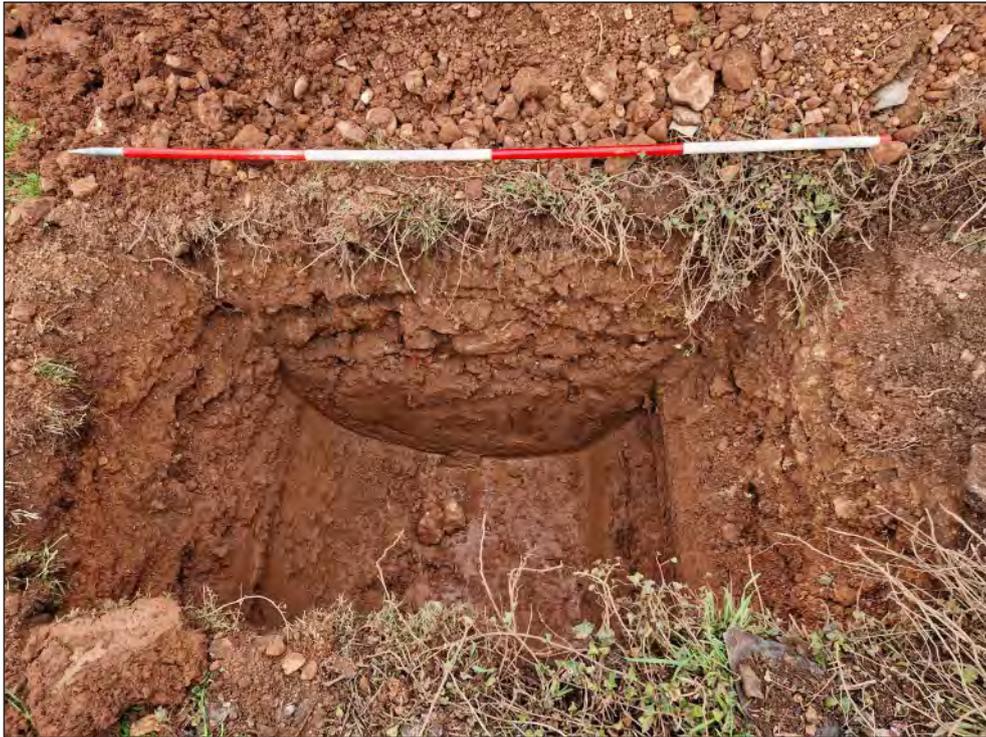
Pl. 33 Close-up showing colluvial subsoil (304) and overlying made ground (302). 2m scale. Looking northwest.
