## Historic building assessment at The Rose and Crown, Nether Stowey, Somerset

**Report No. 22-36**

**December 2022**

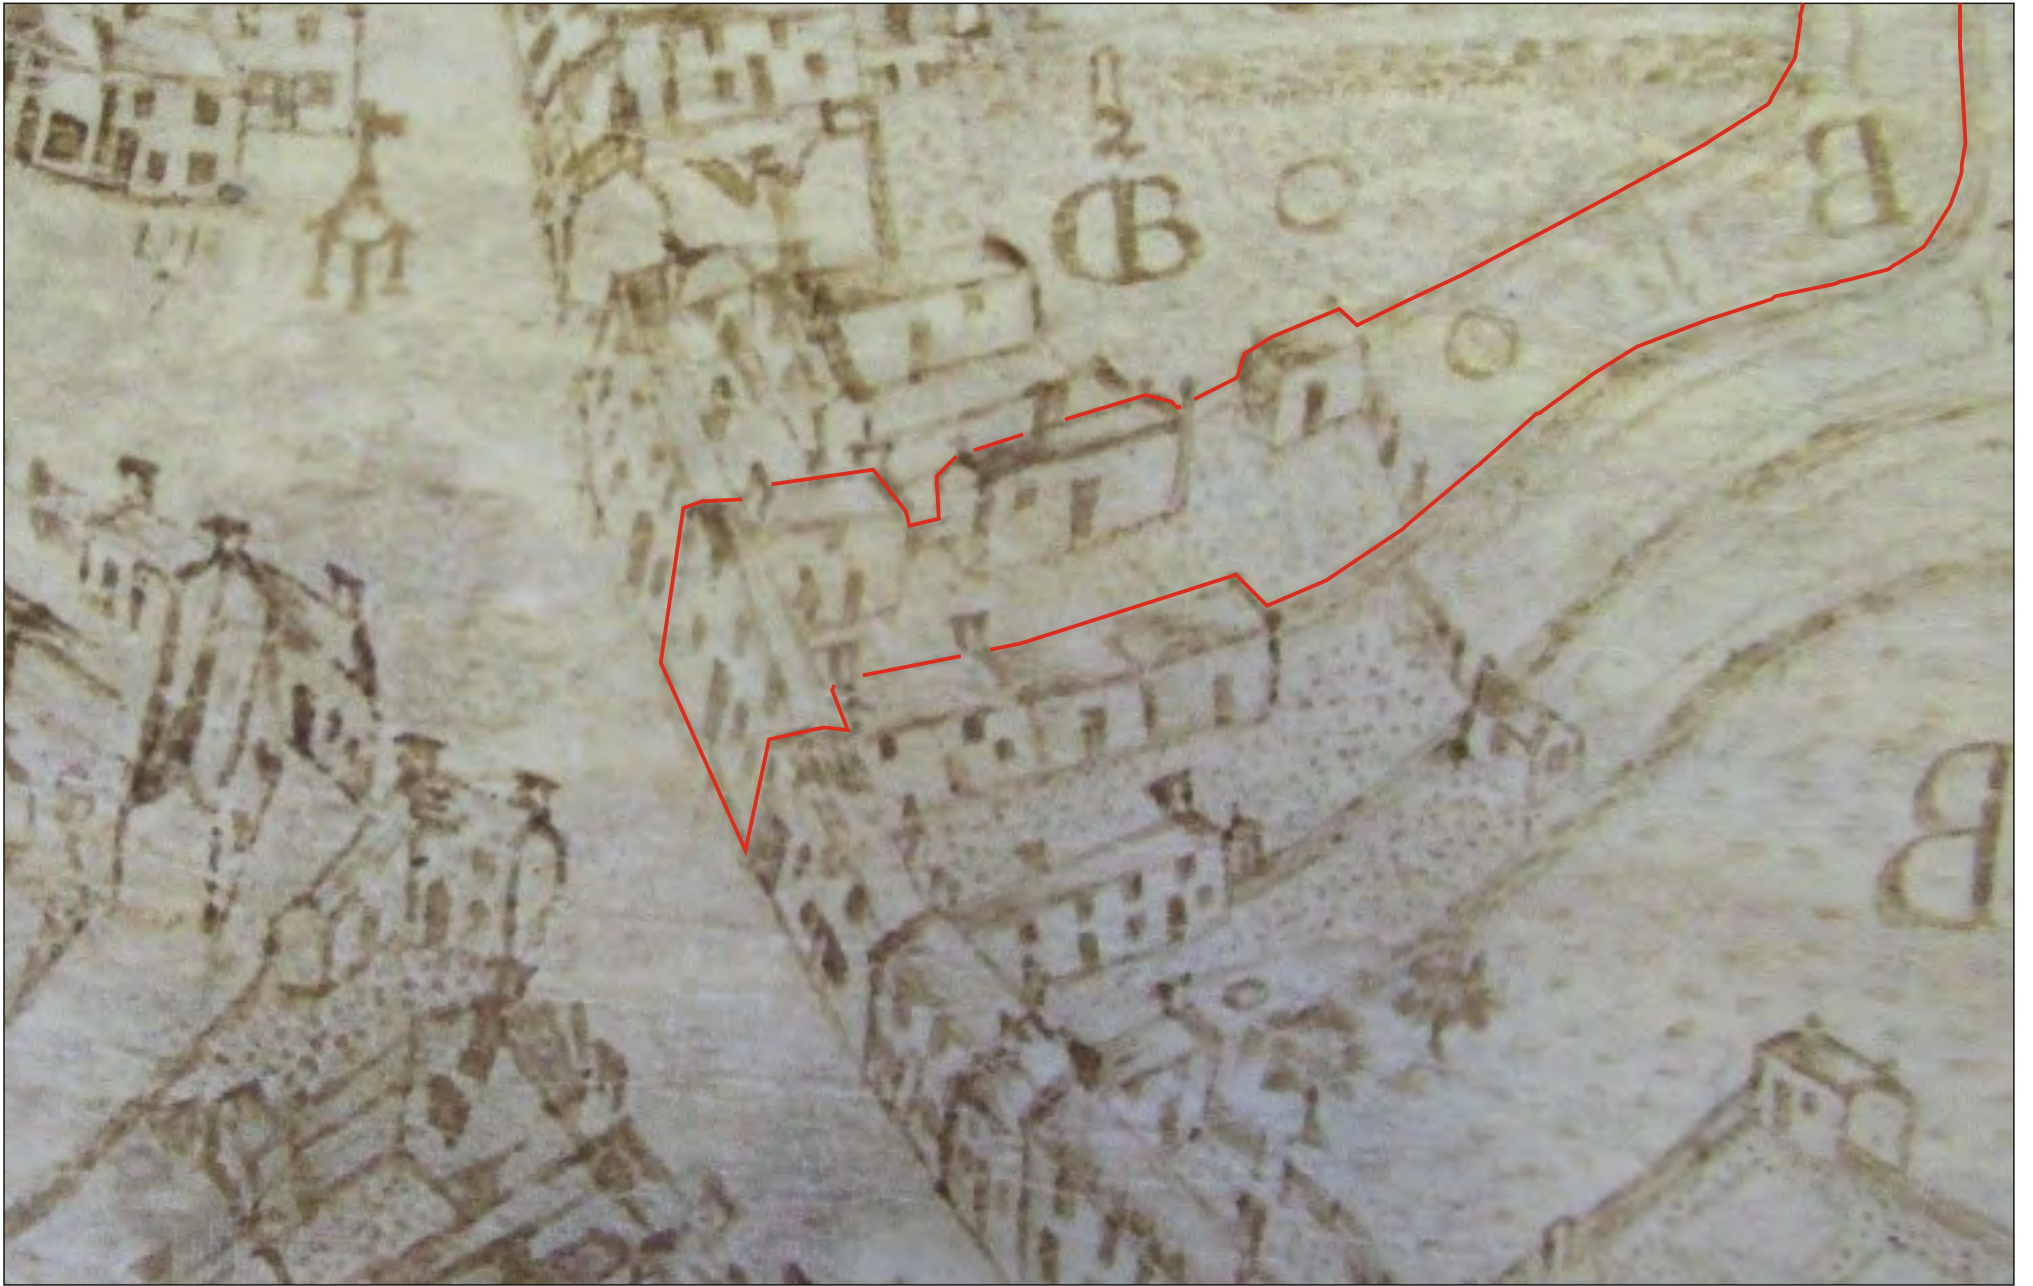
Fig. 3 Detail from the *c.*1775 Map of Nether Stowey by Thomas England.

The property was owned by Sarah Butler throughout the late 1760s, passing to her son Jenkins following her death in 1783. The site is shown in some detail on the c.1775 map (Fig. 3). The front range retains the earlier ground floor arrangement with a wide doorway flanked to the east and west by two and one windows respectively. However, only three windows are shown on the first floor, while the number of axial stacks on the north side of the range has been reduced to two. The projecting western range is shown in greater detail with a ground floor doorway and a single window above. Whether this is the same building as shown on the earlier map is unclear. To the north the western range is shown as a single building with a doorway providing access on the ground floor and a single window to the upper floor. It is unclear again whether this is a simplification of the range by the artist or represents alterations to the previously much larger range of buildings. Finally, a small rectangular structure is shown at the northern end of the yard, although unlike the earlier map this building is shown against the western boundary with the garden beyond. Jenkins Butler leased the inn to Mary Thorn until

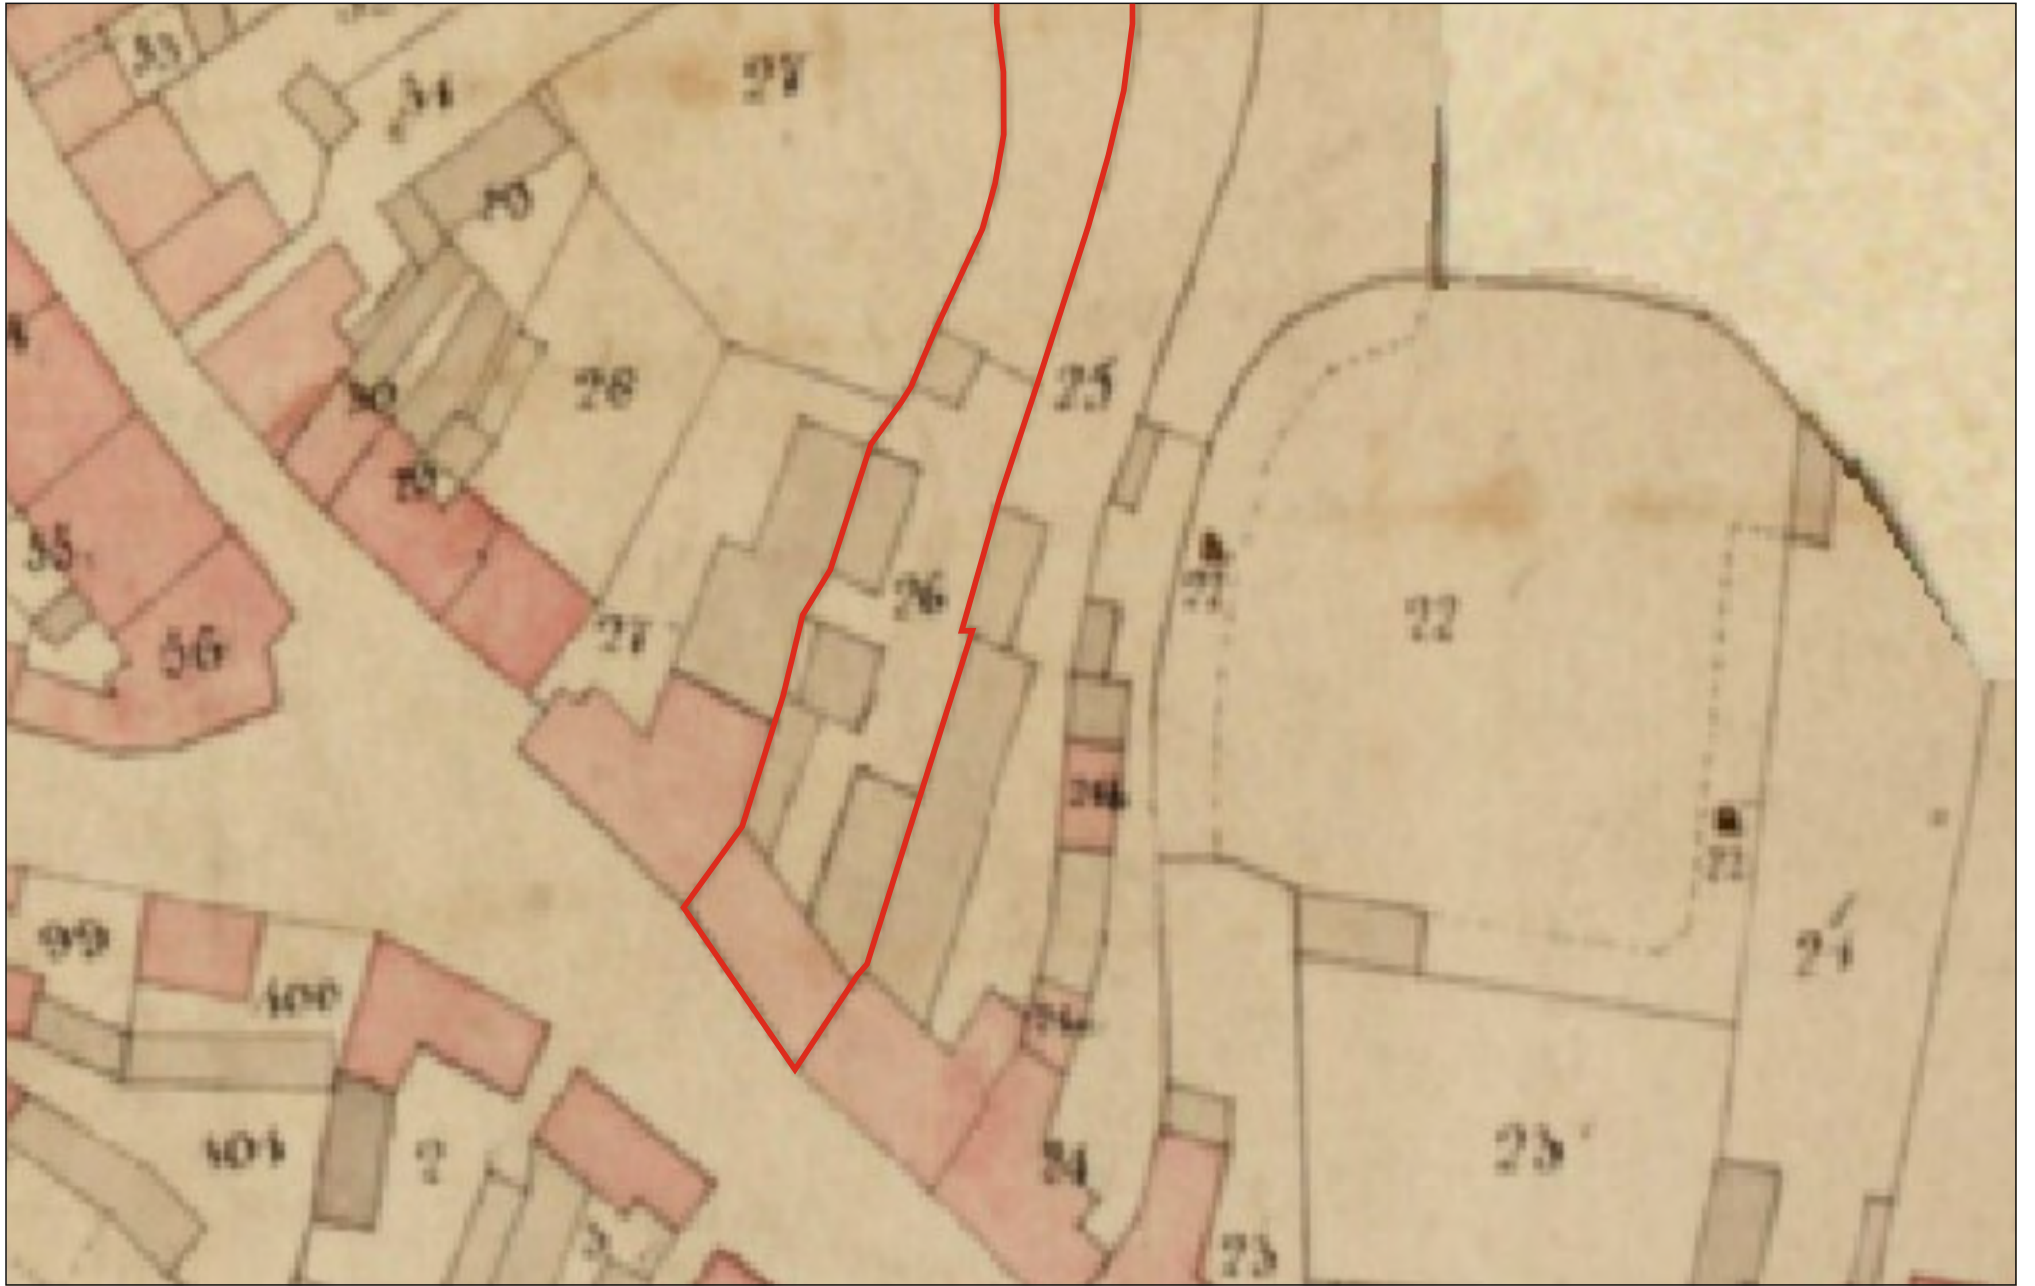
Fig. 4 Detail from the 1840 Nether Stowey Tithe Map.

The tithe survey of Nether Stowey took place in 1840 (Fig. 4), revealing that the property continued to be owned and occupied by William May.<sup>23</sup> The map clearly shows the large front range and the substantial eastern range. On the western side of the plot a narrow range extends along the boundary with a roughly square building at its northern end projecting into the central passage. A short distance to the north is a small rectangular range, with a further small square building immediately to the north. William and his wife Charlotte are listed in the 1841 census, along with 15-year-old Robert Jesty, 5-year-old Frances Hext and 20-year-old Martha Thomas. In 1851 the *Rose and Crown* was still occupied by William and Charlotte, as well as Frances Hext, now listed as a barmaid, 13-year-old Louisa Longman, listed as a visitor, and the 17-year-old servant Mary Ann Naylor.

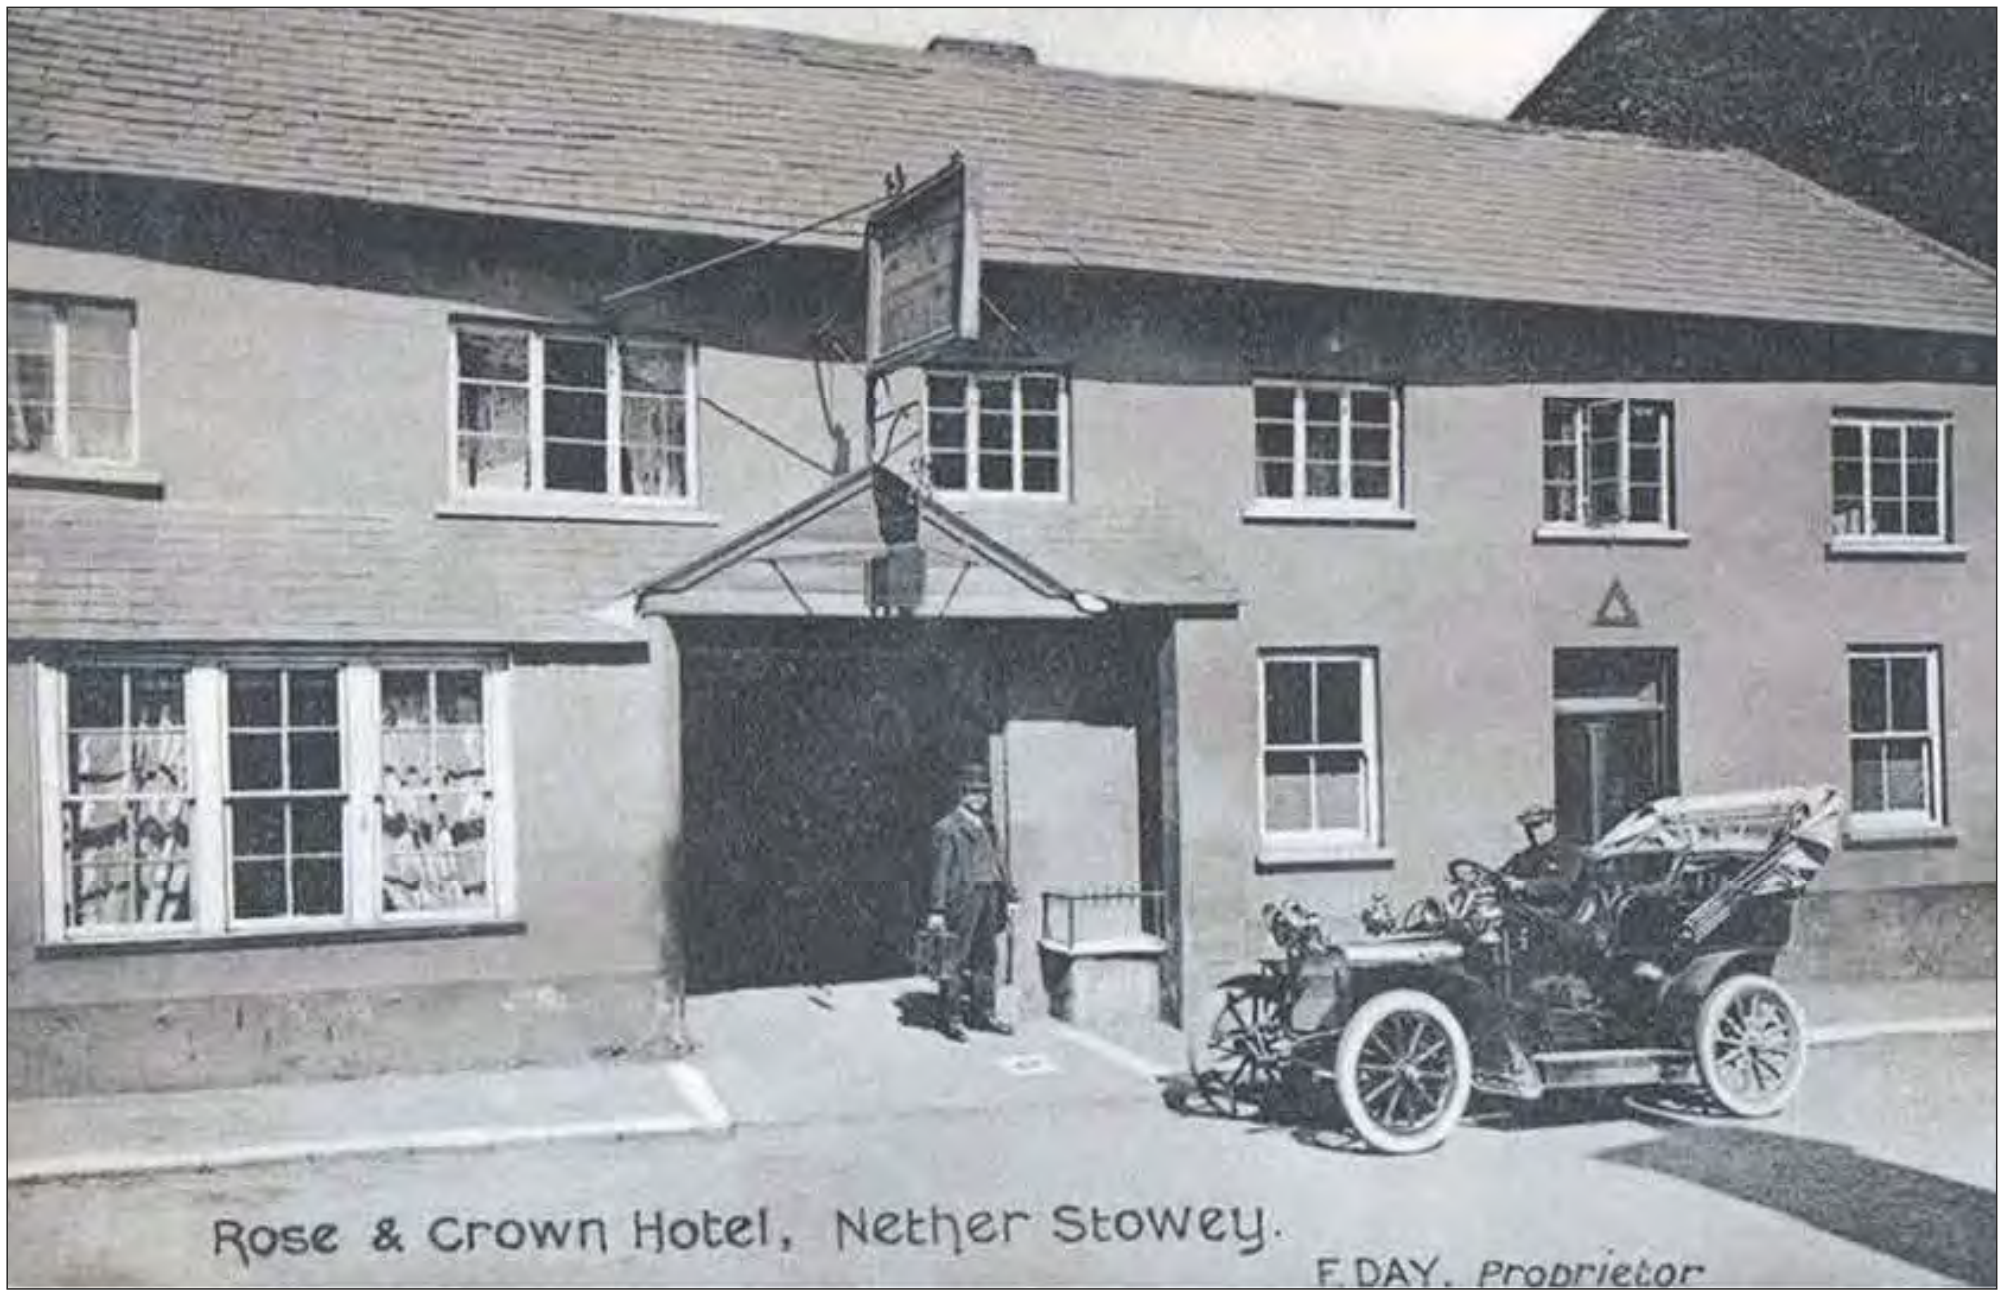
Fig. 7 Early 20th century photograph of the Rose and Crown Hotel.

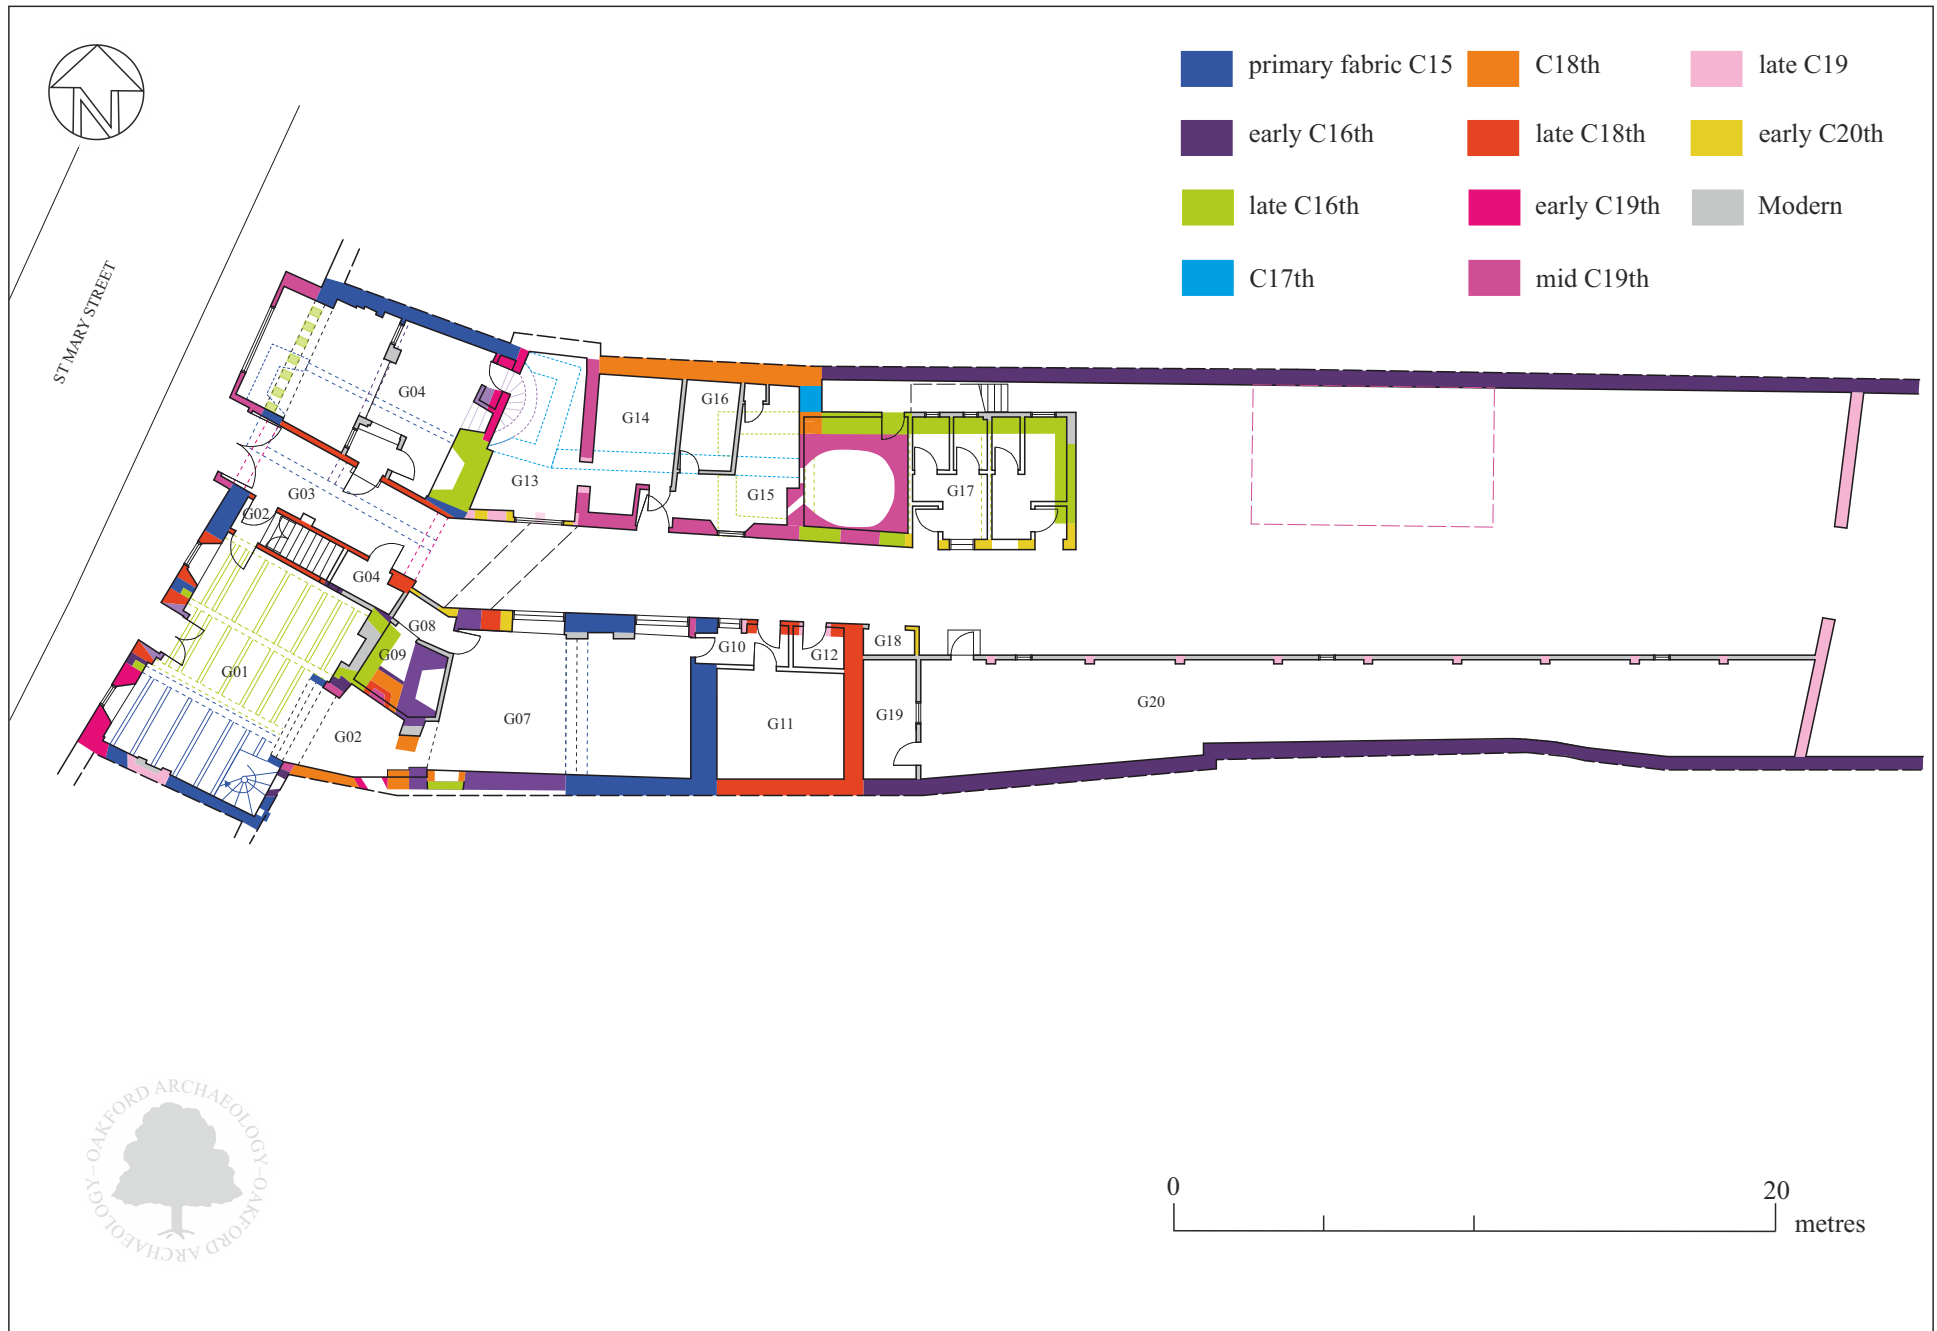
Fig. 8 Plan of ground-floor showing location of observations and suggested phases of development.

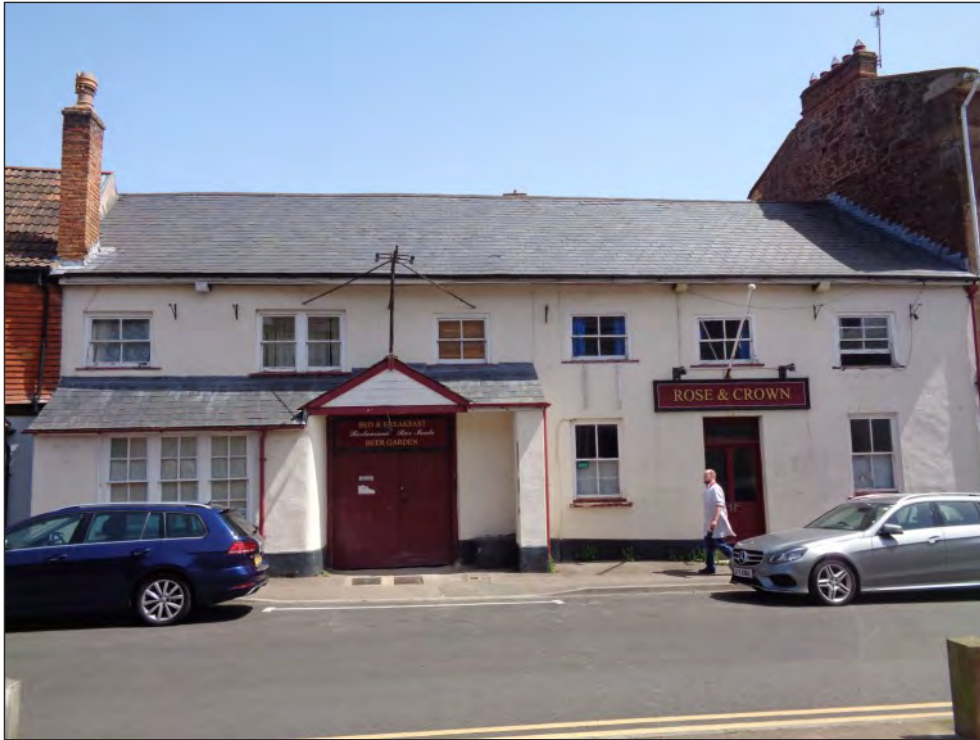
Pl. 1 General view of the south range of the Rose and Crown. Looking northeast.

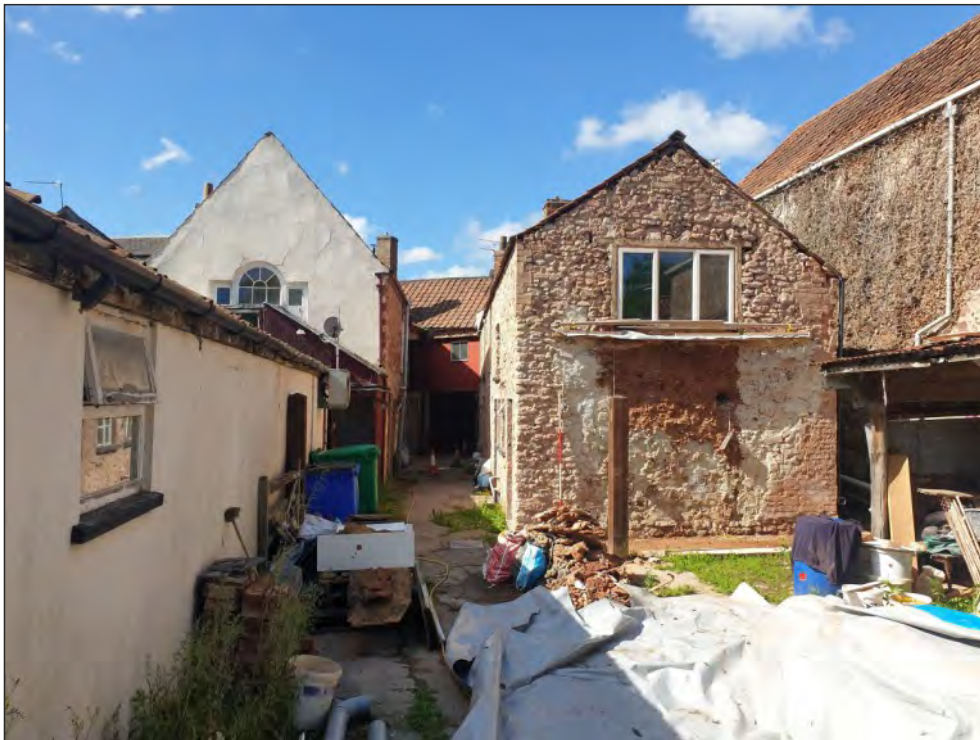
Pl. 2 General view of the rear ranges with the carriageway through the south range of the building in the centre. 2m scale. Looking southwest.

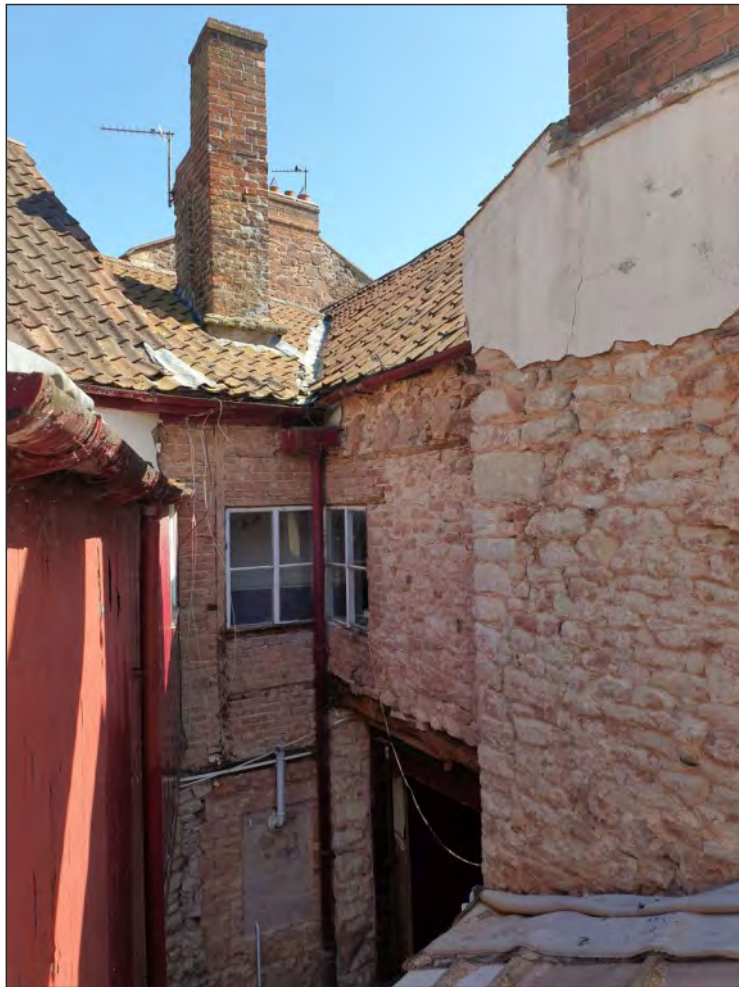
Pl. 3 General view of the rear elevation of the south range showing raised wall level. Looking southeast.

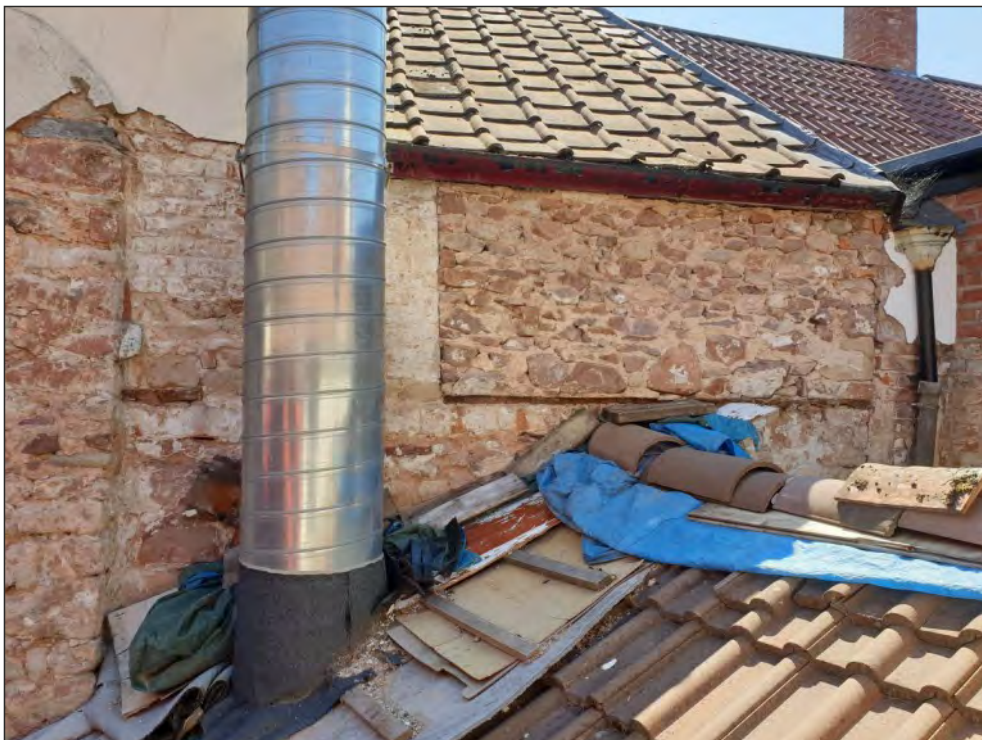
Pl. 4 General view of blocked window (right) and coping stone on west side of chimneystack (centre left). Looking southwest.

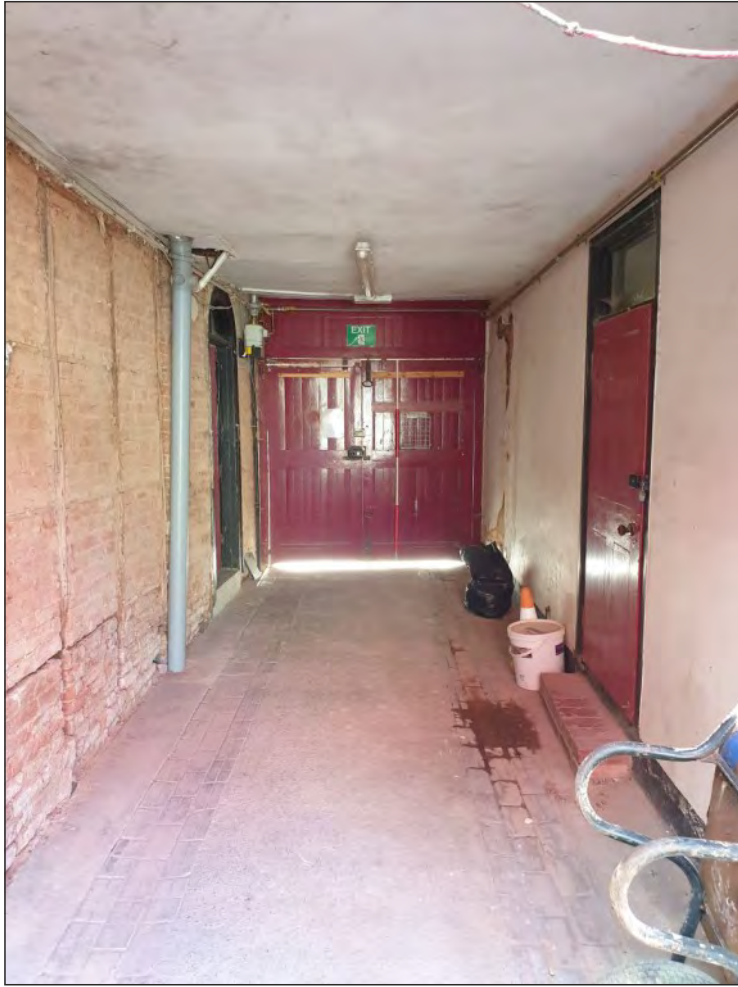
Pl. 5 General view of the carriageway through the south range of the building with the 19th- or early 20th-century double doors at its south end. 2m scale. Looking southwest.

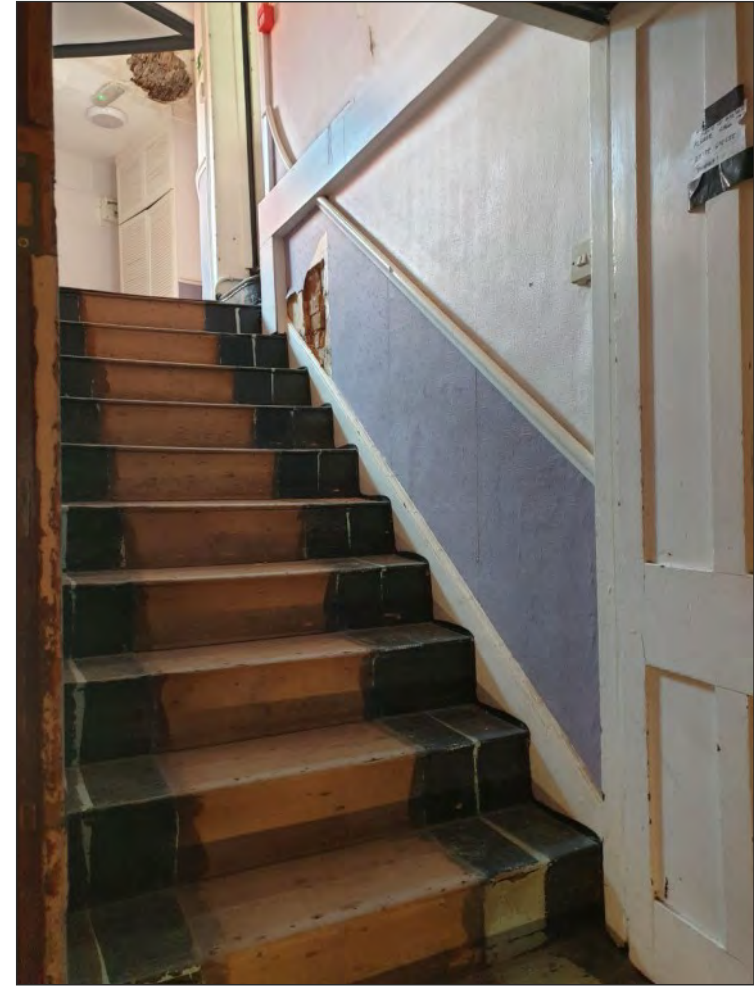
Pl. 6 General view of the main staircase. Looking northeast.

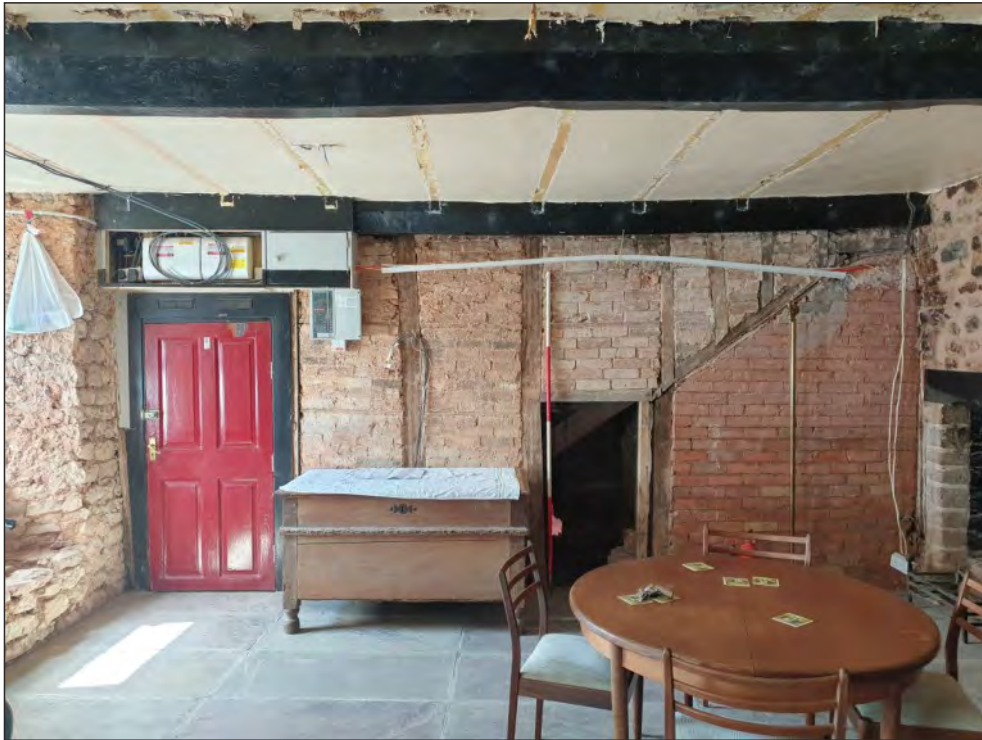
Pl. 7 General view of northwestern timber studwork late 18<sup>th</sup>- or early 19<sup>th</sup>-century partition showing position of former medieval partition (centre) and blocked doorway (right). 2m scale. Looking northwest.

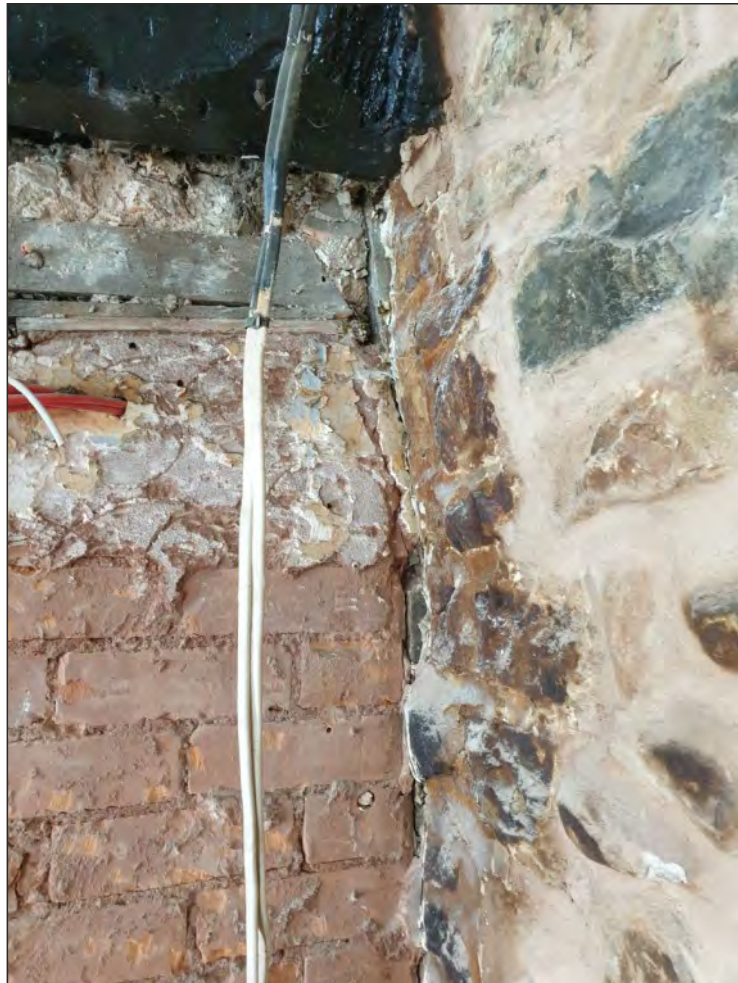
Pl. 8 Close-up of vertical post headed with a 'gunstock' shouldered mortice and tenon joint and two peg-holes. Looking northwest.

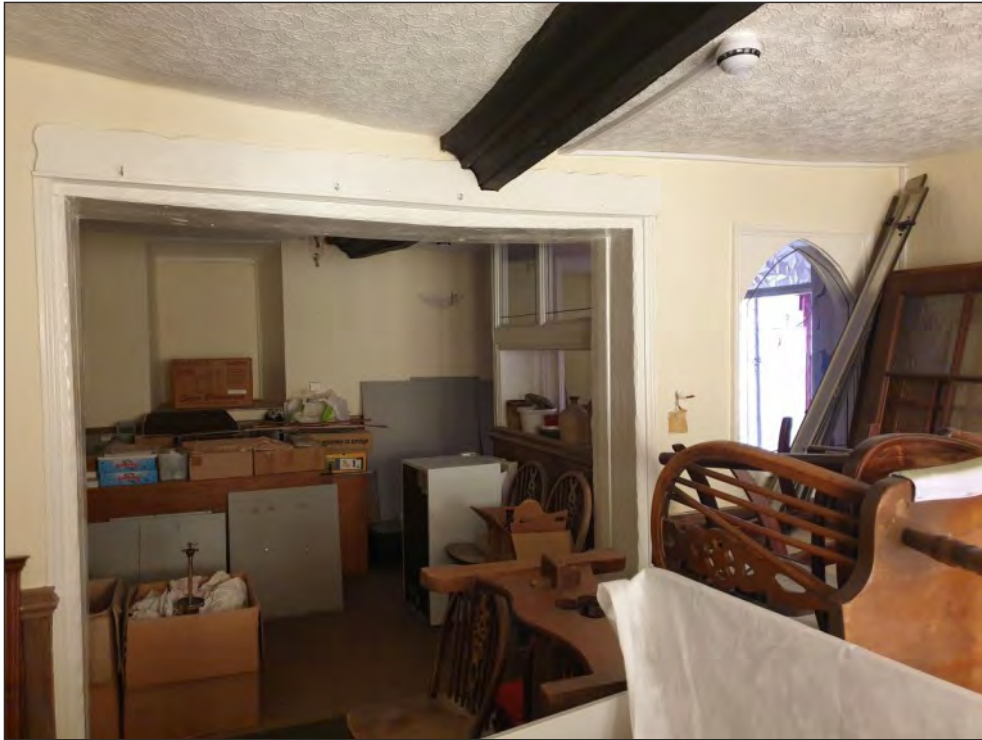
Pl. 9 General view of the western room (G05) divided by a central spine wall containing a flat arch and a 'gothick' arch, and by a subsidiary screen forming a glazed porch within the door to the carriageway. Looking northeast.

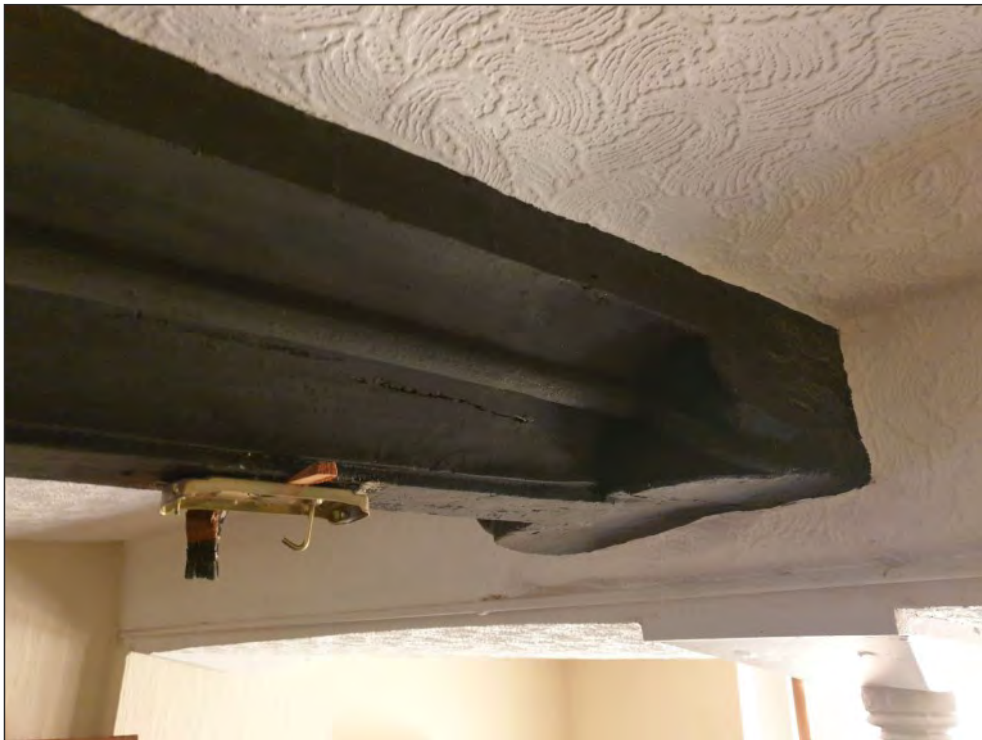
Pl. 10 Close-up of the ceiling beam showing deep hollows and a central moulded fillet on each side. The stops at the south end of the beam are convex run-out stops of a type typical of the early 16<sup>th</sup> century. Looking south.

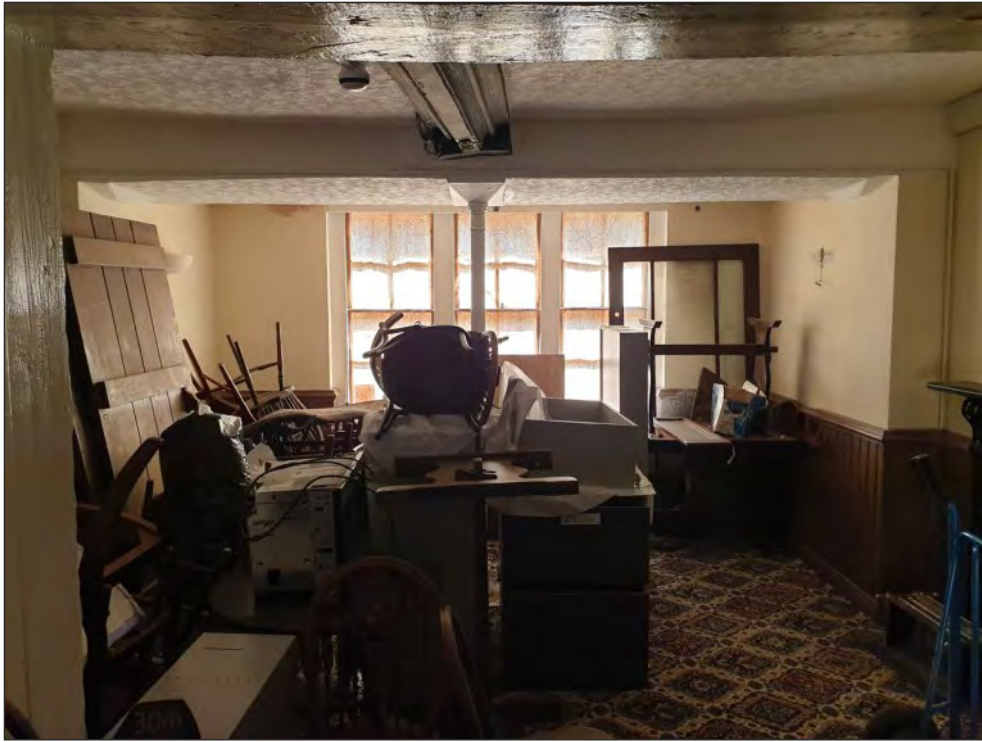
The south wall has been removed almost in its entirety and is now supported by a row of three cast-iron columns to allow the creation of a wide bay window on the street frontage (Pl. 11). The present bay is of 18<sup>th</sup> or 19<sup>th</sup> century date, with later fenestration, but may replace a long 16<sup>th</sup> or 17<sup>th</sup> century mullioned window, or an earlier bay window of the type still surviving at Nos. 10-14 High Street, Dunster, also a former inn. This bay may have superseded a lateral chimney stack, as suggested above.

Pl. 11 General view of row of three cast-iron columns with wide bay window in the background. Looking southwest.

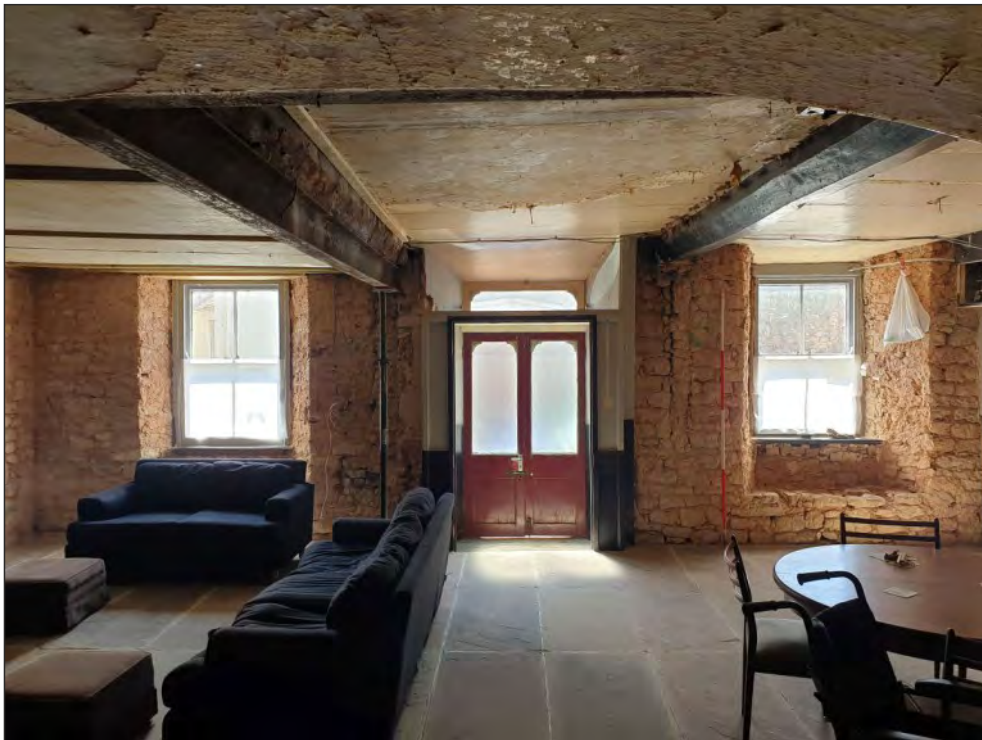
Pl. 12 General view of the south elevation of room G01 showing the remains of the infilled cruck chases. 2m scale. Looking south.

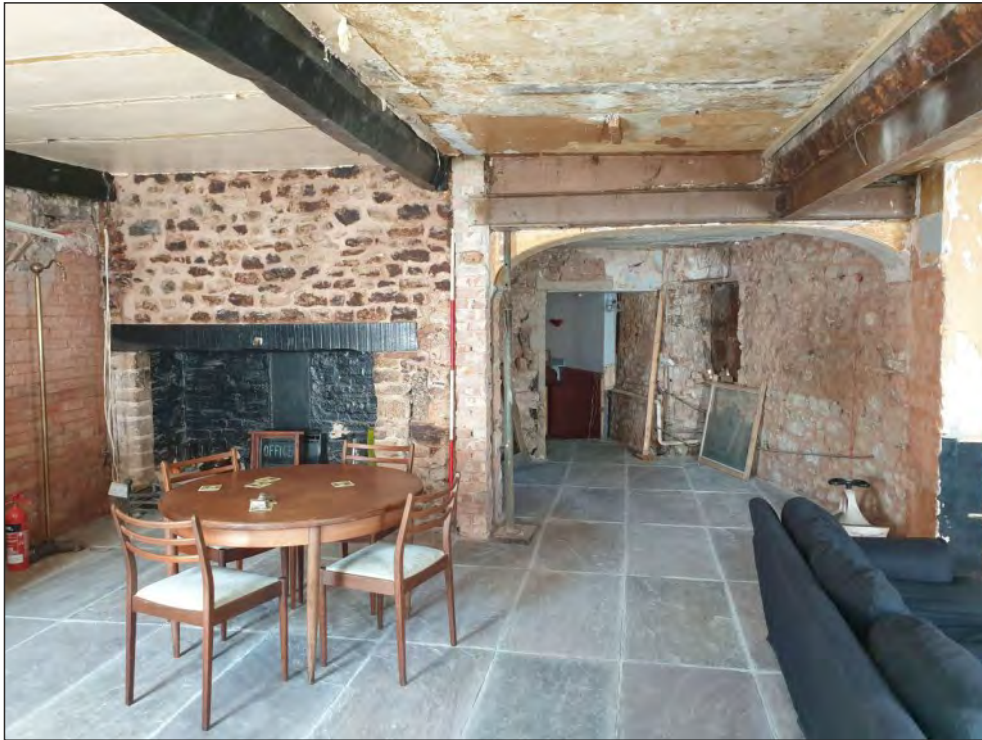
In the north wall of the room (Pl. 13) is a large fireplace. Unfortunately, this has been much rebuilt and the current clavel or lintel is a replacement. Its position immediately within the former doorway in the screen to the trunche shows that it is likely to be a later alteration. Like the corresponding chimneystack to the west, it may have been inserted to replace a lateral stack in the opposite wall, or it may have replaced a central open hearth when the hall was ceiled over. The ceiling beams have broad, plain chamfers which retain mutilated stops of the type characterised by various writers as ‘Geometric’<sup>29</sup> and generally assumed to be typical of the 17<sup>th</sup> century. The joists are obscured by modern plaster. It is possible that the chimney and the ceiling beams of this part of the building are contemporary.

Pl. 13 General view of heavily rebuilt fireplace in north elevation of room G01, with wide archway into the adjacent trapezoidal room G06 to the right. 2m scale. Looking northeast.

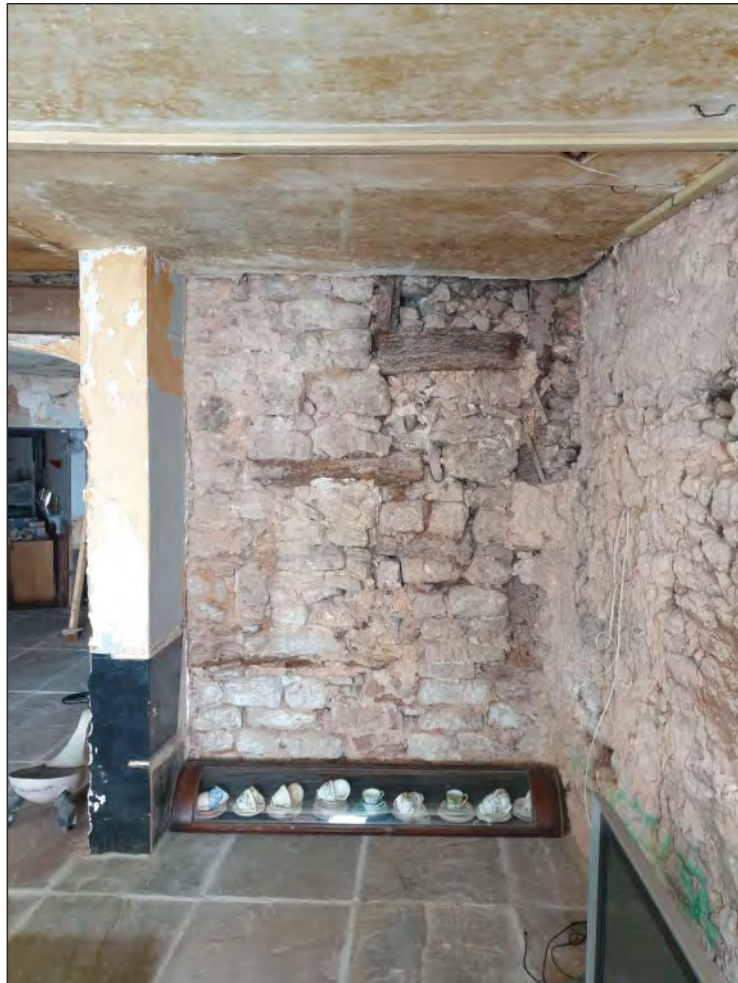
Pl. 14 General view of two small window embrasures rising with a former corner stair. Looking northeast.

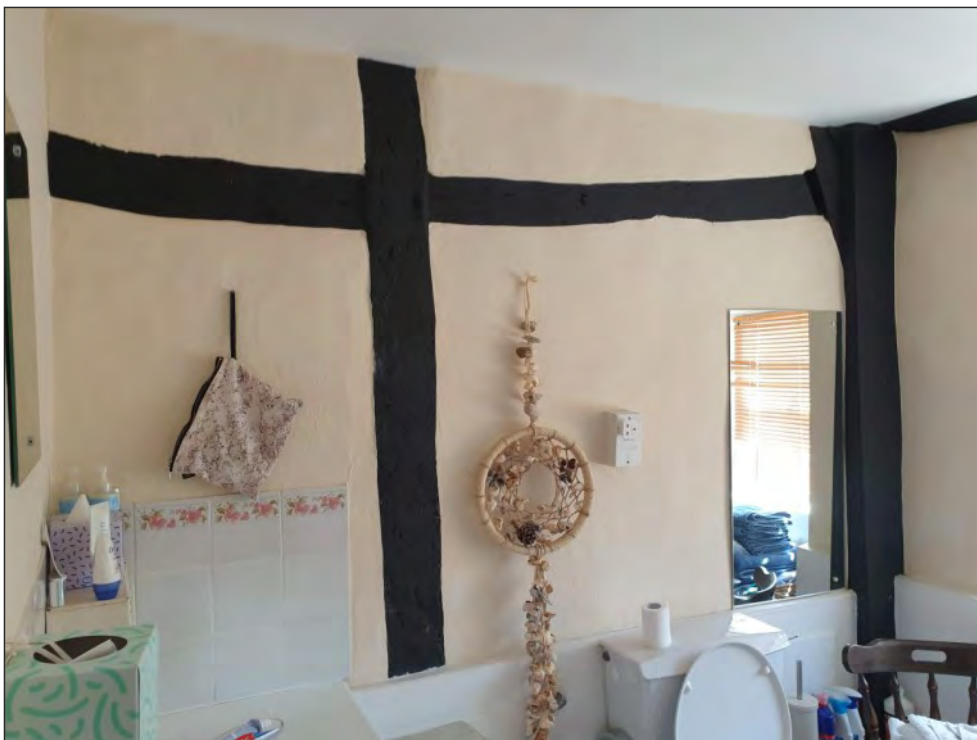
Pl. 15 General view of the full height timber and plaster partition on the east side of room F19. Looking south.
