## Historic building assessment at The Rose and Crown, Nether Stowey, Somerset

**Report No. 22-36**

**December 2022**

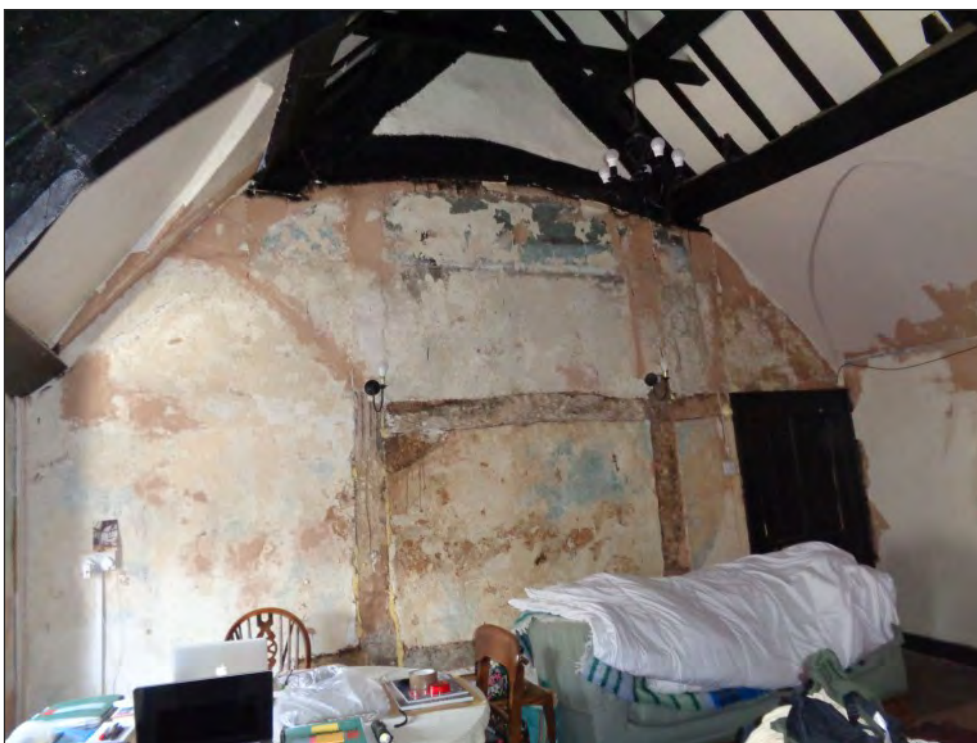
Pl. 16 General view of the full height timber and plaster partition on the west side of room F02. Looking northwest.

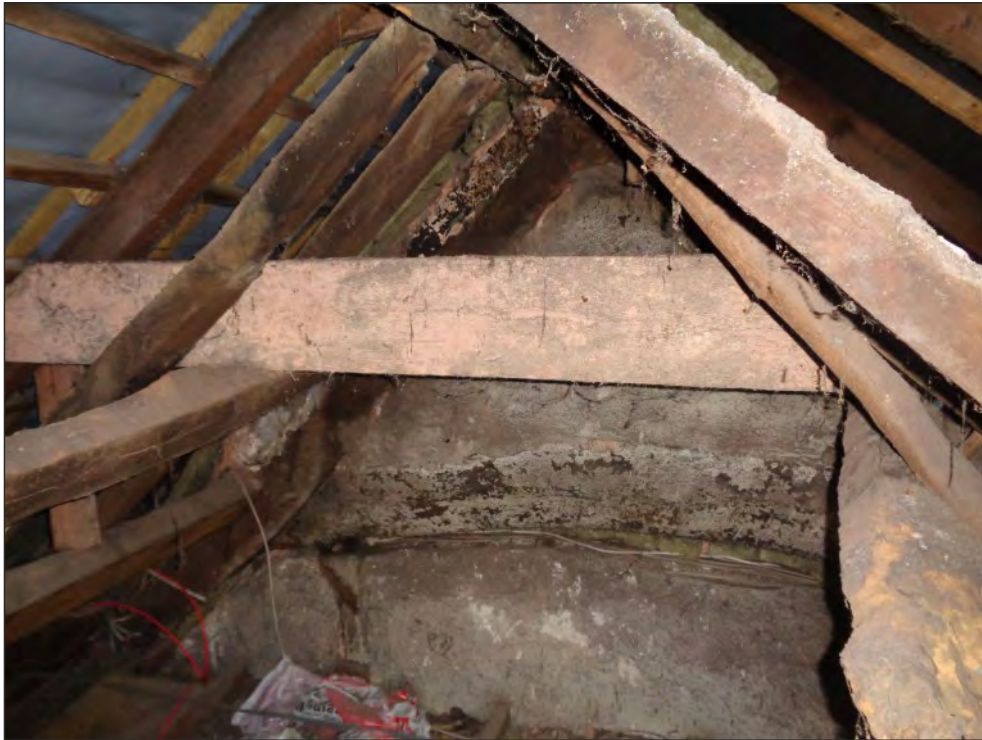
Pl. 17 Close-up of high-level cranked collar without arch bracing. Looking southeast.

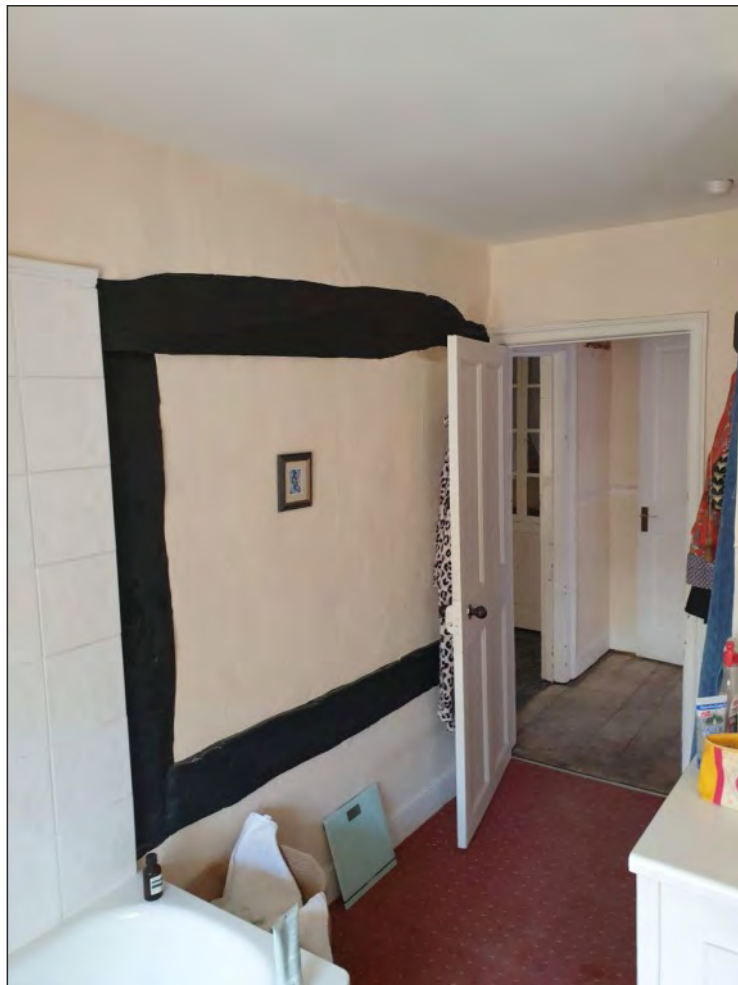
Pl. 18 General view of original partition on west side of room F19. Looking northwest.

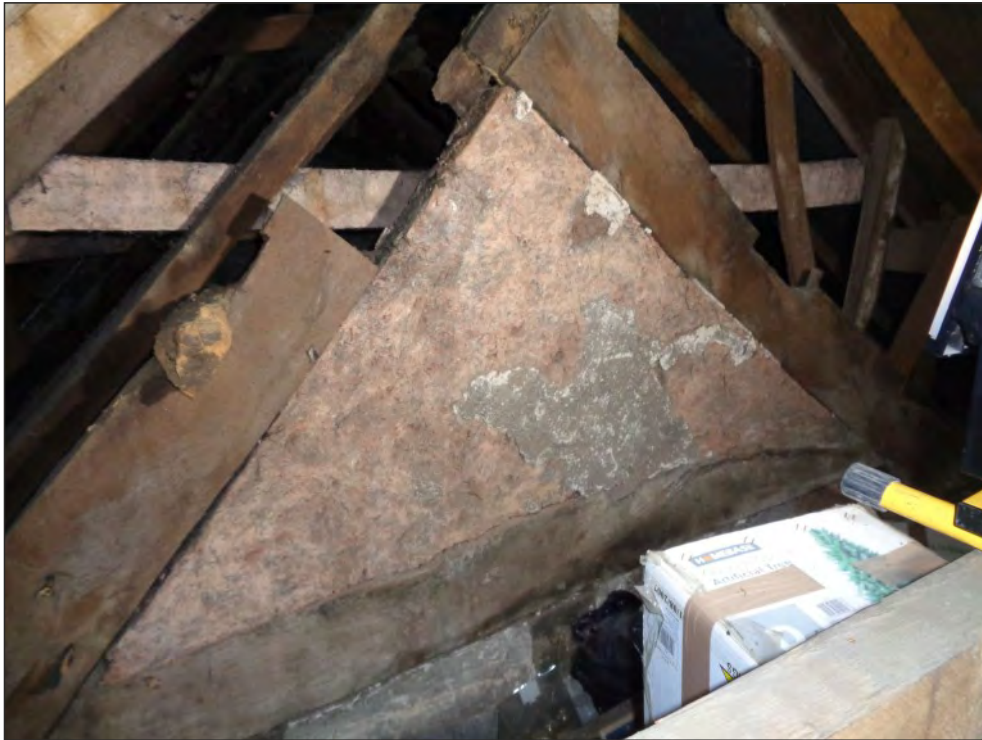
Above the ceiling this truss is also well preserved (Pl. 19), though the apex is missing. The timbers are not smoke blackened and neither are the plaster panels infilling the apex or the body of the partition below. The first-floor rooms over the truss and to the west of it were clearly open to the roof and the present ceilings are much later additions.

Pl. 19 Close-up of cranked collar and without arch braces, with intact plaster infilling. Looking northwest.

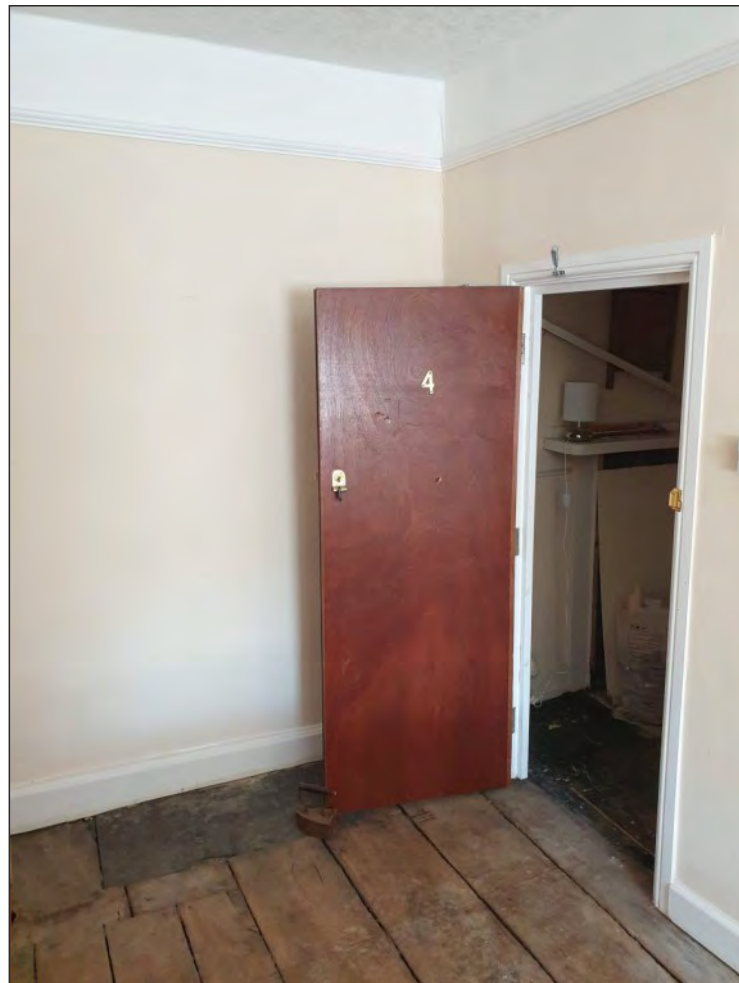
Pl. 20 General view of the later fireplace in the north elevation with the original fireplace visible in corridor F05. Looking northeast.

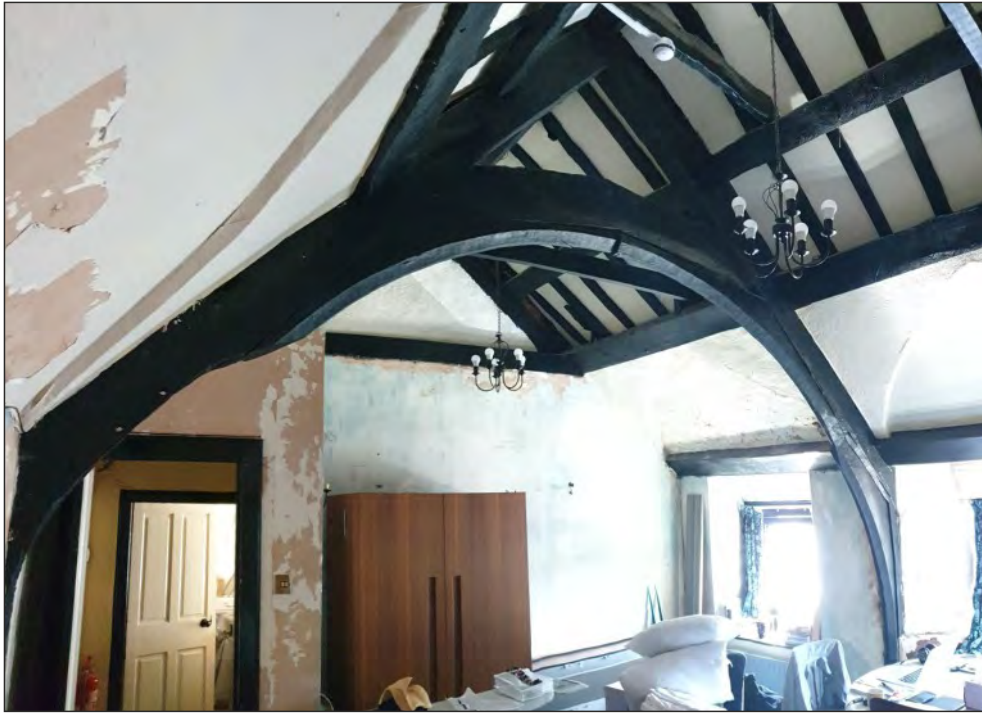
Pl. 21 General view of the single medieval roof truss supported by chamfered upper and lower arch braces and with a high, cranked collar. There are three levels of purlins, the lower sets being linked by curved, flat wind braces, and a very large, diagonally-set ridge tree. Looking southeast.

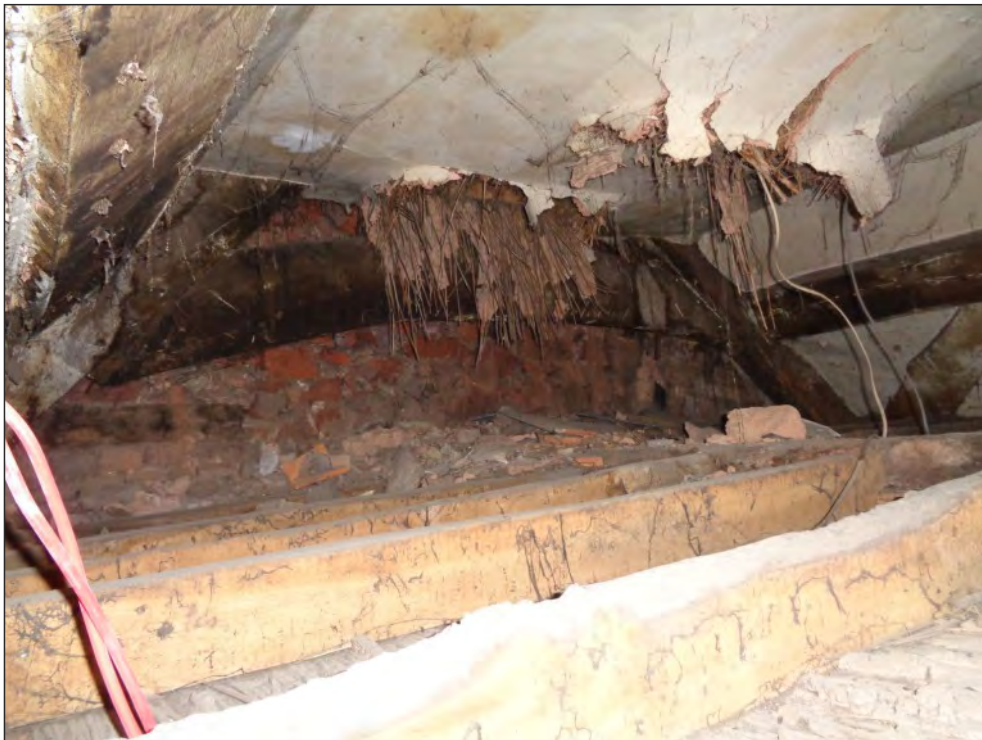
Above the present 19<sup>th</sup> century ceiling much of the medieval roof is visible (Pl. 22), including an 'A'-frame end truss without arch bracing, with a high, cranked collar. This truss and the purlins and wind braces are irregularly smoke stained; more, perhaps, as a result of leakage from the hall than from direct exposure to the open hearth. The intensity of the smoke staining within the hall may be judged by the velvety blackening of the remains of the partition between the room and the hall (Pl. 23), which has been exposed by the removal of the lower part of the partition. This seems, like the one between the hall and room F19, to have had a pair of verticals rising into the underside of the collar and retains its plaster infilling to the apex (though this may not be primary – some medieval rooms were left open at the apex to allow smoke to percolate, as a precaution against pests and to allow heat to circulate). The underside of the collar and most of the joints are very black indeed. Above the collar level an earlier ceiling remains in place, though damaged. The ceiling plaster appears to have been laid over a base of straw lathing, now burst in places.

Pl. 22 General view of A-frame end truss without arch bracing and with a high, cranked collar. Looking southeast.

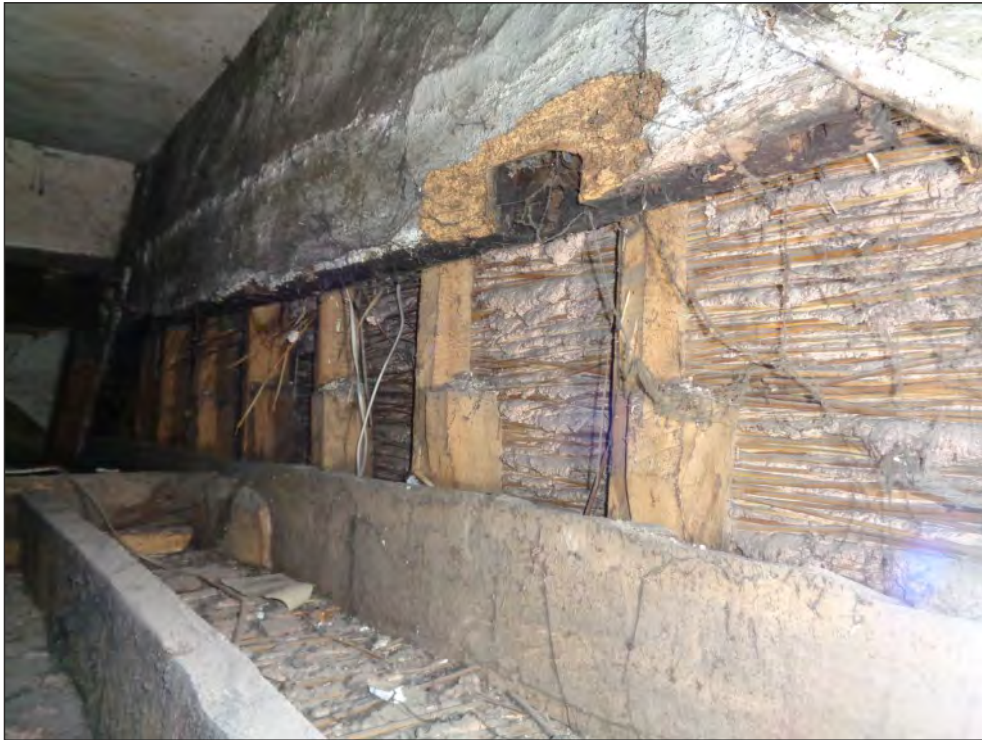
Pl. 23 Close-up of the eastern elevation of the partition between the former hall and inner room showing smoke staining. Looking west.

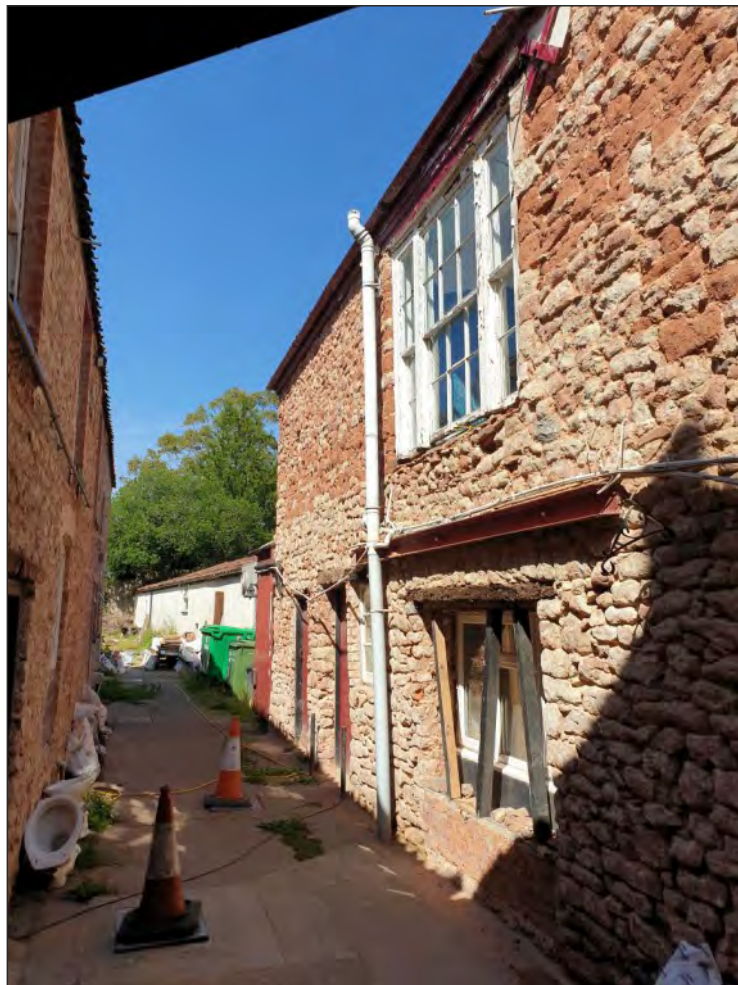
Pl. 24 General view of the west elevation of the east range with the large tripartite sash window on the first floor. Looking northeast.

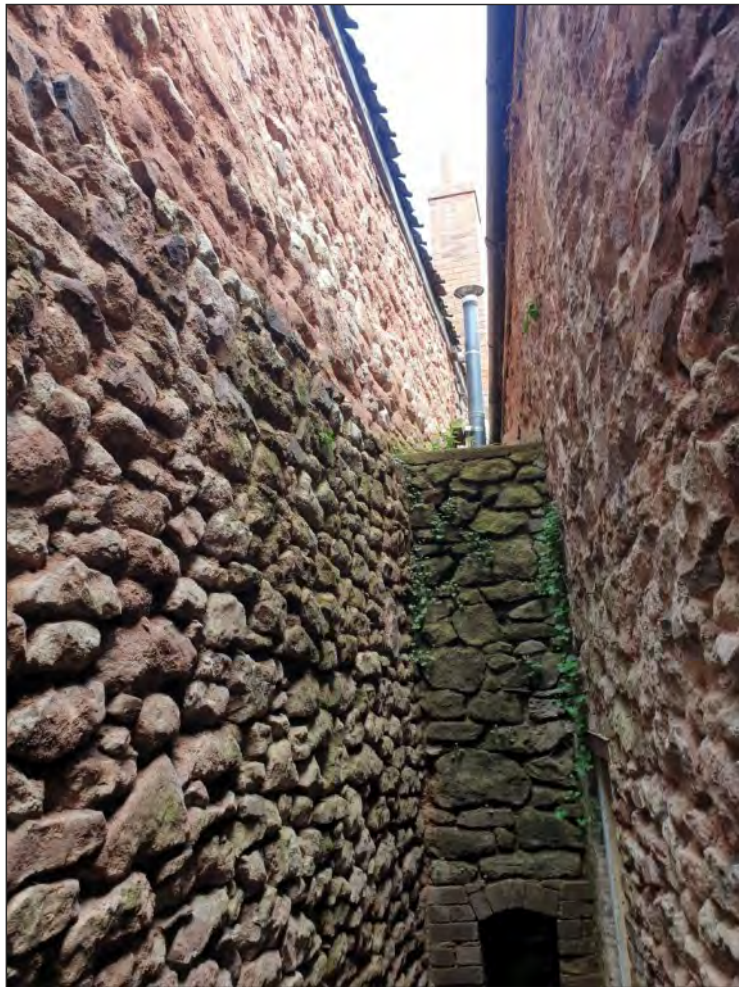
Pl. 25 General view of the very narrow passage between the east range and the adjacent building. Looking northeast.

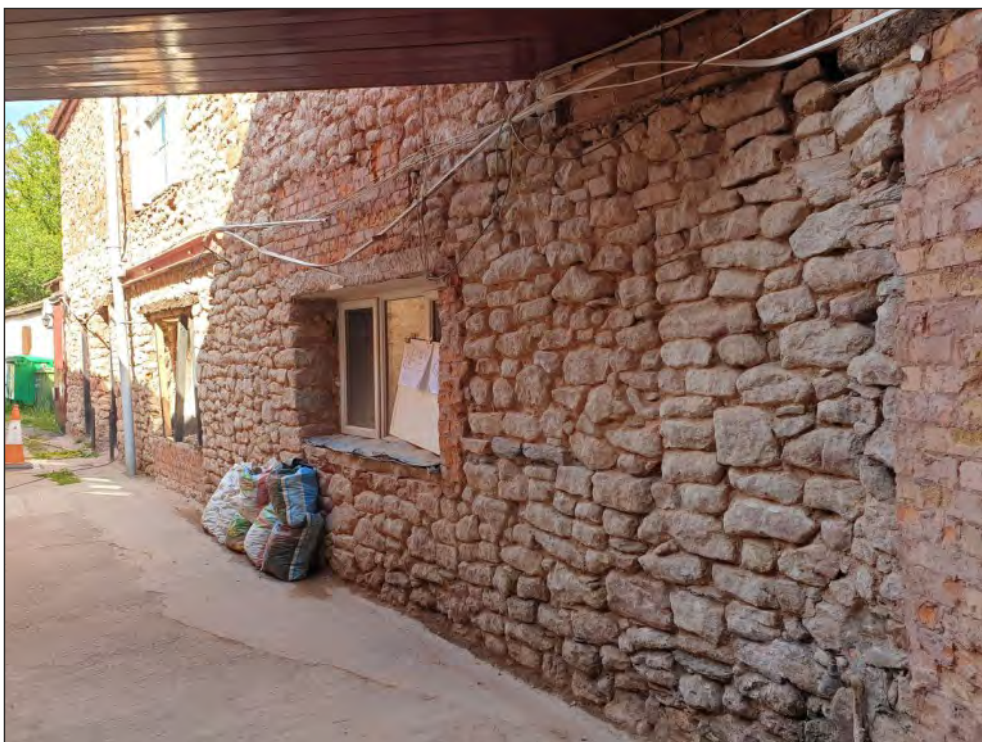
Pl. 26 General view of the west elevation of the east range with the late 19<sup>th</sup>- or early 20<sup>th</sup>-century enclosure, at ground-floor level, of the western part of the small courtyard between the chimneystacks, visible to the right. Looking northeast.

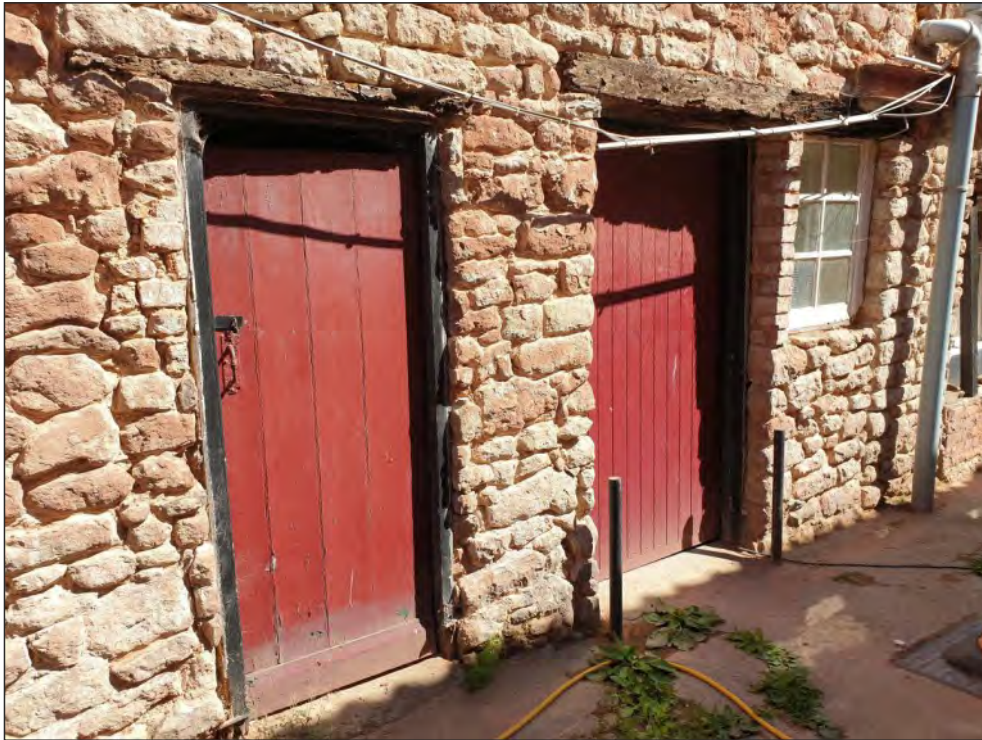
Pl. 27 General view of extension with a pair of doorways under relatively slight timber lintels. Looking southeast.

20<sup>th</sup> century by a very wide opening with a timber lintel. It is likely that this opening formerly also had a timber frame with mullions substantial enough to bear the weight of the superincumbent structures, including the covered bridge, but this was replaced in the late 20<sup>th</sup> century by a modern metal-framed window with no mullions. The lintel is bowing and the bridge has become unsafe.

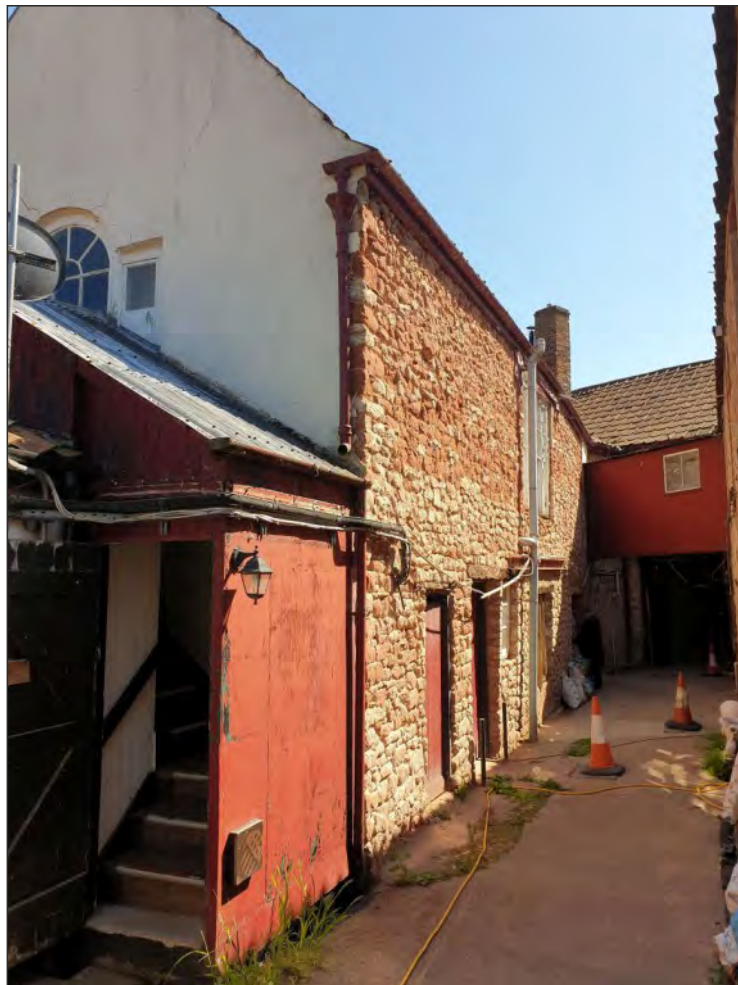
Pl. 28 General view of the north wall of the east range, with the 'Venetian' window partly obscured by a relatively modern external stair, probably a fire escape. Looking south.

The former assembly rooms has a ceiling with coved sides, perhaps formerly decorated with plasterwork, and is lit by a Venetian window at its north end (Pl. 32) and by a large tripartite sash in the west wall. It is possible that the room to the south provided the retirement room or card room. And there is a modern gallery structure or mezzanine at the south end which might conceivably replace an earlier musicians gallery. There is likely to be a blocked fireplace in the east wall, where a tall chimney stack remains visible externally. The approach appears to have been by the main stair within the carriageway, from which a wide doorway opened at the south-western corner of the room.

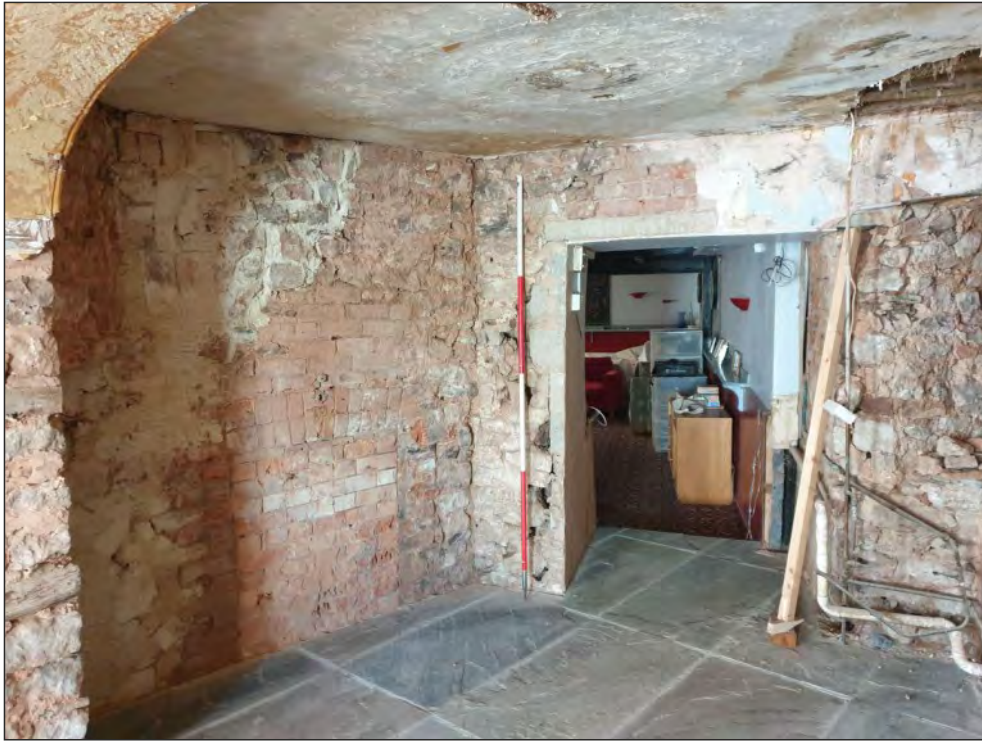
Pl. 29 General view of the small and awkwardly shaped room which was contrived within a triangular space which remained between the south range and the east range, possibly a former yard or court. 2m scale. Looking north.

In the 18<sup>th</sup> or 19<sup>th</sup> centuries a small trapezoidal room was created linking the south and east ranges, infilling part of the small triangular courtyard between the two buildings. This may have served as a small parlour off the eastern end of the hall. Although the southern part of the range may have remained in use as a kitchen, the rest of the east range appears to have ceased to serve a domestic use. The wide openings in this wall, and their ‘industrial’ character, suggests that this part of the building was remodelled to provide a series of large loose boxes for the accommodation of prestigious horses. The upper part of the building was subsequently remodelled to provide an assembly room accessed from the new main stairway and carriageway in the south range.

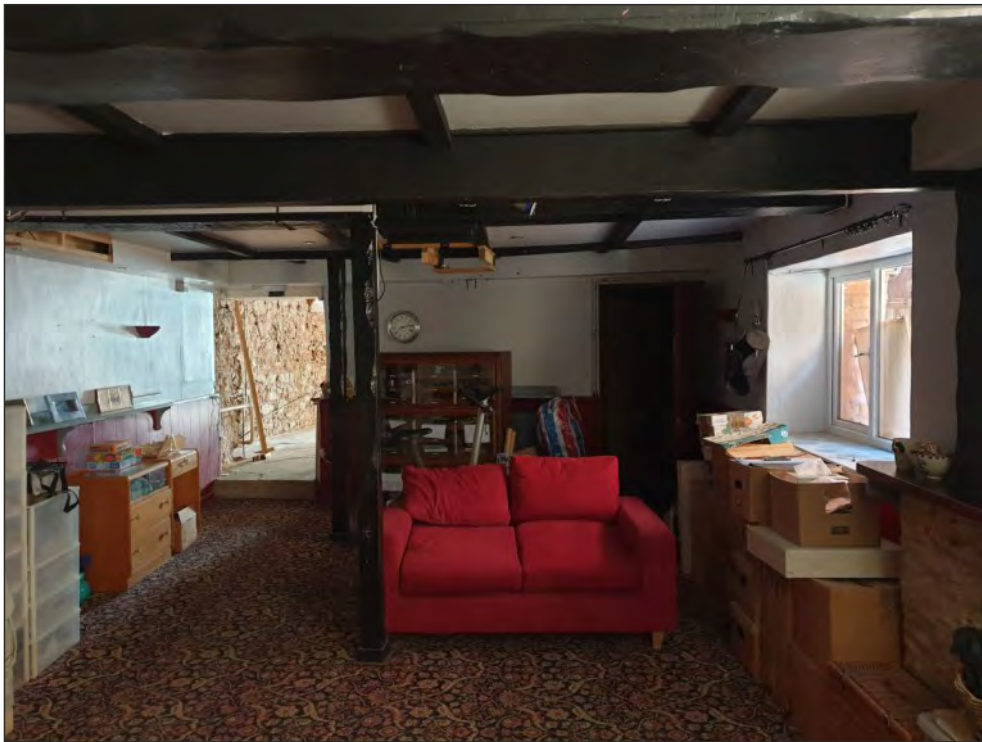
This was one of the areas of the interior which remained as it had been at the closure of the public house, and very few historic features were visible (Pl. 30). All the ceiling beams were boxed in with faux-rustic boarding and supported by carefully gnarled ‘olde worlde’ posts reflecting the popular style of pub *décor* in the 1960s and 1970s. There is probably an early fireplace in the south wall of this room, possibly a very large one, but no other observations are possible at this stage.

Pl. 30 General view of the rear bar with its faux-rustic boarding and supported by carefully gnarled 'olde worlde' posts reflecting the popular style of pub *décor* in the 1960s and 1970s. Looking southwest.

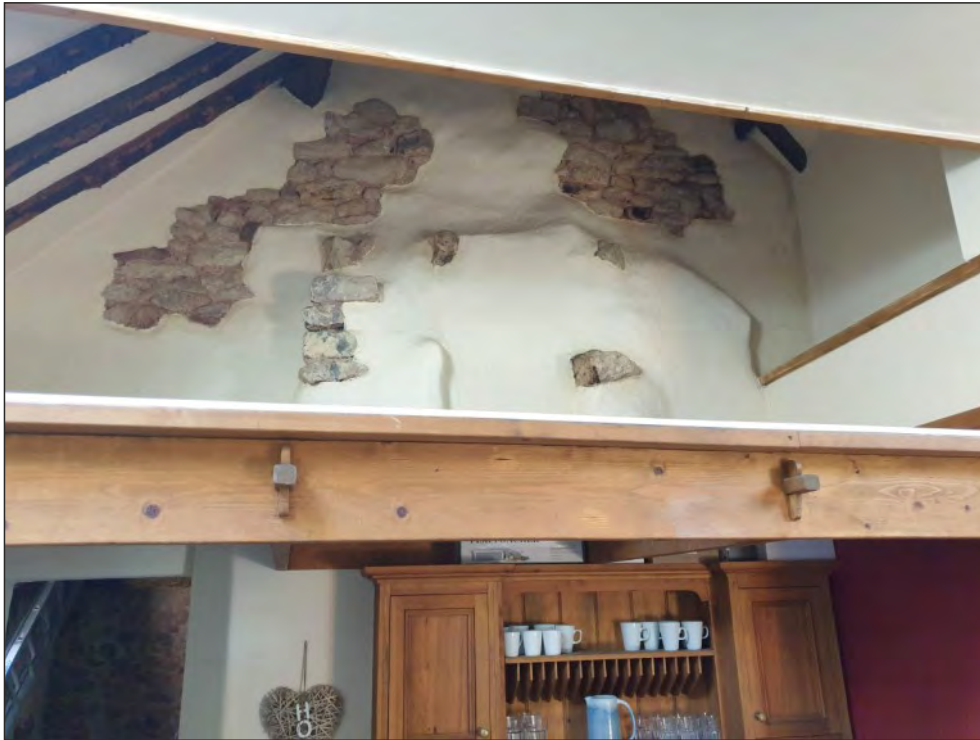
Pl. 31 General view of the south wall of the earlier building showing the remains of a tall, tapering hood of a very large fireplace and chimneystack extending to full height of the gable. Looking southwest.

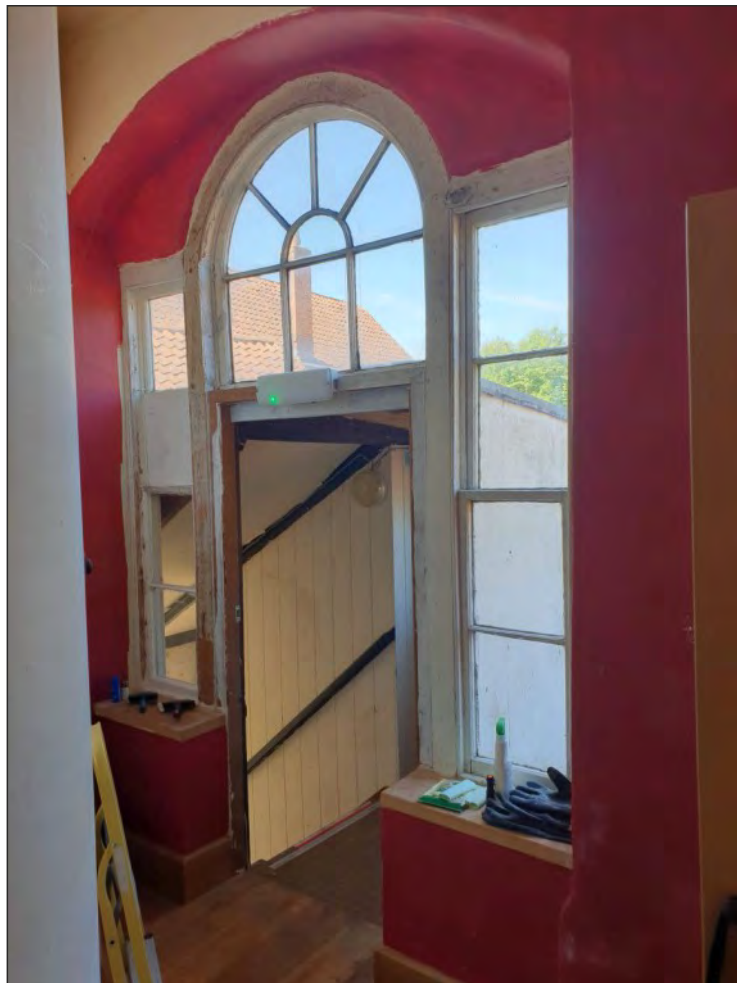
Pl. 32 Close-up of the 'Venetian' window at the north end of the former assembly rooms. Looking northwest.

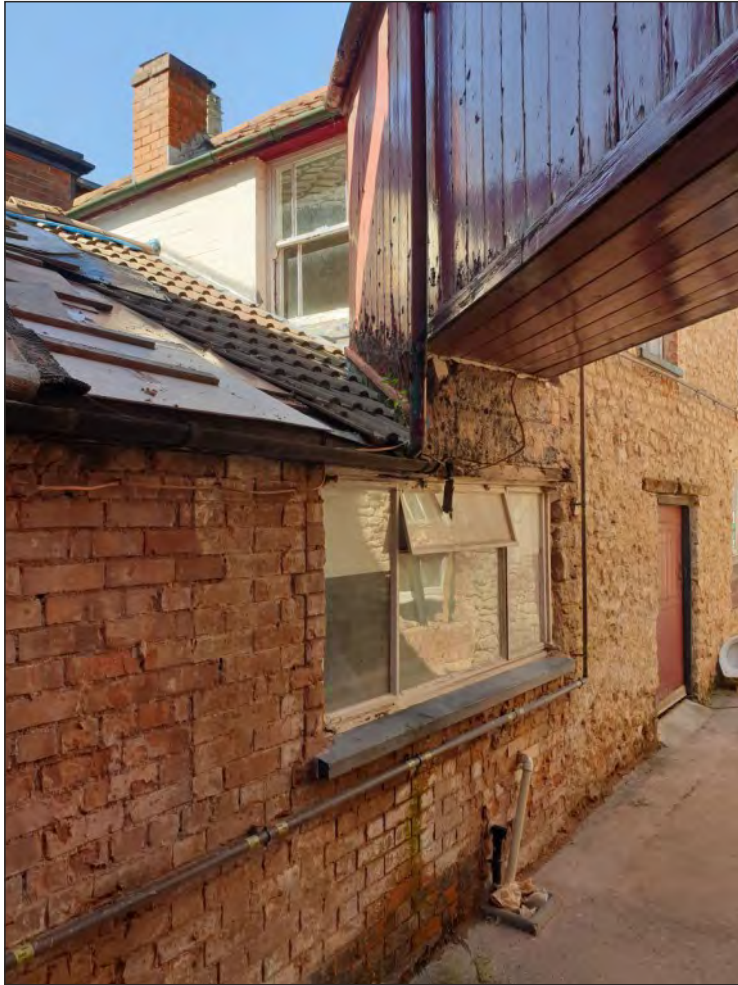
Pl. 33 General view of the late 19<sup>th</sup>-century single-storey brick infill at the south end of the north range containing openings blocked the late 19<sup>th</sup> or early 20<sup>th</sup> century. Looking north.

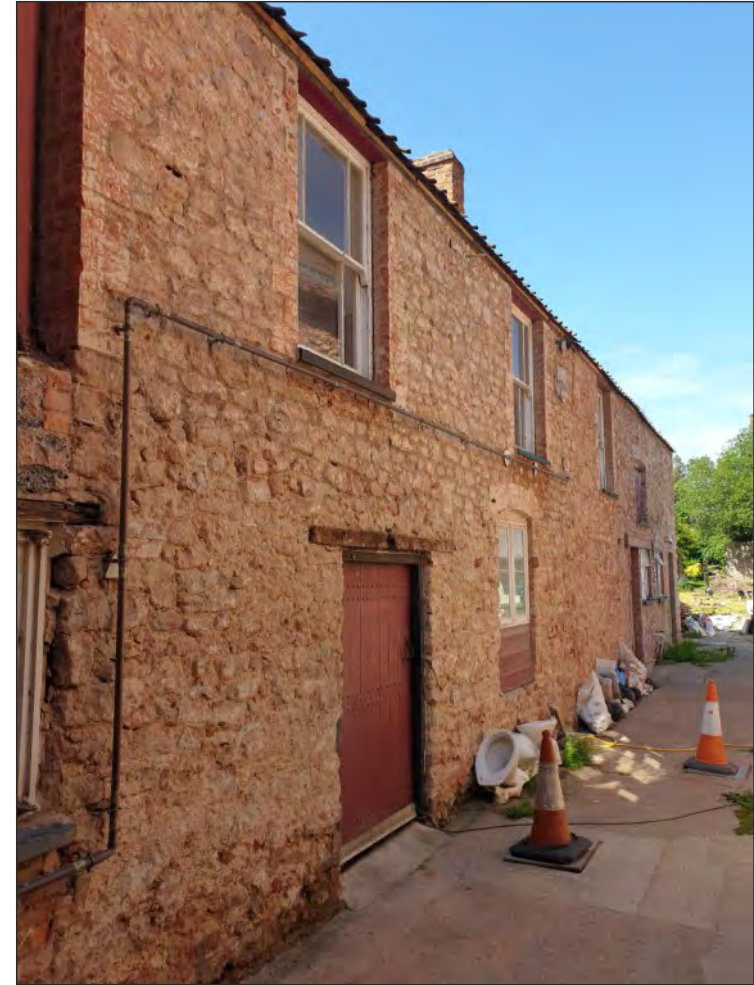
Pl. 34 General view of the east elevation of the west range showing rebuilt upper elevation. Looking north.

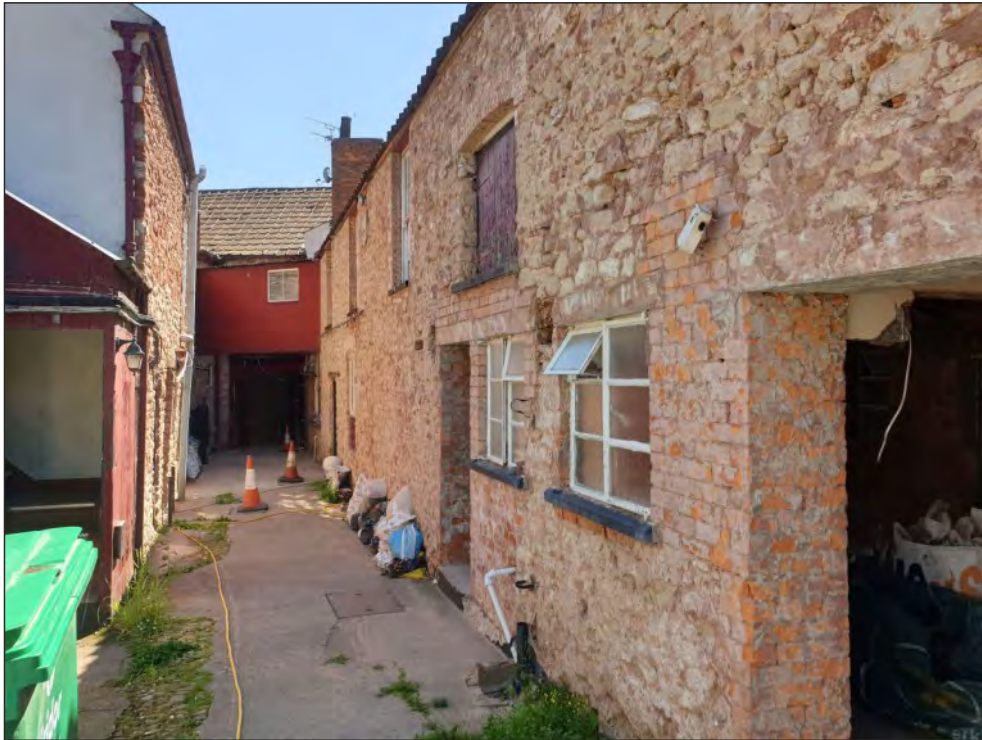
Pl. 35 General view of the north end of the west range rebuilt in the 20<sup>th</sup> century with openings with concrete lintels and metal Crittall window frames. Looking southwest.

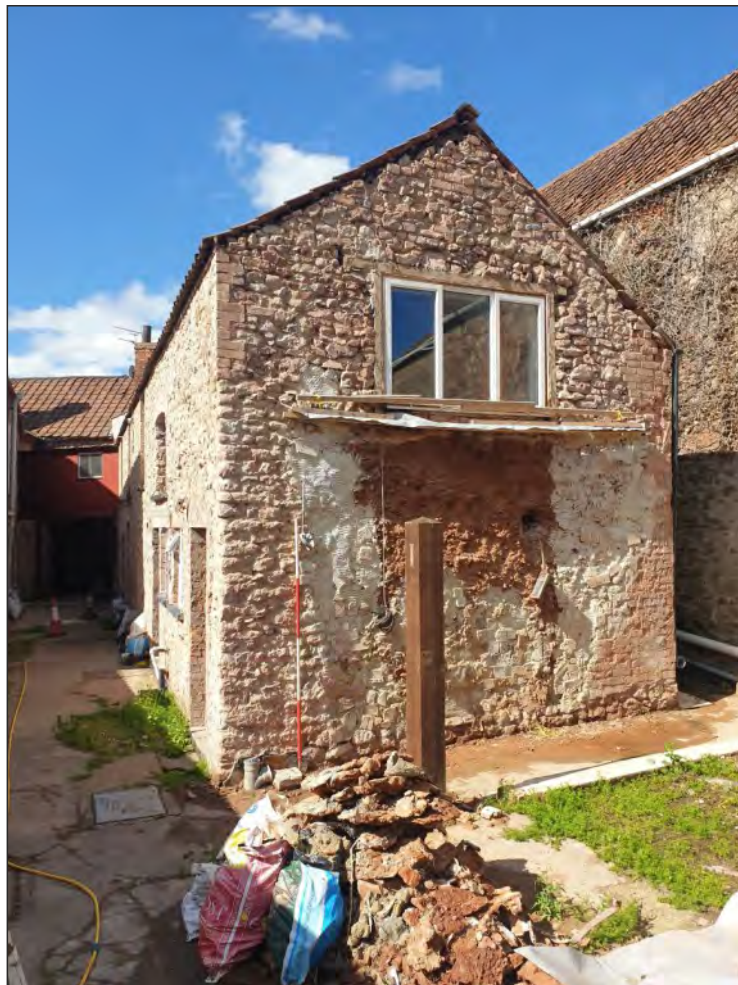
Pl. 36 General view of the north elevation of the north range showing the large area of cob walling forming the centre of the gable end. 2m scale. Looking southwest.

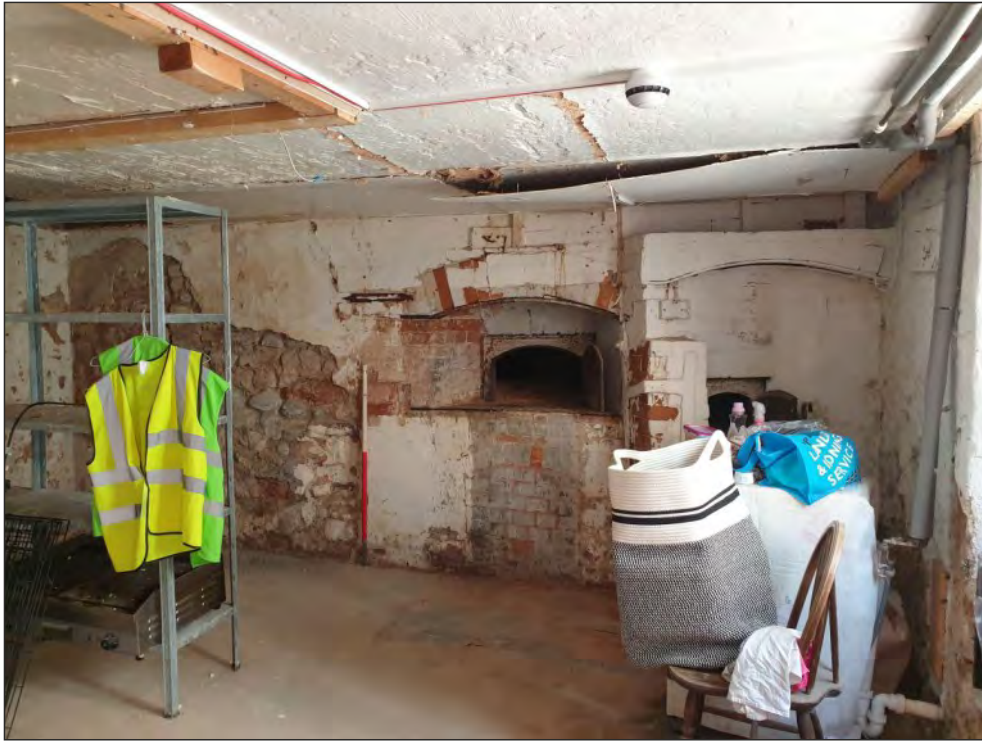
Pl. 37 General view of the mid- to late 19th century oven in room G15. 1m scale. Looking north.

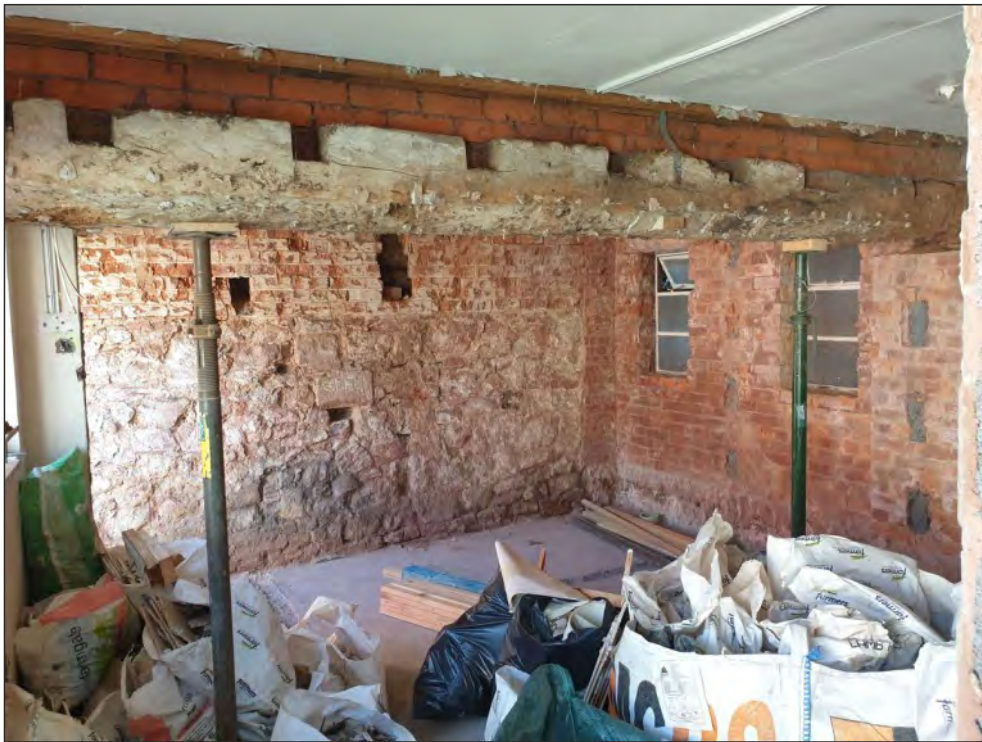
Pl. 38 General view of the principal beam supporting the first floor with chamfered undersides and deep housings for substantial joists. Looking southwest.

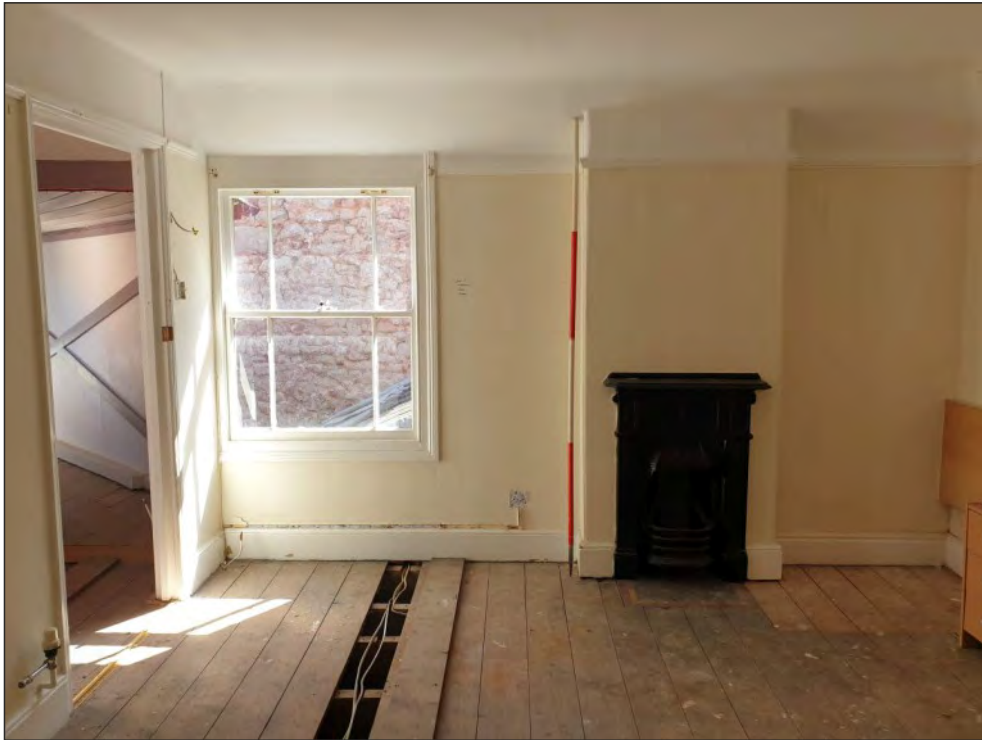
Pl. 39 General view of room F14, part of the late 19<sup>th</sup>- or early 20<sup>th</sup> century, remodelling of the upper storey of the building to provide guest accommodation for the inn. 2m scale. Looking southwest.

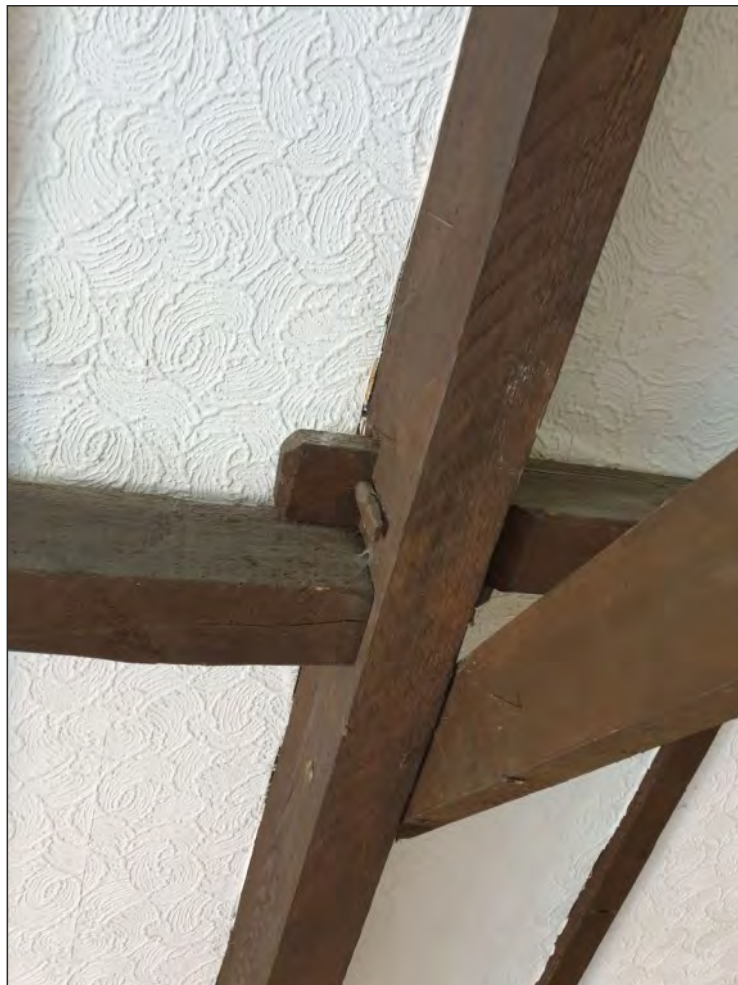
Pl. 40 Close-up of the late 19th century roof structure in F18 with staggered butt purlins secured within the principals by pegs. Looking southeast.
